**Flood Control Project Maintenance
Levee Inspections**

Fall 2010 Levee Maintenance Deficiency Summary Report

Levee Inspection Report By Mile - Fall 2010

Reclamation District No. 0001 Union Island

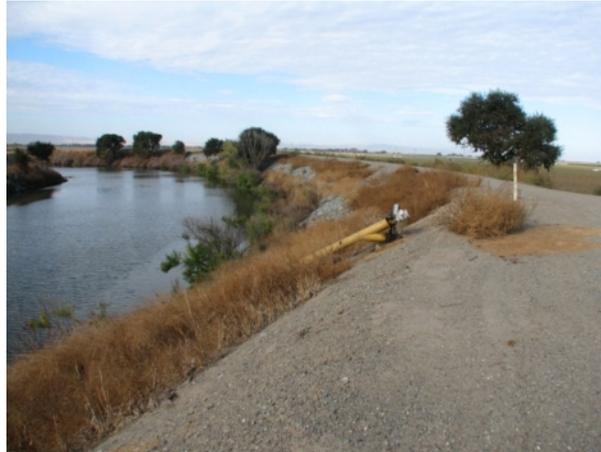
| Levee Mile Report Line | 2 |

| LMR No. | Levee Mile | | Category | Item | * Location | ** Rating | Action/Comment | GPS Latitude/Longitude | | Issue No. Photo |
|---|---|---|---|---|---|---|---|---|---|---|
| 2 | 0.02 | 0.13 | Earthen Levee | Vegetation | WS | M | Control annual grass and weeds on the levee slopes and easements. | 37.822405 ° -121.375763 ° | 37.821885 ° -121.377598 ° | 17 Y |

| Vegetation on the top 20' of waterside slope obstructs visibility. | |

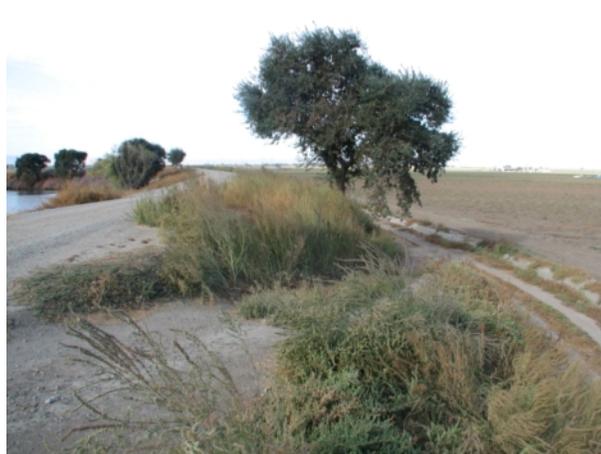
| Levee Mile Report Line | 3 |

| LMR No. | Levee Mile | | Category | Item | * Location | ** Rating | Action/Comment | GPS Latitude/Longitude | | Issue No. Photo |
|---|---|---|---|---|---|---|---|---|---|---|
| 3 | 0.02 | 0.13 | Earthen Levee | Vegetation | LS | M | Control annual grass and weeds on the levee slopes and easements. | 37.822404 ° -121.375766 ° | 37.821817 ° -121.377778 ° | 18 Y |

| Vegetation on the landside slope obstructs visibility. | |

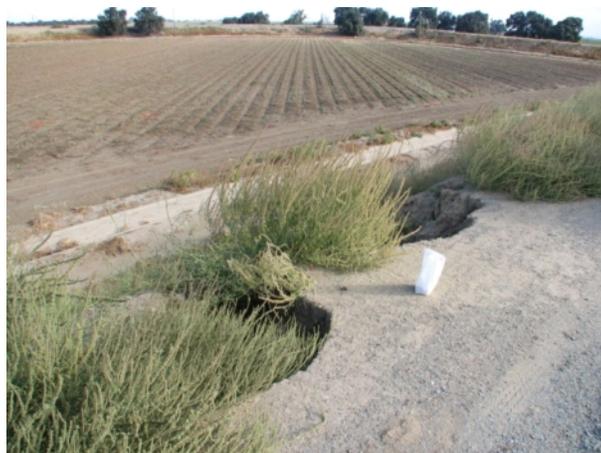
| Levee Mile Report Line | 4 |

| LMR No. | Levee Mile | | Category | Item | * Location | ** Rating | Action/Comment | GPS Latitude/Longitude | | Issue No. Photo |
|---|---|---|---|---|---|---|---|---|---|---|
| 4 | 0.11 | 0.11 | Earthen Levee | Erosion / Bank Caving | LS | U | Schedule repair of erosion site prior to the next inspection. Inspector Comments: Landside slope is eroded creating two large holes at the hinge point. | 37.822051 ° -121.377320 ° | 37.822051 ° -121.377320 ° | 2 Y |

| Two large erosion locations present on landside levee slope. | |

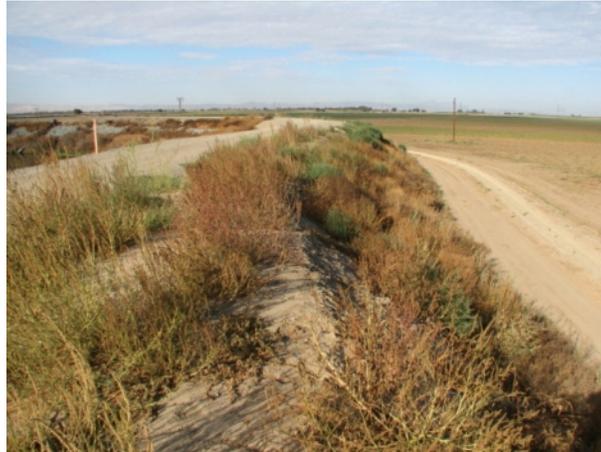
| Levee Mile Report Line | 8 |

| LMR No. | Levee Mile | | Category | Item | * Location | ** Rating | Action/Comment | GPS Latitude/Longitude | | Issue No. Photo |
|---|---|---|---|---|---|---|---|---|---|---|
| 8 | 0.28 | 0.35 | Earthen Levee | Vegetation | LS | M | Control annual grass and weeds on the levee slopes and easements. | 37.820266 ° -121.379010 ° | 37.820161 ° -121.380145 ° | 19 Y |

| Vegetation on the landside slope obstructs visibility. | |

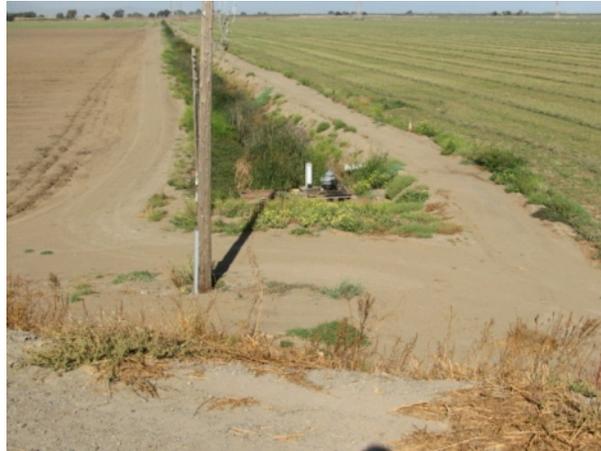
| Levee Mile Report Line | 11 |

| LMR No. | Levee Mile | | Category | Item | * Location | ** Rating | Action/Comment | GPS Latitude/Longitude | | Issue No. Photo |
|---|---|---|---|---|---|---|---|---|---|---|
| 11 | 0.39 | 0.39 | Earthen Levee | Encroachments | WS | W | Pipe Inspector Comments: Irrigation intake through levee crown. | 37.819651 ° -121.380467 ° | 37.819651 ° -121.380467 ° | 7 Y |

| Drainage discharge pipe through levee freeboard. | |

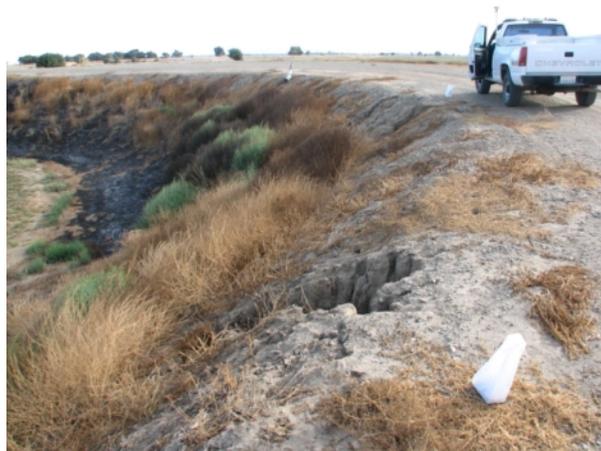
| Levee Mile Report Line | 13 |

| LMR No. | Levee Mile | | Category | Item | * Location | ** Rating | Action/Comment | GPS Latitude/Longitude | | Issue No. Photo |
|---|---|---|---|---|---|---|---|---|---|---|
| 13 | 0.54 | 0.54 | Earthen Levee | Erosion / Bank Caving | LS | M | Schedule repair of erosion site prior to the next inspection. Inspector Comments: Crown width 50'. | 37.817515 ° -121.379943 ° | 37.817515 ° -121.379943 ° | 9 Y |

| Erosion of landside slope at several spots due to surface runoff. | |

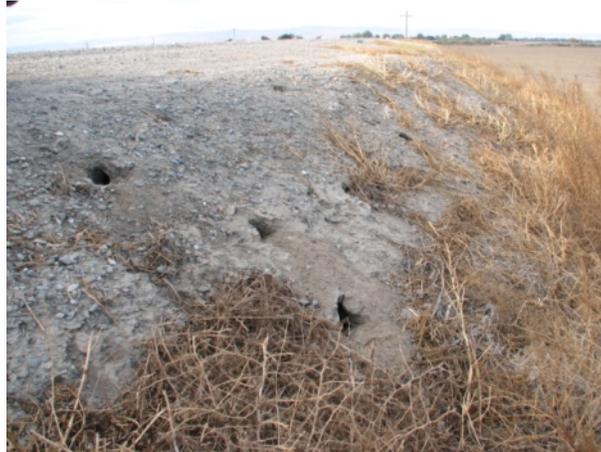
| Levee Mile Report Line | 14 |

| LMR No. | Levee Mile | | Category | Item | * Location | ** Rating | Action/Comment | GPS Latitude/Longitude | | Issue No. Photo |
|---|---|---|---|---|---|---|---|---|---|---|
| 14 | 0.66 | 0.66 | Earthen Levee | Animal Control | LS | M | No rodents visible, but rodent burrows visible; need to backfill and compact or grout borrows. | 37.817249 ° -121.382026 ° | 37.817249 ° -121.382026 ° | 15 Y |

| Active rodent holes on levee slope. | |

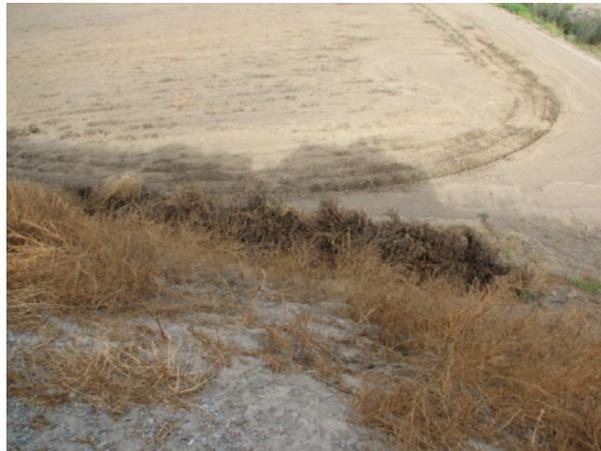
| Levee Mile Report Line | 16 |

| LMR No. | Levee Mile | | Category | Item | * Location | ** Rating | Action/Comment | GPS Latitude/Longitude | | Issue No. Photo |
|---|---|---|---|---|---|---|---|---|---|---|
| 16 | 0.68 | 0.68 | Earthen Levee | Encroachments | LS | M | Prunings Inspector Comments: Thistle piled at levee toe should be removed. | 37.817058 ° -121.382316 ° | 37.817058 ° -121.382316 ° | 14 Y |

| Photo of thistle piled at levee toe. | |

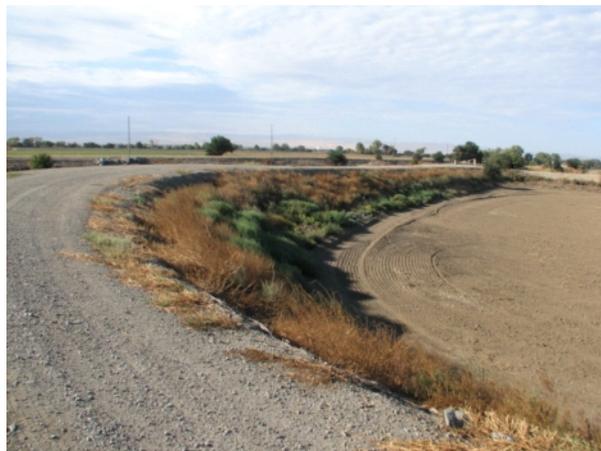
| Levee Mile Report Line | 19 |

| LMR No. | Levee Mile | | Category | Item | * Location | ** Rating | Action/Comment | GPS Latitude/Longitude | | Issue No. Photo |
|---|---|---|---|---|---|---|--|---|---|---|
| 19 | 1.05 | 1.13 | Earthen Levee | Vegetation | LS | M | Control annual grass and weeds on the levee slopes and easements. | 37.812469 ° -121.383755 ° | 37.811824 ° -121.384578 ° | 21 Y |

| Vegetation on landside slope obstructs access. | |
