**Flood Control Project Maintenance
Levee Inspections**

Fall 2012 Levee Maintenance Deficiency Summary Report

Reclamation District No. 0001 Union Island

Waterway	Bank	Unit Miles
Unit No. 01 Old River	Right	1.15

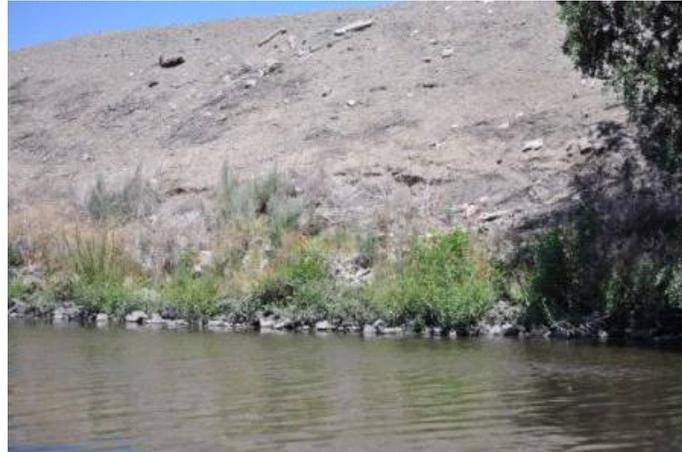
Levee Mile Report Line	4
Start Levee Mile	0.00
End Levee Mile	0.00
Location	Water Side
Category	Supplemental
Item	DWR Erosion Survey

Front view of the erosion

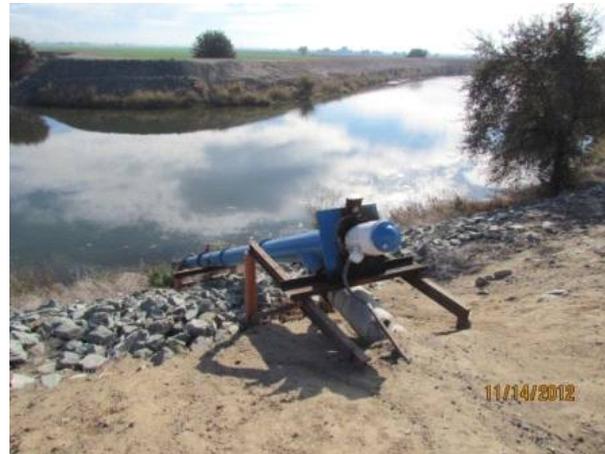
Levee Mile Report Line	5
Start Levee Mile	0.01
End Levee Mile	0.01
Location	Water Side
Category	Earthen Levee
Item	Encroachments

View of irrigation intake pipe on waterside slope.

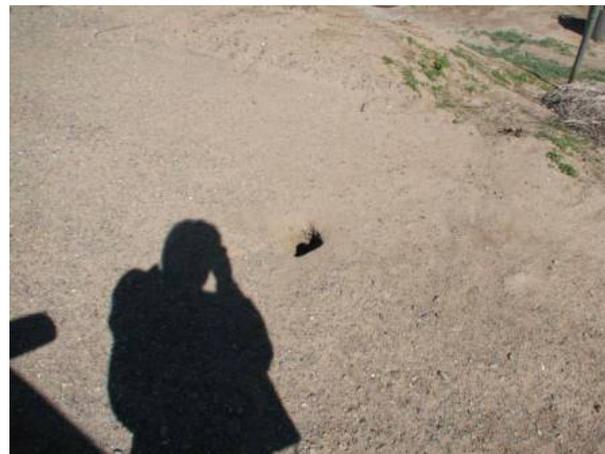
Levee Mile Report Line	6
Start Levee Mile	0.02
End Levee Mile	0.02
Location	Land Side
Category	Earthen Levee
Item	Animal Control

DWR ID: DWR_RD0001_01_s_2012_1		
6	0.02	0.02	Earthen Levee	Animal Control	LS	M Ma	A3 : No rodents visible, but rodent burrows visible; need to backfill and compact or grout burrows. Inspector Comments: Several burrows present	37.822511 ° -121.375857 °	37.822511 ° -121.375857 °	18 Y
								DWR ID: DWR_RD0001_01_s_2012_18		
7	0.03	0.03	Earthen Levee	Animal Control	WS	M Ma	A3 : No rodents visible, but rodent burrows visible; need to backfill and compact or grout burrows. Inspector Comments: Burrow evident on water side, burrow appears to have collapsed.	37.822403 ° -121.375937 °	37.822403 ° -121.375937 °	4 Y
								DWR ID: DWR_RD0001_01_s_2012_4		
8	0.39	0.39	Earthen Levee	Encroachments	WSA/W	PI : Pipe Ma	Inspector Comments: Irrigation intake through levee crown.	37.819651 ° -121.380467 °	37.819651 ° -121.380467 °	7 Y
								DWR ID: DWR_RD0001_01_s_2012_7		
9	0.66	0.66	Earthen Levee	Animal Control	LS	M Ma	A3 : No rodents visible, but rodent burrows visible; need to backfill and compact or grout burrows.	37.817249 ° -121.382026 °	37.817249 ° -121.382026 °	15 Y

04/26/2011 Animal burrow in levee crown.

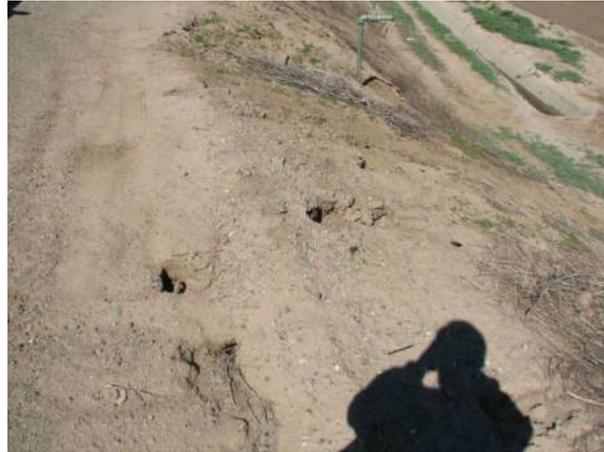
Levee Mile Report Line	6
Start Levee Mile	0.02
End Levee Mile	0.02
Location	Land Side
Category	Earthen Levee
Item	Animal Control
04/26/2011 Several burrows present in levee crown and landside slope.	
mkhashch_f_20120927_042.jpg

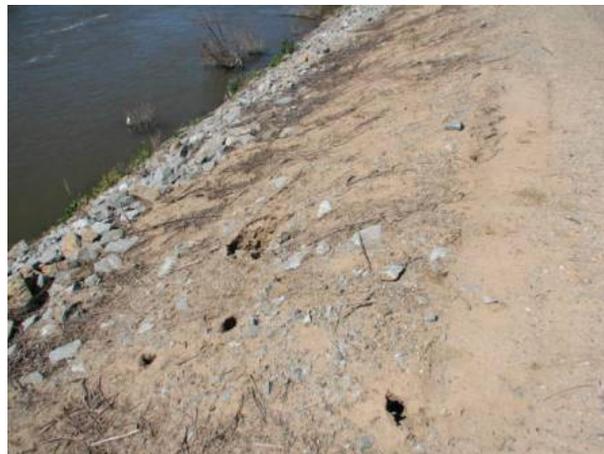
Levee Mile Report Line	7
Start Levee Mile	0.03
End Levee Mile	0.03
Location	Water Side
Category	Earthen Levee
Item	Animal Control
04/26/2011 Several burrows present on water side, burrows appear to be collapsing.	
mkhashch_f_20120927_037.jpg

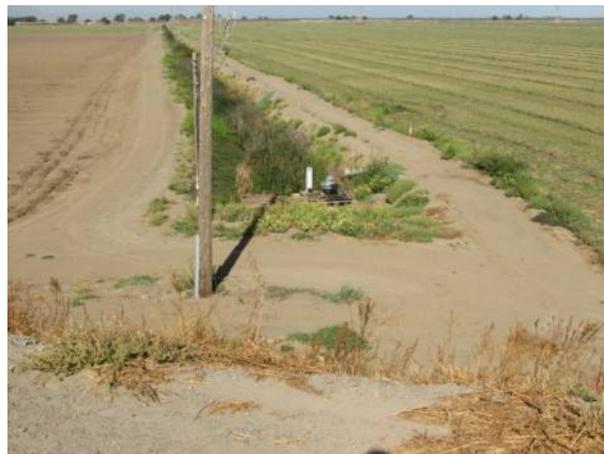
Levee Mile Report Line	8
Start Levee Mile	0.39
End Levee Mile	0.39
Location	Water Side
Category	Earthen Levee
Item	Encroachments
Drainage discharge pipe through levee freeboard.	
mkhashch_f_20120927_038.jpg

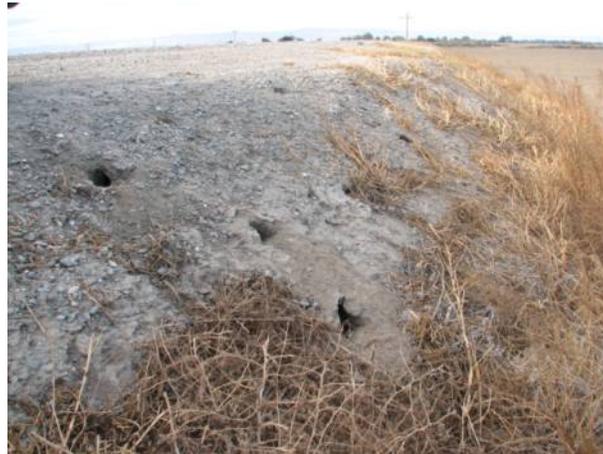
Levee Mile Report Line	9
Start Levee Mile	0.66
End Levee Mile	0.66
Location	Land Side
Category	Earthen Levee
Item	Animal Control
Active rodent holes on levee slope.	
mkhashch_f_20120927_040.jpg

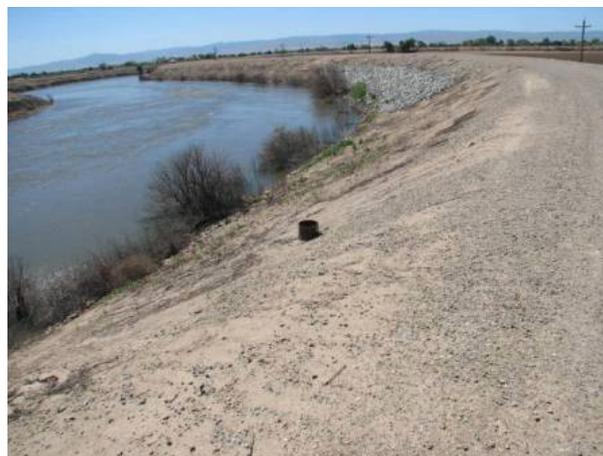
DWR ID: DWR_RD0001_01_s_2012_15		
10	0.67	0.67	Earthen Levee	Encroachments	LS A/W	PI : Pipe Ma	Inspector Comments: Drainage discharge into Old River. No photo found from previous inspection. 04/26/2011 photo added.	37.817134 ° -121.382099 °	37.817134 ° -121.382099 °	20 Y
								DWR ID: DWR_RD0001_01_s_2012_20		
11	0.67	0.67	Earthen Levee	Animal Control	CR	C Ma	A3 : No rodents visible, but rodent burrows visible; need to backfill and compact or grout burrows. Inspector Comments: Deep vertical rodent hole in crown of levee, see photo. Shovel handle stopped at bend in burrow.	37.817109 ° -121.382192 °	37.817109 ° -121.382192 °	27
								DWR ID: DWR_RD0001_01_s_2012_27

Levee Mile Report Line	10
Start Levee Mile	0.67
End Levee Mile	0.67
Location	Land Side
Category	Earthen Levee
Item	Encroachments
04/26/2011 Discharge pipe in water side slope.	
mkhashch_f_20120927_043.jpg

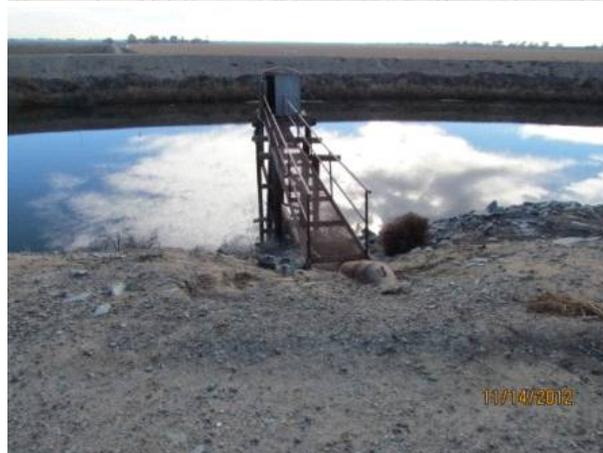
LMIR No.	Levee Mile		Category	Item	* Location	+ Rating	Action/Comment	GPS Latitude/Longitude		Issue No. Photo
	Start	End						Start	End	
12	0.86	0.86	Earthen Levee	Encroachments	LS A/W Ma	PI : Pipe Inspector Comments: Irrigation intake through levee freeboard.	37.814566 ° -121.382450 °	37.814566 ° -121.382450 °	10 Y	
DWR ID: DWR_RD0001_01_s_2012_10										
13	0.91	0.91	Earthen Levee	Vegetation	LS M Ma	V4 : Elderberries are blocking visibility and flood fight capability.	37.814220 ° -121.383336 °	37.814220 ° -121.383336 °	11 Y	
DWR ID: DWR_RD0001_01_s_2012_11

Levee Mile Report Line	12
Start Levee Mile	0.86
End Levee Mile	0.86
Location	Land Side
Category	Earthen Levee
Item	Encroachments
View of irrigation intake pipe on waterside.	
mkhashch_f_20121119_771.JPG

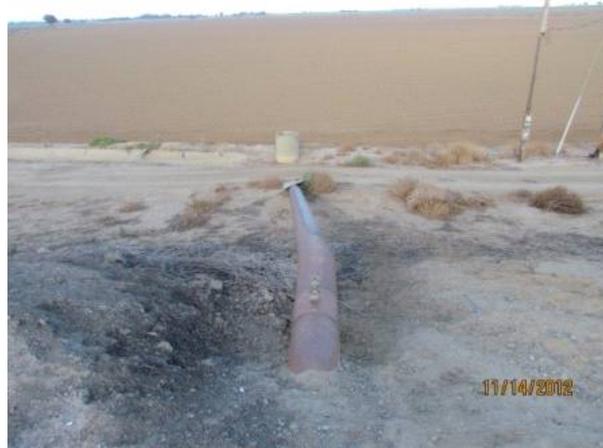
Levee Mile Report Line	12
Start Levee Mile	0.86
End Levee Mile	0.86
Location	Land Side
Category	Earthen Levee
Item	Encroachments

View of irrigation pipe on landside.

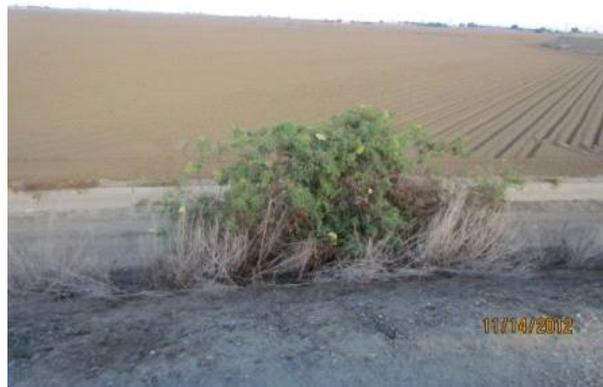
Levee Mile Report Line	13
Start Levee Mile	0.91
End Levee Mile	0.91
Location	Land Side
Category	Earthen Levee
Item	Vegetation

View of Elderberries blocking visibility of landside slope and toe.
