**Flood Control Project Maintenance
Levee Inspections**

Fall 2013 Levee Maintenance Deficiency Summary Report

Reclamation District No. 0001 Union Island

Waterway	Bank	Unit Miles
Unit No. 01 Old River	Right	1.15

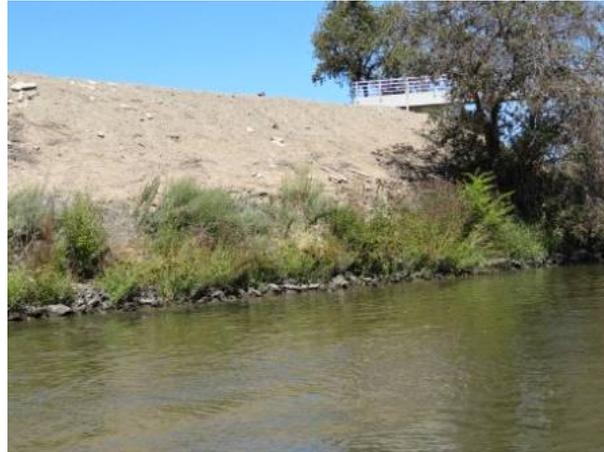
Levee Mile Report Line	4
Start Levee Mile	0.00
End Levee Mile	0.00
Location	Water Side
Category	Supplemental
Item	DWR Erosion Survey

Close view of erosion.

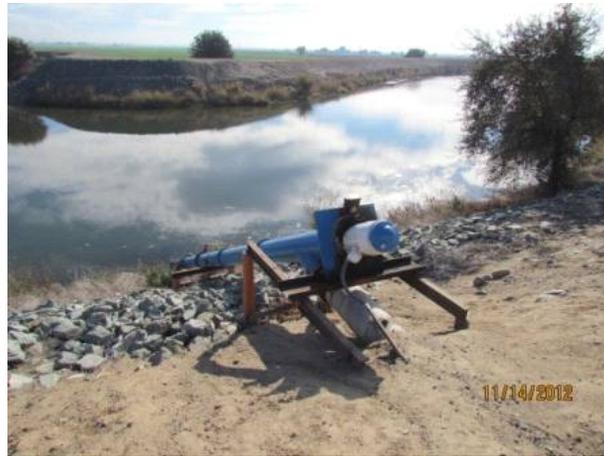
Levee Mile Report Line	5
Start Levee Mile	0.01
End Levee Mile	0.01
Location	Water Side
Category	Earthen Levee
Item	Encroachments

View of irrigation intake pipe on waterside slope.

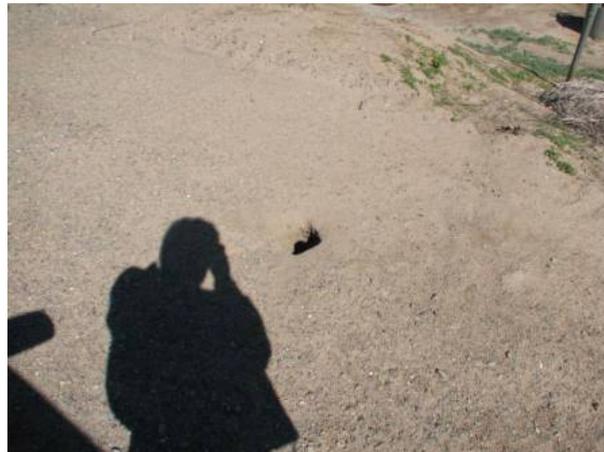
Levee Mile Report Line	6
Start Levee Mile	0.02
End Levee Mile	0.02
Location	Land Side
Category	Earthen Levee
Item	Animal Control

04/26/2011 Animal burrow in levee crown.

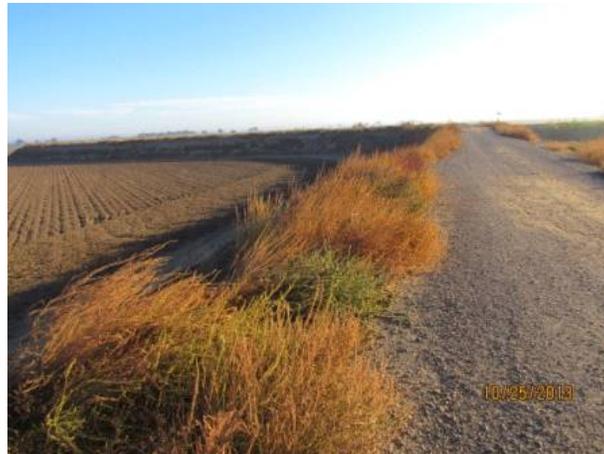
Levee Mile Report Line	7
Start Levee Mile	0.11
End Levee Mile	1.14
Location	Land Side
Category	Earthen Levee
Item	Vegetation
View of the tall vegetation obstructing visibility of the landside levee slope .	
mkhashch_f_20131028_680.JPG

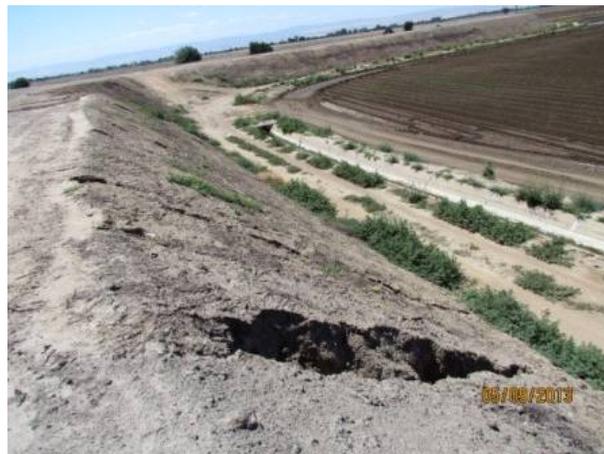
Levee Mile Report Line	8
Start Levee Mile	0.20
End Levee Mile	0.20
Location	Land Side
Category	Earthen Levee
Item	Erosion / Bank Caving
View of the erosion on the landside levee slope.	
mkhashch_f_20130923_123.JPG

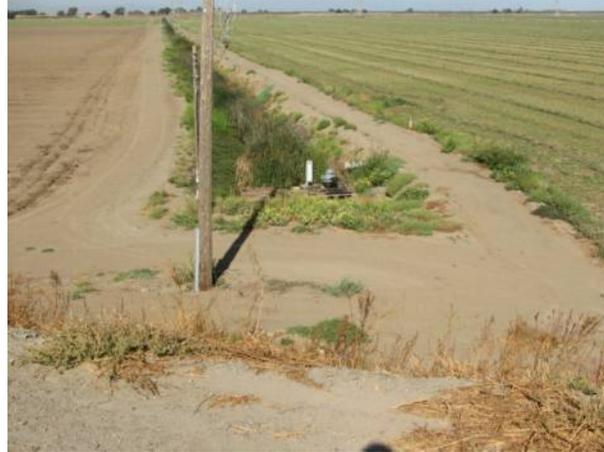
Levee Mile Report Line	9
Start Levee Mile	0.39
End Levee Mile	0.39
Location	Water Side
Category	Earthen Levee
Item	Encroachments
Drainage discharge pipe through levee freeboard.	
mkhashch_f_20130923_124.jpg

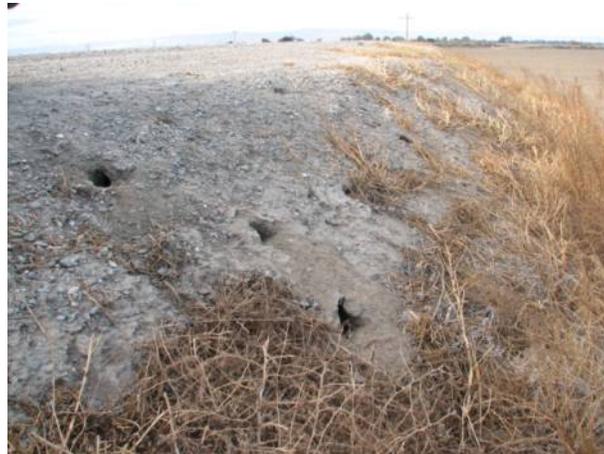
Levee Mile Report Line	10
Start Levee Mile	0.66
End Levee Mile	0.66
Location	Land Side
Category	Earthen Levee
Item	Animal Control
Rodent holes on levee slope.	
mkhashch_f_20130923_128.jpg

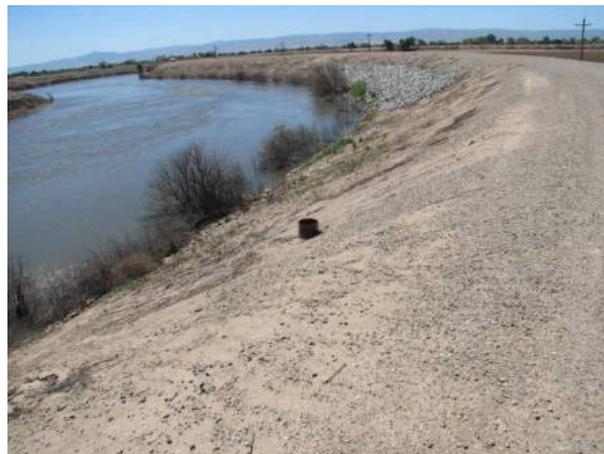
Levee Mile Report Line	11
Start Levee Mile	0.67
End Levee Mile	0.67
Location	Land Side
Category	Earthen Levee
Item	Encroachments
04/26/2011 Discharge pipe in waterside slope.	
mkhashch_f_20130923_131.jpg

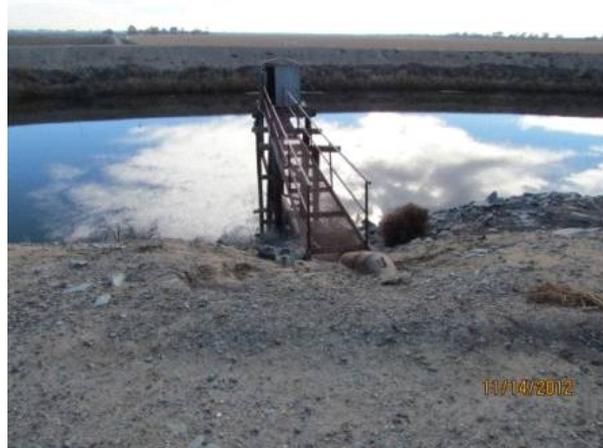
Levee Mile Report Line	13
Start Levee Mile	0.86
End Levee Mile	0.86
Location	Land Side
Category	Earthen Levee
Item	Encroachments
View of irrigation intake pipe on waterside.	
mkhashch_f_20130923_125.JPG

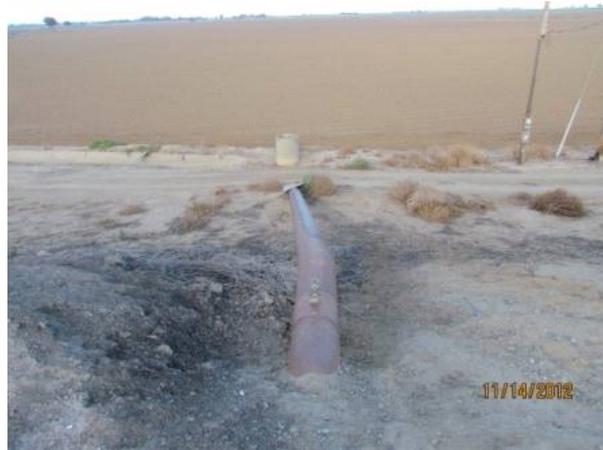
Levee Mile Report Line	13
Start Levee Mile	0.86
End Levee Mile	0.86
Location	Land Side
Category	Earthen Levee
Item	Encroachments
View of irrigation pipe on landside.	
mkhashch_f_20130923_126.JPG

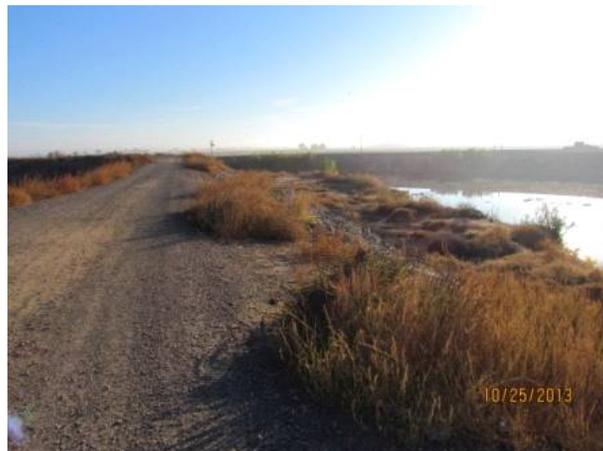
Levee Mile Report Line	15
Start Levee Mile	0.93
End Levee Mile	1.14
Location	Water Side
Category	Earthen Levee
Item	Vegetation
View of the tall vegetation obstructing visibility of the waterside levee slope .	
mkhashch_f_20131028_681.JPG

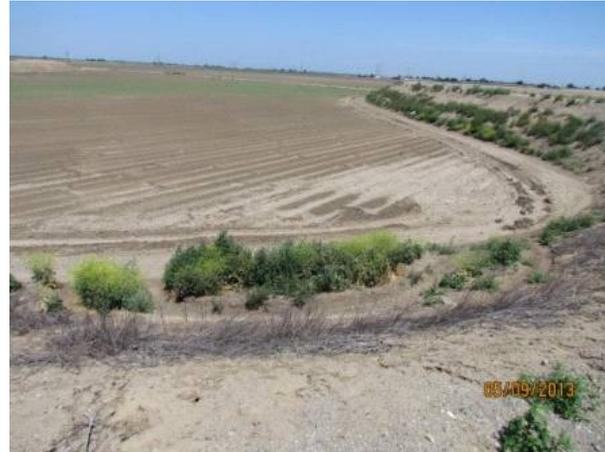
Levee Mile Report Line	16
Start Levee Mile	1.09
End Levee Mile	1.09
Location	Land Side
Category	Earthen Levee
Item	Slope Stability

View of the tire tracks on the landside levee slope.

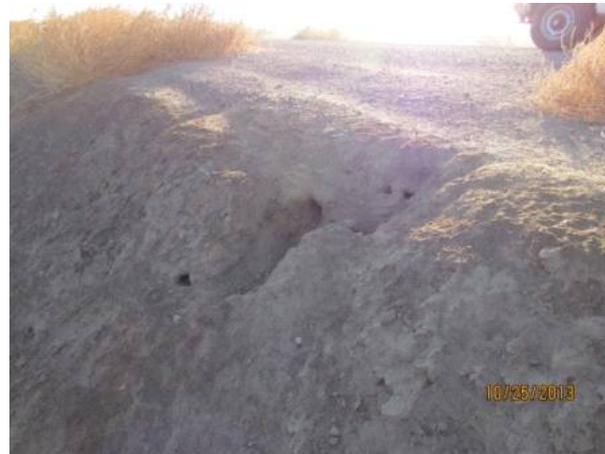
Levee Mile Report Line	18
Start Levee Mile	1.14
End Levee Mile	1.14
Location	Land Side
Category	Earthen Levee
Item	Animal Control

View of the rodent burrow on the landside slope.
