**Flood Control Project Maintenance  
Levee Inspections  
LMA District Cover Sheet  
Spring 2012 Levee Inspection Results**

**Reclamation District No. 0001 Union Island**

**Spring 2012 Levee Inspection Results**

Waterway		Bank	Unit Miles
Unit No. 01 Old River		Right	1.15

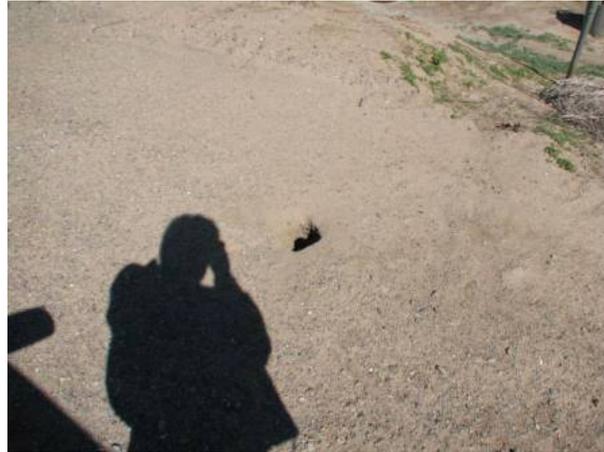
Levee Mile Report Line	5
Start Levee Mile	0.02
End Levee Mile	0.02
Location	Land Side
Category	Earthen Levee
Item	Animal Control
04/26/2011 Animal burrow in levee crown.	
mkhashch_s_20120510_065.jpg

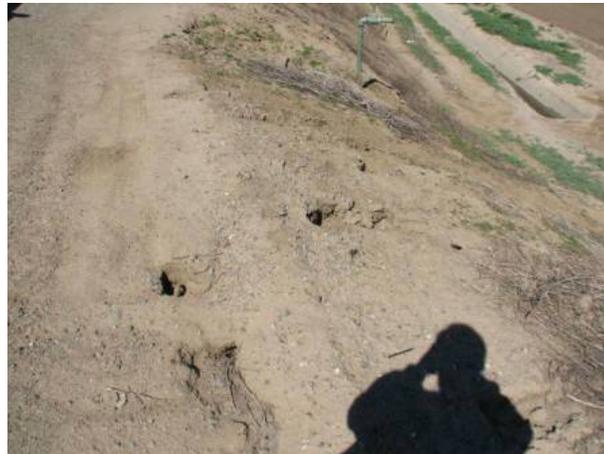
Levee Mile Report Line	5
Start Levee Mile	0.02
End Levee Mile	0.02
Location	Land Side
Category	Earthen Levee
Item	Animal Control
04/26/2011 Several burrows present in levee crown and landside slope.	
mkhashch_s_20120510_066.jpg

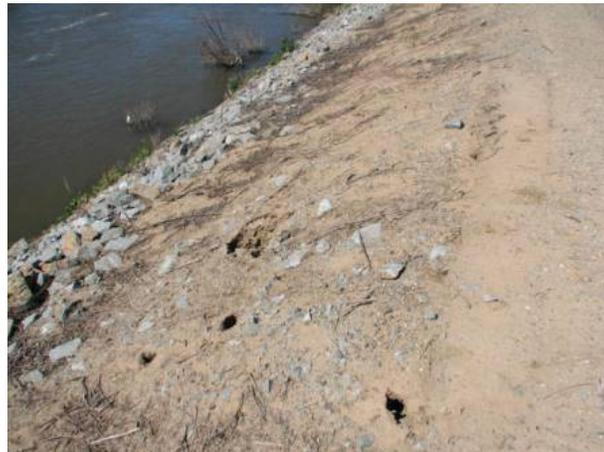
Levee Mile Report Line	6
Start Levee Mile	0.03
End Levee Mile	0.03
Location	Water Side
Category	Earthen Levee
Item	Animal Control
04/26/2011 Several burrows present on water side, burrows appear to be collapsing.	
mkhashch_s_20120510_062.jpg

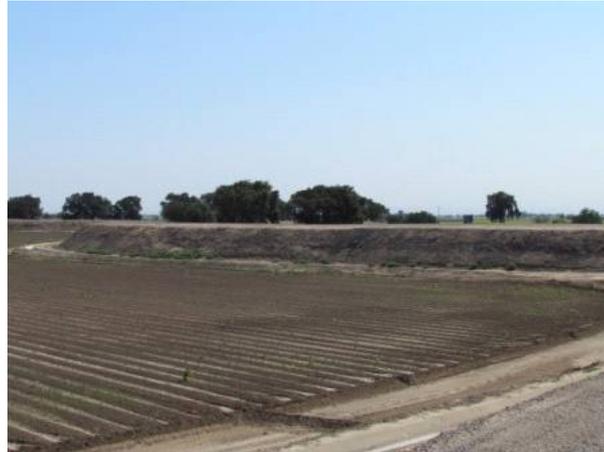
Levee Mile Report Line	7
Start Levee Mile	0.35
End Levee Mile	0.35
Location	Land Side
Category	Earthen Levee
Item	Vegetation

View of acceptably controlled annual vegetation.  
05/24/2012

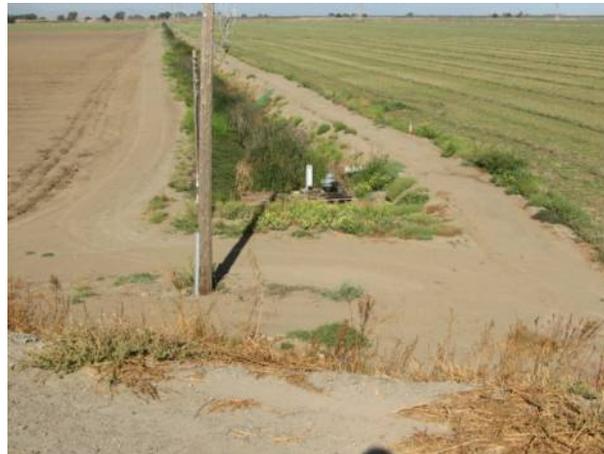
Levee Mile Report Line	8
Start Levee Mile	0.39
End Levee Mile	0.39
Location	Water Side
Category	Earthen Levee
Item	Encroachments

Drainage discharge pipe through levee freeboard.

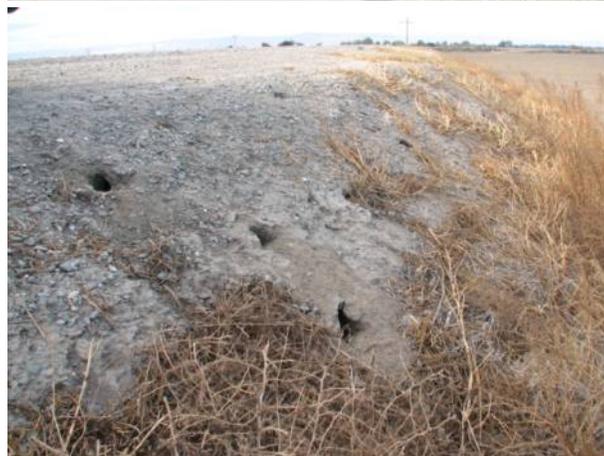
Levee Mile Report Line	9
Start Levee Mile	0.66
End Levee Mile	0.66
Location	Land Side
Category	Earthen Levee
Item	Animal Control

Active rodent holes on levee slope.

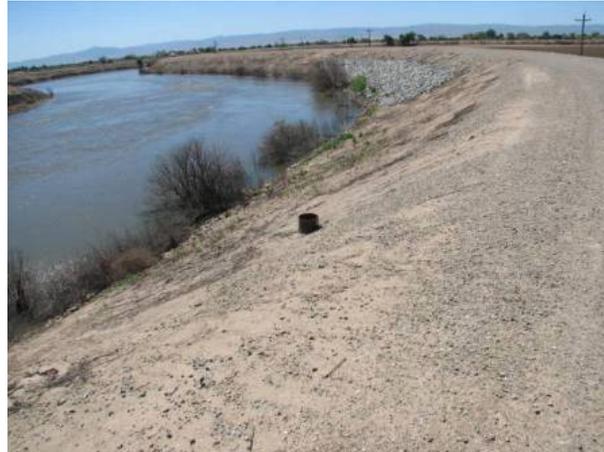
Levee Mile Report Line	10
Start Levee Mile	0.67
End Levee Mile	0.67
Location	Land Side
Category	Earthen Levee
Item	Encroachments
04/26/2011 Discharge pipe in water side slope.	
mkhashch_s_20120510_067.jpg

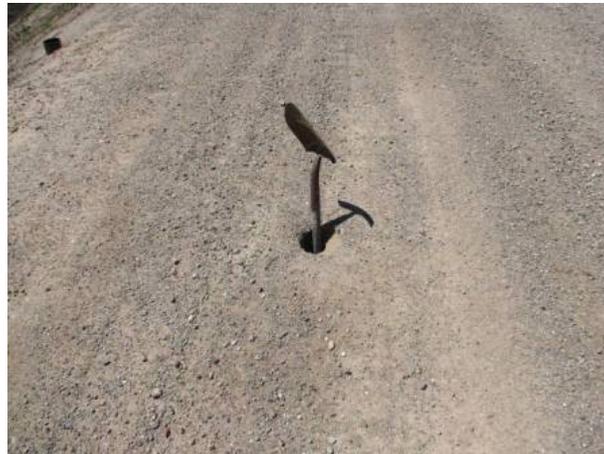
Levee Mile Report Line	11
Start Levee Mile	0.67
End Levee Mile	0.67
Location	Crown
Category	Earthen Levee
Item	Animal Control
04/26/2011 Deep vertical burrow in levee crown.	
mkhashch_s_20120510_068.jpg

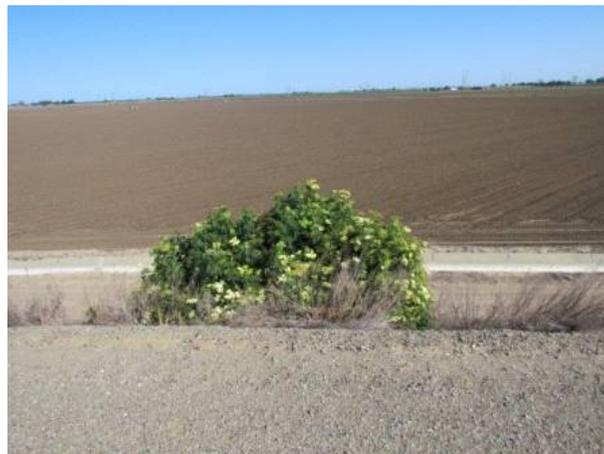
Levee Mile Report Line	13
Start Levee Mile	0.91
End Levee Mile	0.91
Location	Land Side
Category	Earthen Levee
Item	Vegetation
View of Elderberries blocking visibility of landside slope and toe. 05/24/2012	
mkhashch_s_20120525_391.jpg
