**Flood Control Project Maintenance
Levee Inspections**
LMA District Cover Sheet
Spring 2014 Levee Inspection Results

Reclamation District No. 0001 Union Island

Spring 2014 Levee Inspection Results

Waterway	Bank	Unit Miles
Unit No. 01 Old River	Right	1.15

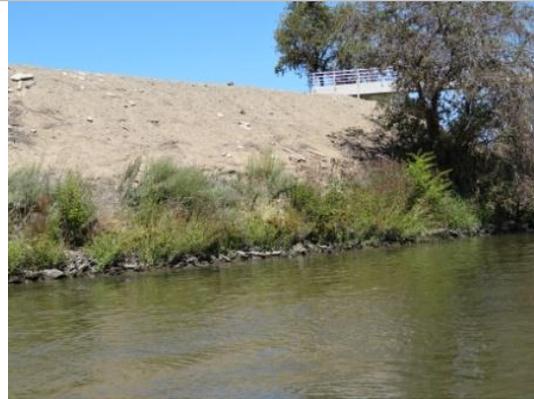
Photo 1 of 1 : mkhashch_s_20140428_00374.jpg

LM Start	0.00	Rating **	M	Issue No.	2
LM End	0.00	Issue Type +	Ma	Location *	WS
Category	Supplemental			GPS Latitude/Longitude	
				Start	End
Item	DWR Erosion Survey			37.822306 °	37.822306 °
				-121.375304 °	-121.375304 °
DWR ID	DWR_RD0001_01_s_2014_2				
Action/Comments					
Inspector Comments: 08/20/2013: No significant change at this site. 08/07/2012: The erosion is at the confluence of Old River and one of its tributary. [2013 Site ID:RD0001U01RM31.4]

Close view of erosion.

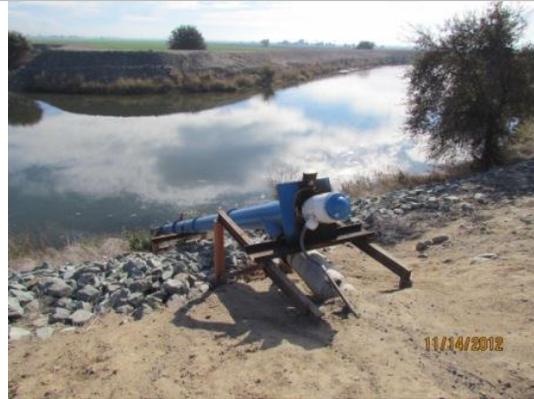
Photo 1 of 1 : mkhashch_s_20140428_00373.jpg

LM Start	0.01	Rating **	A/W	Issue No.	1
LM End	0.01	Issue Type +	En	Location *	WS
Category	Earthen Levee			GPS Latitude/Longitude	
				Start	End
Item	Encroachments			37.822408 °	37.822408 °
				-121.375714 °	-121.375714 °
DWR ID	DWR_RD0001_01_s_2012_1				
Action/Comments					
Pipe Inspector Comments: Steel irrigation intake pipe up levee slope and through freeboard.

View of irrigation intake pipe on waterside slope.

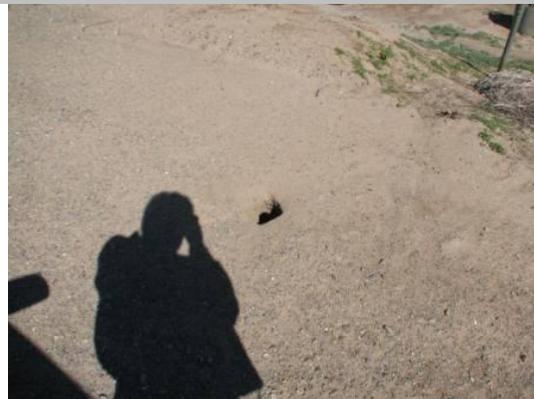
Photo 1 of 2 : mkhashch_s_20140428_00381.jpg

LM Start	0.02	Rating **	M	Issue No.	18
LM End	0.02	Issue Type +	Ma	Location *	LS
Category	Earthen Levee			GPS Latitude/Longitude	
				Start	End
Item	Animal Control			37.822511 °	37.822511 °
				-121.375857 °	-121.375857 °
DWR ID	DWR_RD0001_01_s_2012_18				
Action/Comments					
No rodents visible, but rodent burrows visible; need to backfill and compact or grout burrows. Inspector Comments: Several burrows present

04/26/2011 Animal burrow in levee crown.

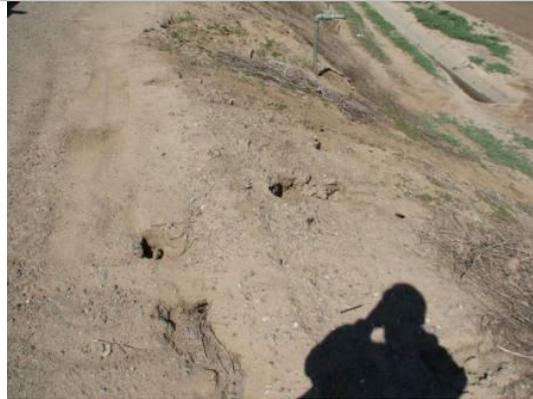
Photo 2 of 2 : mkhashch_s_20140428_00382.jpg

LM Start	0.02	Rating **	M	Issue No.	18 (cont)
LM End	0.02	Issue Type +	Ma	Location *	LS
Category	Earthen Levee		GPS Latitude/Longitude		
			Start	End	
Item	Animal Control		37.822511 °	37.822511 °	
			-121.375857 °	-121.375857 °	
DWR ID	DWR_RD0001_01_s_2012_18				
Action/Comments					
No rodents visible, but rodent burrows visible; need to backfill and compact or grout burrows. Inspector Comments: Several burrows present

04/26/2011 Several burrows present in levee crown and landside slope.

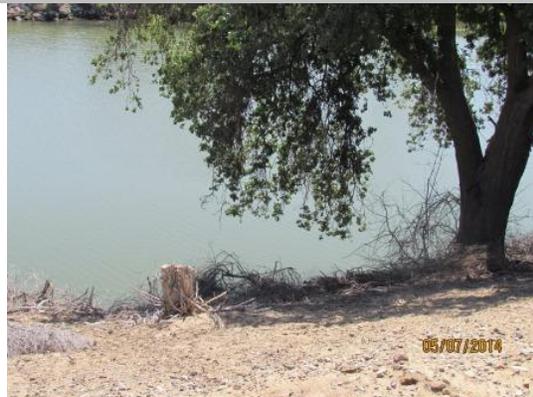
Photo 1 of 1 : mkhashch_s_20140512_01001.jpg

LM Start	0.16	Rating **	N	Issue No.	12
LM End	0.16	Issue Type +	Ma	Location *	WS
Category	Earthen Levee		GPS Latitude/Longitude		
			Start	End	
Item	Trim / Thin Trees		37.821376 °	37.821376 °	
			-121.378044 °	-121.378044 °	
DWR ID	DWR_RD0001_01_s_2014_12				
Action/Comments					
Tree stumps.

View of the tree stump on the waterside levee slope.

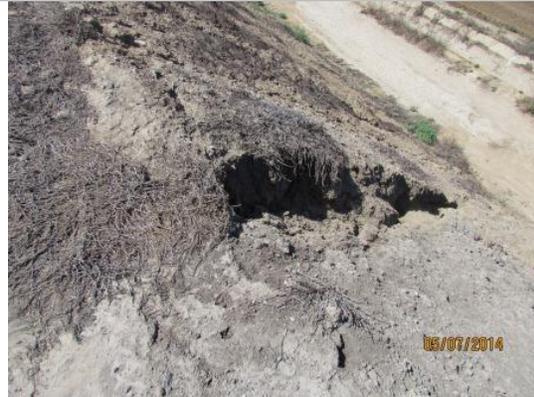
Photo 1 of 1 : mkhashch_s_20140512_01002.jpg

LM Start	0.20	Rating **	M	Issue No.	5
LM End	0.20	Issue Type +	Ma	Location *	LS
Category	Earthen Levee		GPS Latitude/Longitude		
			Start	End	
Item	Erosion / Bank Caving		37.820989 °	37.820989 °	
			-121.378174 °	-121.378174 °	
DWR ID	DWR_RD0001_01_s_2013_5				
Action/Comments					
Schedule repair of erosion site prior to the next inspection.

View of the erosion on the landside levee slope.

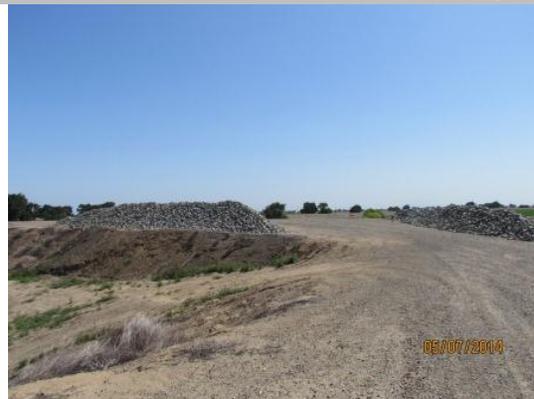
Photo 1 of 1 : mkhashch_s_20140512_01000.jpg

LM Start	0.23	Rating **	M	Issue No.	11
LM End	0.23	Issue Type +	Ma	Location *	CR
Category	Earthen Levee		GPS Latitude/Longitude		
			Start	End	
Item	Encroachments		37.820362 °	37.820362 °	
			-121.378359 °	-121.378359 °	
DWR ID	DWR_RD0001_01_s_2014_11				
Action/Comments					
Material Inspector Comments: Stockpiled riprap on levee crown.

View of the riprap stockpiled on the levee crown.

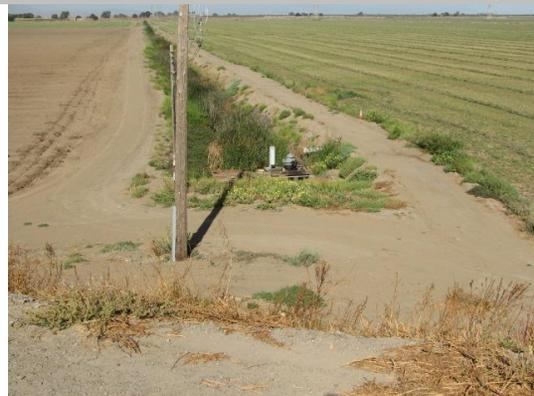
Photo 1 of 1 : mkhashch_s_20140428_00377.jpg

LM Start	0.39	Rating **	A/W	Issue No.	7
LM End	0.39	Issue Type +	En	Location *	WS
Category	Earthen Levee		GPS Latitude/Longitude		
			Start	End	
Item	Encroachments		37.819651 °	37.819651 °	
			-121.380467 °	-121.380467 °	
DWR ID	DWR_RD0001_01_s_2012_7				
Action/Comments					
Pipe Inspector Comments: Irrigation intake through levee crown.

View of the pipe through levee freeboard.

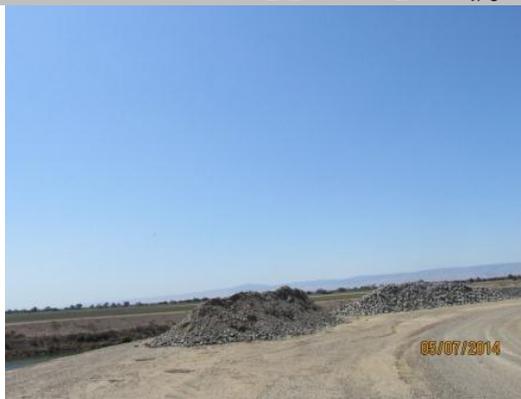
Photo 1 of 1 : mkhashch_s_20140512_01003.jpg

LM Start	0.53	Rating **	M	Issue No.	14
LM End	0.53	Issue Type +	Ma	Location *	CR
Category	Earthen Levee		GPS Latitude/Longitude		
			Start	End	
Item	Encroachments		37.817651 °	37.817651 °	
			-121.379898 °	-121.379898 °	
DWR ID	DWR_RD0001_01_s_2014_14				
Action/Comments					
Material Inspector Comments: Riprap stockpiled on levee crown.

View of the riprap stockpiled on the levee crown.

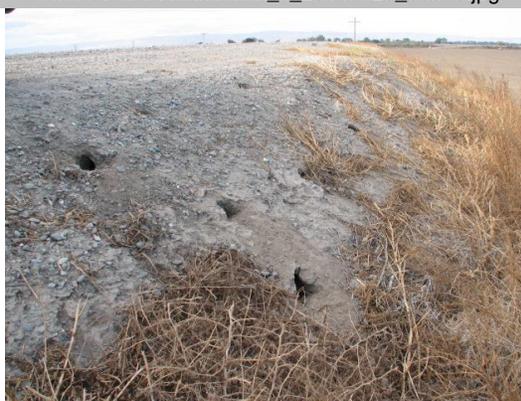
Photo 1 of 1 : mkhashch_s_20140428_00380.jpg

LM Start	0.66	Rating **	M	Issue No.	15
LM End	0.66	Issue Type +	Ma	Location *	LS
Category	Earthen Levee		GPS Latitude/Longitude		
			Start	End	
Item	Animal Control		37.817249 °	37.817249 °	
			-121.382026 °	-121.382026 °	
DWR ID	DWR_RD0001_01_s_2012_15				
Action/Comments					
No rodents visible, but rodent burrows visible; need to backfill and compact or grout burrows.

Rodent holes on levee slope.

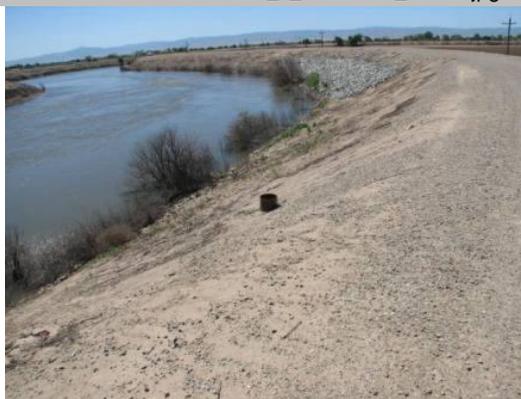
Photo 1 of 1 : mkhashch_s_20140428_00383.jpg

LM Start	0.67	Rating **	A/W	Issue No.	20
LM End	0.67	Issue Type +	En	Location *	LS
Category	Earthen Levee		GPS Latitude/Longitude		
			Start	End	
Item	Encroachments		37.817134 °	37.817134 °	
			-121.382099 °	-121.382099 °	
DWR ID	DWR_RD0001_01_s_2012_20				
Action/Comments					
Pipe Inspector Comments: Drainage discharge into Old River. No photo found from previous inspection. 04/26/2011 photo added.

04/26/2011 Discharge pipe in waterside slope.

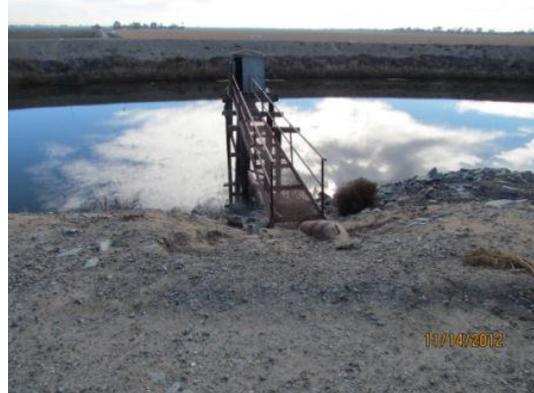
Photo 1 of 2 : mkhashch_s_20140428_00378.jpg

LM Start	0.86	Rating **	A/W	Issue No.	10
LM End	0.86	Issue Type +	En	Location *	LS
Category	Earthen Levee		GPS Latitude/Longitude		
			Start	End	
Item	Encroachments		37.814566 °	37.814566 °	
			-121.382450 °	-121.382450 °	
DWR ID	DWR_RD0001_01_s_2012_10				
Action/Comments					
Pipe Inspector Comments: Irrigation intake through levee freeboard.

View of irrigation intake pipe on waterside.

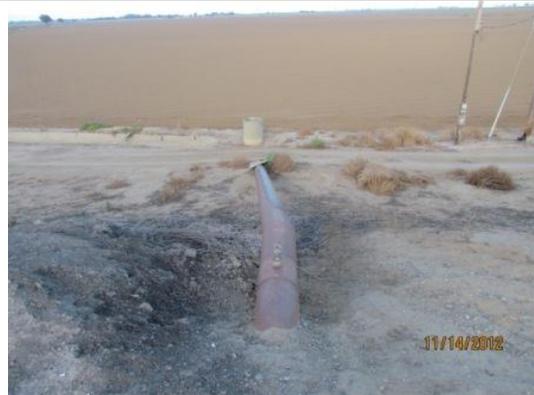
Photo 2 of 2 : mkhashch_s_20140428_00379.jpg

LM Start	0.86	Rating **	A/W	Issue No.	10 (cont)
LM End	0.86	Issue Type +	En	Location *	LS

View of irrigation pipe on landside.

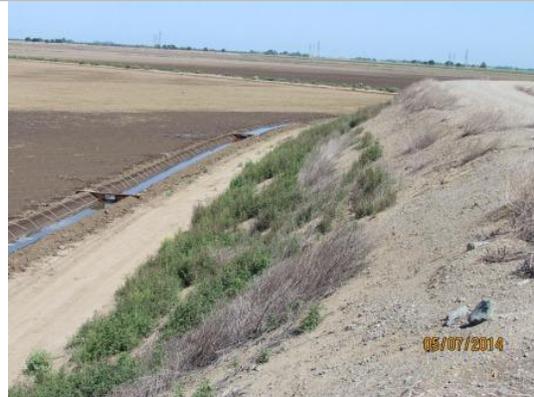
Photo 1 of 1 : mkhashch_s_20140512_00999.jpg

LM Start	0.88	Rating **	M	Issue No.	4
LM End	1.05	Issue Type +	Ma	Location *	LS
Category	Earthen Levee		GPS Latitude/Longitude		
			Start	End	
Item	Vegetation		37.814357 °	37.812346 °	
			-121.382920 °	-121.383754 °	
DWR ID	DWR_RD0001_01_s_2014_4				
Action/Comments					
Control annual grass and weeds on the levee slopes and easements.

View of the vegetation on the landside levee slope.

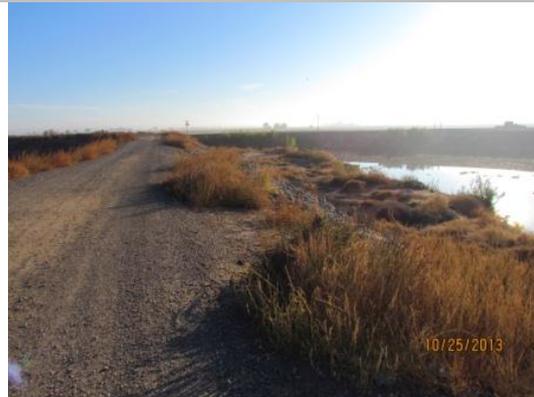
Photo 1 of 1 : mkhashch_s_20140428_00386.jpg

LM Start	0.93	Rating **	M	Issue No.	25
LM End	1.14	Issue Type +	Ma	Location *	WS
Category	Earthen Levee		GPS Latitude/Longitude		
			Start	End	
Item	Vegetation		37.814013 °	37.811775 °	
			-121.383700 °	-121.384764 °	
DWR ID	DWR_RD0001_01_f_2013_25				
Action/Comments					
Remove the wild growth other than native grasses from the levee slopes.

View of the tall vegetation obstructing visibility of the waterside levee slope .

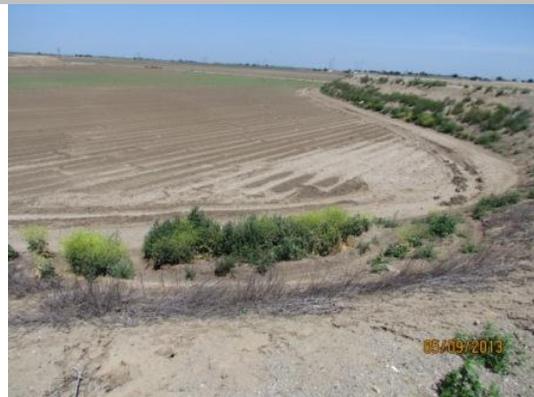
Photo 1 of 1 : mkhashch_s_20140428_00375.jpg

LM Start	1.09	Rating **	M	Issue No.	3
LM End	1.09	Issue Type +	Ma	Location *	LS
Category	Earthen Levee		GPS Latitude/Longitude		
			Start	End	
Item	Slope Stability		37.812021 °	37.812021 °	
			-121.384020 °	-121.384020 °	
DWR ID	DWR_RD0001_01_s_2013_3				
Action/Comments					
Repair the levee slope damaged by vehicle traffic and prevent access where possible.

View of the tire tracks on the landside levee slope.

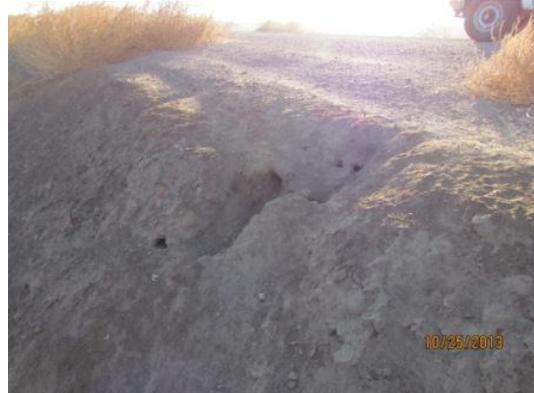
Photo 1 of 1 : mkhashch_s_20140428_00384.jpg

LM Start	1.14	Rating **	M	Issue No.	23
LM End	1.14	Issue Type +	Ma	Location *	LS
Category	Earthen Levee		GPS Latitude/Longitude		
			Start	End	
Item	Animal Control		37.811775 °	37.811775 °	
			-121.384764 °	-121.384764 °	
DWR ID	DWR_RD0001_01_f_2013_23				
Action/Comments					
No rodents visible, but rodent burrows visible; need to backfill and compact or grout burrows.

View of the rodent burrow on the landside slope.
