**Flood Control Project Maintenance  
Levee Inspections**  
**LMA District Cover Sheet**  
**Spring 2015 Levee Inspection Results**

**Reclamation District No. 0001 Union Island**

**Levee Inspection Report By Mile - Spring 2015**

Waterway	Bank	Unit Miles	Inspection Start/End	Inspector
Unit No. 01 Old River	Right	1.14	05/14/2015 05/14/2015	Maksim Khashchuk

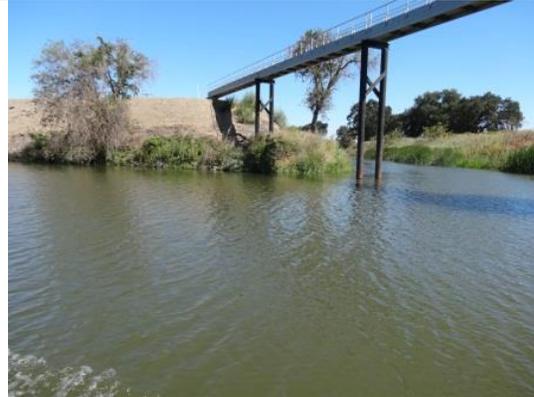
Photo 1 of 1 : SP\_2015\_RD0001\_23\_2\_20150317\_00002.jpg

LM Start	<b>0.00</b>	Rating **	M	Issue No.	<b>2</b>
LM End	<b>0.00</b>	Issue Type +	Ma	Location *	WS
Category	Supplemental			GPS Latitude/Longitude	
				Start	End
Item	DWR Erosion Survey			37.822306 °	37.822306 °
				-121.375304 °	-121.375304 °
DWR ID	DWR_RD0001_01_s_2015_2				
Action/Comments					
Inspector Comments: 07/02/2014: No significant change observed. 08/20/2013: No significant change at this site. 08/07/2012: The erosion is at the confluence of Old River and one of its tributary. [2014 Site ID:RD0001U01RM31.4]

Close view of the erosion.

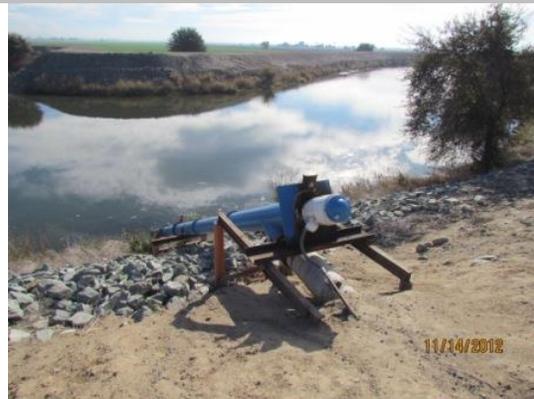
Photo 1 of 1 : SP\_2015\_RD0001\_23\_1\_20150317\_00001.jpg

LM Start	<b>0.01</b>	Rating **	A/W	Issue No.	<b>1</b>
LM End	<b>0.01</b>	Issue Type +	En	Location *	WS
Category	Earthen Levee			GPS Latitude/Longitude	
				Start	End
Item	Encroachments			37.822408 °	37.822408 °
				-121.375714 °	-121.375714 °
DWR ID	DWR_RD0001_01_s_2012_1				
Action/Comments					
Pipe Inspector Comments: Steel irrigation intake pipe up levee slope and through freeboard.

View of irrigation intake pipe on waterside slope.

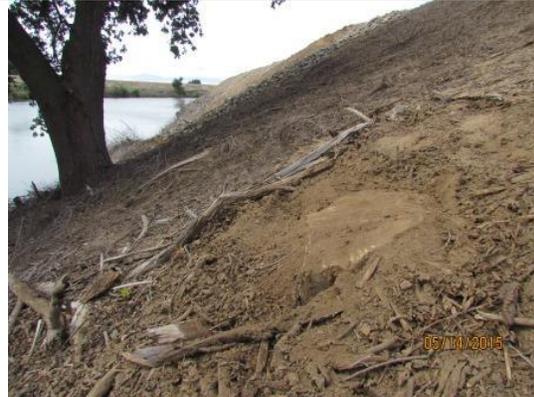
Photo 1 of 1 : SP\_2015\_RD0001\_23\_12\_20150518\_00017.jpg

LM Start	<b>0.17</b>	Rating **	N	Issue No.	<b>12</b>
LM End	<b>0.17</b>	Issue Type +	Ma	Location *	WS
Category	Earthen Levee		GPS Latitude/Longitude		
			Start	End	
Item	Trim / Thin Trees		37.821376 °	37.821376 °	
			-121.378044 °	-121.378044 °	
DWR ID	DWR_RD0001_01_s_2014_12				
Action/Comments					
Tree stumps. Inspector Comments: Remove stump when it becomes rotted to prevent possible seepage path along the roots.

View of the tree stump on the waterside levee slope.

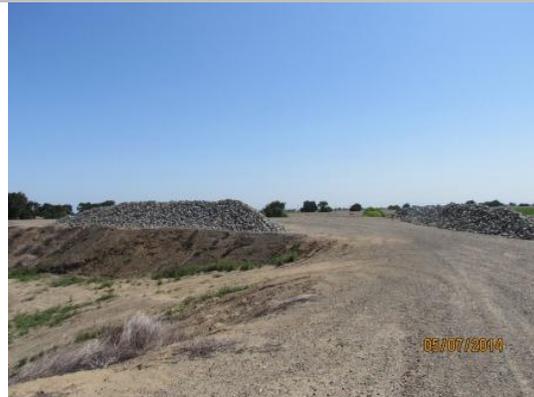
Photo 1 of 1 : SP\_2015\_RD0001\_23\_11\_20150317\_00008.jpg

LM Start	<b>0.24</b>	Rating **	A/W	Issue No.	<b>11</b>
LM End	<b>0.24</b>	Issue Type +	Ma	Location *	CR
Category	Earthen Levee		GPS Latitude/Longitude		
			Start	End	
Item	Encroachments		37.820362 °	37.820362 °	
			-121.378359 °	-121.378359 °	
DWR ID	DWR_RD0001_01_s_2014_11				
Action/Comments					
Material Inspector Comments: Stockpiled riprap on levee crown. Keep the stockpile so that a vehicle could maneuver around the pile to facilitate visibility and access of the levee.

View of the riprap stockpiled on the levee crown.

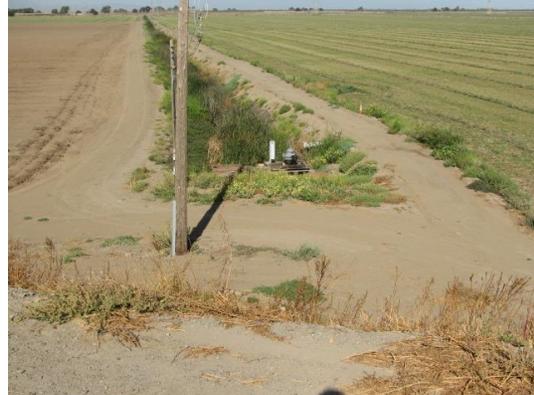
Photo 1 of 1 : SP\_2015\_RD0001\_23\_7\_20150317\_00005.jpg

LM Start	<b>0.38</b>	Rating **	A/W	Issue No.	<b>7</b>
LM End	<b>0.38</b>	Issue Type +	En	Location *	WS
Category	Earthen Levee		GPS Latitude/Longitude		
			Start	End	
Item	Encroachments		37.819651 °	37.819651 °	
			-121.380467 °	-121.380467 °	
DWR ID	DWR_RD0001_01_s_2012_7				
Action/Comments					
Pipe Inspector Comments: Irrigation intake through levee crown.

View of the pipe through levee freeboard.

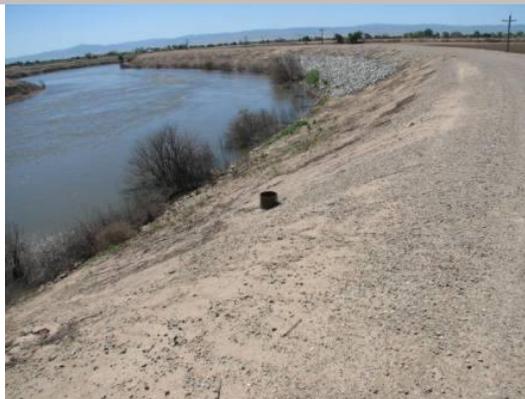
Photo 1 of 1 : SP\_2015\_RD0001\_23\_20\_20150317\_00013.jpg

LM Start	<b>0.66</b>	Rating **	A/W	Issue No.	<b>20</b>
LM End	<b>0.66</b>	Issue Type +	En	Location *	LS
Category	Earthen Levee		GPS Latitude/Longitude		
			Start	End	
Item	Encroachments		37.817134 °	37.817134 °	
			-121.382099 °	-121.382099 °	
DWR ID	DWR_RD0001_01_s_2012_20				
Action/Comments					
Pipe Inspector Comments: Drainage discharge into Old River. No photo found from previous inspection. 04/26/2011 photo added.

04/26/2011 Discharge pipe in waterside slope.

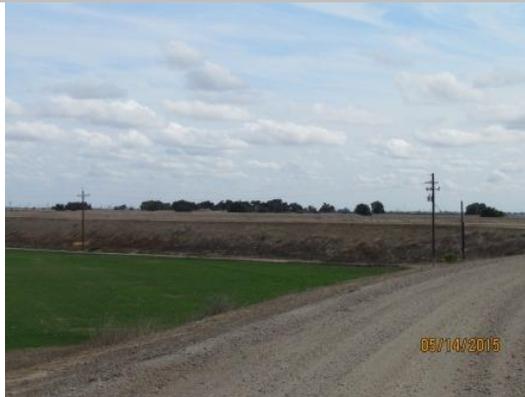
Photo 1 of 1 : SP\_2015\_RD0001\_23\_3\_20150518\_00016.jpg

View of the acceptable vegetation on the landside levee slope.

LM Start	<b>0.73</b>	Rating **	A	Issue No.	<b>3</b>
LM End	<b>0.82</b>	Issue Type +	Ma	Location *	LS
Category	Earthen Levee		GPS Latitude/Longitude		
			Start	End	
Item	Vegetation		37.816280 °	37.814973 °	
			-121.382706 °	-121.382441 °	
DWR ID	DWR_RD0001_01_s_2015_3				
Action/Comments					
Control annual grass and weeds on the levee slopes and easements.

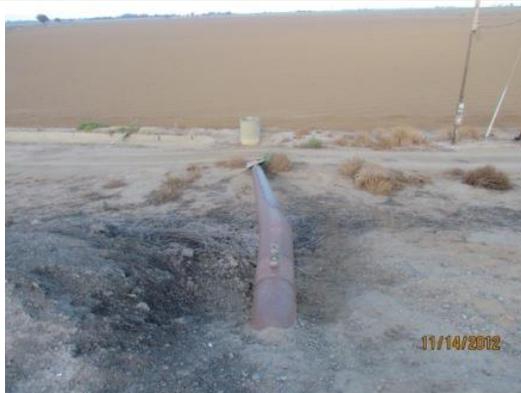
Photo 1 of 2 : SP\_2015\_RD0001\_23\_10\_20150317\_00006.jpg

LM Start	<b>0.85</b>	Rating **	A/W	Issue No.	<b>10</b>
LM End	<b>0.85</b>	Issue Type +	En	Location *	LS
Category	Earthen Levee		GPS Latitude/Longitude		
			Start	End	
Item	Encroachments		37.814566 °	37.814566 °	
			-121.382450 °	-121.382450 °	
DWR ID	DWR_RD0001_01_s_2012_10				
Action/Comments					
Pipe Inspector Comments: Irrigation intake through levee freeboard.

View of irrigation pipe on landside.

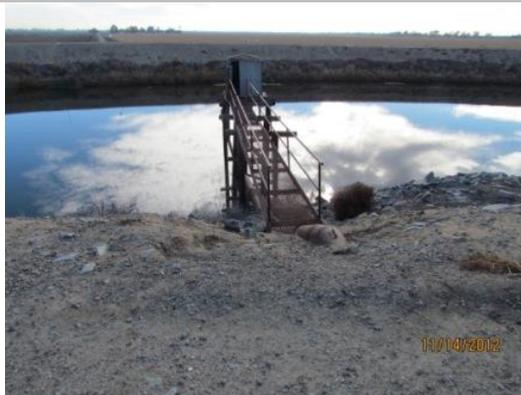
Photo 2 of 2 : SP\_2015\_RD0001\_23\_10\_20150317\_00007.jpg

View of irrigation intake pipe on waterside.
