**Flood Control Project Maintenance
Levee Inspections**
LMA District Cover Sheet
Spring 2016 Levee Inspection Results

Reclamation District No. 0001 Union Island

Levee Inspection Report By Mile - Spring 2016

Waterway	Bank	Unit Miles	Inspection Start/End	Inspector
Unit No. 01 Old River	Right	1.14	03/15/2016 03/15/2016	Maksim Khashchuk

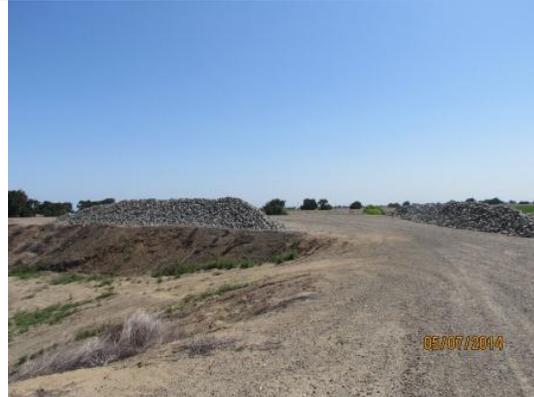
Photo 1 of 1 : SP_2016_RD0001_23_11_20160229_00005.jpg

LM Start	0.24	Rating **	A/W	Issue No.	11
LM End	0.24	Issue Type +	Ma	Location *	CR
Category	Earthen Levee			GPS Latitude/Longitude	
				Start	End
Item	Encroachments			37.820362 °	37.820362 °
				-121.378359 °	-121.378359 °
DWR ID	DWR_RD0001_01_s_2014_11				
Comment Code					
MA : Material					
Inspector Comment					
Stockpiled riprap on levee crown. Keep the stockpile so that a vehicle could maneuver around the pile to facilitate visibility and access of the levee.

View of the riprap stockpiled on the levee crown.

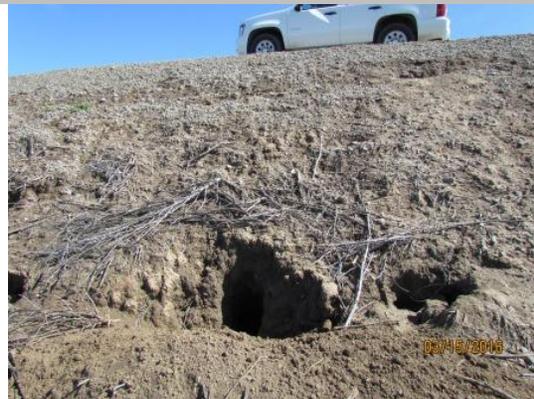
Photo 1 of 1 : SP_2016_RD0001_23_14_20160321_00013.jpg

LM Start	0.44	Rating **	U	Issue No.	14
LM End	0.44	Issue Type +	Ma	Location *	LS
Category	Earthen Levee			GPS Latitude/Longitude	
				Start	End
Item	Animal Control			37.818898 °	37.818898 °
				-121.380332 °	-121.380332 °
DWR ID	DWR_RD0001_01_s_2016_14				
Comment Code					
A1 : Exterminate rodents and backfill and compact or grout burrows.					
Inspector Comment					
Active rodent den a size of a coyote or fox.

View of the large rodent hole on the landside levee slope.

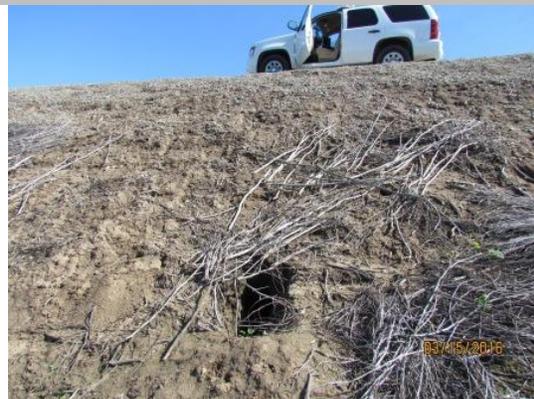
Photo 1 of 1 : SP_2016_RD0001_23_10_20160321_00012.jpg

LM Start	0.45	Rating **	U	Issue No.	10
LM End	0.45	Issue Type +	Ma	Location *	LS
Category	Earthen Levee			GPS Latitude/Longitude	
				Start	End
Item	Animal Control			37.818753 °	37.818753 °
				-121.380249 °	-121.380249 °
DWR ID	DWR_RD0001_01_s_2016_10				
Comment Code					
A3 : No rodents visible, but rodent burrows visible; need to backfill and compact or grout burrows.					
Inspector Comment					
Backfill and compact levee slope with acceptable levee fill.

View of the large rodent hole on the landside levee slope.

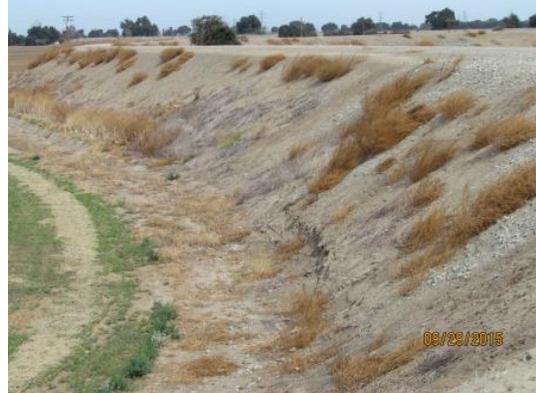
Photo 1 of 1 : SP_2016_RD0001_23_5_20160229_00004.jpg

LM Start	0.51	Rating **	M	Issue No.	5
LM End	0.51	Issue Type +	Ma	Location *	LS
Category	Earthen Levee		GPS Latitude/Longitude		
			Start	End	
Item	Slope Stability		37.818003 °	37.818003 °	
			-121.379845 °	-121.379845 °	
DWR ID	DWR_RD0001_01_f_2015_5				
Comment Code					
S1 : Repair slope instability.					
Inspector Comment					
About a 1 ft. vertical cut is observed at the landside levee toe. Repair the landside levee toe per O&M standards.

View of the vertical cut at the landside levee toe.

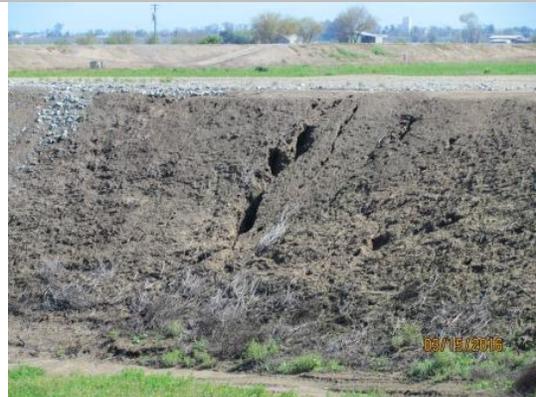
Photo 1 of 1 : SP_2016_RD0001_23_7_20160321_00011.jpg

LM Start	0.52	Rating **	M	Issue No.	7
LM End	0.52	Issue Type +	Ma	Location *	LS
Category	Earthen Levee		GPS Latitude/Longitude		
			Start	End	
Item	Erosion / Bank Caving		37.817825 °	37.817825 °	
			-121.379811 °	-121.379811 °	
DWR ID	DWR_RD0001_01_s_2016_7				
Comment Code					
E2 : Schedule repair of erosion site prior to the next inspection.					
Inspector Comment

View of the erosion on the landside levee slope.

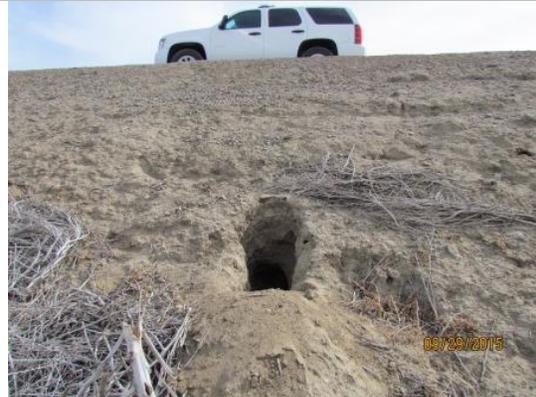
Photo 1 of 1 : SP_2016_RD0001_23_4_20160229_00003.jpg

LM Start	0.76	Rating **	U	Issue No.	4
LM End	0.76	Issue Type +	Ma	Location *	LS
Category	Earthen Levee		GPS Latitude/Longitude		
			Start	End	
Item	Animal Control		37.815881 °	37.815881 °	
			-121.382704 °	-121.382704 °	
DWR ID	DWR_RD0001_01_f_2015_4				
Comment Code					
A1 : Exterminate rodents and backfill and compact or grout burrows.					
Inspector Comment					
Large burrow in the landside levee slope. Possible fox den.

View of a large rodent hole on the landside levee slope.

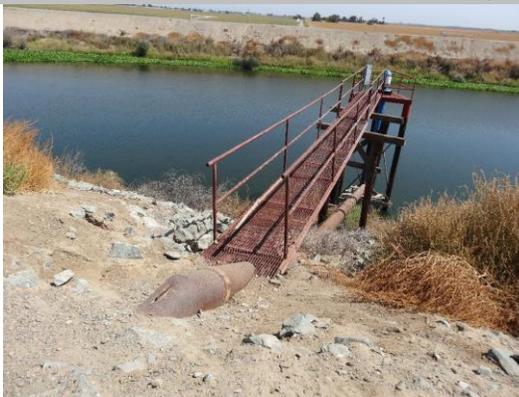
Photo 1 of 2 : UCIP_SP_2016_41600_36004.jpg

LM Start	0.85	Rating **	M	Issue No.	17
LM End	0.85	Issue Type +	En	Location *	LS
Category	Supplemental			GPS Latitude/Longitude	
				Start	End
Item	DWR UCIP Field Study			37.814601 °	37.814601 °
				-121.382509 °	-121.382509 °
DWR ID					
Comment Code					
Inspector Comment					
FS_ID:41600 DS_ID:22691 EP_NO: N/A Repair Type: Non-Urgent Crossing Status: Found UCIP Comments: - 2" electric conduit on WS- pipe exposed on both sides.- power pole on LS. - erosion on WS hinge near walkway. FIELD_STRUCT_DESC: 14-inch pipe and 2-inch electric conduit through the levee, 6.0 feet below the crown, pump on pile structure in the stream, air valve on the landward shoulder, 30-inch concrete standpipe on the landward toe. O&M Manual LSJR 8, 1968 FS Date: 9/12/2013

WS view: exposed pipe, walkway, and pump on pile structure. Soil erosion on levee hinge near walkway.

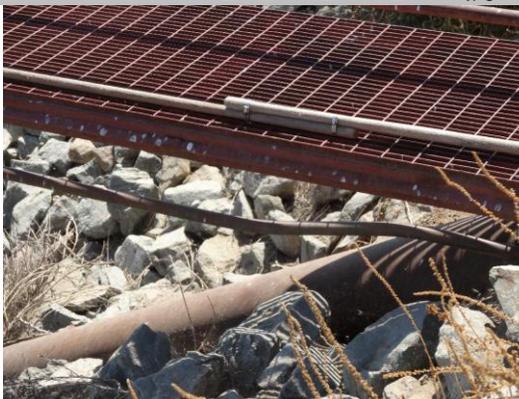
Photo 2 of 2 : UCIP_SP_2016_41600_36003.jpg

WS view: exposed pipe, walkway, and electric conduit under walkway. Rock revetment on lower levee slope.

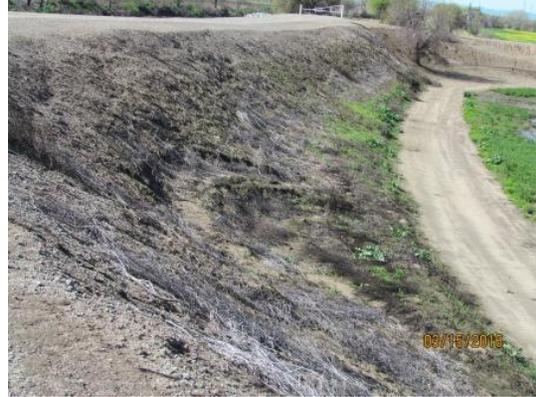
Photo 1 of 1 : SP_2016_RD0001_23_3_20160321_00010.jpg

LM Start	1.08	Rating **	M	Issue No.	3
LM End	1.08	Issue Type +	Ma	Location *	LS
Category	Earthen Levee		GPS Latitude/Longitude		
			Start	End	
Item	Slope Stability		37.812023 °	37.812023 °	
			-121.383961 °	-121.383961 °	
DWR ID	DWR_RD0001_01_s_2016_3				
Comment Code					
S3 : Repair the levee slope damaged by vehicle traffic and prevent access where possible.					
Inspector Comment					
Repair slope damaged by vehicle by placing and compacting acceptable levee material.

View of the landside slope damaged by farm equipment.
