**Flood Control Project Maintenance
Levee Inspections**

Maintenance Issue Types Only, Levee Inspection Report By Mile - Fall 2014

Reclamation District No. 0001 Union Island

Waterway	Bank	Unit Miles	Inspection Start/End	Inspector
Unit No. 01 Old River	Right	1.14	10/27/2014 10/27/2014	Maksim Khashchuk

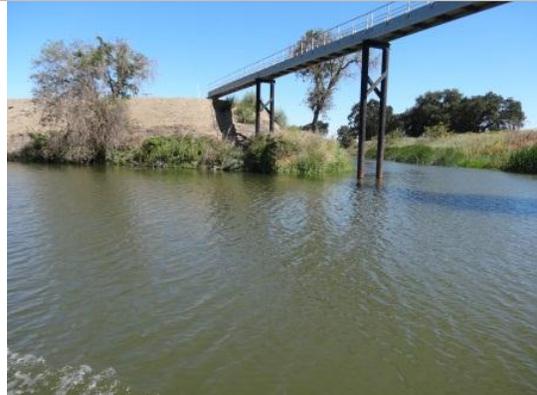
Photo 1 of 1 : SJR2014_RD0001U01RM31.4_1.jpg

LM Start	0.00	Rating **	M	Issue No.	2
LM End	0.00	Issue Type +	Ma	Location *	WS
Category	Supplemental		GPS Latitude/Longitude		
			Start	End	
Item	DWR Erosion Survey		37.822306 °	37.822306 °	
			-121.375304 °	-121.375304 °	
DWR ID					
Action/Comments					
Inspector Comments: 07/02/2014: No significant change observed. 08/20/2013: No significant change at this site. 08/07/2012: The erosion is at the confluence of Old River and one of its tributary. [2014 Site ID:RD0001U01RM31.4]

Close view of the erosion.

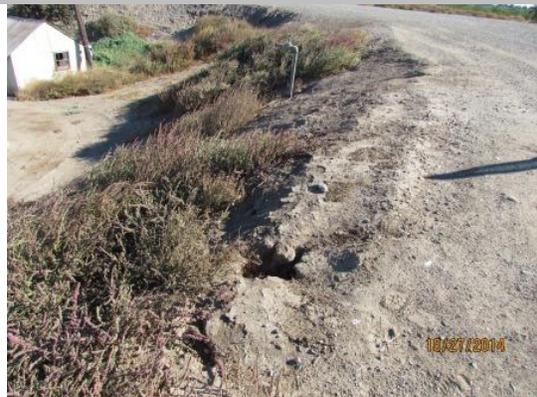
Photo 1 of 1 : FA_2014_RD0001_23_18_20141027_00019.jpg

LM Start	0.02	Rating **	M	Issue No.	18
LM End	0.02	Issue Type +	Ma	Location *	LS
Category	Earthen Levee		GPS Latitude/Longitude		
			Start	End	
Item	Animal Control		37.822511 °	37.822511 °	
			-121.375857 °	-121.375857 °	
DWR ID	DWR_RD0001_01_s_2012_18				
Action/Comments					
No rodents visible, but rodent burrows visible; need to backfill and compact or grout burrows. Inspector Comments: Several burrows present

View of the largest burrow on the landside levee shoulder.

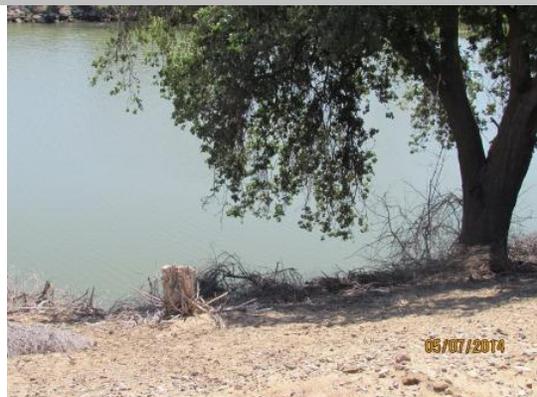
Photo 1 of 1 : FA_2014_RD0001_23_12_20141001_00009.jpg

LM Start	0.16	Rating **	N	Issue No.	12
LM End	0.16	Issue Type +	Ma	Location *	WS
Category	Earthen Levee		GPS Latitude/Longitude		
			Start	End	
Item	Trim / Thin Trees		37.821376 °	37.821376 °	
			-121.378044 °	-121.378044 °	
DWR ID	DWR_RD0001_01_s_2014_12				
Action/Comments					
Tree stumps.

View of the tree stump on the waterside levee slope.

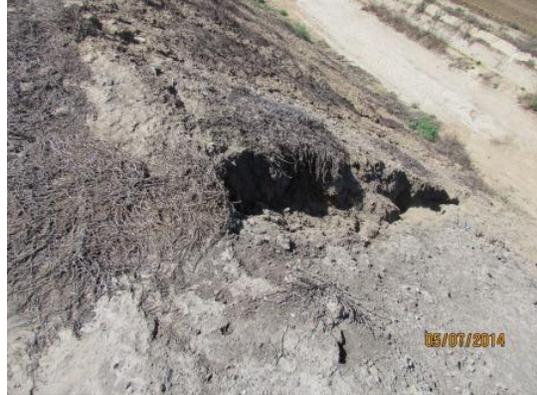
Photo 1 of 1 : FA_2014_RD0001_23_5_20141001_00004.jpg

View of the erosion on the landside levee slope.

LM Start	0.20	Rating **	M	Issue No.	5
LM End	0.20	Issue Type +	Ma	Location *	LS
Category	Earthen Levee		GPS Latitude/Longitude		
			Start	End	
Item	Erosion / Bank Caving		37.820989 °	37.820989 °	
			-121.378174 °	-121.378174 °	
DWR ID	DWR_RD0001_01_s_2013_5				
Action/Comments					
Schedule repair of erosion site prior to the next inspection.

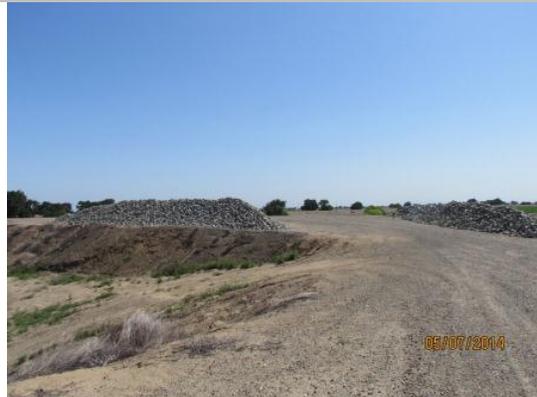
Photo 1 of 1 : FA_2014_RD0001_23_11_20141001_00008.jpg

LM Start	0.23	Rating **	M	Issue No.	11
LM End	0.23	Issue Type +	Ma	Location *	CR
Category	Earthen Levee		GPS Latitude/Longitude		
			Start	End	
Item	Encroachments		37.820362 °	37.820362 °	
			-121.378359 °	-121.378359 °	
DWR ID	DWR_RD0001_01_s_2014_11				
Action/Comments					
Material Inspector Comments: Stockpiled riprap on levee crown.

View of the riprap stockpiled on the levee crown.

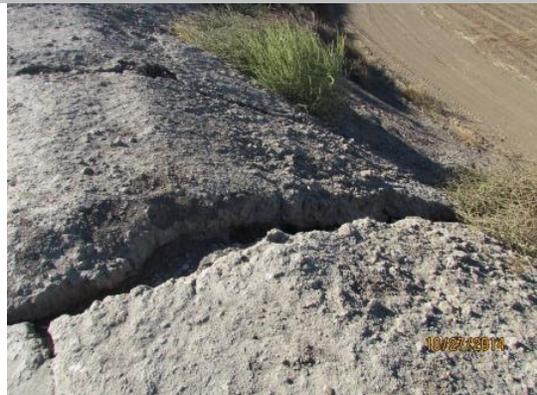
Photo 1 of 1 : FA_2014_RD0001_23_4_20141027_00018.jpg

View of the scour from surface runoff on the landside levee slope.

LM Start	0.50	Rating **	M	Issue No.	4
LM End	0.50	Issue Type +	Ma	Location *	LS
Category	Earthen Levee		GPS Latitude/Longitude		
			Start	End	
Item	Slope Stability		37.818014 °	37.818014 °	
			-121.379829 °	-121.379829 °	
DWR ID	DWR_RD0001_01_f_2014_4				
Action/Comments					
Repair slope instability.

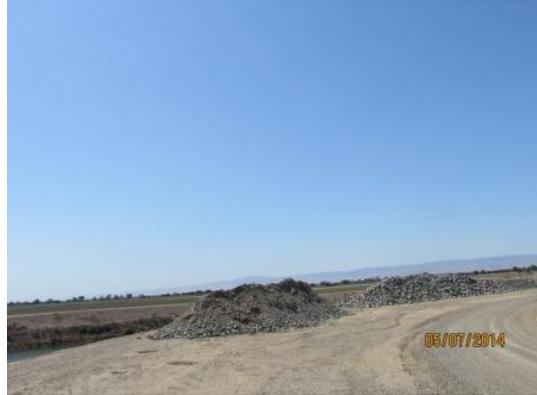
Photo 1 of 1 : FA_2014_RD0001_23_14_20141001_00010.jpg

LM Start	0.53	Rating **	M	Issue No.	14
LM End	0.53	Issue Type +	Ma	Location *	CR
Category	Earthen Levee		GPS Latitude/Longitude		
			Start	End	
Item	Encroachments		37.817651 °	37.817651 °	
			-121.379898 °	-121.379898 °	
DWR ID	DWR_RD0001_01_s_2014_14				
Action/Comments					
Material Inspector Comments: Riprap stockpiled on levee crown.

View of the riprap stockpiled on the levee crown.

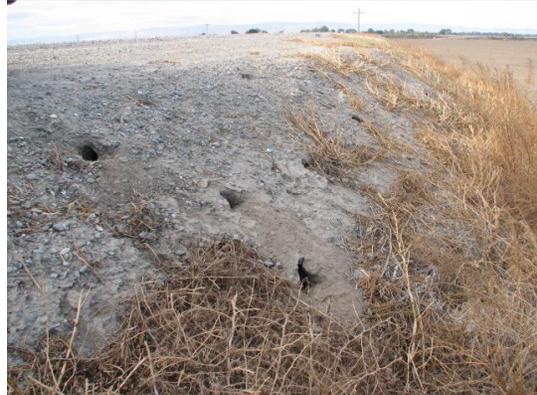
Photo 1 of 1 : FA_2014_RD0001_23_15_20141001_00011.jpg

LM Start	0.66	Rating **	M	Issue No.	15
LM End	0.66	Issue Type +	Ma	Location *	LS
Category	Earthen Levee		GPS Latitude/Longitude		
			Start	End	
Item	Animal Control		37.817249 °	37.817249 °	
			-121.382026 °	-121.382026 °	
DWR ID	DWR_RD0001_01_s_2012_15				
Action/Comments					
No rodents visible, but rodent burrows visible; need to backfill and compact or grout burrows.

Rodent holes on levee slope.

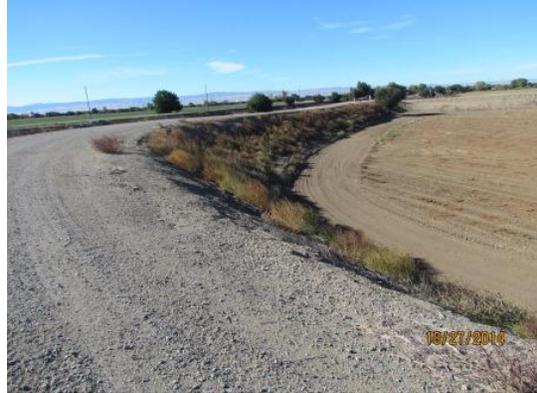
Photo 1 of 1 : FA_2014_RD0001_23_25_20141027_00017.jpg

View of the tall vegetation obstructing visibility on the landside levee slope.

LM Start	0.93	Rating **	M	Issue No.	25
LM End	1.14	Issue Type +	Ma	Location *	LS
Category	Earthen Levee		GPS Latitude/Longitude		
			Start	End	
Item	Vegetation		37.814013 °	37.811775 °	
			-121.383700 °	-121.384764 °	
DWR ID	DWR_RD0001_01_f_2013_25				
Action/Comments					
Remove the wild growth other than native grasses from the levee slopes.
