**Flood Control Project Maintenance  
Levee Inspections**

**Maintenance Issue Types Only, Levee Inspection Report By Mile - Fall 2015**

**Reclamation District No. 0001 Union Island**

Waterway	Bank	Unit Miles	Inspection Start/End	Inspector
Unit No. 01 Old River	Right	1.14	09/29/2015 09/29/2015	Maksim Khashchuk

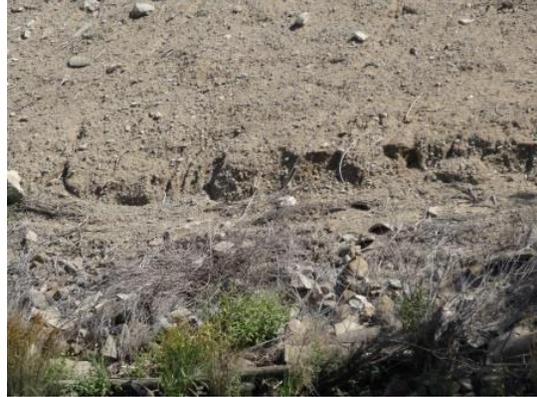
Photo 1 of 2 : SJR2015\_RD0001U01RM31.4\_2.jpg

LM Start	<b>0.00</b>	Rating **	M	Issue No.	<b>1</b>
LM End	<b>0.00</b>	Issue Type +	Ma	Location *	WS
Category	Supplemental			GPS Latitude/Longitude	
				Start	End
Item	DWR Erosion Survey			37.822306 °	37.822306 °
				-121.375304 °	-121.375304 °
DWR ID					
<b>Action/Comments</b>					
Inspector Comments: 06/25/2015: No significant change observed. 07/02/2014: No significant change observed. 08/20/2013: No significant change at this site. 08/07/2012: The erosion is at the confluence of Old River and one of its tributary. [2015 Site ID:RD0001U01RM31.4]

Close view of the erosion.

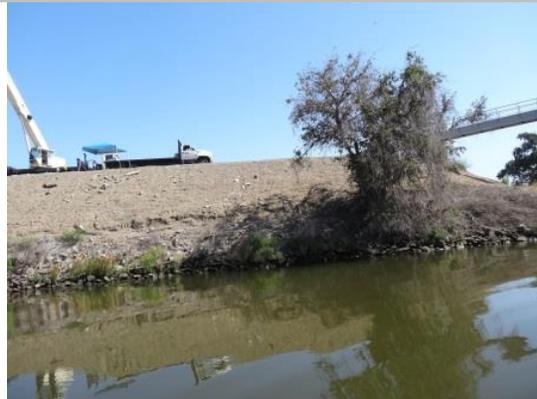
Photo 2 of 2 : SJR2015\_RD0001U01RM31.4\_6.jpg

Front view of the site. Note the large tree on site.

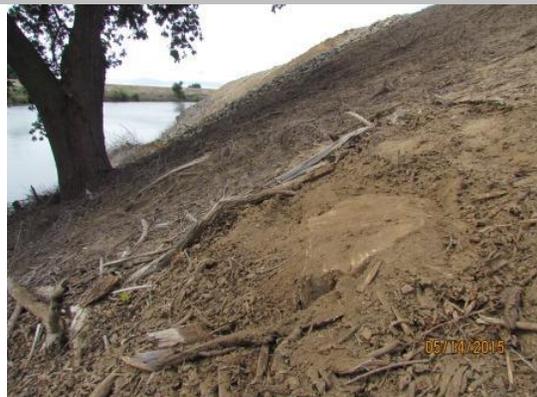
Photo 1 of 1 : FA\_2015\_RD0001\_23\_12\_20150910\_00007.jpg

LM Start	<b>0.17</b>	Rating **	N	Issue No.	<b>12</b>
LM End	<b>0.17</b>	Issue Type +	Ma	Location *	WS
Category	Earthen Levee			GPS Latitude/Longitude	
				Start	End
Item	Trim / Thin Trees			37.821376 °	37.821376 °
				-121.378044 °	-121.378044 °
DWR ID	DWR_RD0001_01_s_2014_12				
<b>Action/Comments</b>					
Tree stumps. Inspector Comments: Remove stump when it becomes rotted to prevent possible seepage path along the roots.

View of the tree stump on the waterside levee slope.

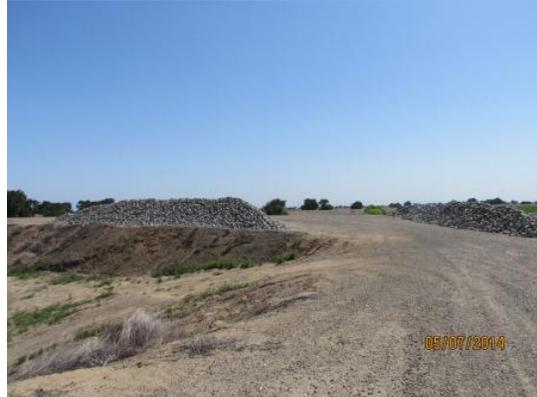
Photo 1 of 1 : FA\_2015\_RD0001\_23\_11\_20150910\_00006.jpg

LM Start	<b>0.24</b>	Rating **	A/W	Issue No.	<b>11</b>
LM End	<b>0.24</b>	Issue Type +	Ma	Location *	CR
Category	Earthen Levee		GPS Latitude/Longitude		
			Start	End	
Item	Encroachments		37.820362 °	37.820362 °	
			-121.378359 °	-121.378359 °	
DWR ID	DWR_RD0001_01_s_2014_11				
Action/Comments					
Material Inspector Comments: Stockpiled riprap on levee crown. Keep the stockpile so that a vehicle could maneuver around the pile to facilitate visibility and access of the levee.

View of the riprap stockpiled on the levee crown.

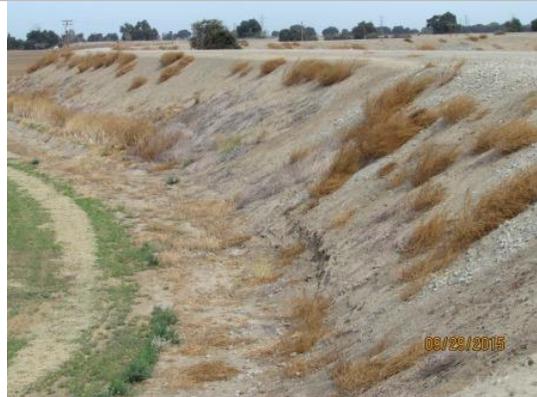
Photo 1 of 1 : FA\_2015\_RD0001\_23\_5\_20151005\_00011.jpg

LM Start	<b>0.51</b>	Rating **	M	Issue No.	<b>5</b>
LM End	<b>0.51</b>	Issue Type +	Ma	Location *	LS
Category	Earthen Levee		GPS Latitude/Longitude		
			Start	End	
Item	Slope Stability		37.818003 °	37.818003 °	
			-121.379845 °	-121.379845 °	
DWR ID	DWR_RD0001_01_f_2015_5				
Action/Comments					
Repair slope instability. Inspector Comments: About a 1 ft. vertical cut is observed at the landside levee toe. Repair the landside levee toe per O&M standards.

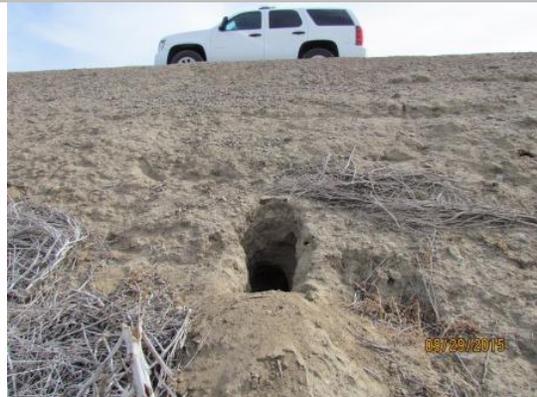
Photo 1 of 1 : FA\_2015\_RD0001\_23\_4\_20151005\_00010.jpg

LM Start	<b>0.76</b>	Rating **	U	Issue No.	<b>4</b>
LM End	<b>0.76</b>	Issue Type +	Ma	Location *	LS
Category	Earthen Levee		GPS Latitude/Longitude		
			Start	End	
Item	Animal Control		37.815881 °	37.815881 °	
			-121.382704 °	-121.382704 °	
DWR ID	DWR_RD0001_01_f_2015_4				
Action/Comments					
Exterminate rodents and backfill and compact or grout burrows. Inspector Comments: Large burrow in the landside levee slope. Possible fox den.

View of a large rodent hole on the landside levee slope.

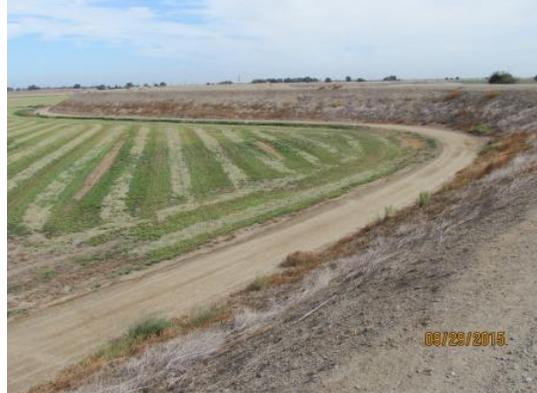
Photo 1 of 1 : FA\_2015\_RD0001\_23\_3\_20151005\_00009.jpg

LM Start	<b>1.11</b>	Rating **	A	Issue No.	<b>3</b>
LM End	<b>1.11</b>	Issue Type +	Ma	Location *	LS
Category	Earthen Levee		GPS Latitude/Longitude		
			Start	End	
Item	Vegetation		37.811839 °	37.811839 °	
			-121.384527 °	-121.384527 °	
DWR ID	DWR_RD0001_01_f_2015_3				
Action/Comments					
Control annual grass and weeds on the levee slopes and easements.

View of the acceptable vegetation control on the landside levee slope.
