**Flood Control Project Maintenance
Levee Inspections**

Maintenance Issue Types Only, Levee Inspection Report By Mile - Spring 2016

Reclamation District No. 0001 Union Island

Waterway	Bank	Unit Miles	Inspection Start/End	Inspector
Unit No. 01 Old River	Right	1.14	03/15/2016 03/15/2016	Maksim Khashchuk

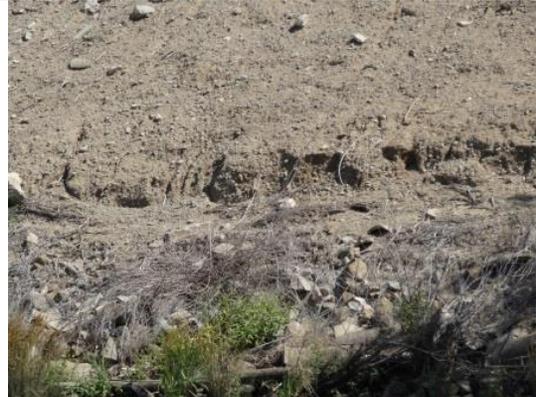
Photo 1 of 2 : SP_2016_RD0001_23_1_20160229_00001.jpg

LM Start	0.00	Rating **	M	Issue No.	1
LM End	0.00	Issue Type +	Ma	Location *	WS
Category	Supplemental			GPS Latitude/Longitude	
				Start	End
Item	DWR Erosion Survey			37.822306 °	37.822306 °
				-121.375304 °	-121.375304 °
DWR ID	DWR_RD0001_01_s_2016_1				
Comment Code					
Inspector Comment					
06/25/2015: No significant change observed. 07/02/2014: No significant change observed. 08/20/2013: No significant change at this site. 08/07/2012: The erosion is at the confluence of Old River and one of its tributary. [2015 Site ID:RD0001U01RM31.4]

Close view of the erosion.

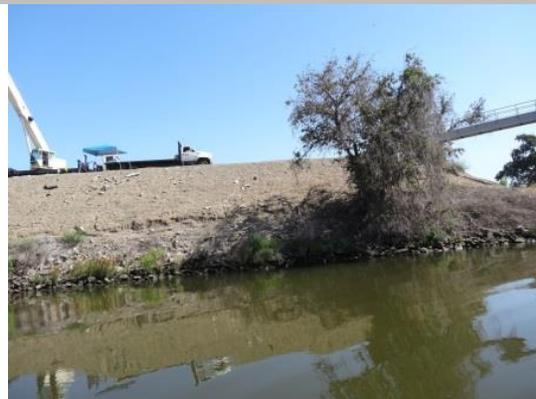
Photo 2 of 2 : SP_2016_RD0001_23_1_20160229_00002.jpg

Front view of the site. Note the large tree on site.

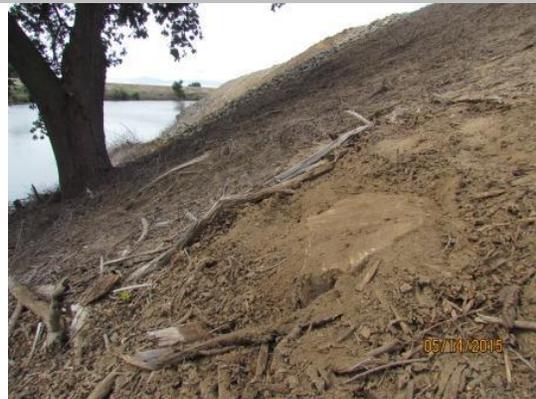
Photo 1 of 1 : SP_2016_RD0001_23_12_20160229_00006.jpg

LM Start	0.17	Rating **	N	Issue No.	12
LM End	0.17	Issue Type +	Ma	Location *	WS
Category	Earthen Levee			GPS Latitude/Longitude	
				Start	End
Item	Trim / Thin Trees			37.821376 °	37.821376 °
				-121.378044 °	-121.378044 °
DWR ID	DWR_RD0001_01_s_2014_12				
Comment Code					
T5 : Tree stumps.					
Inspector Comment					
Remove stump when it becomes rotted to prevent possible seepage path along the roots.

View of the tree stump on the waterside levee slope.

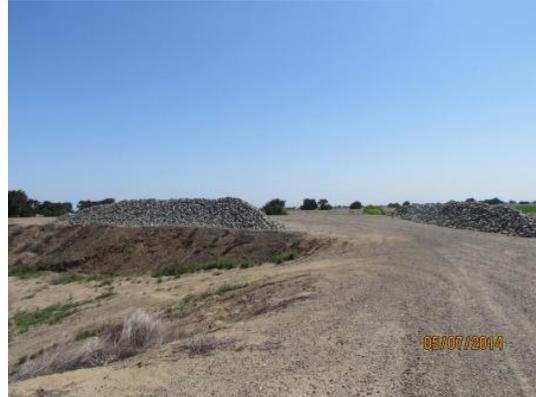
Photo 1 of 1 : SP_2016_RD0001_23_11_20160229_00005.jpg

LM Start	0.24	Rating **	A/W	Issue No.	11
LM End	0.24	Issue Type +	Ma	Location *	CR
Category	Earthen Levee		GPS Latitude/Longitude		
			Start	End	
Item	Encroachments		37.820362 °	37.820362 °	
			-121.378359 °	-121.378359 °	
DWR ID	DWR_RD0001_01_s_2014_11				
Comment Code					
MA : Material					
Inspector Comment					
Stockpiled riprap on levee crown. Keep the stockpile so that a vehicle could maneuver around the pile to facilitate visibility and access of the levee.

View of the riprap stockpiled on the levee crown.

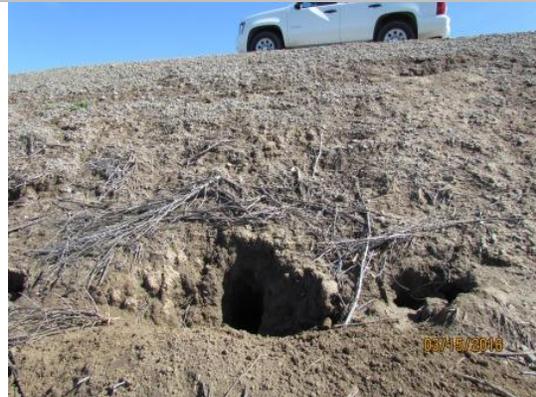
Photo 1 of 1 : SP_2016_RD0001_23_14_20160321_00013.jpg

LM Start	0.44	Rating **	U	Issue No.	14
LM End	0.44	Issue Type +	Ma	Location *	LS
Category	Earthen Levee		GPS Latitude/Longitude		
			Start	End	
Item	Animal Control		37.818898 °	37.818898 °	
			-121.380332 °	-121.380332 °	
DWR ID	DWR_RD0001_01_s_2016_14				
Comment Code					
A1 : Exterminate rodents and backfill and compact or grout burrows.					
Inspector Comment					
Active rodent den a size of a coyote or fox.

View of the large rodent hole on the landside levee slope.

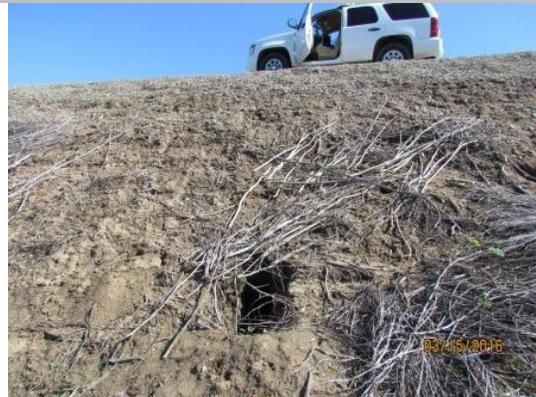
Photo 1 of 1 : SP_2016_RD0001_23_10_20160321_00012.jpg

LM Start	0.45	Rating **	U	Issue No.	10
LM End	0.45	Issue Type +	Ma	Location *	LS
Category	Earthen Levee		GPS Latitude/Longitude		
			Start	End	
Item	Animal Control		37.818753 °	37.818753 °	
			-121.380249 °	-121.380249 °	
DWR ID	DWR_RD0001_01_s_2016_10				
Comment Code					
A3 : No rodents visible, but rodent burrows visible; need to backfill and compact or grout burrows.					
Inspector Comment					
Backfill and compact levee slope with acceptable levee fill.

View of the large rodent hole on the landside levee slope.

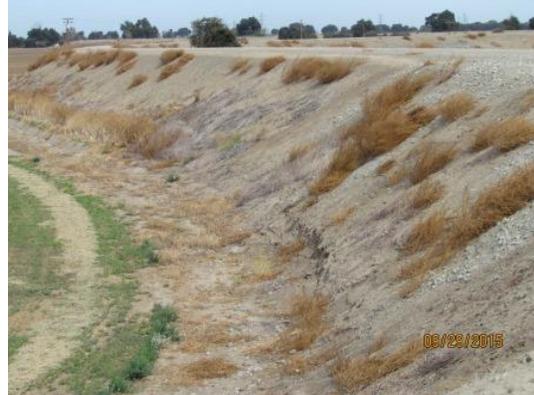
Photo 1 of 1 : SP_2016_RD0001_23_5_20160229_00004.jpg

LM Start	0.51	Rating **	M	Issue No.	5
LM End	0.51	Issue Type +	Ma	Location *	LS
Category	Earthen Levee		GPS Latitude/Longitude		
			Start	End	
Item	Slope Stability		37.818003 °	37.818003 °	
			-121.379845 °	-121.379845 °	
DWR ID	DWR_RD0001_01_f_2015_5				
Comment Code					
S1 : Repair slope instability.					
Inspector Comment					
About a 1 ft. vertical cut is observed at the landside levee toe. Repair the landside levee toe per O&M standards.

View of the vertical cut at the landside levee toe.

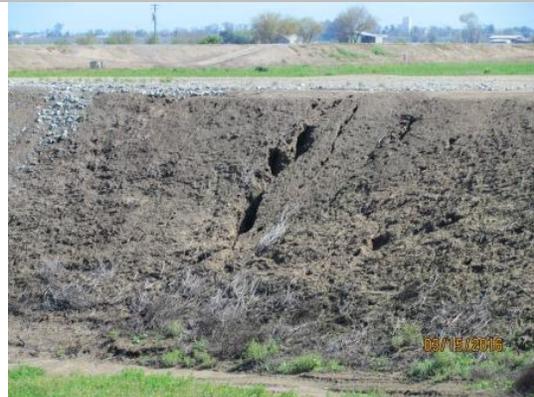
Photo 1 of 1 : SP_2016_RD0001_23_7_20160321_00011.jpg

LM Start	0.52	Rating **	M	Issue No.	7
LM End	0.52	Issue Type +	Ma	Location *	LS
Category	Earthen Levee		GPS Latitude/Longitude		
			Start	End	
Item	Erosion / Bank Caving		37.817825 °	37.817825 °	
			-121.379811 °	-121.379811 °	
DWR ID	DWR_RD0001_01_s_2016_7				
Comment Code					
E2 : Schedule repair of erosion site prior to the next inspection.					
Inspector Comment

View of the erosion on the landside levee slope.

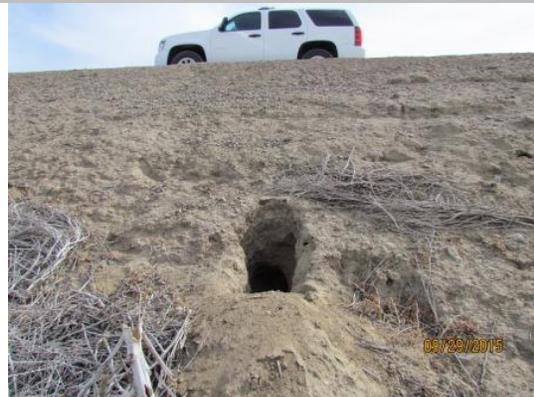
Photo 1 of 1 : SP_2016_RD0001_23_4_20160229_00003.jpg

LM Start	0.76	Rating **	U	Issue No.	4
LM End	0.76	Issue Type +	Ma	Location *	LS
Category	Earthen Levee		GPS Latitude/Longitude		
			Start	End	
Item	Animal Control		37.815881 °	37.815881 °	
			-121.382704 °	-121.382704 °	
DWR ID	DWR_RD0001_01_f_2015_4				
Comment Code					
A1 : Exterminate rodents and backfill and compact or grout burrows.					
Inspector Comment					
Large burrow in the landside levee slope. Possible fox den.

View of a large rodent hole on the landside levee slope.

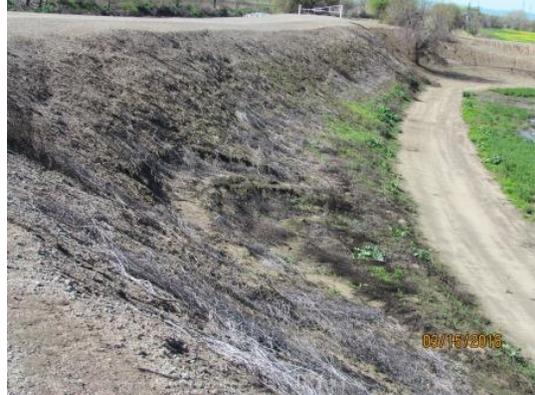
Photo 1 of 1 : SP_2016_RD0001_23_3_20160321_00010.jpg

LM Start	1.08	Rating **	M	Issue No.	3
LM End	1.08	Issue Type +	Ma	Location *	LS
Category	Earthen Levee		GPS Latitude/Longitude		
			Start	End	
Item	Slope Stability		37.812023 °	37.812023 °	
			-121.383961 °	-121.383961 °	
DWR ID	DWR_RD0001_01_s_2016_3				
Comment Code					
S3 : Repair the levee slope damaged by vehicle traffic and prevent access where possible.					
Inspector Comment					
Repair slope damaged by vehicle by placing and compacting acceptable levee material.

View of the landside slope damaged by farm equipment.
