**Flood Control Project Maintenance  
Levee Inspections**  
**LMA District Cover Sheet**  
**Spring 2011 Levee Inspection Results**

**Reclamation District No. 0001 Union Island**

**Levee Inspection Report By Mile - Spring 2011**

| Waterway | Bank | Unit Miles | Inspection Start/End | Inspector |
|---|---|---|---|---|
| Unit No. 01 Old River | Right | 1.15 | 04/26/2011<br>04/26/2011 | Jim Eto |

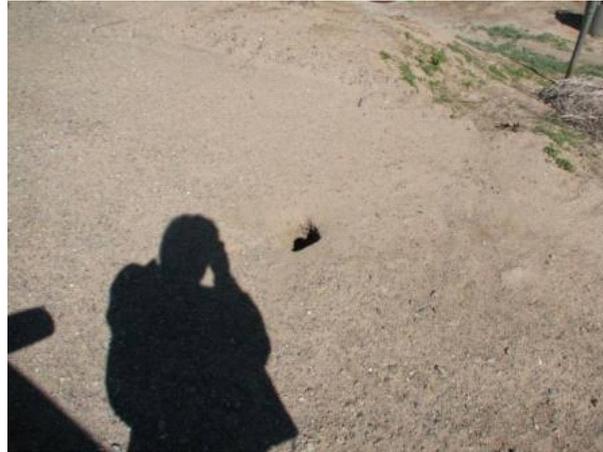
| Levee Mile Report Line | 3 |

| LMR No. | Levee Mile | | Category | Item | Location | Rating | Action/Comment | GPS Latitude/Longitude | | Issue No.<br>Photo |
|---|---|---|---|---|---|---|--|---|---|---|
| 3 | 0.02 | 0.02 | Earthen Levee | Animal Control | LS | M | No rodents visible, but rodent burrows visible; need to backfill and compact or grout burrows.<br>Inspector Comments: Several burrows present | 37.822511 °<br>-121.375857 ° | 37.822511 °<br>-121.375857 ° | 18<br>Y |

| 04/26/2011 Animal burrow in levee crown. | |

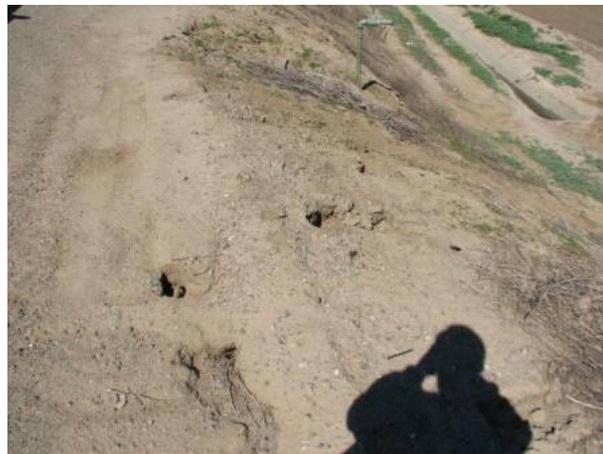
| Levee Mile Report Line | 3 |

| 04/26/2011 Several burrows present in levee crown and landside slope. | |

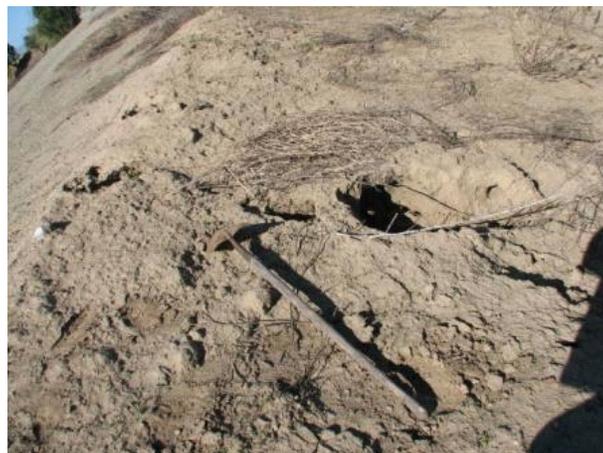
| Levee Mile Report Line | 4 |

| LMR No. | Levee Mile | | Category | Item | Location | Rating | Action/Comment | GPS Latitude/Longitude | | Issue No.<br>Photo |
|---|---|---|---|---|---|---|--|---|---|---|
| 4 | 0.02 | 0.02 | Earthen Levee | Erosion / Bank Caving | LS | M | Schedule repair of erosion site prior to the next inspection.<br>Inspector Comments: Erosion ccurring in area requiring animal control. | 37.822511 °<br>-121.375857 ° | 37.822511 °<br>-121.375857 ° | 3<br>Y |

| 04/26/2011 Erosion, possibly started by animal burrows. | |

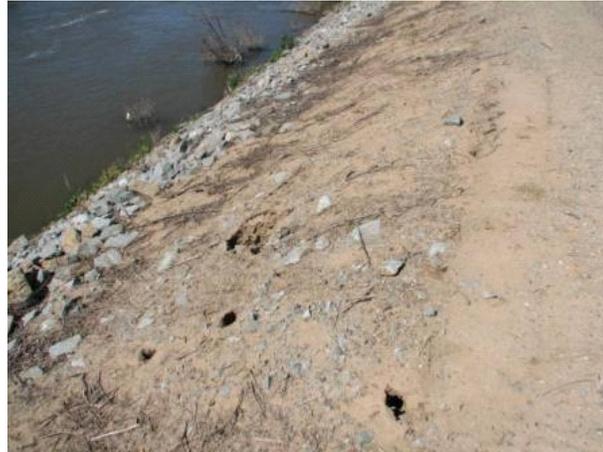
| Levee Mile Report Line | 5 |

| LMR No. | Levee Mile | | Category | Item | Location | Rating | Action/Comment | GPS Latitude/Longitude | | Issue No.<br>Photo |
|---|---|---|---|---|---|---|--|---|---|---|
| 5 | 0.03 | 0.03 | Earthen Levee | Animal Control | WS | M | No rodents visible, but rodent burrows visible; need to backfill and compact or grout burrows.<br>Inspector Comments: Burrow evident on water side, burrow appears to have collapsed. | 37.822403 °<br>-121.375937 ° | 37.822403 °<br>-121.375937 ° | 4<br>Y |

| 04/26/2011 Several burrows present on water side, burrows appear to be collapsing. | |

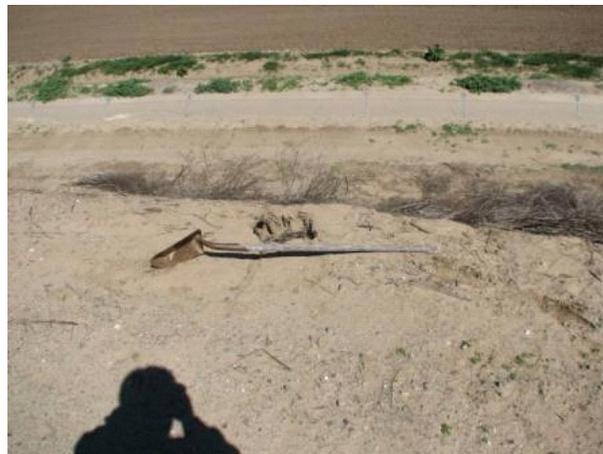
| Levee Mile Report Line | 6 |

| LMR No. | Levee Mile | | Category | Item | Location | Rating | Action/Comment | GPS Latitude/Longitude | | Issue No.<br>Photo |
|---|---|---|---|---|---|---|--|---|---|---|
| 6 | 0.07 | 0.07 | Earthen Levee | Erosion / Bank Caving | LS | M | Note and monitor erosion site.<br>Inspector Comments: Monitor site, erosion appears to be starting due to water runoff at this point | 37.822268 °<br>-121.376762 ° | 37.822268 °<br>-121.376762 ° | 6<br>Y |

| 04/26/2011 Erosion starting at crown. Appears to be caused by storm runoff. | |

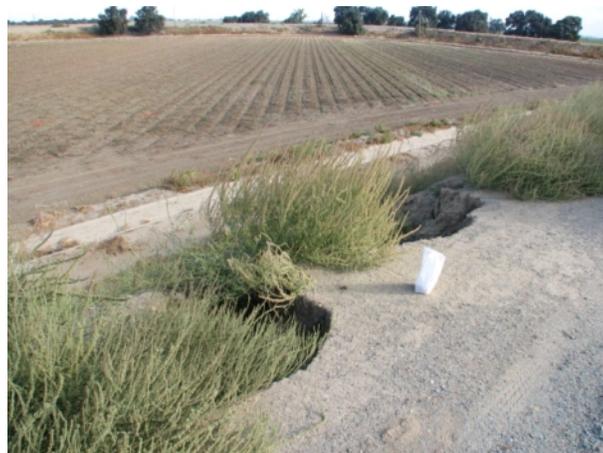
| Levee Mile Report Line | 7 |

| LMR No. | Levee Mile | | Category | Item | Location | Rating | Action/Comment | GPS Latitude/Longitude | | Issue No.<br>Photo |
|---|---|---|---|---|---|---|--|---|---|---|
| 7 | 0.11 | 0.11 | Earthen Levee | Erosion / Bank Caving | LS | U | Schedule repair of erosion site prior to the next inspection.<br>Inspector Comments: Landside slope is eroded creating two large holes at the hinge point.04/26/2011 Repairs have been made to a portion of the location, but are not adequate and need further attention. | 37.822051 °<br>-121.377320 ° | 37.822051 °<br>-121.377320 ° | 2<br>Y |

| Two large erosion locations present on landside levee slope. | |

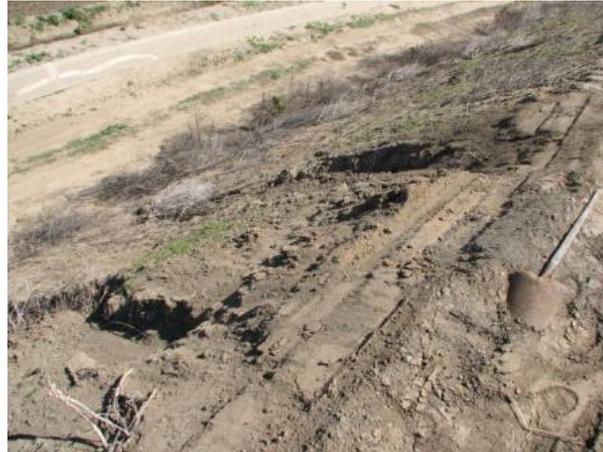
| Levee Mile Report Line | 7 |

| <p>04/26/2011 Crown damage has been repaired, damage remains on landside slope, needs to be filled and compacted.</p> | |

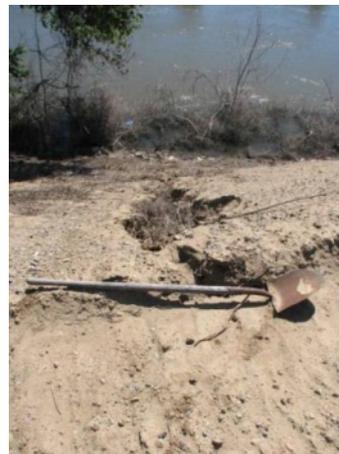
| Levee Mile Report Line | 8 |

| LMR No. | Levee Mile | | Category | Item | Location | Rating | Action/Comment | GPS Latitude/Longitude | | Issue No.<br>Photo |
|---|---|---|---|---|---|---|--|---|---|---|
| 8 | 0.17 | 0.17 | Earthen Levee | Erosion / Bank Caving | WS | M | Note and monitor erosion site.<br>Inspector Comments: Monitor erosion site crown is approximately 40' wide at this point. | 37.821461 °<br>-121.378110 ° | 37.821461 °<br>-121.378110 ° | 8<br>Y |

| <p>04/26/2011 Erosion on landside slope, levee is approximately 40' wide at this point.</p> | |

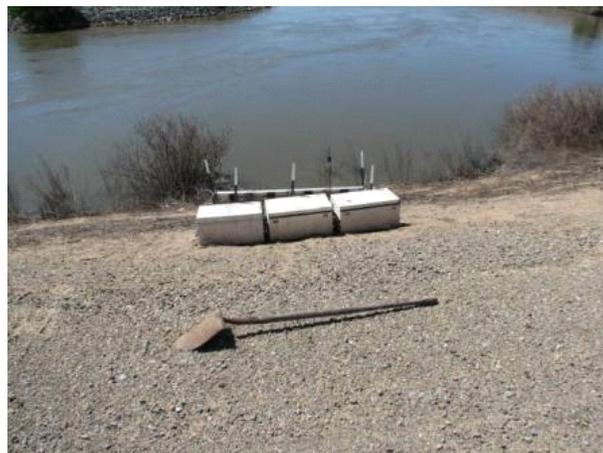
| Levee Mile Report Line | 11 |

| LMR No. | Levee Mile | | Category | Item | Location | Rating | Action/Comment | GPS Latitude/Longitude | | Issue No.<br>Photo |
|---|---|---|---|---|---|---|--|---|---|---|
| 11 | 0.29 | 0.29 | Earthen Levee | Encroachments | WS | A | Equipment<br>Inspector Comments: Solar powered monitoring(?) equipment. | 37.820338 °<br>-121.379095 ° | 37.820338 °<br>-121.379095 ° | 22<br>Y |

| <p>04/26/2011 Appears to be monitoring equipment of some type, solar panels located on water side. An antennae is present between the second and third (from left to right) units.</p> | |

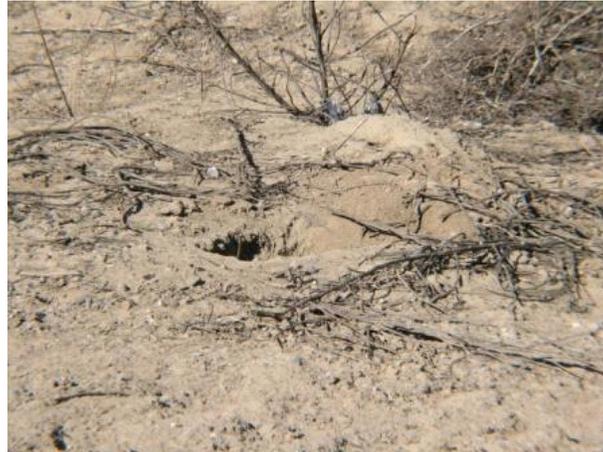
| Levee Mile Report Line | 12 |

| LMR No. | Levee Mile | | Category | Item | Location | Rating | Action/Comment | GPS Latitude/Longitude | | Issue No.<br>Photo |
|---|---|---|---|---|---|---|--|---|---|---|
| 12 | 0.35 | 0.35 | Earthen Levee | Animal Control | LS | M | No rodents visible, but rodent burrows visible; need to backfill and compact or grout burrows.<br>Inspector Comments: 04/26/2011 Active burrows present | 37.820187 °<br>-121.380150 ° | 37.820187 °<br>-121.380150 ° | 12<br>Y |

| 04/26/2011 Active animal burrow on landside slope. | |

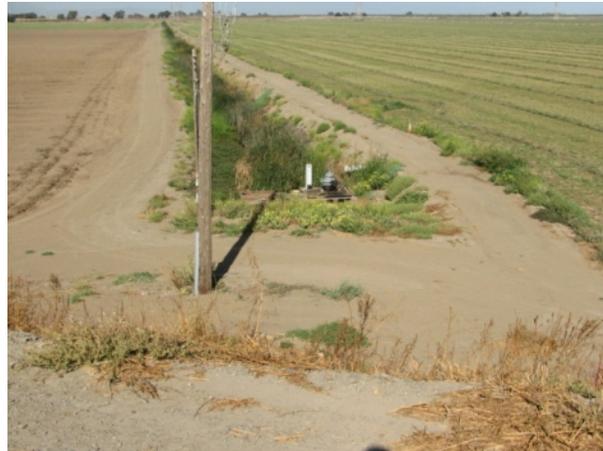
| Levee Mile Report Line | 13 |

| LMR No. | Levee Mile | | Category | Item | Location | Rating | Action/Comment | GPS Latitude/Longitude | | Issue No.<br>Photo |
|---|---|---|---|---|---|---|--|---|---|---|
| 13 | 0.39 | 0.39 | Earthen Levee | Encroachments | WS | W | Pipe<br>Inspector Comments: Irrigation intake through levee crown. | 37.819651 °<br>-121.380467 ° | 37.819651 °<br>-121.380467 ° | 7<br>Y |

| Drainage discharge pipe through levee freeboard. | |

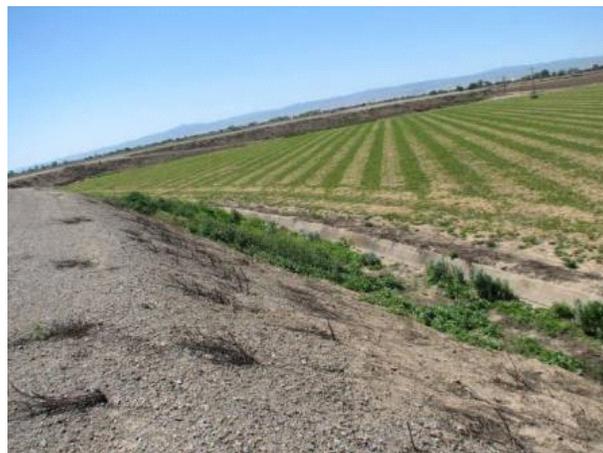
| Levee Mile Report Line | 14 |

| LMR No. | Levee Mile | | Category | Item | Location | Rating | Action/Comment | GPS Latitude/Longitude | | Issue No.<br>Photo |
|---|---|---|---|---|---|---|--|---|---|---|
| 14 | 0.41 | 0.51 | Earthen Levee | Vegetation | LS | M | Control annual grass and weeds on the levee slopes and easements. | 37.819197 °<br>-121.380517 ° | 37.818032 °<br>-121.379797 ° | 23<br>Y |

| Weeds taller than 12" obstruct visibility of landside slope. | |

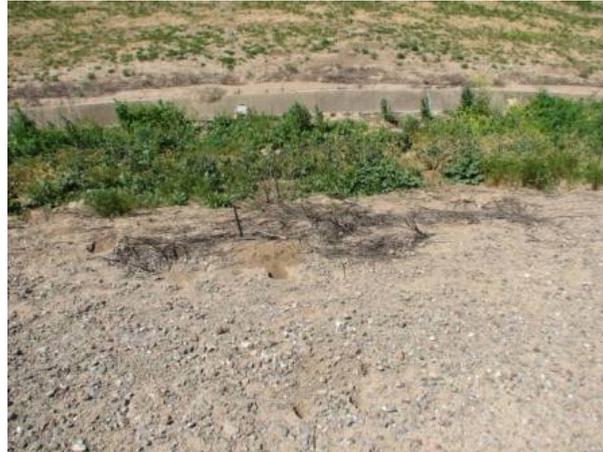
| Levee Mile Report Line | 15 |

| LMR No. | Levee Mile | | Category | Item | Location | Rating | Action/Comment | GPS Latitude/Longitude | | Issue No.<br>Photo |
|---|---|---|---|---|---|---|---|---|---|---|
| 15 | 0.43 | 0.48 | Earthen Levee | Animal Control | LS | M | No rodents visible, but rodent burrows visible; need to backfill and compact or grout burrows.<br>Inspector Comments: Numerous active burrows as evidenced by fresh soil around holes. Burrows are within overgrown vegetation. | 37.818849 °<br>-121.380309 ° | 37.818360 °<br>-121.379956 ° | 24<br>Y |

| 04/26/2011 Numerous active burrows present as evidenced by fresh soil around holes. | |

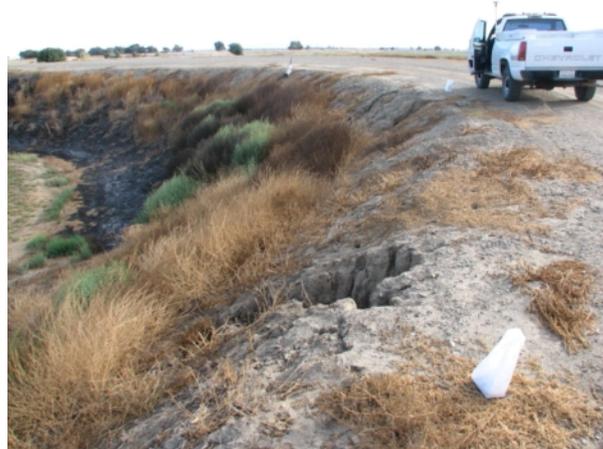
| Levee Mile Report Line | 16 |

| LMR No. | Levee Mile | | Category | Item | Location | Rating | Action/Comment | GPS Latitude/Longitude | | Issue No.<br>Photo |
|---|---|---|---|---|---|---|---|---|---|---|
| 16 | 0.54 | 0.54 | Earthen Levee | Erosion / Bank Caving | LS | M | Schedule repair of erosion site prior to the next inspection.<br>Inspector Comments: Crown width 50'. 04/26/2011 Repair work is not sufficient, crown has been filled, but erosion on levee landside slope has not been repaired. | 37.817515 °<br>-121.379943 ° | 37.817515 °<br>-121.379943 ° | 9<br>Y |

| Erosion of landside slope at several spots due to surface runoff. | |

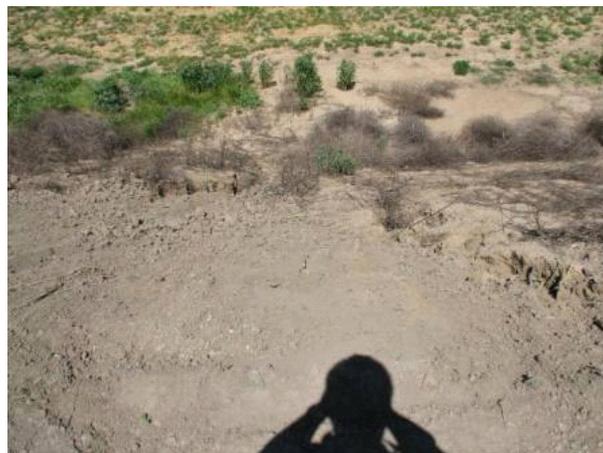
| Levee Mile Report Line | 16 |

| 04/26/2011 Landside erosion is still present after crown repair. | |

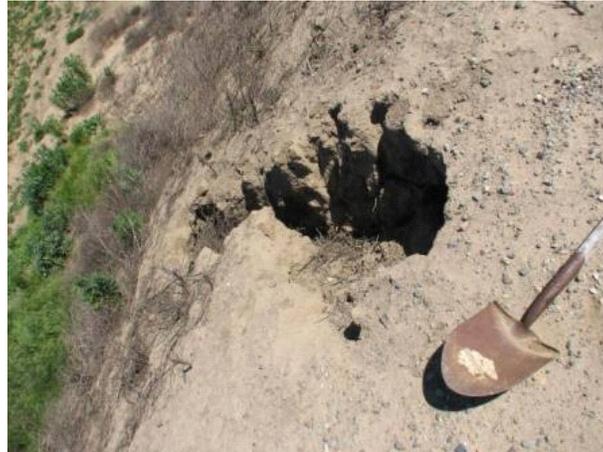
| Levee Mile Report Line | 17 |

| LMR No. | Levee Mile | | Category | Item | Location | Rating | Action/Comment | GPS Latitude/Longitude | | Issue No.<br>Photo |
|---|---|---|---|---|---|---|---|---|---|---|
| 17 | 0.56 | 0.56 | Earthen Levee | Erosion / Bank Caving | LS | M | Schedule repair of erosion site prior to the next inspection.<br>Inspector Comments: New erosion site adjacent to erosion site at LM 0.54 that must also be addressed. | 37.817535 °<br>-121.380279 ° | 37.817535 °<br>-121.380279 ° | 25<br>Y |

| 04/26/2011 Erosion at hinge point continuing down landside slope. | |

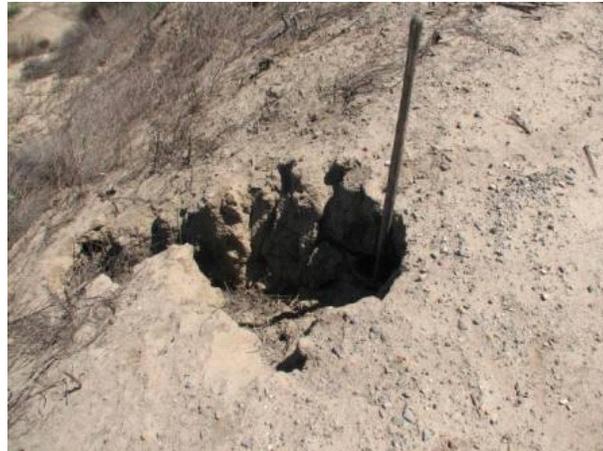
| Levee Mile Report Line | 17 |

| 04/26/2011 Photo showing depth of erosion at hinge point. | |

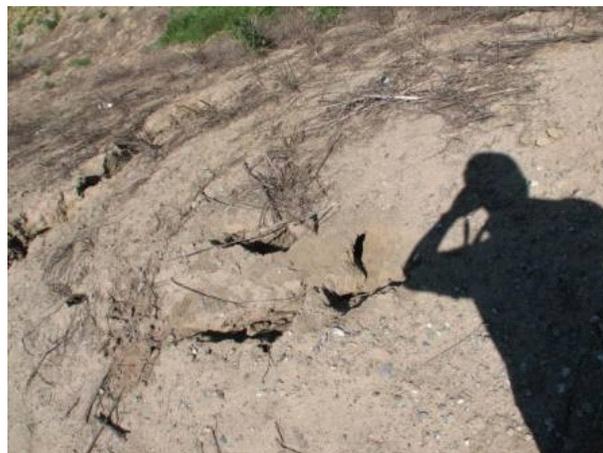
| Levee Mile Report Line | 18 |

| LMR No. | Levee Mile | | Category | Item | Location | Rating | Action/Comment | GPS Latitude/Longitude | | Issue No.<br>Photo |
|---|---|---|---|---|---|---|---|---|---|---|
| 18 | 0.56 | 0.56 | Earthen Levee | Animal Control | LS | M | No rodents visible, but rodent burrows visible; need to backfill and compact or grout burrows.<br>Inspector Comments: Active burrows present, burrows are within erosion site. | 37.817547 °<br>-121.380285 ° | 37.817547 °<br>-121.380285 ° | 26<br>Y |

| 04/26/2011 Animal burrows within erosion site. | |

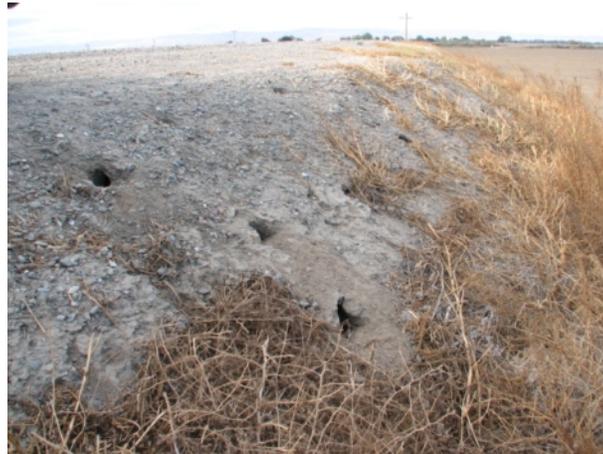
| Levee Mile Report Line | 19 |

| LMR No. | Levee Mile | | Category | Item | Location | Rating | Action/Comment | GPS Latitude/Longitude | | Issue No.<br>Photo |
|---|---|---|---|---|---|---|---|---|---|---|
| 19 | 0.66 | 0.66 | Earthen Levee | Animal Control | LS | M | No rodents visible, but rodent burrows visible; need to backfill and compact or grout burrows. | 37.817249 °<br>-121.382026 ° | 37.817249 °<br>-121.382026 ° | 15<br>Y |

| Active rodent holes on levee slope. | |

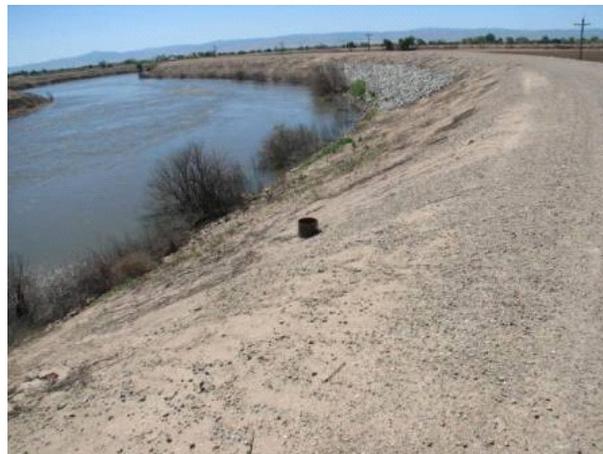
| Levee Mile Report Line | 20 |

| LMR No. | Levee Mile | | Category | Item | Location | Rating | Action/Comment | GPS Latitude/Longitude | | Issue No.<br>Photo |
|---|---|---|---|---|---|---|---|---|---|---|
| 20 | 0.67 | 0.67 | Earthen Levee | Encroachments | LS | W | Pipe<br>Inspector Comments: photo Drainage discharge into Old River. No photo found from prev insp. 04/26/2011 photo added. | 37.817134 °<br>-121.382099 ° | 37.817134 °<br>-121.382099 ° | 20<br>Y |

| 04/26/2011 Discharge pipe in water side slope. | |

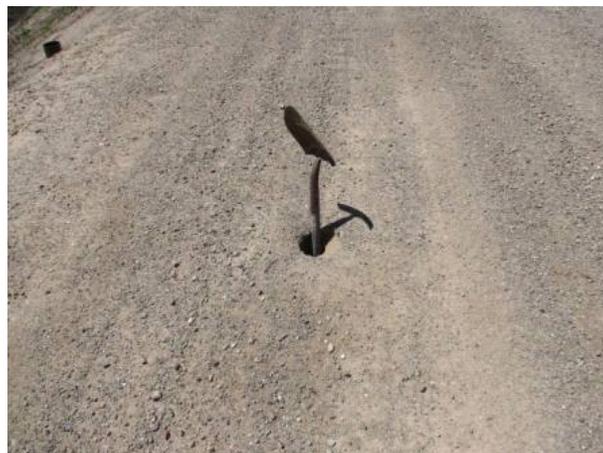
| Levee Mile Report Line | 21 |

| LMR No. | Levee Mile | | Category | Item | Location | Rating | Action/Comment | GPS Latitude/Longitude | | Issue No.<br>Photo |
|---|---|---|---|---|---|---|---|---|---|---|
| 21 | 0.67 | 0.67 | Earthen Levee | Animal Control | CR | M | No rodents visible, but rodent burrows visible; need to backfill and compact or grout burrows.<br>Inspector Comments: Deep vertical rodent hole in crown of levee, see photo. Shovel handle stopped at bend in burrow. | 37.817109 °<br>-121.382192 ° | 37.817109 °<br>-121.382192 ° | 27<br>Y |

| 04/26/2011 Deep vertical burrow in levee crown. | |
