**Flood Control Project Maintenance
Levee Inspections
LMA District Cover Sheet
Spring 2013 Levee Inspection Results**

Reclamation District No. 0001 Union Island

Spring 2013 Levee Inspection Results

Waterway		Bank	Unit Miles
Unit No. 01 Old River		Right	1.15

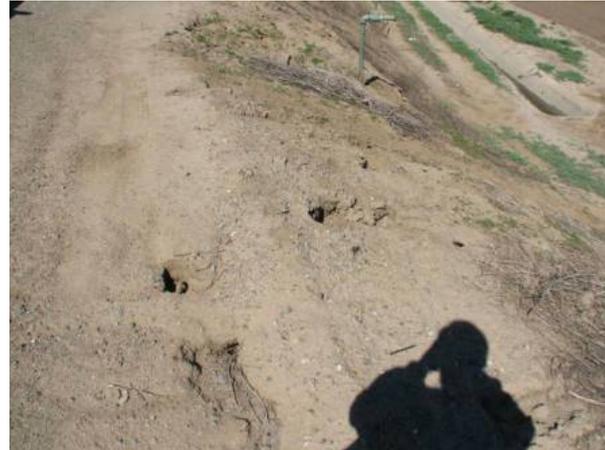
Levee Mile Report Line	6
Start Levee Mile	0.02
End Levee Mile	0.02
Location	Land Side
Category	
Item	Animal Control
04/26/2011 Several burrows present in levee crown and landside slope.	
mkhashch_s_20130225_305.jpg

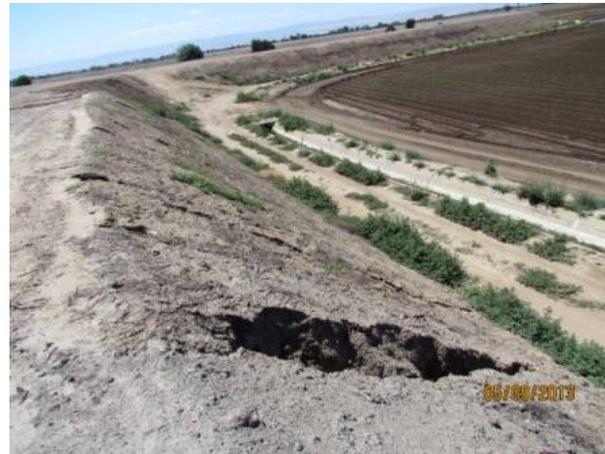
Levee Mile Report Line	8
Start Levee Mile	0.20
End Levee Mile	0.20
Location	Land Side
Category	
Item	Erosion / Bank Caving
View of the erosion on the landside levee slope.	
mkhashch_s_20130509_737.JPG

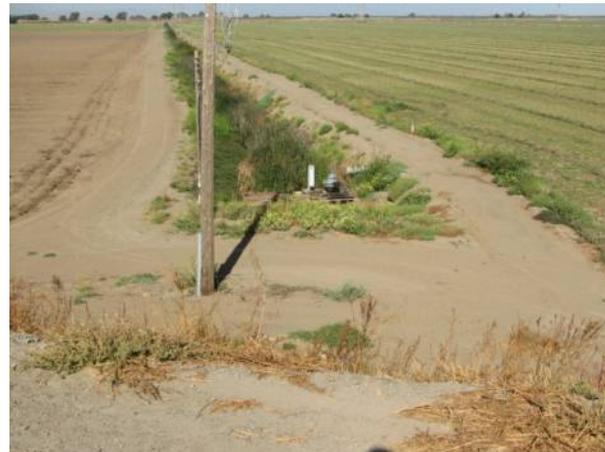
Levee Mile Report Line	9
Start Levee Mile	0.39
End Levee Mile	0.39
Location	Water Side
Category	
Item	Encroachments
Drainage discharge pipe through levee freeboard.	
mkhashch_s_20130225_299.jpg

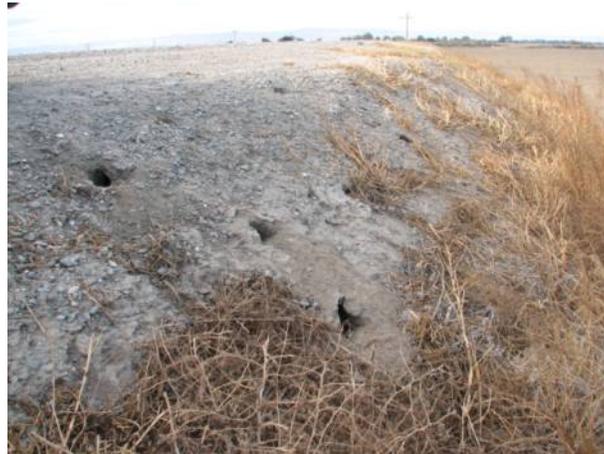
DWR ID: DWR_RD0001_01_s_2012_7			
10	0.66	0.66		Animal Control	LS	M	A3 : No rodents visible, but rodent burrows visible; need to backfill and compact or grout burrows.	37.817249 ° -121.382026 °	37.817249 ° -121.382026 °	15 Y	
								DWR ID: DWR_RD0001_01_s_2012_15			
11	0.67	0.67		Encroachments	LS A/W	PI : Pipe	Inspector Comments: Drainage discharge into Old River. No photo found from previous inspection. 04/26/2011 photo added.	37.817134 ° -121.382099 °	37.817134 ° -121.382099 °	20 Y	
								DWR ID: DWR_RD0001_01_s_2012_20			
12	0.86	0.86		Encroachments	LS A/W	PI : Pipe	Inspector Comments: Irrigation intake through levee freeboard.	37.814566 ° -121.382450 °	37.814566 ° -121.382450 °	10 Y	
								DWR ID: DWR_RD0001_01_s_2012_10

Levee Mile Report Line	10
Start Levee Mile	0.66
End Levee Mile	0.66
Location	Land Side
Category	
Item	Animal Control
Rodent holes on levee slope.	
mkhashch_s_20130225_303.jpg

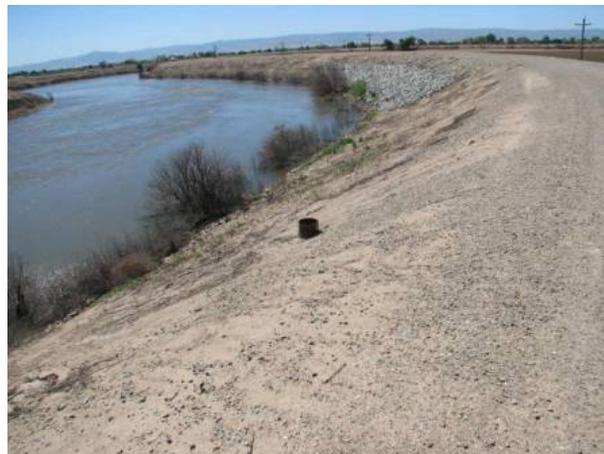
Levee Mile Report Line	11
Start Levee Mile	0.67
End Levee Mile	0.67
Location	Land Side
Category	
Item	Encroachments
04/26/2011 Discharge pipe in water side slope.	
mkhashch_s_20130225_306.jpg

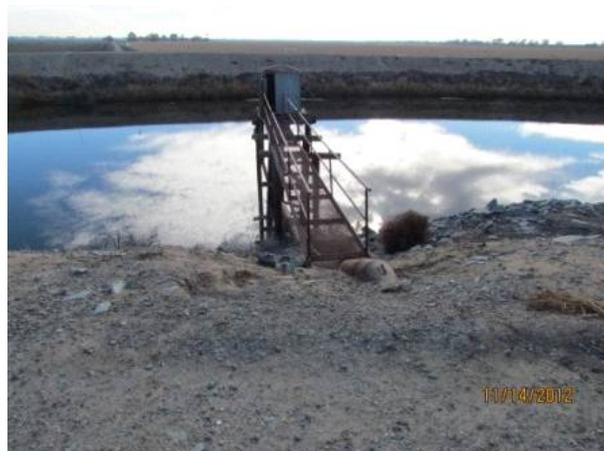
Levee Mile Report Line	12
Start Levee Mile	0.86
End Levee Mile	0.86
Location	Land Side
Category	
Item	Encroachments
View of irrigation intake pipe on waterside.	
mkhashch_s_20130225_300.JPG

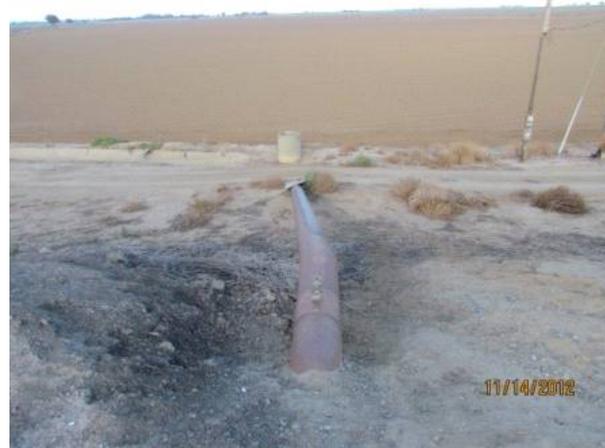
Levee Mile Report Line	12
Start Levee Mile	0.86
End Levee Mile	0.86
Location	Land Side
Category	
Item	Encroachments
View of irrigation pipe on landside.	
mkhashch_s_20130225_301.JPG

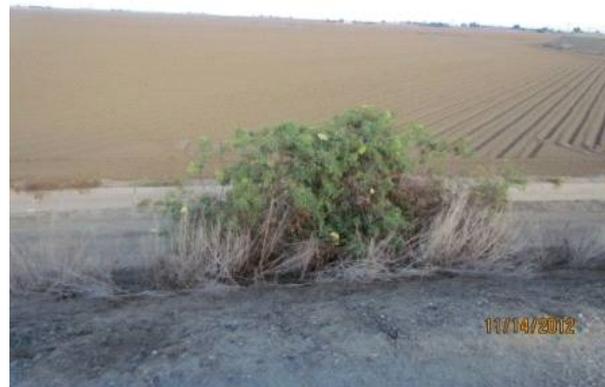
LMIR No.	Levee Mile		Category	Item	* Location	** Rating	Action/Comment	GPS Latitude/Longitude		Issue No. Photo
	Start	End						Start	End	
13	0.91	0.91		Vegetation	LS	M Ma	V4 : Elderberries are blocking visibility and flood fight capability.	37.814220 ° -121.383336 °	37.814220 ° -121.383336 °	11 Y
DWR ID: DWR_RD0001_01_s_ 2012_11										
14	1.09	1.09		Slope Stability	LS	M Ma	S3 : Repair the levee slope damaged by vehicle traffic and prevent access where possible.	37.812021 ° -121.384020 °	37.812021 ° -121.384020 °	3 Y
DWR ID: DWR_RD0001_01_s_ 2013_3

Levee Mile Report Line	13
Start Levee Mile	0.91
End Levee Mile	0.91
Location	Land Side
Category	
Item	Vegetation
View of Elderberries blocking visibility of landside slope and toe.	
mkhashch_s_20130225_302.JPG

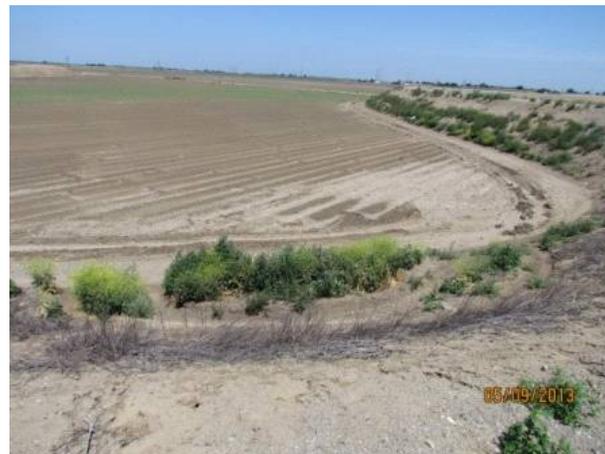
Levee Mile Report Line	14
Start Levee Mile	1.09
End Levee Mile	1.09
Location	Land Side
Category	
Item	Slope Stability
View of the tire tracks on the landside levee slope.	
mkhashch_s_20130509_736.JPG
