**Flood Control Project Maintenance
Levee Inspections
LMA District Cover Sheet
Spring 2011 Levee Inspection Results**

Reclamation District No. 0003 Grand Island

Spring 2011 Levee Inspection Results

Waterway	Bank	Unit Miles
Unit No. 01 Left Bank Steamboat Slough	Left	11.03

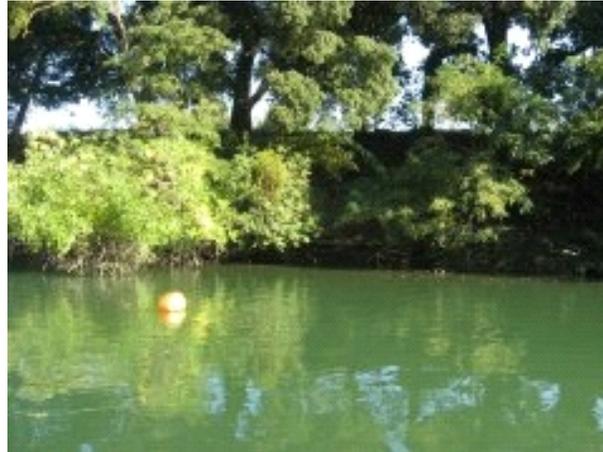
Levee Mile Report Line	3
Start Levee Mile	0.18
End Levee Mile	0.25
Location	Water Side
Category	Supplemental
Item	USACE Erosion Survey
2009: 5 ft berm, 1.5:1 slope, tree hazards, holes, and slumping, clays and silts, 4.76 ft/s [2009 SiteID:STM_26-0_L]	
richard_s_20110215_024.JPG

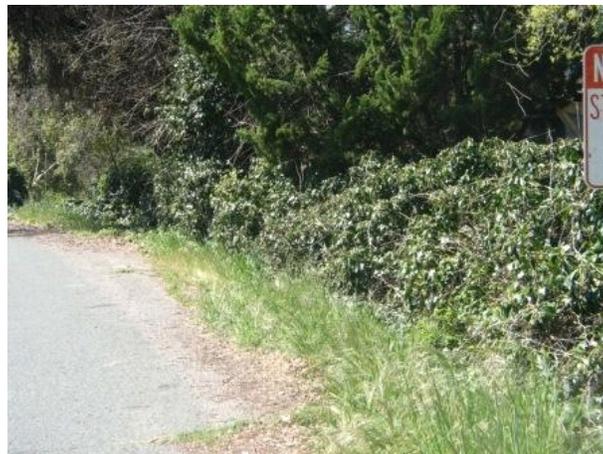
Levee Mile Report Line	4
Start Levee Mile	0.22
End Levee Mile	0.33
Location	Water Side
Category	Earthen Levee
Item	Encroachments
Dense landscaping on waterside from LM 0.22 to 0.28	
richard_s_20110215_015.jpg

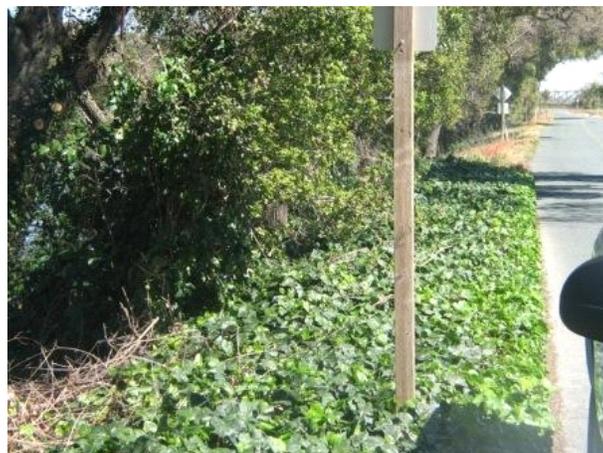
Levee Mile Report Line	4
Start Levee Mile	0.22
End Levee Mile	0.33
Location	Water Side
Category	Earthen Levee
Item	Encroachments
Looking upstream at dense landscaping on waterside slope from LM 0.22 to 0.28	
richard_s_20110215_016.jpg

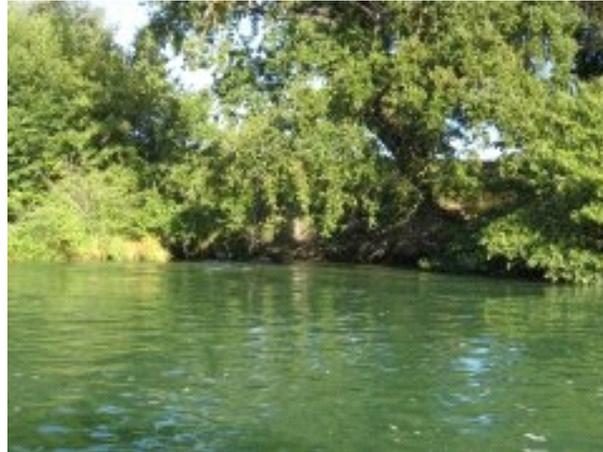
Levee Mile Report Line	9
Start Levee Mile	0.92
End Levee Mile	0.97
Location	Water Side
Category	Supplemental
Item	USACE Erosion Survey
2009: 5 ft berm, 1.5:1 slope, tree hazards and holes, clays and silts, 4.48 ft/s [2009 SiteID:STM_25-0_L]	
richard_s_20110215_026.JPG

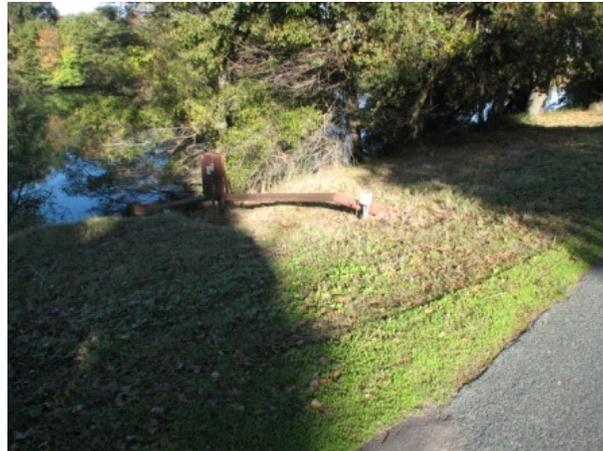
Levee Mile Report Line	10
Start Levee Mile	0.97
End Levee Mile	0.97
Location	Crown
Category	Earthen Levee
Item	Encroachments
Irrigation intake pipe from Steamboat Slough.	
richard_s_20110215_032.jpg

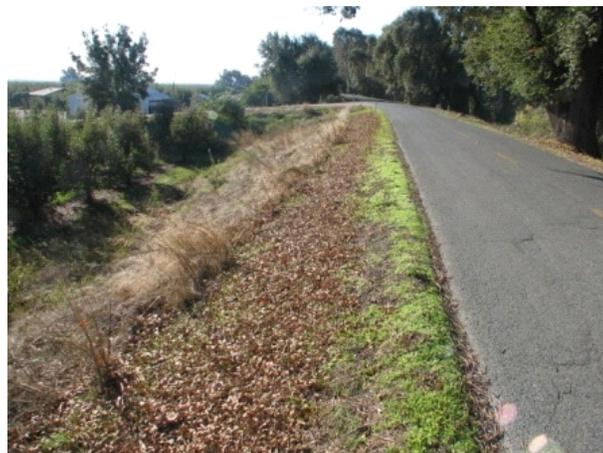
Levee Mile Report Line	11
Start Levee Mile	1.01
End Levee Mile	1.03
Location	Land Side
Category	Earthen Levee
Item	Vegetation
Grass on levee slope and toe exceeds 12" and partially obstructs visibility.	
richard_s_20110215_033.jpg

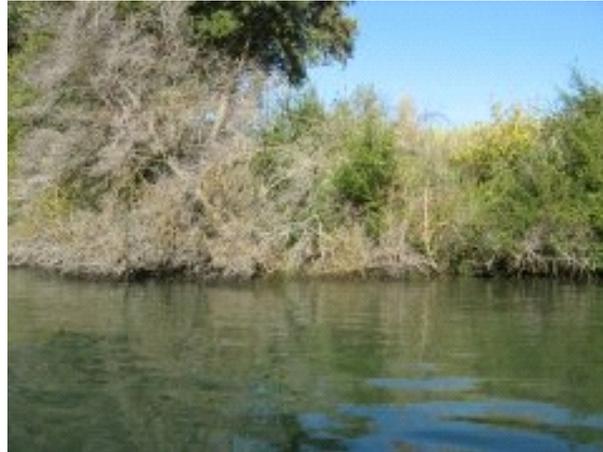
Levee Mile Report Line	12
Start Levee Mile	1.04
End Levee Mile	1.08
Location	Water Side
Category	Supplemental
Item	USACE Erosion Survey
2009: no berm, 1.5:1 slope, tree hazards and holes, clays and silts, 4.9 ft/s [2009 SiteID:STM_24-8_L]	
richard_s_20110215_030.JPG

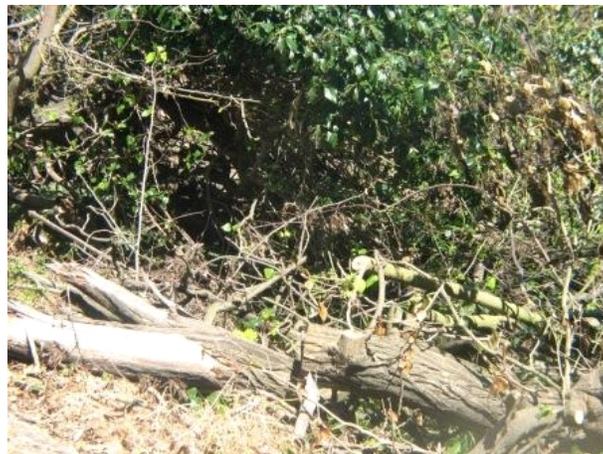
Levee Mile Report Line	13
Start Levee Mile	1.08
End Levee Mile	1.09
Location	Land Side
Category	Earthen Levee
Item	Encroachments
Down tree limbs on landside slope from LM 1.08 to 1.09	
richard_s_20110215_018.jpg

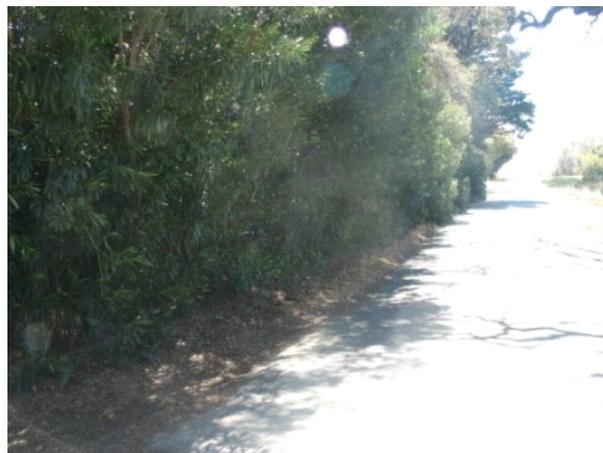
Levee Mile Report Line	14
Start Levee Mile	1.21
End Levee Mile	1.27
Location	Land Side
Category	Earthen Levee
Item	Encroachments
Landscaping on landside slope block view of levee from LM 1.21 to 1.27	
richard_s_20110215_019.jpg

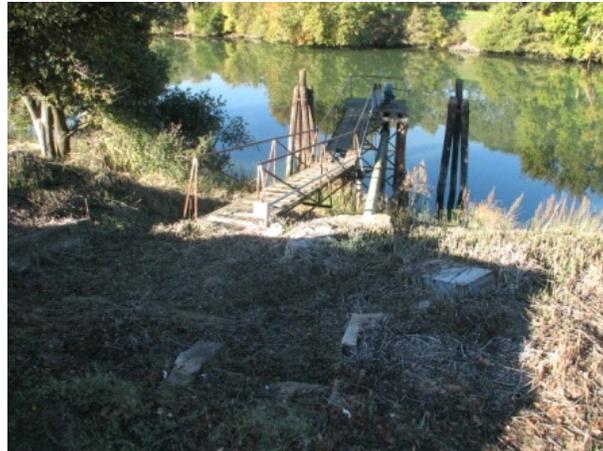
Levee Mile Report Line	16
Start Levee Mile	1.32
End Levee Mile	1.32
Location	Water Side
Category	Earthen Levee
Item	Encroachments
Irrigation pipe penetration.	
richard_s_20110215_034.jpg

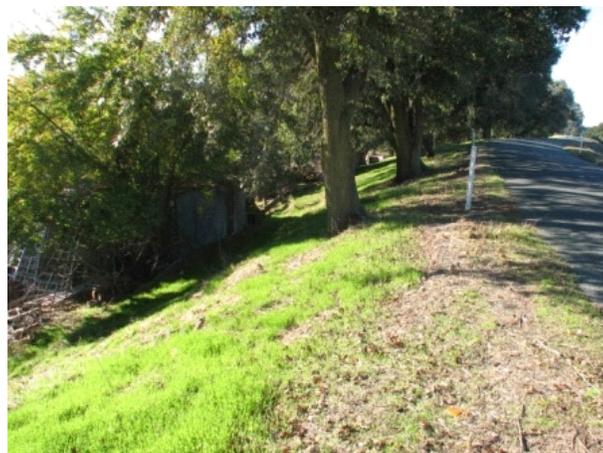
Levee Mile Report Line	17
Start Levee Mile	1.40
End Levee Mile	1.40
Location	Land Side
Category	Earthen Levee
Item	Encroachments
Equipment on levee slope and within 10' of levee toe obstructs access and visibility.	
richard_s_20110215_035.jpg

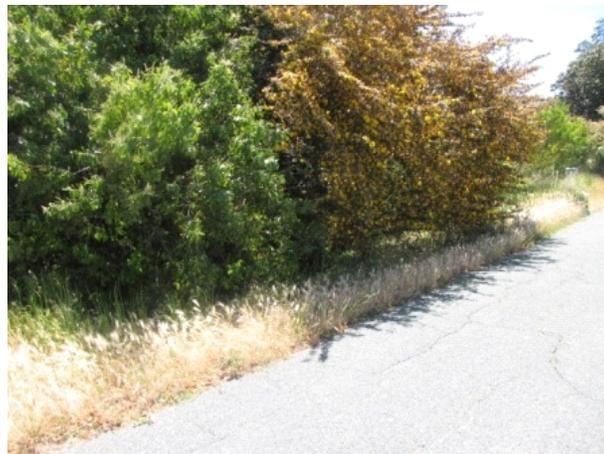
Levee Mile Report Line	19
Start Levee Mile	1.61
End Levee Mile	1.61
Location	Land Side
Category	Earthen Levee
Item	Trim / Thin Trees
Looking northeast at dense trees on landside slope.	
richard_s_20110215_017.jpg

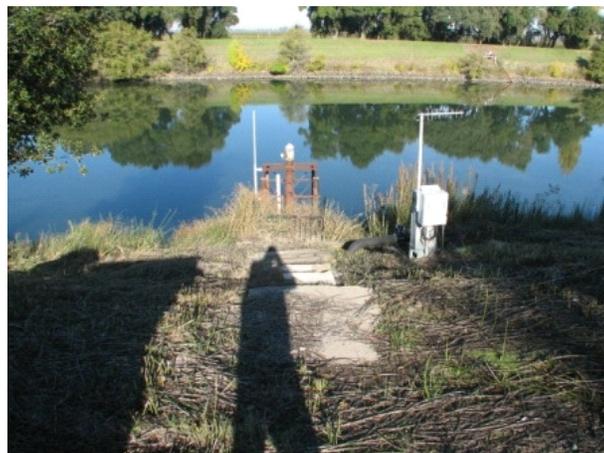
Levee Mile Report Line	20
Start Levee Mile	1.62
End Levee Mile	1.62
Location	Water Side
Category	Earthen Levee
Item	Encroachments
Photo of pipe penetration and USGS equipment.	
richard_s_20110215_036.jpg

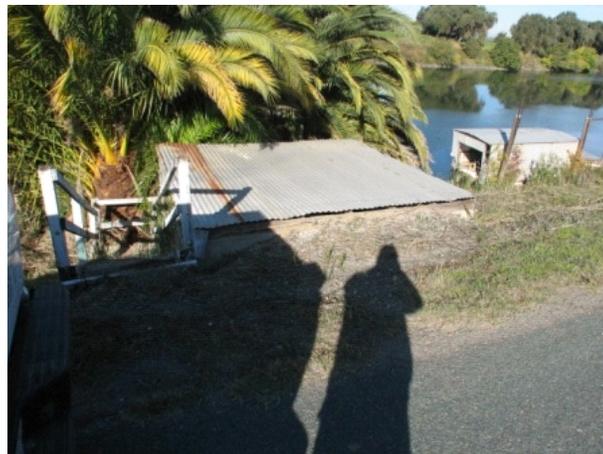
Levee Mile Report Line	25
Start Levee Mile	2.07
End Levee Mile	2.07
Location	Water Side
Category	Earthen Levee
Item	Encroachments
Pipe penetration and pump shed on waterside slope.	
richard_s_20110215_037.jpg

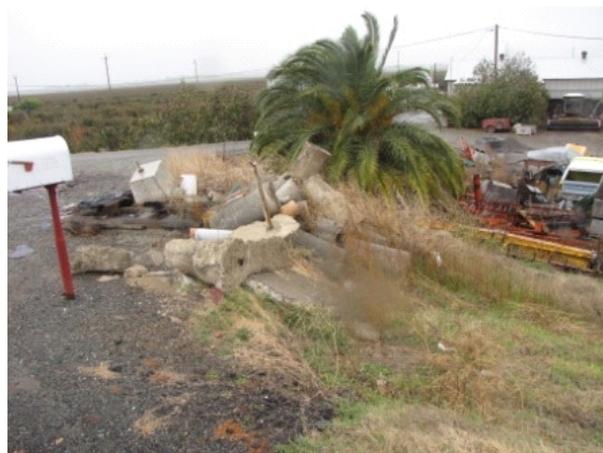
Levee Mile Report Line	26
Start Levee Mile	2.11
End Levee Mile	2.11
Location	Land Side
Category	Earthen Levee
Item	Encroachments
Looking northeast at concrete rubble at landside shoulder and ramp.	
richard_s_20110215_053.jpg

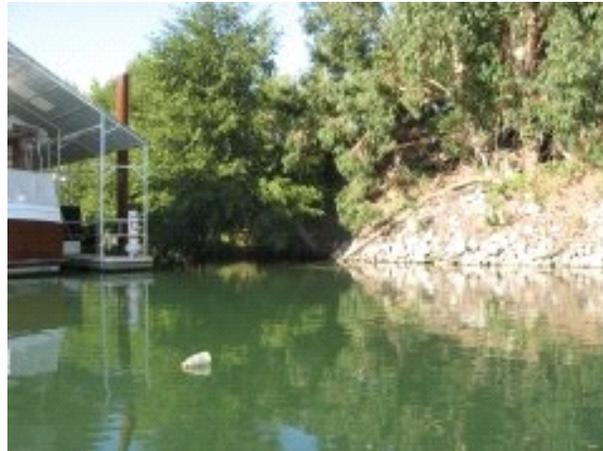
Levee Mile Report Line	30
Start Levee Mile	2.80
End Levee Mile	2.83
Location	Water Side
Category	Supplemental
Item	USACE Erosion Survey
2009: no berm, 1.5:1 slope, tree hazards, clays and silts, 4.66 ft/s [2009 SiteID:STM_23-2_L]	
richard_s_20110215_031.JPG

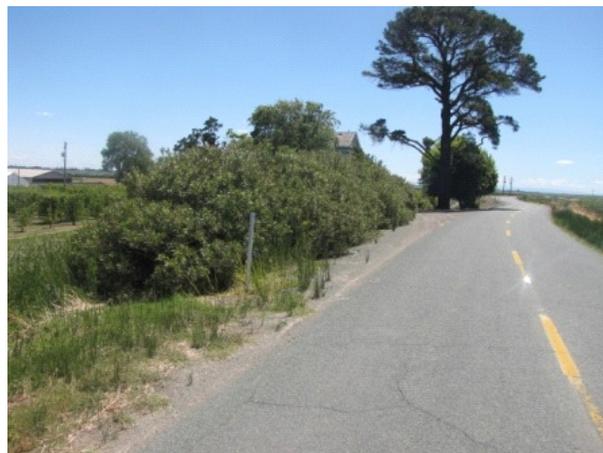
Levee Mile Report Line	34
Start Levee Mile	3.13
End Levee Mile	3.15
Location	Land Side
Category	Earthen Levee
Item	Encroachments
Looking northeast at dense veg. on landside slope.	
richard_s_20110215_021.jpg

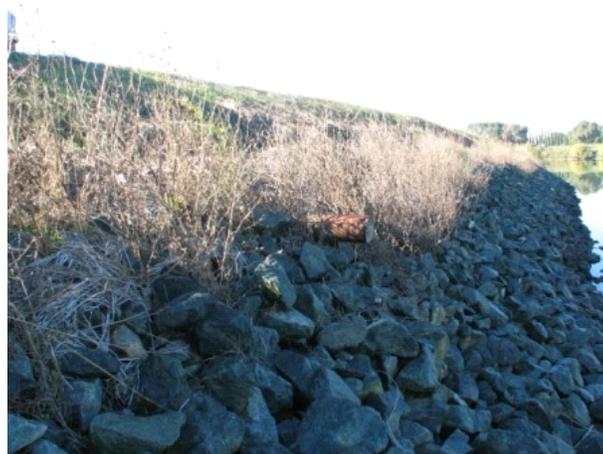
Levee Mile Report Line	39
Start Levee Mile	3.52
End Levee Mile	3.52
Location	Crown
Category	Earthen Levee
Item	Encroachments
Abandoned pipe penetration. Pipe has been grouted.	
richard_s_20110215_039.jpg

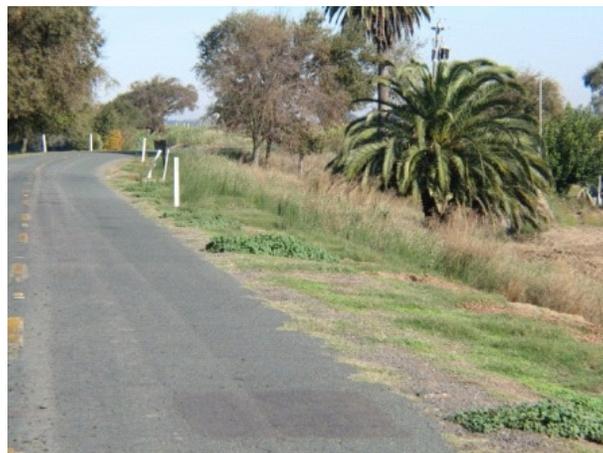
Levee Mile Report Line	46
Start Levee Mile	4.30
End Levee Mile	4.49
Location	Land Side
Category	Earthen Levee
Item	Vegetation
Vegetation on levee slopes and toe partially obstruct visibility.	
richard_s_20110215_040.jpg

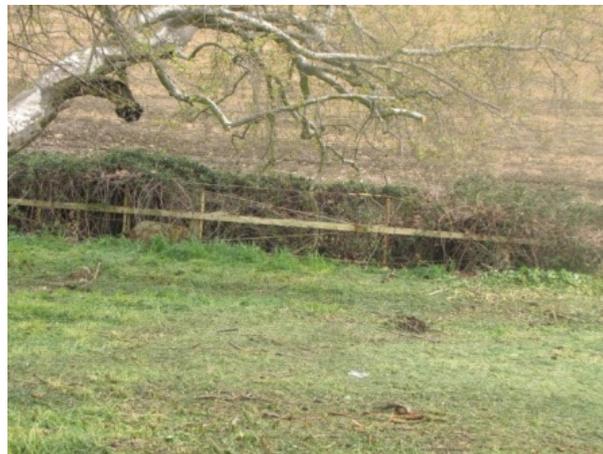
Levee Mile Report Line	54
Start Levee Mile	5.70
End Levee Mile	5.70
Location	Land Side
Category	Earthen Levee
Item	Encroachments
Looking east at dense vegetation covering farm equipment on landside toe.	
richard_s_20110318_451.jpg

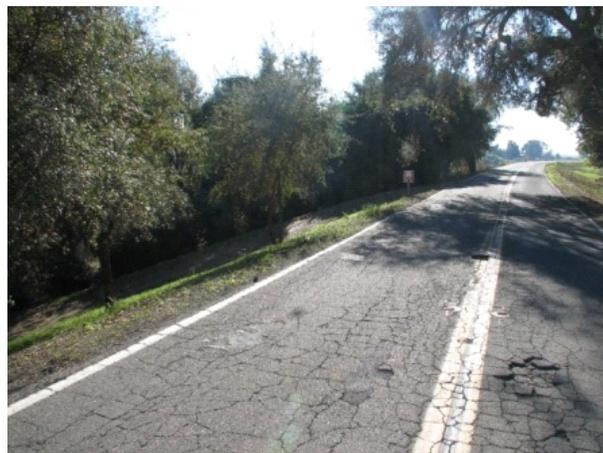
Levee Mile Report Line	55
Start Levee Mile	5.76
End Levee Mile	5.76
Location	Land Side
Category	Earthen Levee
Item	Encroachments
Landscaping on levee slope and within 10' of levee toe obstruct visibility and access.	
richard_s_20110215_041.jpg

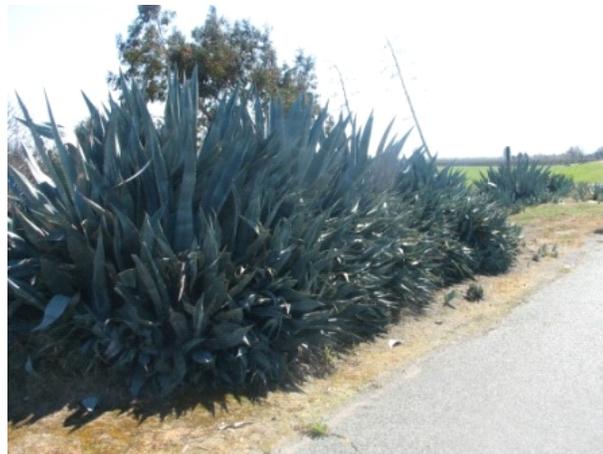
Levee Mile Report Line	62
Start Levee Mile	7.08
End Levee Mile	7.10
Location	Land Side
Category	Earthen Levee
Item	Encroachments
Large Cactus plant on landside shoulder block view of levee slope from LM 7.08 to 7.10	
richard_s_20110215_022.jpg

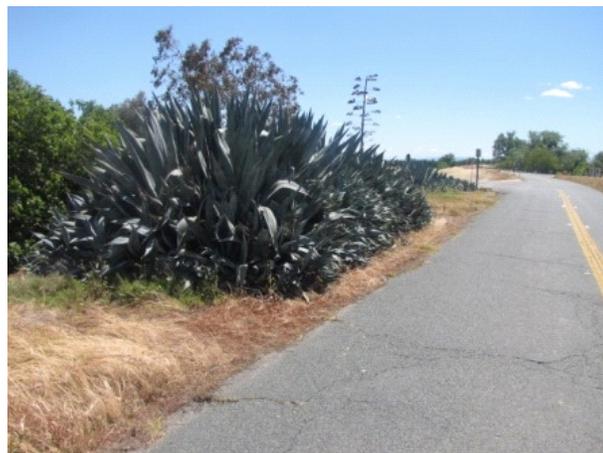
Levee Mile Report Line	62
Start Levee Mile	7.08
End Levee Mile	7.10
Location	Land Side
Category	Earthen Levee
Item	Encroachments
Looking northeast at updated picture (5/2010) century plant on landside shoulder and slope.	
richard_s_20110215_023.jpg

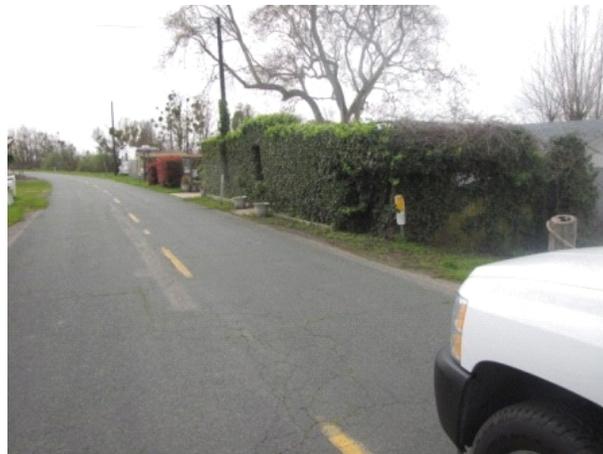
Levee Mile Report Line	65
Start Levee Mile	7.68
End Levee Mile	7.68
Location	Water Side
Category	Earthen Levee
Item	Encroachments
Looking southwest at landscaping in front of a house on waterside berm. Also not in the picture a building on landside berm.	
richard_s_20110318_452.jpg

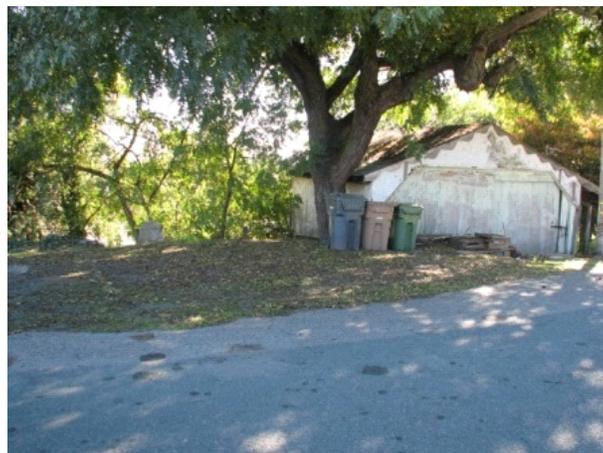
Levee Mile Report Line	66
Start Levee Mile	7.69
End Levee Mile	7.69
Location	Land Side
Category	Earthen Levee
Item	Encroachments
Buildings obstruct access and visibility of levee slope and toe.	
richard_s_20110215_045.jpg

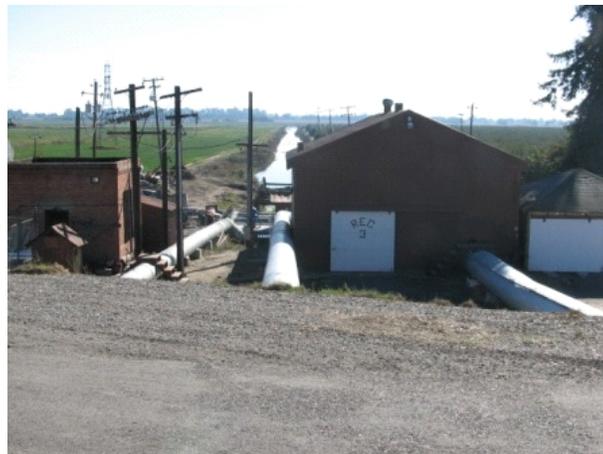
Levee Mile Report Line	79
Start Levee Mile	8.75
End Levee Mile	8.75
Location	Water Side
Category	Earthen Levee
Item	Encroachments
Interior drainage discharge pipes penetrate levee.	
richard_s_20110215_047.jpg

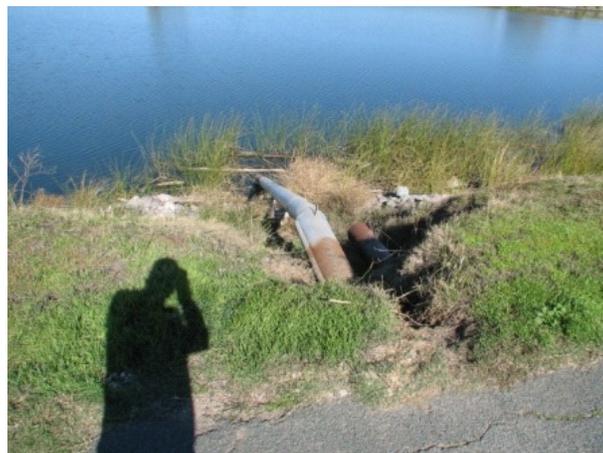
Levee Mile Report Line	83
Start Levee Mile	9.19
End Levee Mile	9.19
Location	Water Side
Category	Earthen Levee
Item	Erosion / Bank Caving
Erosion occurring around pipe penetration.	
richard_s_20110215_049.jpg

83	9.19	9.19	Earthen Levee	Erosion / Bank Caving	WS	M	Schedule repair of erosion site prior to the next inspection. Inspector Comments: Erosion around pipe penetration	38.192301 ° -121.624394 °	38.192301 ° -121.624394 °	89 Y
84	9.19	9.19	Earthen Levee	Encroachments	WS	W	Pipe	38.192306 ° -121.624473 °	38.192306 ° -121.624473 °	88 Y
85	10.19	10.19	Earthen Levee	Encroachments	WS	W	Pipe	38.188725 ° -121.641070 °	38.188725 ° -121.641070 °	90
86	10.20	10.22	Earthen Levee	Trim / Thin Trees	LS	M	Trim and thin trees to allow visibility of the ground and room to flood fight. Inspector Comments: Picture no. 8	38.188613 ° -121.641175 °	38.188388 ° -121.641485 °	27 Y

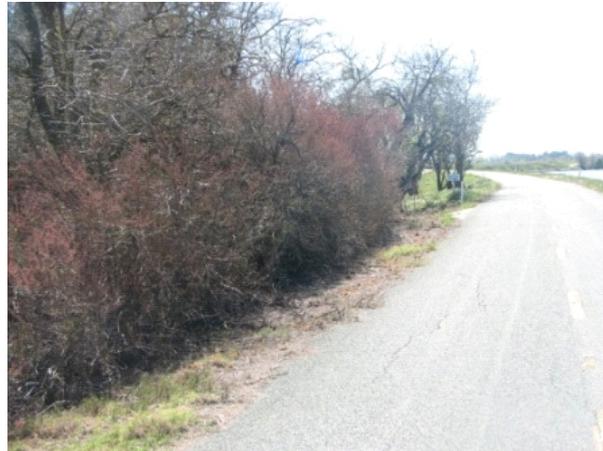
Levee Mile Report Line	86
Start Levee Mile	10.20
End Levee Mile	10.22
Location	Land Side
Category	Earthen Levee
Item	Trim / Thin Trees
Trees to be trimmed on landside shoulder from LM 10.20 to 10.22	
richard_s_20110215_027.jpg

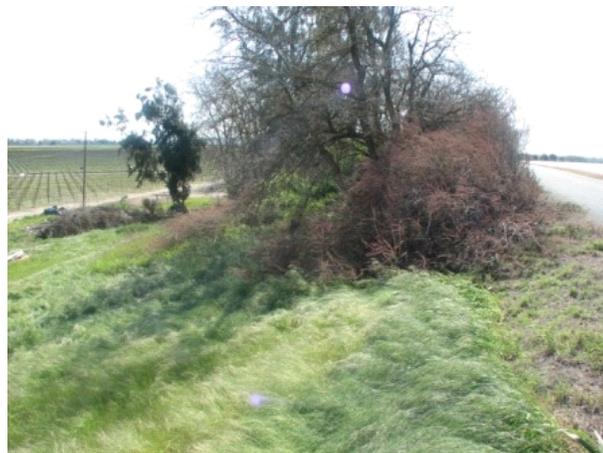
Levee Mile Report Line	86
Start Levee Mile	10.20
End Levee Mile	10.22
Location	Land Side
Category	Earthen Levee
Item	Trim / Thin Trees
Side view of trees on landside shoulder.	
richard_s_20110215_028.jpg

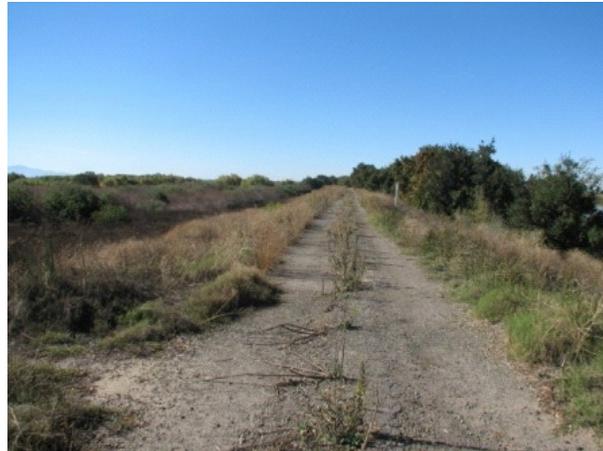
Levee Mile Report Line	89
Start Levee Mile	10.87
End Levee Mile	11.01
Location	Land Side
Category	Earthen Levee
Item	Vegetation
Photo from locked gate of obstructive vegetation on levee slopes and crown.	
richard_s_20110215_050.jpg

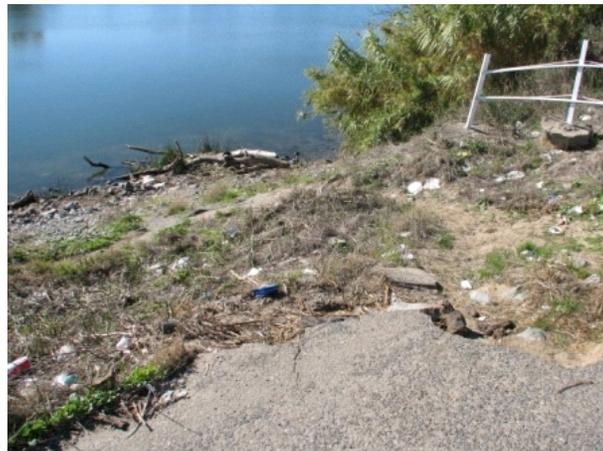
Levee Mile Report Line	7
Start Levee Mile	0.40
End Levee Mile	0.40
Location	Water Side
Category	Earthen Levee
Item	Erosion / Bank Caving

Slope instability caused by foot traffic on levee slope.

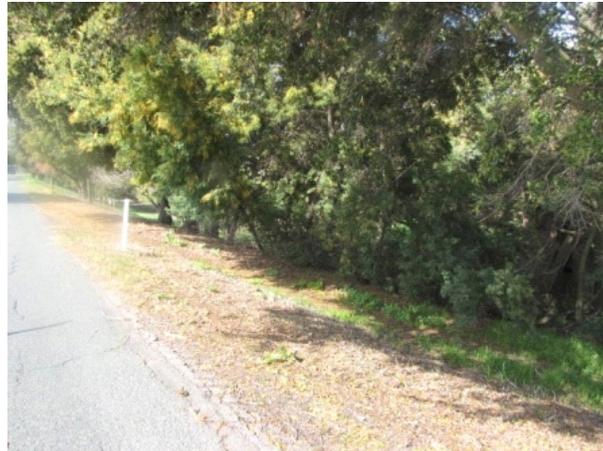
Levee Mile Report Line	16
Start Levee Mile	3.29
End Levee Mile	3.29
Location	Land Side
Category	Earthen Levee
Item	Trim / Thin Trees
Looking west at dense vegetation on landside slope and toe.	
richard_s_20110318_453.jpg

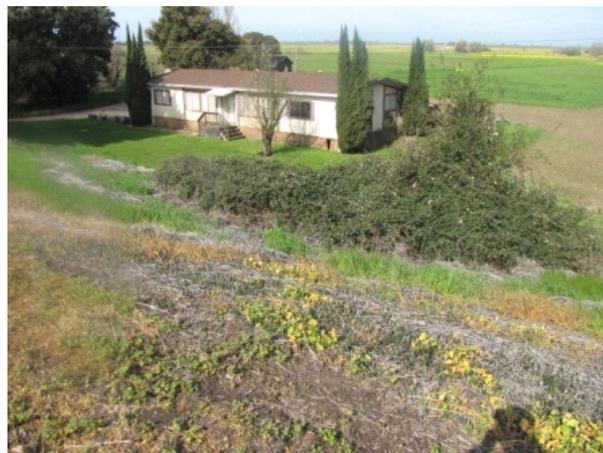
Levee Mile Report Line	17
Start Levee Mile	3.32
End Levee Mile	3.32
Location	Land Side
Category	Earthen Levee
Item	Vegetation
Looking west at berryvines on landside toe.	
richard_s_20110318_454.jpg

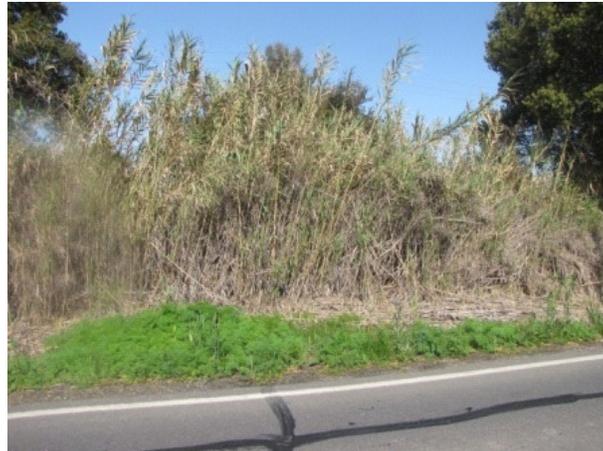
Levee Mile Report Line	21
Start Levee Mile	3.87
End Levee Mile	3.87
Location	Land Side
Category	Earthen Levee
Item	Vegetation
Looking west at dense bamboo on landside slope.	
richard_s_20110318_455.jpg

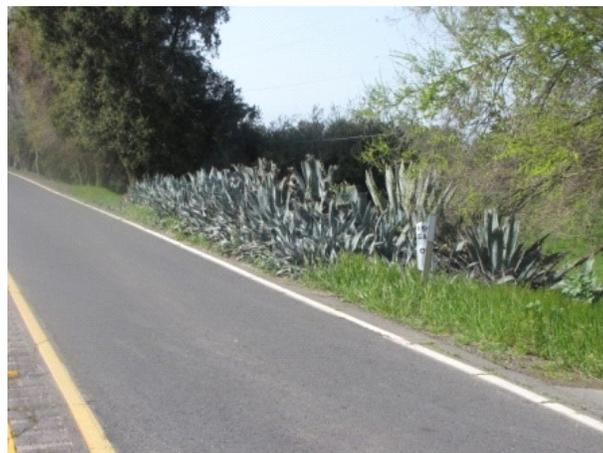
Levee Mile Report Line	24
Start Levee Mile	4.22
End Levee Mile	4.22
Location	Land Side
Category	Earthen Levee
Item	Vegetation
Looking west at cactus on landside slope.	
richard_s_20110318_456.jpg
