**Flood Control Project Maintenance  
Levee Inspections**

## Maintenance Issue Types Only, Levee Inspection Report By Mile - Fall 2014

### Reclamation District No. 0003 Grand Island

Waterway	Bank	Unit Miles	Inspection Start/End	Inspector
Unit No. 01 Left Bank Steamboat Slough	Left	10.95	10/06/2014 10/07/2014	Richard Willoughby

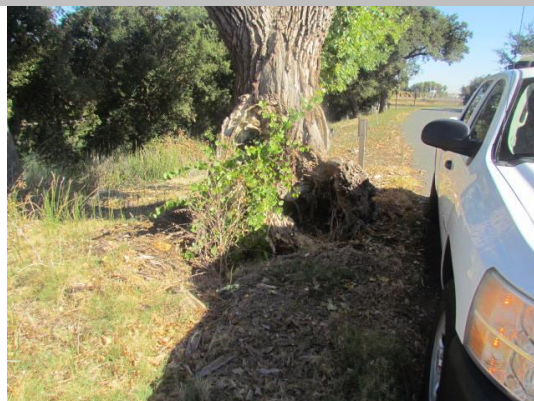
Photo 1 of 3 : FA\_2014\_RD0003\_24\_2\_20141010\_00096.jpg

LM Start	0.14	Rating **	M	Issue No.	2		
LM End	0.14	Issue Type +	Ma	Location *	WS		
Category	Earthen Levee			GPS Latitude/Longitude			
				Start		End	
Item	Erosion / Bank Caving				°		°
					°		°
DWR ID	DWR_RD0003_01_f_2013_2						
Action/Comments							
Schedule repair of erosion site prior to the next inspection.							
Inspector Comments: A hole (8ft x 2.5ft x 5ft) next to a large tree on waterward shoulder.

Looking east at hole at base of tree on waterward shoulder. (2014)

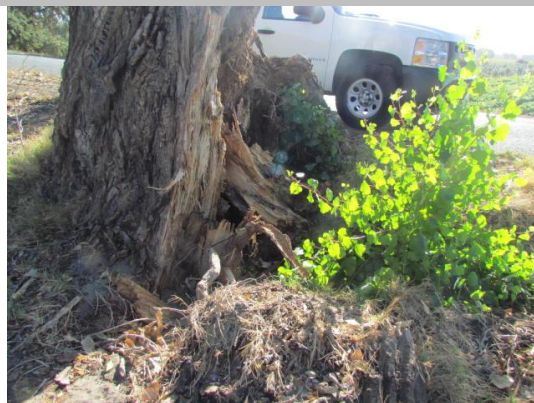
Photo 2 of 3 : FA\_2014\_RD0003\_24\_2\_20141006\_00001.jpg

Looking east at a hole next to oak tree on waterward shoulder.

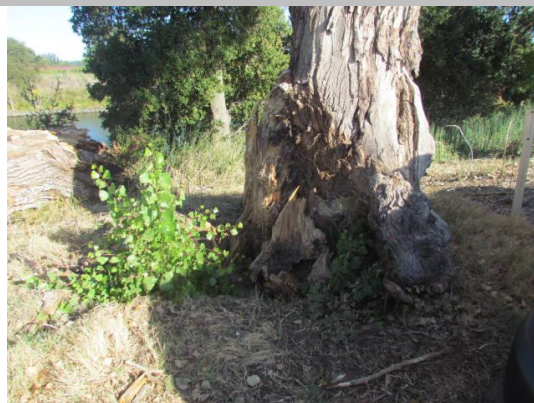
Photo 3 of 3 : FA\_2014\_RD0003\_24\_2\_20141006\_00002.jpg

Looking west at a hole next to oak tree on waterward shoulder.

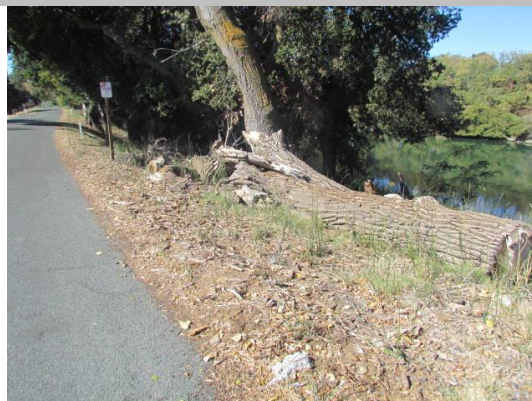
Photo 1 of 2 : FA\_2014\_RD0003\_24\_19\_20141010\_00097.jpg

LM Start	0.14	Rating **	U	Issue No.	19
LM End	0.14	Issue Type +	Ma	Location *	WS
Category	Earthen Levee			GPS Latitude/Longitude	
				Start	End
Item	Encroachments			38.303222 °	38.303222 °
				-121.576648 °	-121.576648 °
DWR ID	DWR_RD0003_01_f_2012_19				
Action/Comments					
Tree or limb					
Inspector Comments: Tree branches and limbs on waterward should.

Looking west at tree branch on waterward shoulder and slope. (Fall 2014)

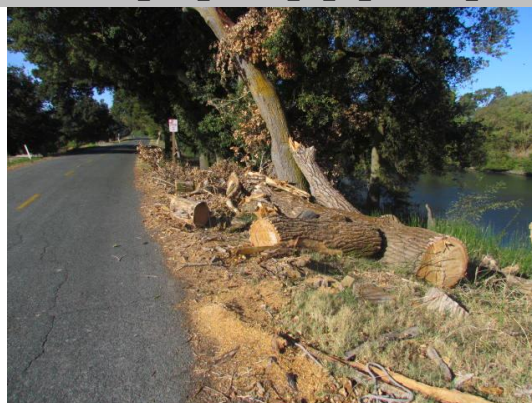
Photo 2 of 2 : FA\_2014\_RD0003\_24\_19\_20141006\_00017.jpg

Looking south at tree branches on waterward shoulder.(Spring 2014)

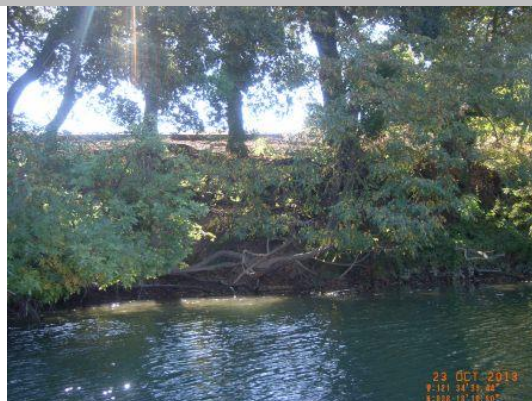
Photo 1 of 1 : FA\_2014\_RD0003\_24\_14\_20141006\_00013.jpg

LM Start	0.18	Rating **	M	Issue No.	14
LM End	0.23	Issue Type +	Ma	Location *	WS
Category	Supplemental			GPS Latitude/Longitude	
				Start	End
Item	USACE Erosion Survey			38.303035 °	38.302544 °
				-121.577357 °	-121.578241 °
DWR ID	DWR_RD0003_01_f_2014_14				
Action/Comments					
Inspector Comments: 1997 - Mass failure of berm slope and wave wash erosion. Large trees on top of berm, some failed trees. New area of low rock to on the upstream end. 2000 - Some minor erosion near the downstream end. 2005 - One new small tree has fallen. 2009 - Minimal new erosion. 2010 - Minor new erosion. 2013: Observed new animal holes and vertical sections at middle of site. [2013 Site ID:

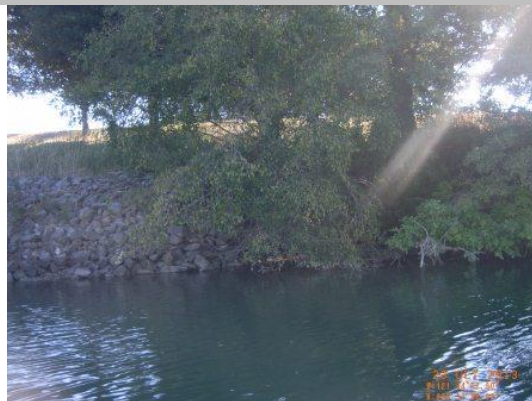
Photo 1 of 1 : FA\_2014\_RD0003\_24\_10\_20141006\_00009.jpg

LM Start	0.92	Rating **	M	Issue No.	10
LM End	1.01	Issue Type +	Ma	Location *	WS
Category	Supplemental			GPS Latitude/Longitude	
				Start	End
Item	USACE Erosion Survey			38.293386 °	38.292675 °
				-121.582554 °	-121.582741 °
DWR ID	DWR_RD0003_01_f_2014_10				
Action/Comments					
Inspector Comments: 1997 - Erosion of sandy levee on top left bank. Site is downstream of a rock section. Large riparian trees on the bank. 1999 - Upstream half of the reach repaired with rock, except for a 30 ft reach at the upstream end. 2001 - Rock repair on the upstream and downstream ends; no revetment at the trees. 2002 - Rock repair is starting to slide off the geotextile at the upstream end. 2005 - One new small tree has fallen. 2006 - 50 ft pocket at the downstream end and at the upstream end with new rock in between. 2007 - Upstream end has been repaired. 2010 - Some minor new erosion. 2011 - Minor new erosion. 2012 - Minor new erosion at the toe. 2013: No observed changes. [2013 Site ID: STM_25-0_L]

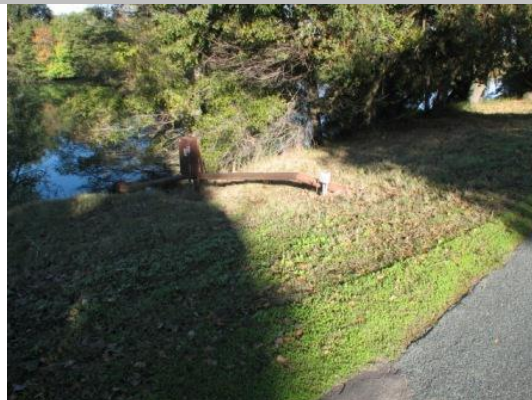
Photo 1 of 1 : FA\_2014\_RD0003\_24\_30\_20141006\_00033.jpg

LM Start	0.97	Rating **	A/W	Issue No.	30
LM End	0.97	Issue Type +	Ma	Location *	CR
Category	Earthen Levee			GPS Latitude/Longitude	
				Start	End
Item	Encroachments			38.292662 °	38.292662 °
				-121.582536 °	-121.582536 °
DWR ID	DWR_RD0003_01_s_2012_30				
Action/Comments					
Pipe Inspector Comments: Irrigation intake pipe through levee.

Irrigation intake pipe from Steamboat Slough.

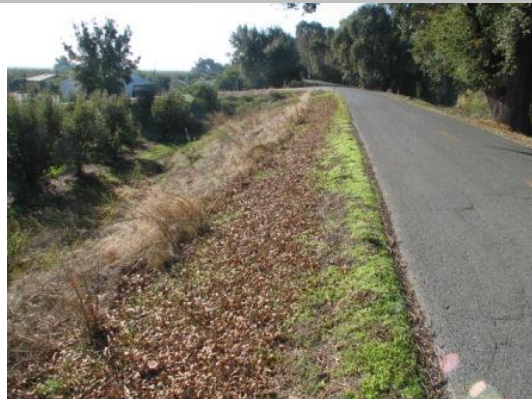
Photo 1 of 1 : FA\_2014\_RD0003\_24\_31\_20141006\_00034.jpg

LM Start	1.01	Rating **	A/W	Issue No.	31
LM End	1.03	Issue Type +	Ma	Location *	LS
Category	Earthen Levee			GPS Latitude/Longitude	
				Start	End
Item	Vegetation			38.292052 °	38.291724 °
				-121.582671 °	-121.582729 °
DWR ID	DWR_RD0003_01_s_2012_31				
Action/Comments					
Remove the wild growth other than native grasses from the levee slopes.					
Inspector Comments: Vegetation on levee slope.

Grass on levee slope and toe exceeds 12" and partially obstructs visibility.

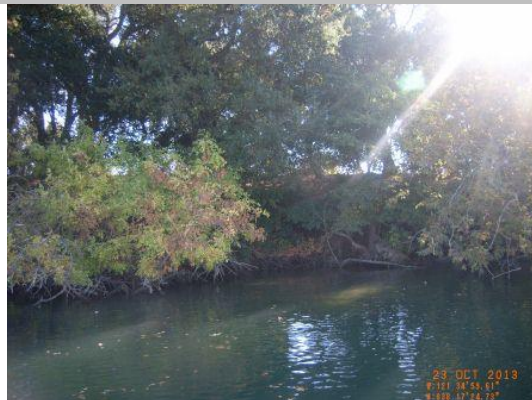
Photo 1 of 2 : FA\_2014\_RD0003\_24\_4\_20141006\_00003.jpg

LM Start	1.06	Rating **	M	Issue No.	4
LM End	1.14	Issue Type +	Ma	Location *	WS
Category	Supplemental			GPS Latitude/Longitude	
				Start	End
Item	USACE Erosion Survey			38.291695 °	38.289575 °
				-121.582993 °	-121.583092 °
DWR ID	DWR_RD0003_01_f_2014_4				
Action/Comments					
Inspector Comments: 2008 - Area closed sign on bank. Newly fallen trees at both ends and pop outs along the bank. 2010 - Site extended downstream. 2011 - New erosion at the toe. More trees popouts. 2013: Short vertical sections observed at the downstream end. [2013 Site ID: STM_24-8_L]

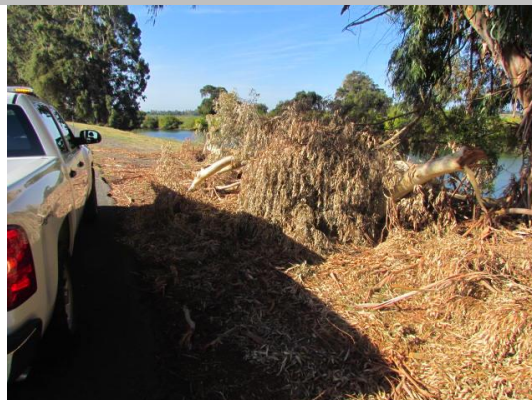
Photo 1 of 1 : FA\_2014\_RD0003\_24\_13\_20141006\_00012.jpg

LM Start	2.60	Rating **	A/W	Issue No.	13
LM End	2.60	Issue Type +	Ma	Location *	WS
Category	Earthen Levee			GPS Latitude/Longitude	
				Start	End
Item	Encroachments				o
					o
DWR ID	DWR_RD0003_01_f_2013_13				
Action/Comments					
Tree or limb					
Inspector Comments: Broken tree limbs on waterward shoulder.

Looking southwest at broken tree limbs on waterward shoulder and slope.

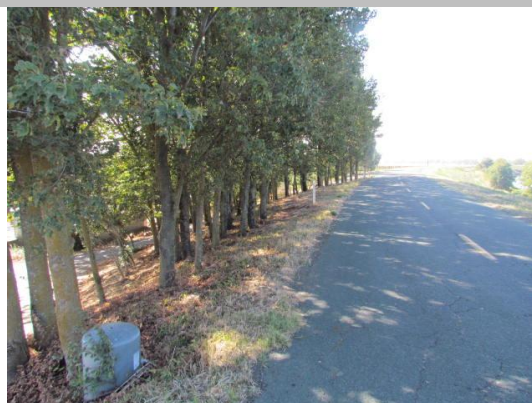
Photo 1 of 1 : FA\_2014\_RD0003\_24\_9\_20141006\_00008.jpg

LM Start	3.85	Rating **	M	Issue No.	9
LM End	3.90	Issue Type +	Ma	Location *	LS
Category	Earthen Levee			GPS Latitude/Longitude	
				Start	End
Item	Trim / Thin Trees			38.258222 °	38.257453 °
				-121.593793 °	-121.593942 °
DWR ID	DWR_RD0003_01_s_2012_9				
Action/Comments					
Trim and thin trees to allow visibility of the ground and room to flood fight.

Looking southeast at trees on landward shoulder and slope.

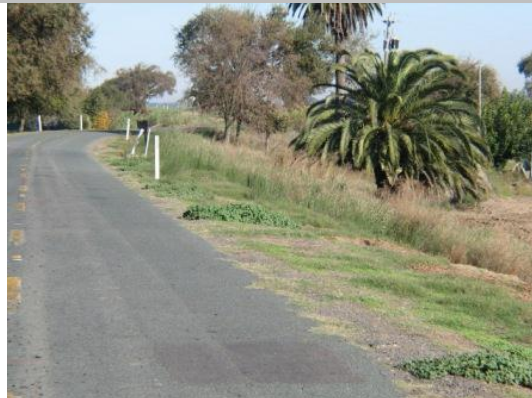
Photo 1 of 1 : FA\_2014\_RD0003\_24\_57\_20141006\_00046.jpg

LM Start	4.30	Rating **	A/W	Issue No.	57
LM End	4.49	Issue Type +	Ma	Location *	LS
Category	Earthen Levee			GPS Latitude/Longitude	
				Start	End
Item	Vegetation			38.253800 °	38.251824 °
				-121.599100 °	-121.600980 °
DWR ID	DWR_RD0003_01_s_2012_57				
Action/Comments					
Remove the wild growth other than native grasses from the levee slopes.

Vegetation on levee slopes and toe partially obstruct visibility.

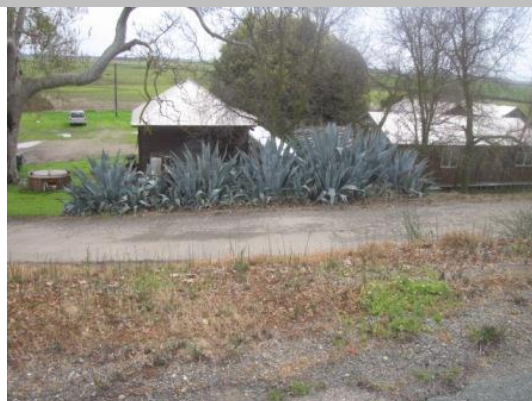
Photo 1 of 1 : FA\_2014\_RD0003\_24\_61\_20141006\_00049.jpg

LM Start	5.33	Rating **	A/W	Issue No.	61
LM End	5.33	Issue Type +	Ma	Location *	LS
Category	Earthen Levee			GPS Latitude/Longitude	
				Start	End
Item	Vegetation			38.239886 °	38.239886 °
				-121.601752 °	-121.601752 °
DWR ID	DWR_RD0003_01_s_2012_61				
Action/Comments					
Remove the wild growth other than native grasses from the levee slopes.					
Inspector Comments: Century plant on landside slope next to ramp.

Looking west at century plants on landside slope next to a ramp.

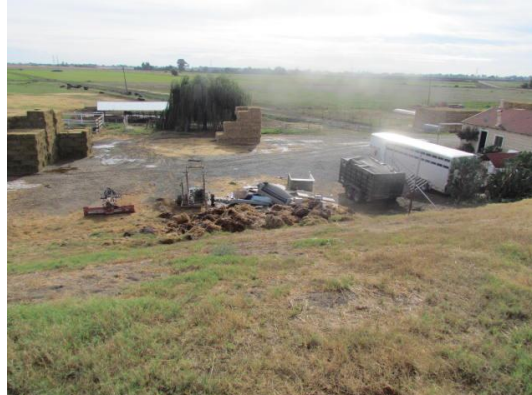
Photo 1 of 1 : FA\_2014\_RD0003\_24\_24\_20141006\_00025.jpg

LM Start	7.00	Rating **	A/W	Issue No.	24
LM End	7.00	Issue Type +	Ma	Location *	LS
Category	Earthen Levee			GPS Latitude/Longitude	
				Start	End
Item	Encroachments			38.216583 °	38.216583 °
				-121.603986 °	-121.603986 °
DWR ID	DWR_RD0003_01_f_2012_24				
Action/Comments					
Garbage

Looking east at garbage at landside toe.

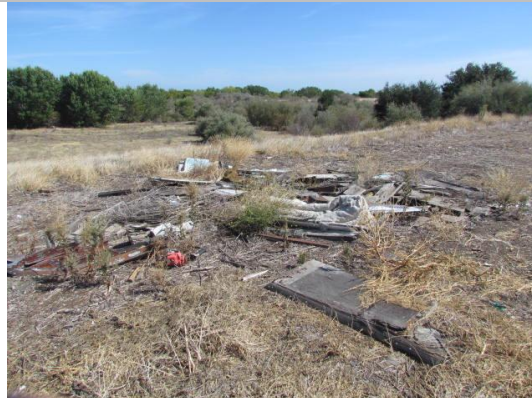
Photo 1 of 1 : FA\_2014\_RD0003\_25\_38\_20141006\_00035.jpg

LM Start	0.09	Rating **	A/W	Issue No.	38
LM End	0.09	Issue Type +	Ma	Location *	LS
Category	Earthen Levee			GPS Latitude/Longitude	
				Start	End
Item	Encroachments			38.175340 °	38.175340 °
				-121.652452 °	-121.652452 °
DWR ID	DWR_RD0003_02_s_2013_38				
Action/Comments					
Garbage

Looking northwest at garbage on landward slope.

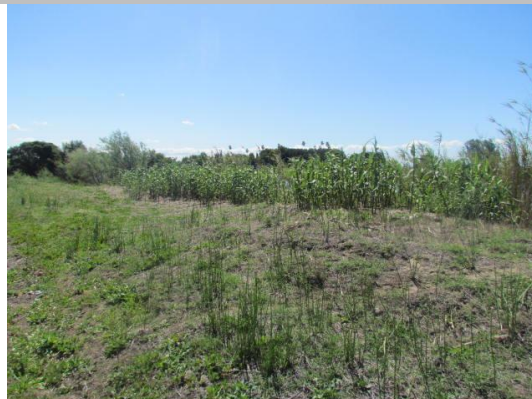
Photo 1 of 2 : FA\_2014\_RD0003\_25\_5\_20141006\_00006.jpg

Looking northeast at the new sprouting of bamboo on waterward slope.

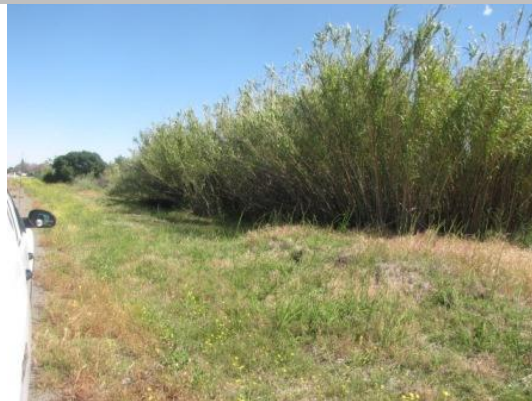
Photo 2 of 2 : FA\_2014\_RD0003\_25\_5\_20141006\_00007.jpg

Looking northeast at bamboo on waterside slope.

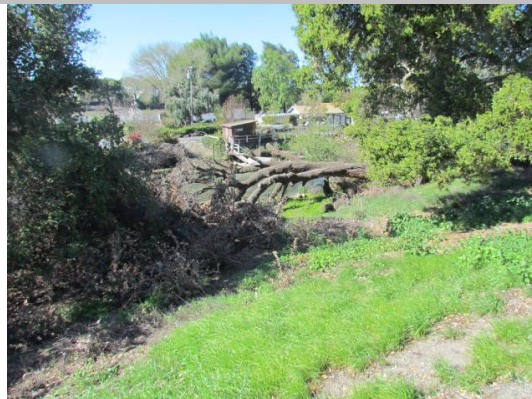
Photo 1 of 2 : FA\_2014\_RD0003\_25\_104\_20141006\_00077.jpg

Looking southeast at downed tree on waterward slope.

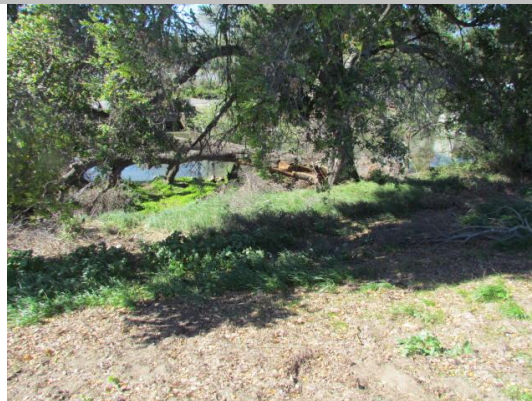
Photo 2 of 2 : FA\_2014\_RD0003\_25\_104\_20141006\_00078.jpg

Looking east at downed tree on waterward slope.

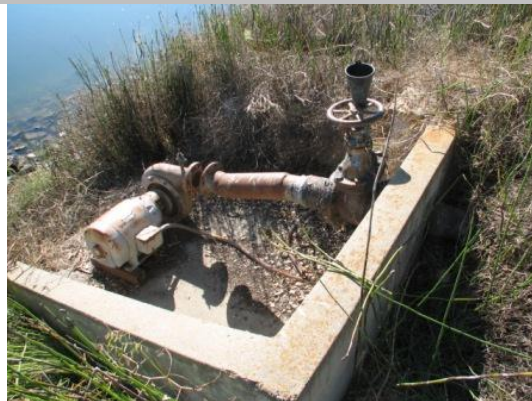
Photo 1 of 1 : FA\_2014\_RD0003\_25\_45\_20141006\_00037.jpg

Pipe penetration, closure valve in open position.

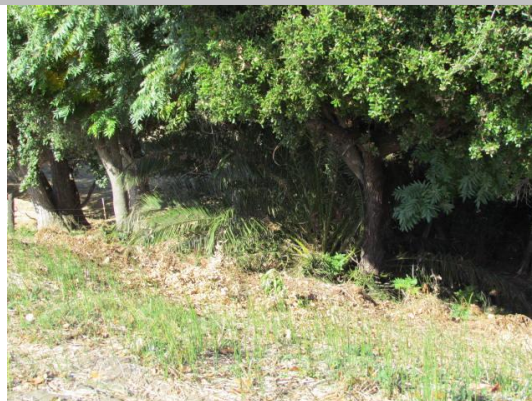
Photo 1 of 1 : FA\_2014\_RD0003\_25\_97\_20141006\_00070.jpg

LM Start	3.56	Rating **	M	Issue No.	97
LM End	3.56	Issue Type +	Ma	Location *	LS
Category	Earthen Levee			GPS Latitude/Longitude	
				Start	End
Item	Vegetation				°
					°
DWR ID	DWR_RD0003_02_f_2013_97				
Action/Comments					
Remove the wild growth other than native grasses from the levee slopes.					
Inspector Comments: Palm tree at landward toe.

Looking west at palm tree on landward toe.

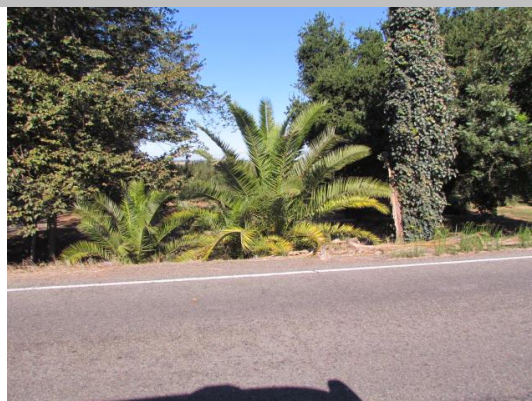
Photo 1 of 1 : FA\_2014\_RD0003\_25\_100\_20141006\_00073.jpg

Looking west at palm trees on landward shoulder and slope.

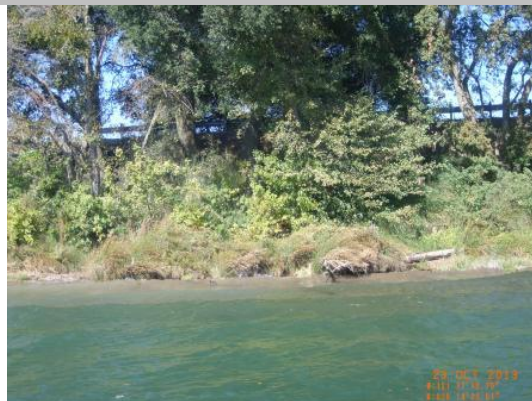
Photo 1 of 2 : FA\_2014\_RD0003\_25\_20\_20141006\_00022.jpg

LM Start	11.56	Rating **	M	Issue No.	20
LM End	11.56	Issue Type +	Ma	Location *	WS
Category	Supplemental			GPS Latitude/Longitude	
				Start	End
Item	USACE Erosion Survey			38.239870 °	38.239983 °
				-121.520989 °	-121.519361 °
DWR ID	DWR_RD0003_02_f_2014_20				
Action/Comments					
Inspector Comments: 2009 - Hole left in levee toe from a fallen tree. Could be repaired under maintenance. 2010 - Minor new erosion. 2013: No observed changes. [2013 Site ID: SAC_26-3_R]

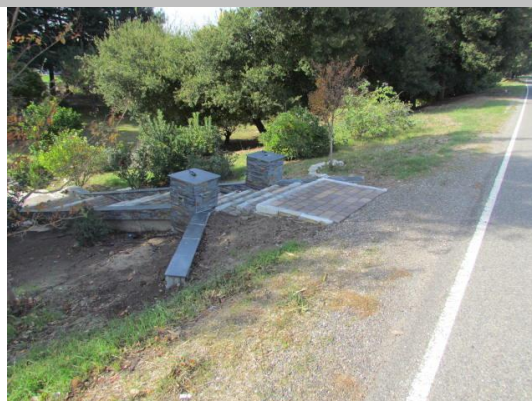
Photo 1 of 2 : FA\_2014\_RD0003\_25\_9\_20141006\_00009.jpg

Looking northwest at stairs on landside slope.

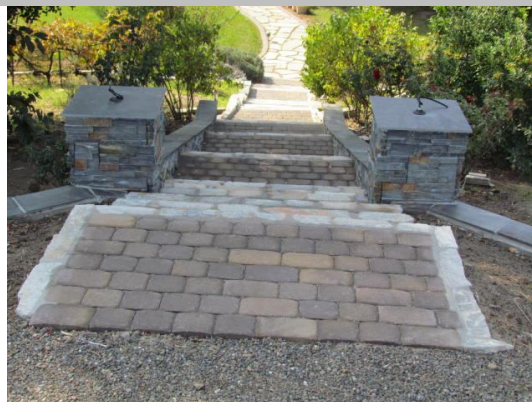
Photo 2 of 2 : FA\_2014\_RD0003\_25\_9\_20141006\_00010.jpg

Looking west at stairs on landside slope.

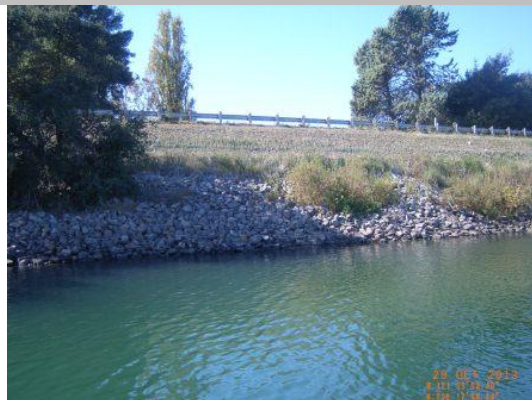
Photo 1 of 1 : FA\_2014\_RD0003\_25\_28\_20141006\_00025.jpg

LM Start	16.80	Rating **	M	Issue No.	28
LM End	16.80	Issue Type +	Ma	Location *	WS
Category	Supplemental			GPS Latitude/Longitude	
				Start	End
Item	USACE Erosion Survey			38.294757 °	38.295730 °
				-121.565376 °	-121.566295 °
DWR ID	DWR_RD0003_02_f_2014_28				
Action/Comments					
Inspector Comments: 1997 - Erosion of supper sandy levee material above the water line, straight reach. 1999 - Small pocket repaired with rock. 2005 - Downstream 400 ft have been repaired. 2011 - Site is overgrown with vegetation. 2013: No observed changes. [2013 Site ID: SAC_31-6_R]

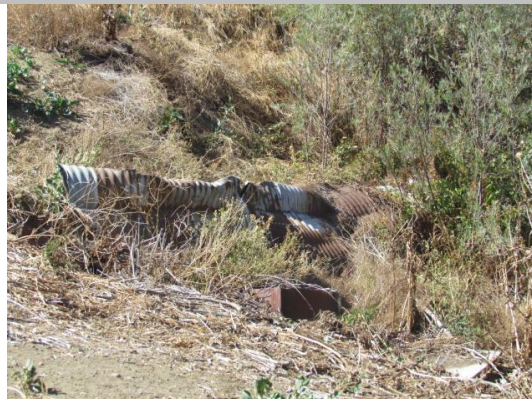
Photo 1 of 1 : FA\_2014\_RD0003\_610\_1\_20141006\_00001.jpg

Looking southeast at old corrugated pipe on waterward slope.

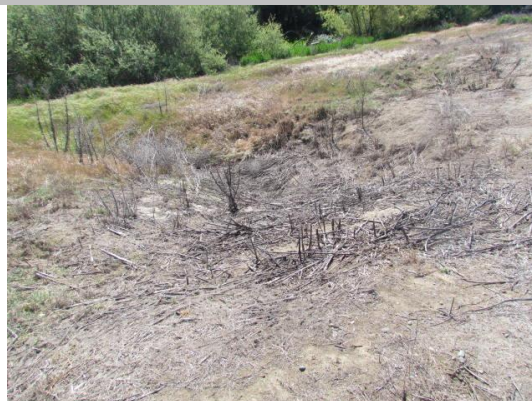
Photo 1 of 2 : FA\_2014\_RD0003\_610\_3\_20141006\_00002.jpg

LM Start	0.06	Rating **	M	Issue No.	3
LM End	0.06	Issue Type +	Ma	Location *	LS
Category	Earthen Levee			GPS Latitude/Longitude	
				Start	End
Item	Slope Stability			38.181427 °	38.181427 °
				-121.653622 °	-121.653622 °
DWR ID	DWR_RD0003_03_s_2013_3				
Action/Comments					
Repair slope instability.					
Inspector Comments: Larger depression on landward slope.

Looking east at depression on landward slope.

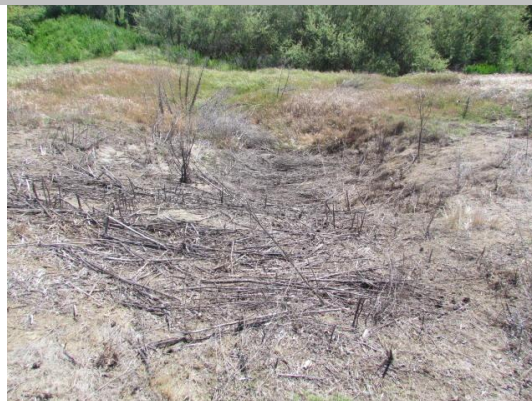
Photo 2 of 2 : FA\_2014\_RD0003\_610\_3\_20141006\_00003.jpg

Looking north on depression on landward slope.
