**Flood Control Project Maintenance
Levee Inspections**

Maintenance Issue Types Only, Levee Inspection Report By Mile - Fall 2015

Reclamation District No. 0003 Grand Island

Waterway	Bank	Unit Miles	Inspection Start/End	Inspector
Unit No. 01 Left Bank Steamboat Slough	Left	10.95	09/22/2015 09/22/2015	Richard Willoughby

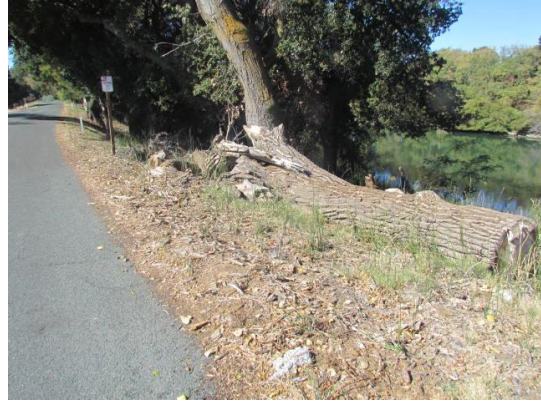
Photo 1 of 2 : FA_2015_RD0003_24_19_20150914_00017.jpg

LM Start	0.13	Rating **	U	Issue No.	19
LM End	0.13	Issue Type +	Ma	Location *	WS
Category	Earthen Levee			GPS Latitude/Longitude	
				Start	End
Item	Encroachments			38.303305 °	38.303305 °
				-121.576537 °	-121.576537 °
DWR ID	DWR_RD0003_01_f_2012_19				
Action/Comments					
Tree or limb					
Inspector Comments: Tree branches and limbs on waterward shoulder.

Looking west at tree branch on waterward shoulder and slope. (Fall 2014)

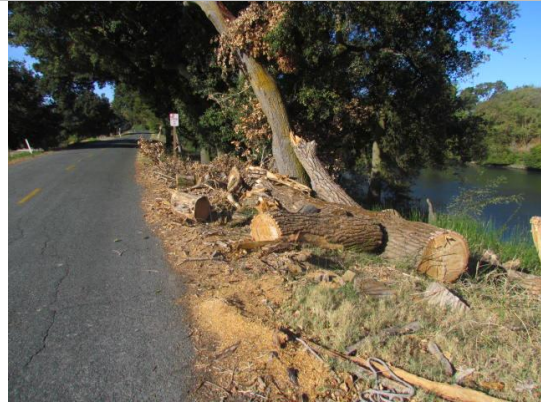
Photo 2 of 2 : FA_2015_RD0003_24_19_20150914_00018.jpg

Looking south at tree branches on waterward shoulder. (Spring 2014)

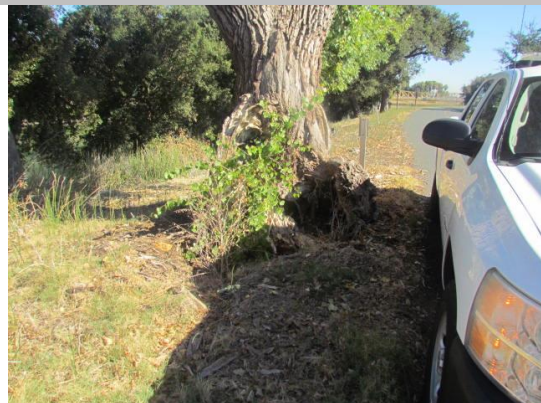
Photo 1 of 3 : FA_2015_RD0003_24_2_20150914_00001.jpg

LM Start	0.13	Rating **	M	Issue No.	2
LM End	0.13	Issue Type +	Ma	Location *	WS
Category	Earthen Levee			GPS Latitude/Longitude	
				Start	End
Item	Erosion / Bank Caving			38.303303 °	38.303303 °
				-121.576538 °	-121.576538 °
DWR ID	DWR_RD0003_01_f_2013_2				
Action/Comments					
Schedule repair of erosion site prior to the next inspection. Inspector Comments: Hole (8ft x 2.5ft x 5ft) next to a large tree on waterward shoulder.

Looking east at hole at base of tree on waterward shoulder. (2014)

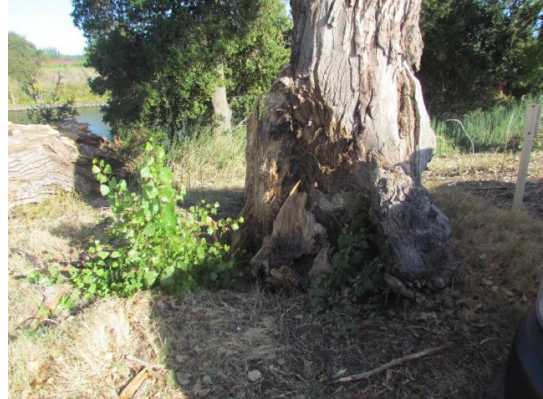
Photo 2 of 3 : FA_2015_RD0003_24_2_20150914_00002.jpg

LM Start	0.13	Rating **	M	Issue No.	2 (cont)	
LM End	0.13	Issue Type +	Ma	Location *	WS	
Category	Earthen Levee			GPS Latitude/Longitude		
				Start	End	
Item	Erosion / Bank Caving			38.303303 °	38.303303 °	
				-121.576538 °	-121.576538 °	
DWR ID	DWR_RD0003_01_f_2013_2					
Action/Comments						
Schedule repair of erosion site prior to the next inspection. Inspector Comments: Hole (8ft x 2.5ft x 5ft) next to a large tree on waterward shoulder.

Looking west at a hole next to oak tree on waterward shoulder.

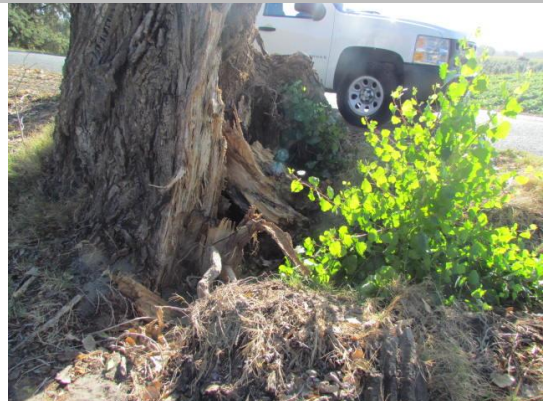
Photo 3 of 3 : FA_2015_RD0003_24_2_20150914_00003.jpg

Looking east at a hole next to oak tree on waterward shoulder.

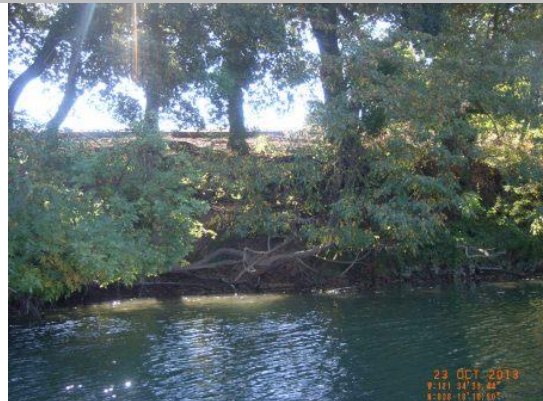
Photo 1 of 1 : USACE2013A_STM_26-0_L_6.jpg

LM Start	0.18	Rating **	M	Issue No.	10
LM End	0.24	Issue Type +	Ma	Location *	WS
Category	Supplemental			GPS Latitude/Longitude	
				Start	End
Item	2015 USACE Erosion Survey, DRAFT			38.303035 °	38.302544 °
				-121.577357 °	-121.578241 °
DWR ID					
Action/Comments					
Inspector Comments: 1997 - Mass failure of berm slope and wave wash erosion. Large trees on top of berm, some failed trees. New area of low rock to on the upstream end. 2000 - Some minor erosion near the downstream end. 2005 - One new small tree has fallen. 2009 - Minimal new erosion. 2010 - Minor new erosion. 2013 - Observed new animal holes and vertical sections at middle of site. 2015: Minor new

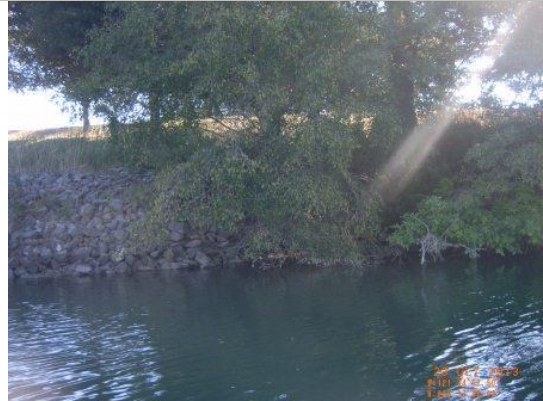
Photo 1 of 1 : USACE2013A_STM_25-0_L_6.jpg

LM Start	0.91	Rating **	M	Issue No.	4
LM End	0.96	Issue Type +	Ma	Location *	WS
Category	Supplemental			GPS Latitude/Longitude	
				Start	End
Item	2015 USACE Erosion Survey, DRAFT			38.293386 °	38.292675 °
				-121.582554 °	-121.582741 °
DWR ID					
Action/Comments					
Inspector Comments: 1997 - Erosion of sandy levee on top left bank. Site is downstream of a rock section. Large riparian trees on the bank. 1999 - Upstream half of the reach repaired with rock, except for a 30 ft reach at the upstream end. 2001 - Rock repair on the upstream and downstream ends; no revetment at the trees. 2002 - Rock repair is starting to slide off the geotextile at the upstream end. 2005 - One new small tree has fallen. 2006 - 50 ft pocket at the downstream end and at the upstream end with new rock in between. 2007 - Upstream end has been repaired. 2010 - Some minor new erosion. 2011 - Minor new erosion. 2012 - Minor new erosion at the toe. 2015: Significant new erosion, large oak tree on verge of popping out. [2015 Site ID: STM_25-0_L]

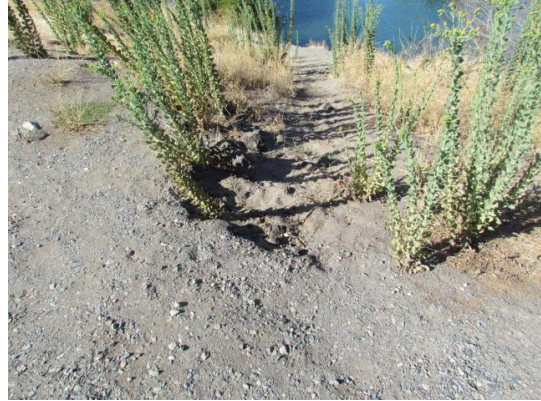
Photo 1 of 1 : FA_2015_RD0003_24_65_20150925_00097.jpg

LM Start	0.98	Rating **	M	Issue No.	65
LM End	0.98	Issue Type +	Ma	Location *	WS
Category	Earthen Levee			GPS Latitude/Longitude	
				Start	End
Item	Slope Stability			38.292392 °	38.292392 °
				-121.582717 °	-121.582717 °
DWR ID	DWR_RD0003_01_f_2015_65				
Action/Comments					
Repair the levee slope damaged by foot traffic and prevent access where possible.					
Inspector Comments: Waterward levee damage caused by foot traffic.

Looking west at foot erosion on waterward slope.

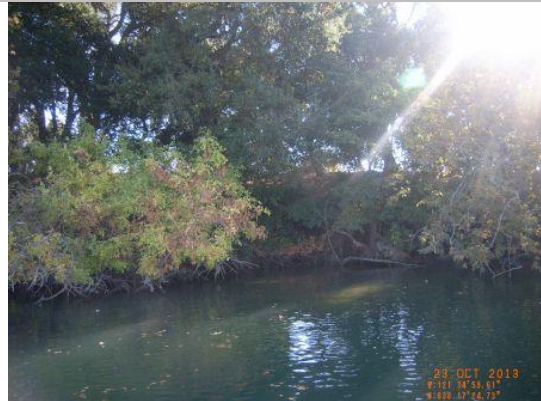
Photo 1 of 2 : USACE2013A_STM_24-8_L_5.jpg

LM Start	1.03	Rating **	M	Issue No.	1
LM End	1.18	Issue Type +	Ma	Location *	WS
Category	Supplemental			GPS Latitude/Longitude	
				Start	End
Item	2015 USACE Erosion Survey, DRAFT			38.291695 °	38.289575 °
				-121.582993 °	-121.583092 °
DWR ID					
Action/Comments					
Inspector Comments: 2008 - Area closed sign on bank. Newly fallen trees at both ends and pop outs along the bank. 2010 - Site extended downstream. 2011 - New erosion at the toe. More trees popouts. 2013 - Short vertical sections observed at the downstream end. 2015: New erosion at toe. [2015 Site ID: STM_24-8_L]

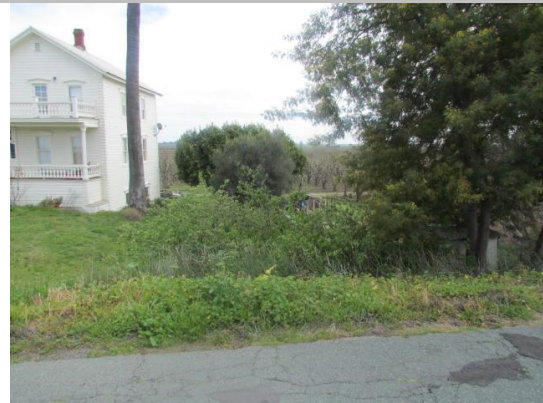
Photo 1 of 1 : FA_2015_RD0003_24_8_20150914_00008.jpg

Looking east at vegetation on landside slope.

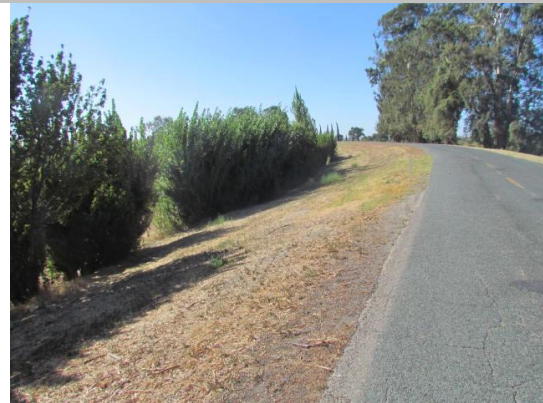
Photo 1 of 1 : FA_2015_RD0003_24_29_20150925_00099.jpg

LM Start	2.53	Rating **	U	Issue No.	29
LM End	2.66	Issue Type +	Ma	Location *	LS
Category	Earthen Levee			GPS Latitude/Longitude	
				Start	End
Item	Trim / Thin Trees			38.272845 °	38.271070 °
				-121.587665 °	-121.588632 °
DWR ID	DWR_RD0003_01_s _ 2013_29				
Action/Comments					
Thin trees to allow visibility of the ground and room to flood fight.

Looking southeast at trees blocking landward toe.

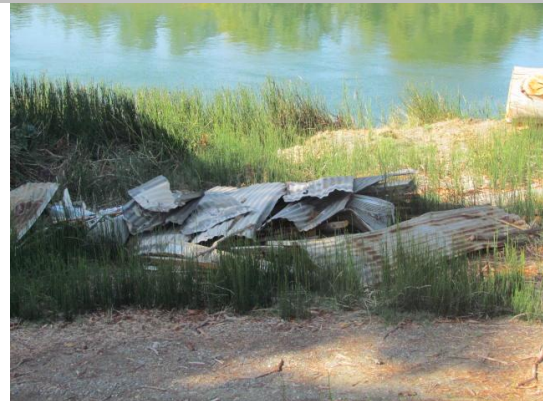
Photo 1 of 1 : FA_2015_RD0003_24_105_20150914_00070.jpg

Looking west at tin roofing material on waterward berm.

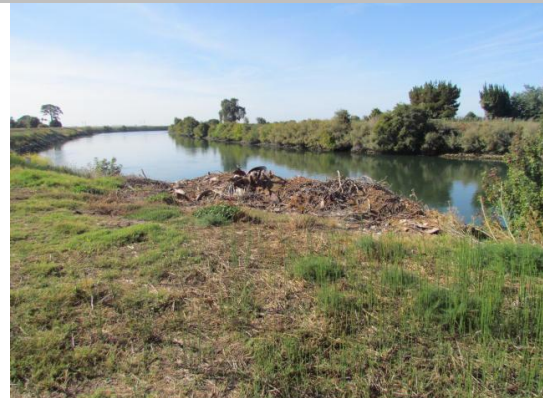
Photo 1 of 1 : FA_2015_RD0003_24_100_20150914_00069.jpg

LM Start	2.91	Rating **	A/W	Issue No.	100
LM End	2.91	Issue Type +	Ma	Location *	WS
Category	Earthen Levee			GPS Latitude/Longitude	
				Start	End
Item	Encroachments			38.267750 °	38.267750 °
				-121.587463 °	-121.587463 °
DWR ID	DWR_RD0003_01_s_2013_100				
Action/Comments					
Prunings Inspector Comments: Grass clippings on waterward slope. Grass clippings outside 20ft. Zone.

Looking southwest at grass clippings on waterward berm.

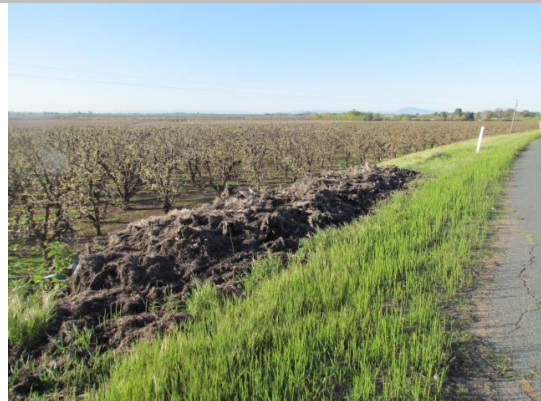
Photo 1 of 2 : FA_2015_RD0003_24_51_20150914_00044.jpg

Looking southeast at cactus mowed/removed by the district

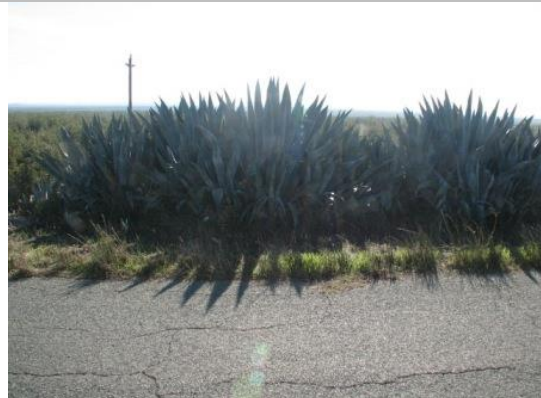
Photo 2 of 2 : FA_2015_RD0003_24_51_20150914_00045.jpg

Large cactus on upper levee slope obstructs access and visibility.

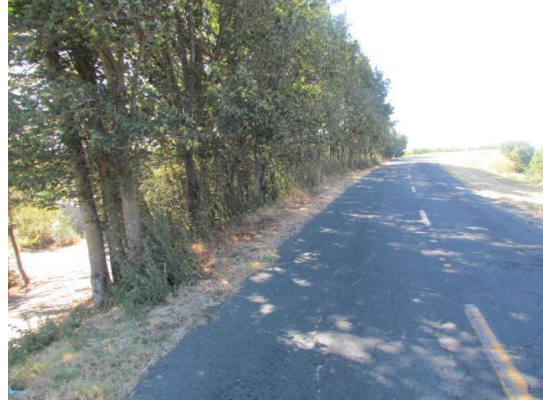
Photo 1 of 2 : FA_2015_RD0003_24_9_20150925_00100.jpg

Looking south at trees on landward shoulder and slope. (Fall 2015)

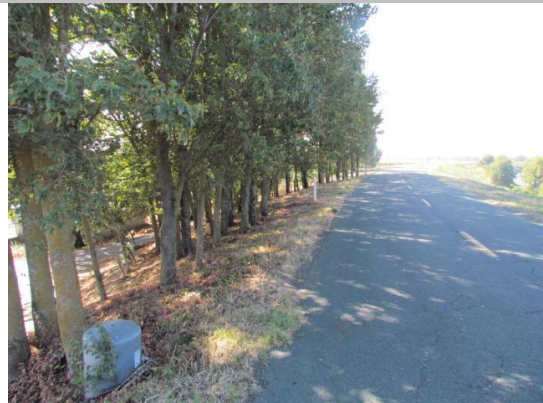
Photo 2 of 2 : FA_2015_RD0003_24_9_20150914_00009.jpg

Looking southeast at trees on landward shoulder and slope. (Fall 2014)

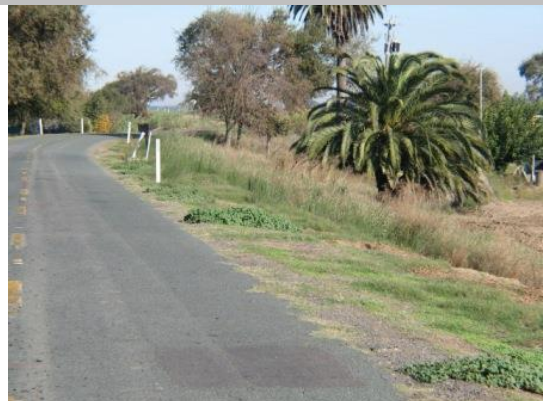
Photo 1 of 1 : FA_2015_RD0003_24_57_20150914_00046.jpg

Vegetation on levee slopes and toe partially obstruct visibility.

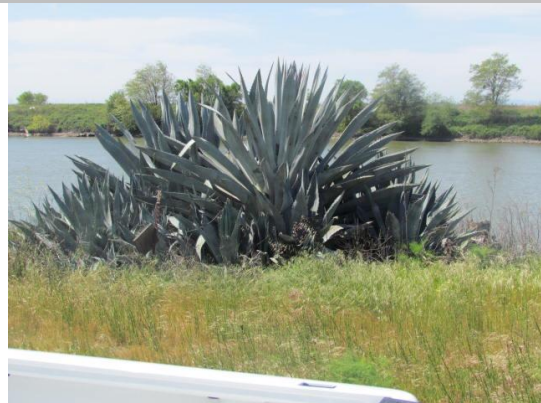
Photo 2 of 2 : FA_2015_RD0003_24_60_20150914_00048.jpg

Looking west at century plant on waterward slope.

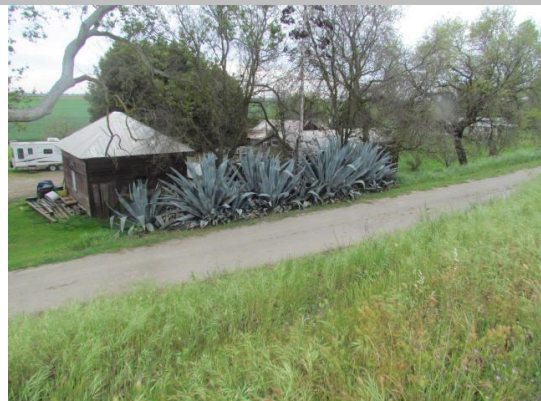
Photo 1 of 2 : FA_2015_RD0003_24_61_20150914_00049.jpg

Looking northwest at century plants on landside slope next to ramp.

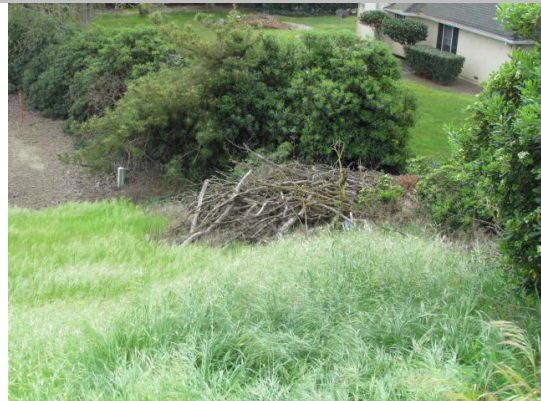
Photo 1 of 1 : FA_2015_RD0003_24_94_20150914_00059.jpg

Looking east at prunings on landward slope.

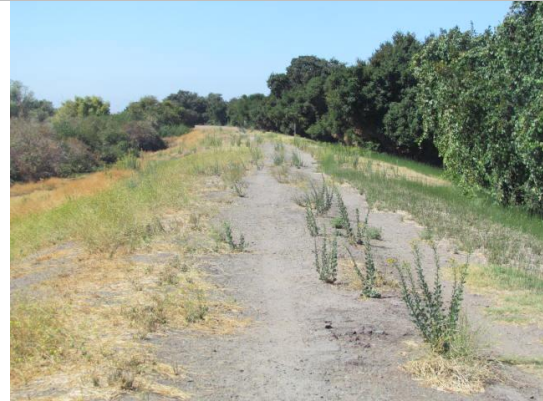
Photo 1 of 1 : FA_2015_RD0003_24_95_20150925_00103.jpg

Looking south at levee crown.

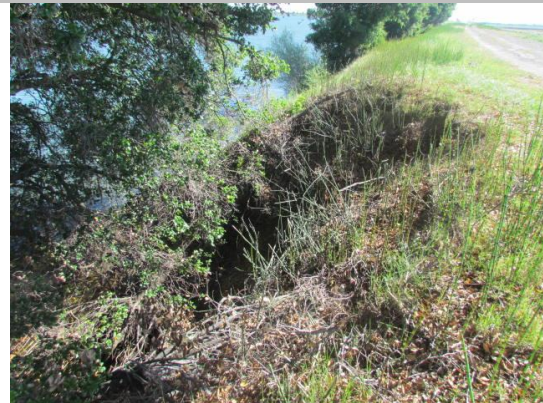
Photo 1 of 2 : FA_2015_RD0003_24_96_20150914_00060.jpg

LM Start	10.75	Rating **	U	Issue No.	96
LM End	10.75	Issue Type +	Ma	Location *	WS
Category	Earthen Levee			GPS Latitude/Longitude	
				Start	End
Item	Erosion / Bank Caving			38.183422 °	38.183422
				-121.650182 °	-121.650182
DWR ID	DWR_RD0003_01_s _ 2013_96				
Action/Comments					
Schedule repair of erosion site prior to the next inspection. Inspector Comments: Erosion extends to waterward shoulder.

Looking northwest at erosion on waterward slope.

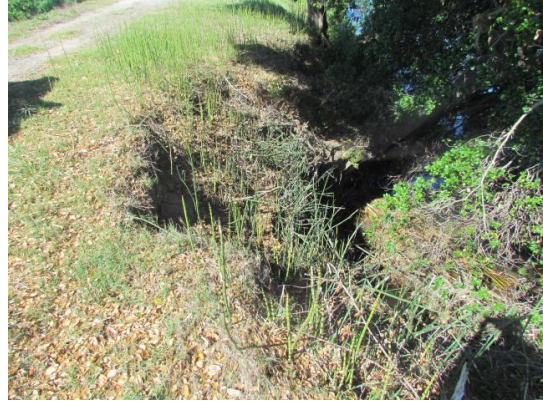
Photo 2 of 2 : FA_2015_RD0003_24_96_20150914_00061.jpg

LM Start	10.75	Rating **	U	Issue No.	96 (cont)
LM End	10.75	Issue Type +	Ma	Location *	WS
Category	Earthen Levee			GPS Latitude/Longitude	
				Start	End
Item	Erosion / Bank Caving			38.183422 °	38.183422 °
				-121.650182 °	-121.650182 °
DWR ID	DWR_RD0003_01_s _ 2013_96				
Action/Comments					
Schedule repair of erosion site prior to the next inspection. Inspector Comments: Erosion extends to waterward shoulder.

Looking southwest at erosion on waterward slope.

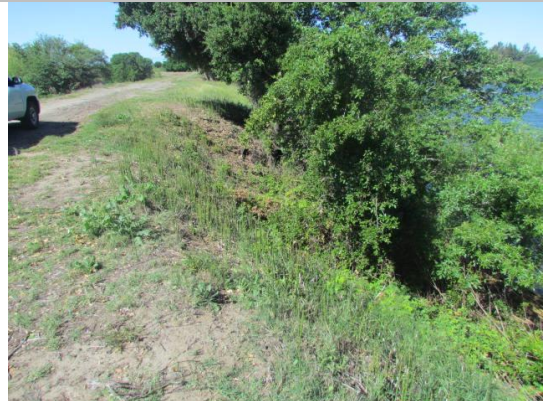
Photo 1 of 2 : FA_2015_RD0003_24_97_20150914_00062.jpg

LM Start	10.78	Rating **	U	Issue No.	97
LM End	10.80	Issue Type +	Ma	Location *	WS
Category	Earthen Levee			GPS Latitude/Longitude	
				Start	End
Item	Erosion / Bank Caving			38.183228 °	38.183123 °
				-121.650797 °	-121.651070 °
DWR ID	DWR_RD0003_01_s _ 2013_97				
Action/Comments					
Schedule repair of erosion site prior to the next inspection.					
Inspector Comments: Erosion extends to waterward shoulder.

Looking south at erosion on waterward slope.

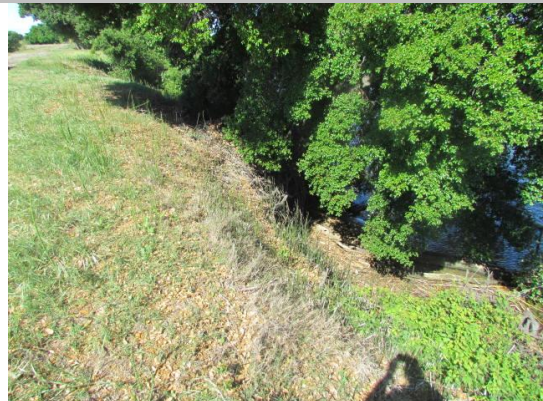
Photo 2 of 2 : FA_2015_RD0003_24_97_20150914_00063.jpg

Looking southwest at erosion on waterward slope.

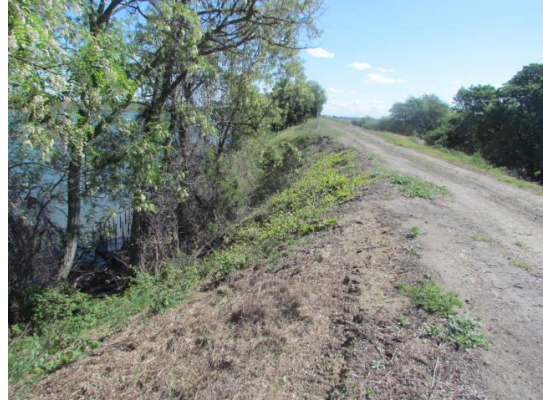
Photo 1 of 3 : FA_2015_RD0003_24_98_20150914_00064.jpg

LM Start	10.86	Rating **	U	Issue No.	98
LM End	10.89	Issue Type +	Ma	Location *	WS
Category	Earthen Levee			GPS Latitude/Longitude	
				Start	End
Item	Erosion / Bank Caving			38.182792 °	38.182672 °
				-121.652142 °	-121.652555 °
DWR ID	DWR_RD0003_01_s _ 2013_98				
Action/Comments					
Schedule repair of erosion site prior to the next inspection.					
Inspector Comments: Erosion extends to waterward shoulder.

Looking north at erosion on waterward slope.

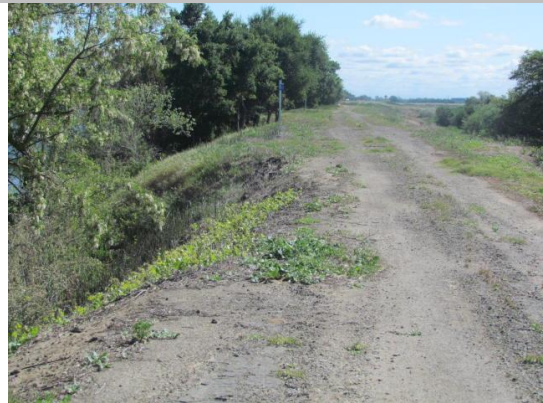
Photo 2 of 3 : FA_2015_RD0003_24_98_20150914_00065.jpg

Looking northwest at erosion on waterward shoulder and slope.

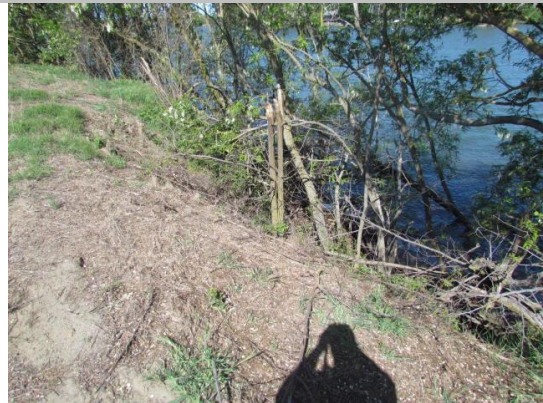
Photo 3 of 3 : FA_2015_RD0003_24_98_20150914_00066.jpg

Looking west at erosion on waterward slope.

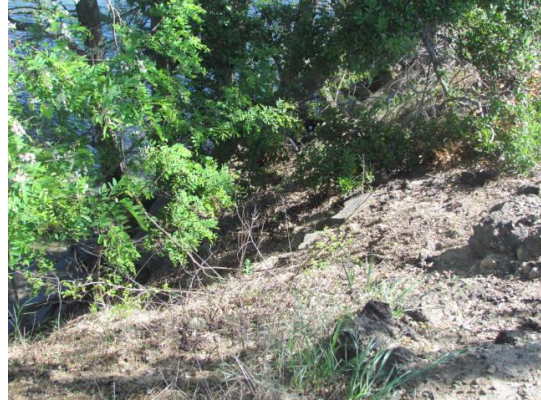
Photo 1 of 2 : FA_2015_RD0003_24_99_20150914_00067.jpg

LM Start	10.91	Rating **	U	Issue No.	99
LM End	10.94	Issue Type +	Ma	Location *	WS
Category	Earthen Levee			GPS Latitude/Longitude	
				Start	End
Item	Erosion / Bank Caving			38.182537 °	38.182388 °
				-121.652987 °	-121.653388 °
DWR ID	DWR_RD0003_01_s _ 2013_99				
Action/Comments					
Schedule repair of erosion site prior to the next inspection. Inspector Comments: Erosion extends to waterward shoulder.

Looking west at erosion on waterward slope.

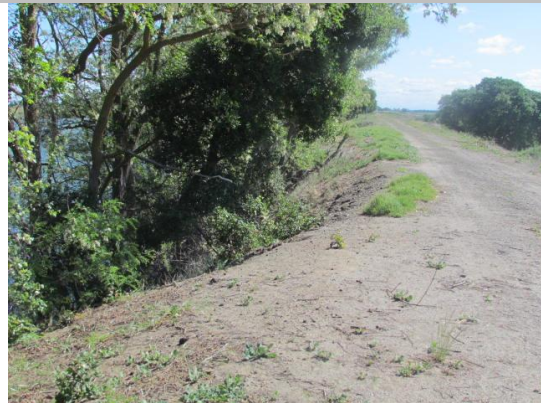
Photo 2 of 2 : FA_2015_RD0003_24_99_20150914_00068.jpg

Looking north at erosion on waterward shoulder and slope.

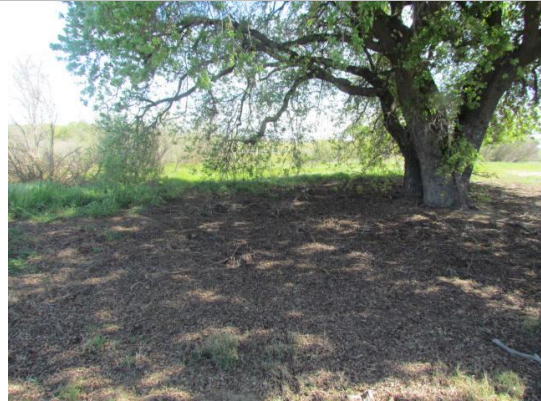
Photo 1 of 1 : FA_2015_RD0003_25_4_20150914_00004.jpg

Looking west at untrimmed tree on landward shoulder.

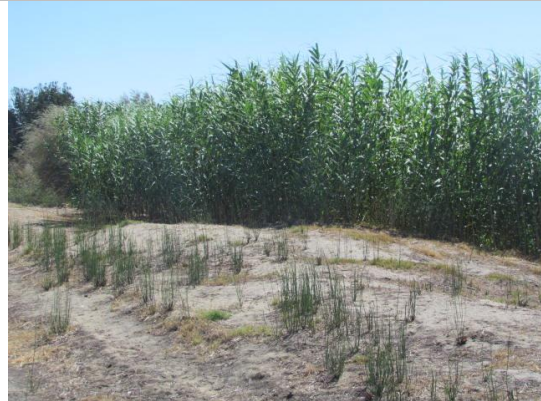
Photo 1 of 3 : FA_2015_RD0003_25_5_20150925_00099.jpg

Looking northeast at established bamboo on waterward shoulder and slope (Fall 2015)

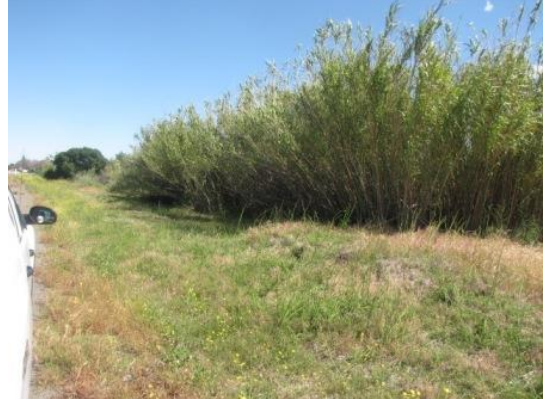
Photo 2 of 3 : FA_2015_RD0003_25_5_20150914_00006.jpg

Looking northeast at bamboo on waterside slope. (Fall 2014)

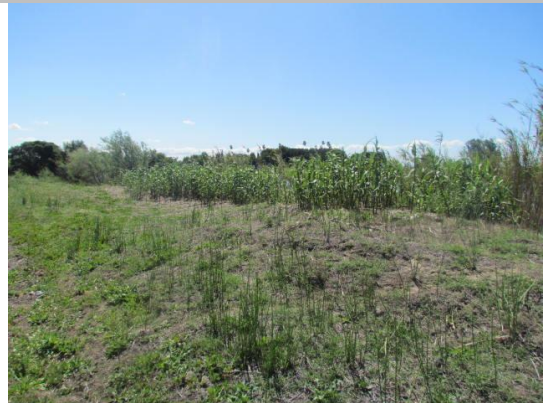
Photo 3 of 3 : FA_2015_RD0003_25_5_20150914_00005.jpg

Looking northeast at the new sprouting of bamboo on waterward slope. (Fall 2013)

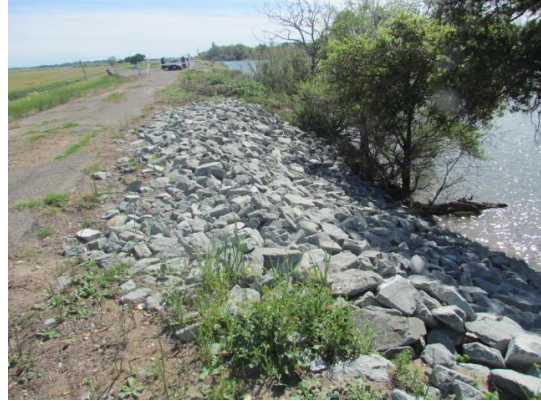
Photo 1 of 3 : FA_2015_RD0003_25_29_20150914_00029.jpg

LM Start	0.36	Rating **	A/W	Issue No.	29
LM End	0.36	Issue Type +	Ma	Location *	WS
Category	Earthen Levee			GPS Latitude/Longitude	
				Start	End
Item	Erosion / Bank Caving			38.174083 °	38.174083 °
				-121.647739 °	-121.647739 °
DWR ID	DWR_RD0003_02_f_2013_29				
Action/Comments					
Schedule repair of erosion site prior to the next inspection. Inspector Comments: Erosion extends from the waterward toe to the waterward shoulder.

Looking northeast at repaired site on waterward shoulder and slope.

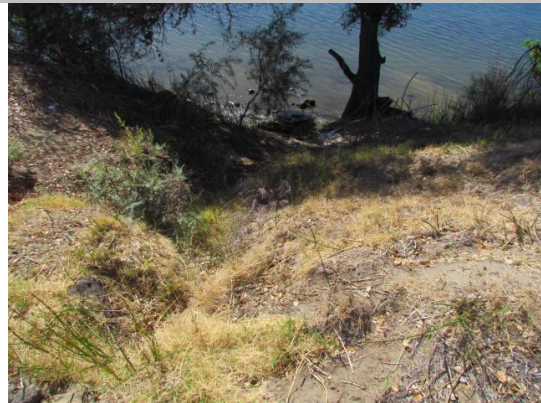
Photo 2 of 3 : FA_2015_RD0003_25_29_20150914_00030.jpg

Looking east at erosion that extends from waterward shoulder to waterward toe.

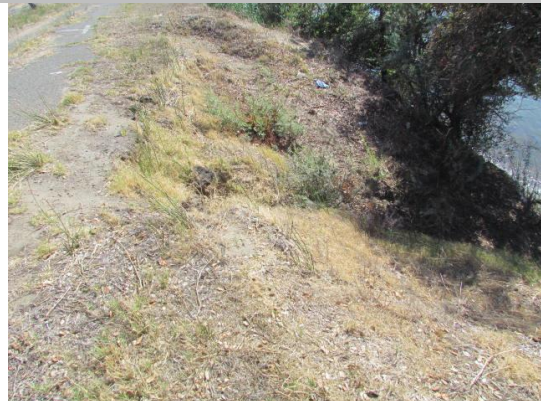
Photo 3 of 3 : FA_2015_RD0003_25_29_20150914_00031.jpg

Looking northeast at erosion on waterward slope and toe.

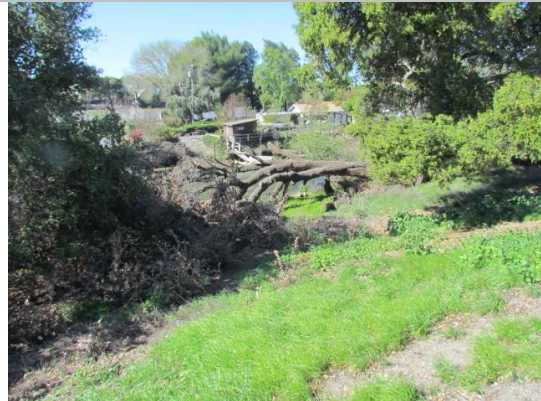
Photo 1 of 2 : FA_2015_RD0003_25_104_20150914_00083.jpg

Looking southeast at downed tree on waterward slope.

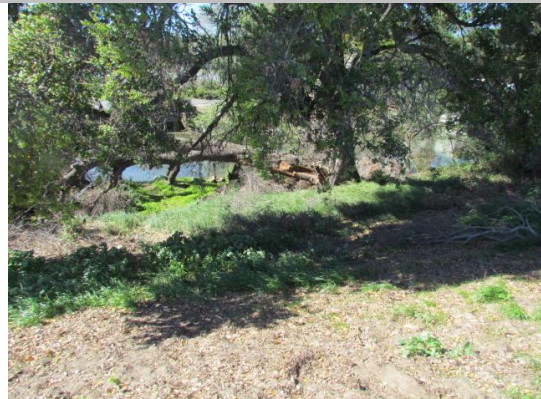
Photo 2 of 2 : FA_2015_RD0003_25_104_20150914_00084.jpg

Looking east at downed tree on waterward slope.

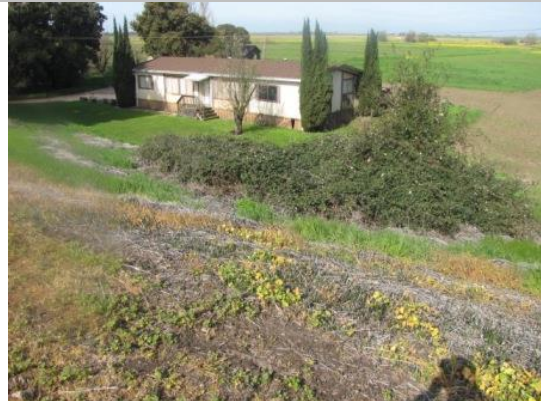
Photo 1 of 1 : FA_2015_RD0003_25_44_20150914_00040.jpg

Looking west at berryvines on landside toe.

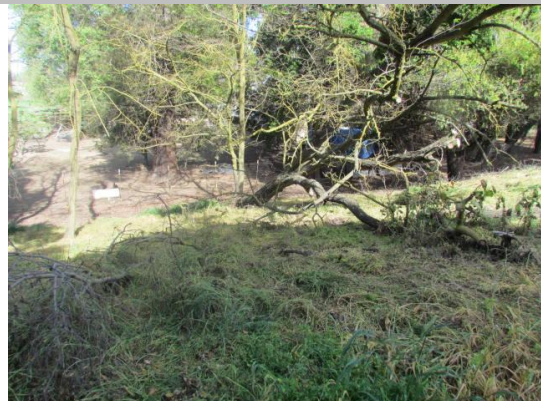
Photo 1 of 1 : FA_2015_RD0003_25_160_20150914_00089.jpg

Looking west at fallen tree on landward slope.

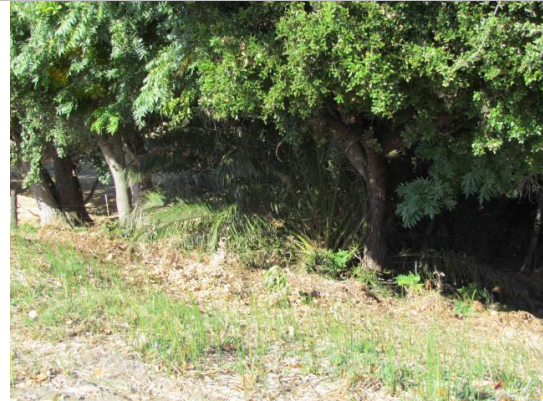
Photo 1 of 1 : FA_2015_RD0003_25_97_20150914_00076.jpg

Looking west at palm tree on landward toe.

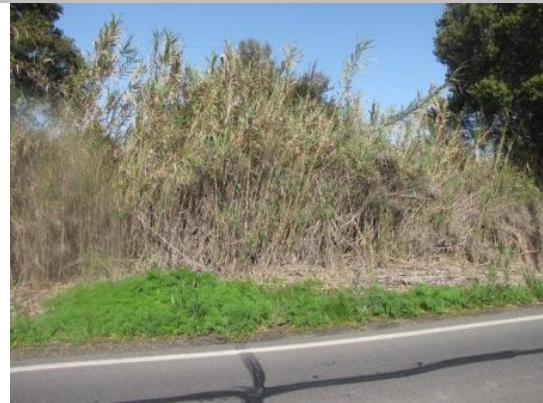
Photo 2 of 2 : FA_2015_RD0003_25_952_20150914_00097.jpg

Looking west at dense bamboo on landside slope.

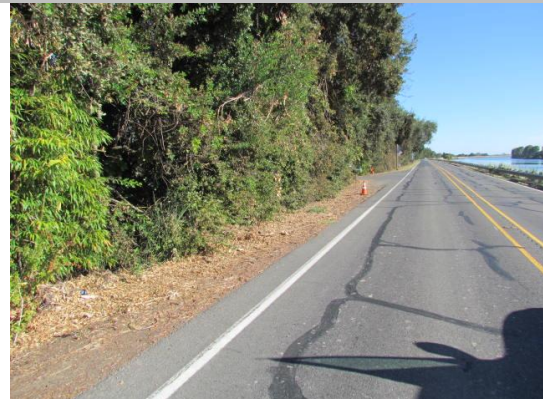
Photo 1 of 1 : FA_2015_RD0003_25_953_20150914_00098.jpg

Looking northwest at dense trees on landward shoulder and slope.

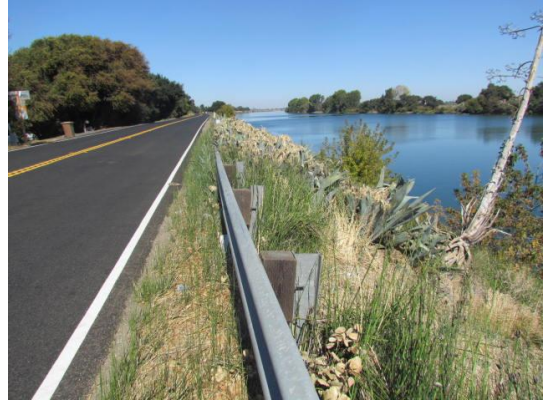
Photo 1 of 1 : FA_2015_RD0003_25_145_20151116_00111.jpg

Looking northeast at century plants on waterward shoulder and slope.

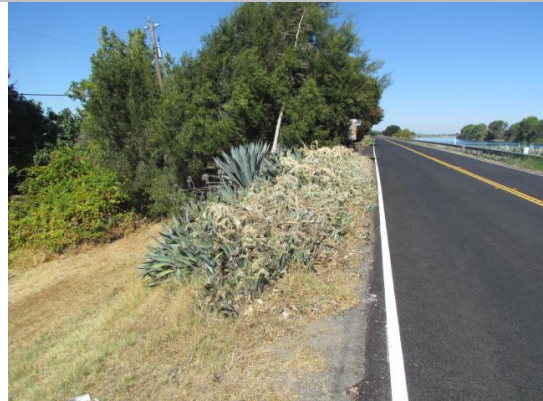
Photo 1 of 1 : FA_2015_RD0003_25_143_20150925_00102.jpg

Looking north at century plants on landward shoulder and slope.

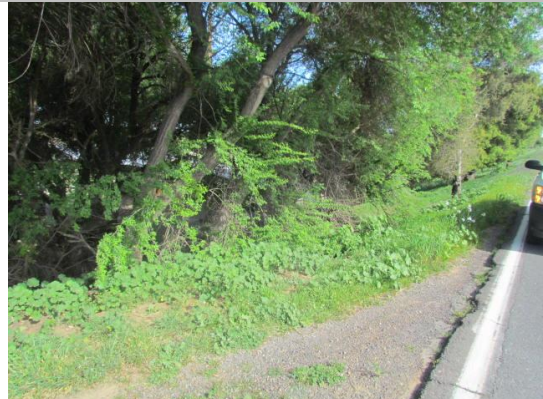
Photo 1 of 1 : FA_2015_RD0003_25_48_20150914_00042.jpg

Looking southwest at dense trees on landward slope.

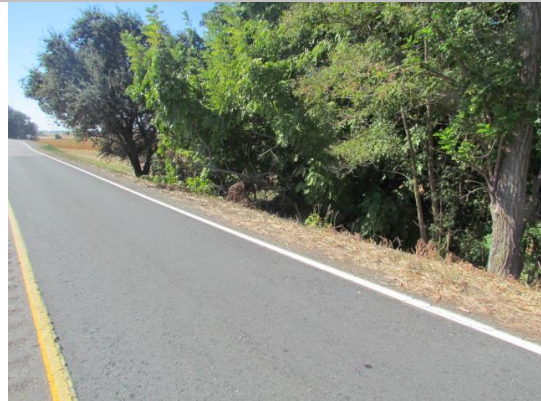
Photo 1 of 1 : FA_2015_RD0003_25_14_20150914_00018.jpg

Looking southwest at untrimmed trees on landward toe.

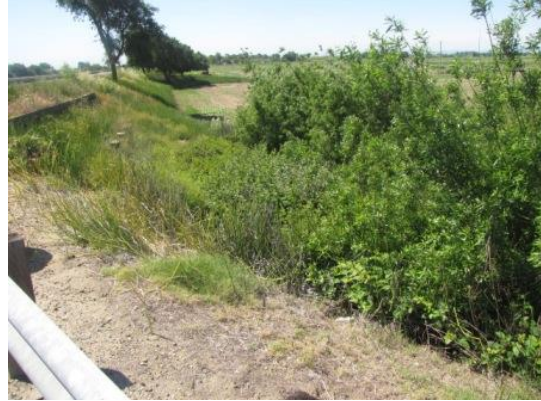
Photo 1 of 1 : FA_2015_RD0003_25_16_20150914_00021.jpg

Looking southwest at dense veg. on landside toe.

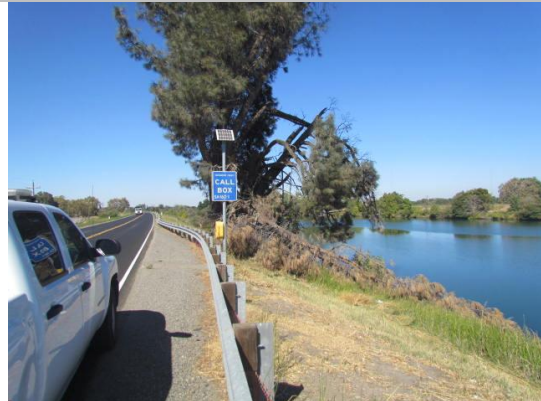
Photo 1 of 2 : FA_2015_RD0003_25_15_20150925_00105.jpg

Looking northeast at broken and cracked tree branches on waterward slope.

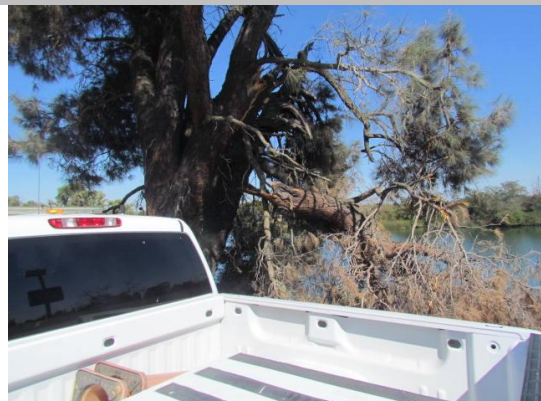
Photo 2 of 2 : FA_2015_RD0003_25_15_20150925_00106.jpg

Looking east at broken and cracked tree branches on waterward slope.

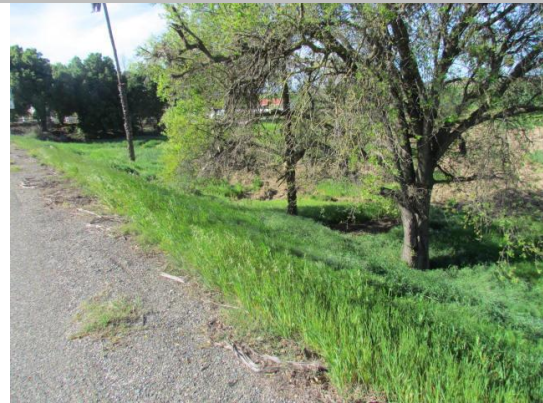
Photo 1 of 1 : FA_2015_RD0003_25_23_20150914_00027.jpg

Looking southwest at untrimmed trees on landward toe.

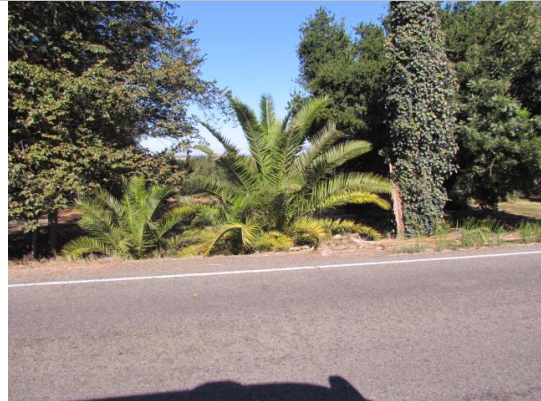
Photo 1 of 1 : FA_2015_RD0003_25_100_20150914_00079.jpg

Looking north at palm trees on landward shoulder and slope.

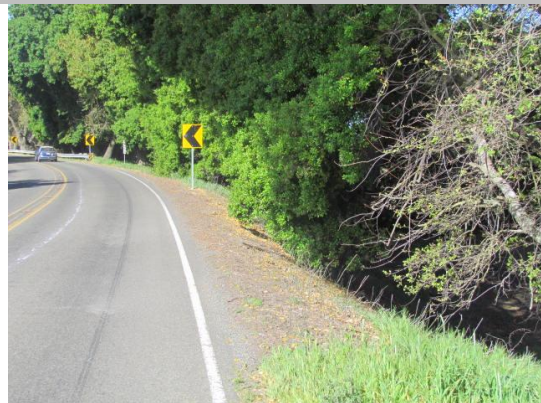
Photo 1 of 1 : FA_2015_RD0003_25_64_20150914_00050.jpg

Looking southwest at dense trees on landward shoulder and slope.

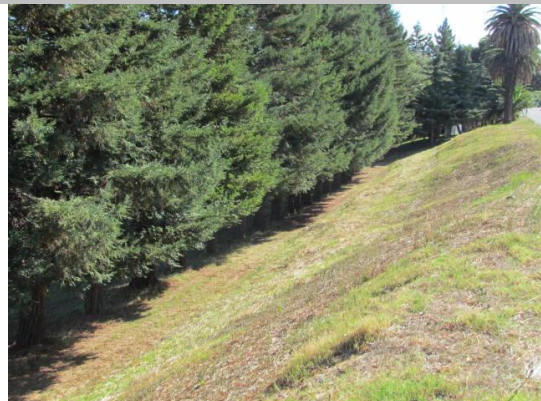
Photo 1 of 2 : FA_2015_RD0003_25_101_20150914_00080.jpg

Looking northeast at dense redwood trees on landward toe and berm.

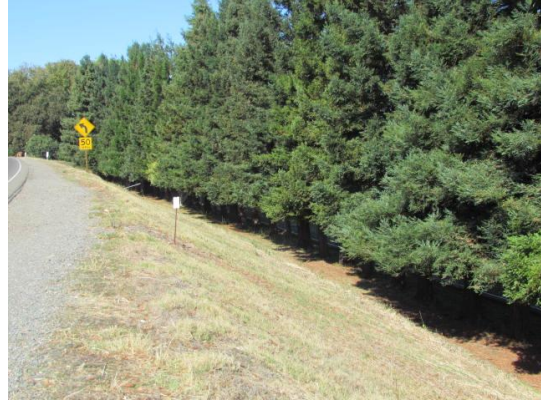
Photo 2 of 2 : FA_2015_RD0003_25_101_20150914_00081.jpg

Looking southwest at dense redwood trees on landward toe and berm.

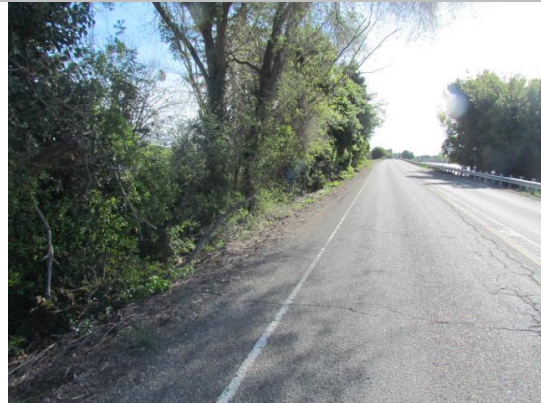
Photo 1 of 1 : FA_2015_RD0003_25_22_20150914_00026.jpg

Looking east at untrimmed trees on landward shoulder and slope.

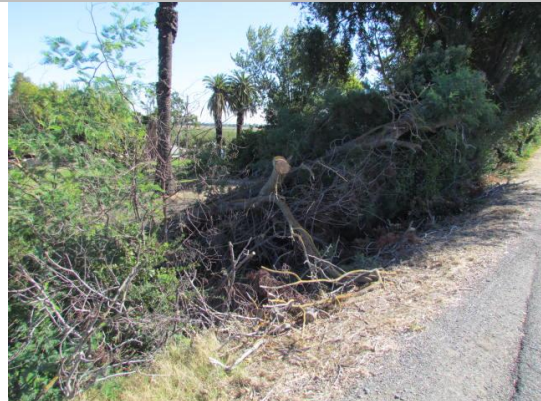
Photo 1 of 1 : FA_2015_RD0003_25_102_20150914_00082.jpg

Looking east at downed tree on landward slope.

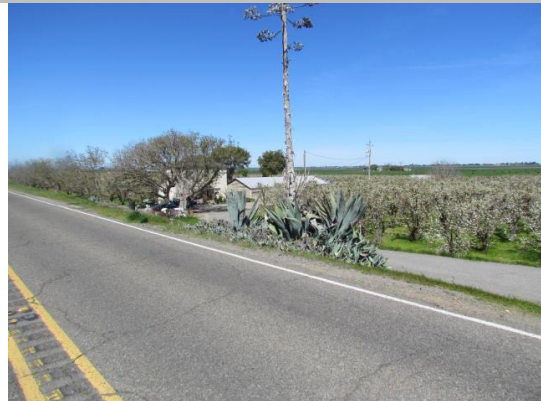
Photo 2 of 2 : FA_2015_RD0003_25_81_20150914_00066.jpg

Looking northwest at century plant on landward shoulder and slope.

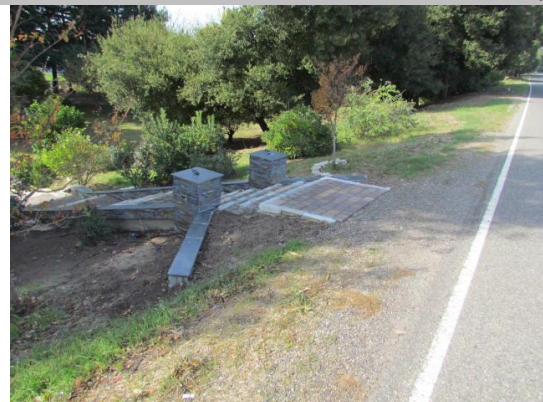
Photo 1 of 2 : FA_2015_RD0003_25_9_20150914_00008.jpg

Looking northwest at stairs on landside slope.

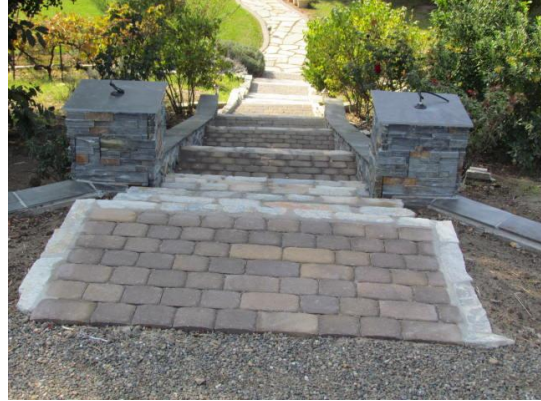
Photo 2 of 2 : FA_2015_RD0003_25_9_20150914_00009.jpg

Looking west at stairs on landside slope.

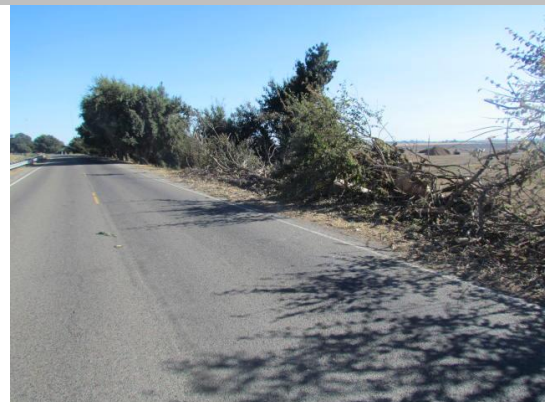
Photo 1 of 1 : FA_2015_RD0003_25_144_20150925_00110.jpg

Looking southwest at prunings on landward shoulder and slope.

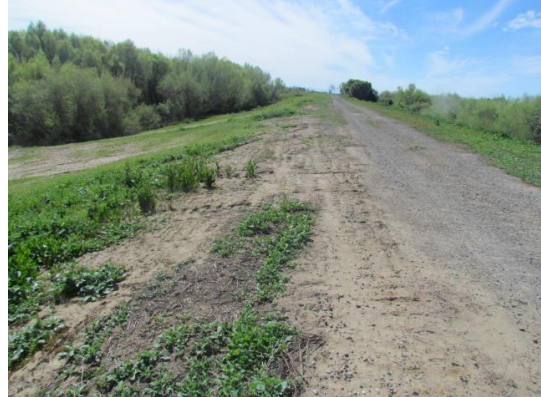
Photo 1 of 3 : FA_2015_RD0003_610_3_20150914_00001.jpg

Looking east at repaired site on landward shoulder and slope.

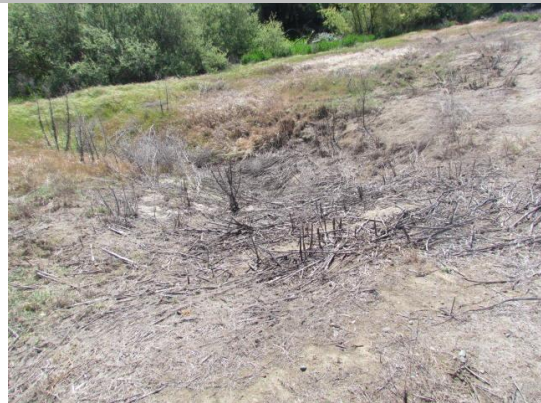
Photo 2 of 3 : FA_2015_RD0003_610_3_20150914_00002.jpg

Looking east at depression on landward slope.

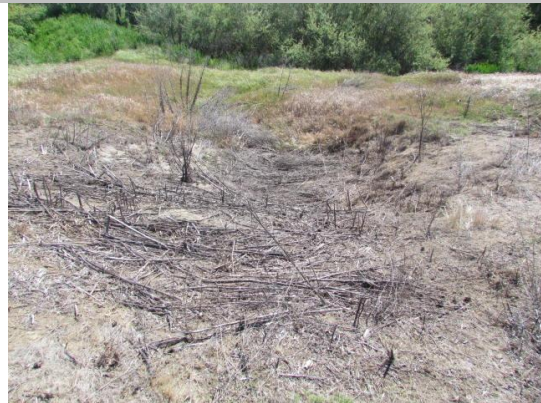
Photo 3 of 3 : FA_2015_RD0003_610_3_20150914_00003.jpg

Looking north on depression on landward slope.
