**Flood Control Project Maintenance  
Levee Inspections**

## Maintenance Issue Types Only, Levee Inspection Report By Mile - Fall 2016

### Reclamation District No. 0003 Grand Island

Waterway	Bank	Unit Miles	Inspection Start/End	Inspector
Unit No. 01 Left Bank Steamboat Slough	Left	10.95	09/27/2016 09/27/2016	Richard Willoughby

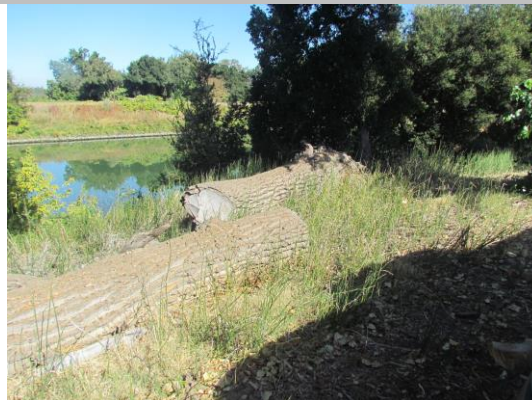
Photo 1 of 4 : FA\_2016\_RD0003\_24\_19\_20160929\_00154.jpg

LM Start	0.13	Rating **	U	Issue No.	19
LM End	0.13	Issue Type +	Ma	Location *	WS
Category	Earthen Levee			GPS Latitude/Longitude	
				Start	End
Item	Encroachments			38.303305 °	38.303305 °
				-121.576537 °	-121.576537 °
DWR ID	DWR_RD0003_01_f_2012_19				
Comment Code					
TR : Tree or limb					
Inspector Comment					
Tree branches and limbs on waterward shoulder.

Looking north at tree branches on waterward slope. (Fall 2016)

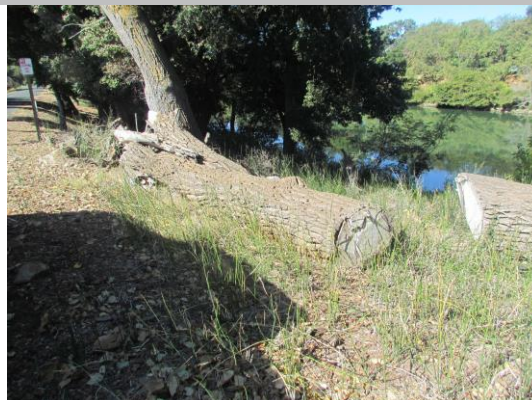
Photo 2 of 4 : FA\_2016\_RD0003\_24\_19\_20160929\_00153.jpg

Looking west at tree branch on waterward shoulder and slope. (Fall 2016)

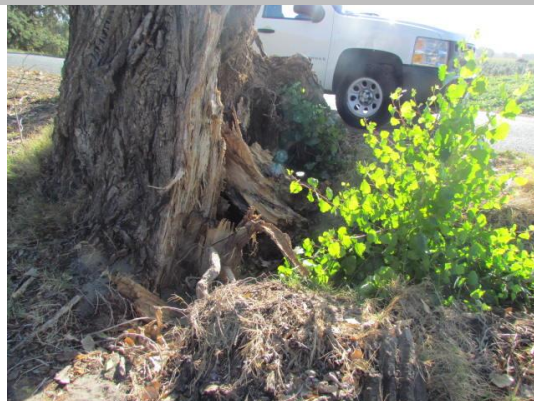
Photo 2 of 3 : FA\_2016\_RD0003\_24\_2\_20160915\_00004.jpg

LM Start	0.13	Rating **	M	Issue No.	2 (cont)	
LM End	0.13	Issue Type +	Ma	Location *	WS	
Category	Earthen Levee			GPS Latitude/Longitude		
				Start		End
Item	Erosion / Bank Caving			38.303303 °		38.303303 °
				-121.576538 °		-121.576538 °
DWR ID	DWR_RD0003_01_f_2013_2					
Comment Code						
E2 : Schedule repair of erosion site prior to the next inspection.						
Inspector Comment						
Hole (8ft x 2.5ft x 5ft) next to a large tree on waterward shoulder.

Looking at a hole next to oak tree on waterward shoulder.(2015)

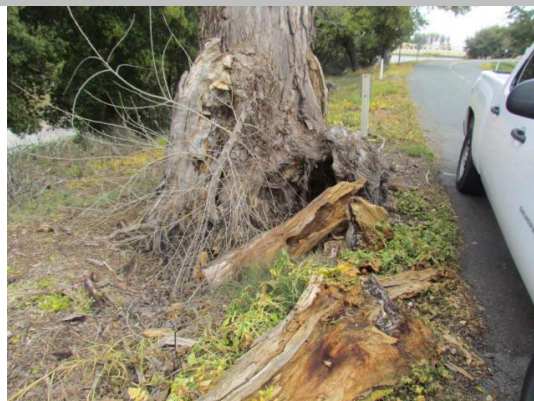
Photo 3 of 3 : FA\_2016\_RD0003\_24\_2\_20160915\_00005.jpg

Looking east at hole at the base of an oak tree on the waterward shoulder. (2016)

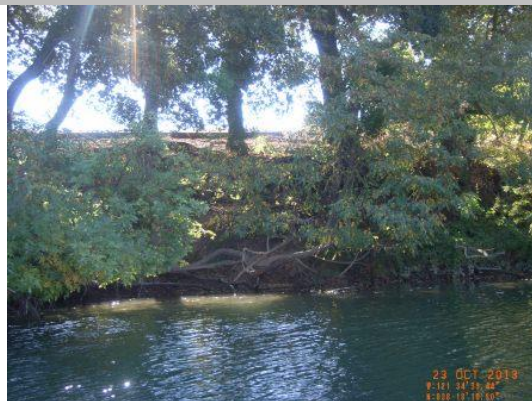
Photo 1 of 1 : FA\_2016\_RD0003\_24\_10\_20160915\_00014.jpg

LM Start	0.18	Rating **	M	Issue No.	10
LM End	0.24	Issue Type +	Ma	Location *	WS
Category	Supplemental			GPS Latitude/Longitude	
				Start	End
Item	2015 USACE Erosion Survey, DRAFT			38.303035 °	38.302544 °
				-121.577357 °	-121.578241 °
DWR ID	DWR_RD0003_01_s_2016_10				
Comment Code					
Inspector Comment					
1997 - Mass failure of berm slope and wave wash erosion. Large trees on top of berm, some failed trees. New area of low rock to on the upstream end. 2000 - Some minor erosion near the downstream end. 2005 - One new small tree has fallen. 2009 - Minimal new erosion. 2010 - Minor new erosion. 2013 - Observed new animal holes and vertical sections at middle of site. 2015: Minor new erosion. [2015 Site ID: STM 26-0 L]

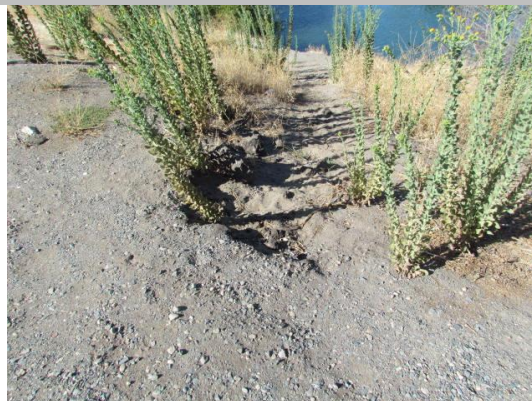
Photo 2 of 2 : FA\_2016\_RD0003\_24\_65\_20160915\_00053.jpg

LM Start	0.98	Rating **	M	Issue No.	65 (cont)	
LM End	0.98	Issue Type +	Ma	Location *	WS	
Category	Earthen Levee			GPS Latitude/Longitude		
				Start		End
Item	Slope Stability			38.292392 °		38.292392 °
				-121.582717 °		-121.582717 °
DWR ID	DWR_RD0003_01_f_2015_65					
Comment Code						
S2 : Repair the levee slope damaged by foot traffic and prevent access where possible.						
Inspector Comment						
Waterward levee damage caused by foot traffic.

Looking west at foot erosion on waterward slope. (Fall 2015)

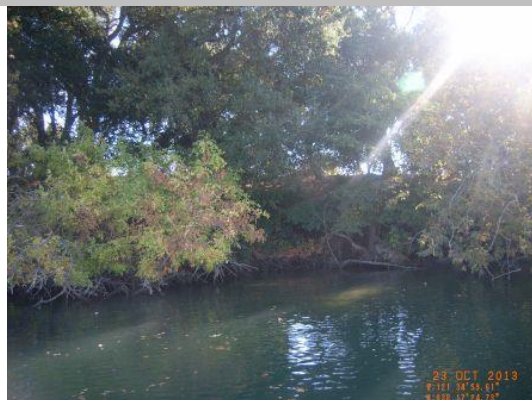
Photo 1 of 2 : FA\_2016\_RD0003\_24\_1\_20160915\_00001.jpg

LM Start	1.03	Rating **	M	Issue No.	1
LM End	1.18	Issue Type +	Ma	Location *	WS
Category	Supplemental			GPS Latitude/Longitude	
				Start	End
Item	2015 USACE Erosion Survey, DRAFT			38.291695 °	38.289575 °
				-121.582993 °	-121.583092 °
DWR ID	DWR_RD0003_01_s_2016_1				
Comment Code					
Inspector Comment					
2008 - Area closed sign on bank. Newly fallen trees at both ends and pop outs along the bank. 2010 - Site extended downstream. 2011 - New erosion at the toe. More trees popouts. 2013 - Short vertical sections observed at the downstream end. 2015: New erosion at toe. [2015 Site ID: STM_24-8_L]

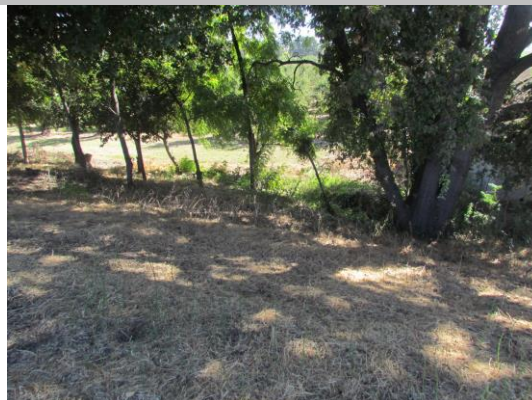
Photo 1 of 1 : FA\_2016\_RD0003\_24\_5\_20160929\_00156.jpg

Looking east at small oak trees at landward toe.

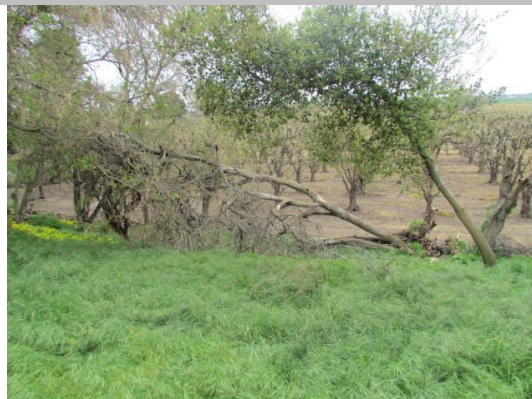
Photo 1 of 1 : FA\_2016\_RD0003\_24\_68\_20160915\_00054.jpg

LM Start	1.29	Rating **	M	Issue No.	68	
LM End	1.29	Issue Type +	Ma	Location *	LS	
Category	Earthen Levee			GPS Latitude/Longitude		
				Start		End
Item	Encroachments			38.287903 °		38.287903 °
				-121.582809 °		-121.582809 °
DWR ID	DWR_RD0003_01_s_2016_68					
Comment Code						
TR : Tree or limb						
Inspector Comment						
Fallen tree on landward toe.

Looking west at fallen tree at landward toe.

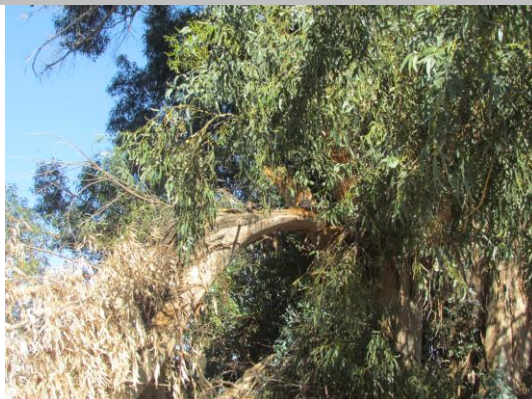
Photo 1 of 2 : FA\_2016\_RD0003\_24\_62\_20160929\_00159.jpg

LM Start	1.69	Rating **	U	Issue No.	62
LM End	1.69	Issue Type +	Ma	Location *	WS
Category	Earthen Levee			GPS Latitude/Longitude	
				Start	End
Item	Encroachments			38.283747 °	38.283747 °
				-121.587622 °	-121.587622 °
DWR ID	DWR_RD0003_01_f_2016_62				
Comment Code					
TR : Tree or limb					
Inspector Comment					
Broken tree branch on waterward slope.

Looking southwest at broken branches on waterward slope.

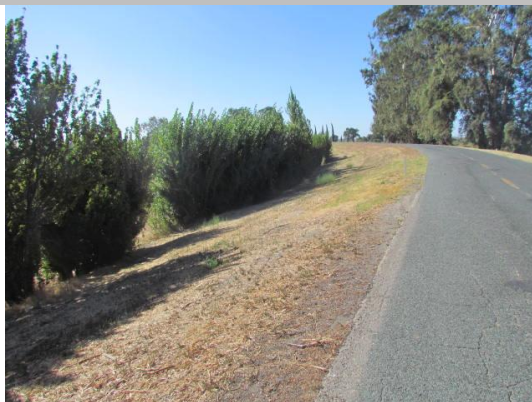
Photo 1 of 1 : FA\_2016\_RD0003\_24\_29\_20160915\_00037.jpg

LM Start	2.53	Rating **	U	Issue No.	29
LM End	2.66	Issue Type +	Ma	Location *	LS
Category	Earthen Levee			GPS Latitude/Longitude	
				Start	End
Item	Trim / Thin Trees			38.272845°	38.271070°
				-121.587665°	-121.588632°
DWR ID	DWR_RD0003_01_s_2013_29				
Comment Code					
T2 : Thin trees to allow visibility of the ground and room to flood fight.					
Inspector Comment

Looking southeast at trees blocking landward toe.

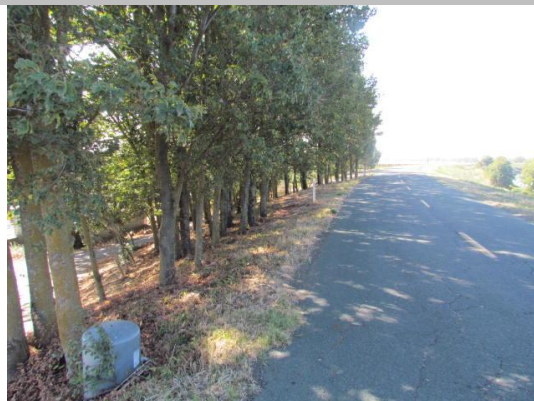
Photo 1 of 3 : FA\_2016\_RD0003\_24\_9\_20160915\_00011.jpg

Looking southeast at trees on landward shoulder and slope. (Fall 2014)

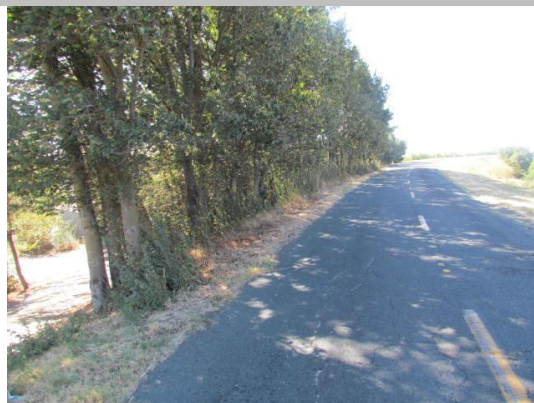
Photo 2 of 3 : FA\_2016\_RD0003\_24\_9\_20160915\_00012.jpg

Looking south at trees on landward shoulder and slope. (Fall 2015)

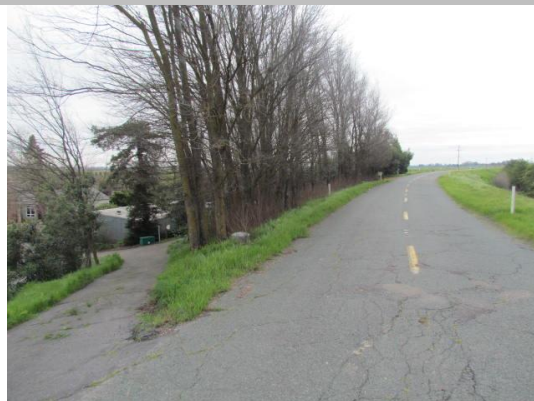
Photo 3 of 3 : FA\_2016\_RD0003\_24\_9\_20160915\_00013.jpg

Looking south at trees on landward shoulder and slope (Spring 2016).

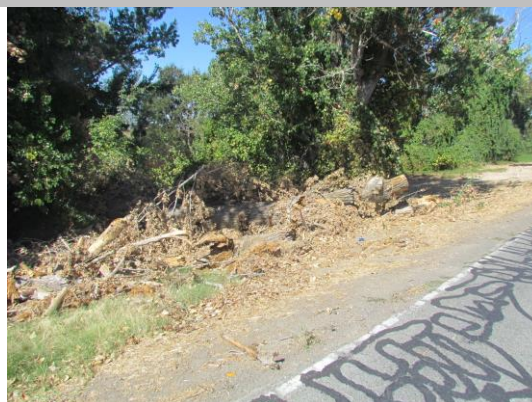
Photo 1 of 1 : FA\_2016\_RD0003\_24\_66\_20160929\_00164.jpg

LM Start	5.77	Rating **	U	Issue No.	66
LM End	5.77	Issue Type +	Ma	Location *	WS
Category	Earthen Levee			GPS Latitude/Longitude	
				Start	End
Item	Encroachments			38.233098 °	38.233098 °
				-121.601323 °	-121.601323 °
DWR ID	DWR_RD0003_01_f_2016_66				
Comment Code					
TR : Tree or limb					
Inspector Comment					
Broken tree branches and limbs on waterward slope.

Looking west at tree branches and limbs on waterward slope.

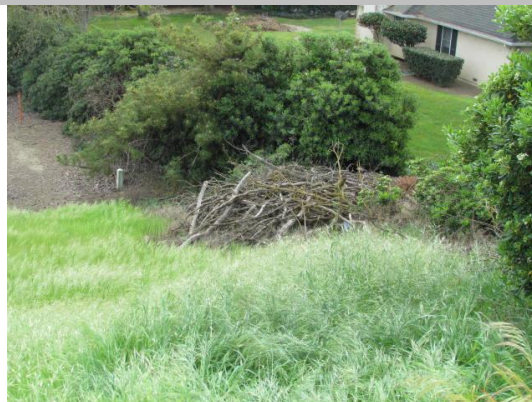
Photo 1 of 2 : FA\_2016\_RD0003\_24\_94\_20160915\_00064.jpg

Looking east at prunings on landward slope. (Fall 2015)

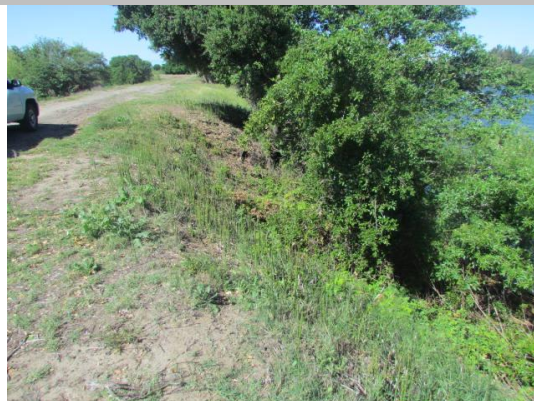
Photo 1 of 2 : FA\_2016\_RD0003\_24\_97\_20160915\_00068.jpg

LM Start	10.78	Rating **	U	Issue No.	97
LM End	10.80	Issue Type +	Ma	Location *	WS
Category	Earthen Levee			GPS Latitude/Longitude	
				Start	End
Item	Erosion / Bank Caving			38.183228 °	38.183123 °
				-121.650797 °	-121.651070 °
DWR ID	DWR_RD0003_01_s_2013_97				
Comment Code					
E2 : Schedule repair of erosion site prior to the next inspection.					
Inspector Comment					
Erosion extends to waterward shoulder.

Looking south at erosion on waterward slope.

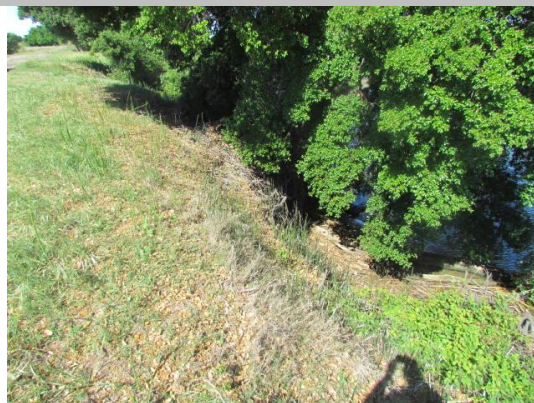
Photo 2 of 2 : FA\_2016\_RD0003\_24\_97\_20160915\_00069.jpg

Looking southwest at erosion on waterward slope.

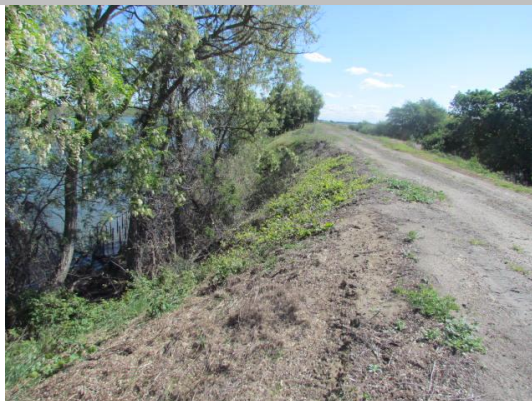
Photo 1 of 3 : FA\_2016\_RD0003\_24\_98\_20160915\_00070.jpg

LM Start	10.86	Rating **	U	Issue No.	98
LM End	10.89	Issue Type +	Ma	Location *	WS
Category	Earthen Levee			GPS Latitude/Longitude	
				Start	End
Item	Erosion / Bank Caving			38.182792 °	38.182672 °
				-121.652142 °	-121.652555 °
DWR ID	DWR_RD0003_01_s_2013_98				
Comment Code					
E2 : Schedule repair of erosion site prior to the next inspection.					
Inspector Comment					
Erosion extends to waterward shoulder.

Looking north at erosion on waterward slope.

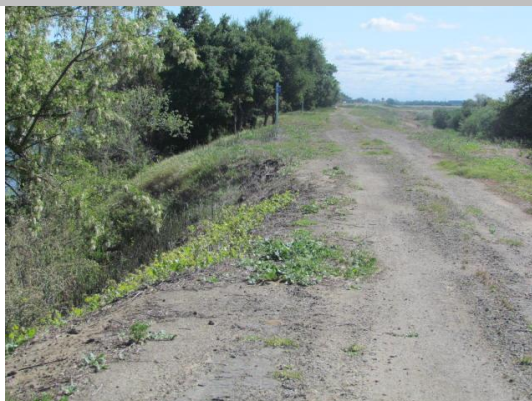
Photo 2 of 3 : FA\_2016\_RD0003\_24\_98\_20160915\_00071.jpg

Looking northwest at erosion on waterward shoulder and slope.

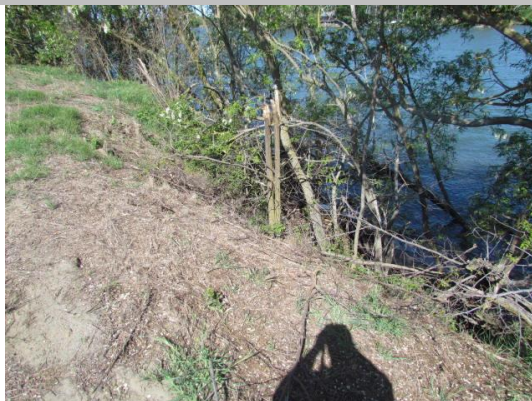
Photo 3 of 3 : FA\_2016\_RD0003\_24\_98\_20160915\_00072.jpg

Looking west at erosion on waterward slope.

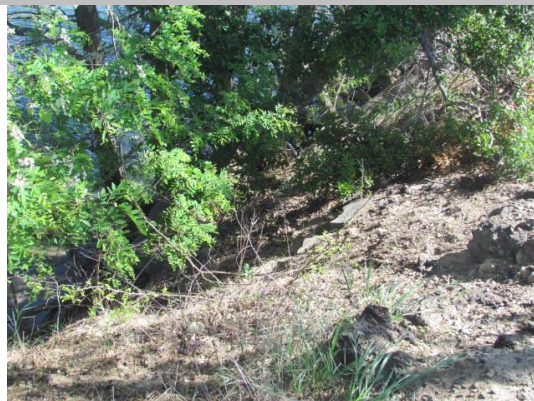
Photo 1 of 2 : FA\_2016\_RD0003\_24\_99\_20160915\_00073.jpg

LM Start	10.91	Rating **	U	Issue No.	99
LM End	10.94	Issue Type +	Ma	Location *	WS
Category	Earthen Levee			GPS Latitude/Longitude	
				Start	End
Item	Erosion / Bank Caving			38.182537 °	38.182388 °
				-121.652987 °	-121.653388 °
DWR ID	DWR_RD0003_01_s_2013_99				
Comment Code					
E2 : Schedule repair of erosion site prior to the next inspection.					
Inspector Comment					
Erosion extends to waterward shoulder.

Looking west at erosion on waterward slope.

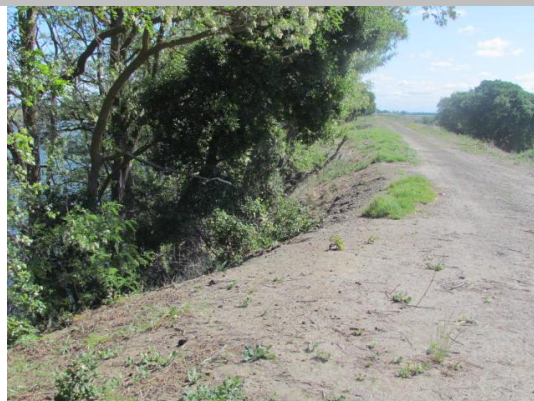
Photo 2 of 2 : FA\_2016\_RD0003\_24\_99\_20160915\_00074.jpg

Looking north at erosion on waterward shoulder and slope.

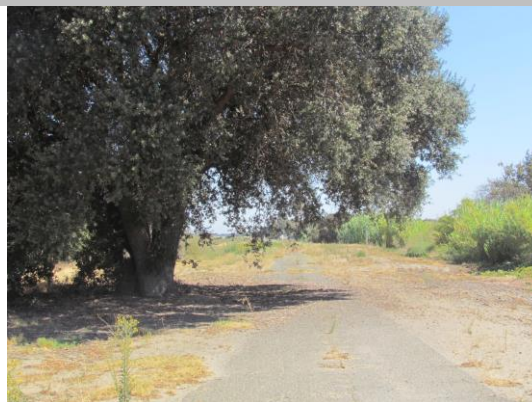
Photo 1 of 1 : FA\_2016\_RD0003\_25\_4\_20160929\_00246.jpg

Looking east at untrimmed tree on landward shoulder.

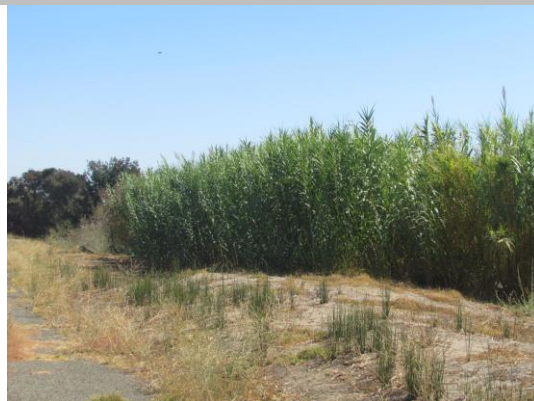
Photo 1 of 2 : FA\_2016\_RD0003\_25\_5\_20160929\_00247.jpg

Looking southeast at bamboo on waterward slope. (Fall 2016)

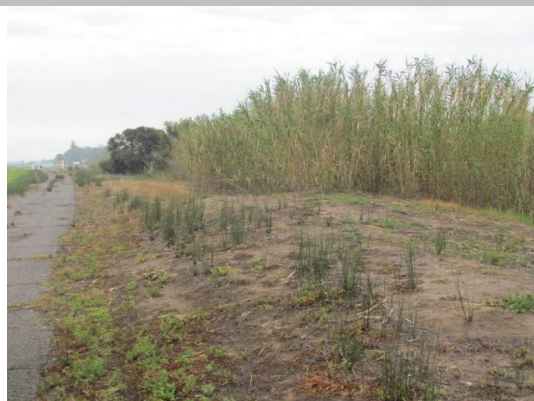
Photo 2 of 2 : FA\_2016\_RD0003\_25\_5\_20160915\_00008.jpg

Looking east at bamboo on waterward slope. (Spring 2016)

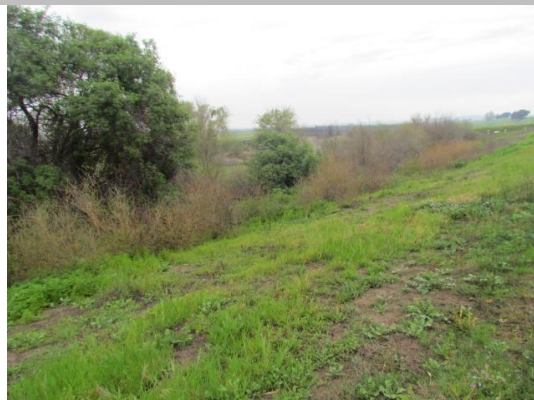
Photo 1 of 1 : FA\_2016\_RD0003\_25\_151\_20160915\_00098.jpg

Looking west at dense vegetation at landward toe.

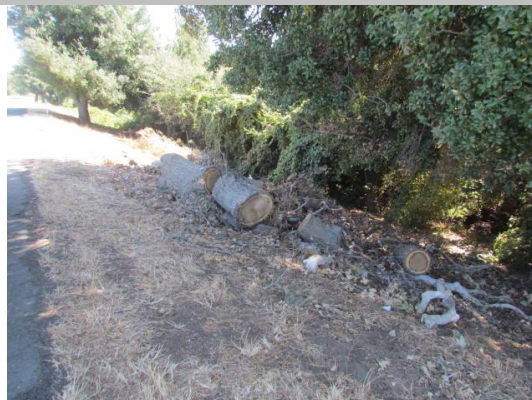
Photo 1 of 1 : FA\_2016\_RD0003\_25\_140\_20160915\_00088.jpg

Looking at tree branches and tree limbs on waterward shoulder and slope.

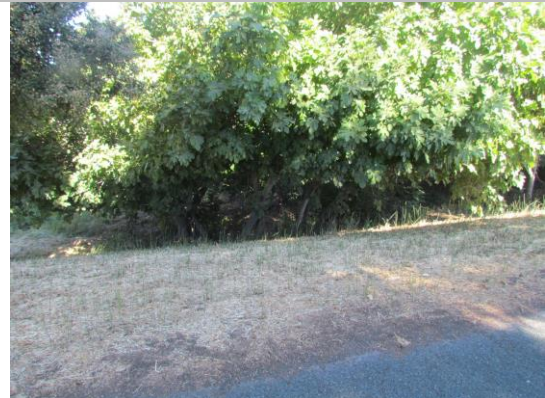
Photo 1 of 1 : FA\_2016\_RD0003\_25\_7\_20160929\_00250.jpg

Looking north at fig tree at landward toe.

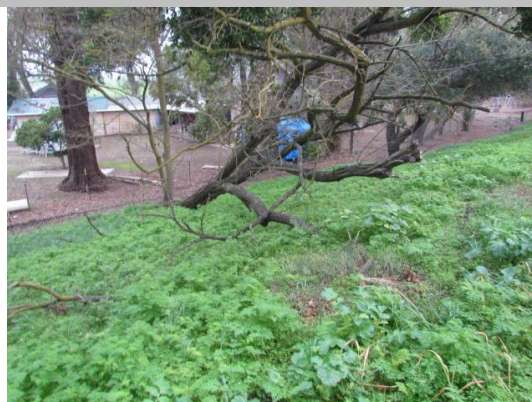
Photo 1 of 2 : FA\_2016\_RD0003\_25\_160\_20160915\_00102.jpg

Looking west at fallen tree on landward slope.(Spring 2016)

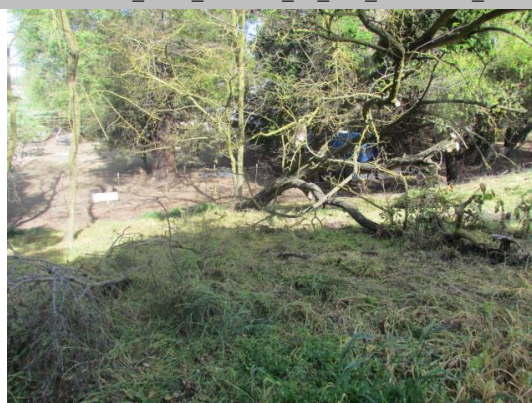
Photo 2 of 2 : FA\_2016\_RD0003\_25\_160\_20160915\_00103.jpg

Looking west at fallen tree on landward slope.

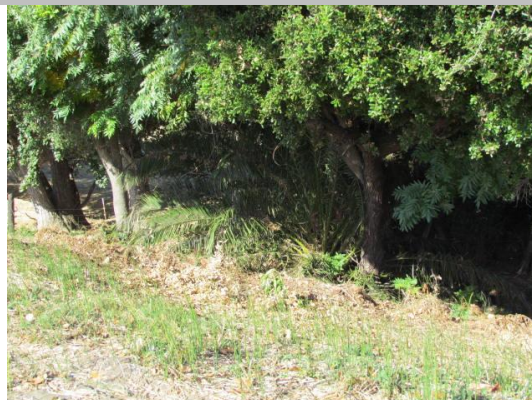
Photo 1 of 1 : FA\_2016\_RD0003\_25\_97\_20160915\_00081.jpg

Looking west at palm tree on landward toe.

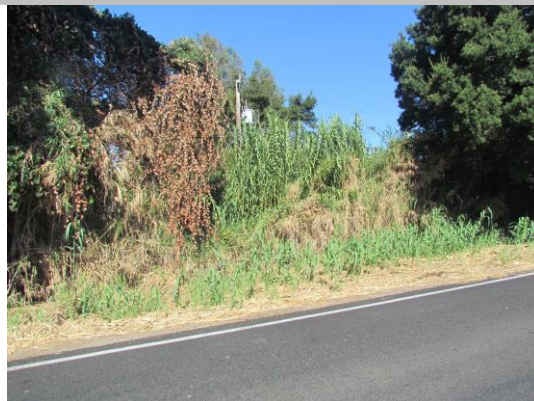
Photo 1 of 2 : FA\_2016\_RD0003\_25\_952\_20160929\_00251.jpg

Looking west at bamboo on landward shoulder and slope. (Fall 2016)

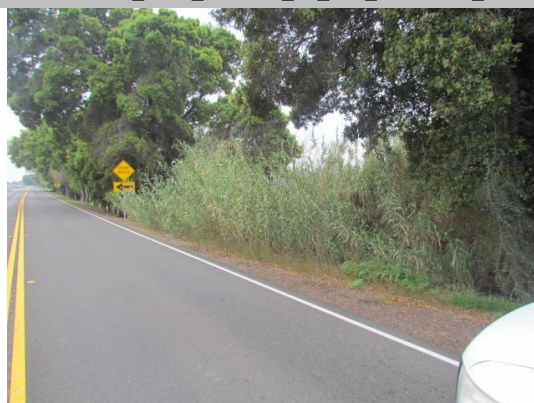
Photo 2 of 2 : FA\_2016\_RD0003\_25\_952\_20160915\_00107.jpg

Looking southwest at dense vegetation on landward slope. (Spring 2016)

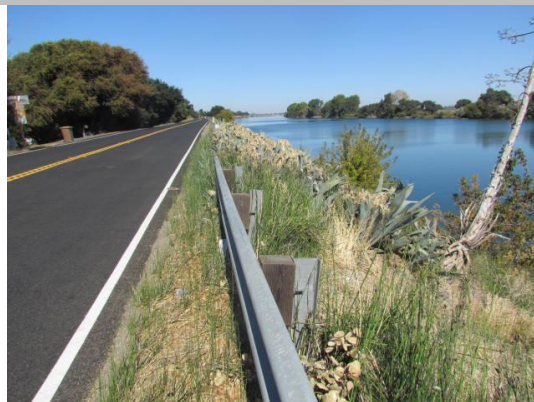
Photo 1 of 1 : FA\_2016\_RD0003\_25\_145\_20160915\_00093.jpg

Looking northeast at century plants on waterward shoulder and slope.

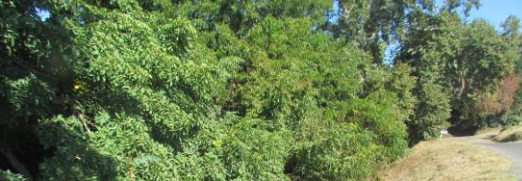
Photo 1 of 2 : FA\_2016\_RD0003\_25\_10\_20160929\_0025.jpg

Looking north at untrimmed trees on landwards slope and toe. (Fall 2016)

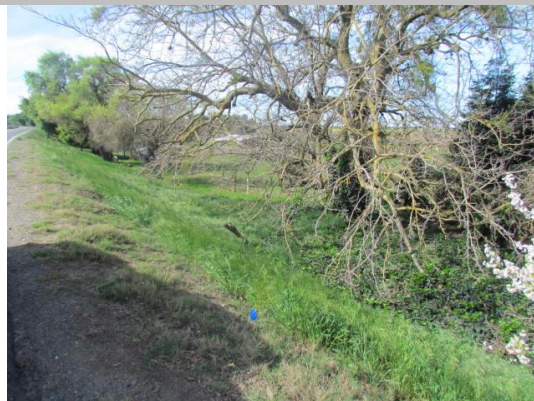
Photo 2 of 2 : FA\_2016\_RD0003\_25\_10\_20160915\_00014.jpg

Looking west at untrimmed tree on landward slope. (Spring 2016)

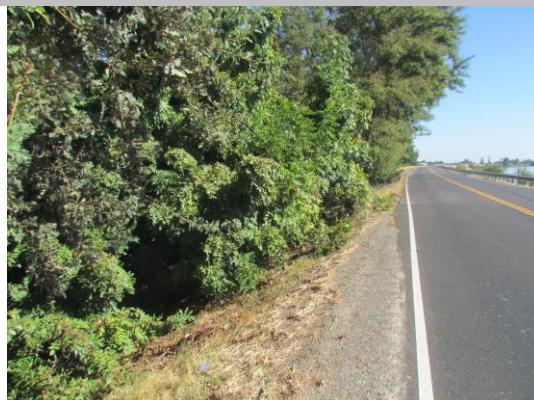
Photo 1 of 2 : FA\_2016\_RD0003\_25\_14\_20160929\_00254.jpg

Looking northeast at dense vegetation on landward shoulder and slope. (Fall 2016)

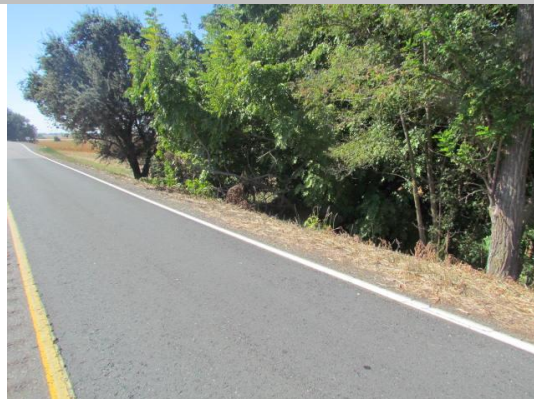
Photo 2 of 2 : FA\_2016\_RD0003\_25\_14\_20160915\_00022.jpg

Looking southwest at untrimmed trees on landward toe. (Spring 2016)

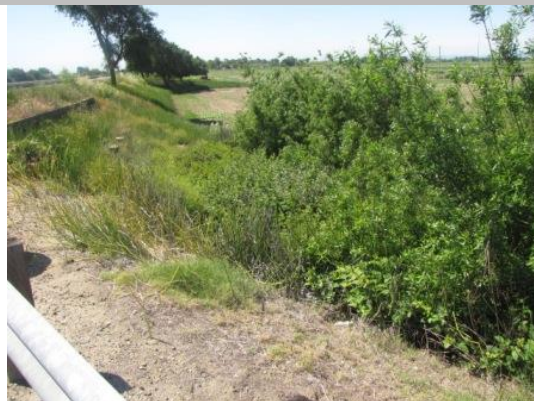
Photo 1 of 1 : FA\_2016\_RD0003\_25\_16\_20160915\_00025.jpg

Looking southwest at dense veg. on landside toe.

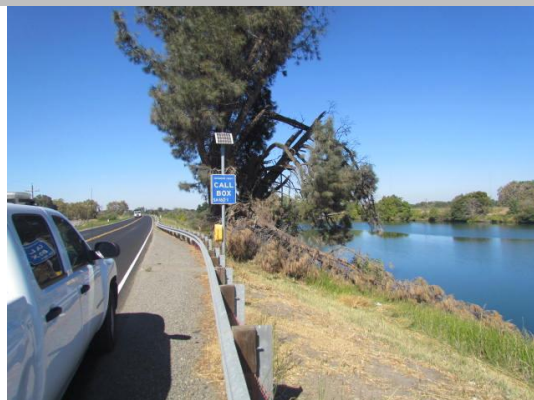
Photo 1 of 2 : FA\_2016\_RD0003\_25\_15\_20160915\_00023.jpg

LM Start	8.11	Rating **	U	Issue No.	15
LM End	8.11	Issue Type +	Ma	Location *	WS
Category	Earthen Levee			GPS Latitude/Longitude	
				Start	End
Item	Encroachments			38.224130 °	38.224130 °
				-121.557206 °	-121.557206 °
DWR ID	DWR_RD0003_02_f_2015_15				
Comment Code					
TR : Tree or limb					
Inspector Comment					
Broken tree branches on waterward shoulder and slope.

Looking northeast at broken and cracked tree branches on waterward slope.

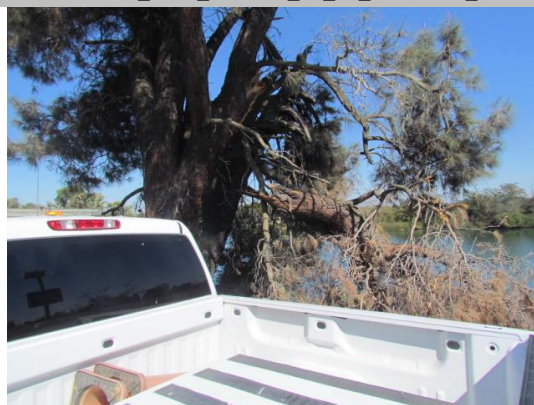
Photo 2 of 2 : FA\_2016\_RD0003\_25\_15\_20160915\_00024.jpg

Looking east at broken and cracked tree branches on waterward slope.

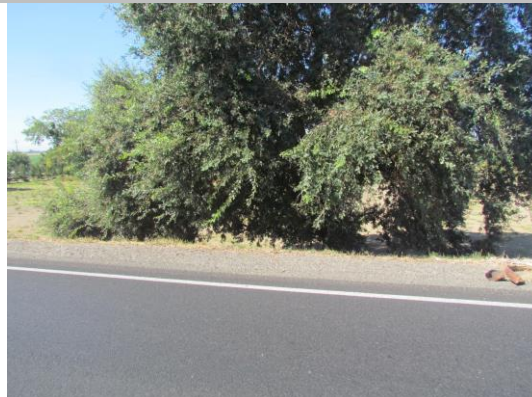
Photo 1 of 1 : FA\_2016\_RD0003\_25\_23\_20160929\_00255.jpg

Looking west at untrimmed trees at landward toe.

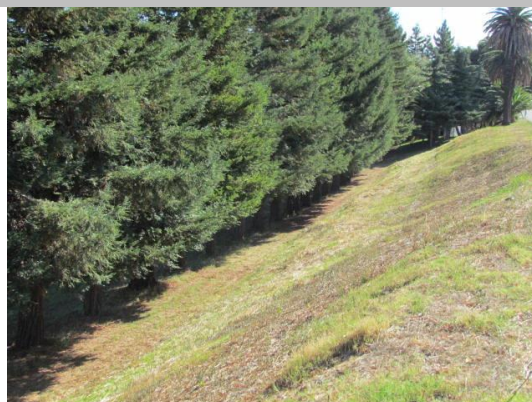
Photo 1 of 2 : FA\_2016\_RD0003\_25\_101\_20160915\_00084.jpg

Looking northeast at dense redwood trees on landward toe and berm.

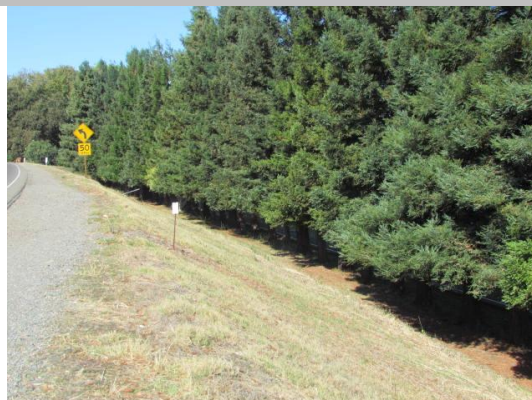
Photo 2 of 2 : FA\_2016\_RD0003\_25\_101\_20160915\_00085.jpg

Looking southwest at dense redwood trees on landward toe and berm.

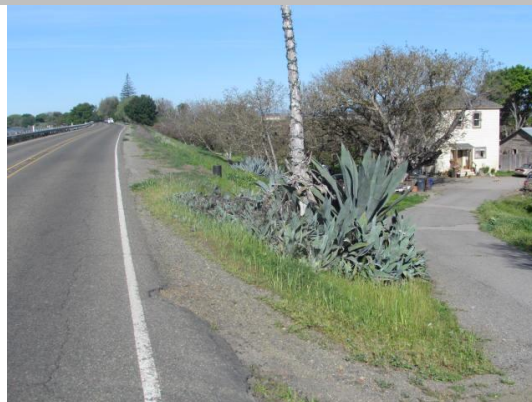
Photo 1 of 2 : FA\_2016\_RD0003\_25\_81\_20160915\_00067.jpg

Looking west at century plant on landward slope. (Spring 2015)

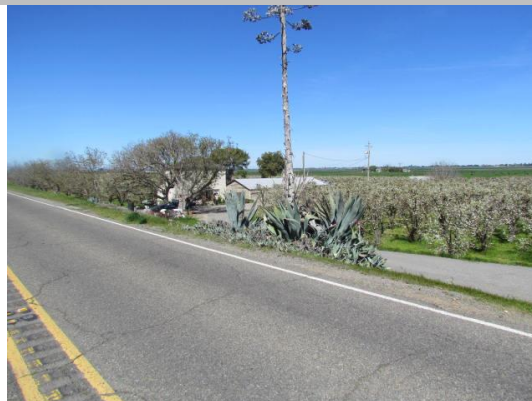
Photo 2 of 2 : FA\_2016\_RD0003\_25\_81\_20160915\_00068.jpg

Looking northwest at century plant on landward shoulder and slope.

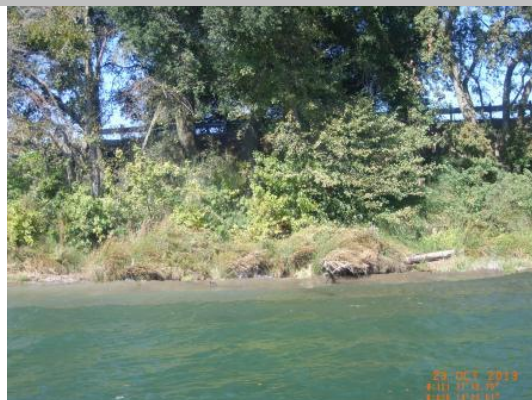
Photo 1 of 2 : FA\_2016\_RD0003\_25\_1\_20160915\_00001.jpg

LM Start	11.33	Rating **	M	Issue No.	1
LM End	11.42	Issue Type +	Ma	Location *	WS
Category	Supplemental			GPS Latitude/Longitude	
				Start	End
Item	2015 USACE Erosion Survey, DRAFT			38.239870 °	38.239983 °
				-121.520989 °	-121.519361 °
DWR ID	DWR_RD0003_02_s_2016_1				
Comment Code					
Inspector Comment					
2009 - Hole left in levee toe from a fallen tree. Could be repaired under maintenance. 2010 - Minor new erosion. 2015: Minor new erosion at toe. [2015 Site ID: SAC_26-3_R]

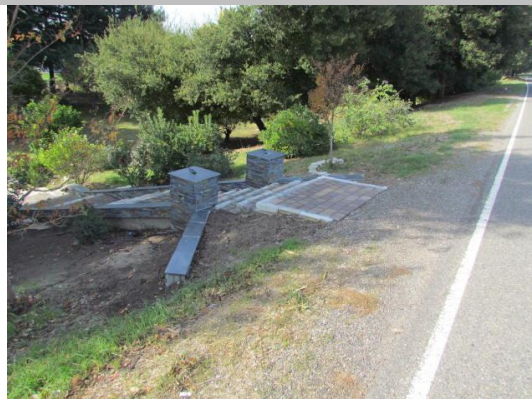
Photo 1 of 2 : FA\_2016\_RD0003\_25\_9\_20160915\_00012.jpg

Looking northwest at stairs on landside slope.

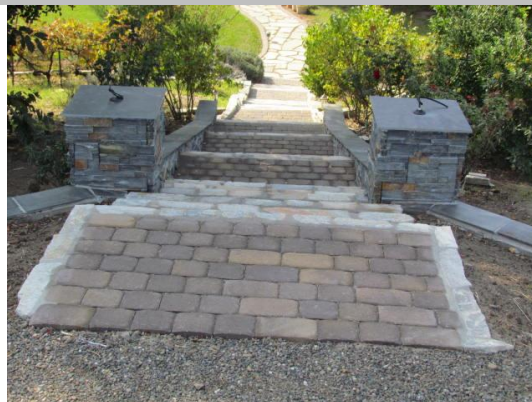
Photo 2 of 2 : FA\_2016\_RD0003\_25\_9\_20160915\_00013.jpg

Looking west at stairs on landside slope.

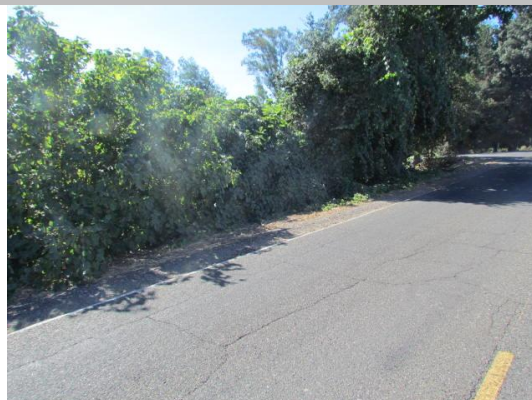
Photo 1 of 2 : FA\_2016\_RD0003\_25\_99\_20160915\_00082.jpg

Looking westly at dense vegetation on landward shoulder and slope.  
(Spring 2016)

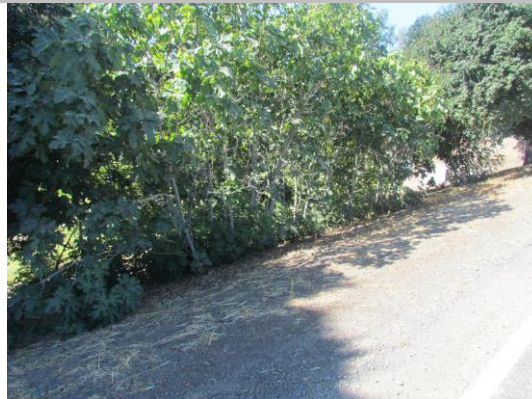
Photo 2 of 2 : FA\_2016\_RD0003\_25\_99\_20160929\_00257.jpg

Looking westly at fig trees on landward slope. (Fall 2016)

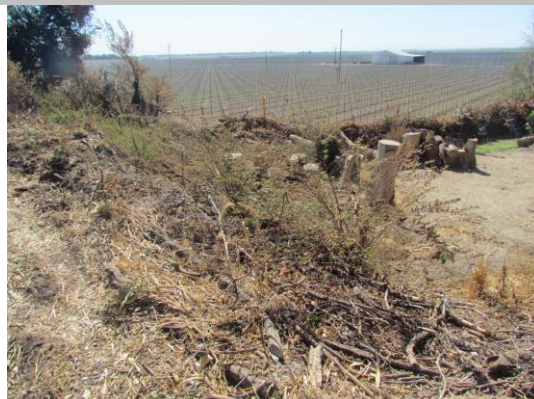
Photo 1 of 2 : FA\_2016\_RD0003\_25\_144\_20160929\_00258.jpg

Looking south at prunings on landward slope. (Fall 2016)

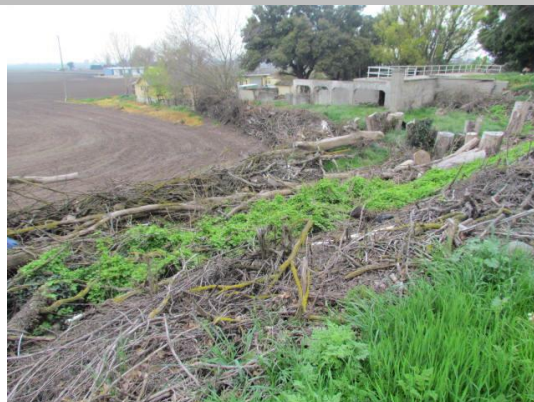
Photo 2 of 2 : FA\_2016\_RD0003\_25\_144\_20160915\_00092.jpg

Looking southwest at prunings on landward slope and toe. (Spring 2016)

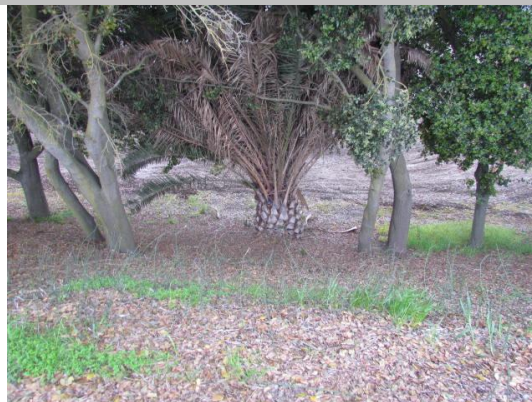
Photo 1 of 1 : FA\_2016\_RD0003\_25\_95\_20160915\_00079.jpg

Looking west at Palm tree at landward toe.

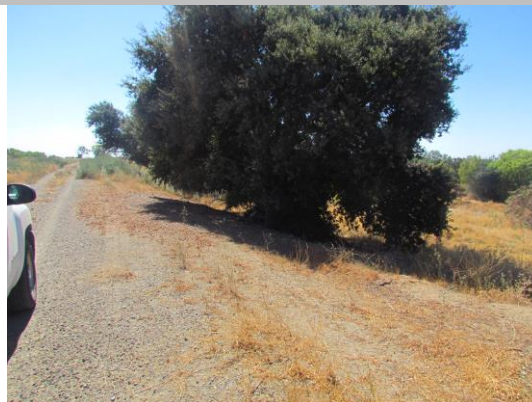
Photo 1 of 1 : FA\_2016\_RD0003\_610\_5\_20160929\_00008.jpg

Looking southeast at untrimmed trees on waterward slope and toe.
