**Flood Control Project Maintenance
Levee Inspections**

Maintenance Issue Types Only, Levee Inspection Report By Mile - Fall 2017

Reclamation District No. 0003 Grand Island

Waterway	Bank	Unit Miles	Inspection Start/End	Inspector
Unit No. 01 Left Bank Steamboat Slough	Left	10.95	09/18/2017 09/18/2017	Dave Torres

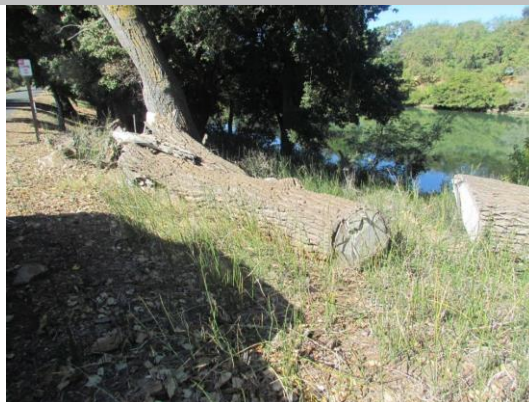
Photo 2 of 4 : FA_2017_RD0003_24_19_20170911_00023.jpg

LM Start	0.13	Rating **	U	Issue No.	19
LM End	0.13	Issue Type +	Ma	Location *	WS
Category	Earthen Levee			GPS Latitude/Longitude	
				Start	End
Item	Encroachments			38.303305 °	38.303305 °
				-121.576537 °	-121.576537 °
DWR ID	DWR_RD0003_01_f_2012_19				
Comment Code					
TR : Tree or limb					
Inspector Comment					
Tree branches and limbs on waterward shoulder.

Looking west at tree branch on waterward shoulder and slope. (Fall 2016)

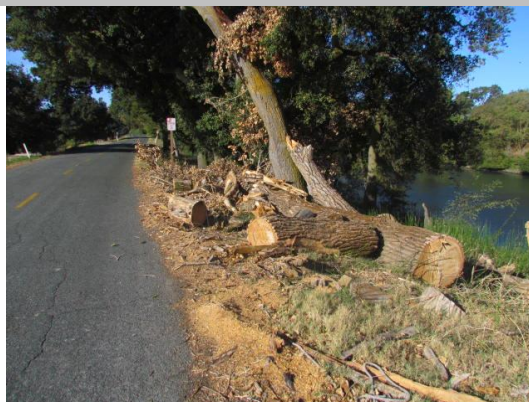
Photo 4 of 4 : FA_2017_RD0003_24_19_20170911_00025.jpg

Looking west at tree branches on waterward shoulder. (Spring 2014)

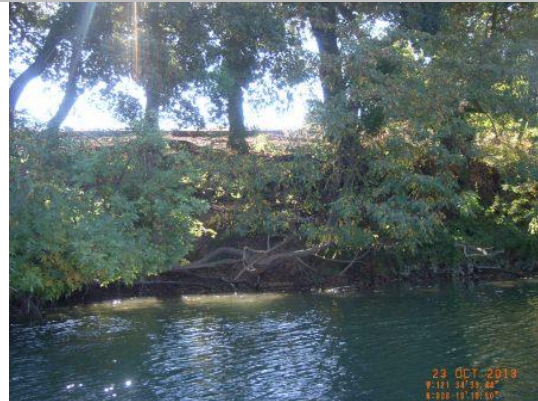
Photo 1 of 1 : FA_2017_RD0003_24_10_20170911_00016.jpg

LM Start	0.18	Rating **	A/W	Issue No.	10
LM End	0.24	Issue Type +	Ma	Location *	WS
Category	Supplemental			GPS Latitude/Longitude	
				Start	End
Item	2015 USACE Erosion Survey, DRAFT			38.303035 °	38.302544 °
				-121.577357 °	-121.578241 °
DWR ID	DWR_RD0003_01_s_2016_10				
Comment Code					
Inspector Comment					
1997 - Mass failure of berm slope and wave wash erosion. Large trees on top of berm, some failed trees. New area of low rock to on the upstream end. 2000 - Some minor erosion near the downstream end. 2005 - One new small tree has fallen. 2009 - Minimal new erosion. 2010 - Minor new erosion. 2013 - Observed new animal holes and vertical sections at middle of site. 2015: Minor new erosion. [2015 Site ID: STM_26-0_L]

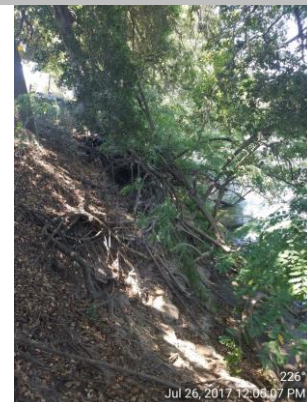
Photo 1 of 3 : LEVAL_FA_2017_274_2391.jpg

LM Start	0.18	Rating **	A/W	Issue No.	54
LM End	0.21	Issue Type +	Ma	Location *	
Category	Supplemental			GPS Latitude/Longitude	
				Start	End
Item	2017 Storm Damage			38.302981 °	38.302778 °
				-121.577336 °	-121.577683 °
DWR ID	DWR_RD0003_01_f_2017_54				
Comment Code					
Inspector Comment					
Levee Evaluation Comments					
Description:District station 9+63 to 10+85, Sec. 07, T. 5 N. R. 4 E., M.D.M. An erosion site exists along approximately 122 linear feet of the water side slope of Steamboat Slough (Unit 1). Erosion commences approximately 1/3 of the way down the slope from the crown to the waterside toe. Erosion is undercutting existing trees.					
Site ID No:274					
Site Designation:LMA-100					
Repair Type: Erosion					
Rating:Serious					
Field Date:7/26/2017					
Notes: trees undercut by erosion

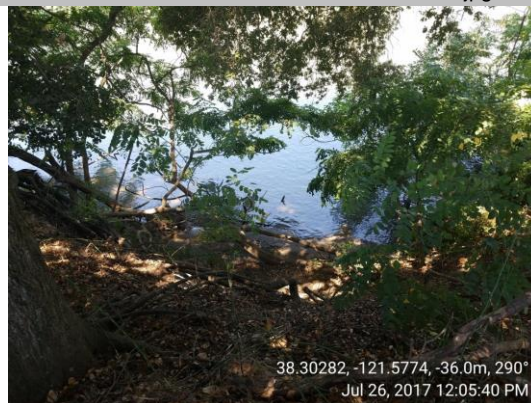
Photo 2 of 3 : LEVAL_FA_2017_274_2392.jpg

LM Start	0.18	Rating **	A/W	Issue No.	54 (cont)	
LM End	0.21	Issue Type +	Ma	Location *		
Category	Supplemental			GPS Latitude/Longitude		
				Start	End	
Item	2017 Storm Damage			38.302981 °	38.302778 °	
				-121.577336 °	-121.577683 °	
DWR ID	DWR_RD0003_01_f_2017_54					
Comment Code						
Inspector Comment						
Levee Evaluation Comments						
Description: District station 9+63 to 10+85, Sec. 07, T. 5 N. R. 4 E., M.D.M. An erosion site exists along approximately 122 linear feet of the water side slope of Steamboat Slough (Unit 1). Erosion commences approximately 1/3 of the way down the slope from the crown to the waterside toe. Erosion is undercutting existing trees.						
Site ID No: 274						
Site Designation: LMA-100						
Repair Type: Erosion						
Rating: Serious						
Field Date: 7/26/2017						
Notes: trees undercut by erosion

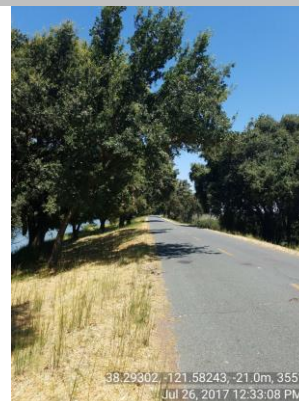
Photo 3 of 3 : LEVAL_FA_2017_275_2399.jpg

LM Start	0.91	Rating **	A/W	Issue No.	55 (cont)
LM End	0.97	Issue Type +	Ma	Location *	
Category	Supplemental			GPS Latitude/Longitude	
				Start	End
Item	2017 Storm Damage			38.293381 °	38.292617 °
				-121.582450 °	-121.582675 °
DWR ID	DWR_RD0003_01_f_2017_55				
Comment Code					
Inspector Comment					
Levee Evaluation Comments					
Description:District station 48+20 to 51+06, Sec. 07, T. 5 N. R. 4 E., M.D.M. An erosion site exists along approximately 286 linear feet of the water side slope of Steamboat Slough (Unit 1). The erosion begins approximately 1/2 ofthe way down the slope from the crown to the waterside toe. Erosion is undercutting existing trees.					
Site ID No:275					
Site Designation:LMA-101					
Repair Type: Erosion					
Rating:Serious					
Field Date:7/26/2017					
Notes:

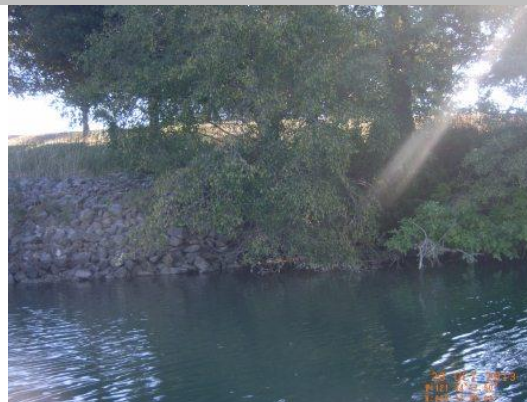
Photo 1 of 1 : FA_2017_RD0003_24_4_20170911_00006.jpg

LM Start	0.91	Rating **	A/W	Issue No.	4
LM End	0.96	Issue Type +	Ma	Location *	WS
Category	Supplemental			GPS Latitude/Longitude	
				Start	End
Item	2015 USACE Erosion Survey, DRAFT			38.293386 °	38.292675 °
				-121.582554 °	-121.582741 °
DWR ID	DWR_RD0003_01_s_2016_4

Comment Code					
Inspector Comment					
1997 - Erosion of sandy levee on top left bank. Site is downstream of a rock section. Large riparian trees on the bank. 1999 - Upstream half of the reach repaired with rock, except for a 30 ft reach at the upstream end. 2001 - Rock repair on the upstream and downstream ends; no revetment at the trees. 2002 - Rock repair is starting to slide off the geotextile at the upstream end. 2005 - One new small tree has fallen. 2006 - 50 ft pocket at the downstream end and at the upstream end with new rock in between. 2007 - Upstream end has been repaired. 2010 - Some minor new erosion. 2011 - Minor new erosion. 2012 - Minor new erosion at the toe. 2015: Significant new erosion, large oak tree on verge of popping out. [2015 Site ID: STM_25-0_L]

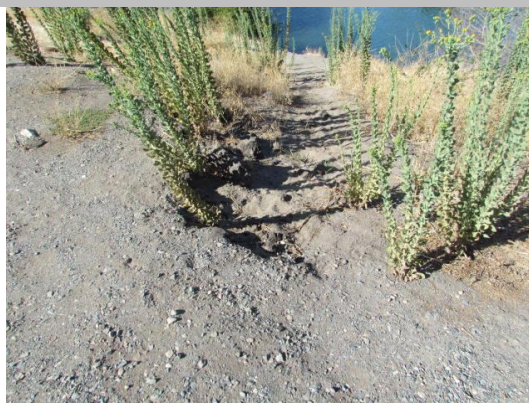
Photo 2 of 2 : FA_2017_RD0003_24_65_20170911_00054.jpg

LM Start	0.98	Rating **	M	Issue No.	65
LM End	0.98	Issue Type +	Ma	Location *	WS
Category	Earthen Levee			GPS Latitude/Longitude	
				Start	End
Item	Slope Stability			38.292392 °	38.292392 °
				-121.582717 °	-121.582717 °
DWR ID	DWR_RD0003_01_f_2015_65				
Comment Code					
S2 : Repair the levee slope damaged by foot traffic and prevent access where possible.					
Inspector Comment					
Waterward levee damage caused by foot traffic.

Looking west at foot erosion on waterward slope. (Fall 2015)

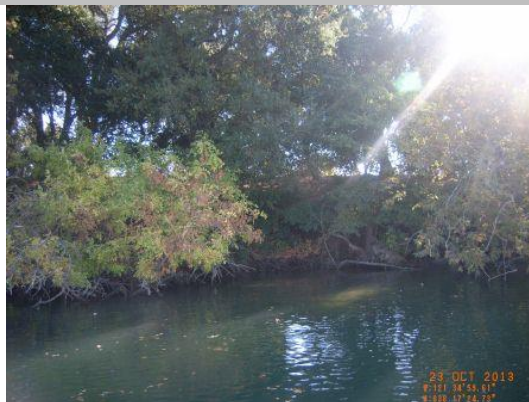
Photo 1 of 2 : FA_2017_RD0003_24_1_20170911_00001.jpg

LM Start	1.03	Rating **	M	Issue No.	1
LM End	1.18	Issue Type +	Ma	Location *	WS
Category	Supplemental			GPS Latitude/Longitude	
				Start	End
Item	2015 USACE Erosion Survey, DRAFT			38.291695 °	38.289575 °
				-121.582993 °	-121.583092 °
DWR ID	DWR_RD0003_01_s_2016_1				
Comment Code					
Inspector Comment					
2008 - Area closed sign on bank. Newly fallen trees at both ends and pop outs along the bank. 2010 - Site extended downstream. 2011 - New erosion at the toe. More trees popouts. 2013 - Short vertical sections observed at the downstream end. 2015: New erosion at toe. [2015 Site ID: STM 24-8 L]

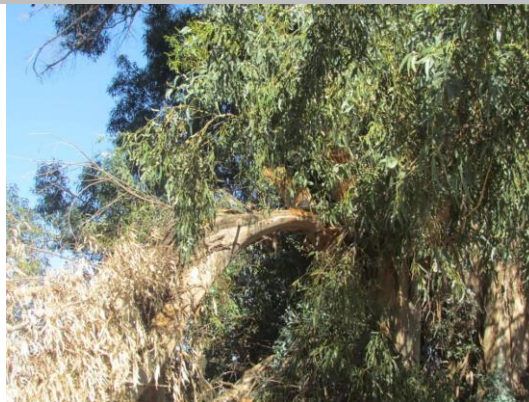
Photo 1 of 2 : FA_2017_RD0003_24_62_20170911_00051.jpg

LM Start	1.69	Rating **	U	Issue No.	62
LM End	1.69	Issue Type +	Ma	Location *	WS
Category	Earthen Levee			GPS Latitude/Longitude	
				Start	End
Item	Encroachments			38.283747 °	38.283747 °
				-121.587622 °	-121.587622 °
DWR ID	DWR_RD0003_01_f_2016_62				
Comment Code					
TR : Tree or limb					
Inspector Comment					
Broken tree branch on waterward slope.

Looking southwest at broken branches on waterward slope.

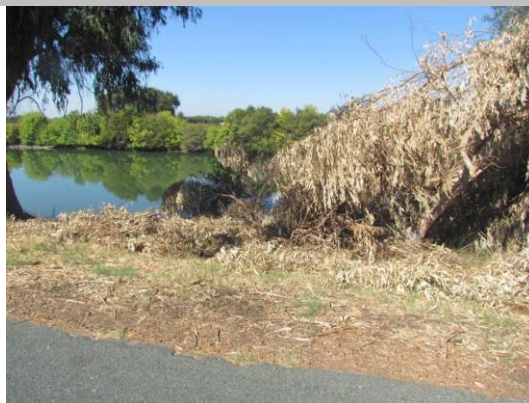
Photo 2 of 2 : FA_2017_RD0003_24_62_20170911_00052.jpg

LM Start	1.69	Rating **	U	Issue No.	62 (cont)	
LM End	1.69	Issue Type +	Ma	Location *	WS	
Category	Earthen Levee			GPS Latitude/Longitude		
				Start		End
Item	Encroachments			38.283747 °		38.283747 °
				-121.587622 °		-121.587622 °
DWR ID	DWR_RD0003_01_f_2016_62					
Comment Code						
TR : Tree or limb						
Inspector Comment						
Broken tree branch on waterward slope.

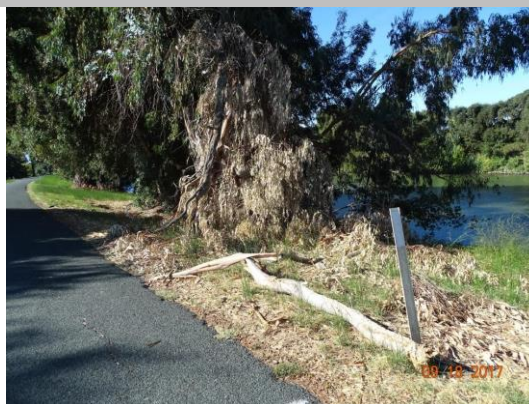
Photo 1 of 1 : FA_2017_RD0003_24_81_20170929_00174.jpg

LM Start	1.93	Rating **	M	Issue No.	81
LM End	1.93	Issue Type +	Ma	Location *	WS
Category	Earthen Levee			GPS Latitude/Longitude	
				Start	End
Item	Encroachments			38.280319 °	38.280319 °
				-121.588426 °	-121.588426 °
DWR ID	DWR_RD0003_01_f_2017_81				
Comment Code					
TR : Tree or limb					
Inspector Comment

Looking southwest at waterside slope.

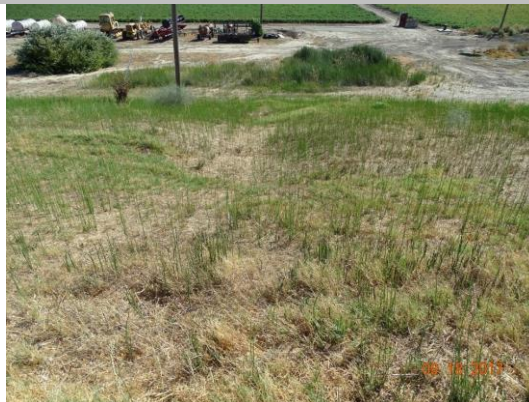
Photo 1 of 1 : FA_2017_RD0003_24_83_20170929_00177.jpg

LM Start	4.87	Rating **	M	Issue No.	83
LM End	4.87	Issue Type +	Ma	Location *	LS
Category	Earthen Levee			GPS Latitude/Longitude	
				Start	End
Item	Slope Stability			38.245903 °	38.245903 °
				-121.600851 °	-121.600851 °
DWR ID	DWR_RD0003_01_f_2017_83				
Comment Code					
S1 : Repair slope instability.					
Inspector Comment					
Landside slope has a depression.

Looking east on landside slope.

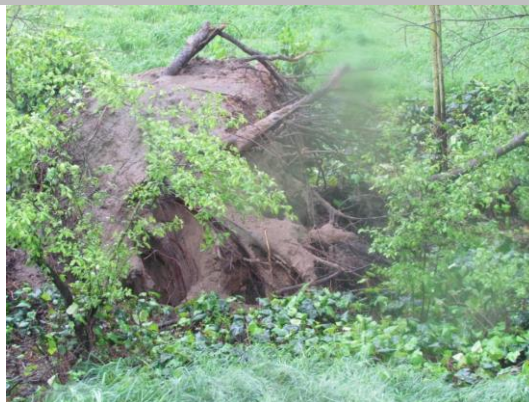
Photo 2 of 2 : FA_2017_RD0003_24_58_20170911_00049.jpg

Looking at large root ball, large hole on landward slope.

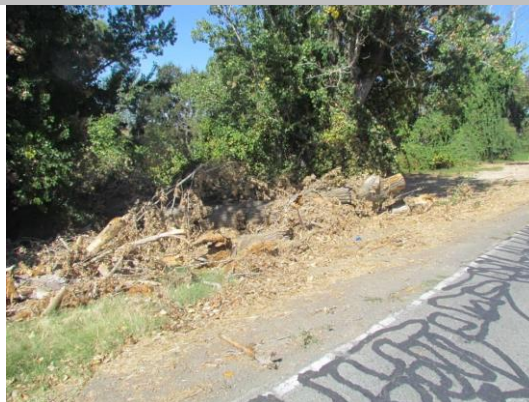
Photo 1 of 1 : FA_2017_RD0003_24_66_20170911_00055.jpg

LM Start	5.77	Rating **	U	Issue No.	66
LM End	5.77	Issue Type +	Ma	Location *	WS
Category	Earthen Levee			GPS Latitude/Longitude	
				Start	End
Item	Encroachments			38.233098 °	38.233098 °
				-121.601323 °	-121.601323 °
DWR ID	DWR_RD0003_01_f_2016_66				
Comment Code					
TR : Tree or limb					
Inspector Comment					
Broken tree branches and limbs on waterward slope.

Looking west at tree branches and limbs on waterward slope.

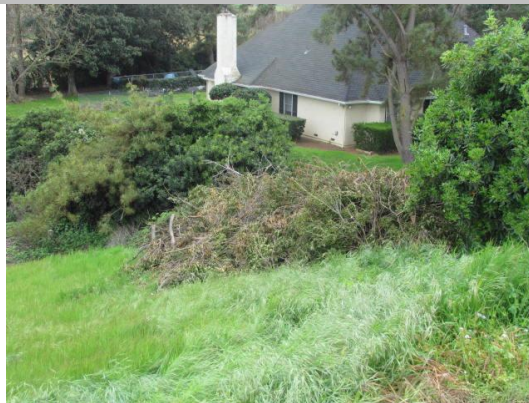
Photo 2 of 2 : FA_2017_RD0003_24_94_20170911_00071.jpg

Looking at prunings on landward slope (Spring 2016)

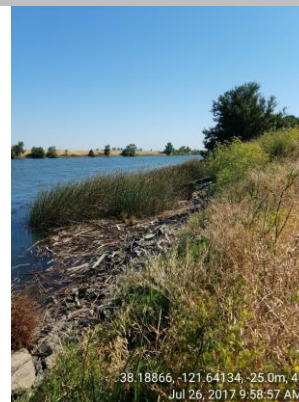
Photo 1 of 3 : LEVAL_FA_2017_277_2366.jpg

LM Start	10.15	Rating **	A/W	Issue No.	72
LM End	10.21	Issue Type +	Ma	Location *	
Category	Supplemental			GPS Latitude/Longitude	
				Start	End
Item	2017 Storm Damage			38.188431 °	38.187803 °
				-121.641703 °	-121.642478 °
DWR ID	DWR_RD0003_01_f_2017_72				
Comment Code					
Inspector Comment					
Levee Evaluation Comments					
Description:District station 536+35 to 539+47, Sec. 16, T. 4 N. R. 3 E., M.D.M. The waterside slope experienced sloughing and erosion along approximately 312 linear feet of Steamboat Slough (Unit 1). Sloughing commences at approximately 1/4 of the way down the slope from the crown and extends to the rip rap.					
Site ID No:277					
Site Designation:LMA-103					
Repair Type: Erosion					
Rating:Area of Concern					
Field Date:7/26/2017					
Notes:

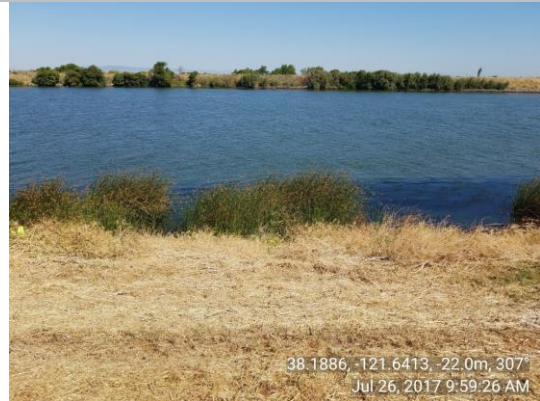
Photo 3 of 3 : LEVAL_FA_2017_277_2368.jpg

LM Start	10.15	Rating **	A/W	Issue No.	72 (cont)
LM End	10.21	Issue Type +	Ma	Location *	
Category	Supplemental			GPS Latitude/Longitude	
				Start	End
Item	2017 Storm Damage			38.188431 °	38.187803 °
				-121.641703 °	-121.642478 °
DWR ID	DWR_RD0003_01_f_2017_72				
Comment Code					
Inspector Comment					
<p>Levee Evaluation Comments</p> <p>Description: District station 536+35 to 539+47, Sec. 16, T. 4 N. R. 3 E., M.D.M. The waterside slope experienced sloughing and erosion along approximately 312 linear feet of Steamboat Slough (Unit 1). Sloughing commences at approximately 1/4 of the way down the slope from the crown and extends to the rip rap.</p> <p>Site ID No: 277</p> <p>Site Designation: LMA-103</p> <p>Repair Type: Erosion</p> <p>Rating: Area of Concern</p> <p>Field Date: 7/26/2017</p> <p>Notes:</p>

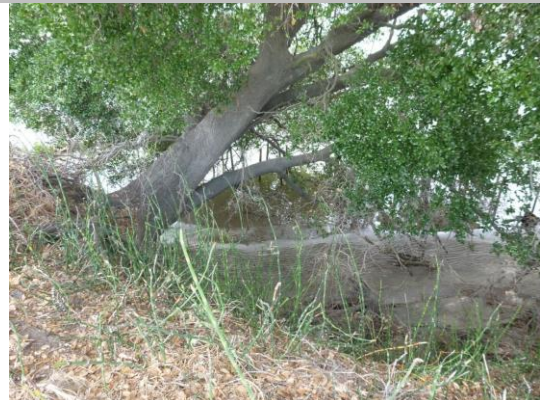
Photo 1 of 3 : LEVAL_FA_2017_63_117.jpg

LM Start	10.67	Rating **	A/W	Issue No.	73
LM End	10.92	Issue Type +	Ma	Location *	
Category	Supplemental			GPS Latitude/Longitude	
				Start	End
Item	2017 Storm Damage			38.183810 °	38.182480 °
				-121.648780 °	-121.653150 °
DWR ID	DWR_RD0003_01_f_2017_73				
Comment Code					
Inspector Comment					
<p>Levee Evaluation Comments</p> <p>Description:</p> <p>Site ID No: 63</p> <p>Site Designation: DWR_RD0003_01_R_2012_03</p> <p>Repair Type: Erosion</p> <p>Rating: Serious</p> <p>Field Date: 6/8/2017</p> <p>Notes: scattered erosion scarps caving into levee crown, within erosion limit crown width ranges from 15 to 30', several trees with exposed tree roots and leaning into the river,</p>

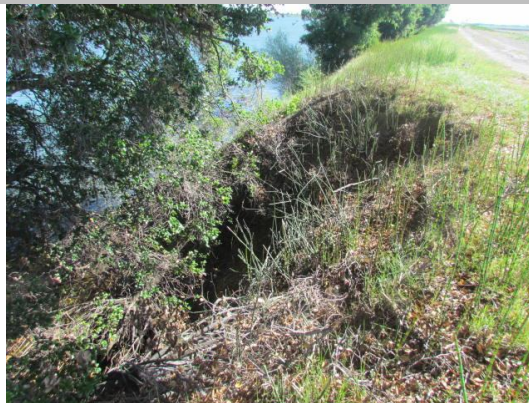
Photo 1 of 2 : FA_2017_RD0003_24_96_20170911_00072.jpg

Looking northwest at erosion on waterward slope.

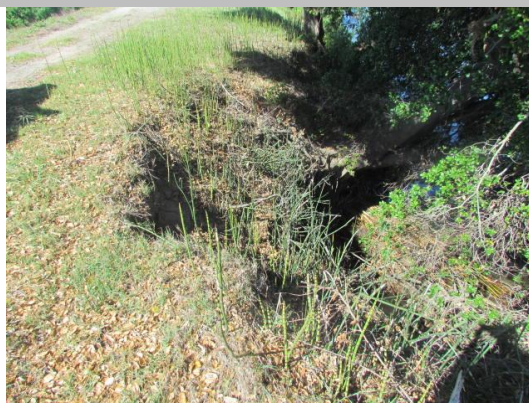
Photo 2 of 2 : FA_2017_RD0003_24_96_20170911_00073.jpg

Looking southwest at erosion on waterward slope.

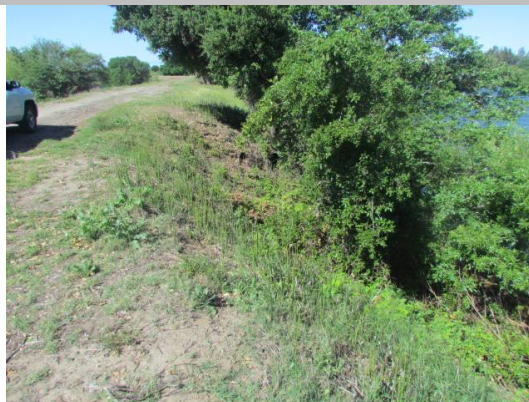
Photo 1 of 2 : FA_2017_RD0003_24_97_20170911_00074.jpg

Looking south at erosion on waterward slope.

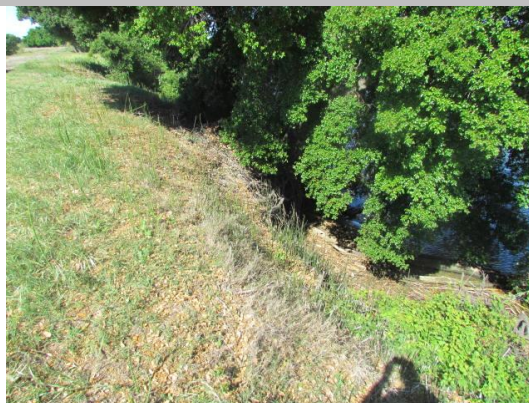
Photo 2 of 2 : FA_2017_RD0003_24_97_20170911_00075.jpg

Looking southwest at erosion on waterward slope.

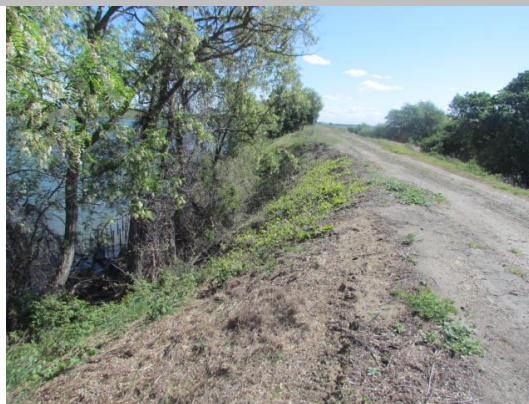
Photo 1 of 3 : FA_2017_RD0003_24_98_20170911_00076.jpg

Looking north at erosion on waterward slope.

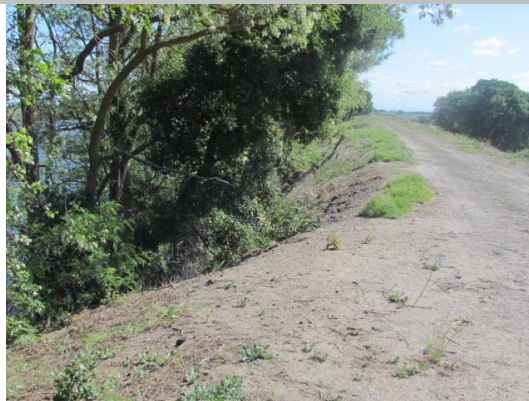
Photo 2 of 2 : FA_2017_RD0003_24_99_20170911_00080.jpg

Looking north at erosion on waterward shoulder and slope.

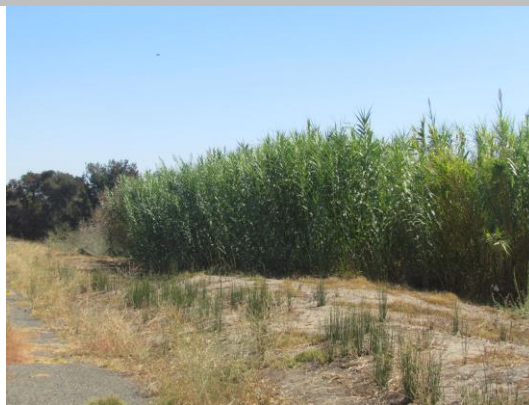
Photo 1 of 2 : FA_2017_RD0003_25_5_20170911_00007.jpg

Looking southeast at bamboo on waterward slope. (Fall 2016)

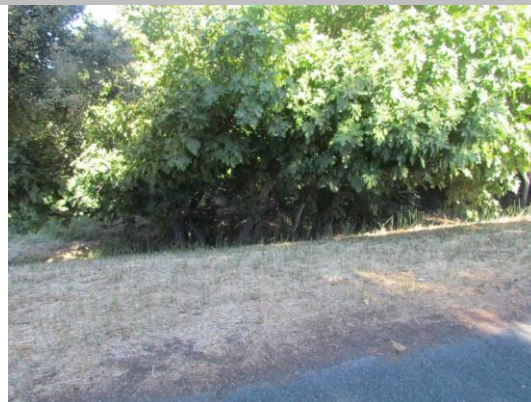
Photo 2 of 2 : FA_2017_RD0003_25_7_20170911_00009.jpg

Looking north at fig tree at landward toe.

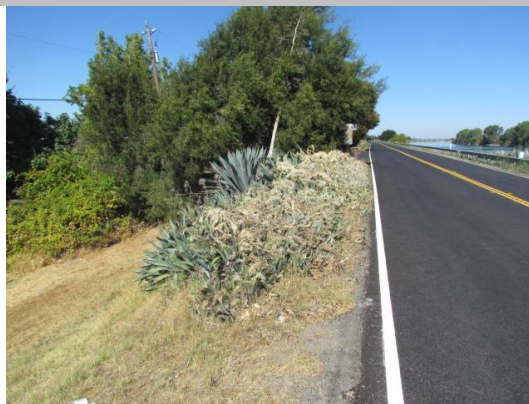
Photo 1 of 1 : FA_2017_RD0003_25_143_20170911_00097.jpg

Looking north at century plants on landward shoulder and slope.

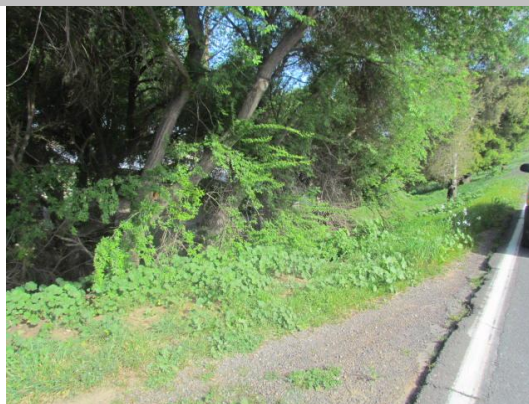
Photo 1 of 1 : FA_2017_RD0003_25_48_20170911_00040.jpg

Looking southwest at dense trees on landward slope.

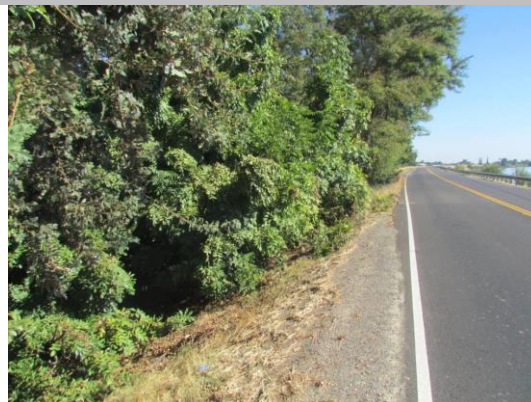
Photo 1 of 2 : FA_2017_RD0003_25_14_20170911_00020.jpg

LM Start	4.94	Rating **	U	Issue No.	14
LM End	4.98	Issue Type +	Ma	Location *	LS
Category	Earthen Levee			GPS Latitude/Longitude	
				Start	End
Item	Trim / Thin Trees			38.188344 °	38.188748 °
				-121.581414 °	-121.580743 °
DWR ID	DWR_RD0003_02_s_2012_14				
Comment Code					
T2 : Thin trees to allow visibility of the ground and room to flood fight.					
Inspector Comment					
Dense untrimmed trees on landside slope and toe.

Looking northeast at dense vegetation on landward shoulder and slope.
(Fall 2016)

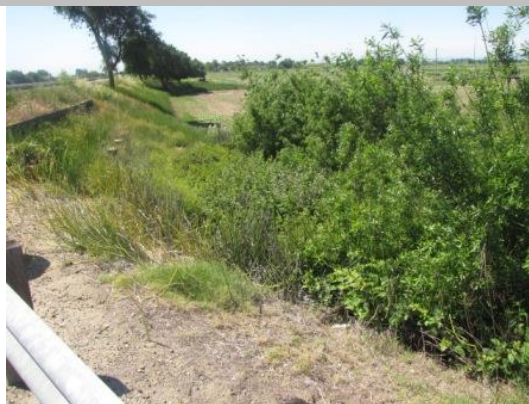
Photo 1 of 1 : FA_2017_RD0003_25_16_20170911_00024.jpg

Looking southwest at dense veg. on landside toe.

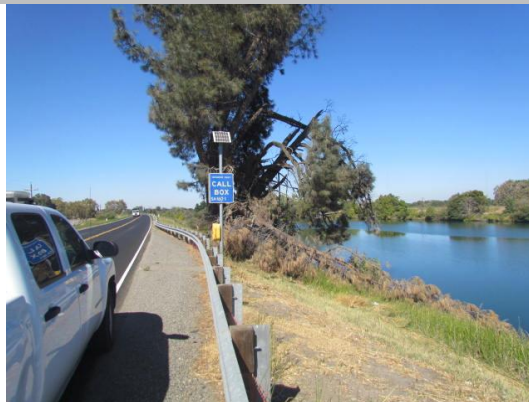
Photo 1 of 2 : FA_2017_RD0003_25_15_20170911_00022.jpg

Looking northeast at broken and cracked tree branches on waterward slope.

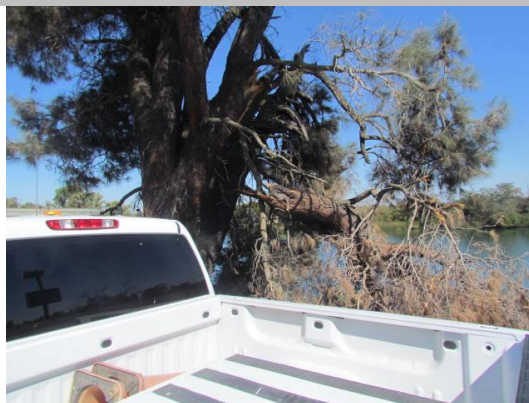
Photo 2 of 2 : FA_2017_RD0003_25_15_20170911_00023.jpg

Looking east at broken and cracked tree branches on waterward slope.

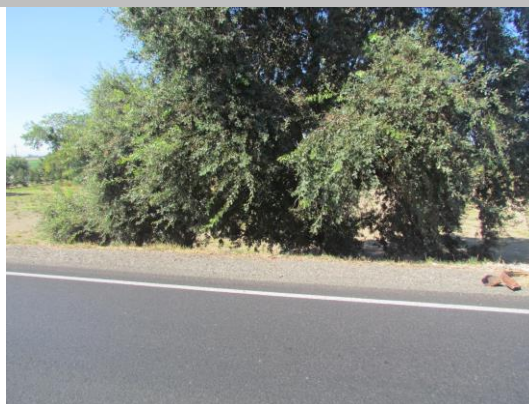
Photo 1 of 1 : FA_2017_RD0003_25_23_20170911_00029.jpg

Looking west at untrimmed trees at landward toe.

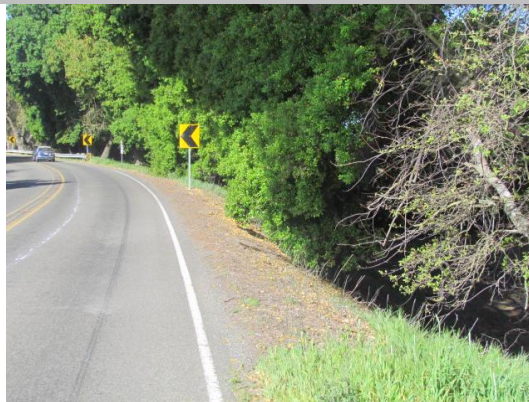
Photo 1 of 1 : FA_2017_RD0003_25_64_20170911_00049.jpg

Looking southwest at dense trees on landward shoulder and slope.

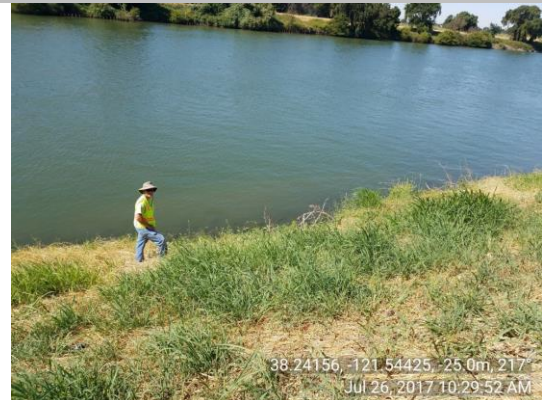
Photo 1 of 3 : LEVAL_FA_2017_280_2378.jpg

LM Start	10.01	Rating **	A/W	Issue No.	138
LM End	10.03	Issue Type +	Ma	Location *	
Category	Supplemental		GPS Latitude/Longitude		
			Start	End	
Item	2017 Storm Damage		38.241481 °	38.241439 °	
			-121.544569 °	-121.544353 °	
DWR ID	DWR_RD0003_02_f_2017_138				
Comment Code					
Inspector Comment					
<p>Levee Evaluation Comments</p> <p>Description: District station 528+97 to 529+58, Sec. 33, T. 5 N. R. 4 E., M.D.M. Approximately 61 linear feet of erosion and sloughing exists along the water side slope of the Sacramento River (Unit 2). The erosion commences approximately 1/2 of the way down the slope from the crown and extends into the rip rap.</p> <p>Site ID No: 280</p> <p>Site Designation: LMA-106</p> <p>Repair Type: Erosion</p> <p>Rating: Area of Concern</p> <p>Field Date: 7/26/2017</p> <p>Notes:</p>

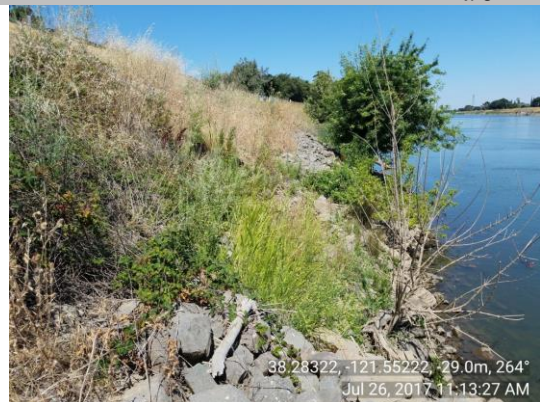
Photo 1 of 3 : LEVAL_FA_2017_283_2386.jpg

LM Start	15.46	Rating **	A/W	Issue No.	149
LM End	15.47	Issue Type +	Ma	Location *	
Category	Supplemental			GPS Latitude/Longitude	
				Start	End
Item	2017 Storm Damage			38.283119 °	38.283172 °
				-121.552250 °	-121.552347 °
DWR ID	DWR_RD0003_02_f_2017_149				
Comment Code					
Inspector Comment					
Levee Evaluation Comments					
Description:District station 816+64 to 816+97, Sec. 16, T. 5 N. R. 4 E., M.D.M. Approximately 33 linear feet of erosion exists along the water side slope of the Sacramento River (Unit 2). The erosion commences approximately 1/2 ofthe way down the slope from the crown and extends into the rip rap. A section of rip rap has eroded away in this location.					
Site ID No:283					
Site Designation:LMA-109					
Repair Type: Erosion					
Rating:Area of Concern					
Field Date:7/26/2017					
Notes:
