**Flood Control Project Maintenance
Levee Inspections**

Maintenance Issue Types Only, Levee Inspection Report By Mile - Fall 2018

Reclamation District No. 0003 Grand Island

Waterway	Bank	Unit Miles	Inspection Start/End	Inspector
Unit No. 01 Left Bank Steamboat Slough	Left	10.95	10/16/2018 10/16/2018	David Julian

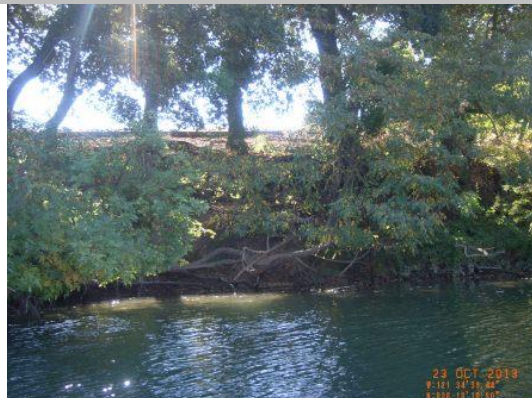
Photo 1 of 1 : FA_2018_RD0003_24_51_20181023_00152.jpg

2017 Site ID: STM 26.0 L
Status: Critical
2018: Deep erosion into waterside toe, I consider this critical (Djulian).
2017 Field Notes: Upgraded to critical. Significant bank failure on upstream end.
Site History: 1997 - Mass failure of berm slope and wave wash erosion. Large trees on top of berm, some failed trees. New area of low rock to on the upstream end. 2000 - Some minor erosion near the downstream end. 2005 - One new small tree has fallen. 2009 - Minimal new erosion. 2010 - Minor new erosion. 2013 - Observed new animal holes and vertical sections at middle of site. 2015 - Minor new erosion.

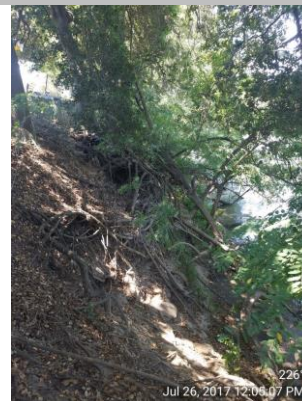
Photo 1 of 3 : LEVAL_FA_2018_274_2391.jpg

Levee Evaluation Comments
Description: District station 9+63 to 10+85, Sec. 07, T. 5 N. R. 4 E., M.D.M. An erosion site exists along approximately 122 linear feet of the water side slope of Steamboat Slough (Unit 1). Erosion commences approximately 1/3 of the way down the slope from the crown to the waterside toe. Erosion is undercutting existing trees.
Site ID No: 274
Site Designation: LMA-100
Repair Type: Erosion
Rating: Serious
Field Date: 7/26/2017
Notes: trees undercut by erosion

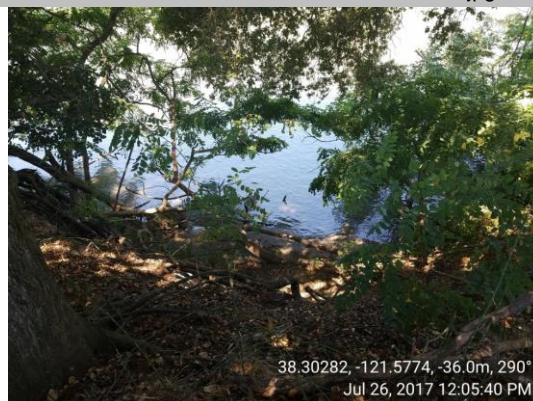
Photo 2 of 3 : LEVAL_FA_2018_274_2392.jpg

LM Start	0.18	Rating **	A/W	Issue No.	52 (cont)					
LM End	0.21	Issue Type +	Ma	Location *						
Category	Supplemental		GPS Latitude/Longitude							
			Start	End						
Item	2017 Storm Damage		38.302981°	38.302778°						
			-121.577336°	-121.577683°						
DWR ID	DWR_RD0003_01_s_2018_52									
Comment Code										
Inspector Comment										
Levee Evaluation Comments Description: District station 9+63 to 10+85, Sec. 07, T. 5 N. R. 4 E., M.D.M. An erosion site exists along approximately 122 linear feet of the water side slope of Steamboat Slough (Unit 1). Erosion commences approximately 1/3 of the way down the slope from the crown to the waterside toe. Erosion is undercutting existing trees. Site ID No: 274 Site Designation: LMA-100 Repair Type: Erosion Rating: Serious Field Date: 7/26/2017 Notes: trees undercut by erosion

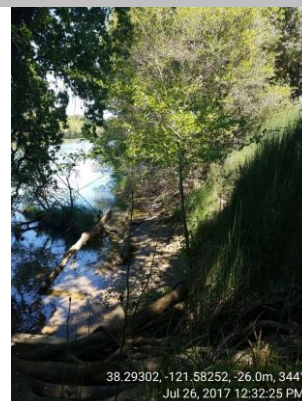
Photo 1 of 3 : LEVAL_FA_2018_275_2396.jpg

LM Start	0.91	Rating **	A/W	Issue No.	53
LM End	0.97	Issue Type +	Ma	Location *	
Category	Supplemental			GPS Latitude/Longitude	
				Start	End
Item	2017 Storm Damage			38.293381 °	38.292617 °
				-121.582450 °	-121.582675 °
DWR ID	DWR_RD0003_01_s_2018_53				
Comment Code					
Inspector Comment					
Levee Evaluation Comments					
Description: District station 48+20 to 51+06, Sec. 07, T. 5 N. R. 4 E., M.D.M. An erosion site exists along approximately 286 linear feet of the water side slope of Steamboat Slough (Unit 1). The erosion begins approximately 1/2 of the way down the slope from the crown to the waterside toe. Erosion is undercutting existing trees.					
Site ID No: 275					
Site Designation: LMA-101					
Repair Type: Erosion					
Rating: Serious					
Field Date: 7/26/2017					
Notes:

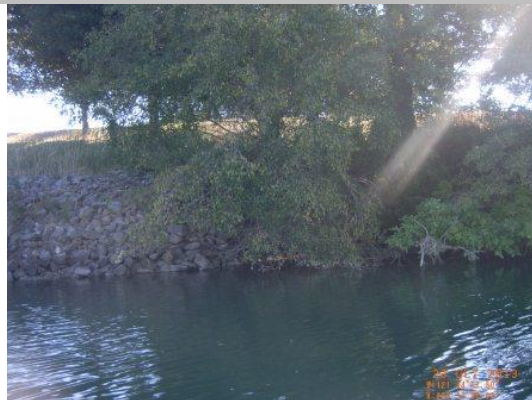
Photo 1 of 1 : FA_2018_RD0003_24_49_20181023_00151.jpg

2017 Site ID: STM 25.0 L
Status: Critical
2018: Deep erosion into levee toe. Roots are exposed. I would consider this critical.
2017 Field Notes: Upgraded to critical. Site has eroded to near vertical at upstream end.
Site History: 1997 - Erosion of sandy levee on top left bank. Site is downstream of a rock section. Large riparian trees on the bank. 1999 - Upstream half of the reach repaired with rock, except for a 30 ft reach at the upstream end. 2001 - Rock repair on the upstream and downstream ends; no revetment at the trees. 2002 - Rock repair is starting to slide off the geotextile at the upstream end. 2005 - One new small tree has fallen. 2006 - 50 ft pocket at the downstream end and at the upstream end with new rock in between. 2007 - Upstream end has been repaired. 2008 - Area closed sign on bank. Newly fallen trees at both ends and pop outs along the bank. 2010 - Site extended downstream. 2011 - New erosion at the toe. More trees popouts. 2013 - Short vertical sections observed at the downstream end. 2015 - Significant new erosion, large oak tree on verge of popping out. 2016 - Sites 24.8 and 25 were combined.

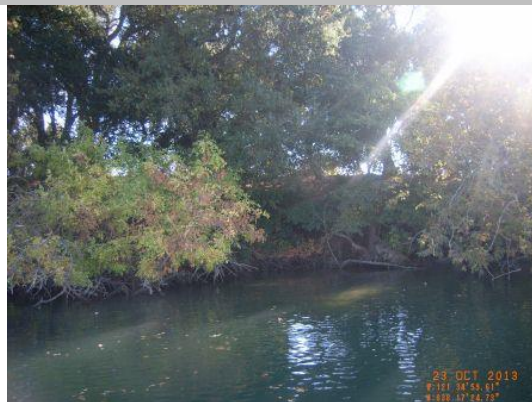
Photo 1 of 2 : FA_2018_RD0003_24_56_20181023_00153.jpg

2017 Site ID: STM 24.8 L
Status: Eroding
2018: Pockets of erosion that are deep into the levee toe that I would consider critical (Djulian).
2017 Field Notes: New erosion at toe.
Site History: 2008 - Area closed sign on bank. Newly fallen trees at both ends and pop outs along the bank. 2010 - Site extended downstream. 2011 - New erosion at the toe. More trees popouts. 2013 - Short vertical sections observed at the downstream end.

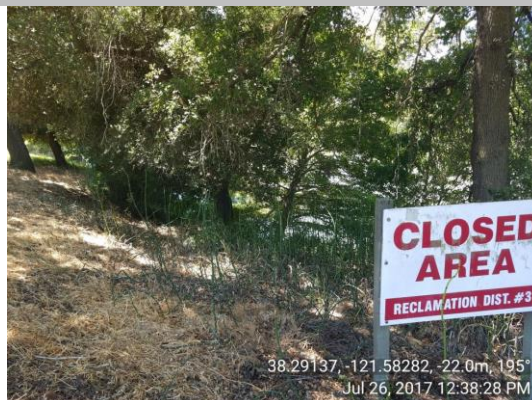
Photo 1 of 3 : FA_2018_RD0003_24_60_20180925_00044.jpg

LM Start	1.09	Rating **	A/W	Issue No.	60
LM End	1.10	Issue Type +	Ma	Location *	
Category	Supplemental			GPS Latitude/Longitude	
				Start	End
Item	2017 Storm Damage			38.290819 °	38.290706 °
				-121.582942 °	-121.582939 °
DWR ID	DWR_RD0003_01_f_2017_60				
Comment Code					
Inspector Comment					
Levee Evaluation Comments					
Description:District station 57+57 to 57+98, Sec. 18, 1. 5 N. R. 4 E., M.D.M. An erosion site exists along approximately 41 linear feet of the water side slope of Steamboat Slough (Unit 1). The erosion commences approximately 1/2 ofthe way down the slope from the crown to the waterside toe.					
Site ID No:276					
Site Designation:LMA-102					
Repair Type: Erosion					
Rating:Area of Concern					
Field Date:7/26/2017					
Notes:

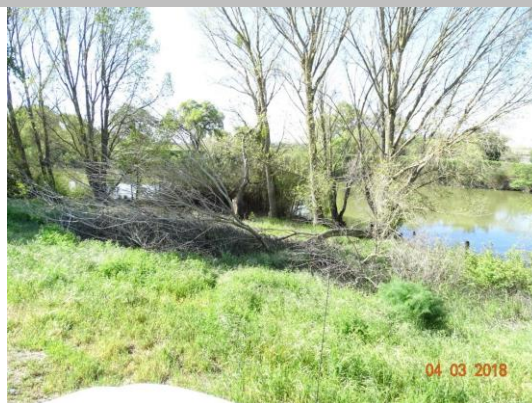
Photo 1 of 1 : FA_2018_RD0003_24_55_20180925_00040.jpg

Fallen tree limb on waterside.

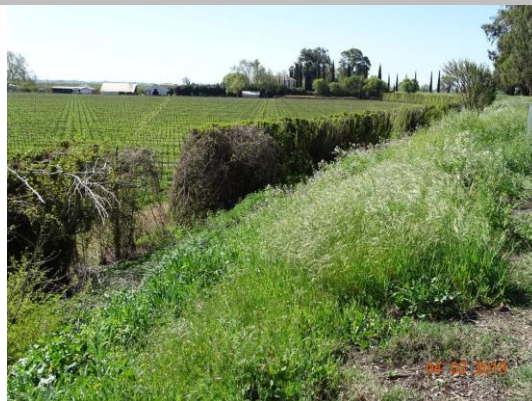
Photo 1 of 1 : FA_2018_RD0003_24_65_20180925_00050.jpg

Landside vegetation.

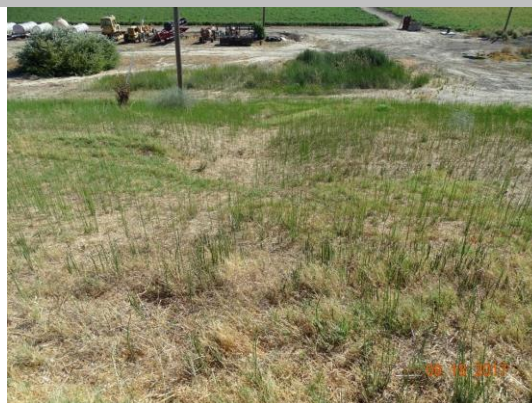
Photo 1 of 1 : FA_2018_RD0003_24_83_20180925_00071.jpg

LM Start	4.87	Rating **	M	Issue No.	83
LM End	4.87	Issue Type +	Ma	Location *	LS
Category	Earthen Levee			GPS Latitude/Longitude	
				Start	End
Item	Slope Stability			38.245903 °	38.245903 °
				-121.600851 °	-121.600851 °
DWR ID	DWR_RD0003_01_f_2017_83				
Comment Code					
S1 : Repair slope instability.					
Inspector Comment					
Landside slope has a depression.

Looking east on landside slope.

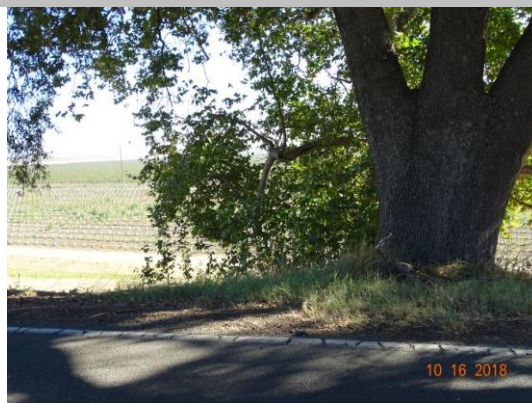
Photo 1 of 2 : FA_2018_RD0003_24_63_20181017_00163.jpg

View of slope where tree limb was removed. Now the extra growth on the existing branches needs to be removed (October 2018).

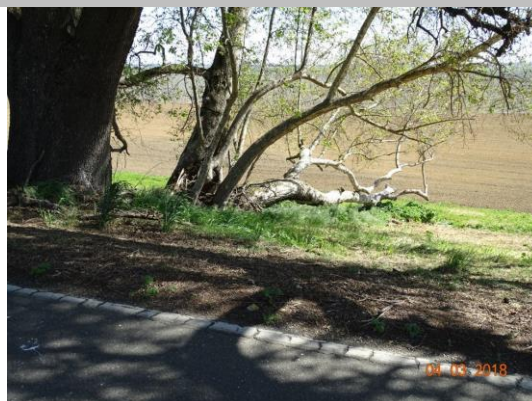
Photo 2 of 2 : FA_2018_RD0003_24_63_20180925_00049.jpg

Low-lying tree limb should be removed from landside slope.

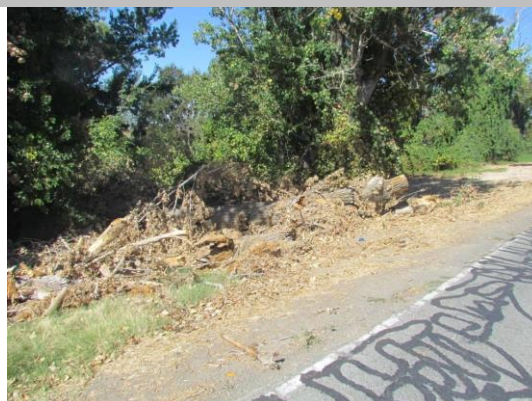
Photo 1 of 1 : FA_2018_RD0003_24_66_20180925_00051.jpg

LM Start	5.77	Rating **	M	Issue No.	66
LM End	5.77	Issue Type +	Ma	Location *	WS
Category	Earthen Levee			GPS Latitude/Longitude	
				Start	End
Item	Encroachments			38.233098 °	38.233098 °
				-121.601323 °	-121.601323 °
DWR ID	DWR_RD0003_01_f_2016_66				
Comment Code					
TR : Tree or limb					
Inspector Comment					
Broken tree branches and limbs on waterward slope.

Looking west at tree branches and limbs on waterward slope.

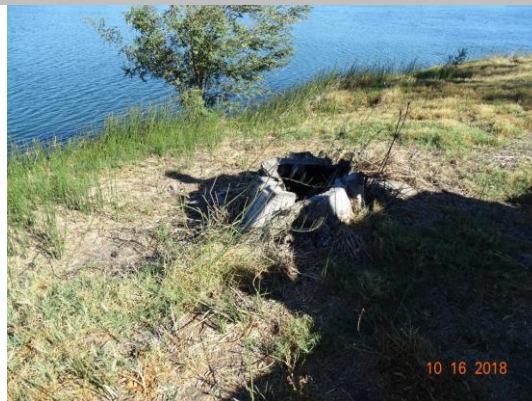
Photo 1 of 1 : FA_2018_RD0003_24_39_20181017_00162.jpg

View of rotting tree stump on water side crown (October 2018).

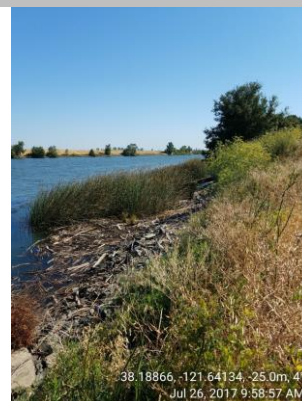
Photo 1 of 3 : FA_2018_RD0003_24_72_20180925_00056.jpg

LM Start	10.15	Rating **	A/W	Issue No.	72	
LM End	10.21	Issue Type +	Ma	Location *		
Category	Supplemental			GPS Latitude/Longitude		
				Start	End	
Item	2017 Storm Damage			38.188431 °	38.187803 °	
				-121.641703 °	-121.642478 °	
DWR ID	DWR_RD0003_01_f_2017_72					
Comment Code						
Inspector Comment						
Levee Evaluation Comments						
Description:District station 536+35 to 539+47, Sec. 16, T. 4 N. R. 3 E., M.D.M. The waterside slope experienced sloughing and erosion along approximately 312 linear feet of Steamboat Slough (Unit 1). Sloughing commences at approximately 1/4 ofthe way down the slope from the crown and extends to the rip rap.						
Site ID No:277						
Site Designation:LMA-103						
Repair Type: Erosion						
Rating:Area of Concern						
Field Date:7/26/2017						
Notes:

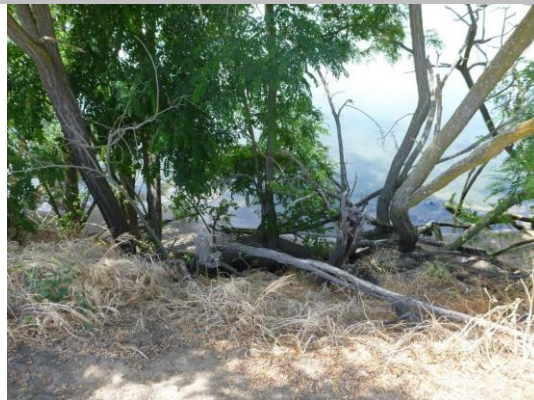
Photo 3 of 3 : FA_2018_RD0003_24_73_20180925_00061.jpg

LM Start	10.67	Rating **	A/W	Issue No.	73 (cont)	
LM End	10.92	Issue Type +	Ma	Location *		
Category	Supplemental			GPS Latitude/Longitude		
				Start		End
Item	2017 Storm Damage			38.183810 °		38.182480 °
				-121.648780 °		-121.653150 °
DWR ID	DWR_RD0003_01_f_2017_73					
Comment Code						
Inspector Comment						
Levee Evaluation Comments						
Description:						
Site ID No:63						
Site Designation:DWR_RD0003_01_R_2012_03						
Repair Type: Erosion						
Rating:Serious						
Field Date:6/8/2017						
Notes: scattered erosion scarps caving into levee crown, within erosion limit crown width ranges from 15 to 30', several trees with exposed tree roots and leaning into the river,

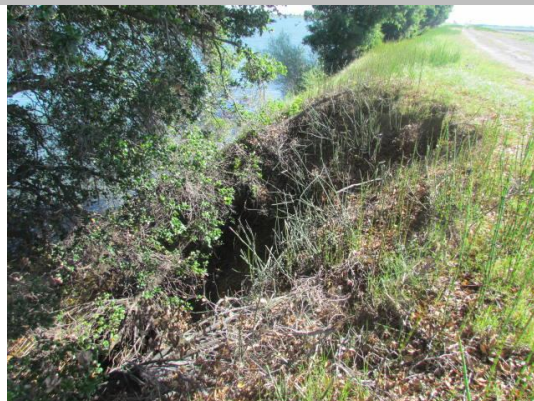
Photo 1 of 2 : FA_2018_RD0003_24_96_20180925_00076.jpg

LM Start	10.75	Rating **	A/W	Issue No.	96
LM End	10.75	Issue Type +	Ma	Location *	WS
Category	Earthen Levee			GPS Latitude/Longitude	
				Start	End
Item	Erosion / Bank Caving			38.183422 °	38.183422 °
				-121.650182 °	-121.650182 °
DWR ID	DWR_RD0003_01_s_2013_96				
Comment Code					
E2 : Schedule repair of erosion site prior to the next inspection.					
Inspector Comment					
Erosion extends to waterward shoulder.

Looking northwest at erosion on waterward slope.

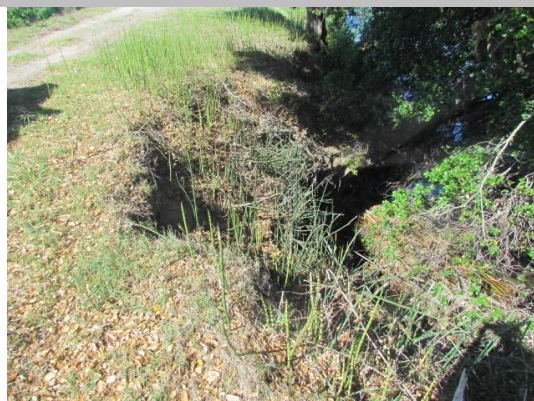
Photo 2 of 2 : FA_2018_RD0003_24_96_20180925_00077.jpg

LM Start	10.75	Rating **	A/W	Issue No.	96 (cont)
LM End	10.75	Issue Type +	Ma	Location *	WS
Category	Earthen Levee			GPS Latitude/Longitude	
				Start	End
Item	Erosion / Bank Caving			38.183422 °	38.183422 °
				-121.650182 °	-121.650182 °
DWR ID	DWR_RD0003_01_s_2013_96				
Comment Code					
E2 : Schedule repair of erosion site prior to the next inspection.					
Inspector Comment					
Erosion extends to waterward shoulder.

Looking southwest at erosion on waterward slope.

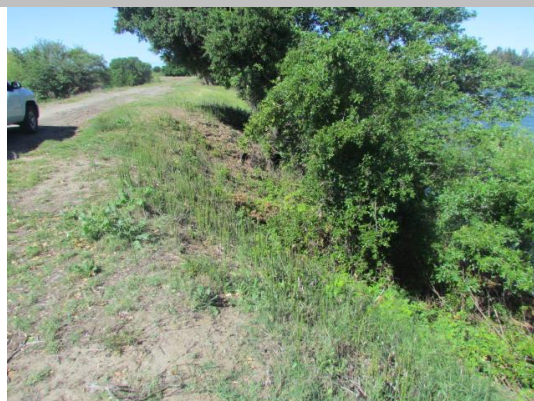
Photo 1 of 2 : FA_2018_RD0003_24_97_20180925_00078.jpg

LM Start	10.78	Rating **	A/W	Issue No.	97
LM End	10.80	Issue Type +	Ma	Location *	WS
Category	Earthen Levee			GPS Latitude/Longitude	
				Start	End
Item	Erosion / Bank Caving			38.183228 °	38.183123 °
				-121.650797 °	-121.651070 °
DWR ID	DWR_RD0003_01_s_2013_97				
Comment Code					
E2 : Schedule repair of erosion site prior to the next inspection.					
Inspector Comment					
Erosion extends to waterward shoulder.

Looking south at erosion on waterward slope.

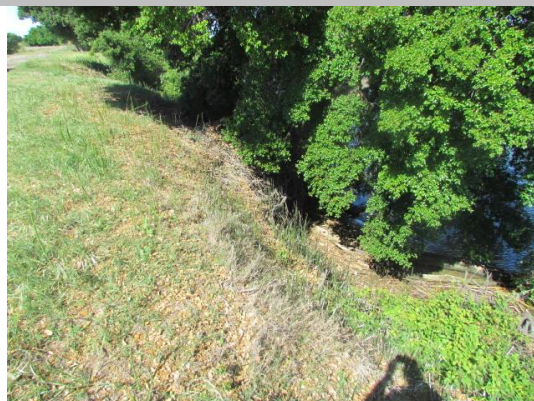
Photo 2 of 2 : FA_2018_RD0003_24_97_20180925_00079.jpg

Looking southwest at erosion on waterward slope.

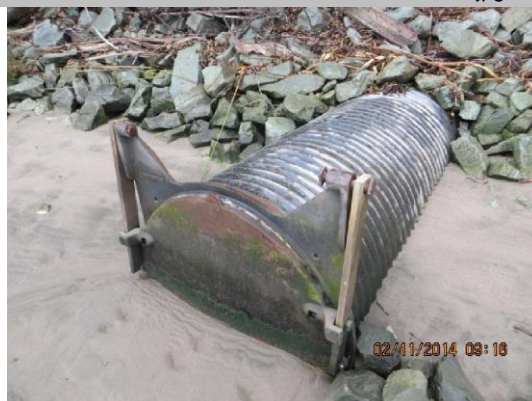
Photo 1 of 3 : UCIP_FA_2018_29165_53866.jpg

Comment Code						
Inspector Comment						
FS_ID:29165						
DS_ID:22206						
EP_NO: N/A						
Repair Type: Non-Urgent						
Crossing Status: Found						
UCIP Comments: Pipe appears abandoned and should be verified as having been done so properly.						
FIELD_STRUCT_DESC: *ABANDONED* 1 of 3: 36-inch corrugated metal drainage pipe through the levee, 15 feet below the crown. Slide gate in a 48-inch corrugated metal pipe (CMP) riser on the waterside (WS) shoulder. Flap gate at the WS toe has been sealed shut with sealant. [Additional Reference(s): DWR Levee Log, 1993, referenced as 24 feet below the crown. USACE Sacramento O&M Manual 104, February 1960, (RM 15.20), referenced as invert elevation 24 feet below the crown].						
FS Date: 2/11/2014

36-inch CMP drainpipe with flapgate on WS toe.

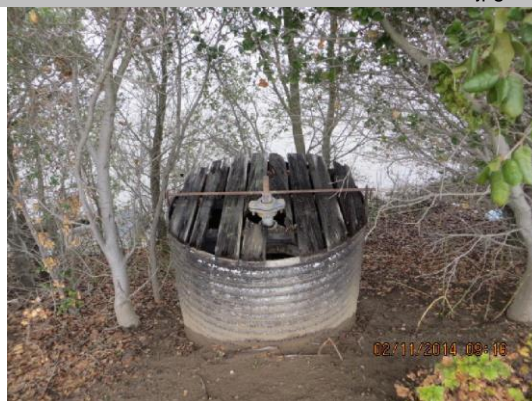
Photo 2 of 3 : UCIP_FA_2018_29165_53865.jpg

Slide gate in 48-inch CMP riser on WS shoulder.

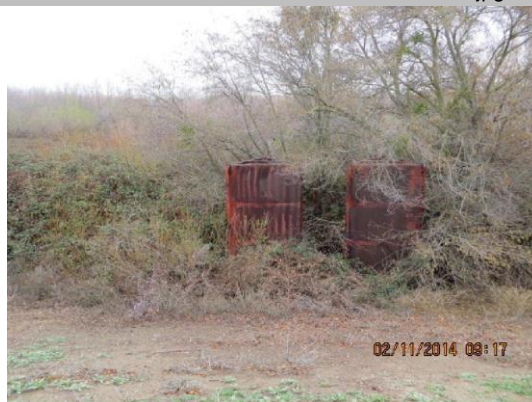
Photo 3 of 3 : UCIP_FA_2018_29165_53864.jpg

Steel weir on LS toe.

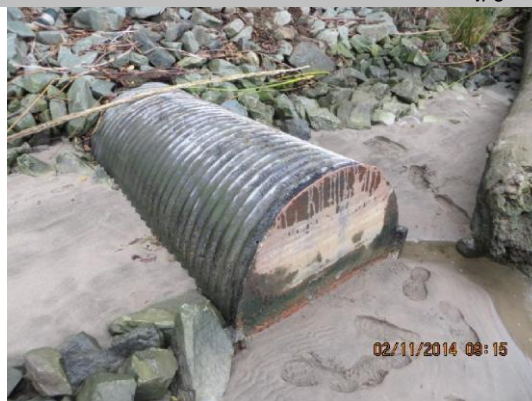
Photo 1 of 3 : UCIP_FA_2018_29164_53862.jpg

Drainpipe visible on WS toe with steel plate welded over end.

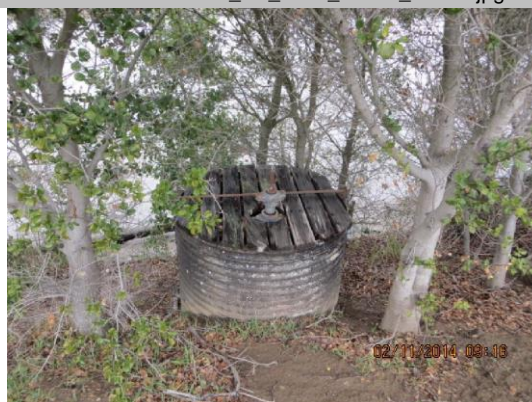
Photo 2 of 3 : UCIP_FA_2018_29164_53861.jpg

48-inch CMP riser with slide gate closed on WS shoulder.

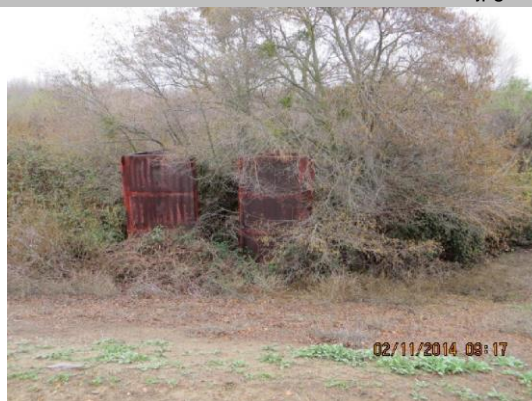
Photo 3 of 3 : UCIP_FA_2018_29164_53860.jpg

Steel weir on LS toe.

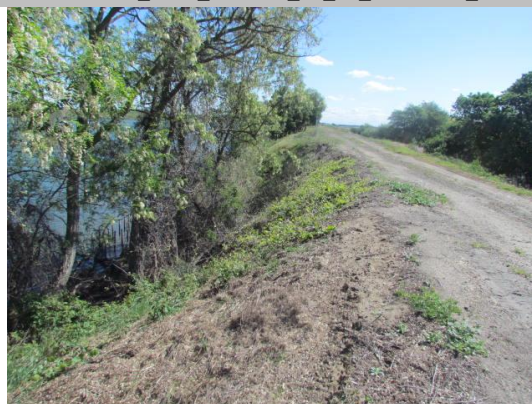
Photo 1 of 3 : FA_2018_RD0003_24_98_20180925_00080.jpg

Looking north at erosion on waterward slope.

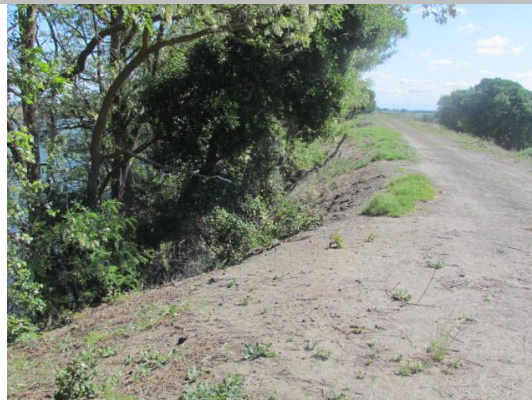
Photo 2 of 2 : FA_2018_RD0003_24_99_20180925_00084.jpg

Looking north at erosion on waterward shoulder and slope.

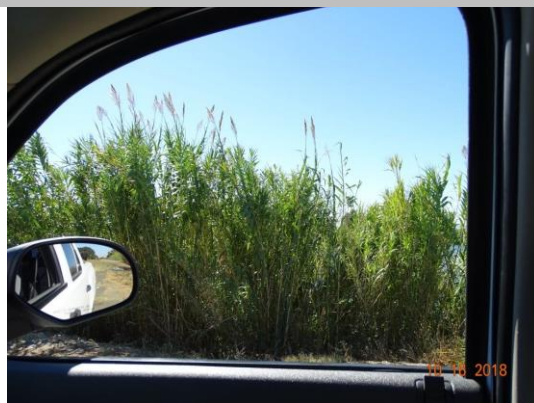
Photo 1 of 1 : FA_2018_RD0003_25_3_20181018_00284.jpg

View of arundo on waterside slope (October 2018).

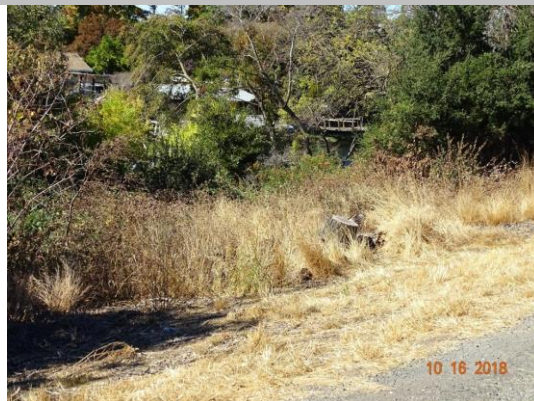
Photo 1 of 3 : FA_2018_RD0003_25_129_20181018_00286.jpg

View of tree limbs that have mostly been removed from water side slope (October 2018).

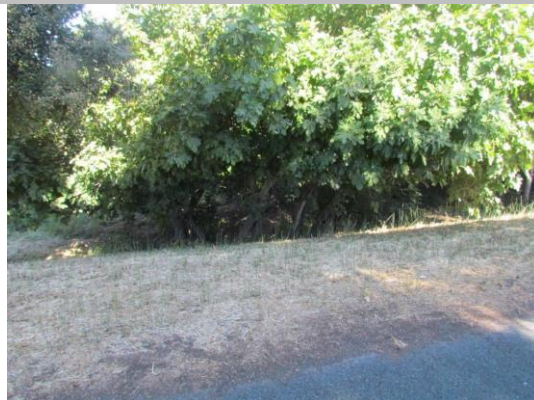
Photo 2 of 2 : FA_2018_RD0003_25_7_20180925_00008.jpg

Looking north at fig tree at landward toe.

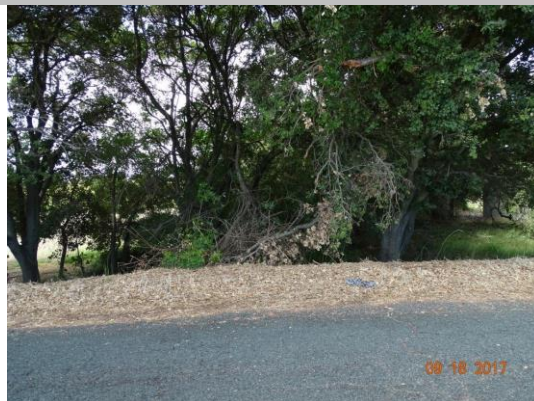
Photo 1 of 1 : FA_2018_RD0003_25_154_20180925_00131.jpg

Looking northwest at the landside slope.

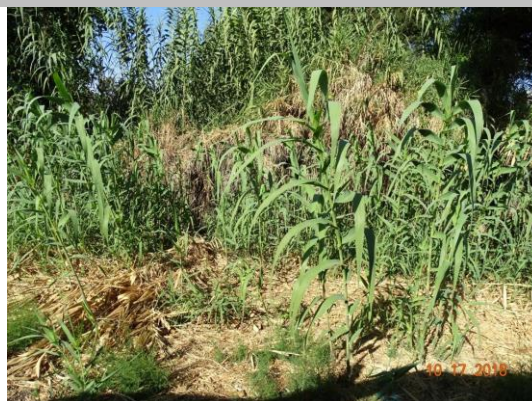
Photo 1 of 1 : FA_2018_RD0003_25_200_20181018_00305.jpg

View of new bamboo growth on the land side slope (October 2018).

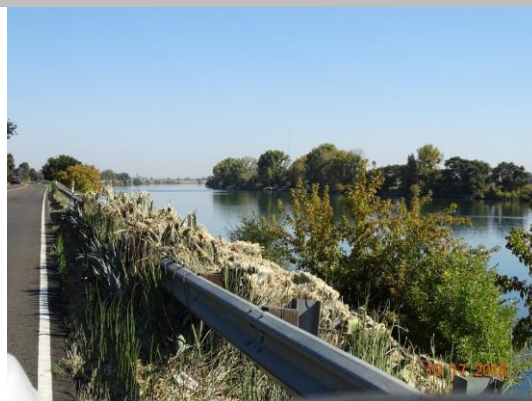
Photo 1 of 2 : FA_2018_RD0003_25_145_20181018_00306.jpg

View of looking upstream at chopped century plants on the water side shoulder and slope (October 2018).

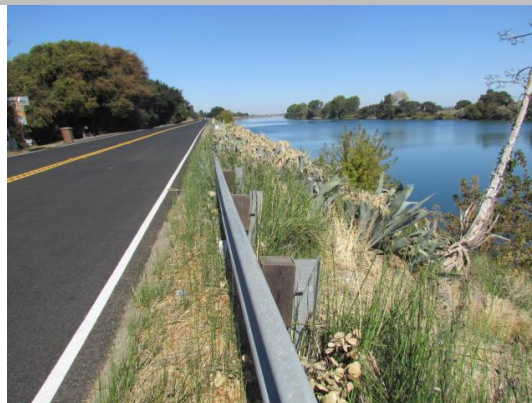
Photo 2 of 2 : FA_2018_RD0003_25_145_20180925_00117.jpg

Looking northeast at century plants on waterward shoulder and slope.

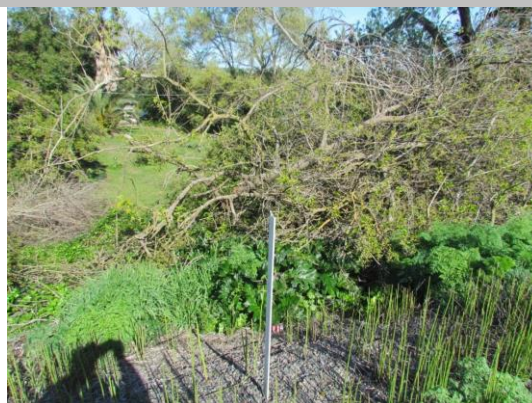
Photo 1 of 1 : FA_2018_RD0003_25_97_20180925_00079.jpg

Looking west at fallen tree on landward slope.

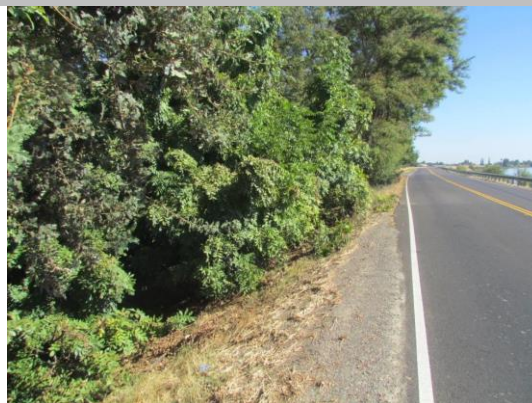
Photo 1 of 2 : FA_2018_RD0003_25_14_20180925_00019.jpg

LM Start	4.94	Rating **	M	Issue No.	14
LM End	4.98	Issue Type +	Ma	Location *	LS
Category	Earthen Levee			GPS Latitude/Longitude	
				Start	End
Item	Trim / Thin Trees			38.188344 °	38.188748 °
				-121.581414 °	-121.580743 °
DWR ID	DWR_RD0003_02_s_2012_14				
Comment Code					
T1 : Trim trees to at least five feet above ground level.					
Inspector Comment					
Untrimmed trees on landside slope and toe.

Looking northeast at dense vegetation on landside shoulder and slope.
(Fall 2016)

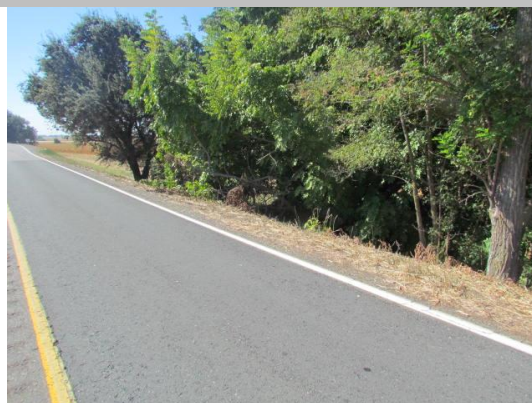
Photo 2 of 2 : FA_2018_RD0003_25_14_20180925_00020.jpg

Looking southwest at untrimmed trees on landward toe. (Spring 2016)

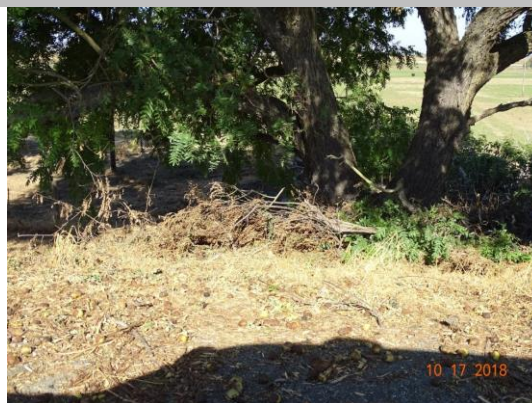
Photo 1 of 1 : FA_2018_RD0003_25_56_20181018_00303.jpg

View of tree limbs on the land side slope (October 2018).

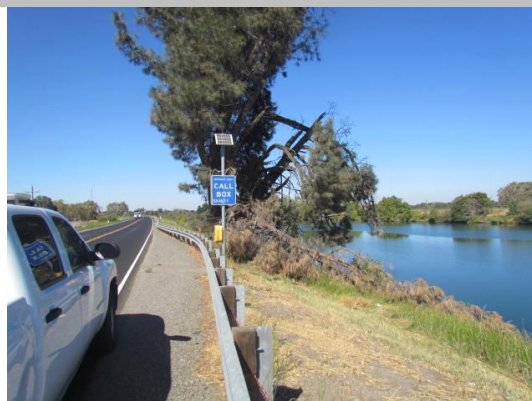
Photo 1 of 2 : FA_2018_RD0003_25_15_20180925_00021.jpg

Looking northeast at broken and cracked tree branches on waterward slope.

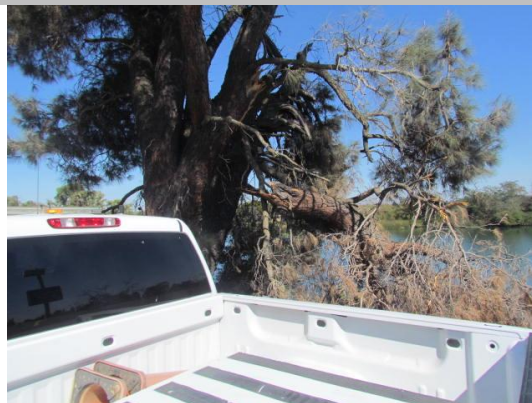
Photo 2 of 2 : FA_2018_RD0003_25_15_20180925_00022.jpg

Looking east at broken and cracked tree branches on waterward slope.

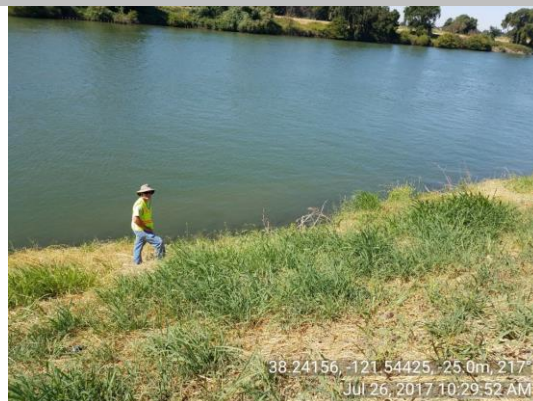
Photo 1 of 3 : FA_2018_RD0003_25_138_20180925_00102.jpg

LM Start	10.01	Rating **	A/W	Issue No.	138
LM End	10.03	Issue Type +	Ma	Location *	
Category	Supplemental			GPS Latitude/Longitude	
				Start	End
Item	2017 Storm Damage			38.241481 °	38.241439 °
				-121.544569 °	-121.544353 °
DWR ID	DWR_RD0003_02_f _ 2017_138				
Comment Code					
Inspector Comment					
Levee Evaluation Comments					
Description:District station 528+97 to 529+58, Sec. 33, T. 5 N. R. 4 E., M.D.M. Approximately 61 linear feet of erosion and sloughing exists along the water side slope of the Sacramento River (Unit 2). The erosion commences approximately 1/2 of the way down the slope from the crown and extends into the rip rap.					
Site ID No:280					
Site Designation:LMA-106					
Repair Type: Erosion					
Rating:Area of Concern					
Field Date:7/26/2017					
Notes:

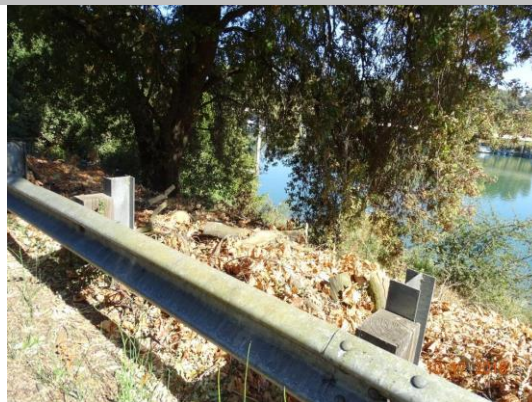
Photo 1 of 1 : FA_2018_RD0003_25_203_20181018_00309.jpg

View of prunings on the water side shoulder (October 2018).

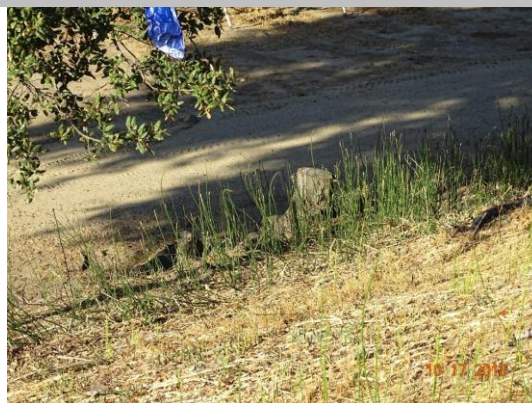
Photo 1 of 1 : FA_2018_RD0003_25_122_20181018_00290.jpg

View of large stump at the land side toe of the levee (October 2018).
