**Flood Control Project Maintenance
Levee Inspections**

Maintenance Issue Types Only, Levee Inspection Report By Mile - Fall 2019

Reclamation District No. 0003 Grand Island

Waterway	Bank	Unit Miles	Inspection Start/End	Inspector
Unit No. 01 Left Bank Steamboat Slough	Left	10.95	10/30/2019 10/30/2019	David Julian

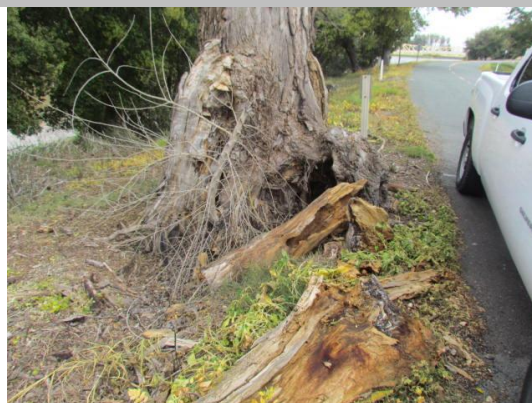
Photo 1 of 3 : FA_2019_RD0003_24_2_20190826_00001.jpg

LM Start	0.13	Rating **	M	Issue No.	2
LM End	0.13	Issue Type +	Ma	Location *	WS
Category	Earthen Levee			GPS Latitude/Longitude	
				Start	End
Item	Erosion / Bank Caving			38.303303°	38.303303°
				-121.576538°	-121.576538°
DWR ID	DWR_RD0003_01_f_2013_2				
Comment Code					
E2 : Schedule repair of erosion site prior to the next inspection.					
Inspector Comment					
A hole (8ft x 2.5ft x 5ft) is next to a large tree on waterward shoulder.

Looking east at hole at the base of an oak tree on the waterward shoulder. (2016)

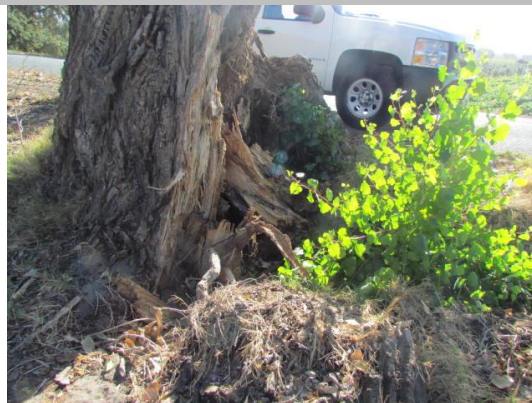
Photo 2 of 3 : FA_2019_RD0003_24_2_20190826_00002.jpg

Looking at a hole next to oak tree on waterward shoulder. (2015)

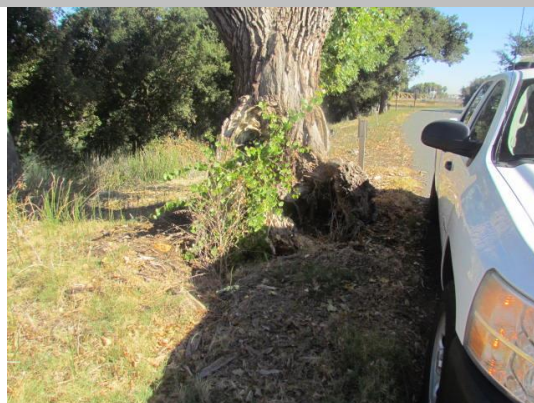
Photo 3 of 3 : FA_2019_RD0003_24_2_20190826_00003.jpg

LM Start	0.13	Rating **	M	Issue No.	2 (cont)	
LM End	0.13	Issue Type +	Ma	Location *	WS	
Category	Earthen Levee			GPS Latitude/Longitude		
				Start		End
Item	Erosion / Bank Caving			38.303303 °	38.303303 °	
				-121.576538 °	-121.576538 °	
DWR ID	DWR_RD0003_01_f_2013_2					
Comment Code						
E2 : Schedule repair of erosion site prior to the next inspection.						
Inspector Comment						
A hole (8ft x 2.5ft x 5ft) is next to a large tree on waterward shoulder.

Looking east at hole at base of tree on waterward shoulder. (2014)

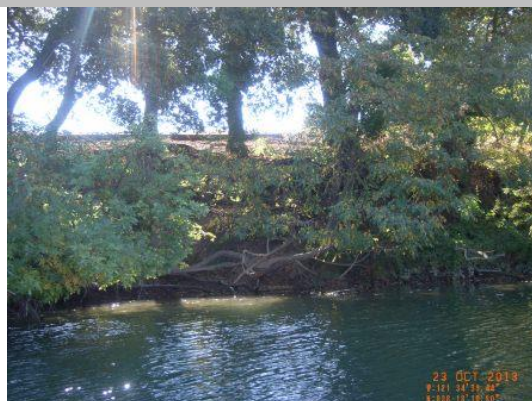
Photo 1 of 1 : FA_2019_RD0003_24_51_20190826_00032.jpg

2017 Site ID: STM 26.0 L
Status: Critical
2017 Field Notes: Upgraded to critical. Significant bank failure on upstream end.
Site History: 1997 - Mass failure of berm slope and wave wash erosion. Large trees on top of berm, some failed trees. New area of low rock to on the upstream end. 2000 - Some minor erosion near the downstream end. 2005 - One new small tree has fallen. 2009 - Minimal new erosion. 2010 - Minor new erosion. 2013 - Observed new animal holes and vertical sections at middle of site. 2015 - Minor new erosion.

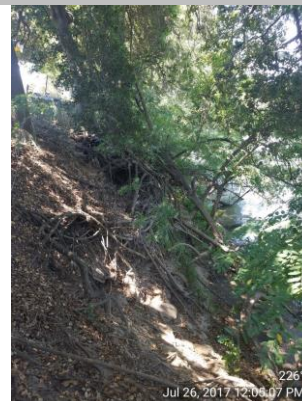
Photo 1 of 3 : LEVAL_FA_2019_274_2391.jpg

Levee Evaluation Comments
Description: District station 9+63 to 10+85, Sec. 07, T. 5 N. R. 4 E., M.D.M. An erosion site exists along approximately 122 linear feet of the waterside slope of Steamboat Slough (Unit 1). Erosion commences approximately 1/3 of the way down the slope from the crown to the waterside toe. Erosion is undercutting existing trees.
Site ID No: 274
Site Designation: LMA-100
Repair Type: Erosion
Rating: Serious
Field Date: 7/26/2017
Notes: trees undercut by erosion

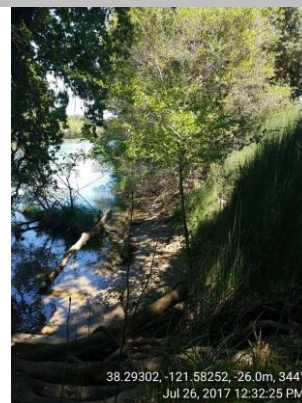
Photo 1 of 3 : LEVAL_FA_2019_275_2396.jpg

LM Start	0.91	Rating **	A/W	Issue No.	53
LM End	0.97	Issue Type +	Ma	Location *	WS
Category	Supplemental			GPS Latitude/Longitude	
				Start	End
Item	2017 Storm Damage			38.293381 °	38.292617 °
				-121.582450 °	-121.582675 °
DWR ID	LMA-101				
Comment Code					
Inspector Comment					
Levee Evaluation Comments					
Description: District station 48+20 to 51+06, Sec. 07, T. 5 N. R. 4 E., M.D.M. An erosion site exists along approximately 286 linear feet of the waterside slope of Steamboat Slough (Unit 1). The erosion begins approximately 1/2 of the way down the slope from the crown to the waterside toe. Erosion is undercutting existing trees.					
Site ID No: 275					
Site Designation: LMA-101					
Repair Type: Erosion					
Rating: Serious					
Field Date: 7/26/2017					
Notes:

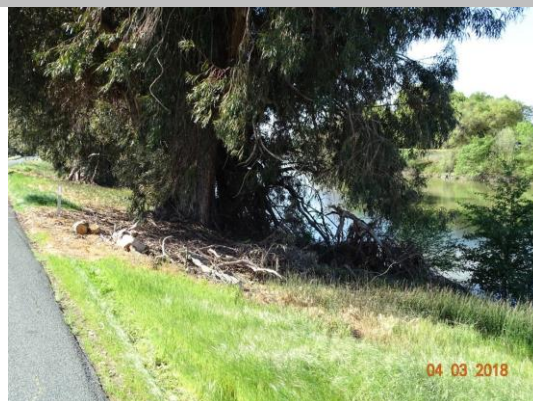
Photo 1 of 1 : FA_2019_RD0003_24_54_20190826_00039.jpg

Cut branches on waterside slope.

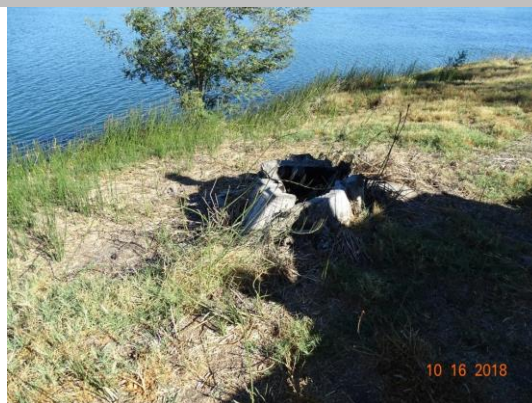
Photo 1 of 1 : FA_2019_RD0003_24_39_20190826_00026.jpg

View of rotting tree stump on water side crown (October 2018).

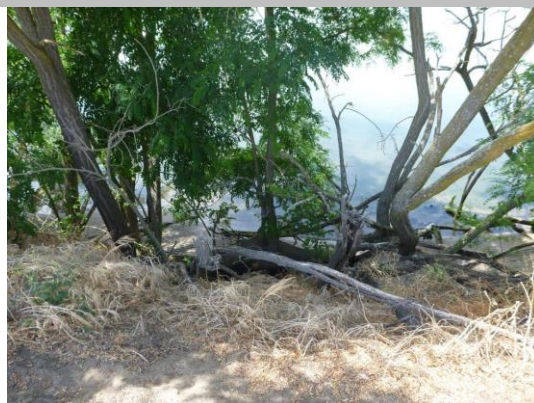
Photo 3 of 3 : FA_2019_RD0003_24_73_20190826_00062.jpg

LM Start	10.67	Rating **	A/W	Issue No.	73 (cont)
LM End	10.92	Issue Type +	Ma	Location *	WS
Category	Supplemental			GPS Latitude/Longitude	
				Start	End
Item	2017 Storm Damage			38.183810 °	38.182480 °
				-121.648780 °	-121.653150 °
DWR ID	DWR_RD0003_01_R_2012_03				
Comment Code					
Inspector Comment					
Levee Evaluation Comments					
Description:					
Site ID No:63					
Site Designation:DWR_RD0003_01_R_2012_03					
Repair Type: Erosion					
Rating:Serious					
Field Date:6/8/2017					
Notes: scattered erosion scarps caving into levee crown, within erosion limit crown width ranges from 15 to 30', several trees with exposed tree roots and leaning into the river.

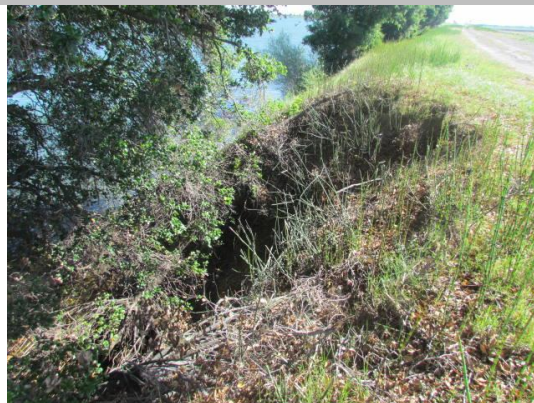
Photo 1 of 2 : FA_2019_RD0003_24_96_20190826_00078.jpg

LM Start	10.75	Rating **	A/W	Issue No.	96
LM End	10.75	Issue Type +	Ma	Location *	WS
Category	Earthen Levee			GPS Latitude/Longitude	
				Start	End
Item	Erosion / Bank Caving			38.183422 °	38.183422 °
				-121.650182 °	-121.650182 °
DWR ID	DWR_RD0003_01_s_2013_96				
Comment Code					
E2 : Schedule repair of erosion site prior to the next inspection.					
Inspector Comment					
Levee is extra wide in this section. Erosion is occurring outside the theoretical prism.

Looking northwest at erosion on waterward slope.

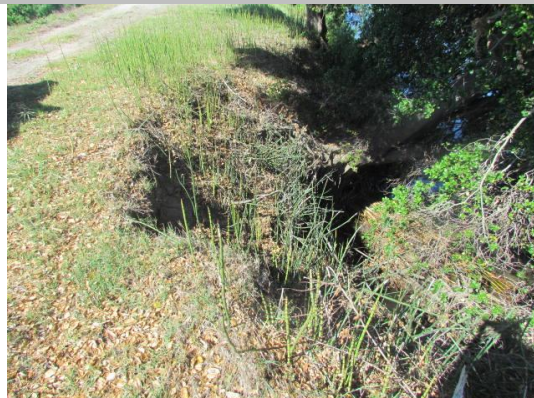
Photo 2 of 2 : FA_2019_RD0003_24_96_20190826_00079.jpg

LM Start	10.75	Rating **	A/W	Issue No.	96 (cont)	
LM End	10.75	Issue Type +	Ma	Location *	WS	
Category	Earthen Levee			GPS Latitude/Longitude		
				Start		End
Item	Erosion / Bank Caving			38.183422 °		38.183422 °
				-121.650182 °		-121.650182 °
DWR ID	DWR_RD0003_01_s_2013_96					
Comment Code						
E2 : Schedule repair of erosion site prior to the next inspection.						
Inspector Comment						
Levee is extra wide in this section. Erosion is occurring outside the theoretical prism.

Looking southwest at erosion on waterward slope.

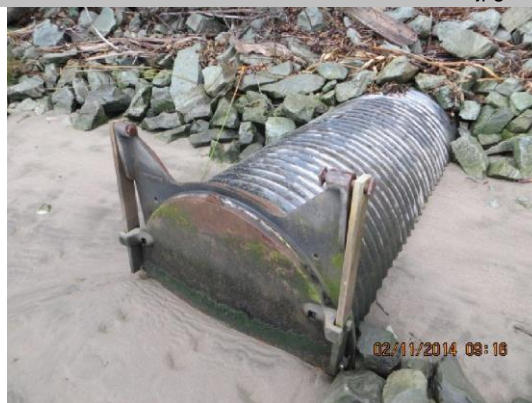
Photo 1 of 3 : UCIP_FA_2019_29165_53866.jpg

Comment Code						
Inspector Comment						
DS_ID:22206 FS_ID:29165 EP_NO: N/A Repair Type: Non-Urgent Crossing Status: Found UCIP Comments: Pipe appears abandoned and should be verified as having been done so properly. FIELD_STRUCT_DESC: *ABANDONED* 1 of 3: 36-inch corrugated metal drainage pipe through the levee, 15 feet below the crown. Slide gate in a 48-inch corrugated metal pipe (CMP) riser on the waterside (WS) shoulder. Flap gate at the WS toe has been sealed shut with sealant. [Additional Reference(s): DWR Levee Log, 1993, referenced as 24 feet below the crown. USACE Sacramento O&M Manual 104, February 1960, (RM 15.20), referenced as invert elevation 24 feet below the crown]. FS Date: 2/11/2014

36-inch CMP drainpipe with flapgate on WS toe.

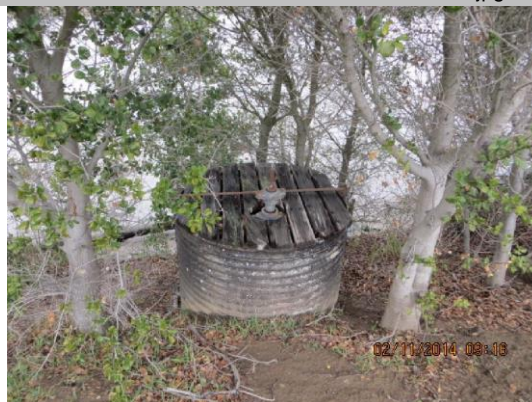
Photo 2 of 3 : UCIP_FA_2019_29164_53861.jpg

48-inch CMP riser with slide gate closed on WS shoulder.

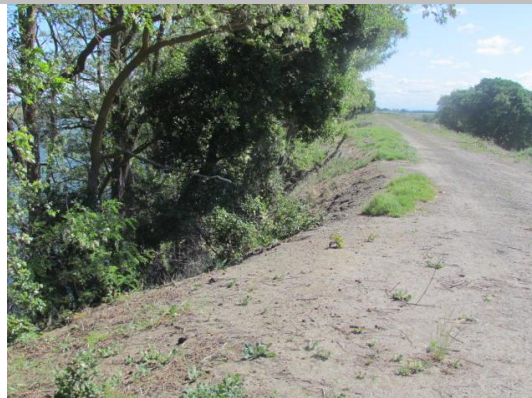
Photo 2 of 2 : FA_2019_RD0003_24_99_20190826_00086.jpg

Looking north at erosion on waterward shoulder and slope.

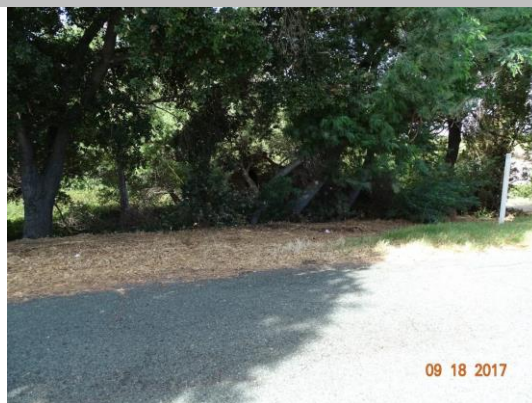
Photo 1 of 2 : FA_2019_RD0003_25_7_20190826_00006.jpg

Looking northwest at the landside slope.

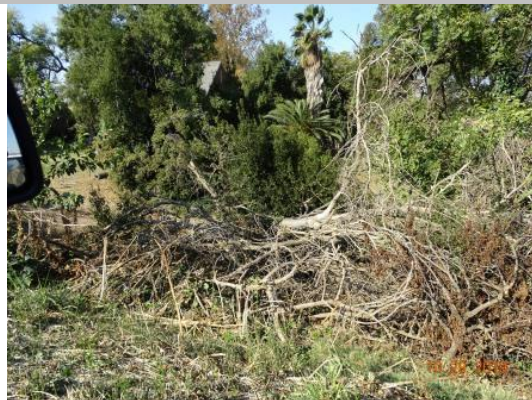
Photo 1 of 1 : FA_2019_RD0003_25_97_20191030_00348.jpg

View of fallen tree on landside slope (Fall 2019).

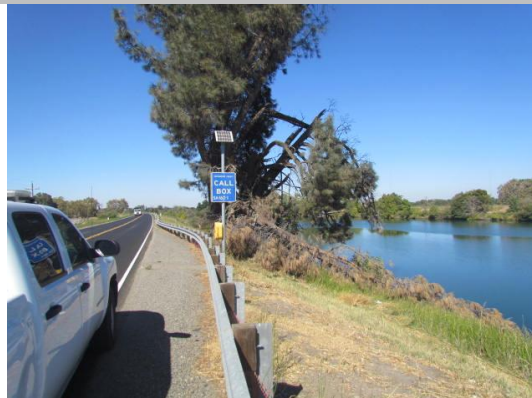
Photo 1 of 2 : FA_2019_RD0003_25_15_20190826_00017.jpg

Looking northeast at broken and cracked tree branches on waterward slope.

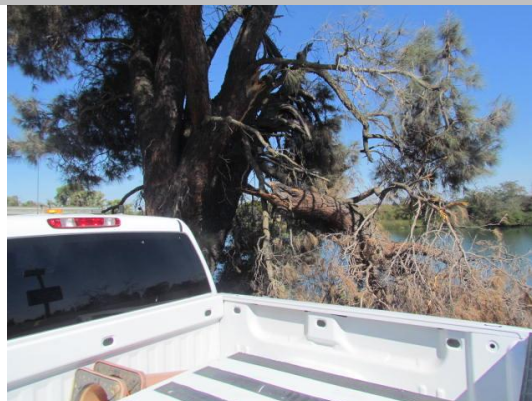
Photo 2 of 2 : FA_2019_RD0003_25_15_20190826_00018.jpg

Looking east at broken and cracked tree branches on waterward slope.

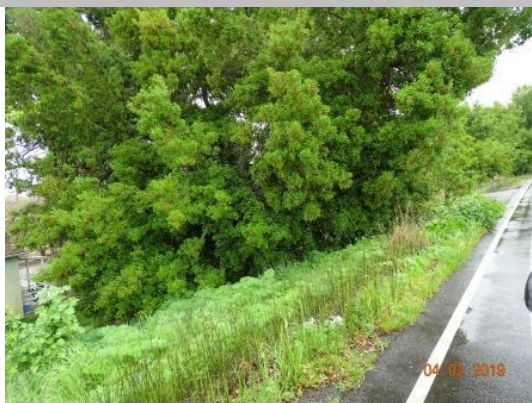
Photo 1 of 1 : FA_2019_RD0003_25_63_20190826_00042.jpg

View looking upstream at thick trees on the landside slope (Spring 2019).

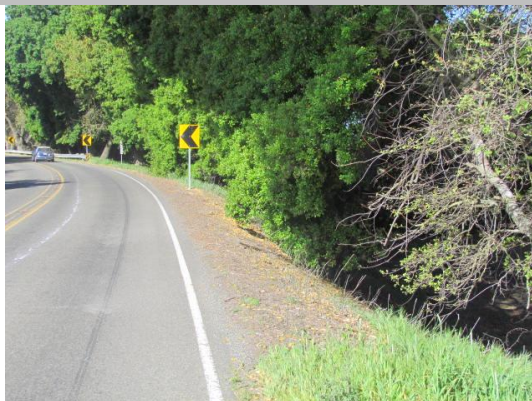
Photo 1 of 1 : FA_2019_RD0003_25_64_20190826_00043.jpg

Looking southwest at dense trees on landward shoulder and slope.

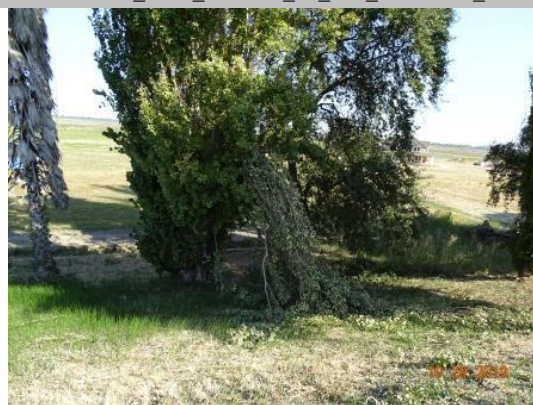
Photo 1 of 1 : FA_2019_RD0003_25_212_20191030_00336.jpg

View of broken tree limb on the landside slope (Fall 2019).

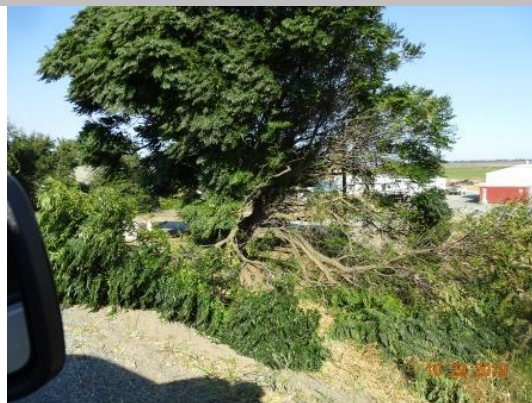
Photo 1 of 1 : FA_2019_RD0003_25_211_20191030_00335.jpg

LM Start	10.11	Rating **	U	Issue No.	211
LM End	10.11	Issue Type +	Ma	Location *	LS
Category	Earthen Levee			GPS Latitude/Longitude	
				Start	End
Item	Trim / Thin Trees			38.241333 °	38.241333 °
				-121.542880 °	-121.542880 °
DWR ID	DWR_RD0003_02_f_2019_211				
Comment Code					
T2 : Thin trees to allow visibility of the ground and room to flood fight.					
Inspector Comment					
Remove broken tree limbs.

View of broken tree limbs on the landside slope (Fall 2019).

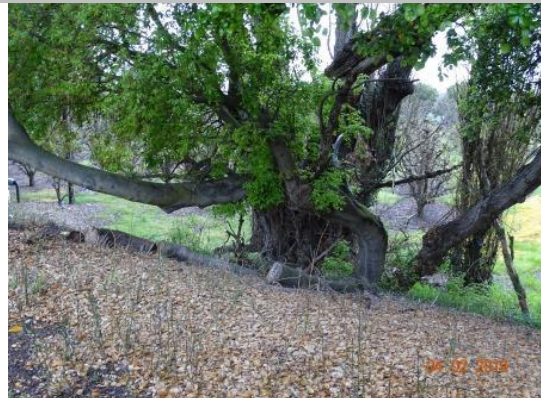
Photo 1 of 1 : FA_2019_RD0003_25_162_20190826_00144.jpg

View looking downslope at fallen tree limbs on the landside slope (Spring 2019).

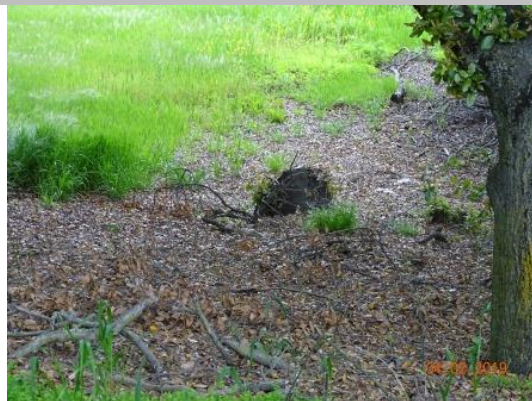
Photo 1 of 1 : FA_2019_RD0003_25_135_20190826_00106.jpg

View looking downslope at tree trunk at the bottom of the landside slope (Spring 2019).

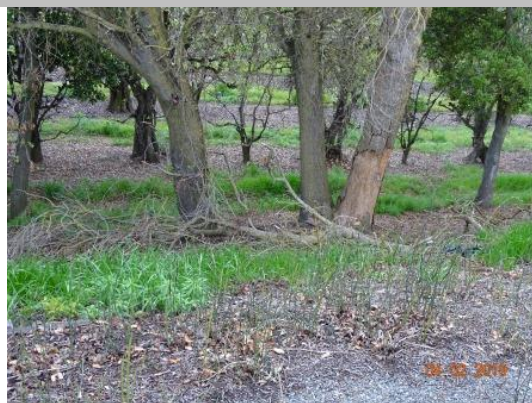
Photo 1 of 1 : FA_2019_RD0003_25_132_20190826_00103.jpg

View looking downslope at tree limbs on the landside slope (Spring 2019).

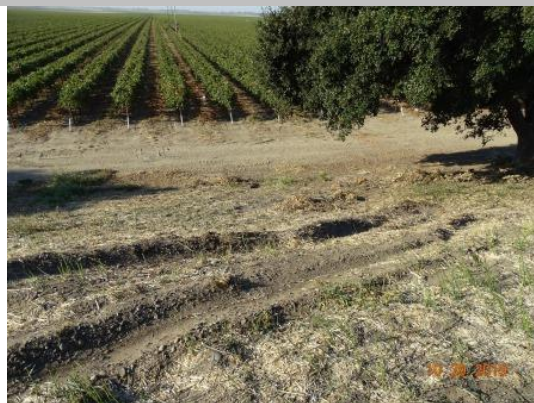
Photo 1 of 1 : FA_2019_RD0003_25_191_20191030_00319.jpg

LM Start	15.17	Rating **	M	Issue No.	191
LM End	15.17	Issue Type +	Ma	Location *	LS
Category	Earthen Levee			GPS Latitude/Longitude	
				Start	End
Item	Slope Stability			38.280443 °	38.280443 °
				-121.548175 °	-121.548175 °
DWR ID	DWR_RD0003_02_f_2019_191				
Comment Code					
S3 : Repair the levee slope damaged by vehicle traffic and prevent access where possible.					
Inspector Comment					
Fresh vehicle tracks on the landside slope.

View of fresh vehicle tracks going down the landside slope (Fall 2019).

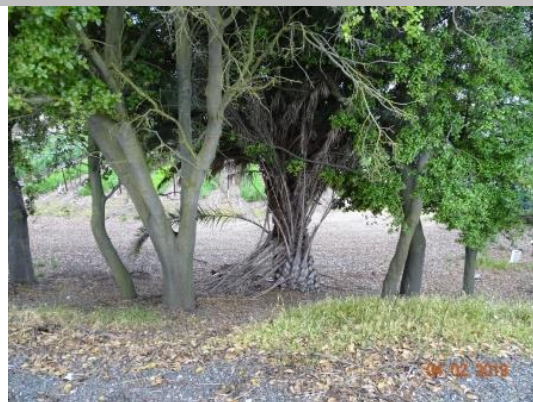
Photo 1 of 1 : FA_2019_RD0003_25_116_20190826_00084.jpg

View looking downslope at fallen palm limbs at the bottom of the landside slope (Spring 2019).

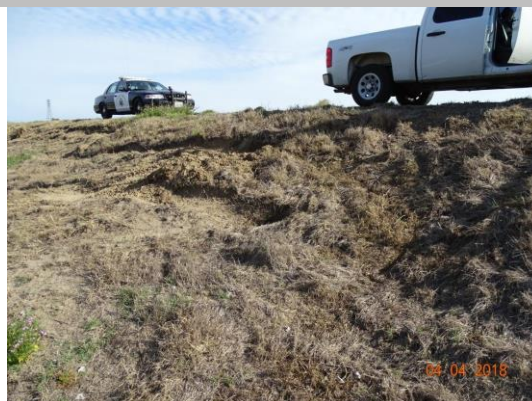
Photo 1 of 1 : FA_2019_RD0003_25_124_20190826_00092.jpg

Vehicle erosion on landside slope should be repaired.

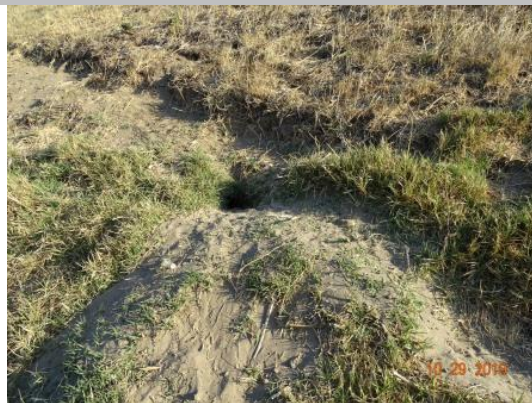
Photo 2 of 3 : FA_2019_RD0003_25_119_20191030_00313.jpg

View of large rodent hole in landside slope (Fall 2019).

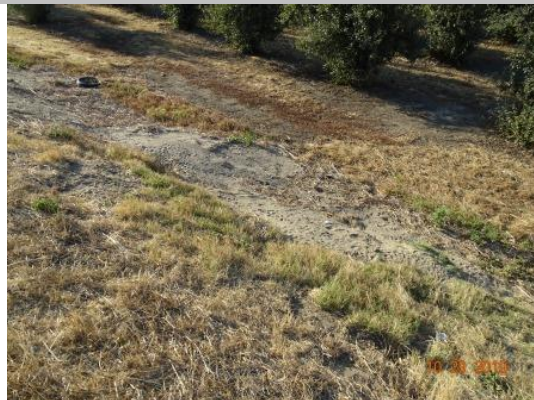
View looking downslope at rodent holes in landside slope (Fall 2019).

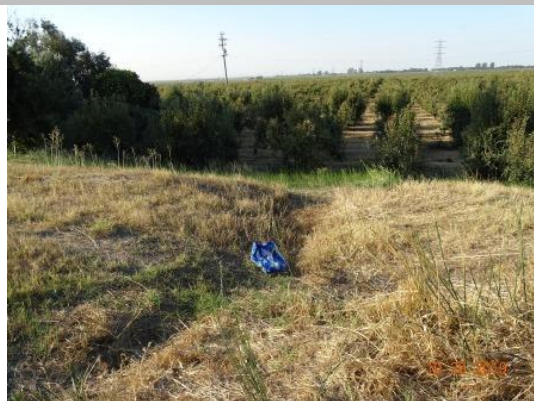
View of depression in the landside slope. Might be due to drainage (Fall 2019).

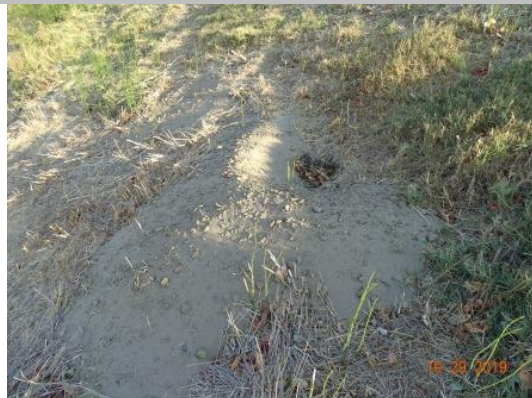
View of large fresh rodent hole on the landside slope (Fall 2019).

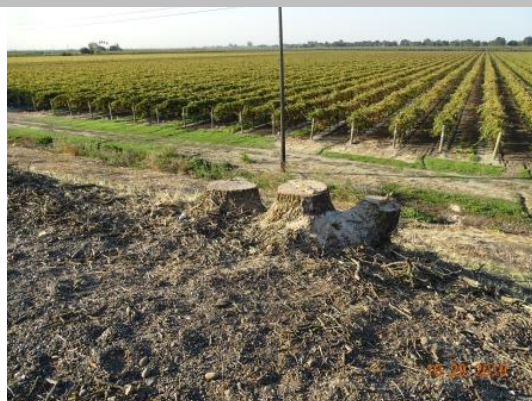
View of recently cut tree stumps on the landside shoulder (Fall 2019).

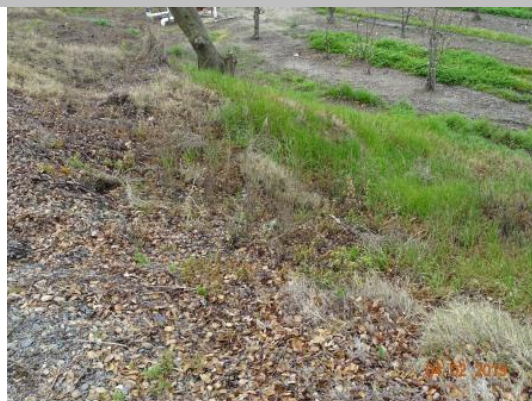
View looking downstream at depression on the landside slope (Spring 2019).

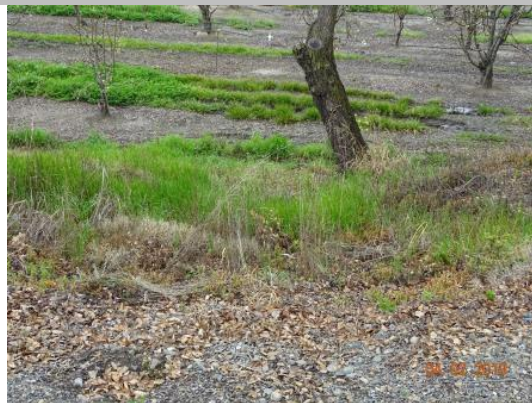
View looking downslope at depression on the landside slope (Spring 2019).

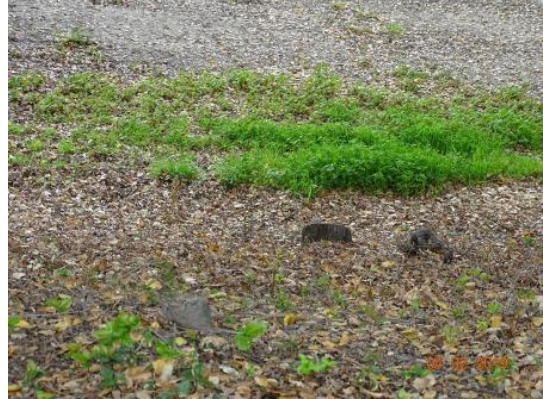
View looking downslope at tree stumps on the landside (Spring 2019).
