**Flood Control Project Maintenance
Levee Inspections**

Maintenance Issue Types Only, Levee Inspection Report By Mile - Fall 2020

Reclamation District No. 0003 Grand Island

Waterway	Bank	Unit Miles	Inspection Start/End	Inspector
Unit No. 01 Left Bank Steamboat Slough	Left	10.95	10/15/2020 10/15/2020	David Julian

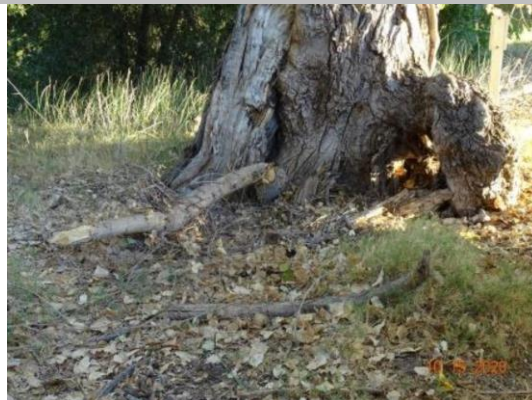
Photo 1 of 1 : FA_2020_RD0003_24_2_20201015_00280.jpg

LM Start	0.13	Rating **	M	Issue No.	2
LM End	0.13	Issue Type +	Ma	Location *	WS
Category	Earthen Levee			GPS Latitude/Longitude	
				Start	End
Item	Erosion / Bank Caving			38.303303 °	38.303303 °
				-121.576538 °	-121.576538 °
DWR ID	DWR_RD0003_01_f_2013_2				
Comment Code					
E2 : Schedule repair of erosion site prior to the next inspection.					
Inspector Comment					
A hole (8ft x 2.5ft x 5ft) is next to a large tree on waterward shoulder.

View of hole on the waterside shoulder due to fallen tree (Fall 2020).

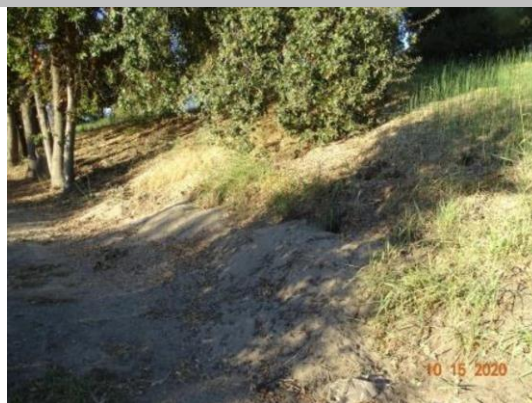
Photo 1 of 1 : FA_2020_RD0003_24_147_20201015_00283.jpg

View looking downstream at multiple fresh rodent holes in the landside slope (Fall 2020).

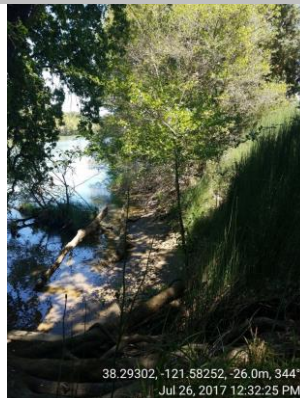
Photo 1 of 3 : LEVAL_FA_2020_275_2396.jpg

LM Start	0.91	Rating **	A/W	Issue No.	53
LM End	0.97	Issue Type +	Ma	Location *	WS
Category	Supplemental			GPS Latitude/Longitude	
				Start	End
Item	2017 Storm Damage			38.293381 °	38.292617 °
				-121.582450 °	-121.582675 °
DWR ID	LMA-101				
Comment Code					
Inspector Comment					
Planned For Repair.					
Levee Evaluation Comments					
Description: District station 48+20 to 51+06, Sec. 07, T. 5 N. R. 4 E., M.D.M. An erosion site exists along approximately 286 linear feet of the waterside slope of Steamboat Slough (Unit 1). The erosion begins approximately 1/2 of the way down the slope from the crown to the waterside toe. Erosion is undercutting existing trees.					
Site ID No:275					
Site Designation:LMA-101					
Repair Type: Erosion					
Rating:Serious					
Field Date:7/26/2017					
Notes:

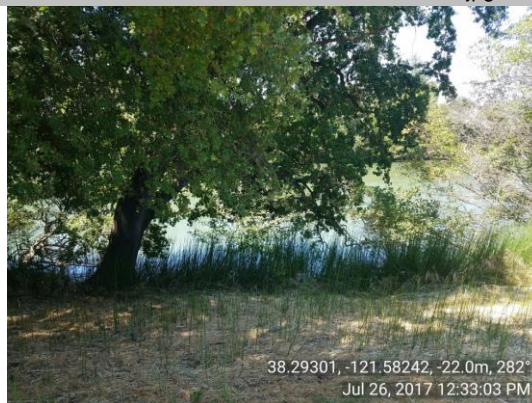
Photo 2 of 3 : LEVAL_FA_2020_275_2398.jpg

LM Start	0.91	Rating **	A/W	Issue No.	53 (cont)
LM End	0.97	Issue Type +	Ma	Location *	WS

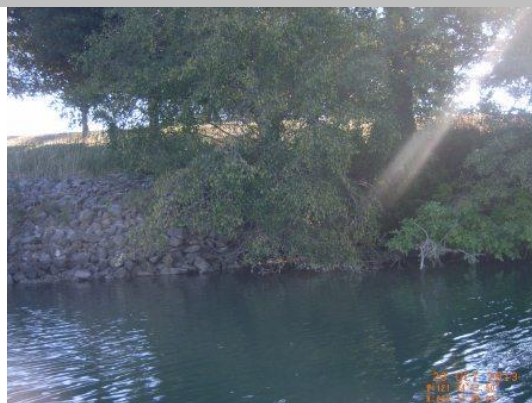
Photo 1 of 1 : FA_2020_RD0003_24_49_20200910_00014.jpg

USACE 2013 Photo #1

Site History: 1997 - Erosion of sandy levee on top left bank. Site is downstream of a rock section. Large riparian trees on the bank. 1999 - Upstream half of the reach repaired with rock, except for a 30 ft reach at the upstream end. 2001 - Rock repair on the upstream and downstream ends; no revetment at the trees. 2002 - Rock repair is starting to slide off the geotextile at the upstream end. 2005 - One new small tree has fallen. 2006 - 50 ft pocket at the downstream end and at the upstream end with new rock in between. 2007 - Upstream end has been repaired. 2008 - Area closed sign on bank. Newly fallen trees at both ends and pop outs along the bank. 2010 - Site extended downstream. 2011 - New erosion at the toe. More trees popouts. 2013 - Short vertical sections observed at the downstream end. 2015 - Significant new erosion, large oak tree on verge of popping out. 2016 - Sites 24.8 and 25 were combined.

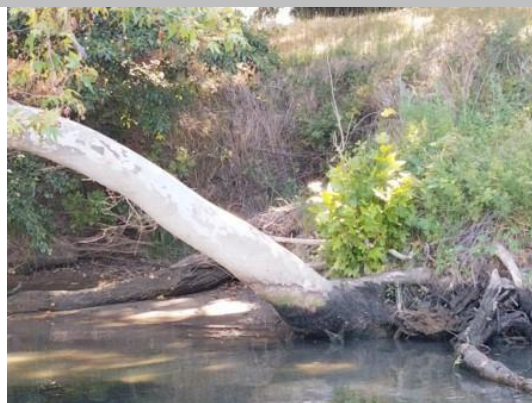
Photo 1 of 2 : FA_2020_RD0003_24_60_20200910_00027.jpg

LM Start	1.09	Rating **	U	Issue No.	60
LM End	1.10	Issue Type +	Ma	Location *	WS
Category	Earthen Levee			GPS Latitude/Longitude	
				Start	End
Item	Erosion / Bank Caving			38.290819 °	38.290706 °
				-121.582942 °	-121.582939 °
DWR ID	LMA-102				
Comment Code					
E2 : Schedule repair of erosion site prior to the next inspection.					
Inspector Comment					
<p>This was a 2017 Storm Damage site.</p> <p>An erosion site exists along approximately 41 linear feet of the water side slope.</p> <p>Site ID No:276</p> <p>Site Designation:LMA-102</p> <p>6/18/2020 Boat Inspection:</p> <p>Significant erosion into waterside prism directly upstream of tree that is leaning into water. That leaning tree is creating an eddy that is causing the erosion. There is also some less significant erosion into the waterside toe upstream of the significant erosion site.</p>

View from the channel of leaning tree and erosion into waterside prism (Summer 2020).

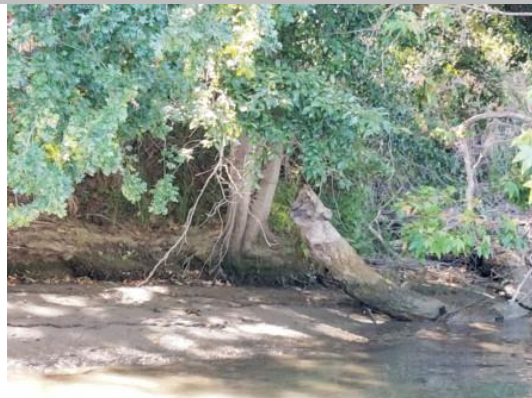
Photo 2 of 2 : FA_2020_RD0003_24_60_20200910_00028.jpg

View from the channel of erosion into waterside toe upstream deep erosion (Summer 2020).

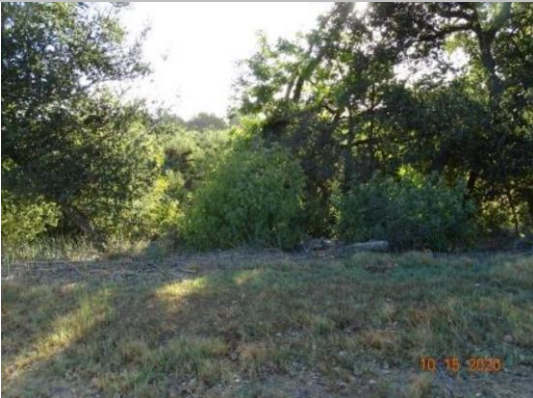
Photo 1 of 1 : FA_2020_RD0003_24_148_20201015_00285.jpg

View of trees partially blocking view down the landside slope (Fall 2020).

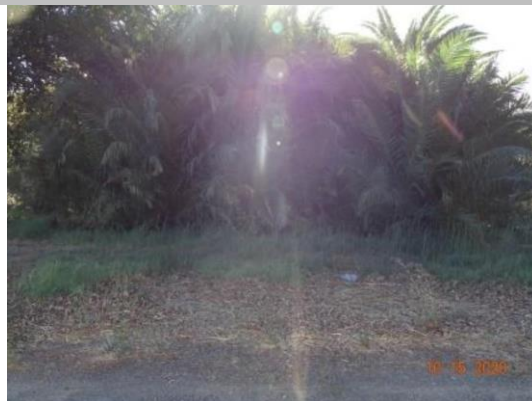
Photo 1 of 1 : FA_2020_RD0003_24_151_20201015_00290.jpg

View of thick palm trees on the landside slope (Fall 2020).

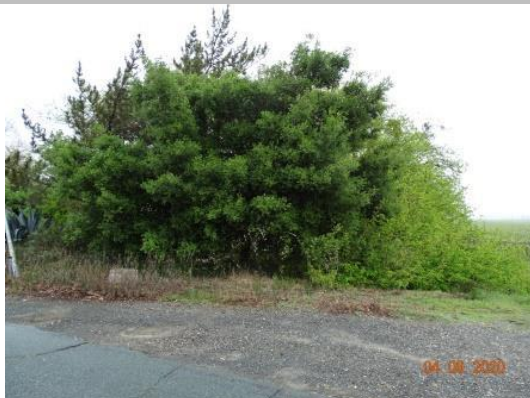
Photo 1 of 1 : FA_2020_RD0003_24_76_20200910_00040.jpg

View of thick tree on the landside slope (Spring 2020).

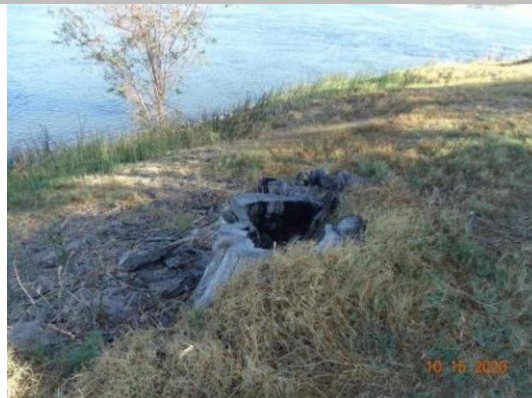
Photo 1 of 1 : FA_2020_RD0003_24_155_20201015_00295.jpg

View of tree stump on the waterside slope (Fall 2020).

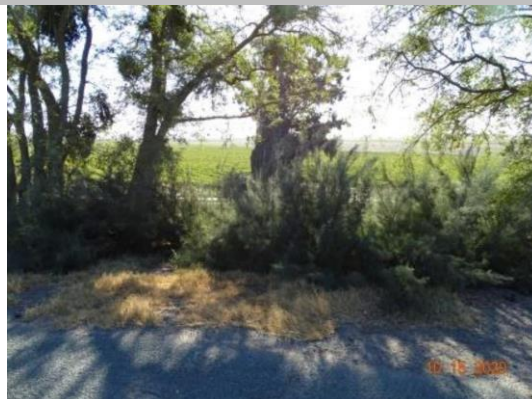
Photo 1 of 1 : FA_2020_RD0003_24_74_20201015_00296.jpg

LM Start	10.13	Rating **	M	Issue No.	74
LM End	10.13	Issue Type +	Ma	Location *	LS
Category	Earthen Levee			GPS Latitude/Longitude	
				Start	End
Item	Vegetation			38.188560 °	38.188560 °
				-121.641283 °	-121.641283 °
DWR ID	DWR_RD0003_01_s_2020_74				
Comment Code					
V2 : Remove the wild growth other than native grasses from the levee slopes.					
Inspector Comment

View of vegetation on the landside shoulder and slope (Fall 2020).

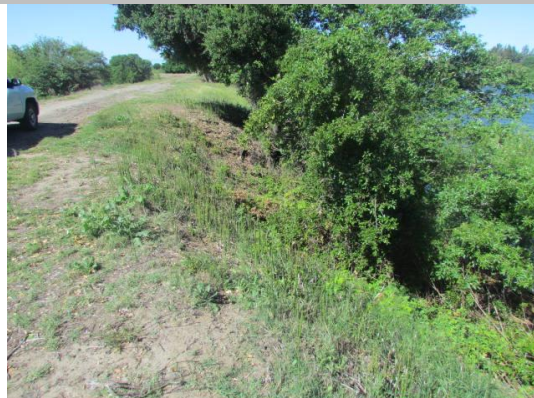
Photo 1 of 3 : FA_2020_RD0003_24_73_20200910_00036.jpg

LM Start	10.67	Rating **	A/W	Issue No.	73
LM End	10.94	Issue Type +	Ma	Location *	WS
Category	Earthen Levee			GPS Latitude/Longitude	
				Start	End
Item	Erosion / Bank Caving			38.183810 °	38.182348 °
				-121.648780 °	-121.653433 °
DWR ID	DWR_RD0003_01_s_2020_73				
Comment Code					
E1 : Note and monitor erosion site.					
Inspector Comment					
This was a 2017 Storm Damage site. Scattered erosion scarps caving into levee crown, within erosion limit crown width ranges from 15 to 30', several trees with exposed tree roots and leaning into the river. Site ID No:63 Site Designation:DWR_RD0003_01_R_2012_03 4/9/2020 Field Notes: Erosion is still outside of theoretical levee prism. LMA has mentioned USACE is in process of repairing. Monitor.

Looking south at erosion on waterside slope.

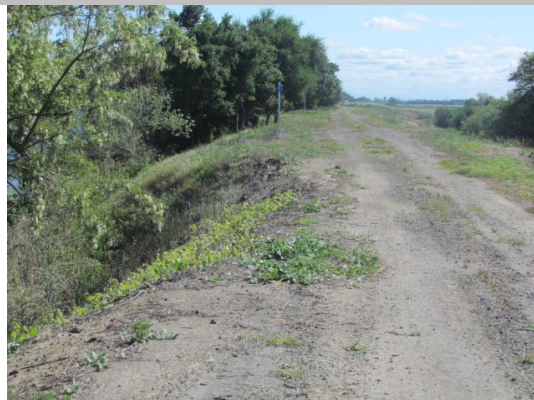
Photo 2 of 3 : FA_2020_RD0003_24_73_20200910_00037.jpg

LM Start	10.67	Rating **	A/W	Issue No.	73 (cont)
LM End	10.94	Issue Type +	Ma	Location *	WS

Looking northwest at erosion on waterside shoulder and slope.

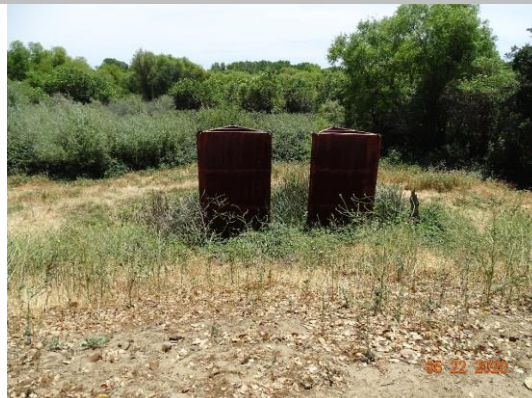
Photo 2 of 3 : UCIP_FA_2020_58704_85967.jpg

LS view: Steel weir on the levee toe.

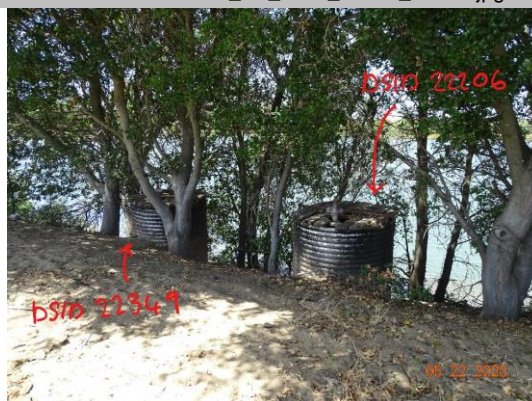
Photo 3 of 3 : UCIP_FA_2020_58704_85968.jpg

WS view: Standpipe on the levee shoulder.

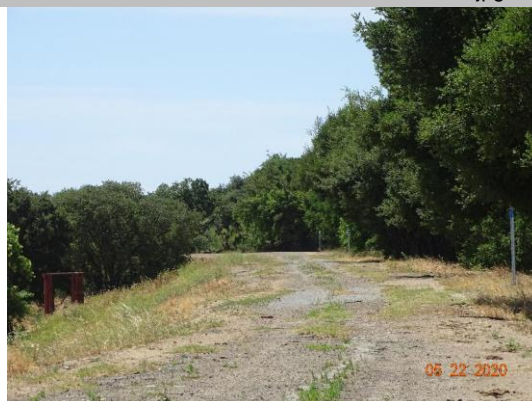
Photo 1 of 3 : UCIP_FA_2020_58705_85978.jpg

Comment Code						
Inspector Comment						
DS_ID:22349 FS_ID:58705 EP_NO: N/A Repair Type: Non-Urgent EVAL Issue: Unauthorized Encroachment, installed decades prior Crossing Status: Found UCIP Comments: 05/22/2020 Record remains Non-Urgent due to missing permit and crossing being abandoned. (S. Donovan - DWR UCIP)02/11/2014 Pipe appears abandoned and should be verified as having been filled with grout. (G. Wylie - DWR UCIP) FIELD_STRUCT_DESC: *ABANDONED* 36-inch corrugated metal drainage pipe through the levee, 15 feet below the crown. Slide gate in a 48-inch corrugated metal pipe (CMP) riser on the waterside (WS) shoulder. Steel intake weir at the landside (LS) toe. Steel plate welded over the pipe on the WS toe. [Additional Reference(s): DWR Levee Log, 1993, referenced as 24 feet below the crown. USACE Sacramento O&M Manual 104, February 1960, (RM 15.20), referenced as invert elevation 24 feet below the crown]. FS Date: 5/22/2020 8:28:00 AM

Overview of the levee crown looking d/s.

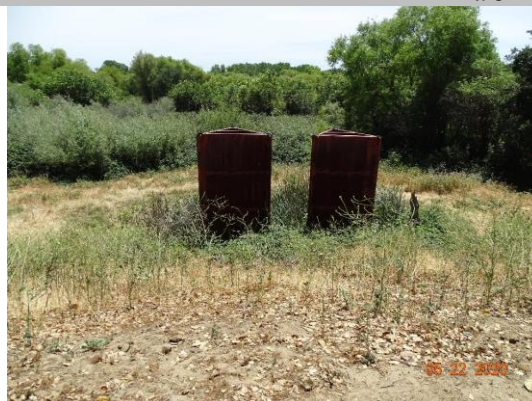
Photo 2 of 3 : UCIP_FA_2020_58705_85973.jpg

LS view: Steel weir on the levee toe.

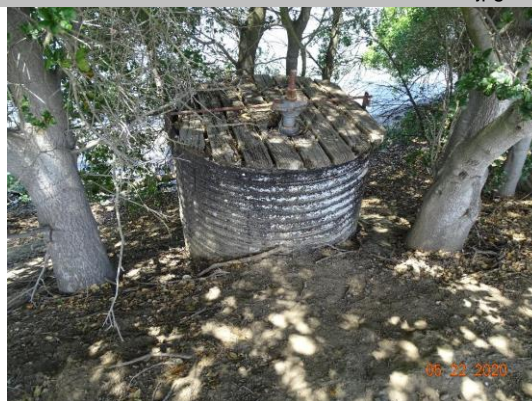
Photo 3 of 3 : UCIP_FA_2020_58705_85974.jpg

WS view: Standpipe on the levee shoulder.

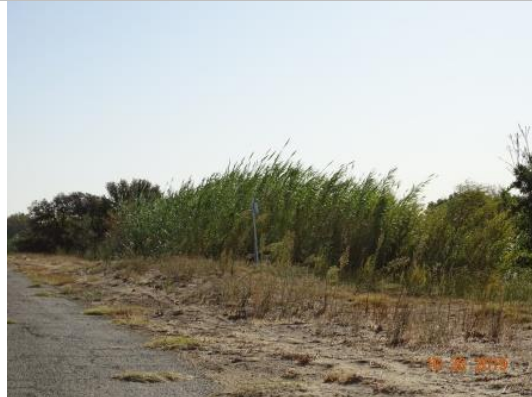
Photo 1 of 1 : FA_2020_RD0003_25_5_20200910_00004.jpg

View looking upstream at arundo on the waterside slope (Fall 2019).

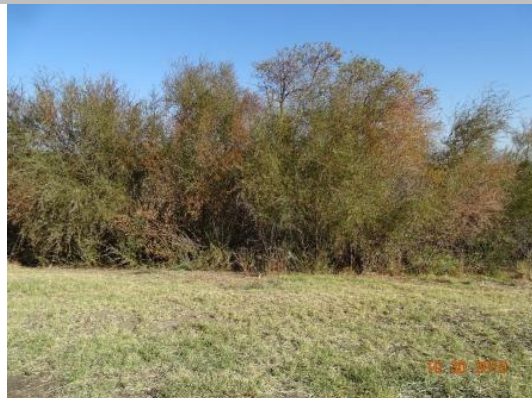
Photo 1 of 1 : FA_2020_RD0003_25_151_20200910_00086.jpg

View of willows on the landside slope (Fall 2019).

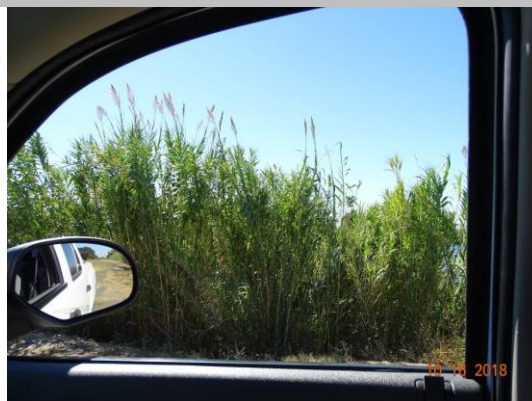
Photo 1 of 1 : FA_2020_RD0003_25_3_20200910_00003.jpg

LM Start	0.37	Rating **	U	Issue No.	3
LM End	0.37	Issue Type +	Ma	Location *	WS
Category	Earthen Levee			GPS Latitude/Longitude	
				Start	End
Item	Vegetation			38.174020 °	38.174020 °
				-121.647458 °	-121.647458 °
DWR ID	DWR_RD0003_02_f_2018_3				
Comment Code					
V2 : Remove the wild growth other than native grasses from the levee slopes.					
Inspector Comment					
Remove arundo from waterside slope.

View of arundo on waterside slope (October 2018).

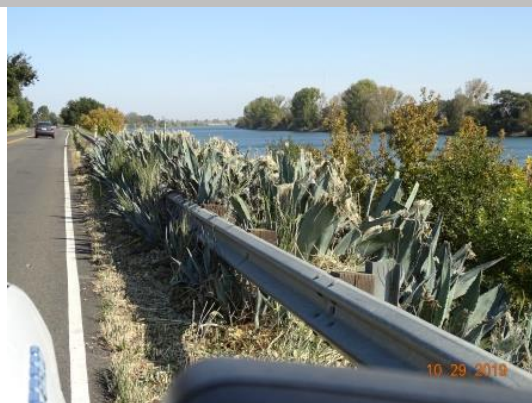
Photo 1 of 1 : FA_2020_RD0003_25_220_20200910_00118.jpg

View looking upstream at century plants on the waterside shoulder (Fall 2019).

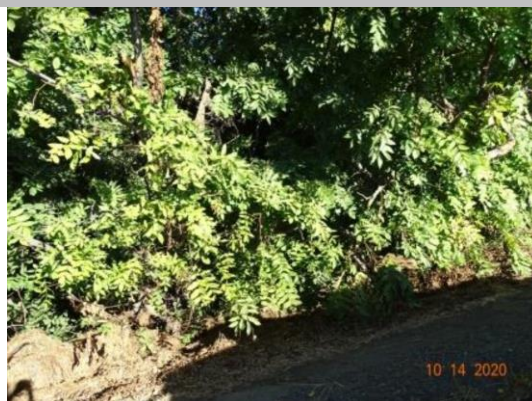
Photo 1 of 1 : FA_2020_RD0003_25_14_20201014_00257.jpg

View of untrimmed trees on the landside slope (Fall 2020).

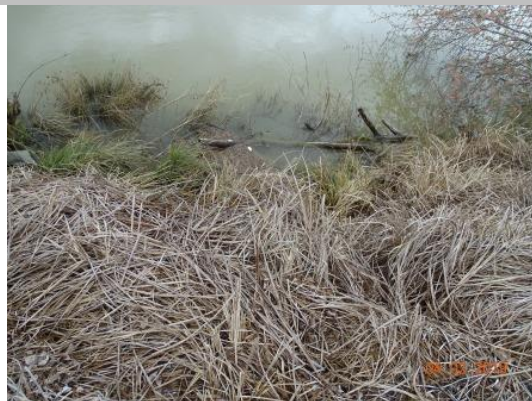
Photo 1 of 1 : FA_2020_RD0003_25_194_20200910_00106.jpg

LM Start	4.94	Rating **	M	Issue No.	194
LM End	4.94	Issue Type +	Ma	Location *	WS
Category	Earthen Levee			GPS Latitude/Longitude	
				Start	End
Item	Erosion / Bank Caving			38.188248 °	38.188248 °
				-121.581225 °	-121.581225 °
DWR ID	DWR_RD0003_02_s_2019_194				
Comment Code					
E2 : Schedule repair of erosion site prior to the next inspection.					
Inspector Comment					
Small amount of bank caving.

View looking downslope at erosion on the waterside slope (Spring 2019).

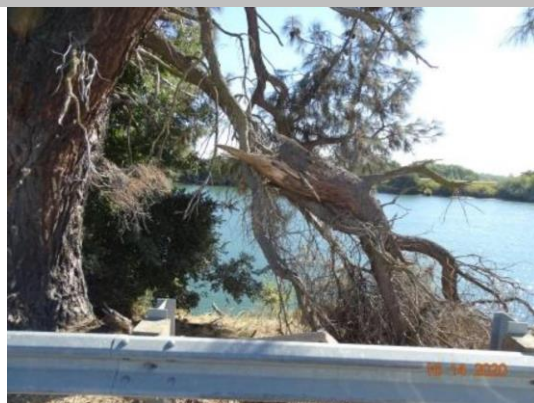
Photo 1 of 1 : FA_2020_RD0003_25_15_20201014_00256.jpg

LM Start	8.11	Rating **	U	Issue No.	15
LM End	8.11	Issue Type +	Ma	Location *	WS
Category	Earthen Levee			GPS Latitude/Longitude	
				Start	End
Item	Encroachments			38.224130 °	38.224130 °
				-121.557206 °	-121.557206 °
DWR ID	DWR_RD0003_02_f _ 2020_15				
Comment Code					
TR : Tree or limb					
Inspector Comment					
Remove broken tree branches on waterside shoulder and slope.

View of fallen tree limb on the waterside slope (Fall 2020).

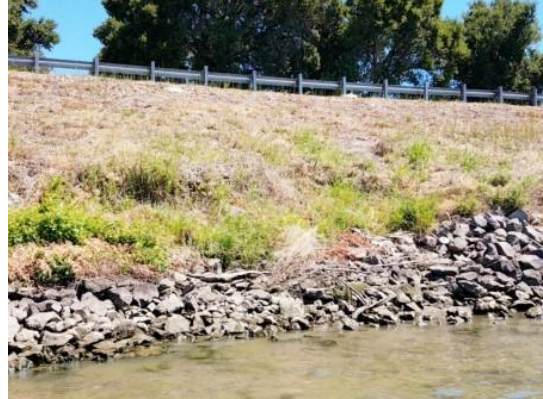
Photo 1 of 2 : FA_2020_RD0003_25_138_20200910_00075.jpg

LM Start	10.01	Rating **	M	Issue No.	138
LM End	10.03	Issue Type +	Ma	Location *	WS
Category	Earthen Levee			GPS Latitude/Longitude	
				Start	End
Item	Erosion / Bank Caving			38.241481 °	38.241439 °
				-121.544569 °	-121.544353 °
DWR ID	LMA-106				
Comment Code					
E2 : Schedule repair of erosion site prior to the next inspection.					
Inspector Comment					
This was a 2017 Storm Damage site. Site ID No:280 Site Designation:LMA-106 6/18/2020 Field Notes: Approximately 2' vertical erosion on surface of waterside slope. The erosion commences approximately 1/2 of the way down the slope from the crown and extends into the riprap. Missing riprap at this location.

View from the channel at erosion on the waterside (Summer 2020).

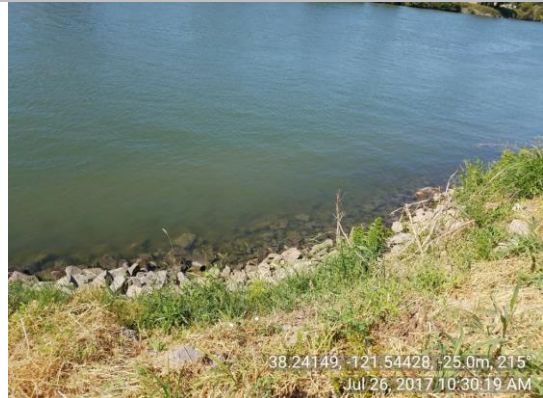
Photo 2 of 2 : FA_2020_RD0003_25_138_20200910_00076.jpg

View looking downslope at erosion on the waterside (2017).

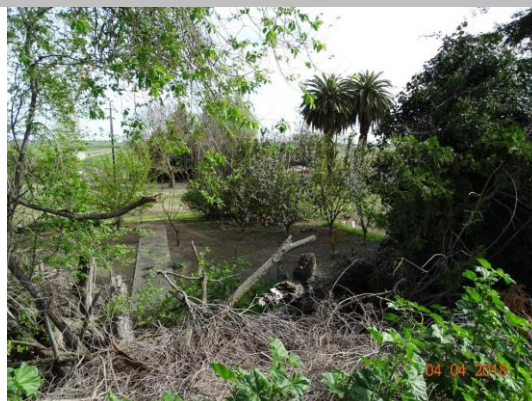
Photo 1 of 1 : FA_2020_RD0003_25_170_20200910_00097.jpg

Fallen tree on landside slope.

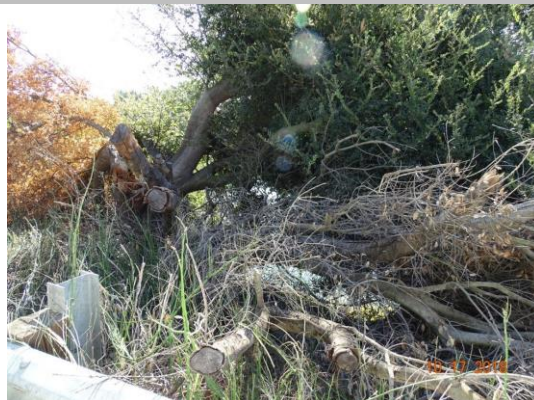
Photo 1 of 1 : FA_2020_RD0003_25_201_20200910_00110.jpg

View of fallen tree that has been chopped up on the waterside slope (October 2018).

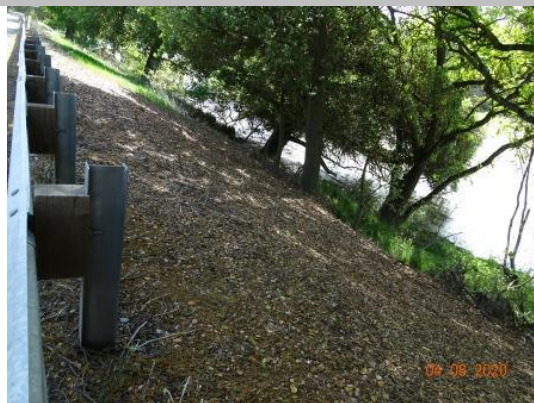
Photo 1 of 1 : FA_2020_RD0003_25_168_20200910_00096.jpg

LM Start	11.37	Rating **	U	Issue No.	168
LM End	11.37	Issue Type +	Ma	Location *	WS
Category	Earthen Levee			GPS Latitude/Longitude	
				Start	End
Item	Erosion / Bank Caving			38.240140 °	38.240140 °
				-121.520310 °	-121.520310 °
DWR ID	DWR_RD0003_02_s_2020_168				
Comment Code					
E2 : Schedule repair of erosion site prior to the next inspection.					
Inspector Comment					
Significant erosion into waterside slope.

View of erosion into the waterside slope (Spring 2020).

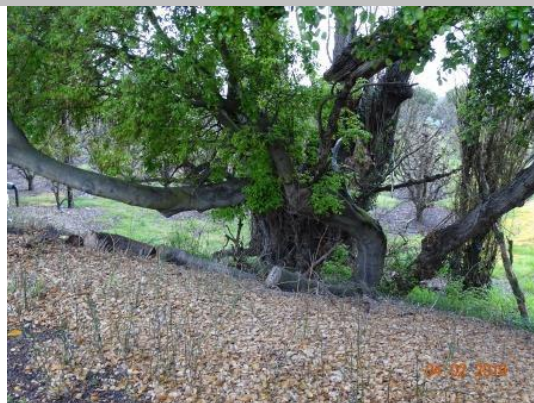
Photo 1 of 1 : FA_2020_RD0003_25_162_20200910_00093.jpg

View looking downslope at fallen tree limbs on the landside slope (Spring 2019).

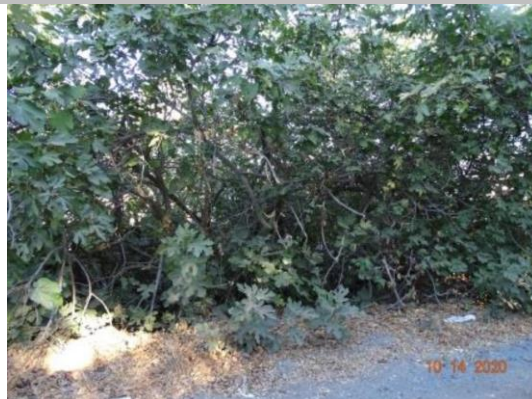
Photo 1 of 1 : FA_2020_RD0003_25_116_20201014_00261.jpg

View of thick fig tree on the landside slope (Fall 2020).

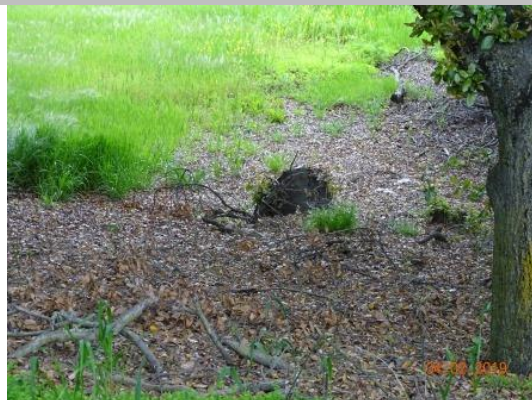
Photo 1 of 1 : FA_2020_RD0003_25_135_20200910_00074.jpg

View looking downslope at tree trunk at the bottom of the landside slope (Spring 2019).

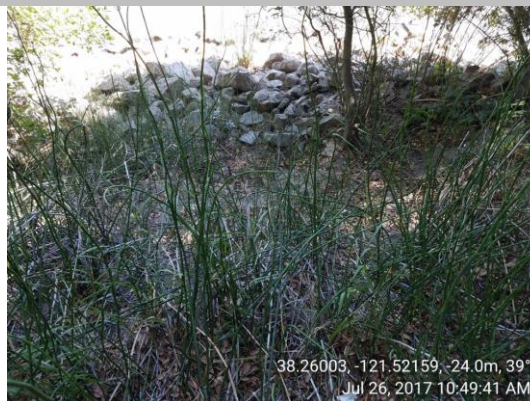
Photo 1 of 1 : FA_2020_RD0003_25_139_20200910_00077.jpg

LM Start	13.15	Rating **	M	Issue No.	139
LM End	13.17	Issue Type +	Ma	Location *	WS
Category	Earthen Levee			GPS Latitude/Longitude	
				Start	End
Item	Erosion / Bank Caving			38.260042 °	38.260219 °
				-121.521581 °	-121.521803 °
DWR ID	LMA-107				
Comment Code					
E2 : Schedule repair of erosion site prior to the next inspection.					
Inspector Comment					
This was a 2017 Storm Damage site. Approximately 89 linear feet of erosion and sloughing. The erosion commences approximately 1/2 of the way down the slope from the crown and extends into the rip rap. Site ID No:281 Site Designation:LMA-107 4/8/2020 Field Notes: Evidence of minor sloughing.

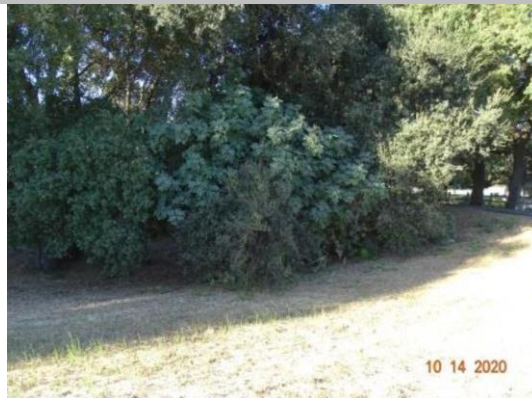
Photo 1 of 1 : FA_2020_RD0003_25_107_20201014_00265.jpg

View of thick trees on the landside slope (Fall 2020).

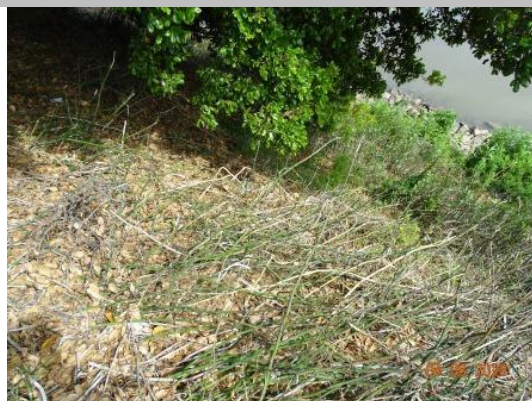
Photo 1 of 1 : FA_2020_RD0003_25_142_20200910_00078.jpg

LM Start	15.04	Rating **	U	Issue No.	142
LM End	15.04	Issue Type +	Ma	Location *	WS
Category	Earthen Levee			GPS Latitude/Longitude	
				Start	End
Item	Erosion / Bank Caving			38.279083 °	38.279083 °
				-121.546406 °	-121.546406 °
DWR ID	LMA-108				
Comment Code					
E2 : Schedule repair of erosion site prior to the next inspection.					
Inspector Comment					
This was a 2017 Storm Damage site. Approximately 330 linear feet of erosion and sloughing. The erosion commences approximately 1/2 of the way down the slope from the crown and extends into the rip rap. Site ID No:282 Site Designation:LMA-108 4/8/2020 Field Notes: Significant erosion into waterside toe.

View erosion into the waterside slope (Spring 2020).

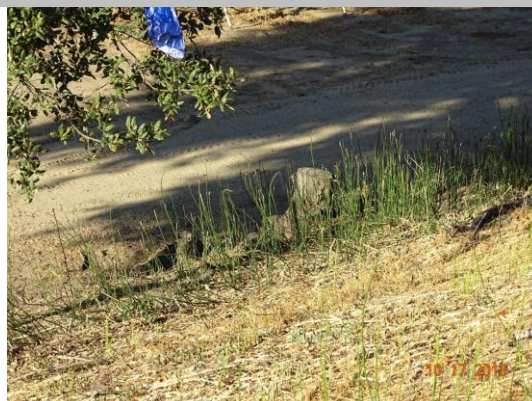
Photo 1 of 1 : FA_2020_RD0003_25_122_20200910_00065.jpg

View of large stump at the landside toe of the levee (October 2018).

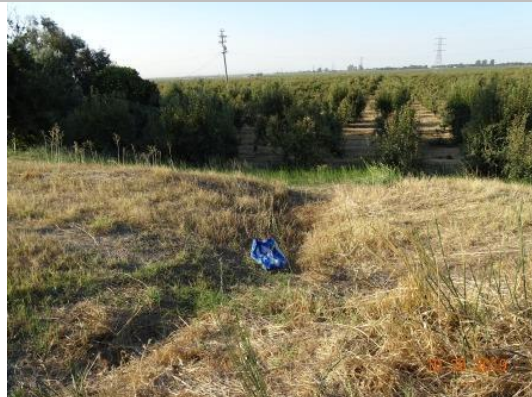
Photo 1 of 1 : FA_2020_RD0003_25_115_20200910_00060.jpg

View of depression in the landside slope. Might be due to drainage (Fall 2019).

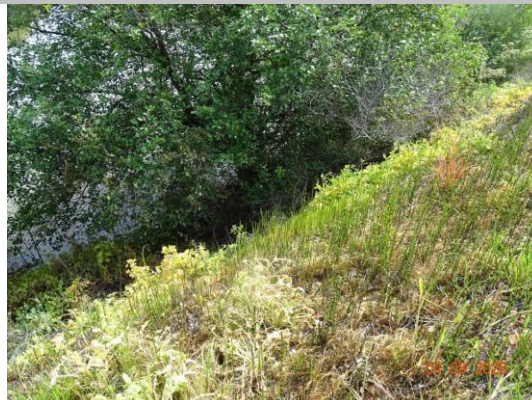
Photo 1 of 1 : FA_2020_RD0003_25_150_20200910_00085.jpg

View of erosion into the waterside slope (Spring 2020).

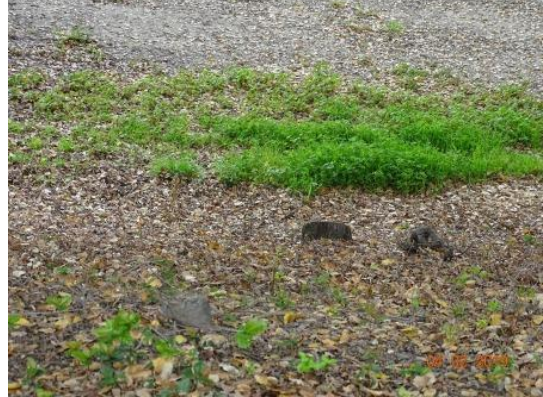
Photo 1 of 1 : FA_2020_RD0003_25_113_20200910_00058.jpg

View looking downslope at tree stumps on the landside (Spring 2019).

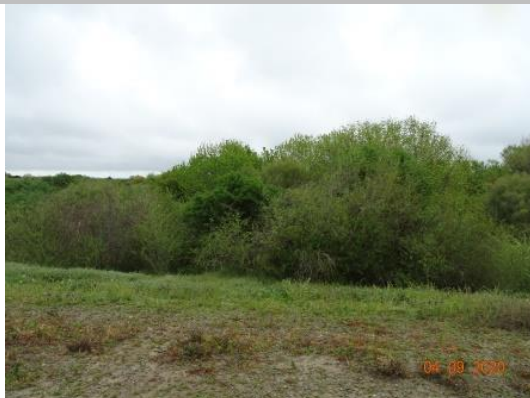
Photo 1 of 1 : FA_2020_RD0003_610_5_20200910_00002.jpg

View of willow tree on the landside slope (Spring 2020).
