**Flood Control Project Maintenance
Levee Inspections**

Maintenance Issue Types Only, Levee Inspection Report By Mile - Fall 2021

Reclamation District No. 0003 Grand Island

Waterway	Bank	Unit Miles	Inspection Start/End	Inspector
Unit No. 01 Left Bank Steamboat Slough	Left	10.95	10/06/2021 10/06/2021	David Julian

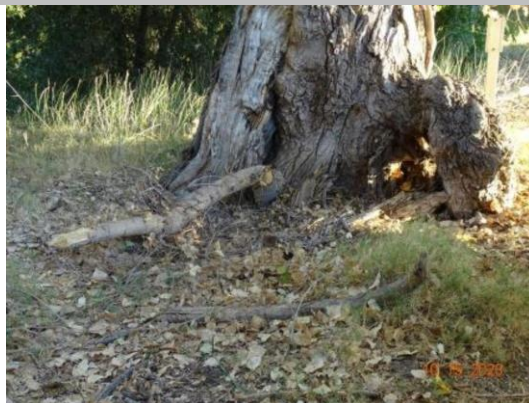
Photo 1 of 1 : FA_2021_RD0003_24_2_20210830_00001.jpg

LM Start	0.13	Rating **	M	Issue No.	2
LM End	0.13	Issue Type +	Ma	Location *	WS
Category	Earthen Levee			GPS Latitude/Longitude	
				Start	End
Item	Erosion / Bank Caving			38.303303 °	38.303303 °
				-121.576538 °	-121.576538 °
DWR ID	DWR_RD0003_01_f_2013_2				
Comment Code					
E2 : Schedule repair of erosion site prior to the next inspection.					
Inspector Comment					
A hole (8ft x 2.5ft x 5ft) is next to a large tree on waterward shoulder.

View of hole on the waterside shoulder due to fallen tree (Fall 2020).

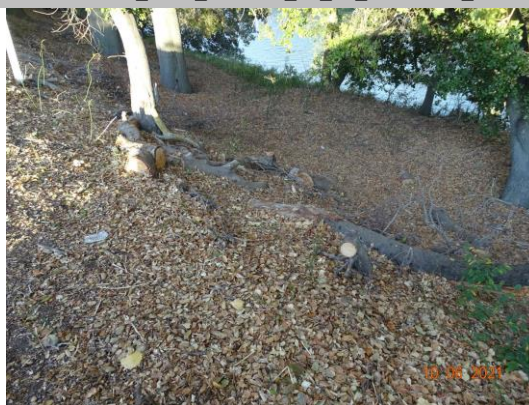
Photo 1 of 1 : FA_2021_RD0003_24_64_20211006_00289.jpg

LM Start	0.14	Rating **	M	Issue No.	64
LM End	0.14	Issue Type +	Ma	Location *	WS
Category	Earthen Levee			GPS Latitude/Longitude	
				Start	End
Item	Encroachments			38.303210 °	38.303210 °
				-121.576642 °	-121.576642 °
DWR ID	DWR_RD0003_01_f_2019_64				
Comment Code					
TR : Tree or limb					
Inspector Comment

View of tree branches on the waterside slope (Fall 2021).

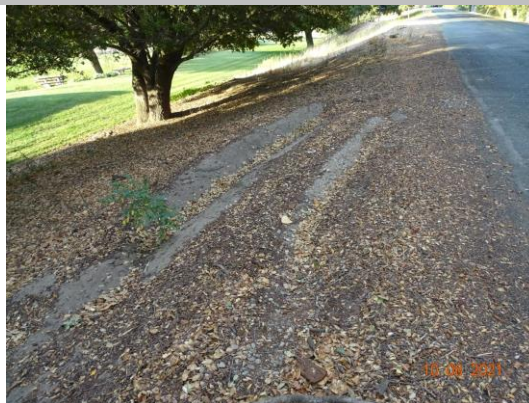
Photo 1 of 1 : FA_2021_RD0003_24_131_20211006_00290.jpg

LM Start	0.16	Rating **	M	Issue No.	131
LM End	0.16	Issue Type +	Ma	Location *	LS
Category	Earthen Levee			GPS Latitude/Longitude	
				Start	End
Item	Slope Stability			38.303111 °	38.303111 °
				-121.576842 °	-121.576842 °
DWR ID	DWR_RD0003_01_f_2021_131				
Comment Code					
S3 : Repair the levee slope damaged by vehicle traffic and prevent access where possible.					
Inspector Comment					
Vehicle tracks dug out hole on the landside hinge.

View looking downstream at vehicle tracks in the landside hinge (Fall 2021).

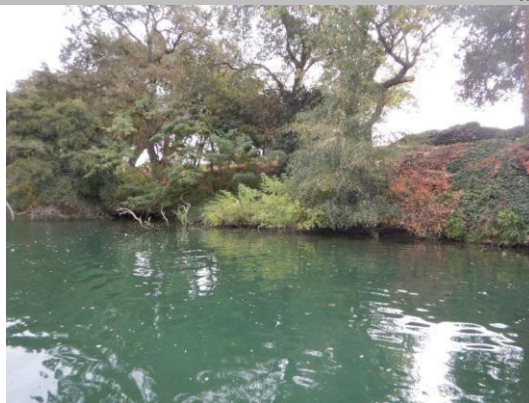
Photo 1 of 2 : FA_2021_RD0003_24_49_20211218_70.jpg

2018 Site ID: STM 26.0 L
 Status: Critical
 2018 Field Notes: New erosion throughout site.
 Site History: 1997 - Mass failure of berm slope and wave wash erosion. Large trees on top of berm, some failed trees. New area of low rock to on the upstream end. 2000 - Some minor erosion near the downstream end. 2005 - One new small tree has fallen. 2009 - Minimal new erosion. 2010 - Minor new erosion. 2013 - Observed new animal holes and vertical sections at middle of site. 2015 - Minor new erosion. 2017 - Upgraded to CRITICAL. Significant bank failure on upstream end.

USACE 2018 Erosion Photo #1

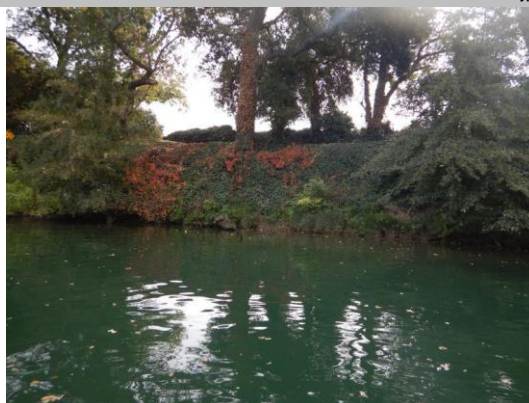
Photo 2 of 2 : FA_2021_RD0003_24_49_20211218_71.jpg

USACE 2018 Erosion Photo #2

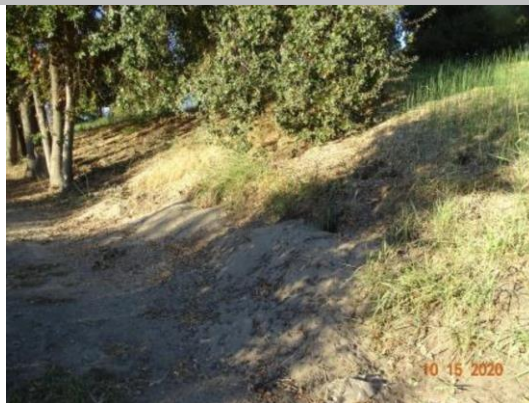
Photo 1 of 1 : FA_2021_RD0003_24_147_20210830_00058.jpg

View looking downstream at multiple fresh rodent holes in the landside slope (Fall 2020).

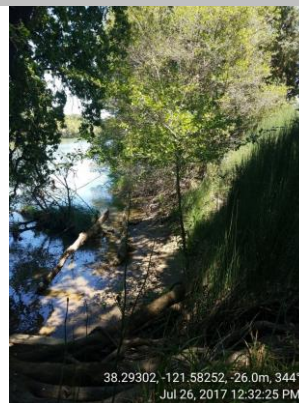
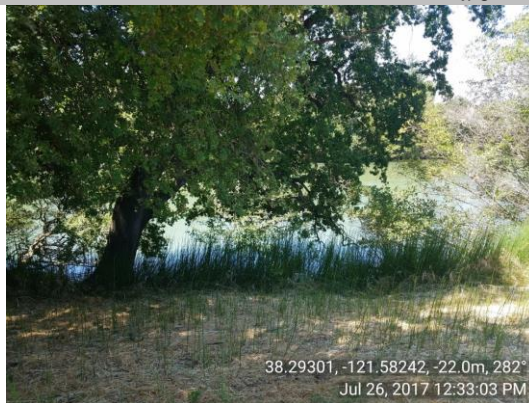
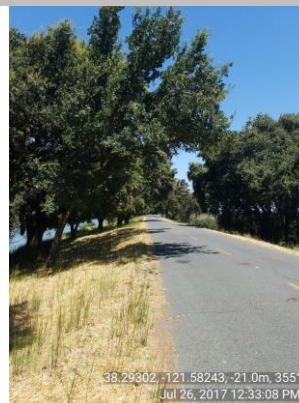
LM Start	0.91	Rating **	A/W	Issue No.	53
LM End	0.97	Issue Type +	Ma	Location *	WS
Category	Supplemental			GPS Latitude/Longitude	
				Start	End
Item	2017 Storm Damage			38.293381 °	38.292617 °
				-121.582450 °	-121.582675 °
DWR ID	LMA-101				
Comment Code					
Inspector Comment					
Planned For Repair.					
Levee Evaluation Comments					
Description:District station 48+20 to 51+06, Sec. 07, T. 5 N. R. 4 E., M.D.M. An erosion site exists along approximately 286 linear feet of the waterside slope of Steamboat Slough (Unit 1). The erosion begins approximately 1/2 of the way down the slope from the crown to the waterside toe. Erosion is undercutting existing trees.					
Site ID No:275					
Site Designation:LMA-101					
Repair Type: Erosion					
Rating:Serious					
Field Date:7/26/2017					
Notes:

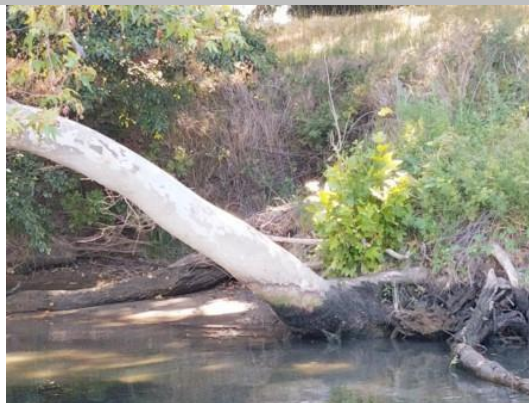
Photo 1 of 2 : FA_2021_RD0003_24_60_20210830_00025.jpg

LM Start	1.09	Rating **	U	Issue No.	60
LM End	1.10	Issue Type +	Ma	Location *	WS
Category	Earthen Levee			GPS Latitude/Longitude	
				Start	End
Item	Erosion / Bank Caving			38.290819 °	38.290706 °
				-121.582942 °	-121.582939 °
DWR ID	LMA-102				
Comment Code					
E2 : Schedule repair of erosion site prior to the next inspection.					
Inspector Comment					
<p>This was a 2017 Storm Damage site.</p> <p>An erosion site exists along approximately 41 linear feet of the water side slope.</p> <p>Site ID No:276</p> <p>Site Designation:LMA-102</p> <p>6/18/2020 Boat Inspection:</p> <p>Significant erosion into waterside prism directly upstream of tree that is leaning into water. That leaning tree is creating an eddy that is causing the erosion. There is also some less significant erosion into the waterside toe upstream of the significant erosion site.</p>

View from the channel of leaning tree and erosion into waterside prism (Summer 2020).

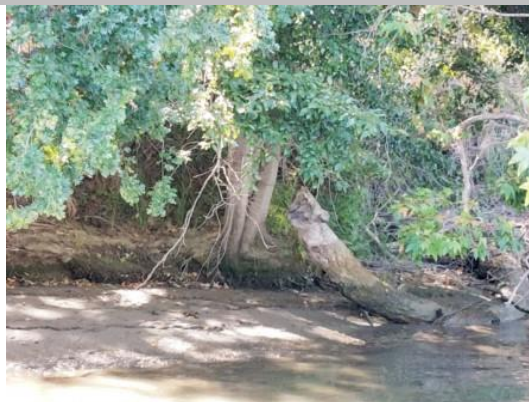
Photo 2 of 2 : FA_2021_RD0003_24_60_20210830_00026.jpg

View from the channel of erosion into waterside toe upstream deep erosion (Summer 2020).

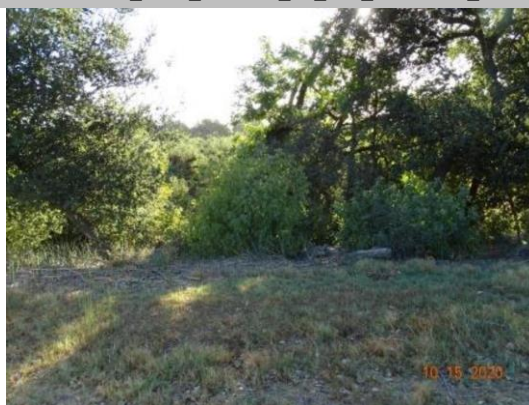
Photo 1 of 1 : FA_2021_RD0003_24_148_20210830_00059.jpg

View of trees partially blocking view down the landside slope (Fall 2020).

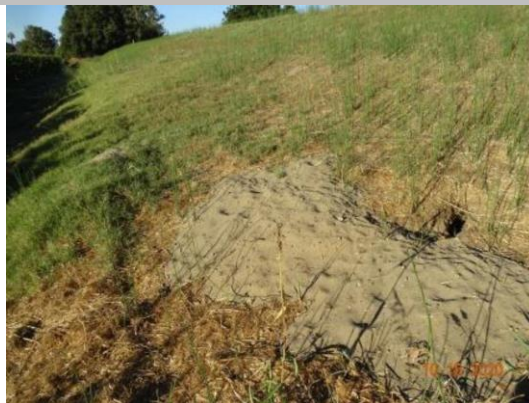
Photo 1 of 1 : FA_2021_RD0003_24_149_20210830_00060.jpg

View of a fresh rodent hole in the landside slope (Fall 2020).

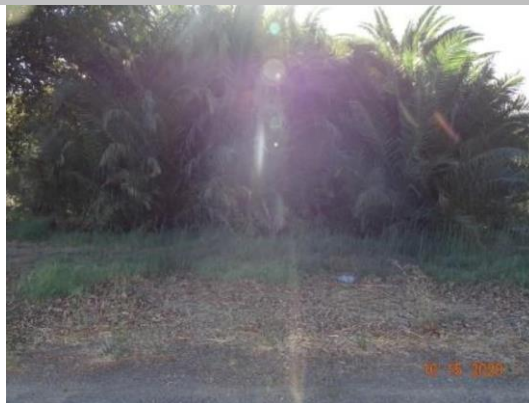
Photo 1 of 1 : FA_2021_RD0003_24_151_20210830_00062.jpg

View of thick palm trees on the landside slope (Fall 2020).

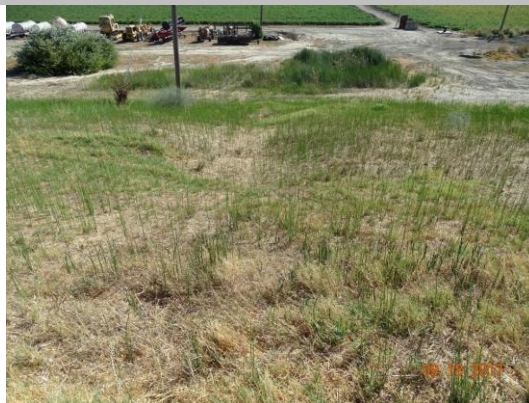
Photo 1 of 1 : FA_2021_RD0003_24_83_20210830_00040.jpg

LM Start	4.87	Rating **	M	Issue No.	83
LM End	4.87	Issue Type +	Ma	Location *	LS
Category	Earthen Levee			GPS Latitude/Longitude	
				Start	End
Item	Slope Stability			38.245903 °	38.245903 °
				-121.600851 °	-121.600851 °
DWR ID	DWR_RD0003_01_f_2017_83				
Comment Code					
S1 : Repair slope instability.					
Inspector Comment					
The landside slope has a depression.

Looking east on landside slope.

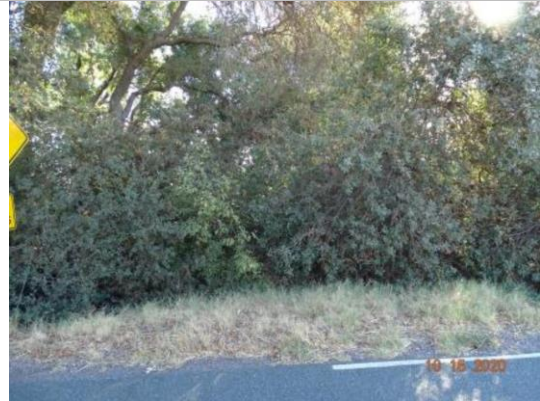
Photo 1 of 1 : FA_2021_RD0003_24_152_20210830_00063.jpg

View of thick trees blocking view down the landside slope (Fall 2020).

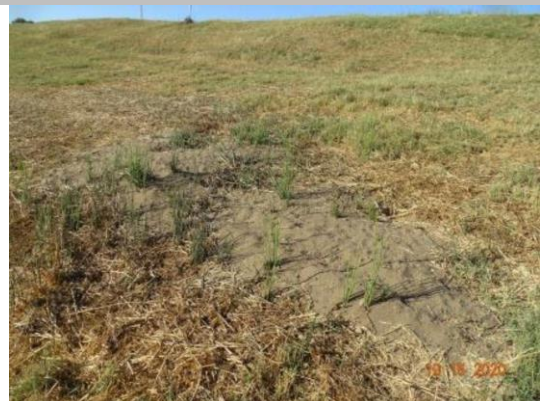
Photo 1 of 1 : FA_2021_RD0003_24_153_20210830_00064.jpg

View looking up slope at a couple fresh rodent holes in the landside slope (Fall 2020).

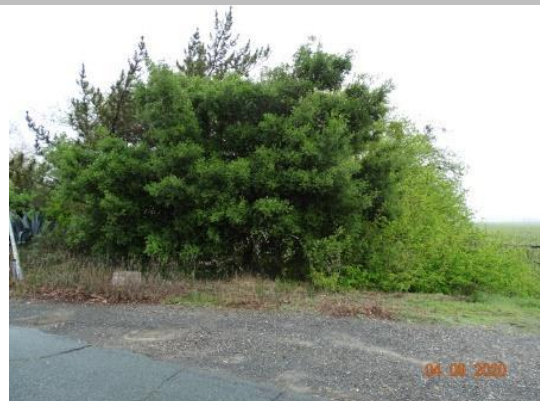
Photo 1 of 1 : FA_2021_RD0003_24_76_20210830_00036.jpg

View of thick tree on the landside slope (Spring 2020).

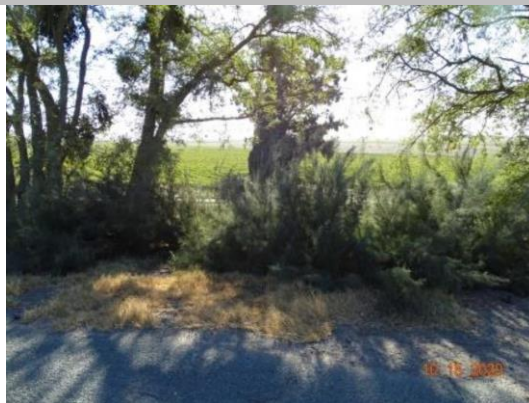
Photo 1 of 1 : FA_2021_RD0003_24_74_20210830_00034.jpg

View of vegetation on the landside shoulder and slope (Fall 2020).

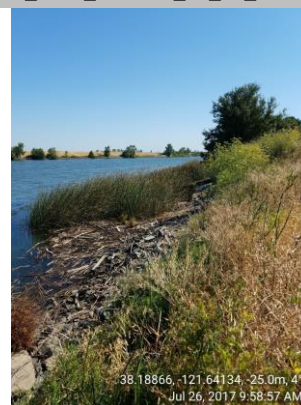
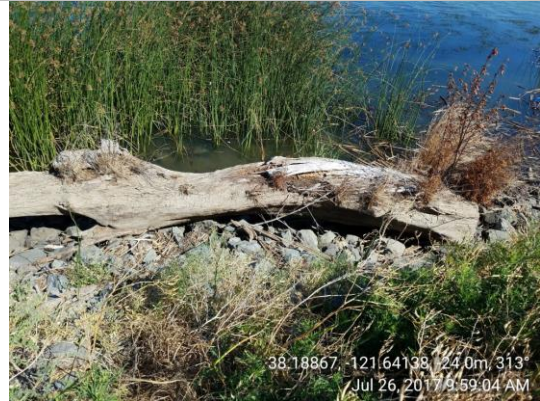
LM Start	10.15	Rating **	U	Issue No.	72
LM End	10.21	Issue Type +	Ma	Location *	WS
Category	Earthen Levee			GPS Latitude/Longitude	
				Start	End
Item	Erosion / Bank Caving			38.188431 °	38.187803 °
				-121.641703 °	-121.642478 °
DWR ID	LMA-103				
Comment Code					
E2 : Schedule repair of erosion site prior to the next inspection.					
Inspector Comment					
This was the 2017 Storm Damage site. The waterside slope experienced sloughing and erosion along approximately 312 linear feet. Sloughing commences at approximately 1/4 of the way down the slope from the crown and extends to the rip rap. Site ID No:277 Site Designation:LMA-103 4/9/2020 Field Notes: Relatively significant erosion into waterside slope.

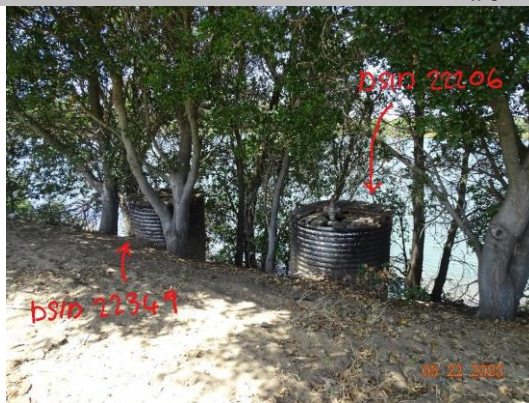
Photo 3 of 3 : UCIP_FA_2021_69662_85968.jpg

Comment Code						
Inspector Comment						
DS_ID:22206 FS_ID:69662 EP_NO: N/A Repair Type: Non-Urgent EVAL Issue: Unauthorized Encroachment, installed decades prior Crossing Status: Found UCIP Comments: 05/22/2020 Record remains Non-Urgent due to missing permit and crossing being abandoned. (S. Donovan - DWR UCIP)02/11/2014 Pipe appears abandoned and should be verified as having been done so properly. (G. Wylie - DWR UCIP) FIELD_STRUCT_DESC: *ABANDONED* 36-inch corrugated metal drainage pipe through the levee, 15.0 feet below the crown. Slide gate in a 48-inch corrugated metal pipe (CMP) riser on the waterside (WS) shoulder. Flap gate at the WS toe has been sealed shut with sealant. [Additional Reference(s): DWR Levee Log, 1993, (HLM 10.90), referenced as 24.0 feet below the crown. USACE Sacramento O&M Manual 104, February 1960, (RM 15.20), referenced as invert elevation 24.0 feet below the crown]. FS Date: 5/22/2020 8:07:00 AM

WS view: Standpipe on the levee shoulder.

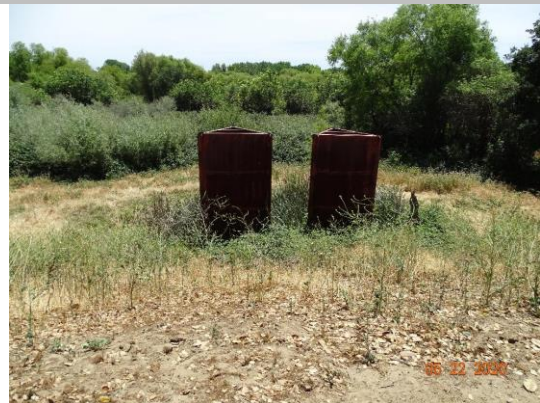
Photo 2 of 3 : UCIP_FA_2021_69663_85973.jpg

DS_ID:22349
FS_ID:69663
EP_NO: N/A
Repair Type: Non-Urgent
EVAL Issue: Unauthorized Encroachment, installed decades prior
Crossing Status: Found
UCIP Comments: 05/22/2020 Record remains Non-Urgent due to missing permit and crossing being abandoned. (S. Donovan - DWR UCIP)02/11/2014 Pipe appears abandoned and should be verified as having been filled with grout. (G. Wylie - DWR UCIP)
FIELD_STRUCT_DESC: *ABANDONED* 36-inch corrugated metal drainage pipe through the levee, 15.0 feet below the crown. Slide gate in a 48-inch corrugated metal pipe (CMP) riser on the waterside (WS) shoulder. Steel intake weir at the landside (LS) toe. Steel plate welded over the pipe on the WS toe. [Additional Reference(s): DWR Levee Log, 1993, (HLM 10.90), referenced as 24.0 feet below the crown. USACE Sacramento O&M Manual 104, February 1960, (RM 15.20), referenced as invert elevation 24.0 feet below the crown].
FS Date: 5/22/2020 8:28:00 AM

LS view: Steel weir on the levee toe.

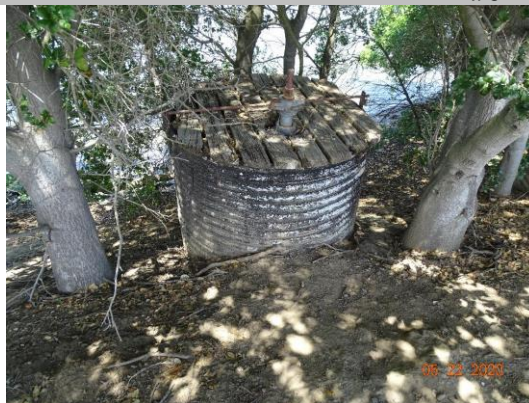
Photo 3 of 3 : UCIP_FA_2021_69663_85974.jpg

WS view: Standpipe on the levee shoulder.

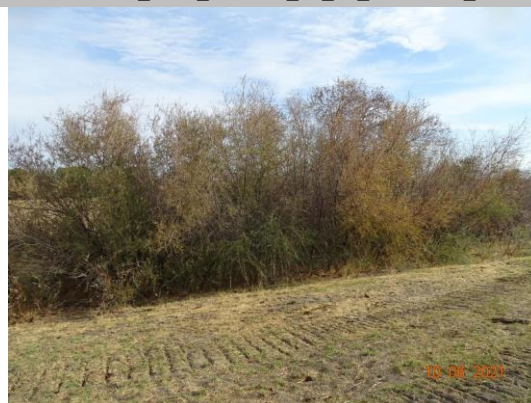
Photo 1 of 1 : FA_2021_RD0003_25_68_20211006_00279.jpg

View of willows on the landside slope (Fall 2021).

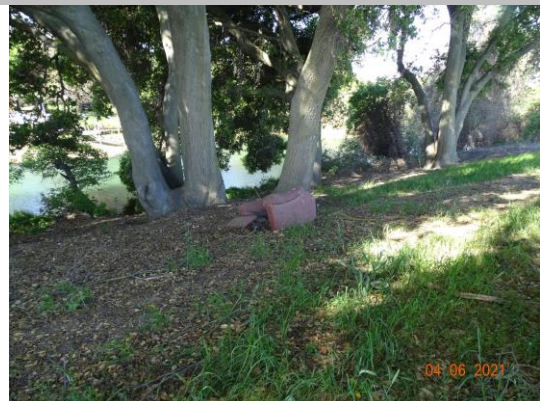
Photo 1 of 1 : FA_2021_RD0003_25_222_20210830_00119.jpg

View of discarded chair on the waterside slope (Spring 2021).

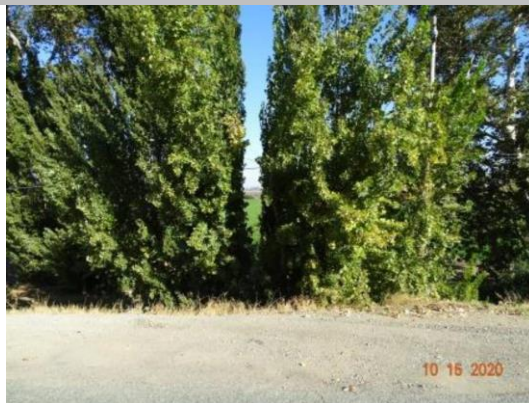
Photo 1 of 1 : FA_2021_RD0003_25_163_20210830_00090.jpg

View of trees partially blocking the view down the landside slope (Fall 2020).

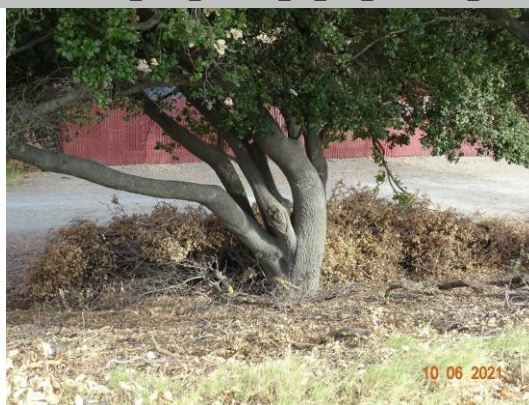
Photo 1 of 1 : FA_2021_RD0003_25_224_20211006_00281.jpg

View of tree prunings on the landside toe (Fall 2021).

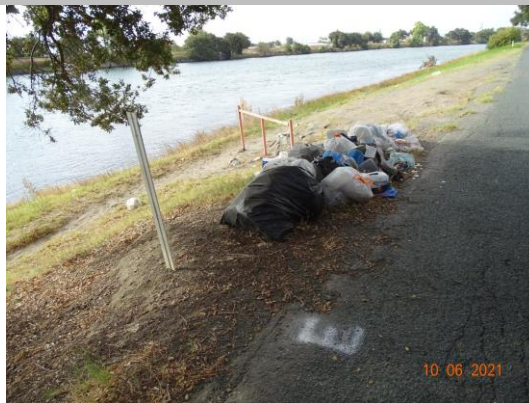
Photo 1 of 1 : FA_2021_RD0003_25_227_20211006_00282.jpg

View looking downstream at garbage on the waterside hinge (Fall 2021).

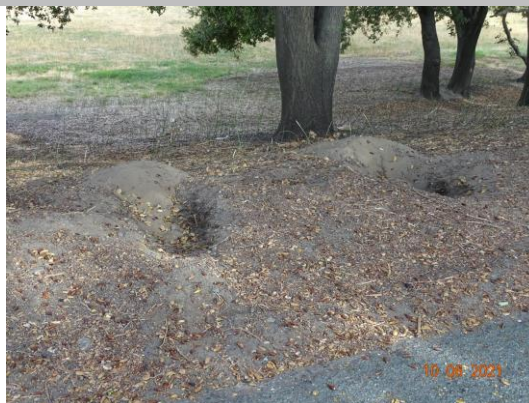
Photo 1 of 1 : FA_2021_RD0003_25_228_20211006_00283.jpg

View of vehicle divots in the landside hinge (Fall 2021).

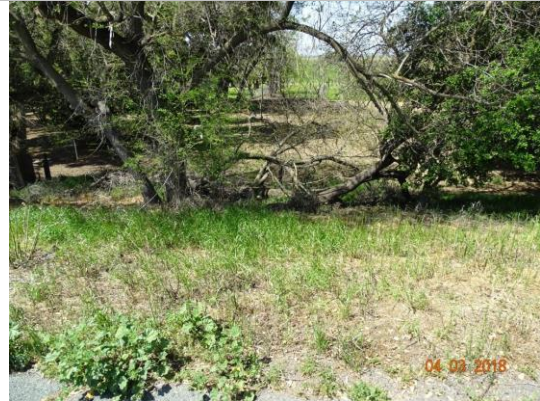
Photo 1 of 1 : FA_2021_RD0003_25_180_20210830_00102.jpg

Fallen tree at landside toe should be removed.

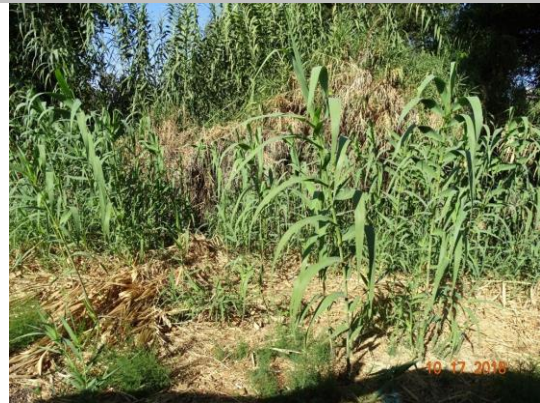
Photo 1 of 1 : FA_2021_RD0003_25_200_20210830_00111.jpg

View of arundo growth on the landside slope (October 2018).

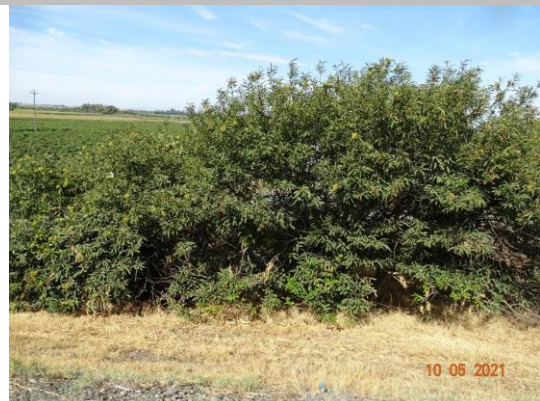
Photo 1 of 1 : FA_2021_RD0003_25_217_20211014_00307.jpg

View of thick tree on the landside slope (Fall 2021).

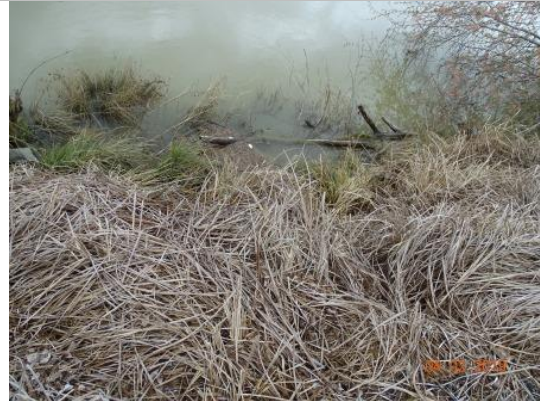
Photo 1 of 1 : FA_2021_RD0003_25_194_20210830_00109.jpg

View looking downslope at erosion on the waterside slope (Spring 2019).

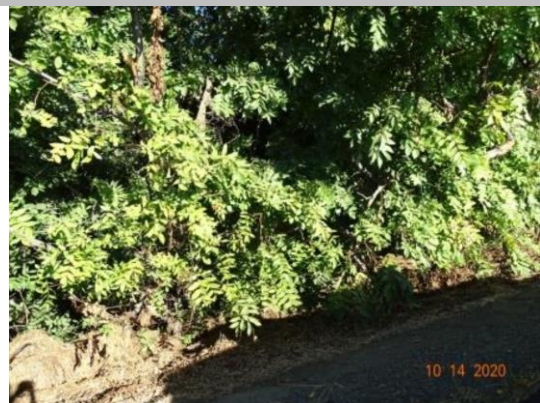
Photo 1 of 1 : FA_2021_RD0003_25_14_20210830_00008.jpg

View of untrimmed trees on the landside slope (Fall 2020).

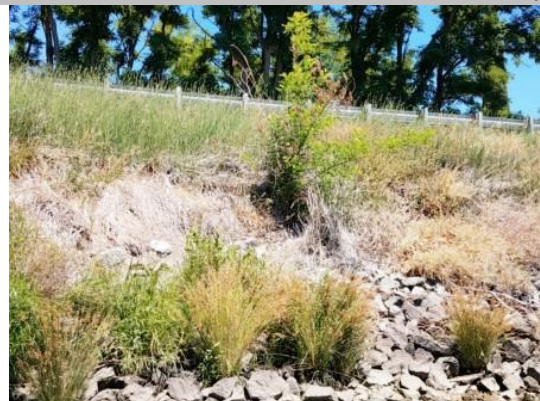
Photo 1 of 1 : FA_2021_RD0003_25_1_20210830_00001.jpg

View from the channel of slightly bowing into the waterside slope (Summer 2020).

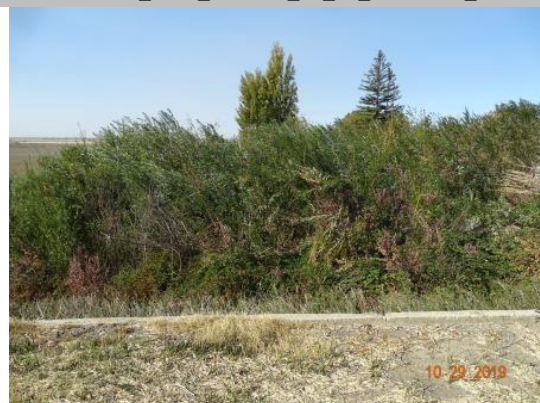
Photo 1 of 1 : FA_2021_RD0003_25_16_20210830_00010.jpg

View of thick vegetation at the landside toe (Fall 2019).

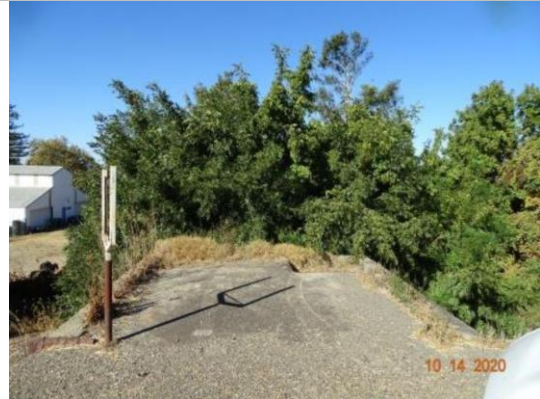
Photo 1 of 1 : FA_2021_RD0003_25_152_20210830_00081.jpg

View of thick trees on the landside slope (Fall 2020).

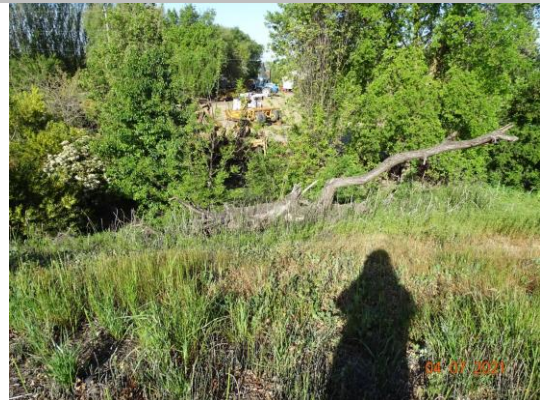
Photo 1 of 1 : FA_2021_RD0003_25_173_20210830_00097.jpg

View of down tree limb on the landside slope (Spring 2021).

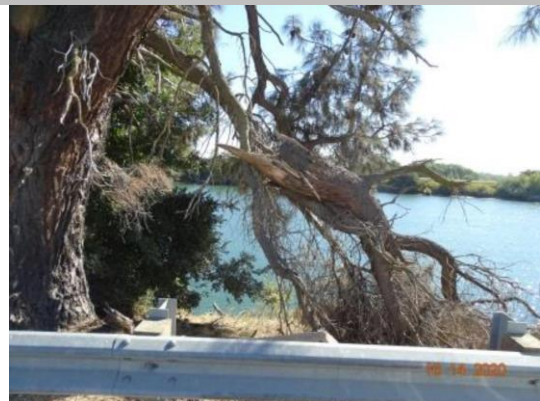
Photo 1 of 1 : FA_2021_RD0003_25_15_20210830_00009.jpg

View of fallen tree limb on the waterside slope (Fall 2020).

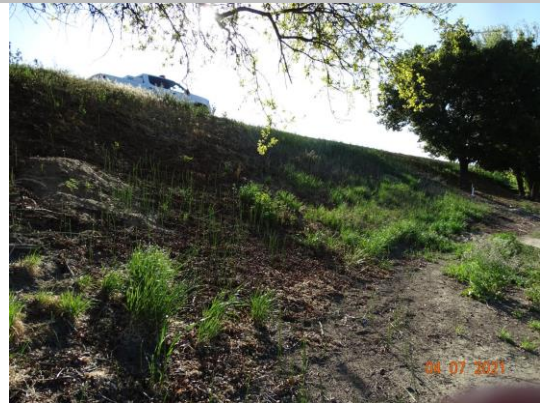
Photo 1 of 1 : FA_2021_RD0003_25_167_20210830_00093.jpg

View of multiple rodent holes in the landside slope (Spring 2021).

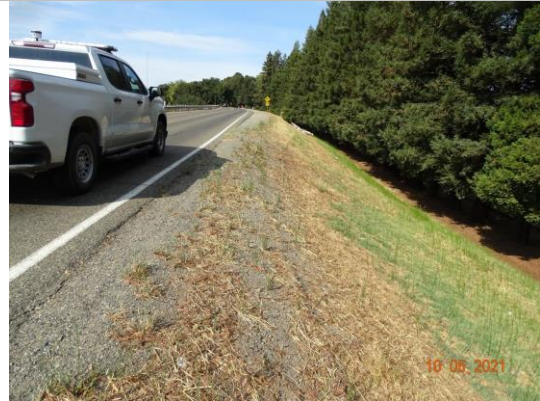
Photo 1 of 1 : FA_2021_RD0003_25_206_20211014_00304.jpg

View of depression in the landside slope getting close to the roadway (Fall 2021).

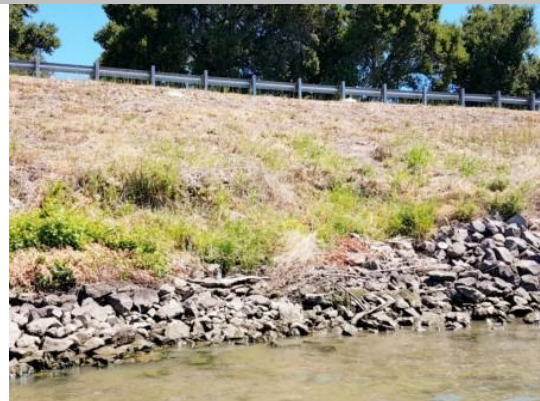
Photo 1 of 1 : FA_2021_RD0003_25_138_20210830_00071.jpg

View from the channel at erosion on the waterside (Summer 2020).

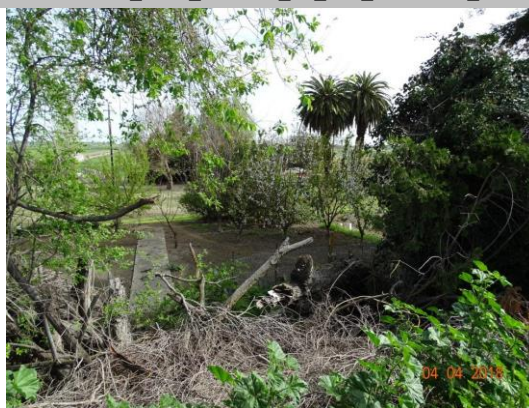
Photo 1 of 1 : FA_2021_RD0003_25_170_20210830_00095.jpg

Fallen tree on landside slope.

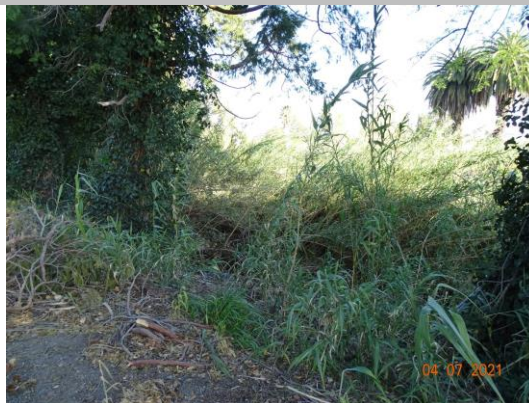
Photo 1 of 1 : FA_2021_RD0003_25_145_20210830_00075.jpg

View of thick arundo on the landside slope (Spring 2021).

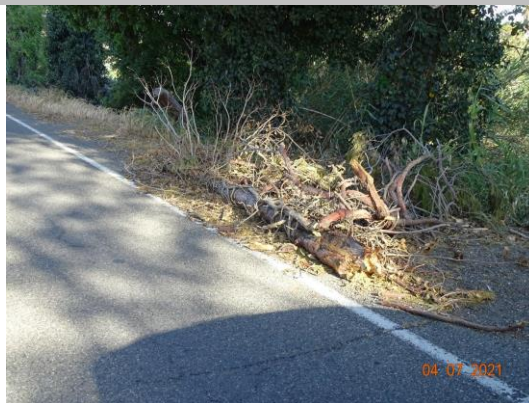
Photo 1 of 1 : FA_2021_RD0003_25_148_20210830_00078.jpg

View of down tree limb on the landside hinge (Spring 2021).

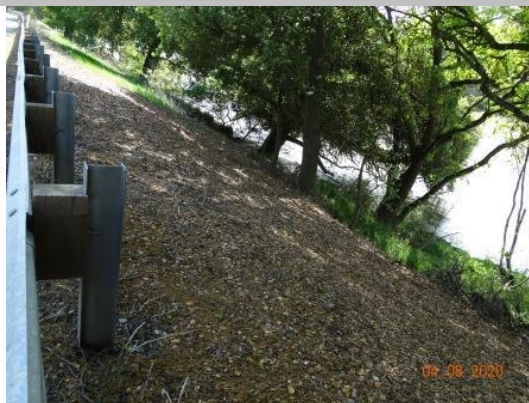
Photo 1 of 1 : FA_2021_RD0003_25_168_20210830_00094.jpg

View of erosion into the waterside slope (Spring 2020).

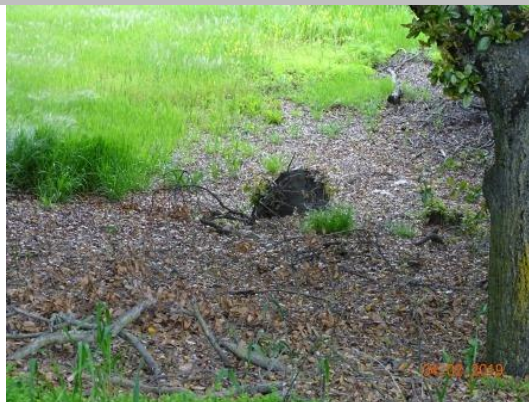
Photo 1 of 1 : FA_2021_RD0003_25_135_20210830_00068.jpg

View looking downslope at tree trunk at the bottom of the landside slope (Spring 2019).

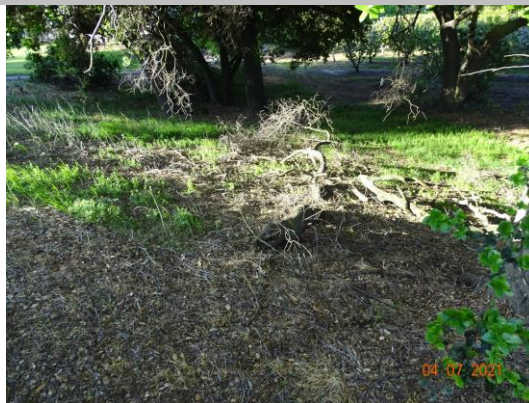
Photo 1 of 1 : FA_2021_RD0003_25_124_20210830_00061.jpg

View of down tree limbs on the landside slope (Spring 2021).

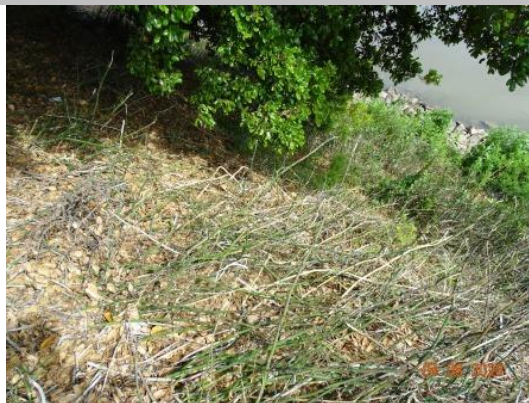
Photo 1 of 1 : FA_2021_RD0003_25_142_20210830_00074.jpg

View erosion into the waterside slope (Spring 2020).

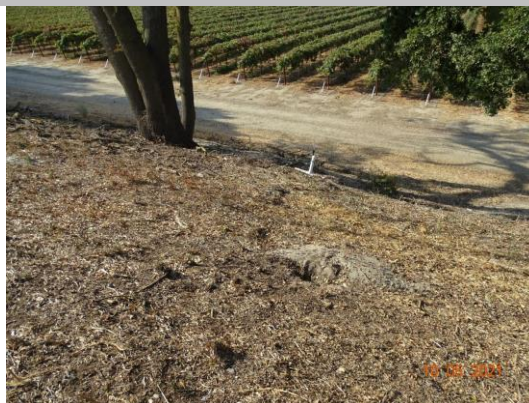
Photo 1 of 1 : FA_2021_RD0003_25_177_20211014_00295.jpg

View looking downslope at fresh rodent holes and rodent bait station in the landside slope (Fall 2021).

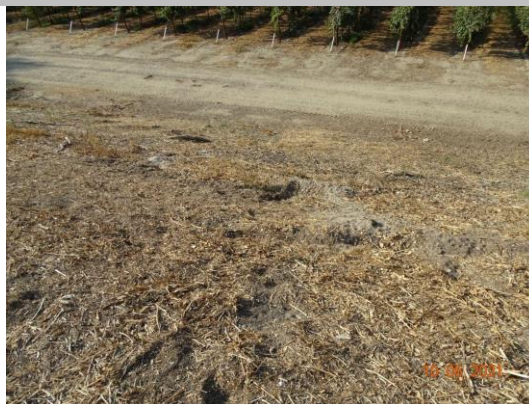
Photo 1 of 1 : FA_2021_RD0003_25_151_20211014_00294.jpg

View looking downslope at fresh rodent holes in the landside slope (Fall 2021).

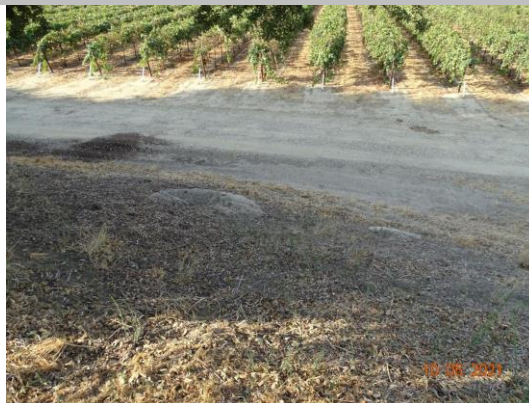
Photo 1 of 1 : FA_2021_RD0003_25_144_20211014_00293.jpg

View of looking downslope at fresh rodent holes in the landside slope (Fall 2021).

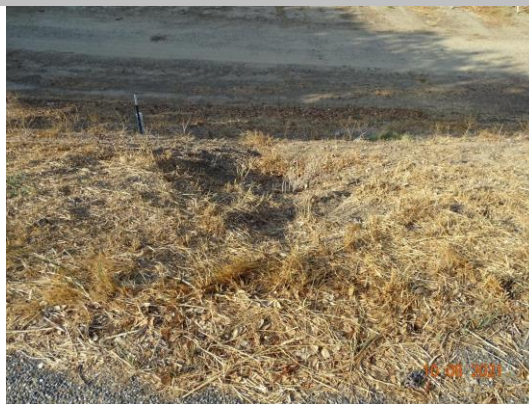
Photo 1 of 1 : FA_2021_RD0003_25_143_20211014_00292.jpg

View looking downslope at depression in the landside slope (Fall 2021).

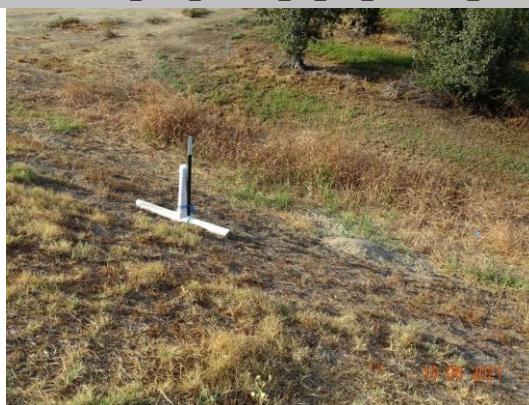
Photo 1 of 1 : FA_2021_RD0003_25_104_20211014_00290.jpg

View looking downstream at fresh rodent hole and bait station on the landside slope (Fall 2021).

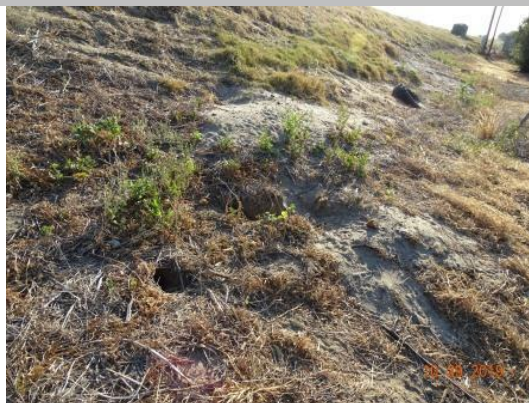
Photo 1 of 1 : FA_2021_RD0003_25_119_20210830_00057.jpg

View looking downstream at fresh rodent holes in landside slope (Fall 2019).

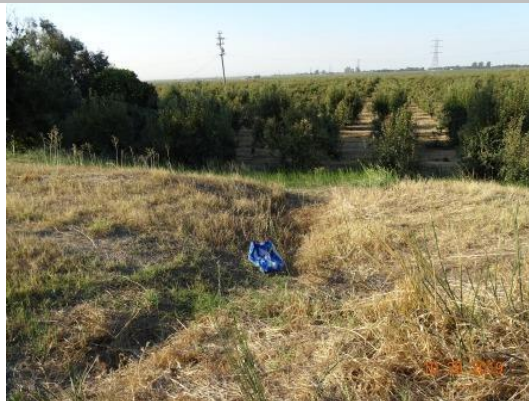
Photo 1 of 1 : FA_2021_RD0003_25_115_20210830_00054.jpg

View of depression in the landside slope. Might be due to drainage (Fall 2019).

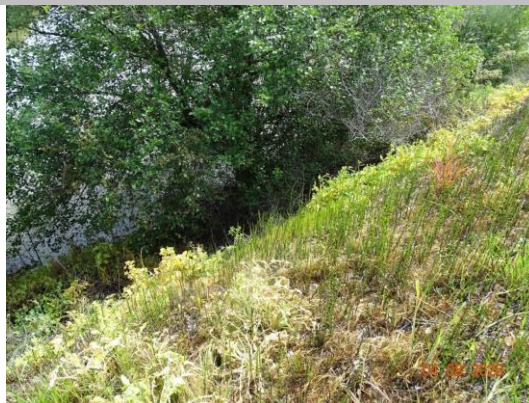
Photo 1 of 1 : FA_2021_RD0003_25_150_20210830_00080.jpg

View of erosion into the waterside slope (Spring 2020).

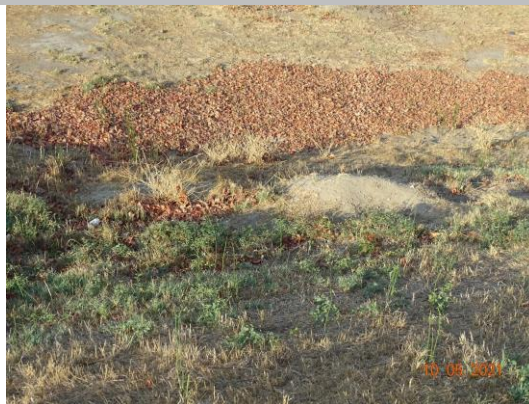
Photo 1 of 1 : FA_2021_RD0003_25_112_20211014_00288.jpg

View looking downslope at fresh rodent holes on the landside slope (Fall 2021).

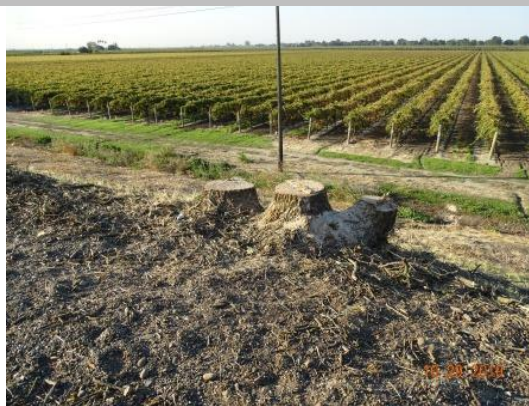
Photo 1 of 1 : FA_2021_RD0003_25_111_20210830_00050.jpg

View of recently cut tree stumps on the landside shoulder (Fall 2019).

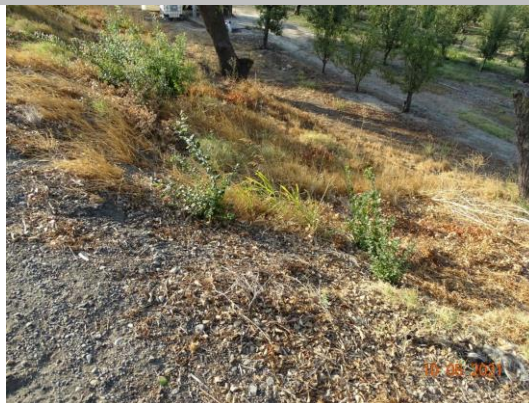
Photo 1 of 1 : FA_2021_RD0003_25_114_20211014_00285.jpg

View looking downstream at depression on the landside slope (Fall 2021).

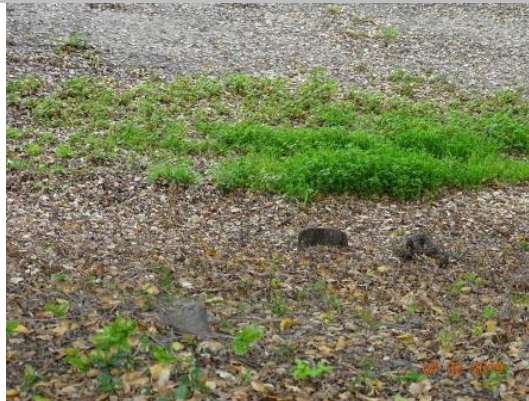
Photo 1 of 1 : FA_2021_RD0003_25_113_20210830_00052.jpg

View looking downslope at tree stumps on the landside (Spring 2019).

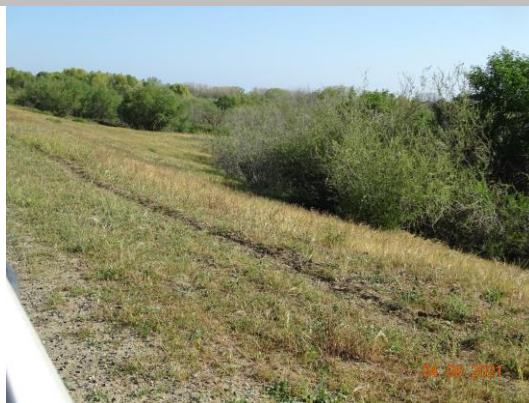
Photo 1 of 1 : FA_2021_RD0003_610_5_20210830_00001.jpg

View of willows on the landside slope (Spring 2021).
