**Flood Control Project Maintenance
Levee Inspections**

Maintenance Issue Types Only, Levee Inspection Report By Mile - Fall 2022

Reclamation District No. 0003 Grand Island

Waterway	Bank	Unit Miles	Inspection Start/End	Inspector
Unit No. 01 Left Bank Steamboat Slough	Left	10.95	09/06/2022 09/06/2022	Saskia Donovan

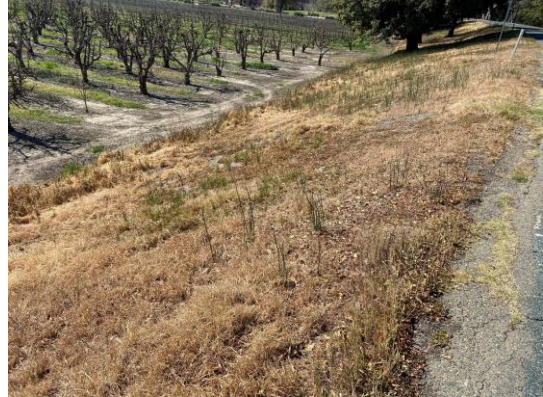
Photo 1 of 1 : FA_2022_RD0003_24_187_20220831_00071.jpg

LM Start	0.06	Rating **	A/W	Issue No.	187
LM End	0.06	Issue Type +	Ma	Location *	LS
Category	Earthen Levee			GPS Latitude/Longitude	
				Start	End
Item	Slope Stability			38.303884 °	38.303884 °
				-121.575334 °	-121.575334 °
DWR ID	DWR_RD0003_01_s_2022_187				
Comment Code					
S1 : Repair slope instability.					
Inspector Comment

View looking downstream of shallow depression on the landside slope (Spring 2022)

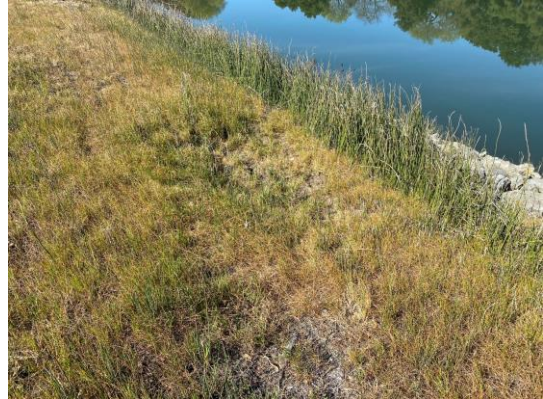
Photo 1 of 1 : FA_2022_RD0003_24_189_20220831_00072.jpg

LM Start	0.06	Rating **	M	Issue No.	189
LM End	0.06	Issue Type +	Ma	Location *	WS
Category	Earthen Levee			GPS Latitude/Longitude	
				Start	End
Item	Slope Stability			38.303884 °	38.303884 °
				-121.575334 °	-121.575334 °
DWR ID	DWR_RD0003_01_s_2022_189				
Comment Code					
S1 : Repair slope instability.					
Inspector Comment

View of small depression at waterside hinge (Spring 2022).

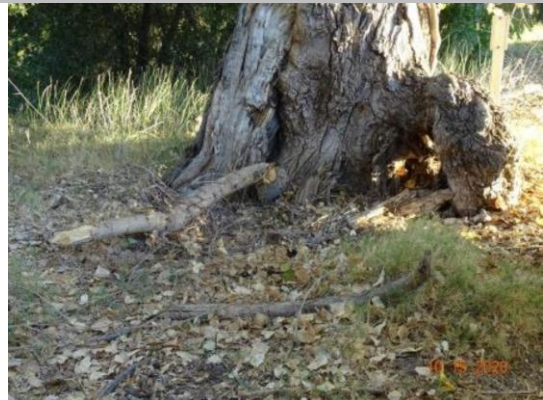
Photo 1 of 1 : FA_2022_RD0003_24_2_20220831_00001.jpg

LM Start	0.13	Rating **	M	Issue No.	2
LM End	0.13	Issue Type +	Ma	Location *	WS
Category	Earthen Levee			GPS Latitude/Longitude	
				Start	End
Item	Erosion / Bank Caving			38.303303 °	38.303303 °
				-121.576538 °	-121.576538 °
DWR ID	DWR_RD0003_01_f_2013_2				
Comment Code					
E2 : Schedule repair of erosion site prior to the next inspection.					
Inspector Comment					
A hole (8ft x 2.5ft x 5ft) is next to a large tree on waterward shoulder.

View of hole on the waterside shoulder due to fallen tree (Fall 2020).

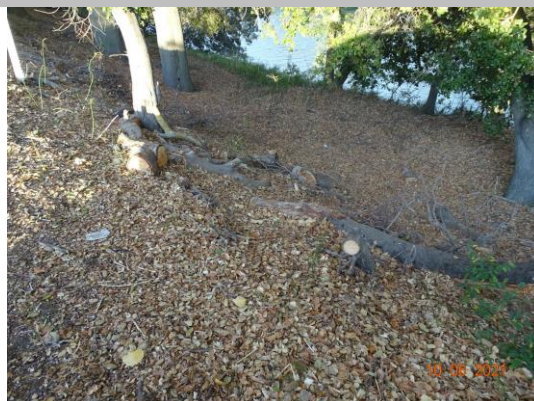
Photo 1 of 1 : FA_2022_RD0003_24_64_20220831_00029.jpg

View of tree branches on the waterside slope (Fall 2021).

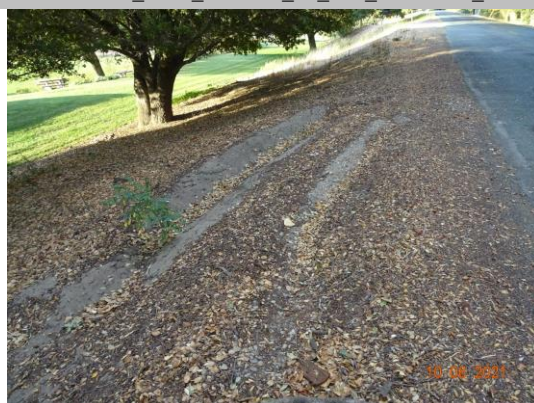
Photo 1 of 1 : FA_2022_RD0003_24_131_20220831_00053.jpg

LM Start	0.16	Rating **	M	Issue No.	131
LM End	0.16	Issue Type +	Ma	Location *	LS
Category	Earthen Levee			GPS Latitude/Longitude	
				Start	End
Item	Erosion / Vehicle Traffic			38.303111 °	38.303111 °
				-121.576842 °	-121.576842 °
DWR ID	DWR_RD0003_01_f_2021_131				
Comment Code					
E6 : Repair the levee slope damaged by vehicle traffic and prevent access where possible.					
Inspector Comment					
Vehicle tracks dug out hole on the landside hinge.

View looking downstream at vehicle tracks in the landside hinge (Fall 2021).

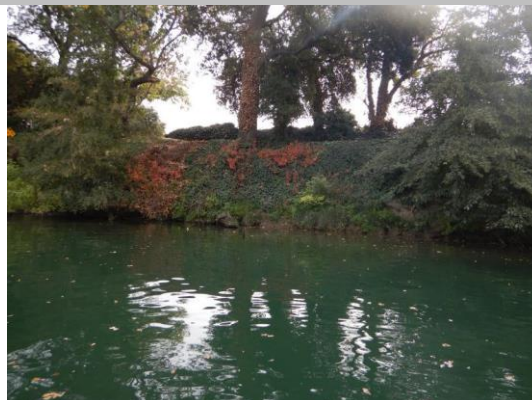
Photo 2 of 2 : FA_2022_RD0003_24_49_20220831_00017.jpg

2018 Site ID: STM 26.0 L
Status: Critical
2018 Field Notes: New erosion throughout site.
Site History: 1997 - Mass failure of berm slope and wave wash erosion. Large trees on top of berm, some failed trees. New area of low rock to on the upstream end. 2000 - Some minor erosion near the downstream end. 2005 - One new small tree has fallen. 2009 - Minimal new erosion. 2010 - Minor new erosion. 2013 - Observed new animal holes and vertical sections at middle of site. 2015 - Minor new erosion. 2017 - Upgraded to CRITICAL. Significant bank failure on upstream end.

USACE 2018 Erosion Photo #2

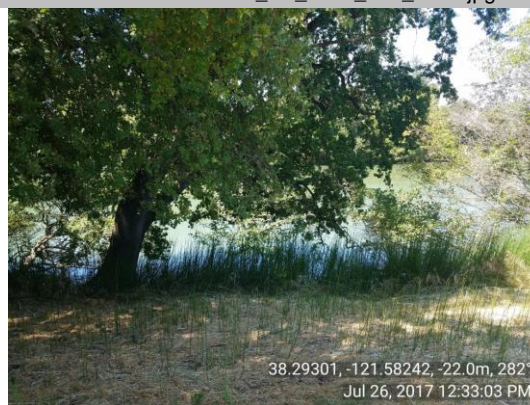
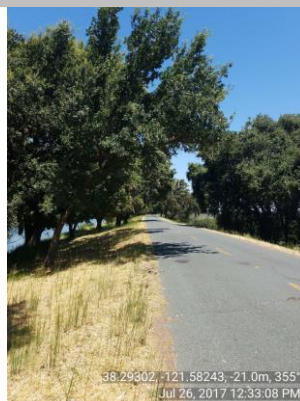
LM Start	0.91	Rating **	A/W	Issue No.	53
LM End	0.97	Issue Type +	Ma	Location *	WS
Category	Supplemental			GPS Latitude/Longitude	
				Start	End
Item	2017 Storm Damage			38.293381 °	38.292617 °
				-121.582450 °	-121.582675 °
DWR ID	LMA-101				
Comment Code					
Inspector Comment					
Fall 2022: Repair in progress. Levee Evaluation Comments Description:District station 48+20 to 51+06, Sec. 07, T. 5 N. R. 4 E., M.D.M. An erosion site exists along approximately 286 linear feet of the waterside slope of Steamboat Slough (Unit 1). The erosion begins approximately 1/2 of the way down the slope from the crown to the waterside toe. Erosion is undercutting existing trees. Site ID No:275 Site Designation:LMA-101 Repair Type: Erosion Rating:Serious Field Date:7/26/2017 Notes:

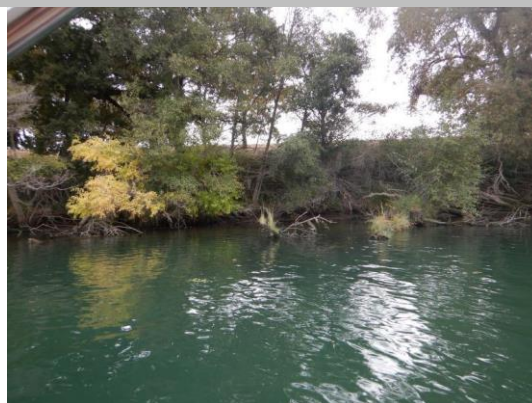
Photo 1 of 2 : FA_2022_RD0003_24_46_20220831_00013.jpg

2018 Site ID: STM 25.0 L
Status: Critical
2018 Field Notes: Minor new erosion at toe. Site extended downstream to include new erosion pocket.
Site History: 1997 - Erosion of sandy levee on top left bank. Site is downstream of a rock section. Large riparian trees on the bank. 1999 - Upstream half of the reach repaired with rock, except for a 30 ft reach at the upstream end. 2001 - Rock repair on the upstream and downstream ends; no revetment at the trees. 2002 - Rock repair is starting to slide off the geotextile at the upstream end. 2005 - One new small tree has fallen. 2006 - 50 ft pocket at the downstream end and at the upstream end with new rock in between. 2007 - Upstream end has been repaired. 2008 - Area closed sign on bank. Newly fallen trees at both ends and pop outs along the bank. 2010 - Site extended downstream. 2011 - New erosion at the toe. More trees popouts. 2013 - Short vertical sections observed at the downstream end. 2015 - Significant new erosion, large oak tree on verge of popping out. 2016 - Sites 24.8 and 25 were combined. 2017 - Site upgraded to CRITICAL. Site has eroded to near vertical at the upstream end.

USACE 2018 Erosion Photo #1

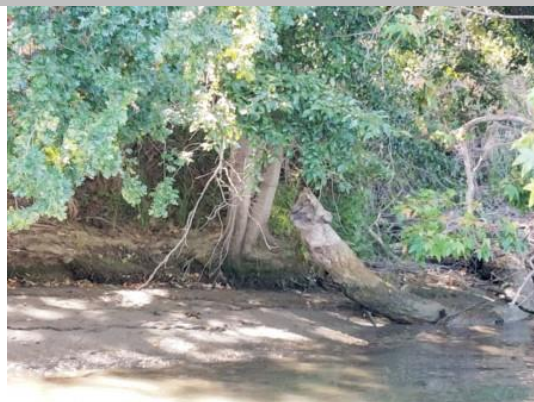
Photo 2 of 2 : FA_2022_RD0003_24_60_20220831_00028.jpg

This was a 2017 Storm Damage site.
An erosion site exists along approximately 41 linear feet of the water side slope.
Site ID No:276
Site Designation:LMA-102
6/18/2020 Boat Inspection:
Significant erosion into waterside prism directly upstream of tree that is leaning into water. That leaning tree is creating an eddy that is causing the erosion. There is also some less significant erosion into the waterside toe upstream of the significant erosion site.

View from the channel of erosion into waterside toe upstream deep erosion (Summer 2020).

E2 : Schedule repair of erosion site prior to the next inspection.

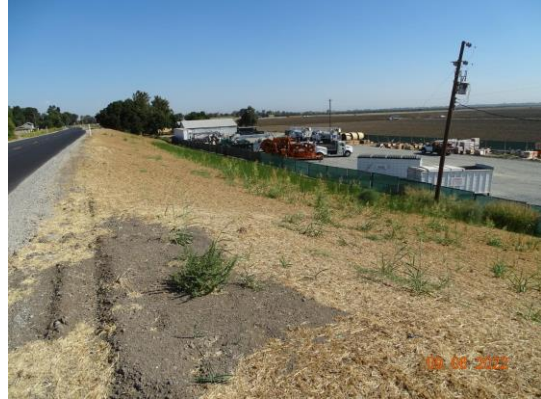
Photo 1 of 1 : FA_2022_RD0003_24_83_20220921_00304.jpg

LM Start	4.87	Rating **	M	Issue No.	83
LM End	4.87	Issue Type +	Ma	Location *	LS
Category	Earthen Levee			GPS Latitude/Longitude	
				Start	End
Item	Slope Stability			38.245903 °	38.245903 °
				-121.600851 °	-121.600851 °
DWR ID	DWR_RD0003_01_f_2017_83				
Comment Code					
S1 : Repair slope instability.					
Inspector Comment					
The landside slope has a depression.

View of the depression on the LS levee slope (Fall 2022).

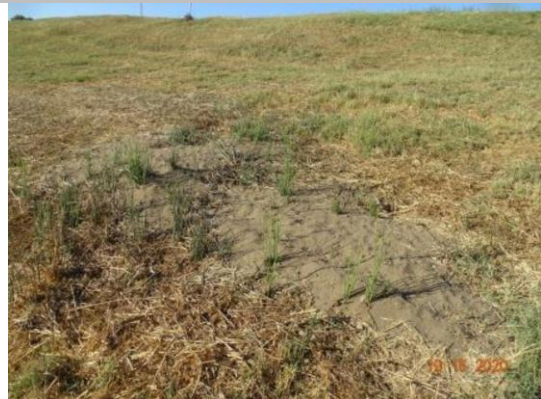
Photo 1 of 1 : FA_2022_RD0003_24_153_20220831_00064.jpg

LM Start	6.04	Rating **	M	Issue No.	153
LM End	6.04	Issue Type +	Ma	Location *	LS
Category	Earthen Levee			GPS Latitude/Longitude	
				Start	End
Item	Animal Control			38.229205 °	38.229205 °
				-121.601802 °	-121.601802 °
DWR ID	DWR_RD0003_01_f_2020_153				
Comment Code					
A1 : Exterminate rodents and backfill and compact or grout burrows.					
Inspector Comment					
A couple of rodent holes on the landside slope.

View looking up slope at a couple fresh rodent holes in the landside slope (Fall 2020).

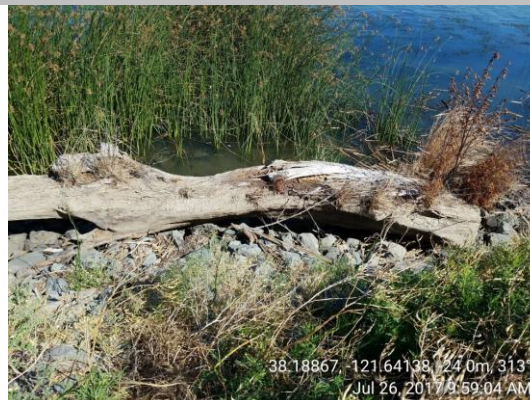
LM Start	10.15	Rating **	U	Issue No.	72
LM End	10.21	Issue Type +	Ma	Location *	WS
Category	Earthen Levee			GPS Latitude/Longitude	
				Start	End
Item	Erosion / Bank Caving			38.188431 °	38.187803 °
				-121.641703 °	-121.642478 °
DWR ID	LMA-103				
Comment Code					
E2 : Schedule repair of erosion site prior to the next inspection.					
Inspector Comment					
This was a 2017 Storm Damage site. The waterside slope experienced sloughing and erosion along approximately 312 linear feet. Sloughing commences at approximately 1/4 of the way down the slope from the crown and extends to the rip rap. Site ID No:277 Site Designation:LMA-103 4/9/2020 Field Notes: Relatively significant erosion into waterside slope.

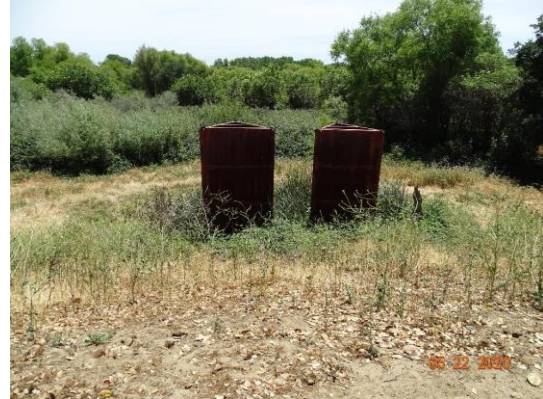
Photo 2 of 3 : UCIP_FA_2022_69662_85967.jpg

DS_ID:22206
 FS_ID:69662
 EP_NO: N/A
 Repair Type: Non-Urgent
 EVAL Issue:
 Crossing Status: Found
 UCIP Comments: 05/22/2020 Record remains Non-Urgent due to missing permit and crossing being abandoned. (S. Donovan - DWR UCIP)02/11/2014 Pipe appears abandoned and should be verified as having been done so properly. (G. Wylie - DWR UCIP)
 FIELD_STRUCT_DESC: *ABANDONED* 36-inch corrugated metal drainage pipe through the levee, 15.0 feet below the crown. Slide gate in a 48-inch corrugated metal pipe (CMP) riser on the waterside (WS) shoulder. Flap gate at the WS toe has been sealed shut with sealant.
 [Additional Reference(s): DWR Levee Log, 1993, (HLM 10.90), referenced as 24.0 feet below the crown. USACE Sacramento O&M Manual 104, February 1960, (RM 15.20), referenced as invert elevation 24.0 feet below the crown].
 FS Date: 5/22/2020 8:07:00 AM

LS view: Steel weir on the levee toe.

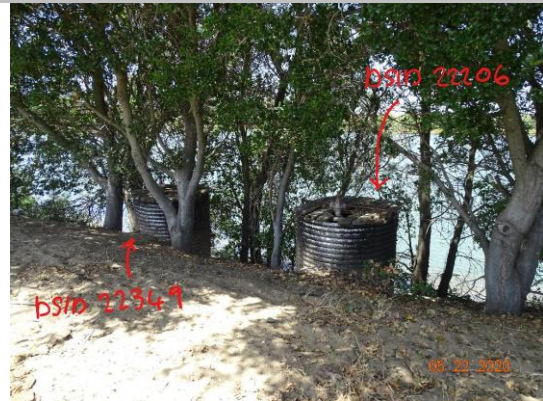
Photo 3 of 3 : UCIP_FA_2022_69662_85968.jpg

WS view: Standpipe on the levee shoulder.

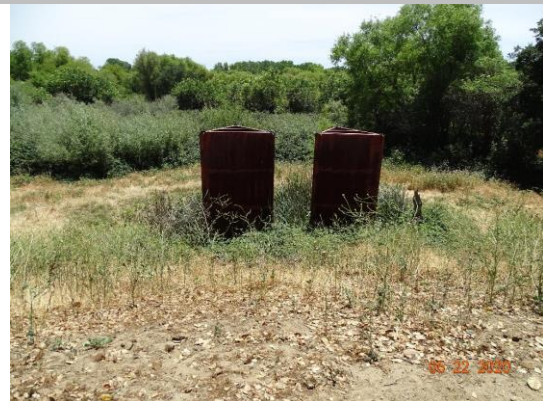
Photo 2 of 3 : UCIP_FA_2022_69663_85973.jpg

Comment Code					
Inspector Comment					
DS_ID:22349 FS_ID:69663 EP_NO: N/A Repair Type: Non-Urgent EVAL Issue: Crossing Status: Found UCIP Comments: 05/22/2020 Record remains Non-Urgent due to missing permit and crossing being abandoned. (S. Donovan - DWR UCIP)02/11/2014 Pipe appears abandoned and should be verified as having been filled with grout. (G. Wylie - DWR UCIP) FIELD_STRUCT_DESC: *ABANDONED* 36-inch corrugated metal drainage pipe through the levee, 15.0 feet below the crown. Slide gate in a 48-inch corrugated metal pipe (CMP) riser on the waterside (WS) shoulder. Steel intake weir at the landside (LS) toe. Steel plate welded over the pipe on the WS toe. [Additional Reference(s): DWR Levee Log, 1993, (HLM 10.90), referenced as 24.0 feet below the crown. USACE Sacramento O&M Manual 104, February 1960, (RM 15.20), referenced as invert elevation 24.0 feet below the crown]. FS Date: 5/22/2020 8:28:00 AM

LS view: Steel weir on the levee toe.

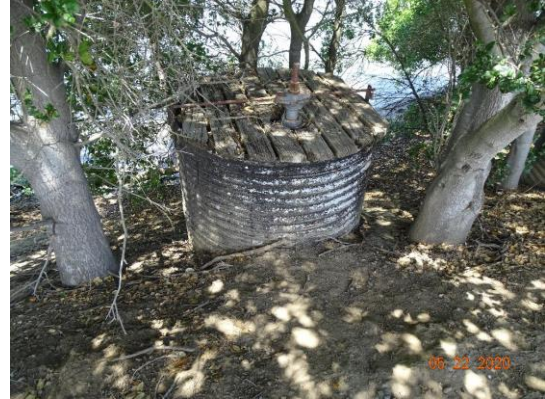
Photo 3 of 3 : UCIP_FA_2022_69663_85974.jpg

WS view: Standpipe on the levee shoulder.

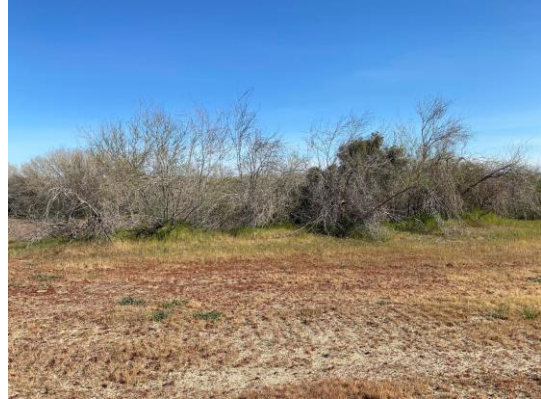
Photo 1 of 1 : FA_2022_RD0003_25_97_20220831_00040.jpg

View of willows on the landside shoulder (Spring 2022).

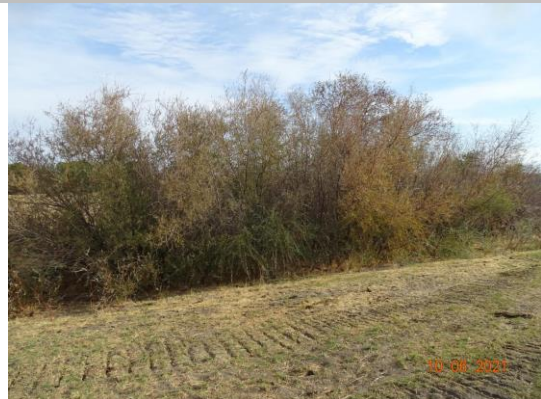
Photo 1 of 1 : FA_2022_RD0003_25_68_20220831_00025.jpg

View of willows on the landside slope (Fall 2021).

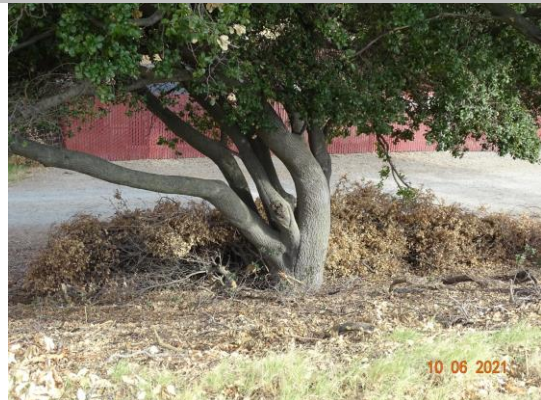
Photo 1 of 1 : FA_2022_RD0003_25_224_20220831_00138.jpg

View of tree prunings on the landside toe (Fall 2021).

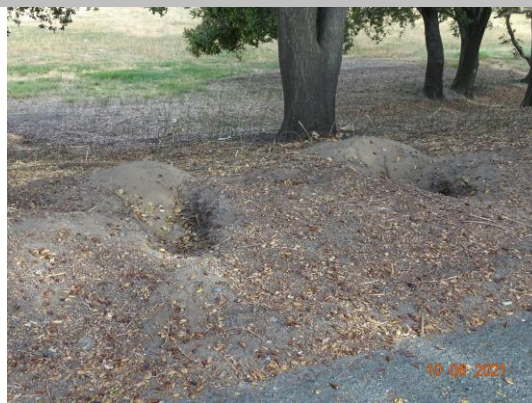
Photo 1 of 1 : FA_2022_RD0003_25_228_20220831_00140.jpg

LM Start	3.08	Rating **	M	Issue No.	228
LM End	3.08	Issue Type +	Ma	Location *	LS
Category	Earthen Levee			GPS Latitude/Longitude	
				Start	End
Item	Erosion / Vehicle Traffic			38.166805 °	38.166805 °
				-121.601264 °	-121.601264 °
DWR ID	DWR_RD0003_02_f_2021_228				
Comment Code					
E6 : Repair the levee slope damaged by vehicle traffic and prevent access where possible.					
Inspector Comment					
There are vehicle spin-out divots in the landside hinge.

View of vehicle divots in the landside hinge (Fall 2021).

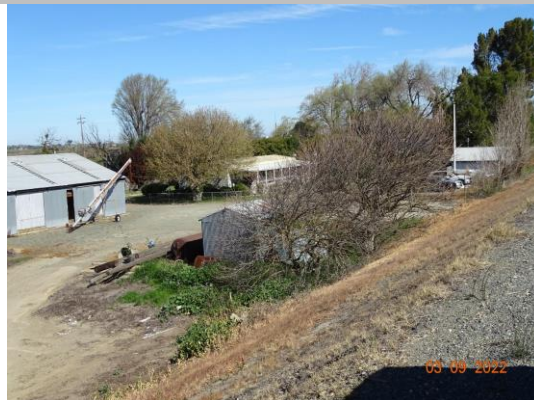
Photo 1 of 1 : FA_2022_RD0003_25_217_20220831_00133.jpg

View looking upstream at trees on the landside slope (Spring 2022).

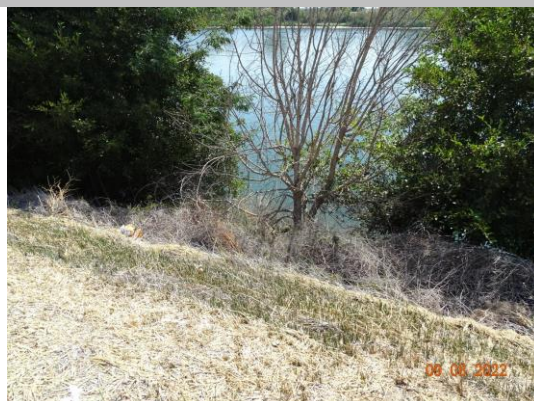
Photo 1 of 1 : FA_2022_RD0003_25_194_20220923_00191.jpg

LM Start	4.94	Rating **	M	Issue No.	194
LM End	4.94	Issue Type +	Ma	Location *	WS
Category	Earthen Levee			GPS Latitude/Longitude	
				Start	End
Item	Erosion / Bank Caving			38.188248 °	38.188248 °
				-121.581225 °	-121.581225 °
DWR ID	DWR_RD0003_02_s_2019_194				
Comment Code					
E2 : Schedule repair of erosion site prior to the next inspection.					
Inspector Comment					
There is a small amount of bank caving that should be repaired.

View of the erosion on the lower WS slope (Fall 2022).

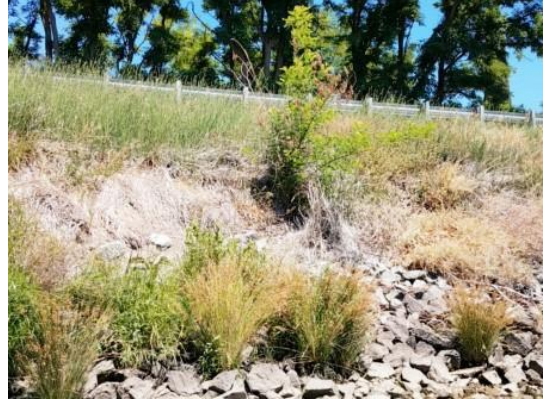
Photo 1 of 1 : FA_2022_RD0003_25_1_20220831_00001.jpg

LM Start	4.96	Rating **	A/W	Issue No.	1
LM End	4.96	Issue Type +	Ma	Location *	WS
Category	Earthen Levee			GPS Latitude/Longitude	
				Start	End
Item	Slope Stability			38.188420 °	38.188420 °
				-121.580910 °	-121.580910 °
DWR ID	DWR_RD0003_02_s_2020_1				
Comment Code					
S1 : Repair slope instability.					
Inspector Comment					
Waterside slope bowed in slightly, indicating possible slope instability.

View from the channel of slightly bowing into the waterside slope (Summer 2020).

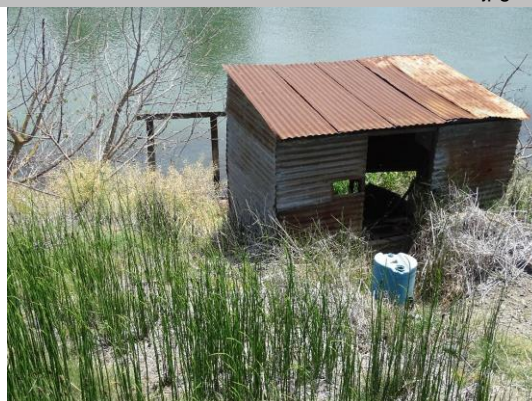
Photo 2 of 3 : UCIP_FA_2022_77006_113085.jpg

LM Start	6.07	Rating **	M	Issue No.	956	
LM End	6.07	Issue Type +	Ma	Location *		
Category	Supplemental			GPS Latitude/Longitude		
				Start		End
Item	DWR UCIP LMA Responsibility			38.195513 °	38.195513 °	
				-121.562812 °	-121.562812 °	
DWR ID	22239					
Comment Code						
Inspector Comment						
DS_ID:22239 FS_ID:77006 EP_NO: N/A Repair Type: Non-Urgent EVAL Issue: Crossing Status: Not Found UCIP Comments: 05/19/2022 Not found, unauthorized and abandoned encroachment found in LL and O&M, pipe replaced by DSID 22238, non-urgent. (A. McDonald - DWR UCIP) FIELD_STRUCT_DESC: *ABANDONED* 10-inch steel pipe of an unknown purpose through the levee, invert elevation 2.8 feet below the crown. Pipe is capped on the waterside (WS) end. [Additional Reference(s): DWR Levee Log, 1993. USACE Sacramento O&M Manual 104, February 1960, (RM 20.99)]. FS Date: 5/19/2022

WS overview, pump house and replacement pipe on slope

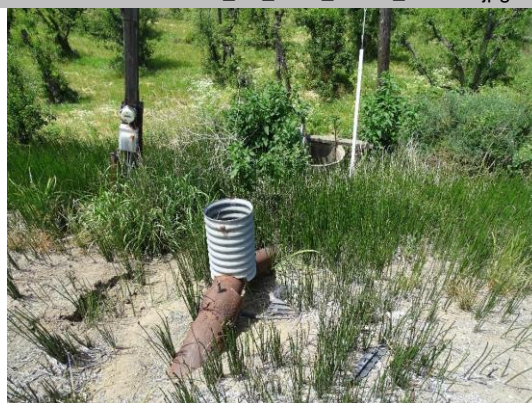
Photo 3 of 3 : UCIP_FA_2022_77006_113086.jpg

LS overview, replacement pipe and appurtenances on slope and toe

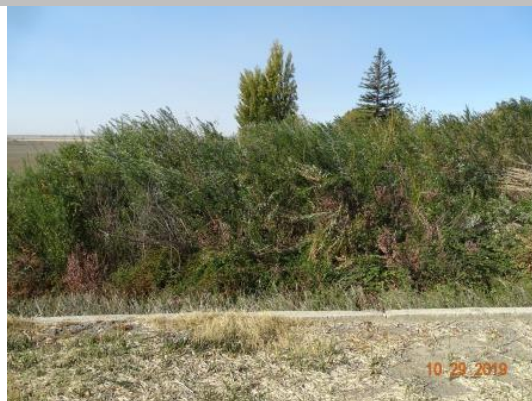
Photo 1 of 1 : FA_2022_RD0003_25_16_20220831_00008.jpg

View of thick vegetation at the landside toe (Fall 2019).

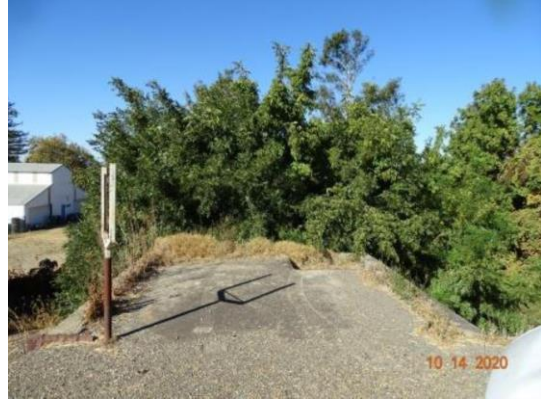
Photo 1 of 1 : FA_2022_RD0003_25_152_20220831_00086.jpg

View of thick trees on the landside slope (Fall 2020).

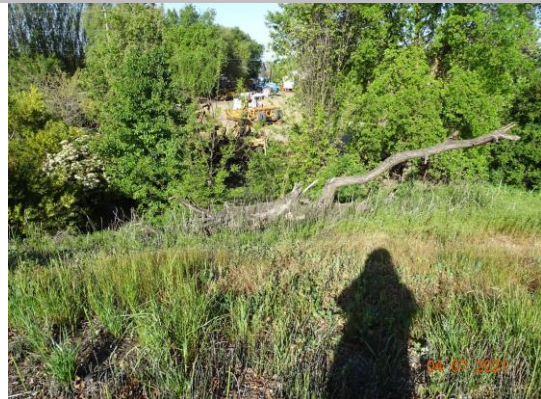
Photo 1 of 1 : FA_2022_RD0003_25_173_20220831_00103.jpg

View of down tree limb on the landside slope (Spring 2021).

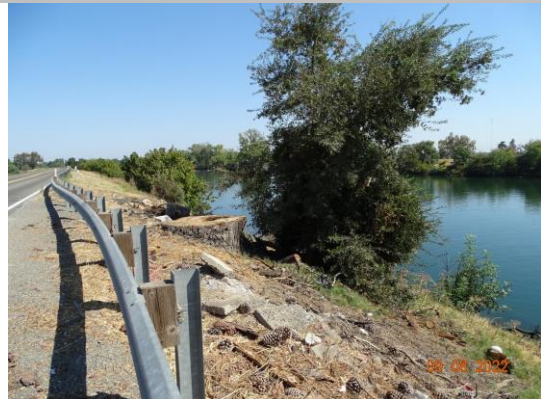
Photo 1 of 1 : FA_2022_RD0003_25_15_20220923_00187.jpg

View of the tree stump below the WS shoulder (Fall 2022).

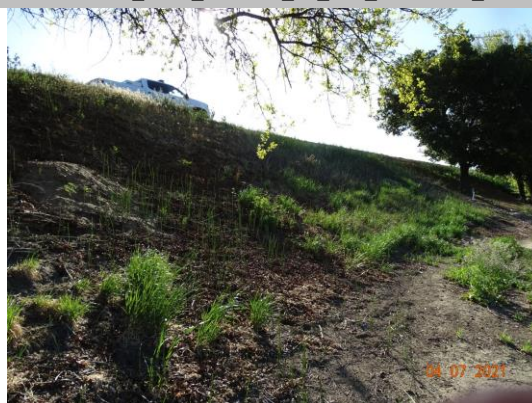
Photo 1 of 1 : FA_2022_RD0003_25_167_20220831_00098.jpg

View of multiple rodent holes in the landside slope (Spring 2021).

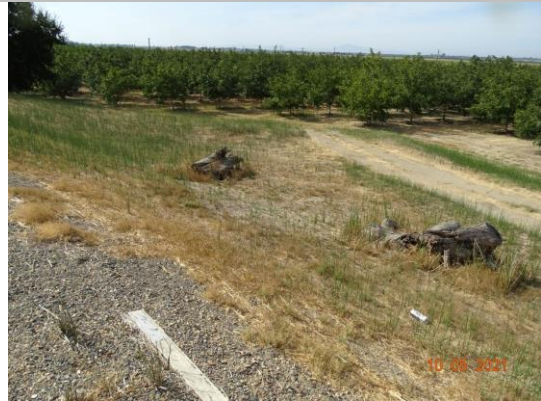
Photo 1 of 1 : FA_2022_RD0003_25_211_20220831_00130.jpg

View looking slightly downstream at tree logs on the landside slope (Fall 2021).

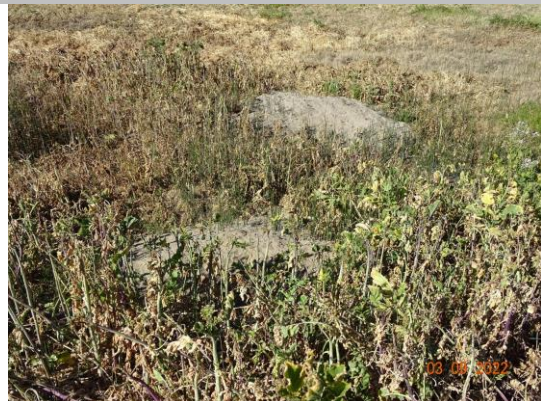
Photo 1 of 1 : FA_2022_RD0003_25_161_20220831_00093.jpg

View of a couple fresh rodent holes on the landside slope (Spring 2022).

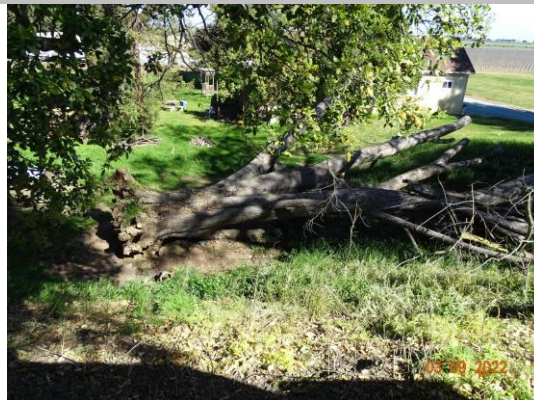
Photo 1 of 1 : FA_2022_RD0003_25_132_20220831_00068.jpg

View of large downed tree on the landside toe (Spring 2022).

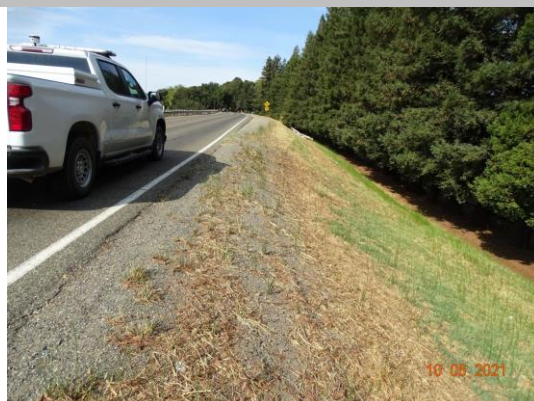
Photo 1 of 1 : FA_2022_RD0003_25_206_20220831_00127.jpg

View of depression in the landside slope getting close to the roadway (Fall 2021).

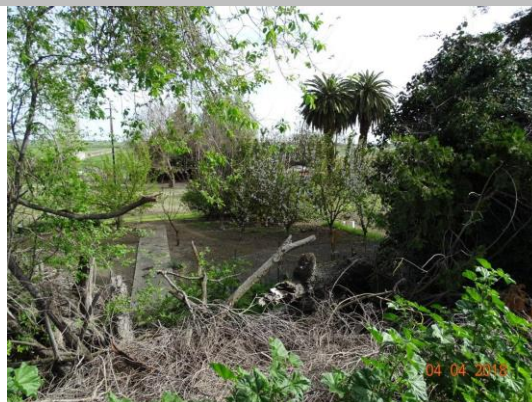
Photo 1 of 1 : FA_2022_RD0003_25_170_20220831_00101.jpg

Fallen tree on landside slope.

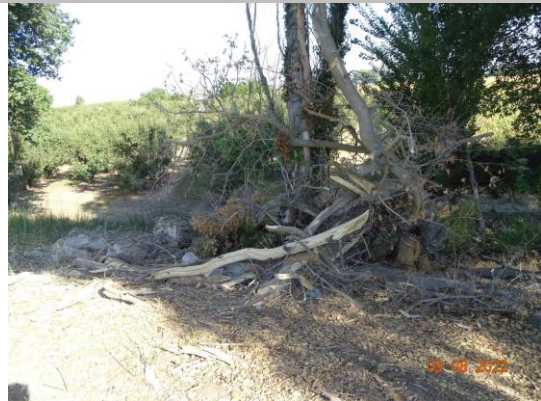
Photo 1 of 1 : FA_2022_RD0003_25_162_20220923_00180.jpg

View of the tree limbs at the LS toe (Fall 2022).

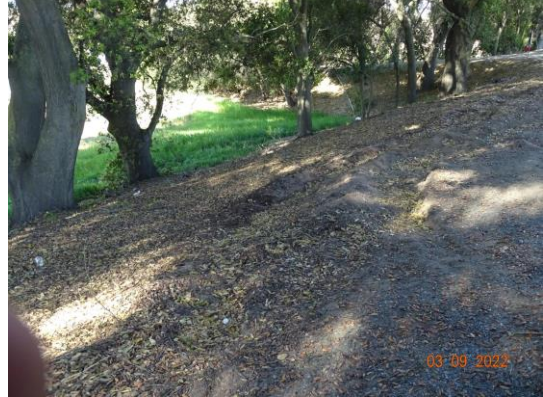
Photo 1 of 1 : FA_2022_RD0003_25_131_20220831_00067.jpg

View of surface erosion due to vehicle tire on the landside shoulder (Spring 2022).

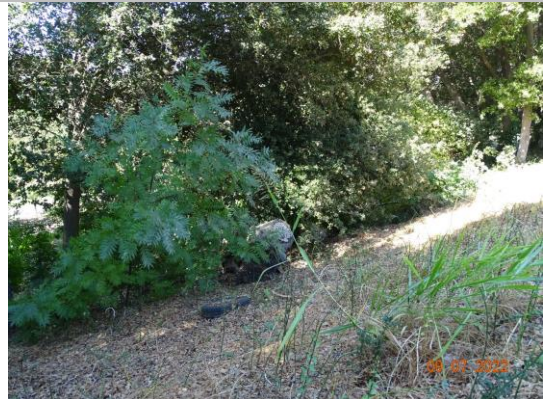
Photo 1 of 1 : FA_2022_RD0003_25_147_20220923_00174.jpg

View of the tree log on the LS slope (Fall 2022).

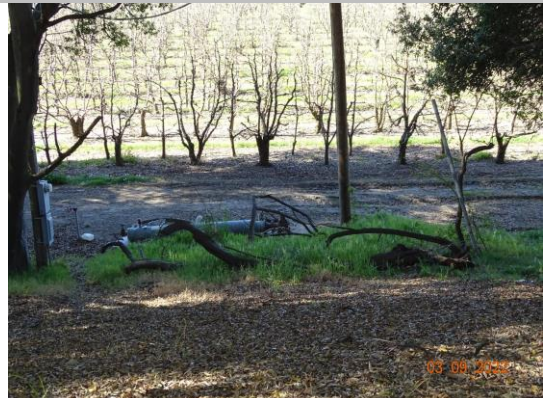
Photo 1 of 1 : FA_2022_RD0003_25_189_20220831_00115.jpg

View of down tree limb on the landside toe (Spring 2022).

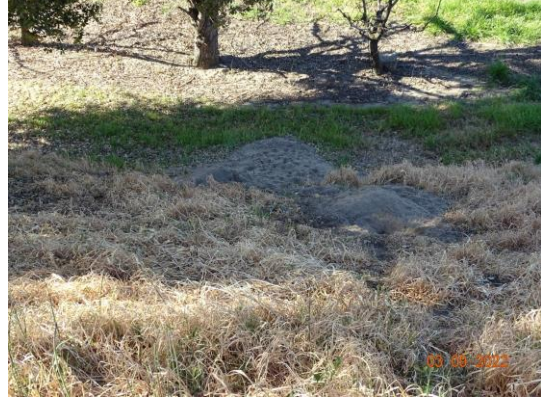
Photo 1 of 1 : FA_2022_RD0003_25_118_20220831_00057.jpg

View looking downslope at multiple rodent holes in the landside slope (Spring 2022).

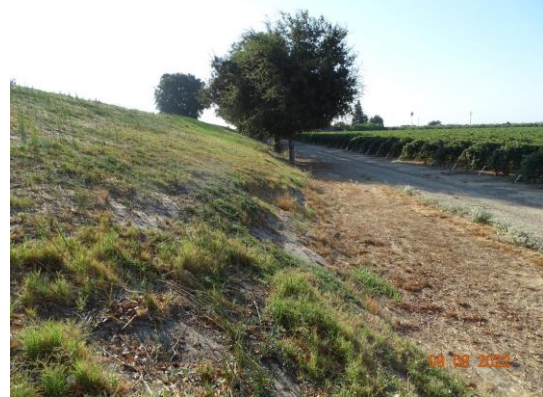
Photo 1 of 1 : FA_2022_RD0003_25_280_20220923_00178.jpg

View of the erosion at the LS toe (Fall 2022).

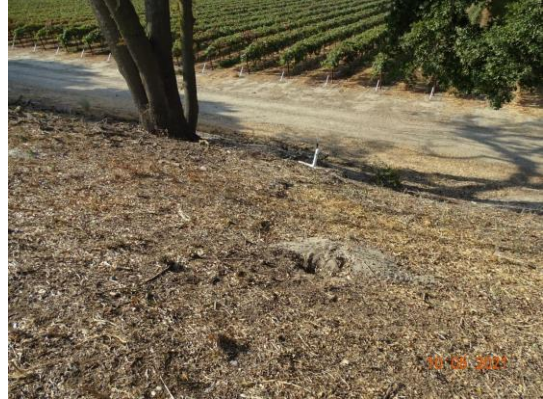
Photo 1 of 1 : FA_2022_RD0003_25_177_20220831_00106.jpg

View looking downslope at fresh rodent holes and rodent bait station in the landside slope (Fall 2021).

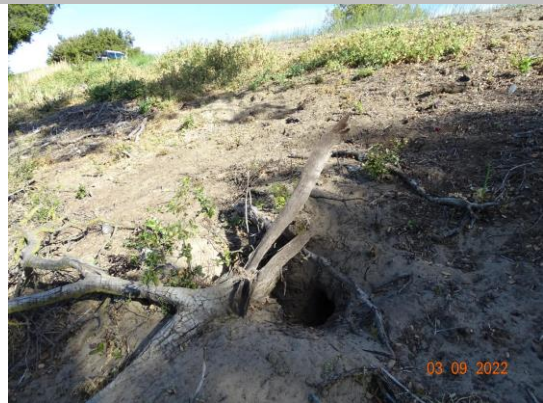
Photo 1 of 1 : FA_2022_RD0003_25_110_20220831_00049.jpg

View looking upslope at large rodent hole in landside slope (Spring 2022).

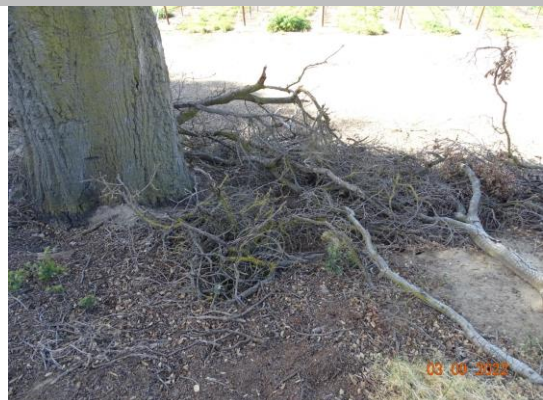
Photo 1 of 1 : FA_2022_RD0003_25_107_20220831_00048.jpg

View of down tree limbs on the landside toe (Spring 2022).

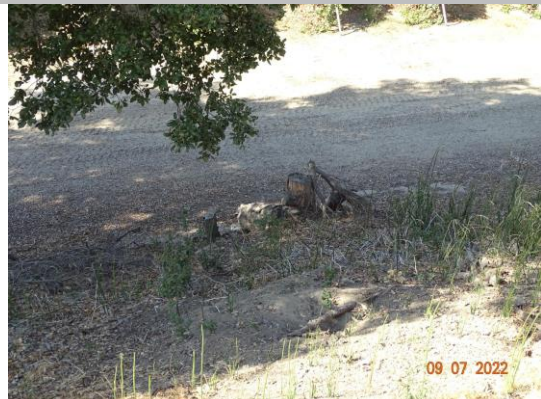
Photo 1 of 1 : FA_2022_RD0003_25_122_20220923_00162.jpg

View of the tree stump at the LS toe (Fall 2022).

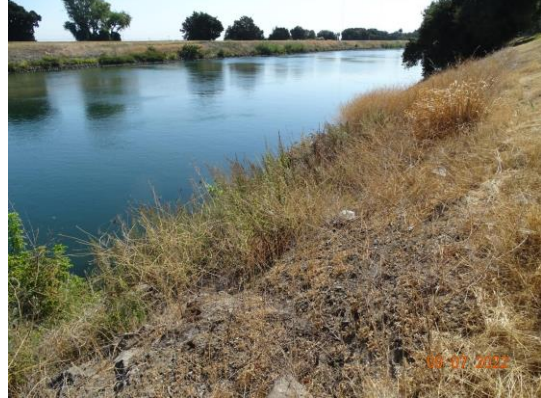
Photo 1 of 1 : FA_2022_RD0003_25_149_20220923_00159.jpg

View of the erosion on the WS slope (Fall 2022).

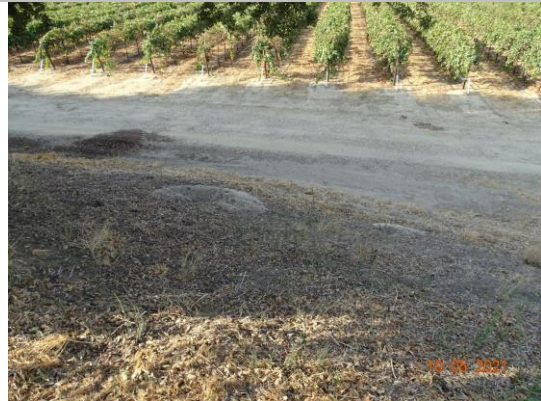
Photo 1 of 1 : FA_2022_RD0003_25_144_20220831_00078.jpg

View of looking downslope at fresh rodent holes in the landside slope (Fall 2021).

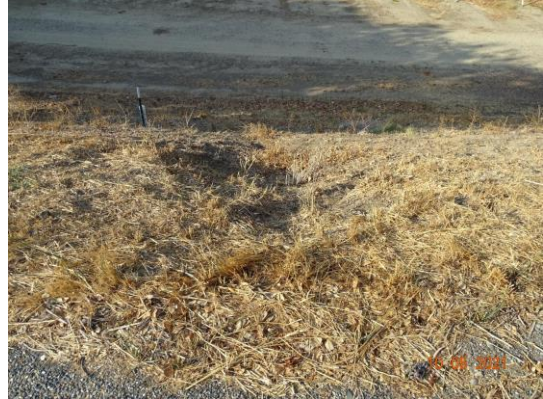
Photo 1 of 1 : FA_2022_RD0003_25_143_20220831_00077.jpg

View looking downslope at depression in the landside slope (Fall 2021).

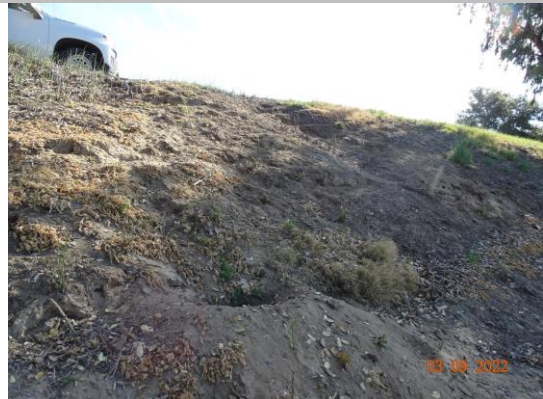
Photo 1 of 1 : FA_2022_RD0003_25_133_20220831_00069.jpg

View looking upslope at rodent holes in the landside slope (Spring 2022).

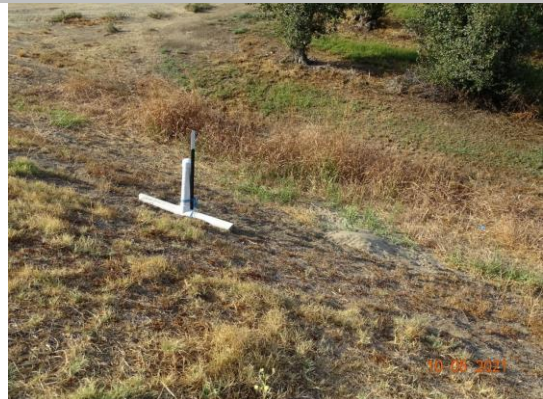
Photo 1 of 1 : FA_2022_RD0003_25_104_20220831_00046.jpg

View looking downstream at fresh rodent hole and bait station on the landside slope (Fall 2021).

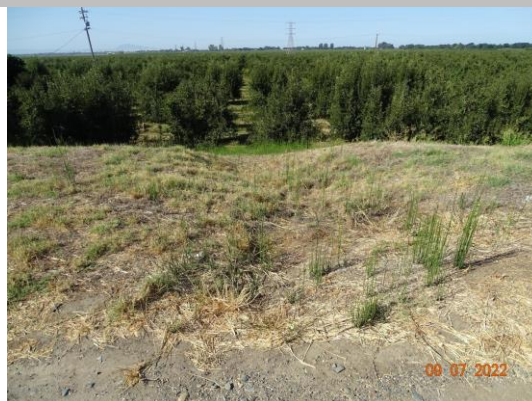
Photo 1 of 1 : FA_2022_RD0003_25_115_20220923_00150.jpg

View of the depression on the LS slope (Fall 2022).

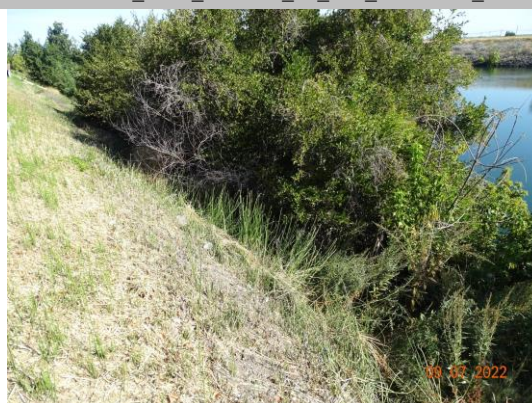
Photo 1 of 1 : FA_2022_RD0003_25_150_20220923_00148.jpg

View of the erosion on the WS slope (Fall 2022).

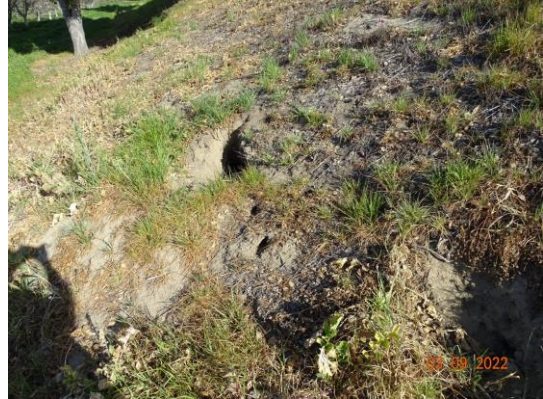
Photo 1 of 1 : FA_2022_RD0003_25_112_20220831_00051.jpg

View of large rodent hole in the landside slope (Spring 2022).

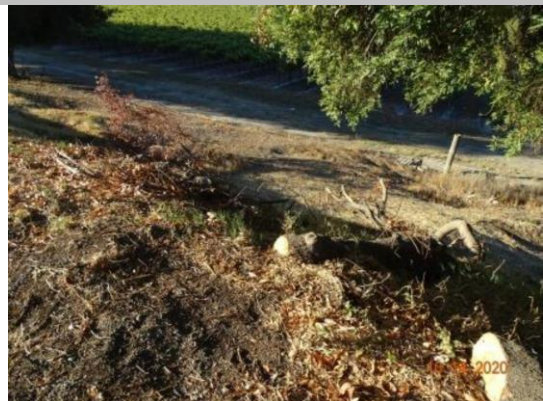
Photo 1 of 1 : FA_2022_RD0003_25_105_20220831_00047.jpg

View of down tree limb on the landside slope (Fall 2020).

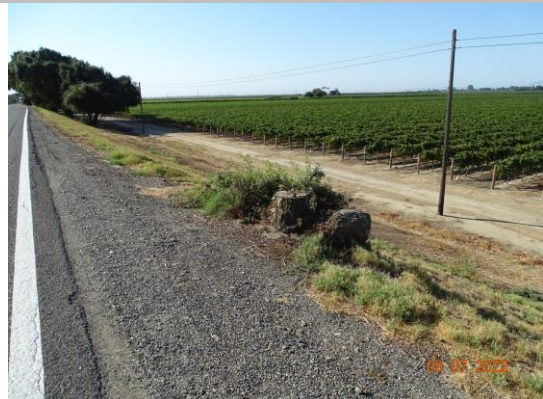
Photo 1 of 1 : FA_2022_RD0003_25_111_20220923_00145.jpg

View of the tree stumps on the LS shoulder (Fall 2022).

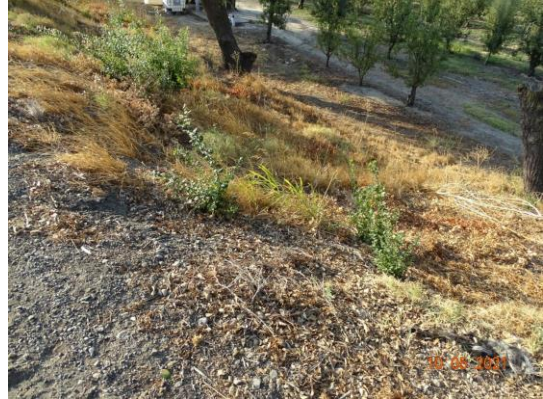
Photo 1 of 1 : FA_2022_RD0003_25_114_20220831_00053.jpg

View looking downstream at depression on the landside slope (Fall 2021).

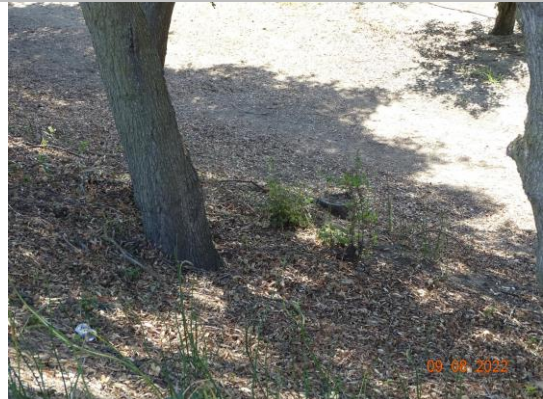
Photo 1 of 1 : FA_2022_RD0003_25_113_20220923_00195.jpg

View of the tree stumps on the lower LS slope (Fall 2022).

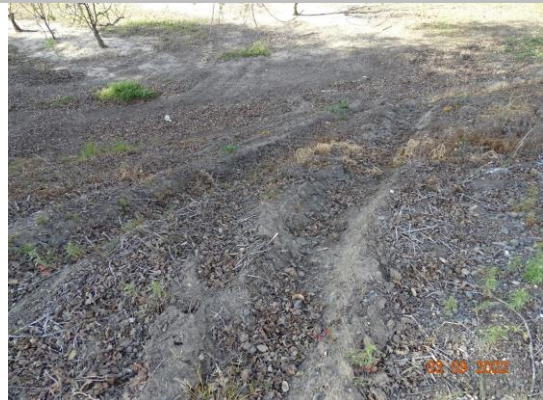
Photo 1 of 1 : FA_2022_RD0003_25_98_20220831_00041.jpg

View of surface erosion due to vehicle driving on the landside slope (Spring 2022).
