**Flood Control Project Maintenance  
Levee Inspections**

**Maintenance Issue Types Only, Levee Inspection Report By Mile - Fall 2023**

**Reclamation District No. 0003 Grand Island**

Waterway	Bank	Unit Miles	Inspection Start/End	Inspector
Unit No. 01 Left Bank Steamboat Slough	Left	10.95	10/23/2023 10/23/2023	Brooks Weisser

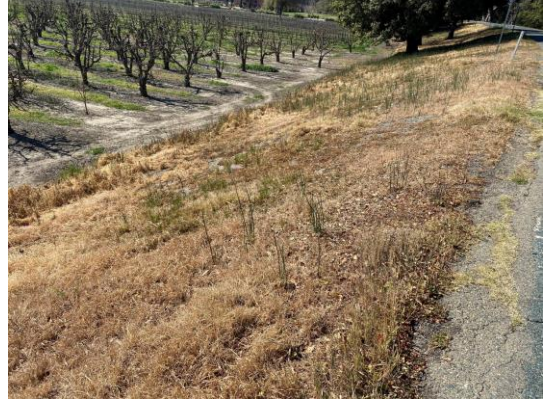
Photo 1 of 1 : FA\_2023\_RD0003\_24\_187\_20231019\_00060.jpg

LM Start	0.06	Rating **	A/W	Issue No.	187
LM End	0.06	Issue Type +	Ma	Location *	LS
Category	Earthen Levee			GPS Latitude/Longitude	
				Start	End
Item	Slope Stability			38.303884°	38.303884°
				-121.575334°	-121.575334°
DWR ID	DWR_RD0003_01_s_2022_187				
Comment Code					
S1 : Repair slope instability.					
Inspector Comment					
This is located at DSID 22134 (abandoned pipe crossing). Recommend monitoring for now.

View looking downstream of shallow depression on the landside slope (Spring 2022)

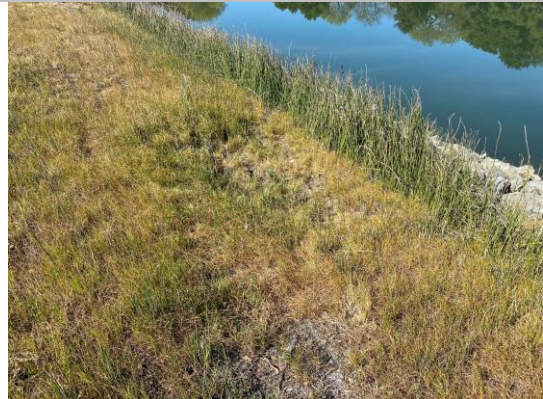
Photo 1 of 1 : FA\_2023\_RD0003\_24\_189\_20231019\_00061.jpg

LM Start	0.06	Rating **	A/W	Issue No.	189
LM End	0.06	Issue Type +	Ma	Location *	WS
Category	Earthen Levee			GPS Latitude/Longitude	
				Start	End
Item	Slope Stability			38.303884°	38.303884°
				-121.575334°	-121.575334°
DWR ID	DWR_RD0003_01_s_2022_189				
Comment Code					
S1 : Repair slope instability.					
Inspector Comment					
This is located at DSID 22134 (abandoned pipe crossing). Recommend monitoring for now.

View of small depression at waterside hinge (Spring 2022).

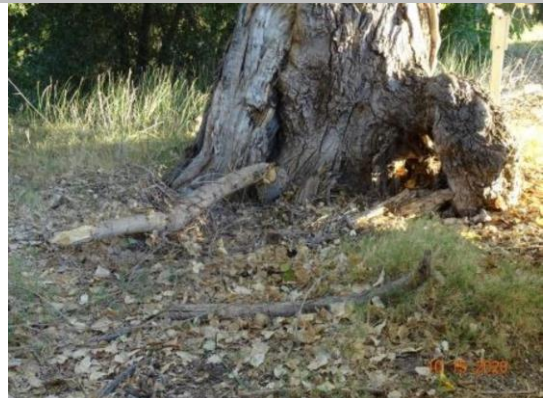
Photo 1 of 1 : FA\_2023\_RD0003\_24\_2\_20231019\_00001.jpg

LM Start	0.13	Rating **	M	Issue No.	2
LM End	0.13	Issue Type +	Ma	Location *	WS
Category	Earthen Levee			GPS Latitude/Longitude	
				Start	End
Item	Erosion / Bank Caving			38.303303°	38.303303°
				-121.576538°	-121.576538°
DWR ID	DWR_RD0003_01_f_2013_2				
Comment Code					
E2 : Schedule repair of erosion site prior to the next inspection.					
Inspector Comment					
A hole (8ft x 2.5ft x 5ft) is next to a large tree on waterward shoulder.

View of hole on the waterside shoulder due to fallen tree (Fall 2020).

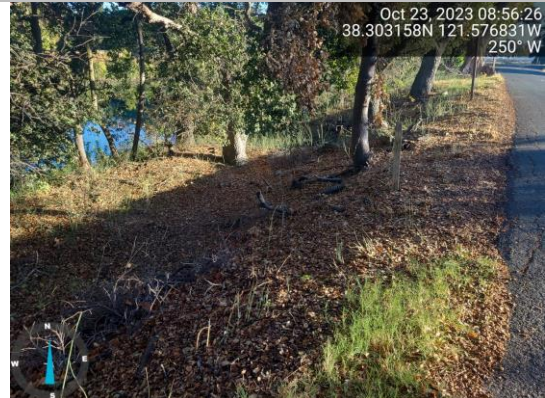
Photo 1 of 1 : FA\_2023\_RD0003\_24\_64\_20231025\_00131.jpg

View of tree branches on the waterside slope (Fall 2023).

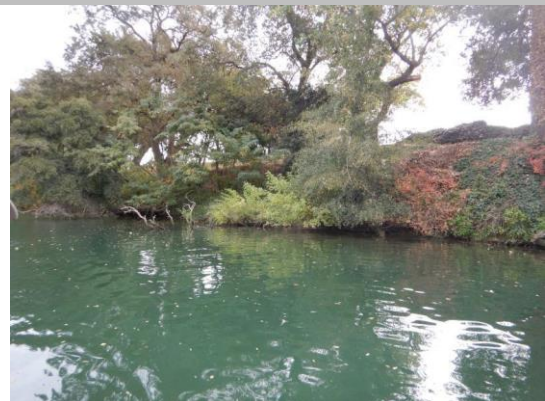
Photo 1 of 2 : FA\_2023\_RD0003\_24\_49\_20231019\_00018.jpg

LM Start	0.18	Rating **	A/W	Issue No.	49
LM End	0.24	Issue Type +	Ma	Location *	WS
Category	Supplemental			GPS Latitude/Longitude	
				Start	End
Item	2018 USACE Erosion Survey			38.303035°	38.302544°
				-121.577357°	-121.578241°
DWR ID	DWR_RD0003_01_s_2022_49

Comment Code					
Inspector Comment					
2018 Site ID: STM 26.0 L					
Status: Critical					
2018 Field Notes: New erosion throughout site.					
Site History: 1997 - Mass failure of berm slope and wave wash erosion.					
Large trees on top of berm, some failed trees. New area of low rock to					
on the upstream end. 2000 - Some minor erosion near the downstream					
end. 2005 - One new small tree has fallen. 2009 - Minimal new					
erosion. 2010 - Minor new erosion. 2013 - Observed new animal holes					
and vertical sections at middle of site. 2015 - Minor new erosion.					
2017 - Upgraded to CRITICAL. Significant bank failure on upstream					
end.

USACE 2018 Erosion Photo #1

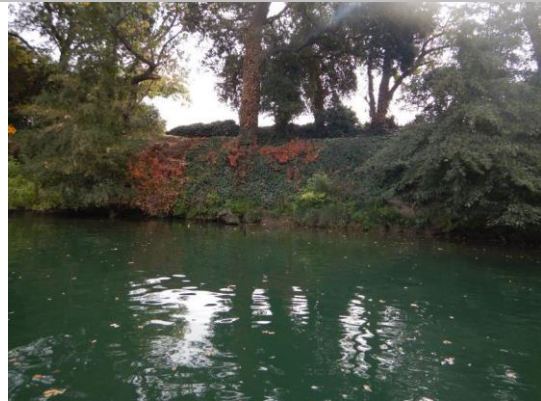
Photo 2 of 2 : FA\_2023\_RD0003\_24\_49\_20231019\_00019.jpg

USACE 2018 Erosion Photo #2

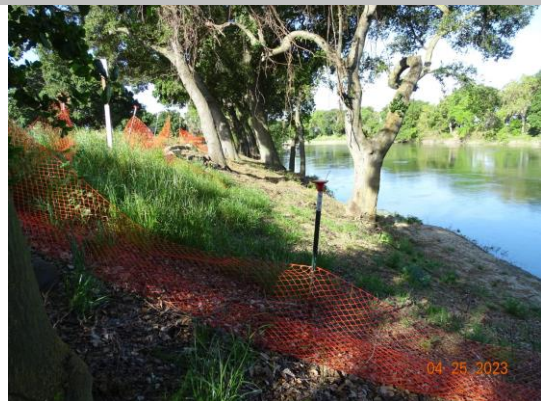
Photo 1 of 1 : FA\_2023\_RD0003\_24\_52\_20231019\_00020.jpg

LM Start	<b>0.18</b>	Rating **	A/W	Issue No.	<b>52</b>
LM End	<b>0.21</b>	Issue Type +	Ma	Location *	WS
Category	Earthen Levee			GPS Latitude/Longitude	
				Start	End
Item	Erosion / Bank Caving			38.302981°	38.302778°
				-121.577336°	-121.577683°
DWR ID	DWR_RD0003_01_s_2023_52

This was a 2017 Storm Damage Site. Repairs are in progress.

View of the erosion site on the WS (Spring 2023).

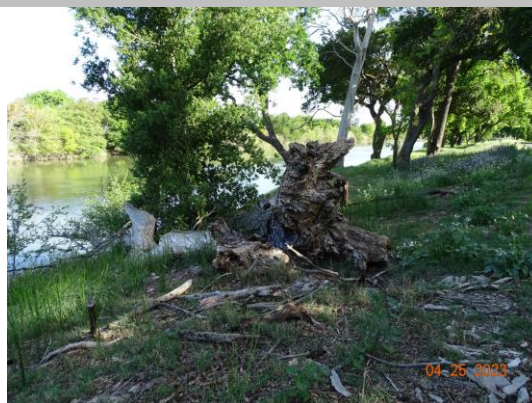
Photo 1 of 1 : FA\_2023\_RD0003\_24\_130\_20231019\_00045.jpg

View of the tree limb on the WS slope (Spring 2023).

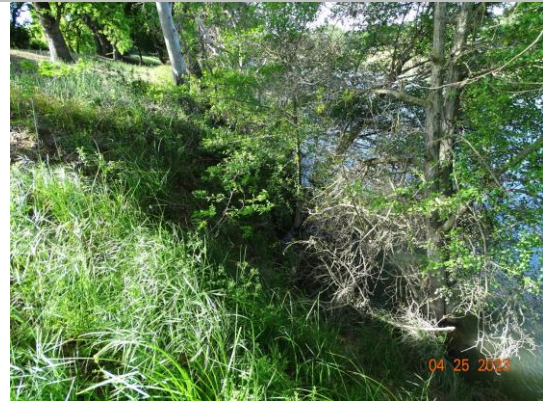
Photo 1 of 1 : FA\_2023\_RD0003\_24\_60\_20231019\_00023.jpg

This was a 2017 Storm Damage site.  
An erosion site exists along approximately 41 linear feet of the waterside slope.  
Site ID No:276  
Site Designation:LMA-102  
6/18/2020 Boat Inspection:  
Significant erosion into waterside prism directly upstream of tree that is leaning into water. That leaning tree is creating an eddy that is causing the erosion. There is also some less significant erosion into the waterside toe upstream of the significant erosion site.

View of the erosion on the WS slope (Spring 2023).

E2 : Schedule repair of erosion site prior to the next inspection.

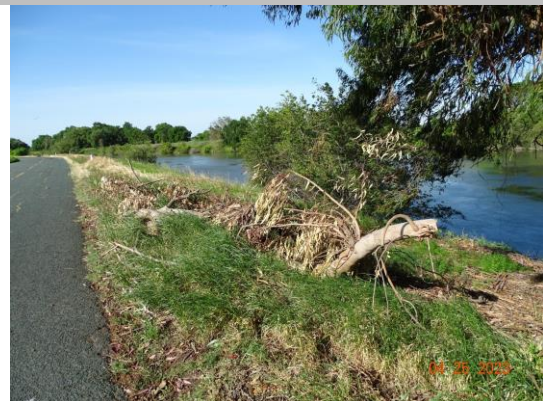
Photo 1 of 1 : FA\_2023\_RD0003\_24\_32\_20231019\_00009.jpg

View of the tree limb on the WS slope (Spring 2023).

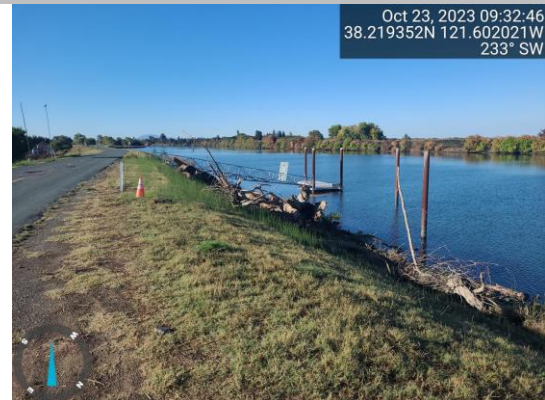
Photo 1 of 1 : FA\_2023\_RD0003\_24\_38\_20231025\_00141.jpg

View of a fallen tree on waterside slope (Fall 2023).

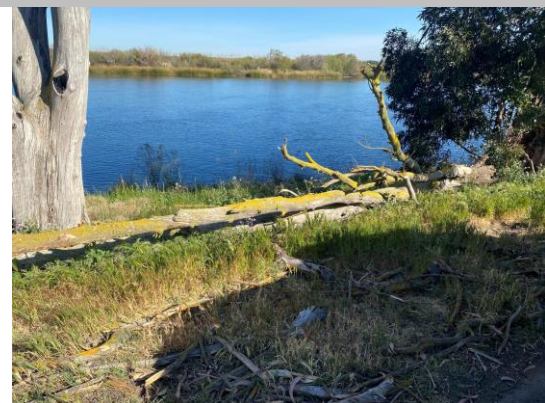
Photo 1 of 1 : FA\_2023\_RD0003\_24\_170\_20231019\_00058.jpg

View of downed tree limb on the waterside shoulder (Spring 2022).

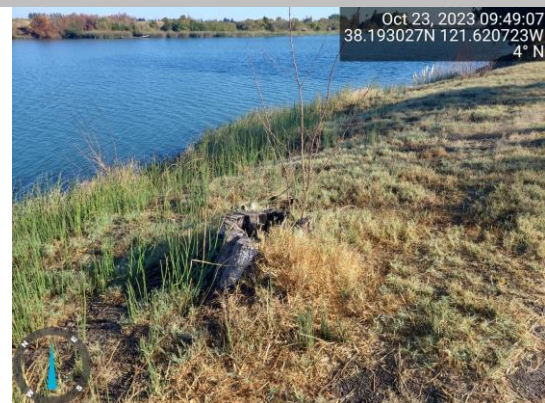
Photo 1 of 1 : FA\_2023\_RD0003\_24\_155\_20231025\_00143.jpg

View of tree stump on the waterside slope (Fall 2023).

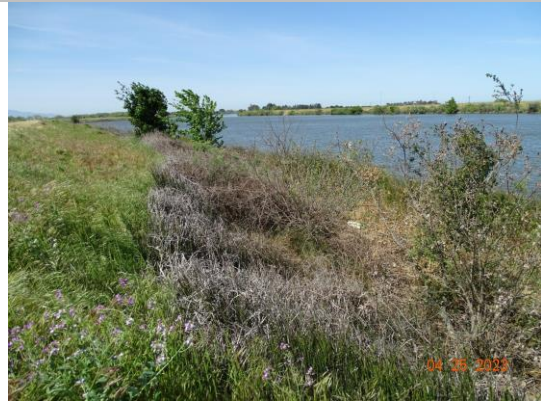
Photo 1 of 1 : FA\_2023\_RD0003\_24\_72\_20231019\_00027.jpg

LM Start	10.15	Rating **	U	Issue No.	72
LM End	10.21	Issue Type +	Ma	Location *	WS
Category	Earthen Levee			GPS Latitude/Longitude	
				Start	End
Item	Erosion / Bank Caving			38.188431°	38.187803°
				-121.641703°	-121.642478°
DWR ID	LMA-103				
Comment Code					
E2 : Schedule repair of erosion site prior to the next inspection.					
Inspector Comment					
This was a 2017 Storm Damage site. The waterside slope experienced sloughing and erosion along approximately 312 linear feet. Sloughing commences at approximately 1/4 of the way down the slope from the crown and extends to the rip rap. Site ID No:277 Site Designation:LMA-103 4/9/2020 Field Notes: Relatively significant erosion into waterside slope.

View of the erosion on the WS (Spring 2023).

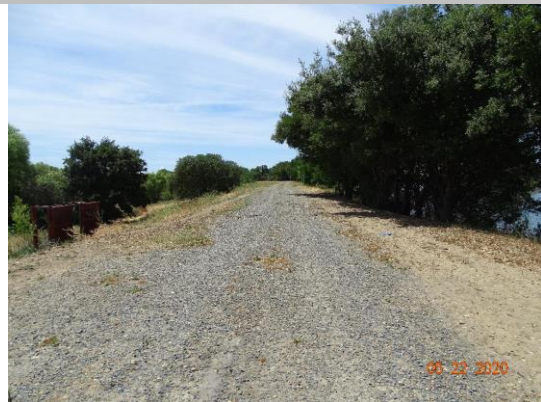
Photo 1 of 3 : UCIP\_FA\_2023\_69661\_85964.jpg

LM Start	10.82	Rating **	M	Issue No.	210
LM End	10.82	Issue Type +	Ma	Location *	
Category	Supplemental			GPS Latitude/Longitude	
				Start	End
Item	DWR UCIP LMA Responsibility			38.183044°	38.183044°
				-121.651367°	-121.651367°
DWR ID	22350				
Comment Code					
Inspector Comment					
DS_ID:22350 FS_ID:69661 EP_NO: N/A Repair Type: Non-Urgent EVAL Issue: Crossing Status: Not Found UCIP Comments: 05/22/2020 Record upgraded to Non-Urgent due to missing permit. No signs of pipe found during inspection. Geophysical study (07-24-2018) suggests no pipe present at this location. (S. Donovan - DWR UCIP) FIELD_STRUCT_DESC: 36-inch corrugated metal drainage pipe through the levee, invert elevation 24.0 feet below the crown. [Additional Reference(s): DWR Levee Log, 1993, (HLM 10.90). USACE Sacramento O&M Manual 104, February 1960, (RM 15.20)]. FS Date: 5/22/2020 7:49:00 AM

Overview of the levee crown looking d/s.

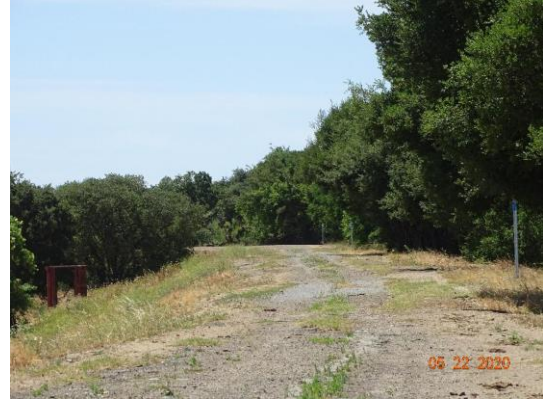
Photo 1 of 3 : UCIP\_FA\_2023\_69662\_85972.jpg

Comment Code					
Inspector Comment					
DS_ID:22206 FS_ID:69662 EP_NO: N/A Repair Type: Non-Urgent EVAL Issue: Crossing Status: Found UCIP Comments: 05/22/2020 Record remains Non-Urgent due to missing permit and crossing being abandoned. (S. Donovan - DWR UCIP)02/11/2014 Pipe appears abandoned and should be verified as having been done so properly. (G. Wylie - DWR UCIP) FIELD_STRUCT_DESC: 36-inch corrugated metal drainage pipe through the levee, 15.0 feet below the crown. Slide gate in a 48-inch corrugated metal pipe (CMP) riser on the waterside (WS) shoulder. Flap gate at the WS toe has been sealed shut with sealant. [Additional Reference(s): DWR Levee Log, 1993, (HLM 10.90), referenced as 24.0 feet below the crown. USACE Sacramento O&M Manual 104, February 1960, (RM 15.20), referenced as invert elevation 24.0 feet below the crown]. FS Date: 5/22/2020 8:07:00 AM

Overview of the levee crown looking d/s.

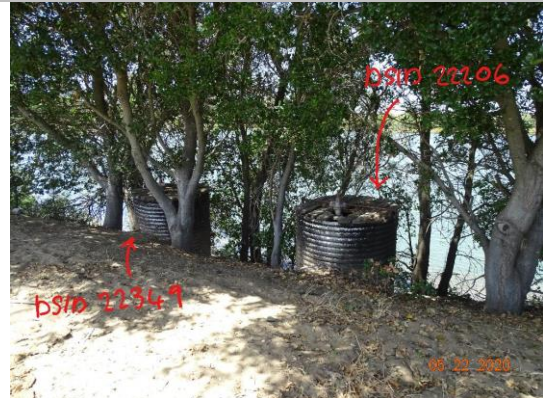
Photo 3 of 3 : UCIP\_FA\_2023\_69662\_85968.jpg

WS view: Standpipe on th levee shoulder.

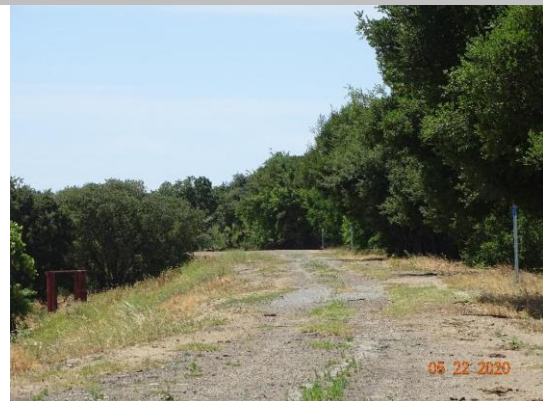
Photo 1 of 3 : UCIP\_FA\_2023\_69663\_85978.jpg

DS\_ID:22349  
 FS\_ID:69663  
 EP\_NO: N/A  
 Repair Type: Non-Urgent  
 EVAL Issue:  
 Crossing Status: Found  
 UCIP Comments: 05/22/2020 Record remains Non-Urgent due to missing permit and crossing being abandoned. (S. Donovan - DWR UCIP)02/11/2014 Pipe appears abandoned and should be verified as having been filled with grout. (G. Wylie - DWR UCIP)  
 FIELD\_STRUCT\_DESC: 36-inch corrugated metal drainage pipe through the levee, 15.0 feet below the crown. Slide gate in a 48-inch corrugated metal pipe (CMP) riser on the waterside (WS) shoulder. Steel intake weir at the landside (LS) toe. Steel plate welded over the pipe on the WS toe. [Additional Reference(s): DWR Levee Log, 1993, (HLM 10.90), referenced as 24.0 feet below the crown. USACE Sacramento O&M Manual 104, February 1960, (RM 15.20), referenced as invert elevation 24.0 feet below the crown].  
 FS Date: 5/22/2020 8:28:00 AM

Overview of the levee crown looking d/s.

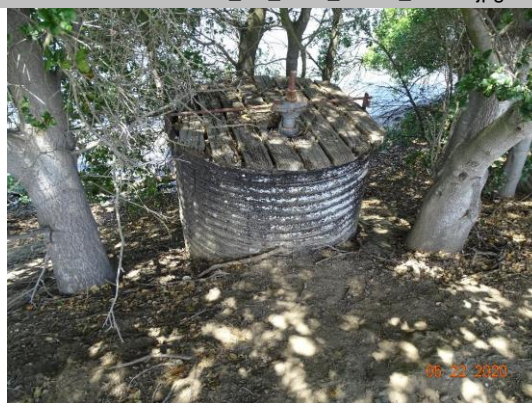
Photo 3 of 3 : UCIP\_FA\_2023\_69663\_85974.jpg

WS view: Standpipe on the levee shoulder.

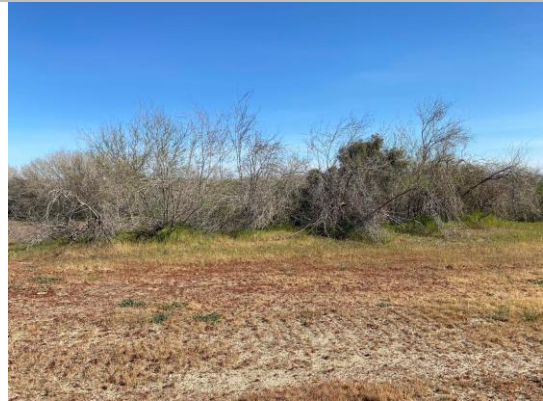
Photo 1 of 1 : FA\_2023\_RD0003\_25\_97\_20231019\_00042.jpg

View of willows on the landside shoulder (Spring 2022).

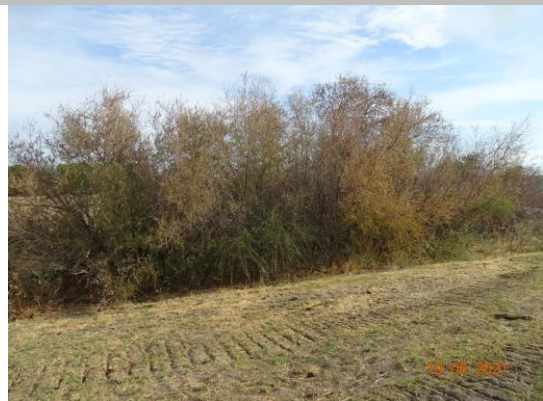
Photo 1 of 1 : FA\_2023\_RD0003\_25\_68\_20231019\_00026.jpg

View of willows on the landside slope (Fall 2021).

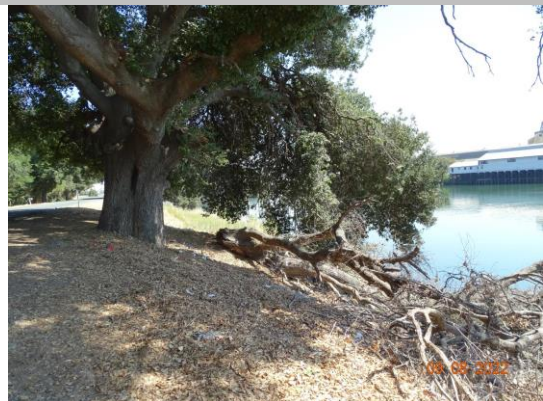
Photo 1 of 1 : FA\_2023\_RD0003\_25\_283\_20231019\_00130.jpg

View of the tree limb on the WS slope (Fall 2022).

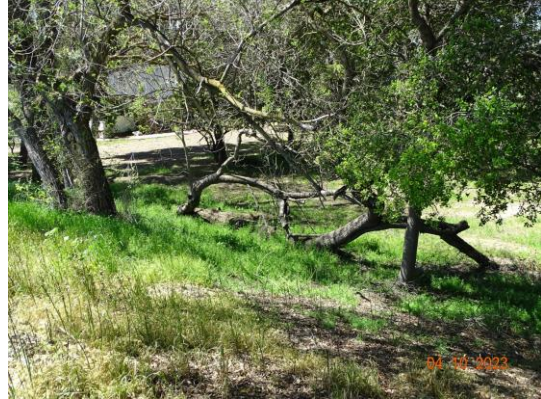
Photo 1 of 1 : FA\_2023\_RD0003\_25\_180\_20231019\_00102.jpg

View of the tree limb on the LS toe (Spring 2023).

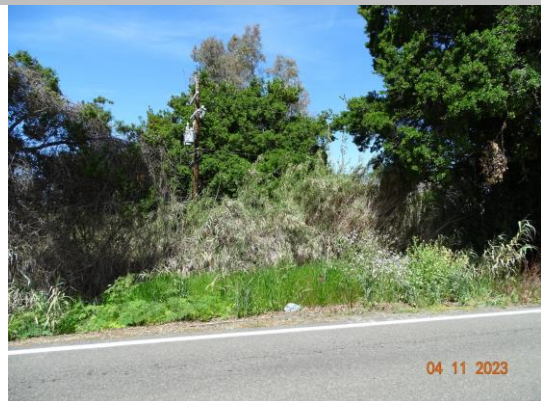
Photo 1 of 1 : FA\_2023\_RD0003\_25\_200\_20231019\_00114.jpg

View of the arundo on the LS slope (Spring 2023).

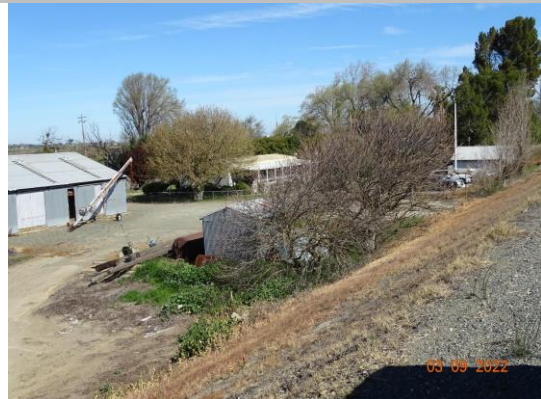
Photo 1 of 1 : FA\_2023\_RD0003\_25\_217\_20231019\_00122.jpg

View looking upstream at trees on the landside slope (Spring 2022).

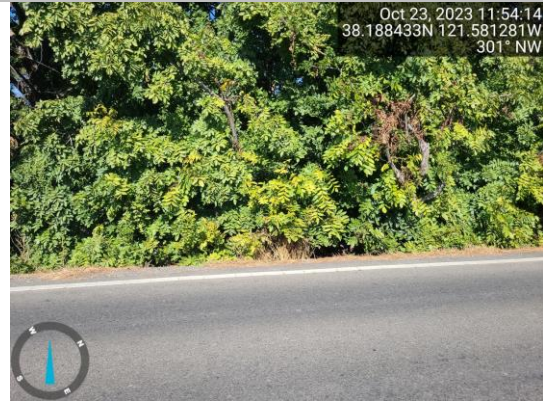
Photo 1 of 1 : FA\_2023\_RD0003\_25\_14\_20231025\_00201.jpg

View of untrimmed trees on the landside slope (Fall 2023).

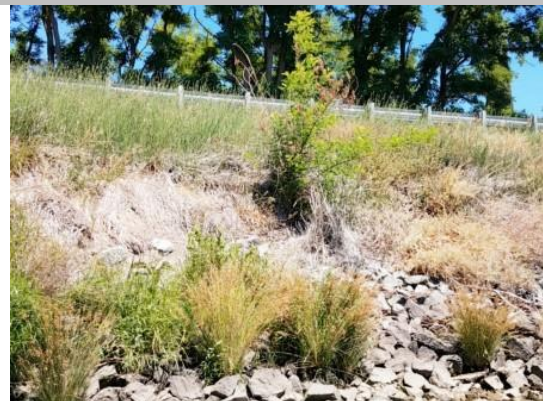
Photo 1 of 1 : FA\_2023\_RD0003\_25\_1\_20231019\_00001.jpg

LM Start	4.96	Rating **	A/W	Issue No.	1
LM End	4.96	Issue Type +	Ma	Location *	WS
Category	Earthen Levee			GPS Latitude/Longitude	
				Start	End
Item	Slope Stability			38.188420°	38.188420°
				-121.580910°	-121.580910°
DWR ID	DWR_RD0003_02_s_2020_1				
Comment Code					
S1 : Repair slope instability.					
Inspector Comment					
Waterside slope bowed in slightly, indicating possible slope instability. Monitor the area for worsening conditions.

View from the channel of slightly bowing into the waterside slope (Summer 2020).

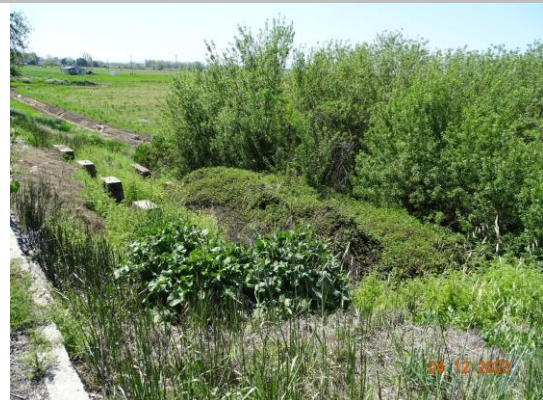
Photo 1 of 1 : FA\_2023\_RD0003\_25\_16\_20231019\_00008.jpg

View of the vegetation and trees on the LS slope and toe (Spring 2023).

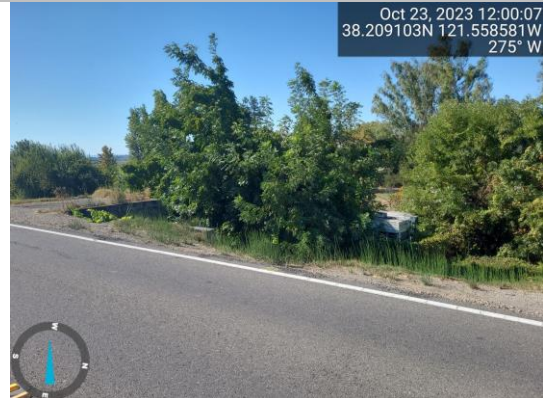
Photo 1 of 1 : FA\_2023\_RD0003\_25\_152\_20231025\_00204.jpg

View of thick trees on the landside slope (Fall 2023).

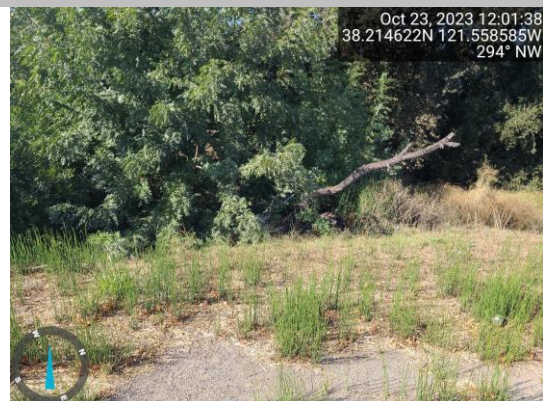
Photo 1 of 1 : FA\_2023\_RD0003\_25\_173\_20231025\_00205.jpg

View of downed tree limb on the landside slope (Fall 2023).

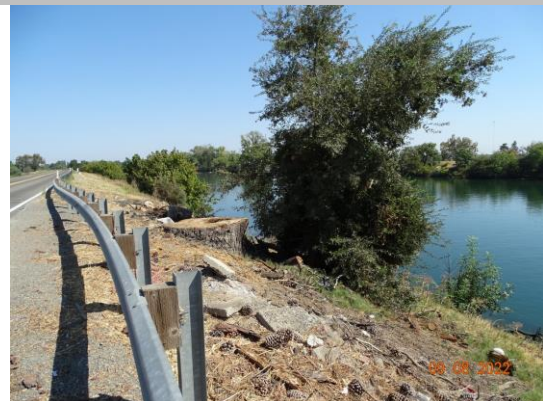
Photo 1 of 1 : FA\_2023\_RD0003\_25\_15\_20231019\_00007.jpg

View of the tree stump below the WS shoulder (Fall 2022).

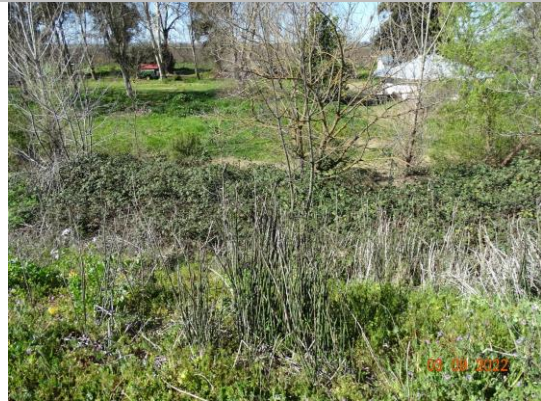
Photo 1 of 1 : FA\_2023\_RD0003\_25\_179\_20231019\_00101.jpg

View of blackberries on the landside toe (Spring 2022).

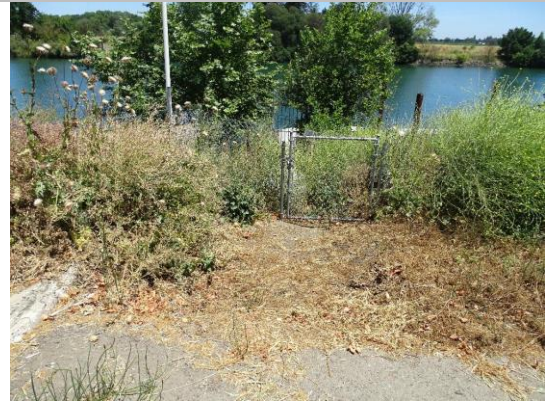
Photo 2 of 3 : UCIP\_FA\_2023\_77154\_114740.jpg

LM Start	8.48	Rating **	M	Issue No.	958	
LM End	8.48	Issue Type +	Ma	Location *		
Category	Supplemental			GPS Latitude/Longitude		
				Start	End	
Item	DWR UCIP LMA Responsibility			38.229477°	38.229477°	
				-121.557255°	-121.557255°	
DWR ID	22261					
Comment Code						
Inspector Comment						
DS_ID:22261 FS_ID:77154 EP_NO: N/A Repair Type: Non-Urgent EVAL Issue: Crossing Status: Not Found UCIP Comments: 06/09/2022 Abandoned, not found, unauthorized encroachment, USACE legacy system pipe, non-urgent. (A. McDonald - DWR UCIP) FIELD_STRUCT_DESC: 10-inch steel gravity drainage pipe through the levee, invert elevation 5.8 feet below the crown. Concrete pad and retaining wall on the waterside (WS) slope. [Additional Reference(s): DWR Levee Log, 1993. USACE Sacramento O&M Manual 104, February 1960, (RM 23.43)]. FS Date: 6/9/2022

WS overview, gate, walkway, and dock on slope and river

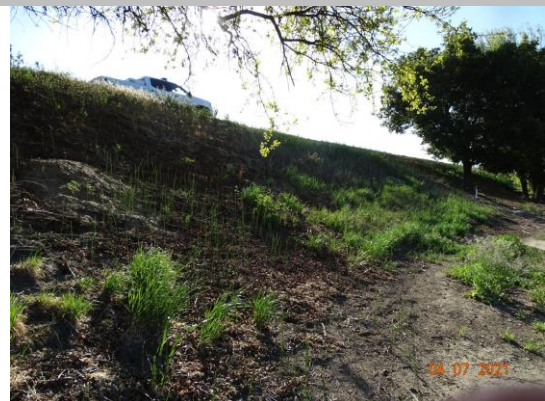
Photo 1 of 1 : FA\_2023\_RD0003\_25\_167\_20231019\_00092.jpg

View of multiple rodent holes in the landside slope (Spring 2021).

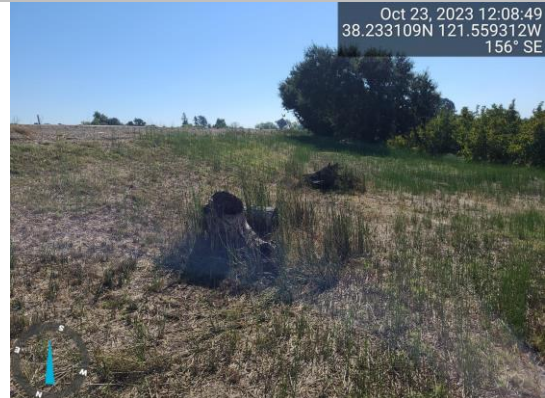
Photo 1 of 1 : FA\_2023\_RD0003\_25\_211\_20231025\_00208.jpg

View looking slightly downstream at tree logs on the landside slope (Fall 2023).

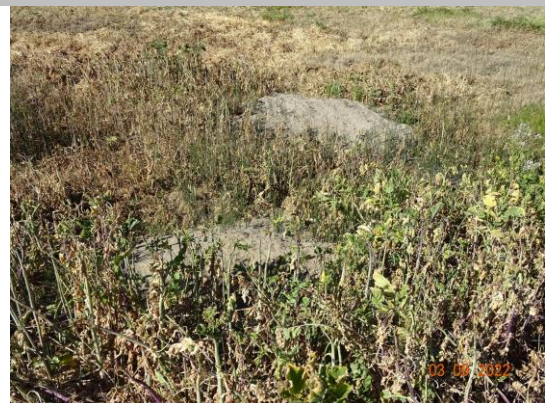
Photo 1 of 1 : FA\_2023\_RD0003\_25\_161\_20231019\_00088.jpg

View of a couple fresh rodent holes on the landside slope (Spring 2022).

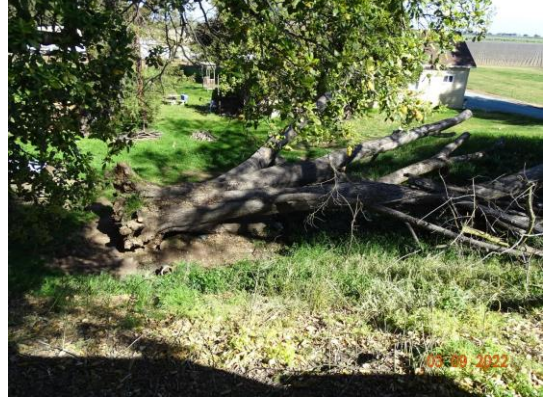
Photo 1 of 1 : FA\_2023\_RD0003\_25\_132\_20231019\_00066.jpg

View of large downed tree on the landside toe (Spring 2022).

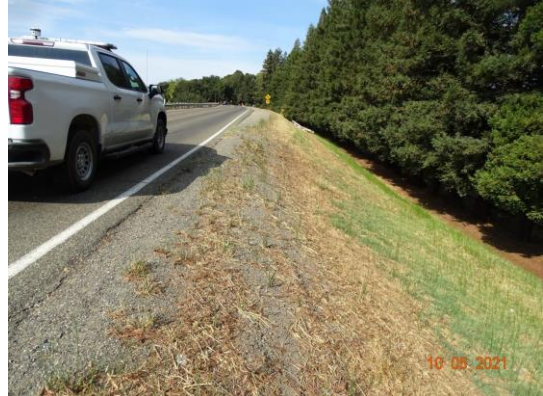
Photo 1 of 1 : FA\_2023\_RD0003\_25\_206\_20231019\_00117.jpg

LM Start	9.74	Rating **	M	Issue No.	206
LM End	9.74	Issue Type +	Ma	Location *	LS
Category	Earthen Levee			GPS Latitude/Longitude	
				Start	End
Item	Slope Stability			38.242332°	38.242332°
				-121.549485°	-121.549485°
DWR ID	DWR_RD0003_02_f_2021_206				
Comment Code					
S1 : Repair slope instability.					
Inspector Comment					
Landside slope getting close to edge of roadway. Slight cracking in roadway.

View of depression in the landside slope getting close to the roadway (Fall 2021).

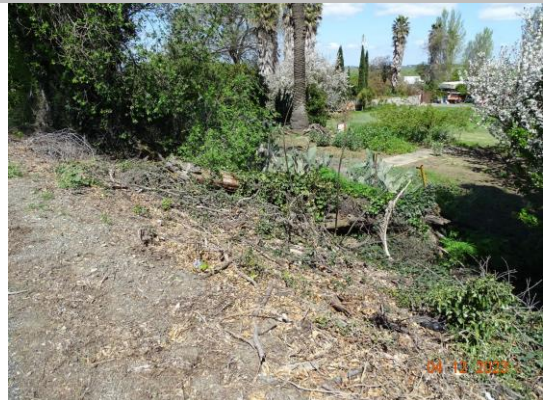
Photo 1 of 1 : FA\_2023\_RD0003\_25\_170\_20231019\_00094.jpg

View of the tree on the LS slope (Spring 2023).

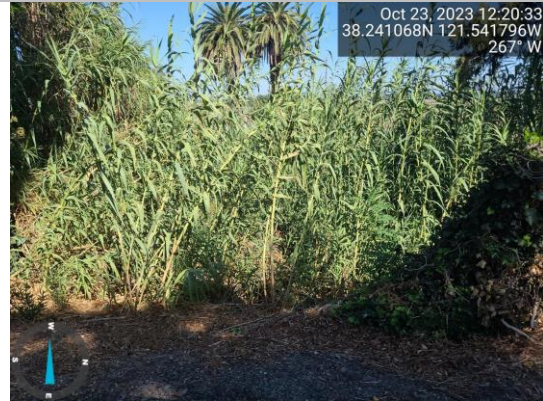
Photo 1 of 1 : FA\_2023\_RD0003\_25\_145\_20231025\_00214.jpg

View of thick arundo on the landside slope (Fall 2023).

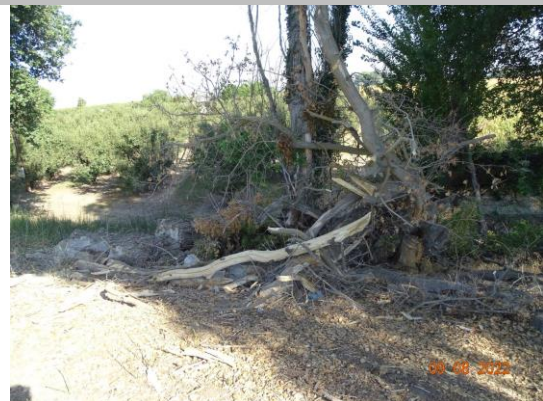
Photo 1 of 1 : FA\_2023\_RD0003\_25\_162\_20231019\_00089.jpg

View of the tree limbs at the LS toe (Fall 2022).

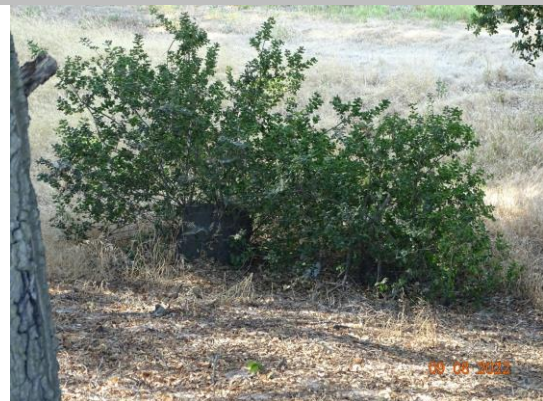
Photo 1 of 1 : FA\_2023\_RD0003\_25\_135\_20231019\_00068.jpg

View of the tree stump at the LS toe (Fall 2022).

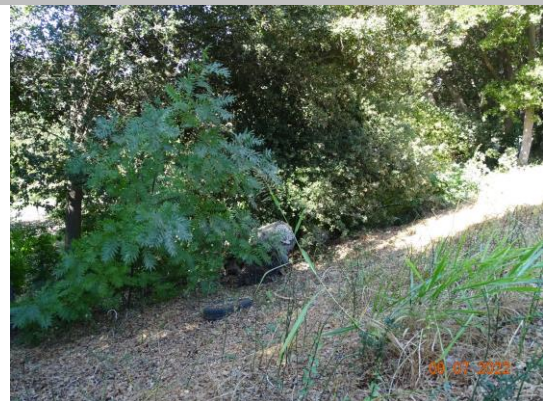
Photo 1 of 1 : FA\_2023\_RD0003\_25\_147\_20231019\_00077.jpg

View of the tree log on the LS slope (Fall 2022).

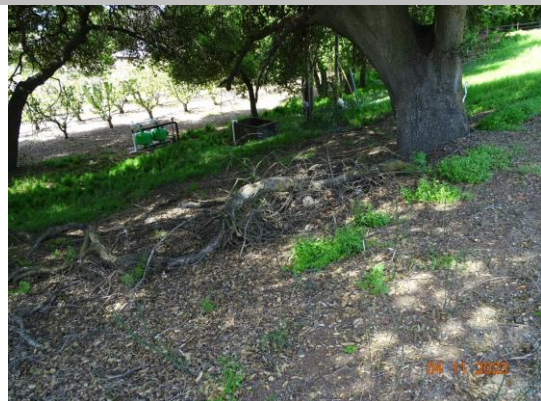
Photo 1 of 1 : FA\_2023\_RD0003\_25\_124\_20231019\_00063.jpg

View of the tree limb on the LS slope (Spring 2023).

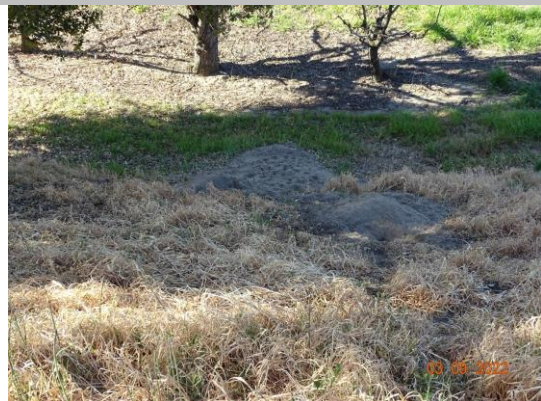
Photo 1 of 1 : FA\_2023\_RD0003\_25\_118\_20231019\_00059.jpg

View looking downslope at multiple rodent holes in the landside slope (Spring 2022).

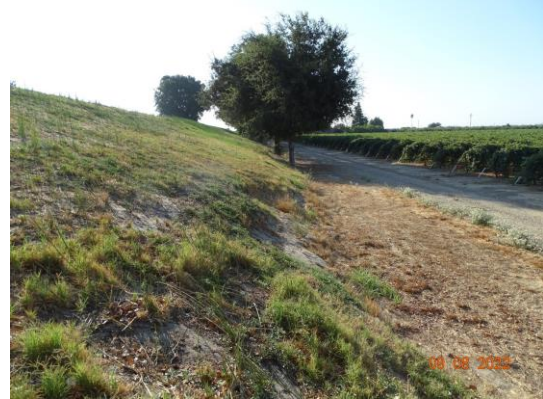
Photo 1 of 1 : FA\_2023\_RD0003\_25\_280\_20231019\_00129.jpg

View of the erosion at the LS toe (Fall 2022).

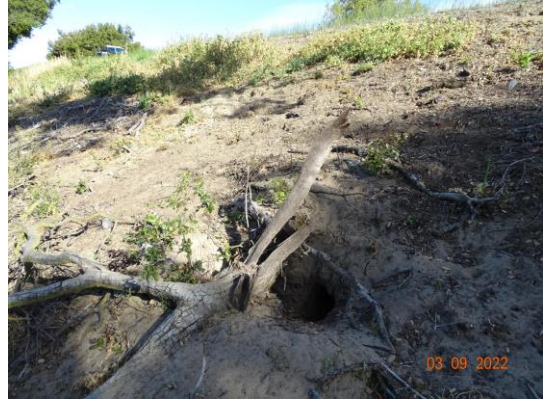
Photo 1 of 1 : FA\_2023\_RD0003\_25\_110\_20231019\_00051.jpg

View looking upslope at large rodent hole in landside slope (Spring 2022).

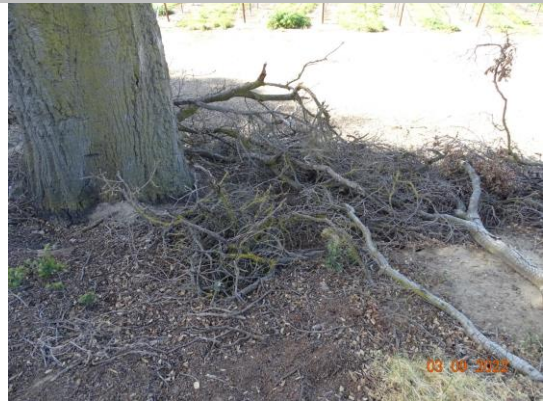
Photo 1 of 1 : FA\_2023\_RD0003\_25\_107\_20231019\_00050.jpg

View of downed tree limbs on the landside toe (Spring 2022).

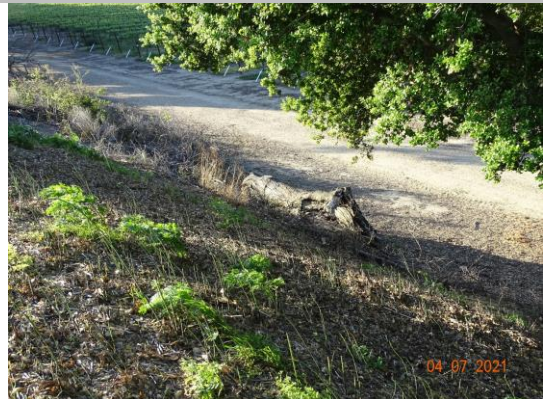
Photo 1 of 1 : FA\_2023\_RD0003\_25\_185\_20231019\_00105.jpg

View of downed tree limb on the landside toe (Spring 2021).

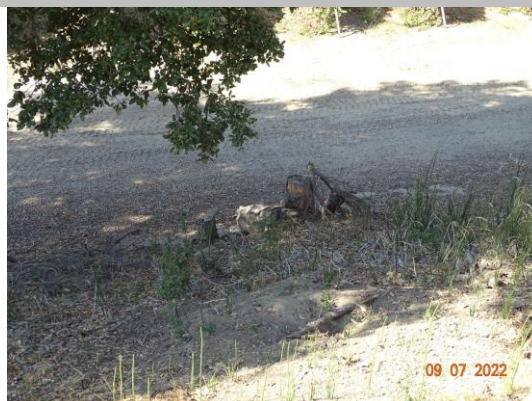
Photo 1 of 1 : FA\_2023\_RD0003\_25\_122\_20231019\_00062.jpg

View of the tree stump at the LS toe (Fall 2022).

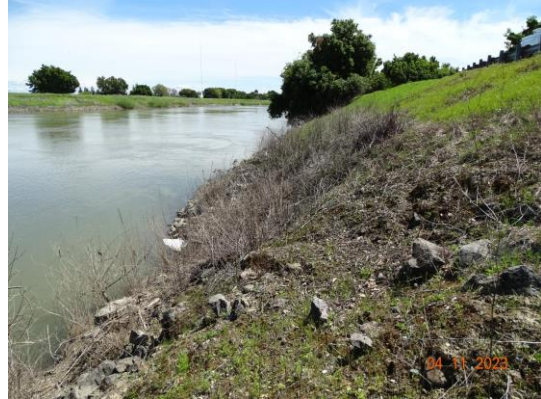
Photo 1 of 1 : FA\_2023\_RD0003\_25\_149\_20231019\_00078.jpg

View of the erosion on the WS slope (Spring 2023).

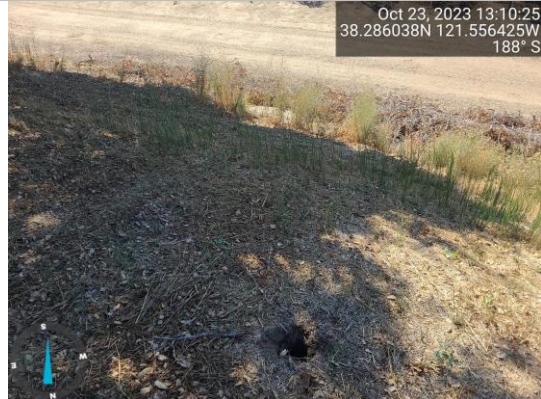
Photo 1 of 1 : FA\_2023\_RD0003\_25\_144\_20231025\_00222.jpg

View looking downslope at rodent holes in the landside slope (Fall 2023).

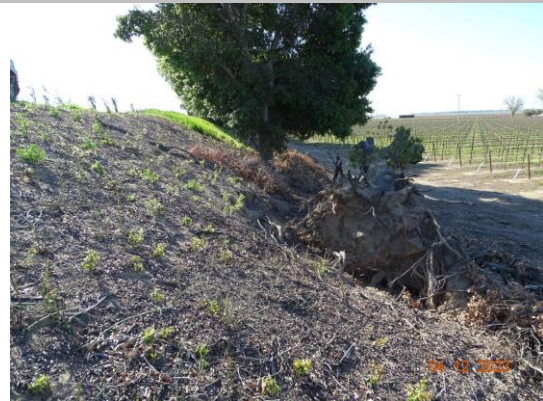
Photo 1 of 1 : FA\_2023\_RD0003\_25\_39\_20231019\_00016.jpg

View of the tree on the LS slope (Spring 2023).

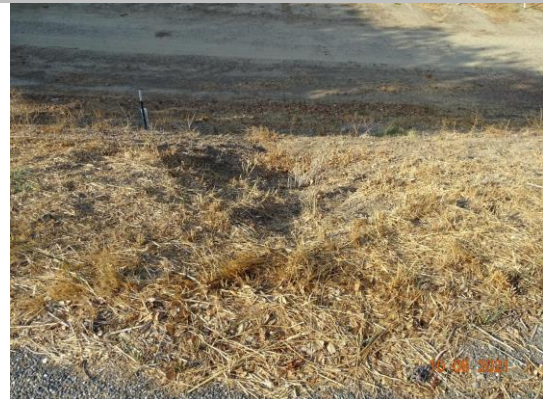
Photo 1 of 1 : FA\_2023\_RD0003\_25\_143\_20231019\_00073.jpg

View looking downslope at depression in the landside slope (Fall 2021).

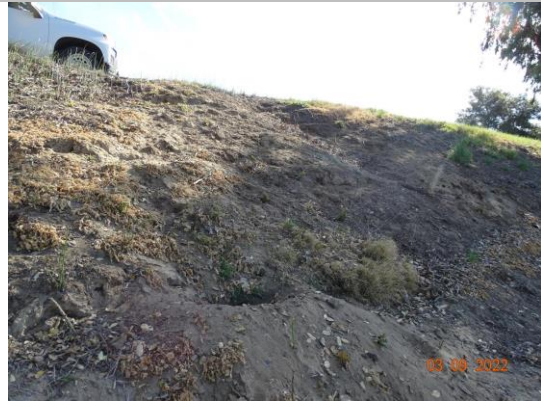
Photo 1 of 1 : FA\_2023\_RD0003\_25\_133\_20231019\_00067.jpg

View looking upslope at rodent holes in the landside slope (Spring 2022).

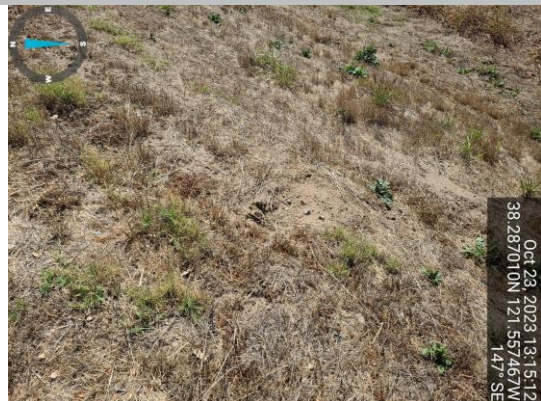
Photo 1 of 1 : FA\_2023\_RD0003\_25\_104\_20231025\_00225.jpg

View looking downstream at rodent hole on the landside slope (Fall 2023).

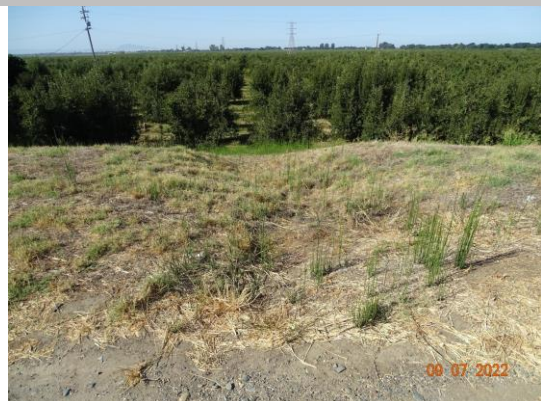
Photo 1 of 1 : FA\_2023\_RD0003\_25\_115\_20231019\_00056.jpg

View of the depression on the LS slope (Fall 2022).

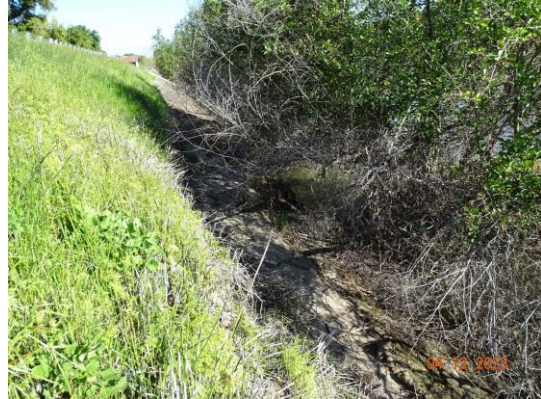
Photo 1 of 1 : FA\_2023\_RD0003\_25\_150\_20231019\_00079.jpg

View of the erosion on the WS slope (Spring 2023).

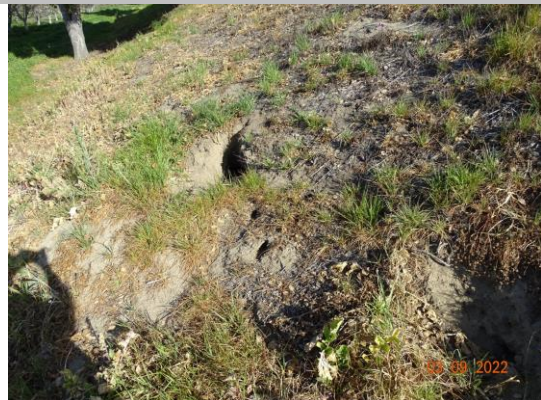
Photo 1 of 1 : FA\_2023\_RD0003\_25\_112\_20231019\_00053.jpg

View of large rodent hole in the landside slope (Spring 2022).

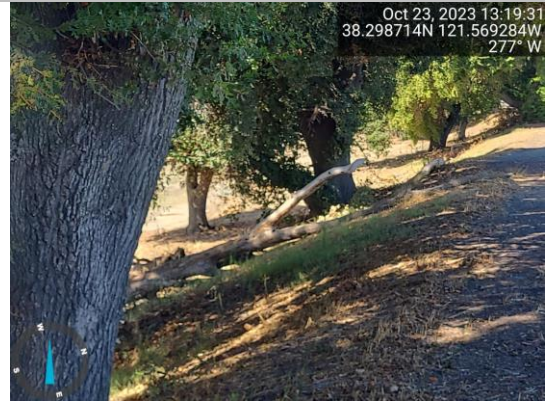
Photo 1 of 1 : FA\_2023\_RD0003\_25\_105\_20231025\_00227.jpg

View of downed tree limb on the landside slope (Fall 2023).

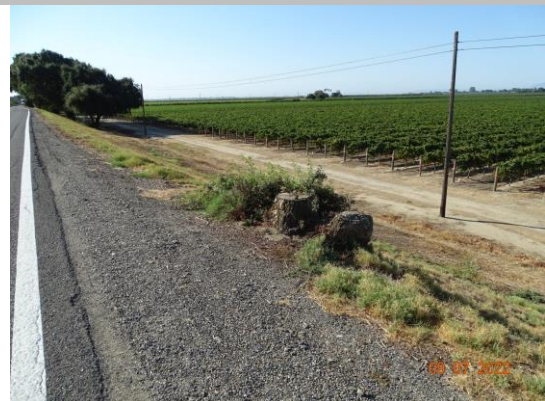
Photo 1 of 1 : FA\_2023\_RD0003\_25\_111\_20231019\_00052.jpg

View of the tree stumps on the LS shoulder (Fall 2022).

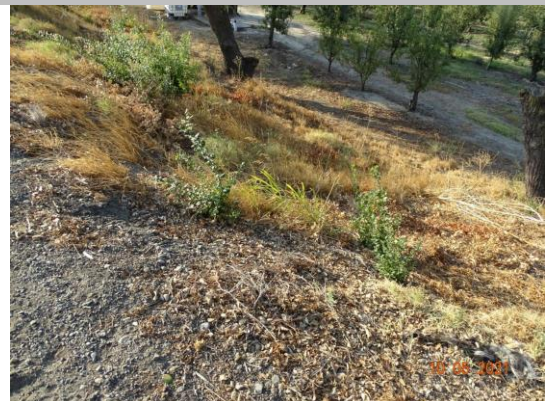
Photo 1 of 1 : FA\_2023\_RD0003\_25\_114\_20231019\_00055.jpg

View looking downstream at depression on the landside slope (Fall 2021).

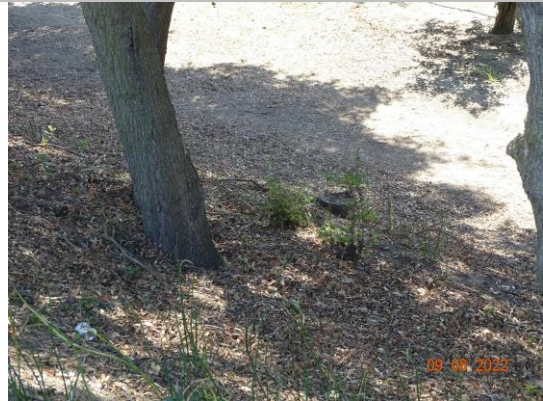
Photo 1 of 1 : FA\_2023\_RD0003\_25\_113\_20231019\_00054.jpg

View of the tree stumps on the lower LS slope (Fall 2022).

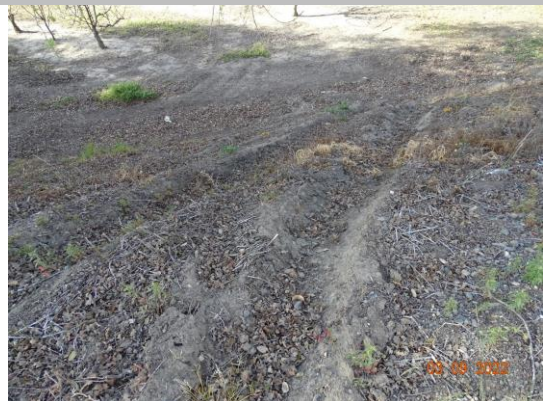
Photo 1 of 1 : FA\_2023\_RD0003\_25\_98\_20231019\_00043.jpg

View of surface erosion due to vehicle driving on the landside slope (Spring 2022).

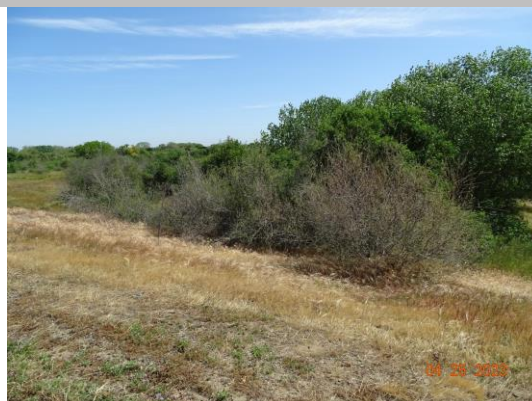
Photo 1 of 1 : FA\_2023\_RD0003\_610\_5\_20231019\_00002.jpg

View of the willows on the LS slope (Spring 2023).
