**Flood Control Project Maintenance
Levee Inspections****Maintenance Issue Types Only, Levee Inspection Report By Mile - Fall 2024****Reclamation District No. 0003 Grand Island**

Waterway	Bank	Unit Miles	Inspection Start/End	Inspector
Unit No. 01 Left Bank Steamboat Slough	Left	10.95	11/05/2024 11/05/2024	Gregg McMillon

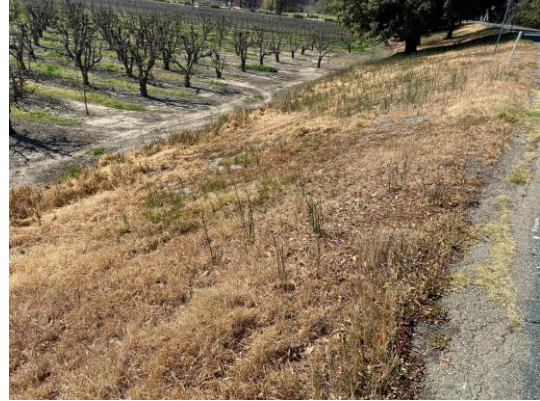
Photo 1 of 1 : FA_2024_RD0003_24_187_20241001_00046.jpg

LM Start	0.06	Rating **	A/W	Issue No.	187
LM End	0.06	Issue Type +	Ma	Location *	LS
Category	Earthen Levee			GPS Latitude/Longitude	
				Start	End
Item	Slope Stability			38.303884°	38.303884°
				-121.575334°	-121.575334°
DWR ID	DWR_RD0003_01_s_2022_187				
Comment Code					
S1 : Repair slope instability.					
Inspector Comment					
This is located at DSID 22134 (abandoned pipe crossing). Recommend monitoring for now.

View looking downstream of shallow depression on the landside slope (Spring 2022)

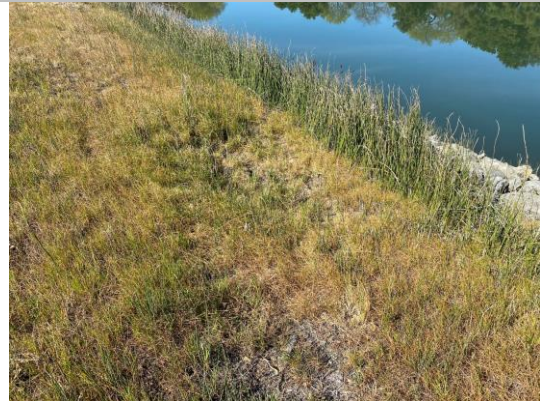
Photo 1 of 1 : FA_2024_RD0003_24_189_20241001_00047.jpg

LM Start	0.06	Rating **	A/W	Issue No.	189
LM End	0.06	Issue Type +	Ma	Location *	WS
Category	Earthen Levee			GPS Latitude/Longitude	
				Start	End
Item	Slope Stability			38.303884°	38.303884°
				-121.575334°	-121.575334°
DWR ID	DWR_RD0003_01_s_2022_189				
Comment Code					
S1 : Repair slope instability.					
Inspector Comment					
This is located at DSID 22134 (abandoned pipe crossing). Recommend monitoring for now.

View of small depression at waterside hinge (Spring 2022).

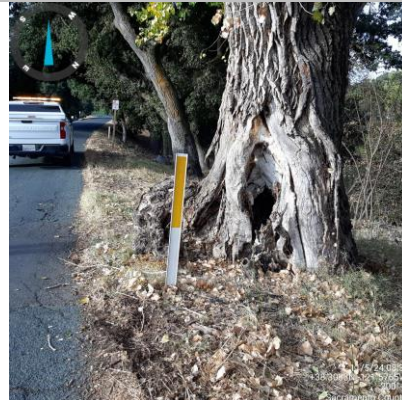
Photo 1 of 1 : FA_2024_RD0003_24_2_20241105_00117.jpg

LM Start	0.13	Rating **	A/W	Issue No.	2
LM End	0.13	Issue Type +	Ma	Location *	WS
Category	Earthen Levee			GPS Latitude/Longitude	
				Start	End
Item	Erosion / Bank Caving			38.303303°	38.303303°
				-121.576538°	-121.576538°
DWR ID	DWR_RD0003_01_f_2013_2				
Comment Code					
E1 : Note and monitor erosion site.					
Inspector Comment					
A depression was observed next to a tree with a hollow trunk. The LMA should monitor the area for additional depression and the tree's health.

View of hollow tree that should be monitored on the waterside hinge. (Fall 2024)

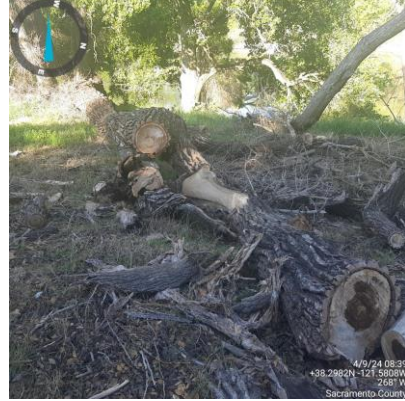
Photo 1 of 1 : FA_2024_RD0003_24_39_20241001_00013.jpg

View of fallen tree on WS slope to be removed. (Spring 2024)

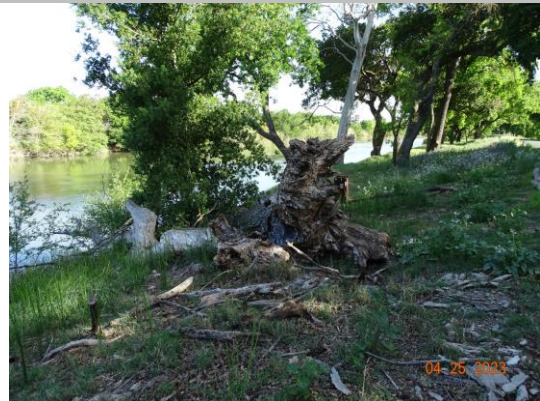
Photo 1 of 1 : FA_2024_RD0003_24_130_20241001_00037.jpg

LM Start	0.97	Rating **	M	Issue No.	130
LM End	0.97	Issue Type +	Ma	Location *	WS
Category	Earthen Levee			GPS Latitude/Longitude	
				Start	End
Item	Trim / Thin Trees			38.292549°	38.292549°
				-121.582563°	-121.582563°
DWR ID	DWR_RD0003_01_s_2022_130				
Comment Code					
T2 : Tree or limb.					
Inspector Comment

View of the tree limb on the WS slope (Spring 2023).

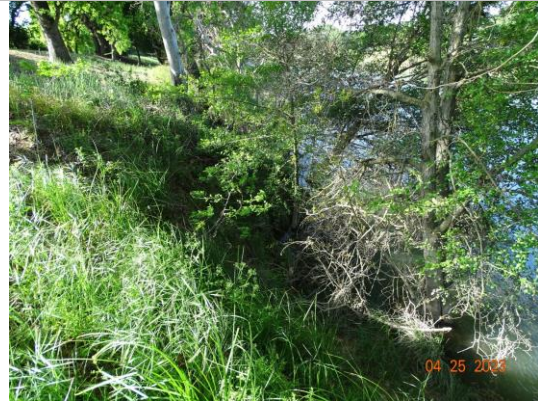
Photo 1 of 1 : FA_2024_RD0003_24_60_20241001_00021.jpg

LM Start	1.09	Rating **	U	Issue No.	60
LM End	1.10	Issue Type +	Ma	Location *	WS
Category	Earthen Levee			GPS Latitude/Longitude	
				Start	End
Item	Erosion / Bank Caving			38.290819°	38.290706°
				-121.582942°	-121.582939°
DWR ID	LMA-102				
Comment Code					
E2 : Schedule repair of erosion site prior to the next inspection.					
Inspector Comment					
This was a 2017 Storm Damage site. An erosion site exists along approximately 41 linear feet of the waterside slope. Site ID No:276 Site Designation:LMA-102 6/18/2020 Boat Inspection: Significant erosion into waterside prism directly upstream of tree that is leaning into water. That leaning tree is creating an eddy that is causing the erosion. There is also some less significant erosion into the waterside toe upstream of the significant erosion site.

View of the erosion on the WS slope (Spring 2023).

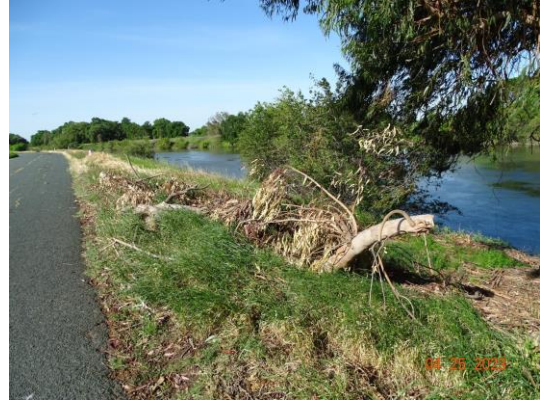
Photo 1 of 1 : FA_2024_RD0003_24_32_20241001_00009.jpg

View of the tree limb on the WS slope (Spring 2023).

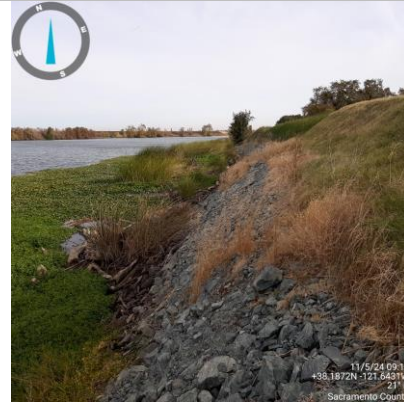
Photo 1 of 1 : FA_2024_RD0003_24_72_20241105_00119.jpg

LM Start	10.15	Rating **	A/W	Issue No.	72
LM End	10.21	Issue Type +	Ma	Location *	WS
Category	Earthen Levee			GPS Latitude/Longitude	
				Start	End
Item	Erosion / Bank Caving			38.188431°	38.187803°
				-121.641703°	-121.642478°
DWR ID	LMA-103				
Comment Code					
E1 : Note and monitor erosion site.					
Inspector Comment					
Rip rap was placed on the slope. Monitor for further erosion. This was a 2017 Storm Damage site. The waterside slope experienced sloughing and erosion along approximately 312 linear feet. Sloughing commences at approximately 1/4 of the way down the slope from the crown and extends to the rip rap. Site ID No:277 Site Designation:LMA-103

View of rip rap placed on waterside slope. (Fall 2024)

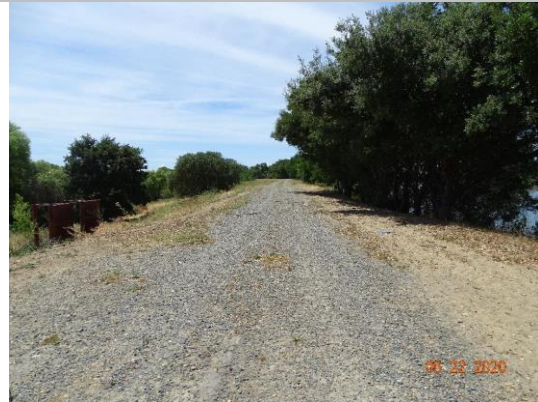
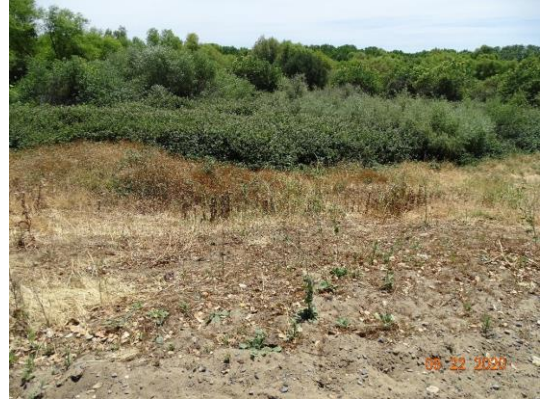
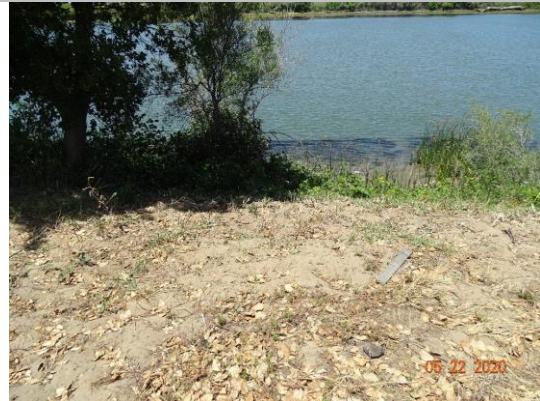
LM Start	10.82	Rating **	M	Issue No.	210
LM End	10.82	Issue Type +	Ma	Location *	
Category	Supplemental			GPS Latitude/Longitude	
				Start	End
Item	DWR UCIP LMA Responsibility			38.183044°	38.183044°
				-121.651367°	-121.651367°
DWR ID	22350				
Comment Code					
Inspector Comment					
DS_ID:22350 FS_ID:69661 EP_NO: N/A Repair Type: Non-Urgent EVAL Issue: Crossing Status: Not Found UCIP Comments: 05/22/2020 Record upgraded to Non-Urgent due to missing permit. No signs of pipe found during inspection. Geophysical study (07-24-2018) suggests no pipe present at this location. (S. Donovan - DWR UCIP) FIELD_STRUCT_DESC: 36-inch corrugated metal drainage pipe through the levee, invert elevation 24.0 feet below the crown. [Additional Reference(s): DWR Levee Log, 1993, (HLM 10.90). USACE Sacramento O&M Manual 104, February 1960, (RM 15.20)]. FS Date: 5/22/2020 7:49:00 AM

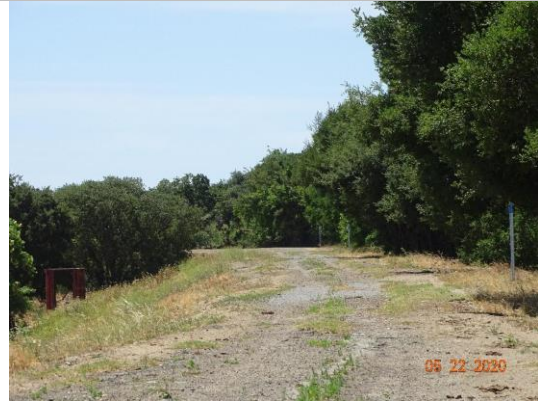
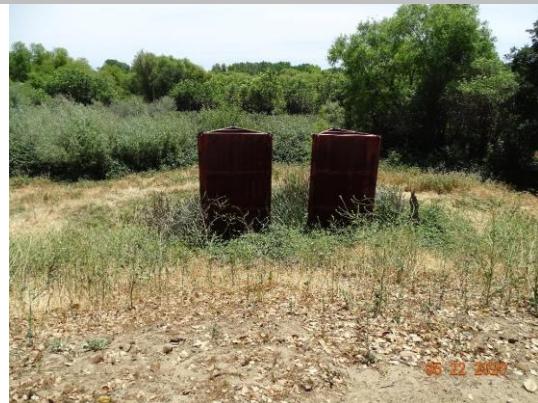
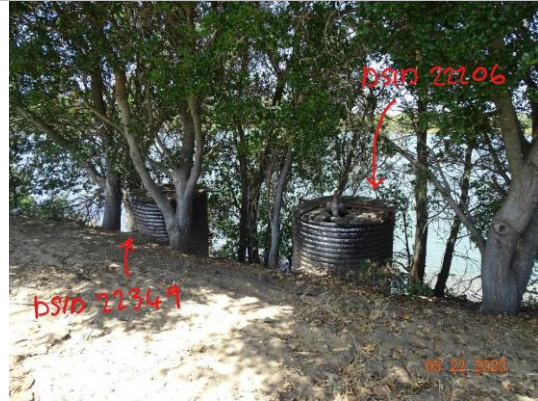
Comment Code					
Inspector Comment					
DS_ID:22206 FS_ID:69662 EP_NO: N/A Repair Type: Non-Urgent EVAL Issue: Crossing Status: Found UCIP Comments: 05/22/2020 Record remains Non-Urgent due to missing permit and crossing being abandoned. (S. Donovan - DWR UCIP) 02/11/2014 Pipe appears abandoned and should be verified as having been done so properly. (G. Wylie - DWR UCIP) FIELD_STRUCT_DESC: 36-inch corrugated metal drainage pipe through the levee, 15.0 feet below the crown. Slide gate in a 48-inch corrugated metal pipe (CMP) riser on the waterside (WS) shoulder. Flap gate at the WS toe has been sealed shut with sealant. [Additional Reference(s): DWR Levee Log, 1993, (HLM 10.90), referenced as 24.0 feet below the crown. USACE Sacramento O&M Manual 104, February 1960, (RM 15.20), referenced as invert elevation 24.0 feet below the crown]. FS Date: 5/22/2020 8:07:00 AM

LS view: Steet weir on the levee toe.

WS view: Standpipe on th levee shoulder.

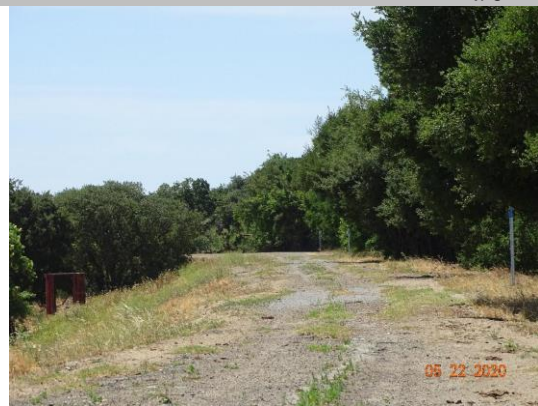
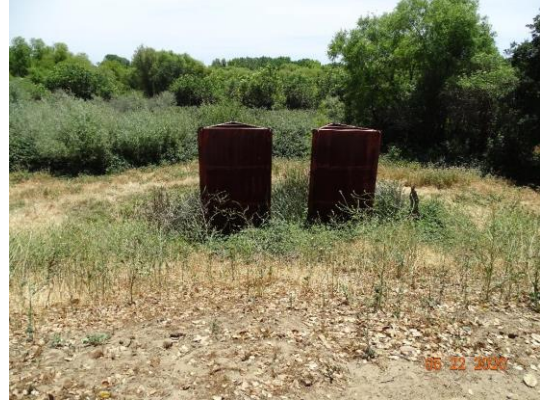
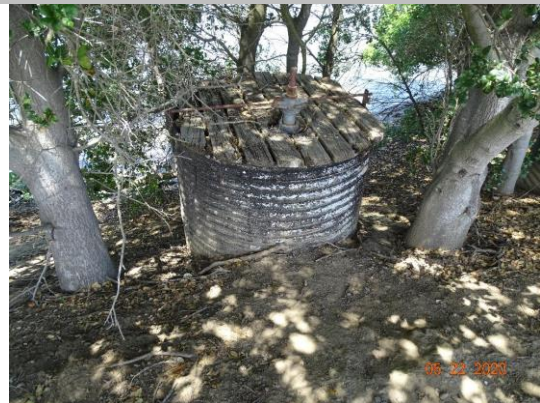
DS_ID:22349
FS_ID:69663
EP_NO: N/A
Repair Type: Non-Urgent
EVAL Issue:
Crossing Status: Found
UCIP Comments: 05/22/2020 Record remains Non-Urgent due to missing permit and crossing being abandoned. (S. Donovan - DWR UCIP)
FIELD_STRUCT_DESC: 36-inch corrugated metal drainage pipe through the levee, 15.0 feet below the crown. Slide gate in a 48-inch corrugated metal pipe (CMP) riser on the waterside (WS) shoulder. Steel intake weir at the landside (LS) toe. Steel plate welded over the pipe on the WS toe. [Additional Reference(s): DWR Levee Log, 1993, (HLM 10.90), referenced as 24.0 feet below the crown. USACE Sacramento O&M Manual 104, February 1960, (RM 15.20), referenced as invert elevation 24.0 feet below the crown].
FS Date: 5/22/2020 8:28:00 AM

LS view: Steel weir on the levee toe.

WS view: Standpipe on the levee shoulder.

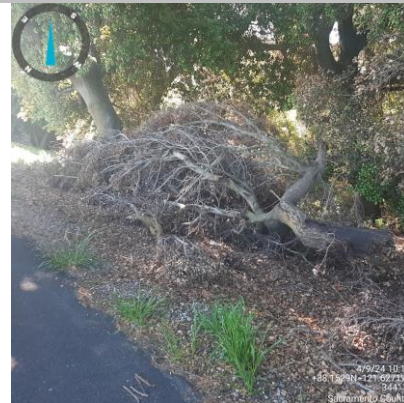
Photo 1 of 1 : FA_2024_RD0003_25_44_20241001_00021.jpg

View of fallen tree on WS shoulder. (Spring 2024)

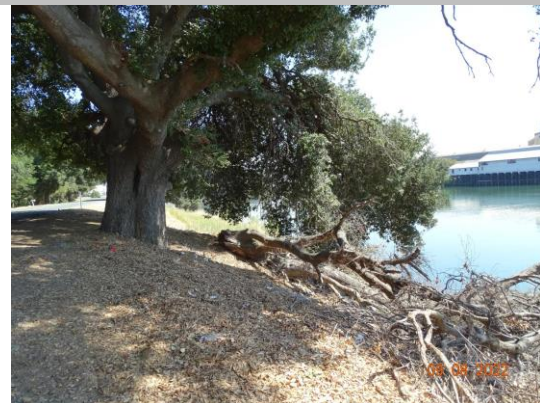
Photo 1 of 1 : FA_2024_RD0003_25_283_20241001_00124.jpg

LM Start	3.35	Rating **	M	Issue No.	283
LM End	3.35	Issue Type +	Ma	Location *	WS
Category	Earthen Levee			GPS Latitude/Longitude	
				Start	End
Item	Trim / Thin Trees			38.169280°	38.169280°
				-121.597585°	-121.597585°
DWR ID	DWR_RD0003_02_f_2022_283				
Comment Code					
T2 : Tree or limb.					
Inspector Comment					
There is a large tree limb on the waterside slope.

View of the tree limb on the waterside slope (Fall 2022).

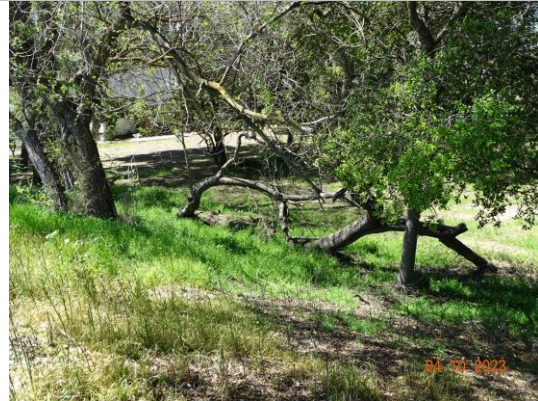
Photo 1 of 1 : FA_2024_RD0003_25_180_20241001_00100.jpg

View of the tree limb on the LS toe (Spring 2023).

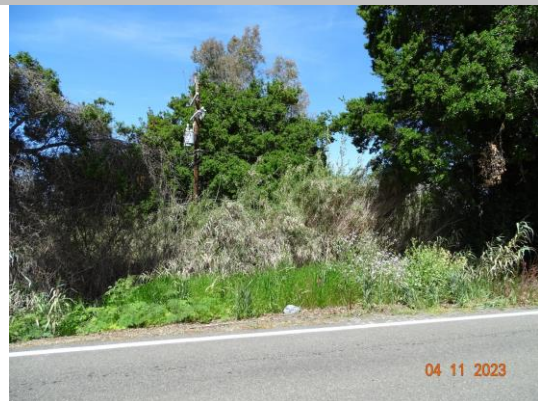
Photo 1 of 1 : FA_2024_RD0003_25_200_20241001_00110.jpg

View of the arundo on the LS slope (Spring 2023).

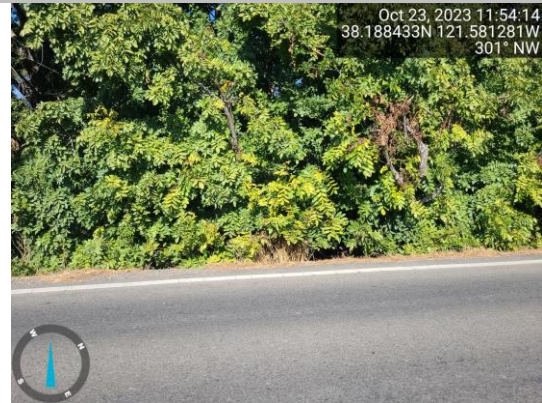
Photo 1 of 1 : FA_2024_RD0003_25_14_20241001_00006.jpg

View of untrimmed trees on the landside slope (Fall 2023).

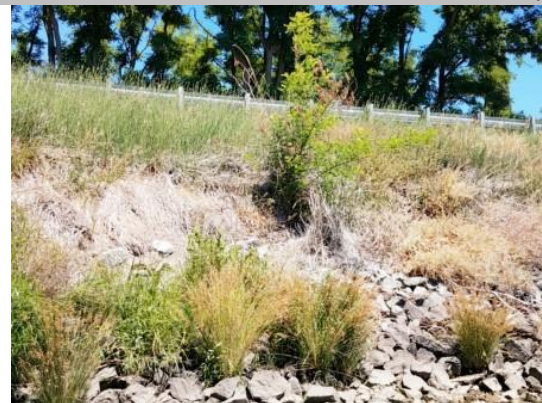
Photo 1 of 1 : FA_2024_RD0003_25_1_20241001_00001.jpg

LM Start	4.96	Rating **	A/W	Issue No.	1
LM End	4.96	Issue Type +	Ma	Location *	WS
Category	Earthen Levee			GPS Latitude/Longitude	
				Start	End
Item	Slope Stability			38.188420°	38.188420°
				-121.580910°	-121.580910°
DWR ID	DWR_RD0003_02_s_2020_1				
Comment Code					
S1 : Repair slope instability.					
Inspector Comment					
Waterside slope bowed in slightly, indicating possible slope instability. Monitor the area for worsening conditions.

View from the channel of slightly bowing into the waterside slope (Summer 2020).

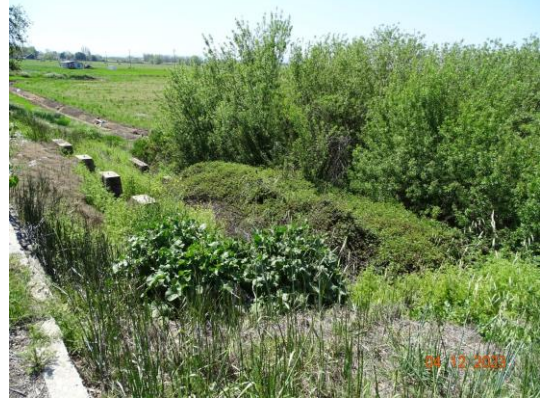
Photo 1 of 1 : FA_2024_RD0003_25_16_20241001_00008.jpg

View of the vegetation and trees on the LS slope and toe (Spring 2023).

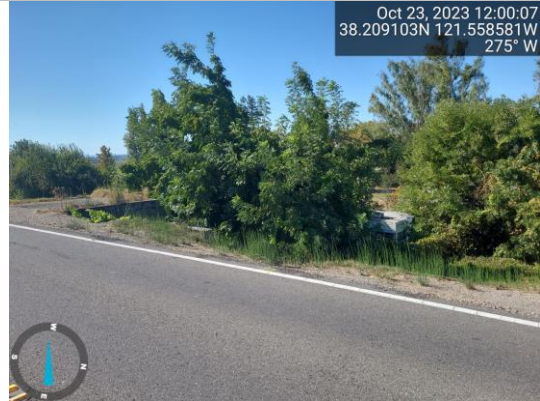
Photo 1 of 1 : FA_2024_RD0003_25_152_20241001_00080.jpg

View of thick trees on the landside slope (Fall 2023).

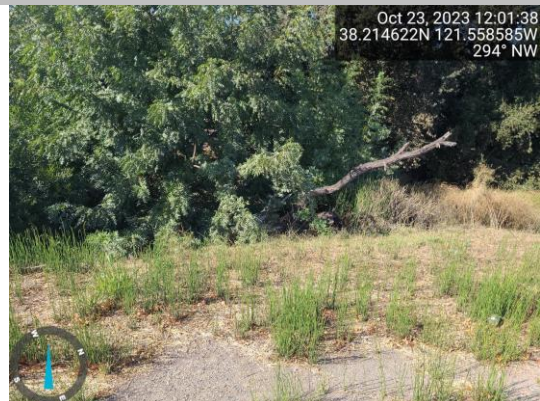
Photo 1 of 1 : FA_2024_RD0003_25_173_20241001_00095.jpg

View of downed tree limb on the landside slope (Fall 2023).

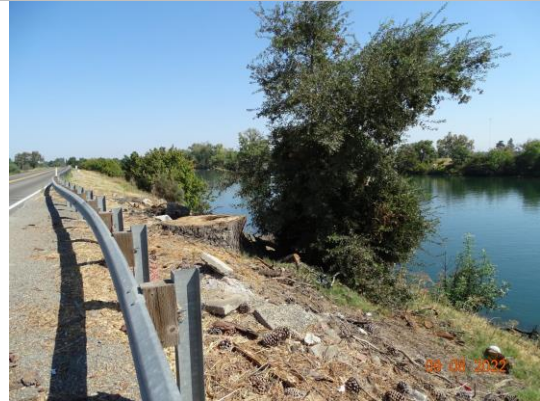
Photo 1 of 1 : FA_2024_RD0003_25_15_20241001_00007.jpg

View of the tree stump below the WS shoulder (Fall 2022).

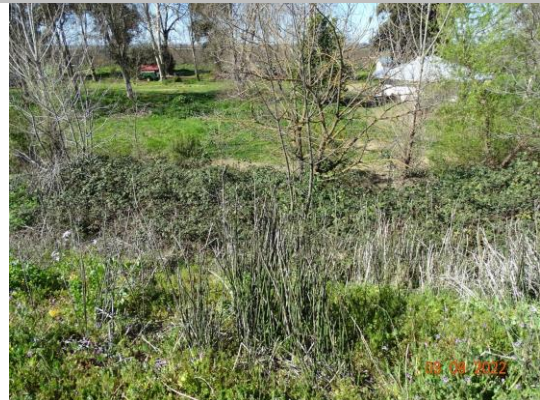
Photo 1 of 1 : FA_2024_RD0003_25_179_20241001_00099.jpg

View of blackberries on the landside toe (Spring 2022).

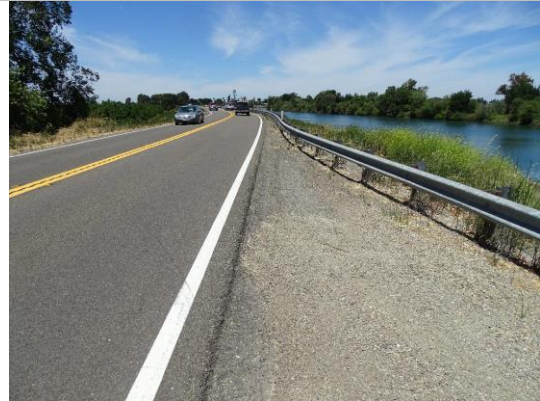
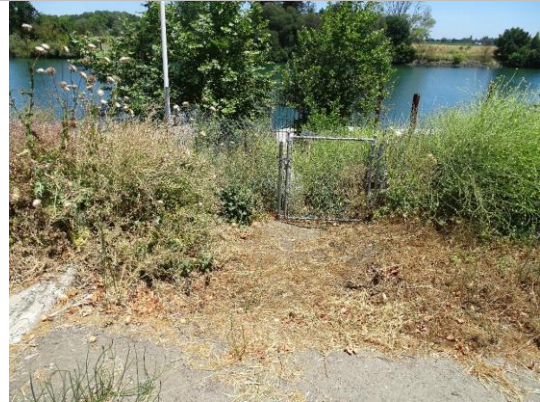
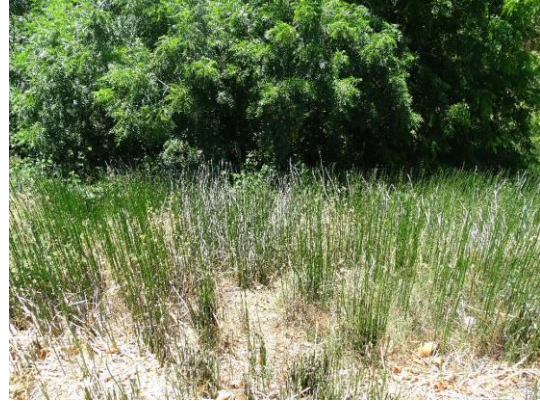
LM Start	8.48	Rating **	M	Issue No.	959	
LM End	8.48	Issue Type +	Ma	Location *		
Category	Supplemental			GPS Latitude/Longitude		
				Start	End	
Item	DWR UCIP LMA Responsibility			38.229477°	38.229477°	
				-121.557255°	-121.557255°	
DWR ID	22261					
Comment Code						
Inspector Comment						
DS_ID:22261 FS_ID:77154 EP_NO: N/A Repair Type: Non-Urgent EVAL Issue: Crossing Status: Not Found UCIP Comments: 06/09/2022 Abandoned, not found, unauthorized encroachment, USACE legacy system pipe, non-urgent. (A. McDonald - DWR UCIP) FIELD_STRUCT_DESC: 10-inch steel gravity drainage pipe through the levee, invert elevation 5.8 feet below the crown. Concrete pad and retaining wall on the waterside (WS) slope. [Additional Reference(s): DWR Levee Log, 1993. USACE Sacramento O&M Manual 104, February 1960, (RM 23.43)]. FS Date: 6/9/2022

WS overview, gate, walkway, and dock on slope and river

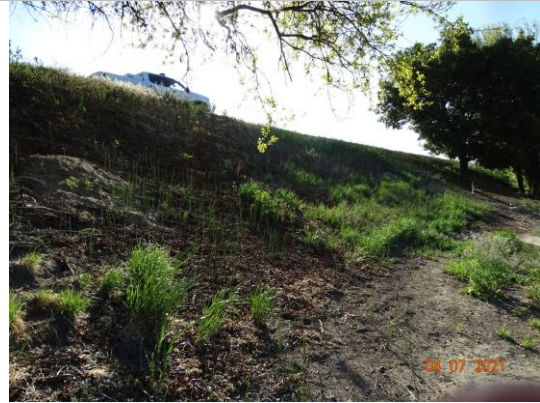
Photo 1 of 1 : FA_2024_RD0003_25_167_20241001_00091.jpg

View of multiple rodent holes in the landside slope (Spring 2021).

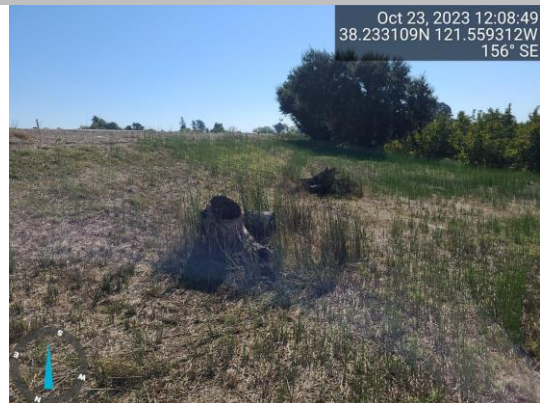
Photo 1 of 1 : FA_2024_RD0003_25_211_20241001_00114.jpg

View looking slightly downstream at tree logs on the landside slope (Fall 2023).

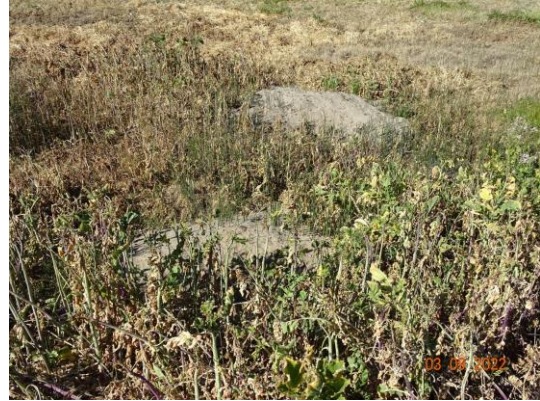
Photo 1 of 1 : FA_2024_RD0003_25_161_20241001_00087.jpg

View of a couple rodent holes on the landside slope (Spring 2022).

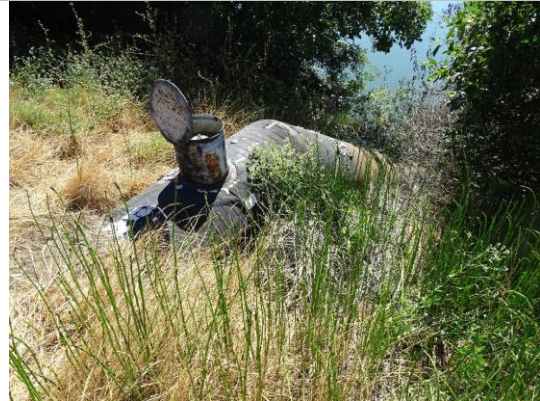
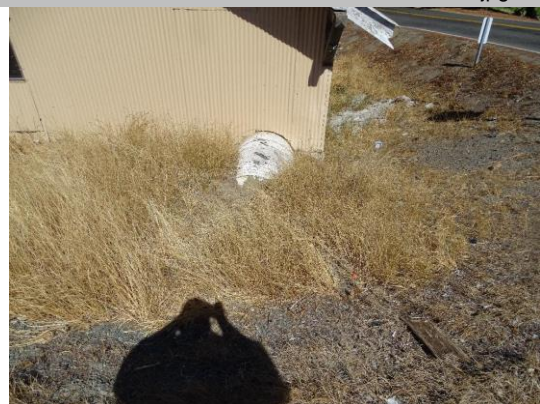
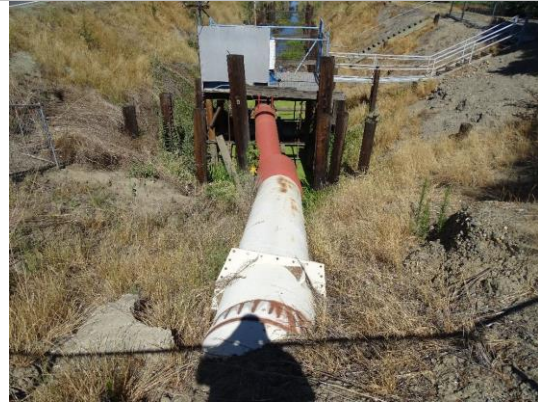
Comment Code						
Inspector Comment						
DS_ID:22269 FS_ID:76526 EP_NO: 4385 Repair Type: No Action Needed EVAL Issue: Crossing Status: Found UCIP Comments: 06/15/2022 Drainage pipe compliant with permit, no action needed. (A. McDonald - DWR UCIP) FIELD_STRUCT_DESC: [Reclamation District No. 3 (RD0003) Drainage Plant] 42-inch steel drainage discharge pipe through the levee, 3 feet below the crown. Pump on a pier at the end of the drainage channel, 220 feet off the landside (LS) toe. Siphon breaker in a 16-inch steel riser on the waterside (WS) slope. Pipe runs through the building on the LS slope. (A 42-inch pipe replaced the existing 40-inch pipe at the same location in 2007 under a revision to Permit No. 4385, 1963 - RD0003). [Additional Reference(s): DWR Levee Log, 1993, 44-inch pipe referenced, 12 feet below the crown. USACE Sacramento O&M Manual 104, February 1960, (RM 24.08), 48-inch pipe referenced, invert elevation 12 feet below the crown]. FS Date: 6/15/2022

Close-up of drainage pipe on WS slope, siphon breaker on shoulder

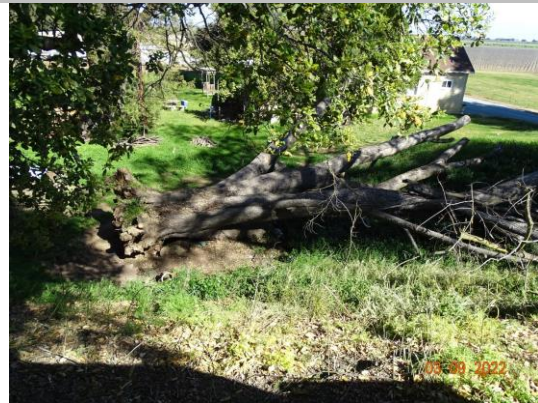
Photo 1 of 1 : FA_2024_RD0003_25_132_20241001_00068.jpg

View of large downed tree on the landside toe (Spring 2022).

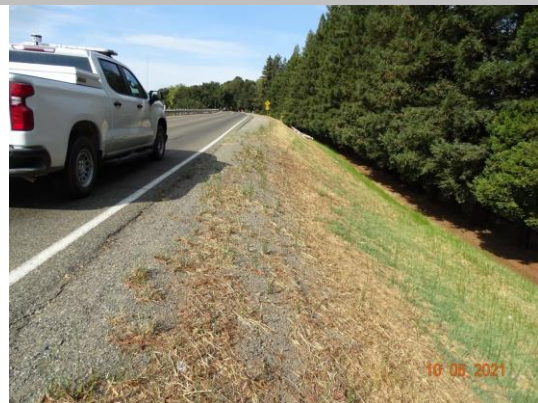
Photo 1 of 1 : FA_2024_RD0003_25_206_20241001_00112.jpg

Landside slope getting close to edge of roadway. Slight cracking in roadway. Continue to monitor.

View of depression in the landside slope getting close to the roadway (Fall 2021).

S1 : Repair slope instability.

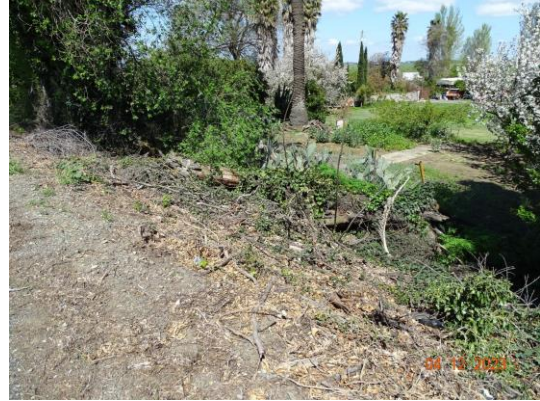
Photo 1 of 1 : FA_2024_RD0003_25_170_20241001_00093.jpg

View of the tree on the LS slope (Spring 2023).

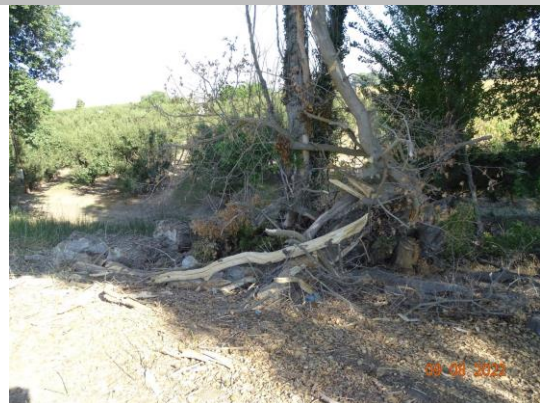
Photo 1 of 1 : FA_2024_RD0003_25_162_20241001_00088.jpg

View of the tree limbs at the LS toe (Fall 2022).

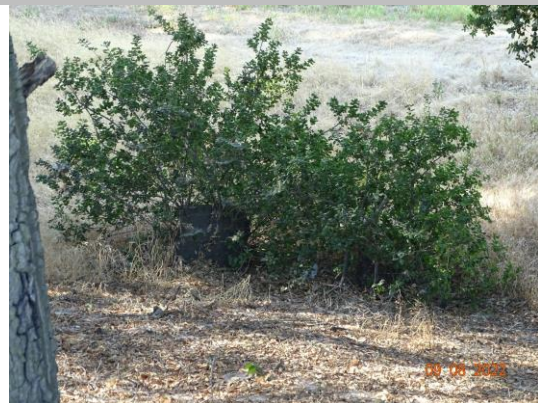
Photo 1 of 1 : FA_2024_RD0003_25_135_20241001_00070.jpg

View of the tree stump at the LS toe (Fall 2022).

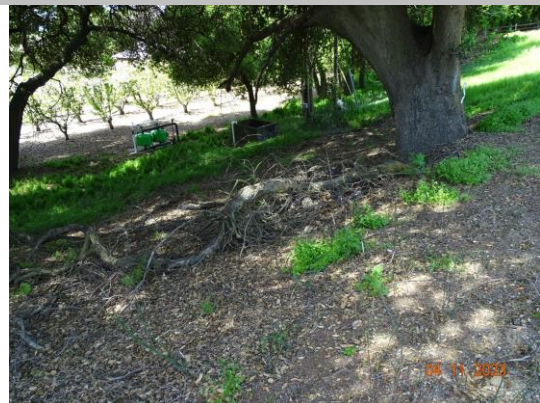
Photo 1 of 1 : FA_2024_RD0003_25_124_20241001_00065.jpg

View of the tree limb on the LS slope (Spring 2023).

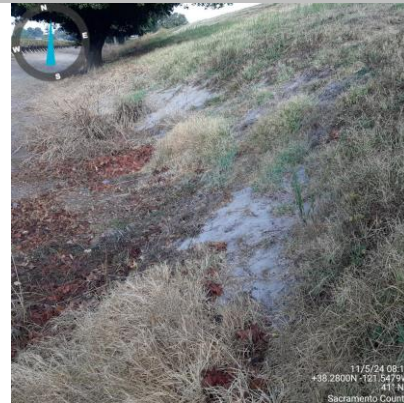
Photo 1 of 1 : FA_2024_RD0003_25_280_20241105_00202.jpg

LM Start	15.15	Rating **	M	Issue No.	280
LM End	15.15	Issue Type +	Ma	Location *	LS
Category	Earthen Levee			GPS Latitude/Longitude	
				Start	End
Item	Erosion / Bank Caving			38.280140°	38.280140°
				-121.547861°	-121.547861°
DWR ID	DWR_RD0003_02_s_2024_280				
Comment Code					
E2 : Schedule repair of erosion site prior to the next inspection.					
Inspector Comment					
There is erosion along the landside levee toe. LMA should repair the toe and monitor the area for additional erosion.

View of the erosion at the landside toe. (Fall 2024)

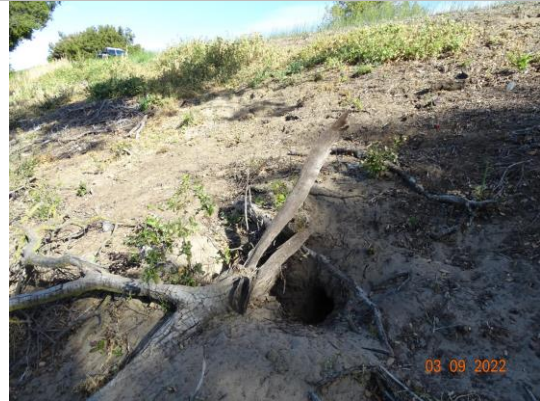
Photo 1 of 1 : FA_2024_RD0003_25_110_20241001_00054.jpg

View looking upslope at large rodent hole in landside slope (Spring 2022).

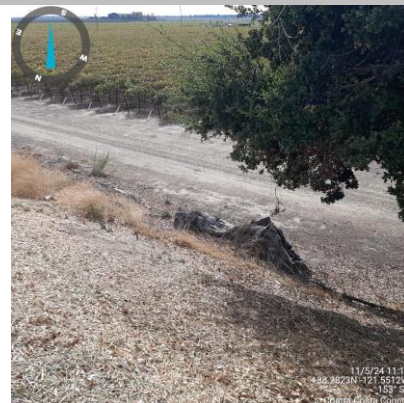
Photo 1 of 1 : FA_2024_RD0003_25_185_20241105_00203.jpg

View of downed tree limb on the landside toe. (Spring 2024)

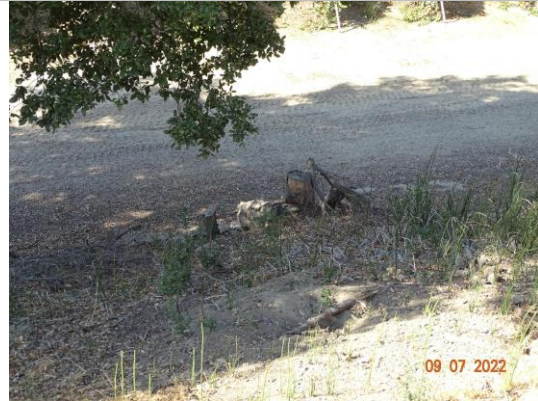
Photo 1 of 1 : FA_2024_RD0003_25_122_20241001_00064.jpg

View of the tree stump at the LS toe (Fall 2022).

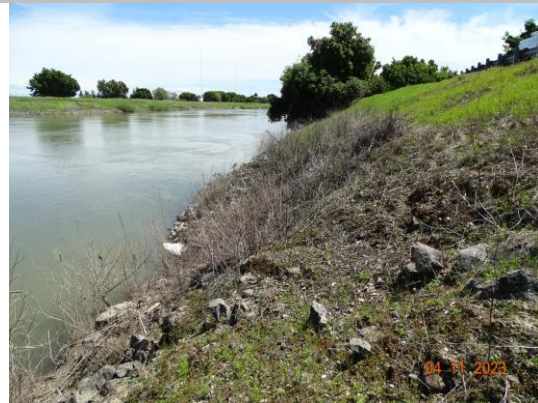
Photo 1 of 1 : FA_2024_RD0003_25_149_20241001_00079.jpg

LM Start	15.46	Rating **	A/W	Issue No.	149
LM End	15.47	Issue Type +	Ma	Location *	WS
Category	Earthen Levee			GPS Latitude/Longitude	
				Start	End
Item	Erosion / Bank Caving			38.283119°	38.283172°
				-121.552250°	-121.552347°
DWR ID	LMA-109				
Comment Code					
E1 : Note and monitor erosion site.					
Inspector Comment					
Fall 2022: At LM 15.46 some erosion on mid slope visible above riprap. This was a 2017 Storm Damage site. Approximately 33 linear feet of erosion. The erosion commences approximately 1/2 of the way down the slope from the crown and extends into the rip rap. A section of rip rap has eroded away in this location. Site ID No:283 Site Designation:LMA-109 4/8/2020 Field Notes: Very minor erosion into waterside toe. Monitor.

View of the erosion on the WS slope (Spring 2023).

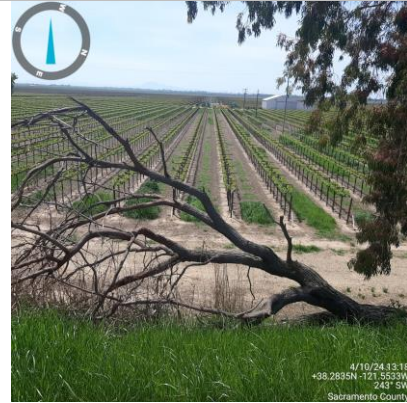
Photo 1 of 1 : FA_2024_RD0003_25_77_20241001_00035.jpg

View of fallen tree on LS slope. (Spring 2024)

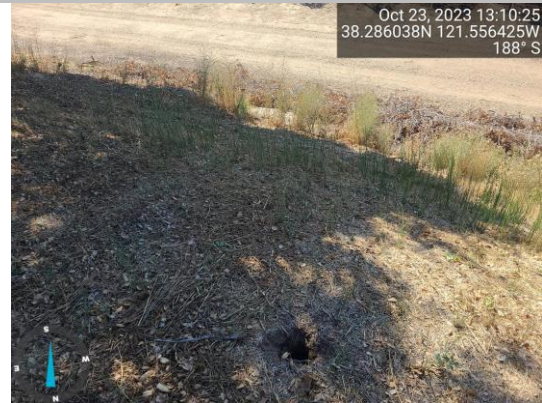
Photo 1 of 1 : FA_2024_RD0003_25_144_20241001_00075.jpg

View looking downslope at rodent holes in the landside slope (Fall 2023).

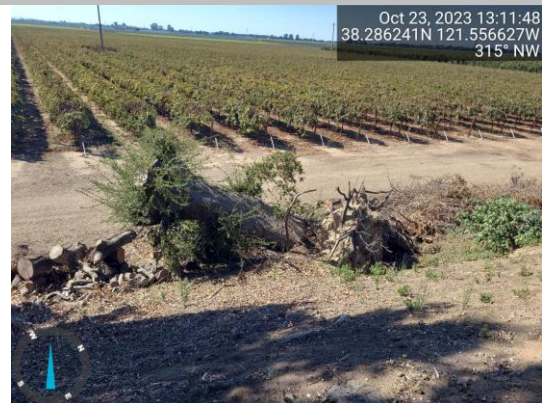
Photo 1 of 1 : FA_2024_RD0003_25_42_20241001_00020.jpg

View of a fallen tree trunk and root ball (Fall 2023).

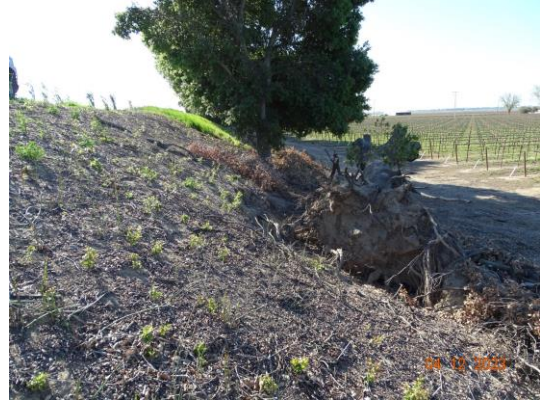
Photo 1 of 1 : FA_2024_RD0003_25_39_20241001_00017.jpg

View of the tree on the LS slope (Spring 2023).

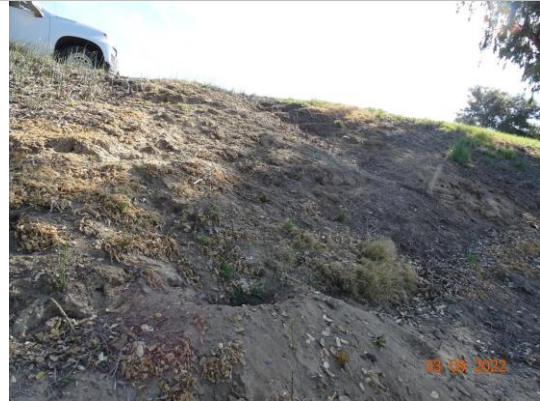
Photo 1 of 1 : FA_2024_RD0003_25_133_20241001_00069.jpg

View looking upslope at rodent holes in the landside slope (Spring 2022).

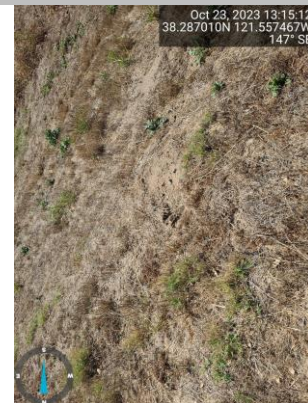
Photo 1 of 1 : FA_2024_RD0003_25_104_20241001_00051.jpg

View looking downstream at rodent hole on the landside slope (Fall 2023).

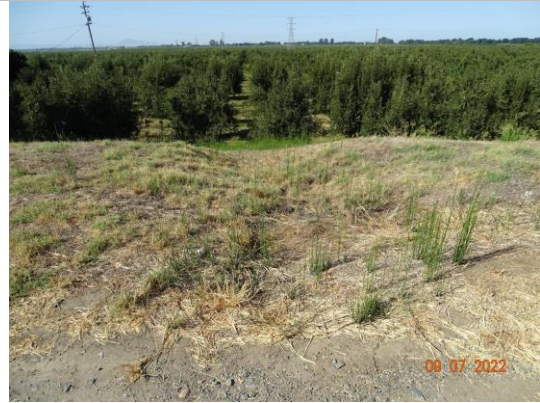
Photo 1 of 1 : FA_2024_RD0003_25_115_20241001_00058.jpg

View of the depression on the LS slope (Fall 2022).

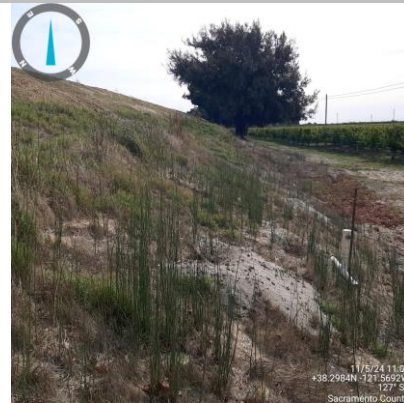
Photo 1 of 1 : FA_2024_RD0003_25_112_20241105_00205.jpg

View of rodent hole damage on the landside slope. (Fall 2024)

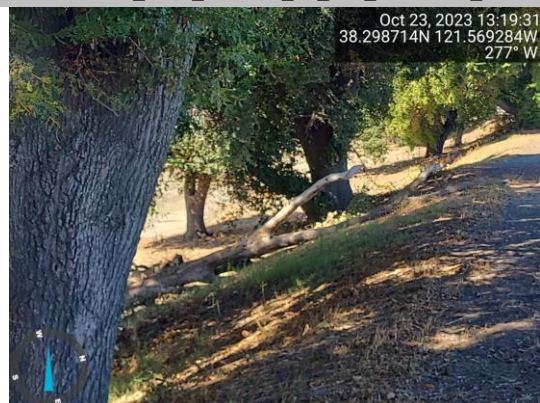
Photo 1 of 1 : FA_2024_RD0003_25_105_20241001_00052.jpg

View of downed tree limb on the landside slope (Fall 2023).

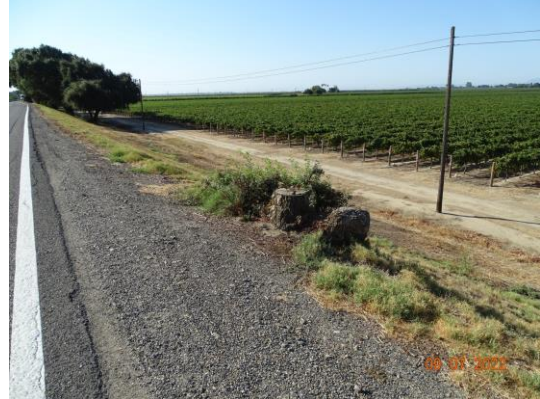
Photo 1 of 1 : FA_2024_RD0003_25_111_20241001_00055.jpg

View of the tree stumps on the LS shoulder (Fall 2022).

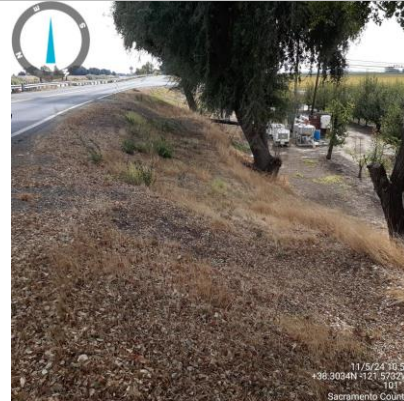
Photo 1 of 1 : FA_2024_RD0003_25_114_20241105_00206.jpg

View looking downstream at depression on the landside slope (Fall 2024).
