**Flood Control Project Maintenance
Levee Inspections**

Fall 2013 Levee Maintenance Deficiency Summary Report

**Flood Control Project Maintenance
Levee Inspections
LMA District Cover Sheet
Fall 2013 Levee Inspection Results**

Reclamation District No. 0010 Honcut

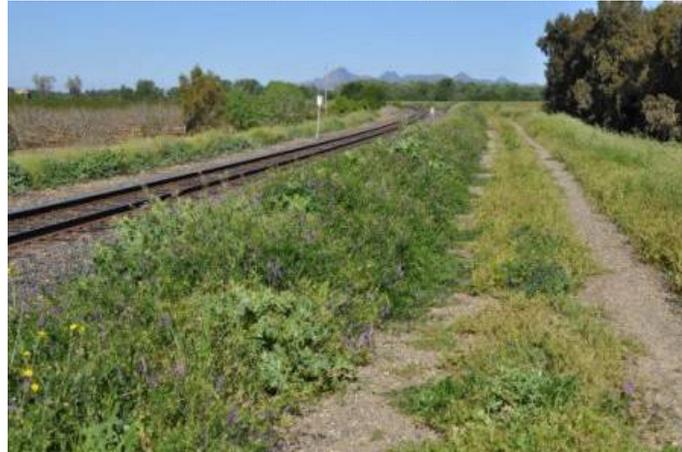
Levee Mile Report Line	7
Start Levee Mile	0.44
End Levee Mile	0.44
Location	Crown
Category	Supplemental
Item	DWR UCIP Field Study
Enter photo 1 description or comment here.	
UCIP_11192.jpg

39.162719 °	-121.601920 °	
								DWR ID: DWR_RD0010_01_f_2013_3		
7	0.44	0.44	Supplemental	DWR UCIP Field Study	LS	M En	Inspector Comments: FS_ID:19244 EP_NO: 13015 Repair Type: Non-Urgent Crossing Status: Found UCIP Comments: Dense vegetation limits the inspector's visibility to identify signs of pipe failure (leaks) along the slope. Recommend removing vegetation along pipe alignment to conduct proper inspection of structure and appurtenances. FIELD_STRUCT_DESC: 4-inch pipe sleeved through an 8-inch pipe through the levee, 30.0 feet below the crown. Annular spaced grouted. Cutoff walls on both ends within the levee. (Permit No. 13015-1981) FS Date: 4/29/2013	39.162719 °	-121.601920 °	4

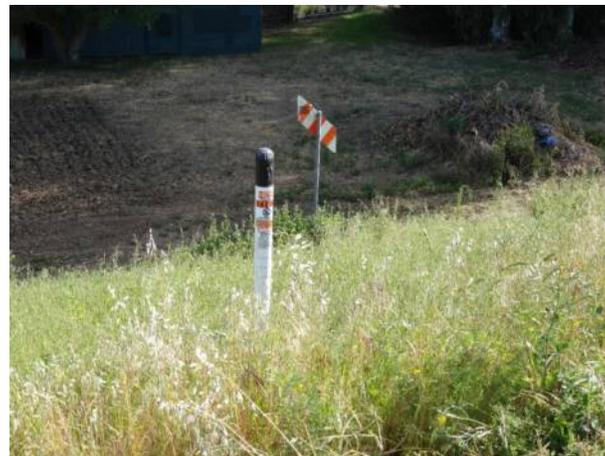
39.162719 °	-121.601920 °	Y
								DWR ID: DWR_RD0010_01_f_2013_4		
8	0.71	0.71	Earthen Levee	Slope Stability	LS	M Ob	S3 : Repair the levee slope damaged by vehicle traffic and prevent access where possible.	39.161198 °	39.161198 °	48
								-121.597102 °	-121.597102 °	Y
								DWR ID: DWR_RD0010_01_f_2013_48

Levee Mile Report Line	8
Start Levee Mile	0.71
End Levee Mile	0.71
Location	Land Side
Category	Earthen Levee
Item	Slope Stability
This photo was taken from the crown looking down the landward slope at an ATV access road that has been formed over time to provide access to the waterward side. Fall 2013.	
mhoffman_f_20131115_695.JPG

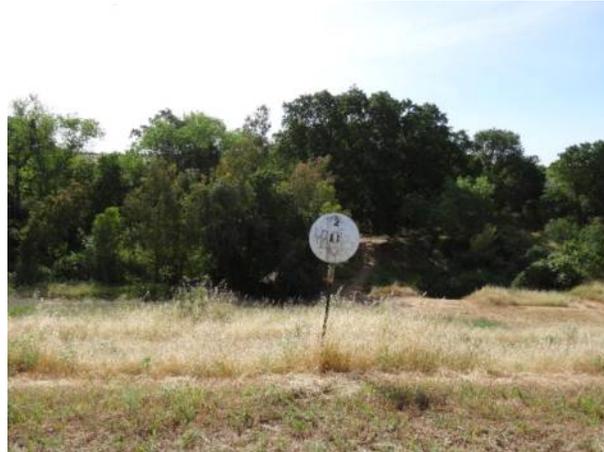
Levee Mile Report Line	12
Start Levee Mile	0.90
End Levee Mile	0.90
Location	Land Side
Category	Supplemental
Item	DWR UCIP Field Study
Enter photo 1 description or comment here.	
UCIP_11225.jpg

LMIR No.	Levee Mile		Category	Item	Location	Rating	Action/Comment	GPS Latitude/Longitude		Issue No. Photo
	Start	End						Start	End	
12	0.90	0.90	Supplemental	DWR UCIP Field Study	LS	M En	Inspector Comments: FS_ID:17709 EP_NO: N/A Repair Type: Non-Urgent Crossing Status: Found UCIP Comments: dense vegetation present on slopes FIELD_STRUCT_DESC: 24-inch CM drainpipe through the levee, 29.5 feet below the crown. Two CM cutoff walls around pipe on both ends. Slide gate on the landward end. Flap gate on the waterward end. Concrete headwall at the landward toe. (USACE-1955). This entry matches the Drainage or Irrigation Structure referenced in O&M manual (Station 37+66). FS Date: 4/29/2013	39.163439 ° 39.163439 °	-121.595445 ° -121.595445 °	13 Y
DWR ID: DWR_RD0010_01_f_2013_13										
13	0.90	0.90	Supplemental	DWR UCIP Field Study	LS	M En	Inspector Comments: FS_ID:19263 EP_NO: N/A Repair Type: Non-Urgent Crossing Status: Found UCIP Comments: Dense vegetation limits the inspector's visibility to identify signs of pipe failure (leaks) along the slope. Recommend removing vegetation along pipe alignment to conduct proper inspection of structure and appurtenances. FIELD_STRUCT_DESC: 24-inch CM drainpipe through the levee, 29.5 feet below the crown. Two CM cutoff walls around pipe on both ends. Slide gate on the landward end. Flap gate on the waterward end. Concrete headwall at the landward toe. (USACE-1955). This entry matches the Drainage or Irrigation Structure referenced in O&M manual (Station 37+66). FS Date: 4/29/2013	39.163439 ° 39.163439 °	-121.595445 ° -121.595445 °	14

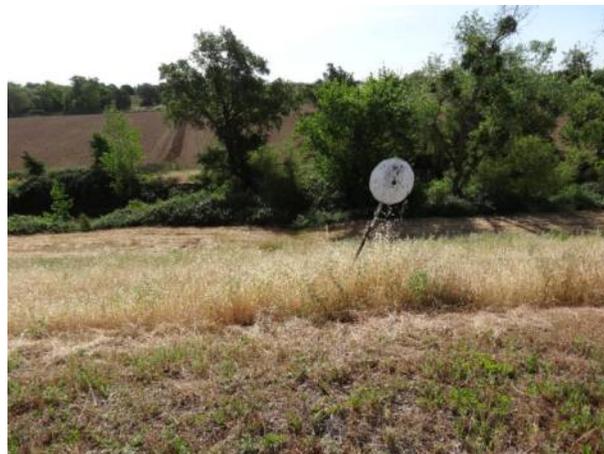
Levee Mile Report Line	16
Start Levee Mile	1.34
End Levee Mile	1.34
Location	Land Side
Category	Supplemental
Item	DWR UCIP Field Study
Enter photo 8 description or comment here.	
UCIP_11250.jpg

16	1.34	1.34	Supplemental	DWR UCIP Field Study	LS	M En	Inspector Comments: FS_ID:17734 EP_NO: N/A Repair Type: Non-Urgent Crossing Status: Found UCIP Comments: FIELD_STRUCT_DESC: 10-inch steel pipe through the levee, 7.3 feet below the crown. Siphon breaker in CM riser on the waterward slope. Pump on the waterward berm. Switch house on the waterward slope. 24-inch concrete standpipe at the landward toe. (USACE-1955). This entry matches the Drainage or Irrigation Structure referenced in O&M manual (Station 14+82). FS Date: 4/29/2013	39.168729 °	-121.590965 °	16
								DWR ID: DWR_RD0010_01_f_2013_16		Y

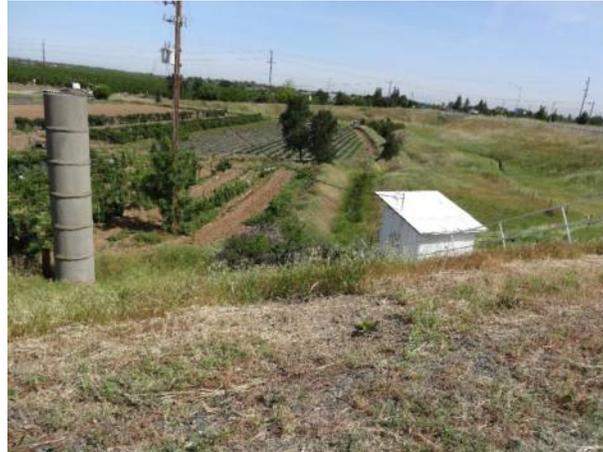
Levee Mile Report Line	19
Start Levee Mile	1.37
End Levee Mile	1.37
Location	Land Side
Category	Supplemental
Item	DWR UCIP Field Study
Enter photo 1 description or comment here.	
UCIP_11276.jpg

19	1.37	1.37	Supplemental	DWR UCIP Field Study	LS	M En	Inspector Comments: FS_ID:17714 EP_NO: N/A Repair Type: Non-Urgent Crossing Status: Found UCIP Comments: Veg on WS FIELD_STRUCT_DESC: [R.D. No 10 Drainage Plant] 16-inch steel pipe through the levee, 7.0 feet below the crown. Steel cutoff plate around pipe at center of levee. Siphon breaker on the landward slope. Flap gate on the waterward end. Pump in pit at landward toe, with steps along the landward slope. Saddle and splash apron (8-foot) at the discharge end of the pipe. Concrete headwall at landward toe. Metal shed on landward slope. (USACE-1955). This entry matches the Drainage or Irrigation Structure referenced in O&M manual (Station 13+88). FS Date: 4/29/2013	39.168820 °	-121.590302 °	19 Y
----	------	------	--------------	----------------------	----	---------	---	-------------	---------------	---------

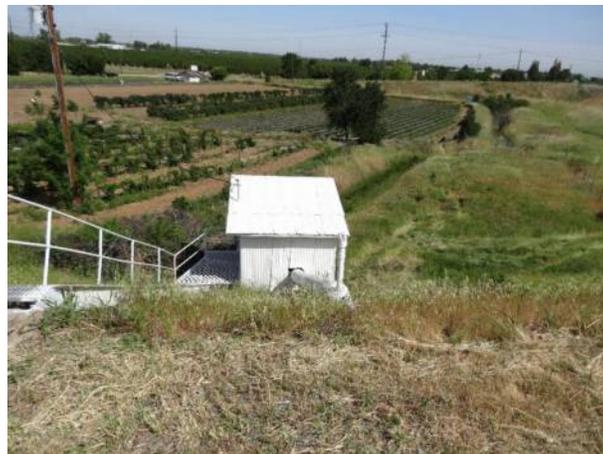
Levee Mile Report Line	22
Start Levee Mile	1.40
End Levee Mile	1.40
Location	Land Side
Category	Supplemental
Item	DWR UCIP Field Study
Enter photo 4 description or comment here.	
UCIP_11295.jpg

22	1.40	1.40	Supplemental	DWR UCIP Field Study	LS	M En	Inspector Comments: FS_ID:17735 EP_NO: N/A Repair Type: Non-Urgent Crossing Status: Found UCIP Comments: FIELD_STRUCT_DESC: 30-inch CM pipe through the levee, approximately 30 feet below the crown. Two CM cutoff walls around the pipe on both sides. Saddle and splash apron at the discharge end of the pipe. Concrete saddle and apron on waterward side. (USACE-1955). This entry matches the Drainage or Irrigation Structure referenced in O&M manual (Station 10+38). FS Date: 4/29/2013	39.168964 °	-121.589799 °	22
----	------	------	--------------	----------------------	----	---------	--	-------------	---------------	----

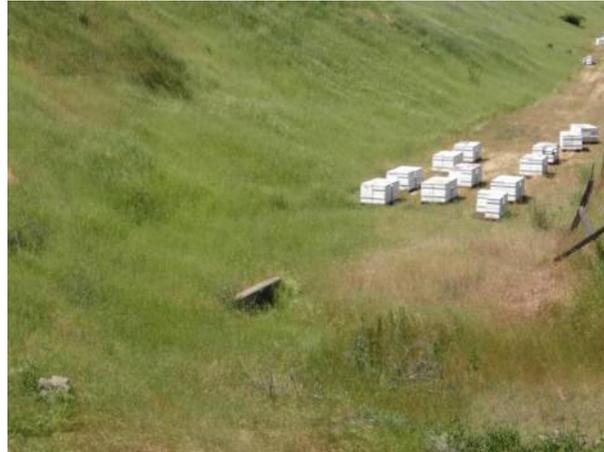
Levee Mile Report Line	26
Start Levee Mile	2.16
End Levee Mile	2.16
Location	Land Side
Category	Supplemental
Item	DWR UCIP Field Study
Enter photo 1 description or comment here.	
UCIP_11324.jpg

26	2.16	2.16	Supplemental	DWR UCIP Field Study	LS	M En	Inspector Comments: FS_ID:19272 EP_NO: N/A Repair Type: Non-Urgent Crossing Status: Found UCIP Comments: Dense vegetation limits the inspector's visibility to identify signs of pipe failure (leaks) along the slope. Recommend removing vegetation along pipe alignment to conduct proper inspection of structure and appurtenances. FIELD_STRUCT_DESC: 24-inch pipe through the levee, 30.0 feet below the crown. Flap gate on waterward end. Concrete headwall at both toes. FS Date: 4/29/2013	39.177051 °	-121.584829 °	25 Y
								DWR ID: DWR_RD0010_01_f_2013_25

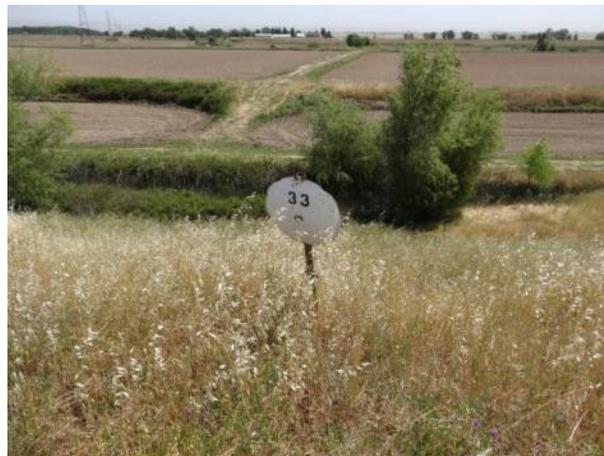
Levee Mile Report Line	28
Start Levee Mile	2.79
End Levee Mile	2.79
Location	Land Side
Category	Supplemental
Item	DWR UCIP Field Study
Enter photo 4 description or comment here.	
UCIP_11333.jpg

DWR ID: DWR_RD0010_01_f_2013_27		
29	2.79	2.79	Supplemental	DWR UCIP Field Study	LS	M En	Inspector Comments: FS_ID:17724 EP_NO: 14020 Repair Type: Non-Urgent Crossing Status: Indicator Found UCIP Comments: confirm with Finney to determine if pump and controls belong to pipe crossing FIELD_STRUCT_DESC: 10-inch steel drainpipe sleeved through a 16-inch steel pipe, 5.0 feet below the crown. Annular gap grouted. Concrete cutoff wall around pipe at center of levee. Siphon breaker at waterward shoulder. Flap gate and concrete headwall at waterward end. (Permit No. 14020-1986) FS Date: 4/29/2013	39.186118 °	-121.583605 °	28
								DWR ID: DWR_RD0010_01_f_2013_28

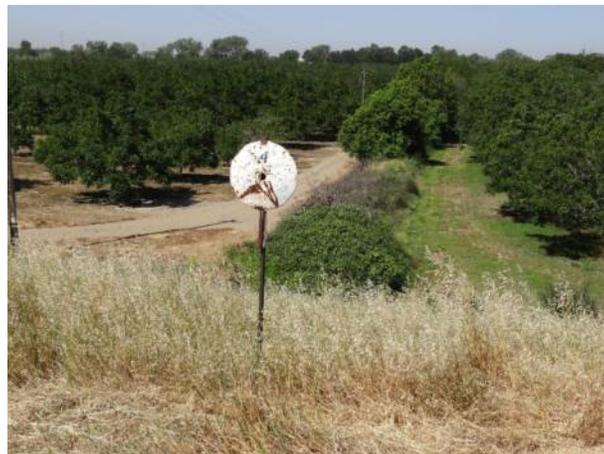
Levee Mile Report Line	6
Start Levee Mile	1.35
End Levee Mile	1.35
Location	Land Side
Category	Earthen Levee
Item	Vegetation
This photo was taken from the crown looking down the landward slope at landscaping and a fence. Fall 2013.	
mhoffman_f_20131115_696.JPG
