**Flood Control Project Maintenance
Levee Inspections**

Fall 2015 Levee Maintenance Deficiency Summary Report

Sacramento River Basin

Reclamation District No. 0010 Honcut

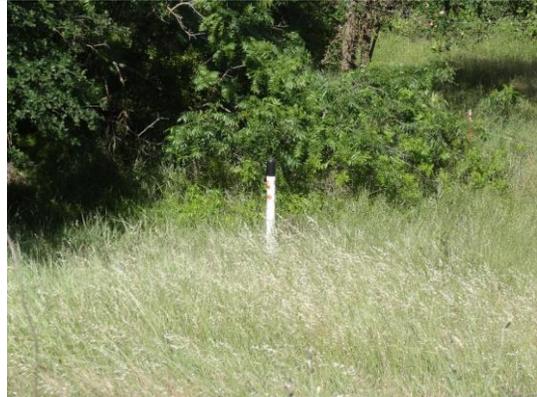
Photo 1 of 2 : UCIP_FA_2015_3233.jpg

LM Start	0.00	Rating **	M	Issue No.	49
LM End	0.00	Issue Type +	En	Location *	N/A
Category	Supplemental			GPS Latitude/Longitude	
				Start	End
Item	DWR UCIP Field Study			39.163750 °	39.163750 °
				-121.609963 °	-121.609963 °
DWR ID					
Action/Comments					
Inspector Comments: FS_ID:27714 DS_ID:24651 EP_NO: N/A FS_HLM: 0 Repair Type: Non-Urgent Crossing Status: Indicator Found UCIP Comments: Need to contact owner--unable to determine if crossing is authorized (no permit found). FIELD_STRUCT_DESC: Fiber optic line markers on levee slope unable to determine if line goes through levee. Multiple markers visible on waterward and landward side. FS Date: 04/29/2013

Marker visible on waterward slope.

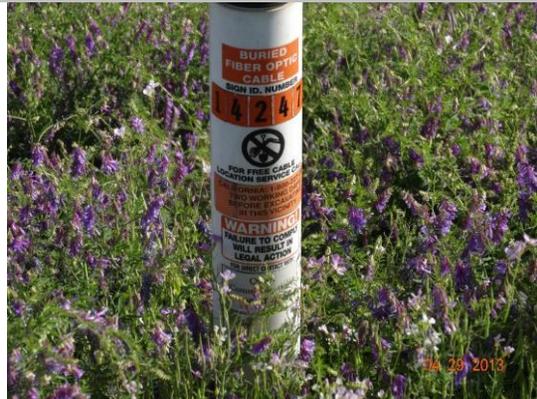
Photo 2 of 2 : UCIP_FA_2015_3230.jpg

LM Start	0.23	Rating **	M	Issue No.	50
LM End	0.23	Issue Type +	En	Location *	N/A
Category	Supplemental			GPS Latitude/Longitude	
				Start	End
Item	DWR UCIP Field Study			39.163407 °	39.163407 °
				-121.605645 °	-121.605645 °
DWR ID					
Action/Comments					
Inspector Comments: FS_ID:27712 DS_ID:24653 EP_NO: N/A FS_HLM: 0.23 Repair Type: Non-Urgent Crossing Status: Indicator Found

Contact information for buried fiber optic cable.

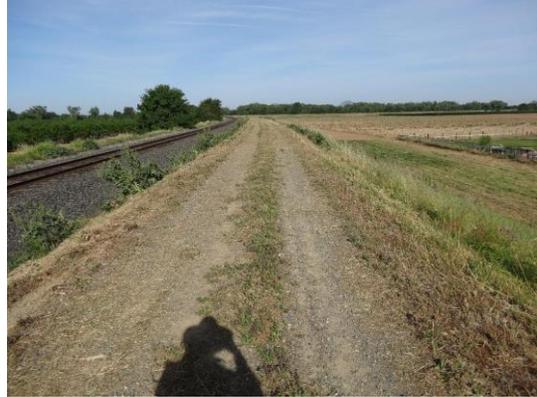
Photo 1 of 3 : UCIP_FA_2015_2811.jpg

LM Start	0.41	Rating **	M	Issue No.	51
LM End	0.41	Issue Type +	En	Location *	N/A
Category	Supplemental			GPS Latitude/Longitude	
				Start	End
Item	DWR UCIP Field Study			39.162847 °	39.162847 °
				-121.602440 °	-121.602440 °
DWR ID					
Action/Comments					
Inspector Comments: FS_ID:24806 DS_ID:21257 EP_NO: 13015 FS_HLM: 0.41 Repair Type: Non-Urgent Crossing Status: Found

View of levee crown looking upstream.

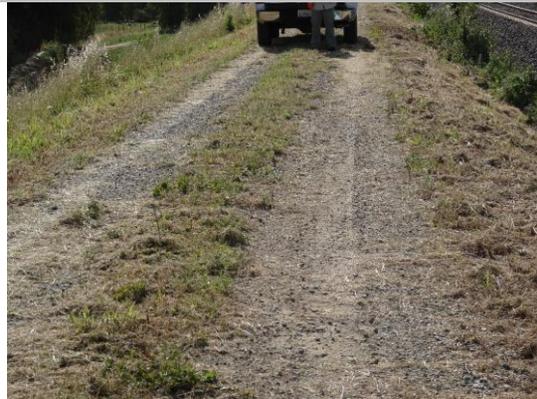
Photo 2 of 3 : UCIP_FA_2015_2812.jpg

View of levee crown looking downstream.

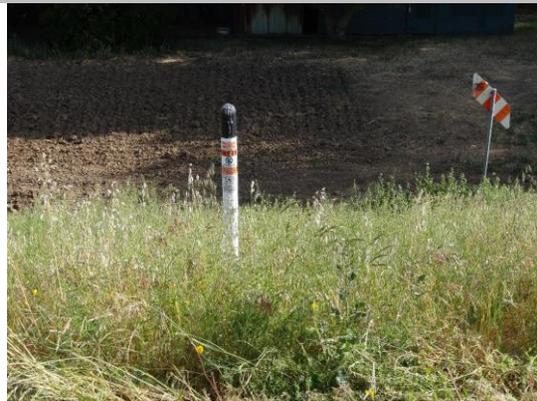
Photo 1 of 2 : UCIP_FA_2015_3231.jpg

LM Start	0.41	Rating **	M	Issue No.	52
LM End	0.41	Issue Type +	En	Location *	N/A
Category	Supplemental			GPS Latitude/Longitude	
				Start	End
Item	DWR UCIP Field Study			39.162853 °	39.162853 °
				-121.602435 °	-121.602435 °
DWR ID					
Action/Comments					
Inspector Comments: FS_ID:27713 DS_ID:24654 EP_NO: N/A FS_HLM: 0.41 Repair Type: Non-Urgent Crossing Status: Indicator Found UCIP Comments: Need to contact owner--unable to determine if crossing is authorized (no permit found) also need to determine if crossing goes through levee. FIELD_STRUCT_DESC: Fiber optic line markers on levee slope unable to determine if line goes through levee. FS Date: 04/29/2013

View of landward side--communication line marker.

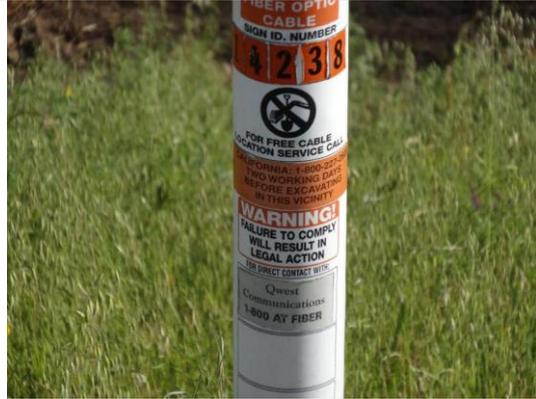
Photo 2 of 2 : UCIP_FA_2015_3232.jpg

Contact information for communication line.

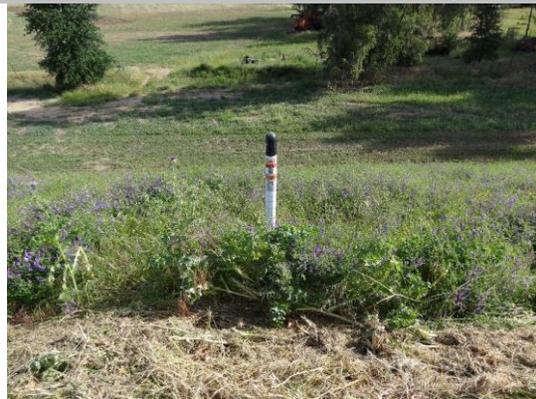
Photo 1 of 2 : UCIP_FA_2015_3227.jpg

LM Start	0.53	Rating **	M	Issue No.	53
LM End	0.53	Issue Type +	En	Location *	N/A
Category	Supplemental			GPS Latitude/Longitude	
	Start		End		
Item	DWR UCIP Field Study			39.162277 °	39.162277 °
				-121.600219 °	-121.600219 °
DWR ID					
Action/Comments					
Inspector Comments: FS_ID:27710 DS_ID:24655 EP_NO: N/A FS_HLM: 0.54 Repair Type: Non-Urgent Crossing Status: Indicator Found UCIP Comments: Need to contact owner--unable to determine if crossing is authorized (no permit found) also need to determine if crossing goes through levee. FIELD_STRUCT_DESC: Fiber optic line markers on levee slope unable to determine if line goes through levee. FS Date: 04/29/2013

View of marker located on landward side.

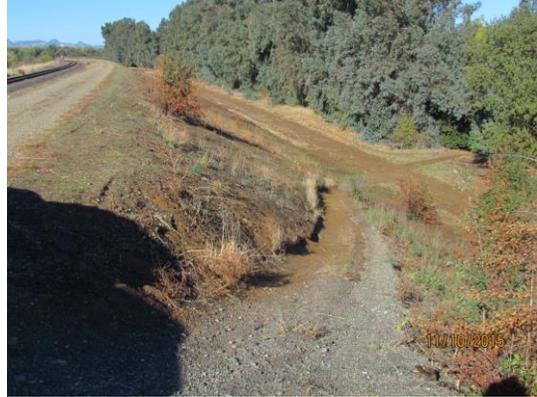
Photo 2 of 2 : FA_2015_RD0010_163_48_20151113_00026.jpg

LM Start	0.72	Rating **	M	Issue No.	48 (cont)
LM End	0.72	Issue Type +	Ob	Location *	LS
Category	Earthen Levee			GPS Latitude/Longitude	
				Start	End
Item	Slope Stability			39.161198 °	39.161198 °
				-121.597102 °	-121.597102 °
DWR ID	DWR_RD0010_01_f_2013_48				
Action/Comments					
Repair the levee slope damaged by vehicle traffic and prevent access where possible. Inspector Comments: Ramp is caused by constant ATV use on levee slope.

View of the slope stability on the landward side of the levee looking downstream. Fall 2015.

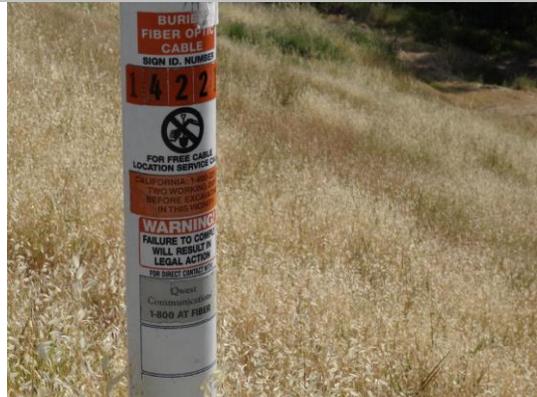
Photo 1 of 2 : UCIP_FA_2015_3235.jpg

LM Start	0.72	Rating **	M	Issue No.	54
LM End	0.72	Issue Type +	En	Location *	LS
Category	Supplemental			GPS Latitude/Longitude	
				Start	End
Item	DWR UCIP Field Study			39.161229 °	39.161229 °
				-121.597072 °	-121.597072 °
DWR ID					
Action/Comments					
Inspector Comments: FS_ID:27715 DS_ID:24656 EP_NO: N/A FS_HLM: 0.72 Repair Type: Non-Urgent Crossing Status: Indicator Found UCIP Comments: Need to contact owner--unable to determine if crossing is authorized (no permit found) also need to determine if crossing goes through levee. FIELD_STRUCT_DESC: Fiber optic line markers on levee slope unable to determine if line goes through levee. FS Date: 04/29/2013

Contact information and ID number for buried fiber optic cable.

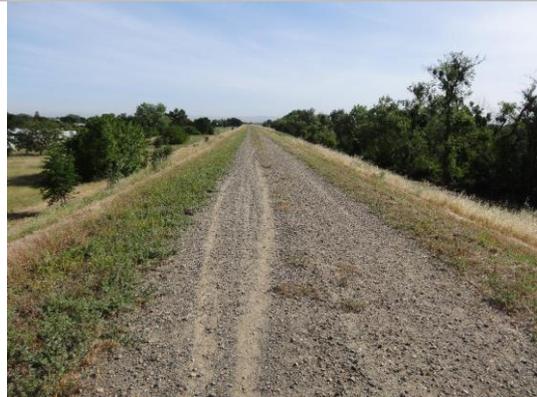
Photo 1 of 3 : UCIP_FA_2015_3293.jpg

LM Start	0.74	Rating **	U	Issue No.	55	
LM End	0.74	Issue Type +	En	Location *	LS	
Category	Supplemental			GPS Latitude/Longitude		
			Start	End		
Item	DWR UCIP Field Study			39.161497 °	39.161497 °	
				-121.596816 °	-121.596816 °	
DWR ID						
Action/Comments						
Inspector Comments: FS_ID:27735 DS_ID:21258 EP_NO: N/A FS_HLM: 0.75 Repair Type: Urgent Crossing Status: Found UCIP Comments: Damaged flap gate on waterward side and damaged stem on screw gate on landward side. Need to contact owner to determine if crossing is still active. If crossing is still in use owner will need to address damage on flap gate and screw gate. If crossing is no longer in use owner will need to contact the CVFPB to comply with Title 23. This crossing is referenced in the USACE Periodic Inspection as item USACE_CESPK_HON1_2013_p_0053 and 0057. FIELD_STRUCT_DESC: 24-inch CM drainpipe through the levee, 31.0 feet below the crown. Two CM cutoff walls around pipe and concrete headwall at both ends. Flap gate on the waterward end. Slide gate on the landward end. Discharges into 6-foot concrete splash apron. (USACE-1953). This entry matches the Drainage or Irrigation Structure referenced in O&M manual (Station 46+60). FS Date: 04/29/2013

View of levee crown looking downstream.

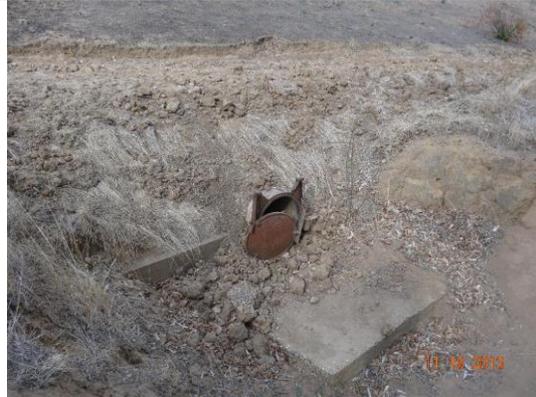
Photo 2 of 3 : UCIP_FA_2015_3330.jpg

LM Start	0.74	Rating **	U	Issue No.	55 (cont)
LM End	0.74	Issue Type +	En	Location *	LS
Category	Supplemental			GPS Latitude/Longitude	
			Start	End	
Item	DWR UCIP Field Study			39.161497 °	39.161497 °
				-121.596816 °	-121.596816 °
DWR ID					
Action/Comments					
Inspector Comments: FS_ID:27735 DS_ID:21258 EP_NO: N/A FS_HLM: 0.75 Repair Type: Urgent Crossing Status: Found UCIP Comments: Damaged flap gate on waterward side and damaged stem on screw gate on landward side. Need to contact owner to determine if crossing is still active. If crossing is still in use owner will need to address damage on flap gate and screw gate. If crossing is no longer in use owner will need to contact the CVFPB to comply with Title 23. This crossing is referenced in the USACE Periodic Inspection as item USACE_CESPK_HON1_2013_p_0053 and 0057. FIELD_STRUCT_DESC: 24-inch CM drainpipe through the levee, 31.0 feet below the crown. Two CM cutoff walls around pipe and concrete headwall at both ends. Flap gate on the waterward end. Slide gate on the landward end. Discharges into 6-foot concrete splash apron. (USACE-1953). This entry matches the Drainage or Irrigation Structure referenced in O&M manual (Station 46+60). FS Date: 04/29/2013

Damage flap gate located on waterward side.

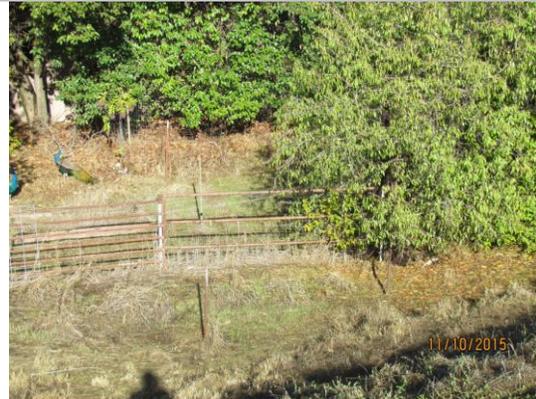
Photo 1 of 1 : FA_2015_RD0010_163_2_20151113_00025.jpg

View of the fence at the toe of the levee on the landward side of the levee. Fall 2015.

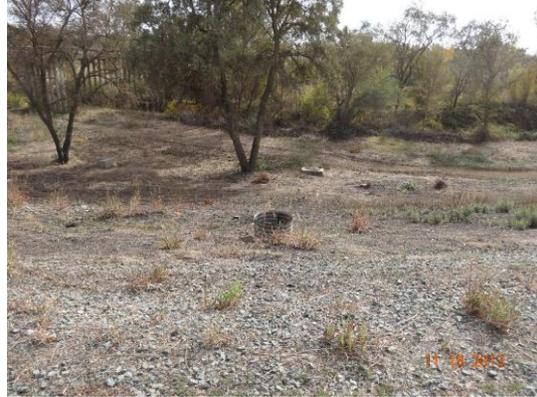
Photo 1 of 3 : UCIP_FA_2015_3253.jpg

Inspector Comments: FS_ID:27725
 DS_ID:21262
 EP_NO: N/A
 FS_HLM: 1.33
 Repair Type: Non-Urgent
 Crossing Status: Found
 UCIP Comments: Crossing appears not to be in use--need to contact owner. Need to coordinate with owner to determine status of crossing. If crossing is no longer in use owner will need to contact the CVFPB to comply with Title 23. This crossing is referenced in the USACE Periodic Inspection as item USACE_CESPK_HON1_2013_p_0012.
 FIELD_STRUCT_DESC: 10-inch steel pipe through the levee, 7.3 feet below the crown. Siphon breaker in CM riser on the waterward slope. Pump on the waterward berm-pump not present. Switch house on the waterward slope-no switch house present. 24-inch concrete standpipe at the landward toe. (USACE-1955). This entry matches the Drainage or Irrigation Structure referenced in O&M manual (Station 14+82). Concrete pad is still present on waterward side.
 FS Date: 04/29/2013

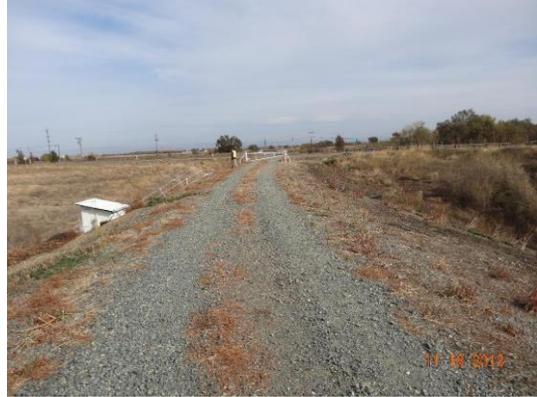
Photo 3 of 3 : UCIP_FA_2015_3255.jpg

LM Start	1.33	Rating **	M	Issue No.	57 (cont)
LM End	1.33	Issue Type +	En	Location *	LS
Category	Supplemental			GPS Latitude/Longitude	
				Start	End
Item	DWR UCIP Field Study			39.168583 °	39.168583 °
				-121.590929 °	-121.590929 °
DWR ID					
Action/Comments					
Inspector Comments: FS_ID:27725 DS_ID:21262 EP_NO: N/A FS_HLM: 1.33 Repair Type: Non-Urgent Crossing Status: Found UCIP Comments: Crossing appears not to be in use--need to contact owner. Need to coordinate with owner to determine status of crossing. If crossing is no longer in use owner will need to contact the CVFPB to comply with Title 23. This crossing is referenced in the USACE Periodic Inspection as item USACE_CESPK_HON1_2013_p_0012. FIELD_STRUCT_DESC: 10-inch steel pipe through the levee, 7.3 feet below the crown. Siphon breaker in CM riser on the waterward slope. Pump on the waterward berm-pump not present. Switch house on the waterward slope-no switch house present. 24-inch concrete standpipe at the landward toe. (USACE-1955). This entry matches the Drainage or Irrigation Structure referenced in O&M manual (Station 14+82). Concrete pad is still present on waterward side. FS Date: 04/29/2013

View of levee crown looking downstream.

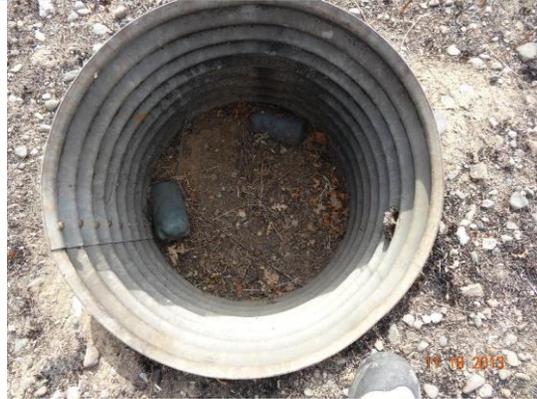
Photo 1 of 3 : UCIP_FA_2015_2839.jpg

Inspector Comments: FS_ID:24810
 DS_ID:21263
 EP_NO: N/A
 FS_HLM: 1.35
 Repair Type: Non-Urgent
 Crossing Status: Found
 UCIP Comments: Pipe has been capped on waterward side--see photos. Need to coordinate with DWR Inspector to determine whether crossing is compliant with Title 23. This crossing is referenced in the USACE Periodic Inspection as item USACE_CESPK_HON1_2013_p_0016.
 FIELD_STRUCT_DESC: 10-inch steel pipe through the levee, 6.8 feet below the crown. Steel cutoff plate around pipe at center of levee. Siphon breaker in CM riser on the waterward slope. Pump on concrete base on the waterward berm-not present. 36-inch concrete standpipe at the landward toe. Metal shed and service pole on the waterward slope-not present. (USACE-1955). This entry matches the Drainage or Irrigation Structure referenced in O&M manual (Station 14+16).
 FS Date: 04/29/2013

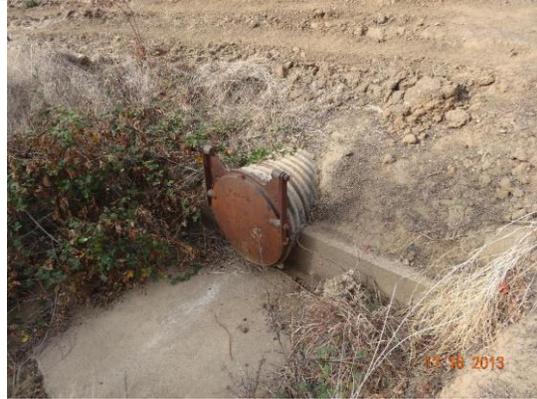
Photo 1 of 3 : UCIP_FA_2015_2851.jpg

LM Start	1.41	Rating **	M	Issue No.	60
LM End	1.41	Issue Type +	En	Location *	LS
Category	Supplemental			GPS Latitude/Longitude	
				Start	End
Item	DWR UCIP Field Study			39.169080 °	39.169080 °
				-121.589478 °	-121.589478 °
DWR ID					
Action/Comments					
Inspector Comments: FS_ID:42872 DS_ID:21318 EP_NO: N/A FS_HLM: 1.42 Repair Type: Non-Urgent Crossing Status: Found UCIP Comments: Holes present on pipe wall. Need to contact owner to notify of issue with pipe. Also need to contact DWR Inspector and CVFPB to determine how to address issue. This crossing is referenced in the USACE Periodic Inspection as item USACE_CESPK_HON1_2013_p_0140. Pipe should be 30-inch instead of 36-inch mentioned Periodic Inspection. FIELD_STRUCT_DESC: 30-inch CM pipe through the levee, approximately 30 feet below the crown. Two CM cutoff walls around the pipe on both sides. Saddle and splash apron at the discharge end of the pipe. Concrete saddle and apron on waterward side. (USACE-1955). This entry matches the Drainage or Irrigation Structure referenced in O&M manual (Station 10+38). FS Date: 04/29/2013

View of headwall, pipe, and flap gate located on waterward side.

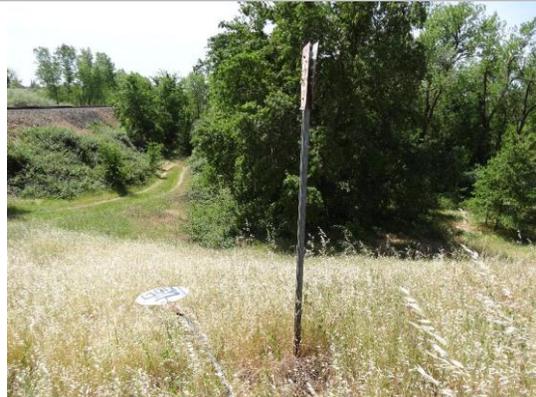
Photo 1 of 3 : UCIP_FA_2015_3352.jpg

LM Start	1.59	Rating **	M	Issue No.	61	
LM End	1.59	Issue Type +	En	Location *	LS	
Category	Supplemental			GPS Latitude/Longitude		
			Start	End		
Item	DWR UCIP Field Study			39.169234 °	39.169234 °	
				-121.586203 °	-121.586203 °	
DWR ID						
Action/Comments						
Inspector Comments: FS_ID:27791 DS_ID:21268 EP_NO: N/A FS_HLM: 1.598 Repair Type: Non-Urgent Crossing Status: Found UCIP Comments: Vegetation has been cleared from slope. This crossing is referenced in the USACE Periodic Inspection as item USACE_CESPK_HON1_2013_p_0158. FIELD_STRUCT_DESC: 24-inch CM drainpipe through the levee, 30.0 feet below the crown. Flap gate on the waterward end. Slide gate on the landward end. Concrete saddle and apron on waterward side. (USACE-1955). This entry matches the Drainage or Irrigation Structure referenced in O&M manual (Station 1+00). FS Date: 04/29/2013

Pipe marker visible on ground--sign has been bent.

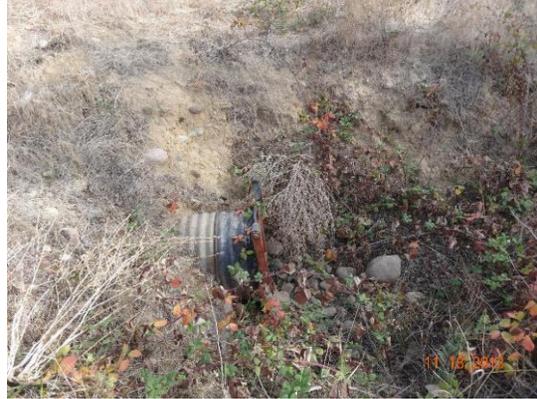
Photo 3 of 3 : UCIP_FA_2015_3354.jpg

View of pipe and flap gate located on waterward side.

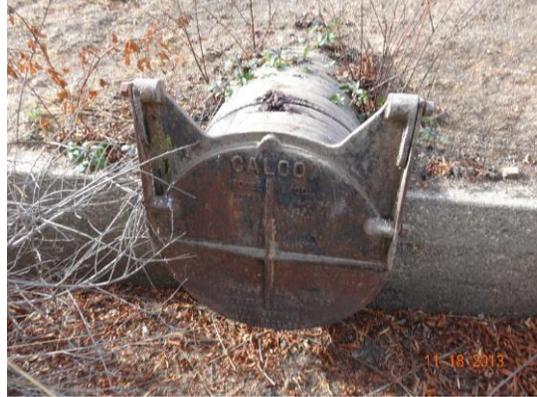
Photo 1 of 3 : UCIP_FA_2015_2959.jpg

LM Start	2.14	Rating **	M	Issue No.	62
LM End	2.14	Issue Type +	En	Location *	LS
Category	Supplemental			GPS Latitude/Longitude	
				Start	End
Item	DWR UCIP Field Study			39.176936 °	39.176936 °
				-121.584848 °	-121.584848 °
DWR ID					
Action/Comments					
Inspector Comments: FS_ID:27745 DS_ID:21271 EP_NO: N/A FS_HLM: 2.15 Repair Type: Non-Urgent Crossing Status: Found

Flap gate appears to be in good condition.

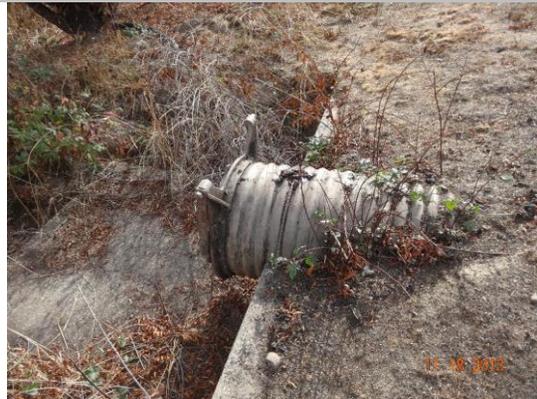
Photo 2 of 3 : UCIP_FA_2015_2960.jpg

View of pipe, headwall, and flap gate located on waterward side.

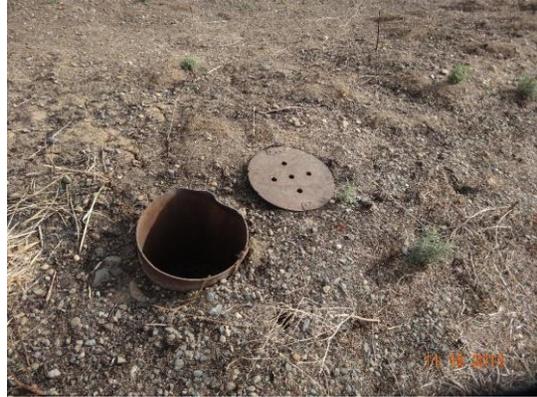
Photo 1 of 3 : UCIP_FA_2015_2882.jpg

View of riser with damage lid located on waterward shoulder.

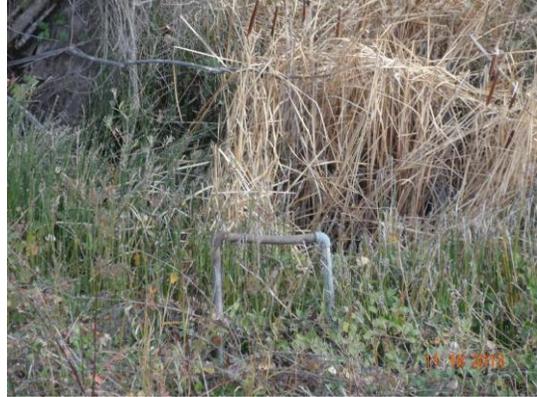
Photo 3 of 3 : UCIP_FA_2015_2887.jpg

Unable to confirm crossing--only visible sign is U shaped pipe through vegetation.

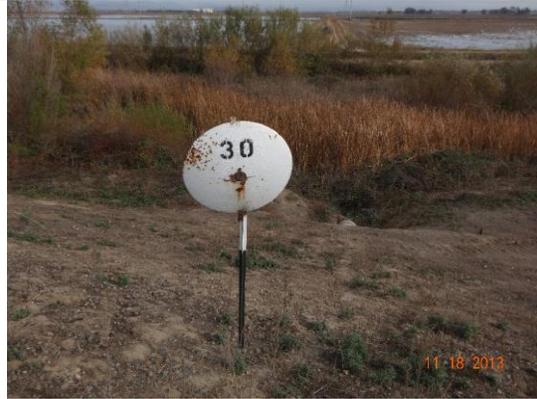
Photo 1 of 3 : UCIP_FA_2015_2962.jpg

View of waterward side--marker indicating crossing located on waterward shoulder.

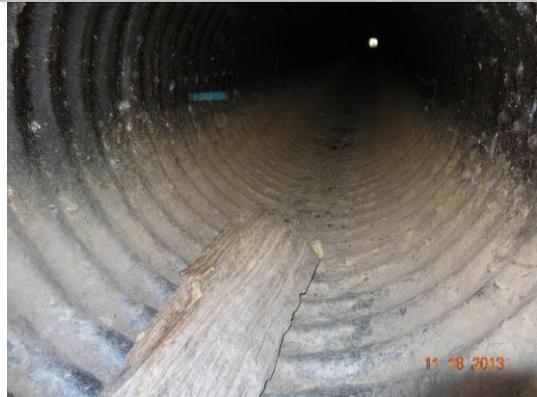
Photo 2 of 3 : UCIP_FA_2015_2963.jpg

Internal view of pipe wall using camera with flash.

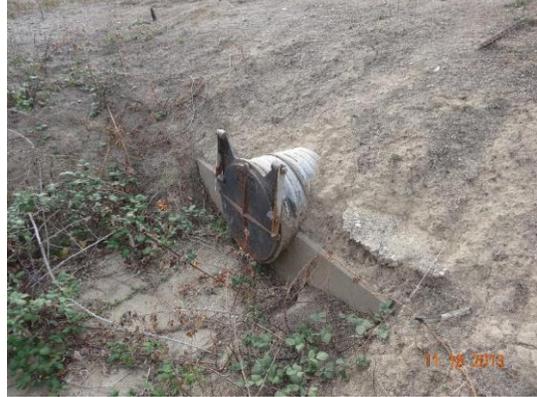
Photo 3 of 3 : UCIP_FA_2015_2964.jpg

View of pipe, flap gate, and headwall located on waterward toe.

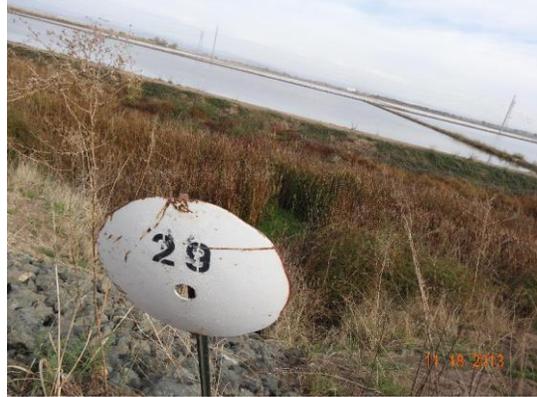
Photo 3 of 3 : UCIP_FA_2015_2229.jpg

Marker for pipe crossing visible on waterward shoulder.

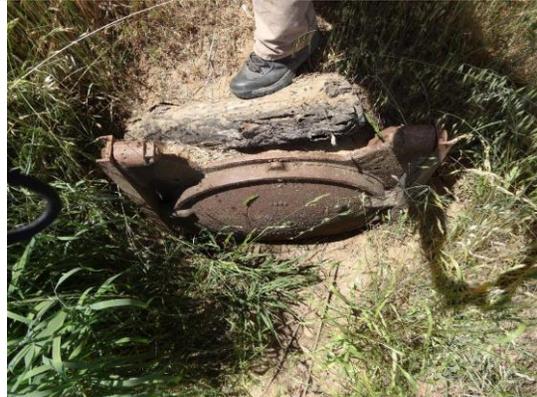
Photo 1 of 3 : UCIP_FA_2015_2671.jpg

Pipe and flap gate confirmed on waterward side.

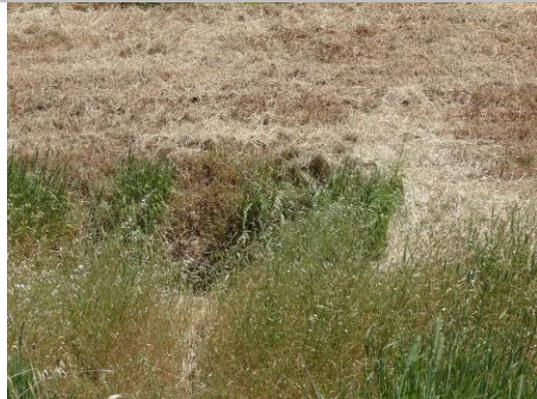
Photo 2 of 3 : UCIP_FA_2015_2672.jpg

View of waterward toe where pipe daylights.

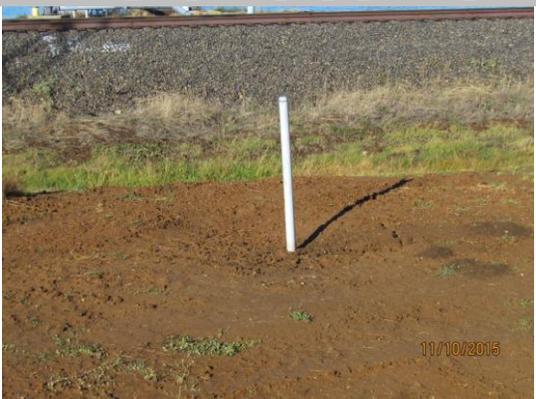
Photo 3 of 4 : FA_2015_RD0010_163_27_20151113_00022.jpg

The culvert seems to be linked to the pipe on the waterward side. Fall 2015.

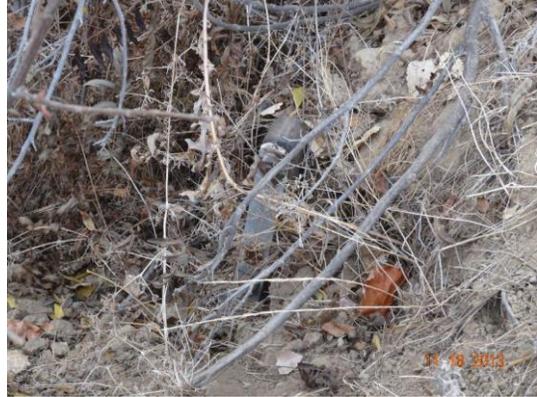
Photo 3 of 3 : UCIP_FA_2015_3374.jpg

Buried flap gate on waterward side.

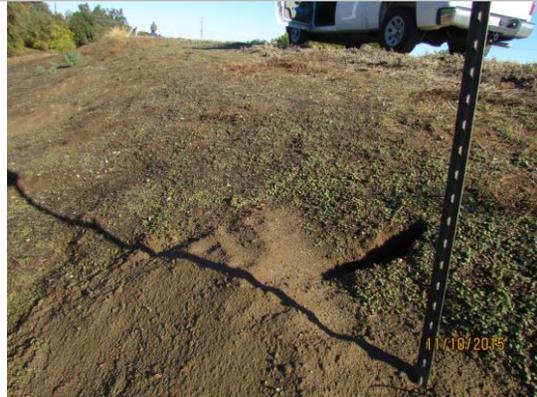
Photo 1 of 1 : FA_2015_RD0010_164_28_20151113_00021.jpg

View of the rodent hole on the waterward side of the levee looking upstream. Fall 2015.

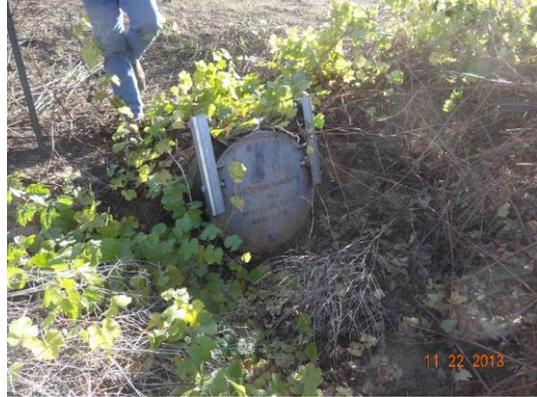
Photo 1 of 3 : UCIP_FA_2015_2910.jpg

View of flap gate located on waterward side.

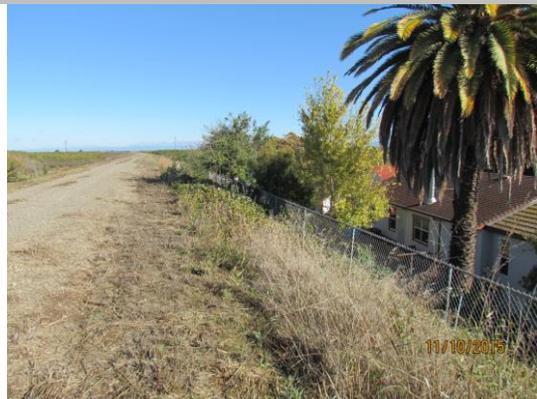
Photo 2 of 2 : FA_2015_RD0010_164_9_20151113_00022.jpg

View of the landscaping on the landward side of the levee looking upstream. Fall 2015.

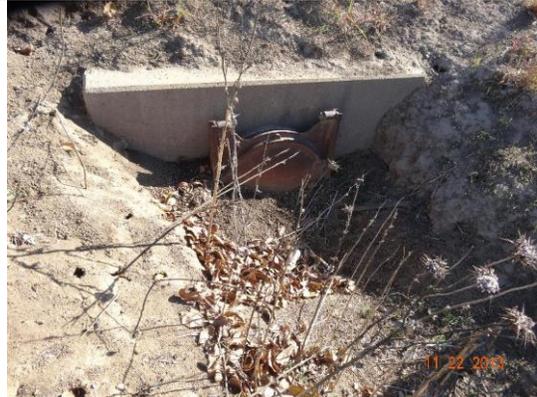
Photo 1 of 3 : UCIP_FA_2015_2117.jpg

Flap gate located on waterward side--debris blocking gate.

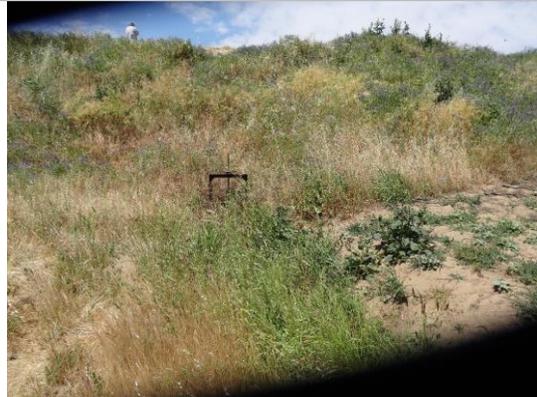
Photo 1 of 3 : UCIP_FA_2015_2848.jpg

View of landward side--dense vegetation.

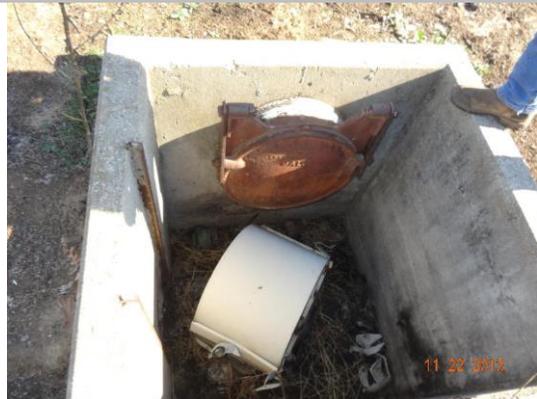
Photo 2 of 3 : UCIP_FA_2015_2804.jpg

View of flap gate located inside concrete distribution box. Debris scattered inside box.

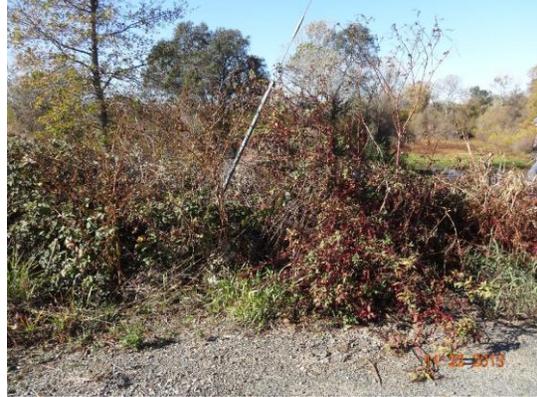
Photo 2 of 4 : UCIP_FA_2015_2168.jpg

View of waterward shoulder behind vegetation is standpipe.

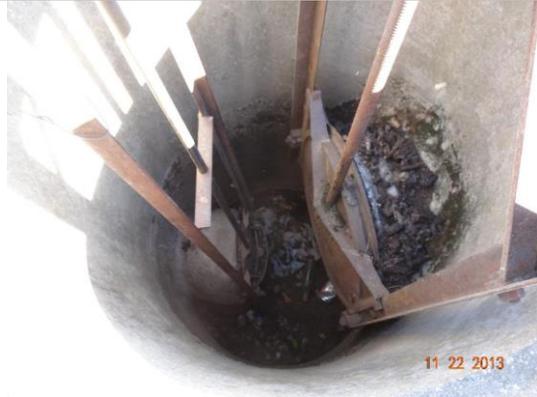
Photo 2 of 3 : UCIP_FA_2015_2188.jpg

Inside view of concrete standpipe with 2 screw gates inside.

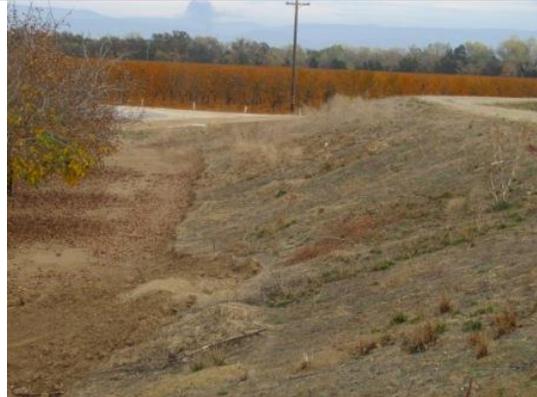
Photo 1 of 1 : FA_2015_RD0010_165_18_20151030_00004.jpg

This photo was taken from the levee crown facing north looking down the waterward slope at agricultural tilling causing a cut at the levee toe. Fall 2013.

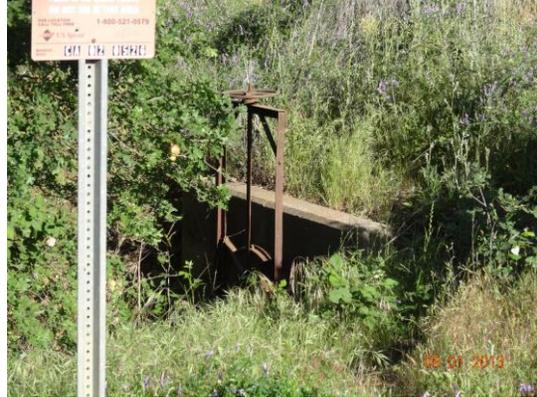
Photo 1 of 1 : UCIP_FA_2015_2202.jpg

View of slide gate and concrete headwall located on landward side.
