**Flood Control Project Maintenance
Levee Inspections
LMA District Cover Sheet
Spring 2010 Levee Inspection Results**

Reclamation District No. 0010 Honcut

Levee Inspection Report By Mile - Spring 2010

Waterway	Bank	Unit Miles	Inspection Start/End	Inspector
Unit No. 01 Simmerly Slough	Right	7.68	04/15/2010 04/15/2010	Clay Thomas

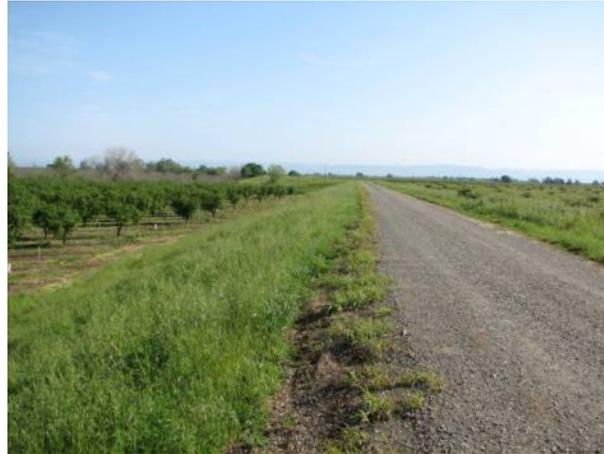
Levee Mile Report Line	1
Start Levee Mile	0.00
End Levee Mile	11.19
Location	Water Side
Category	Earthen Levee
Item	Vegetation
Water side vegetation levee mile 6.69.	
cathom_s_20100520_054.jpg

Waterway				Bank	Unit Miles	Inspection Start/End	Inspector			
Unit No. 02 Feather River				Left	11.24	04/15/2010 04/15/2010	Clay Thomas			
LMIR No	Levee Mile		Category	Item	Location	Rating	Action/Comment	GPS Latitude/Longitude		Issue No. Photo
	Start	End						Start	End	
1	0.00	11.19	Earthen Levee	Vegetation	WS	M	Control annual grass and weeds on the levee slopes and easements.	39.163714 ° -121.609940 °	39.307024 ° -121.617313 °	2 Y
2	0.00	11.19	Earthen Levee	Vegetation	LS	M	Control annual grass and weeds on the levee slopes and easements.	39.163714 ° -121.609940 °	39.307024 ° -121.617311 °	1 Y
3	1.35	1.35	Earthen Levee	Encroachments	LS	PO	Landscaping	39.182957 ° -121.609800 °	39.182957 ° -121.609800 °	9
4	4.93	4.93	Earthen Levee	Encroachments	LS	C	Debris	39.233245 ° -121.614648 °	39.233245 ° -121.614648 °	40
5	5.15	5.15	Earthen Levee	Animal Control	LS	C	No rodents visible, but rodent burrows visible; need to backfill and compact or grout borrows.	39.236373 ° -121.615112 °	39.236373 ° -121.615112 °	32

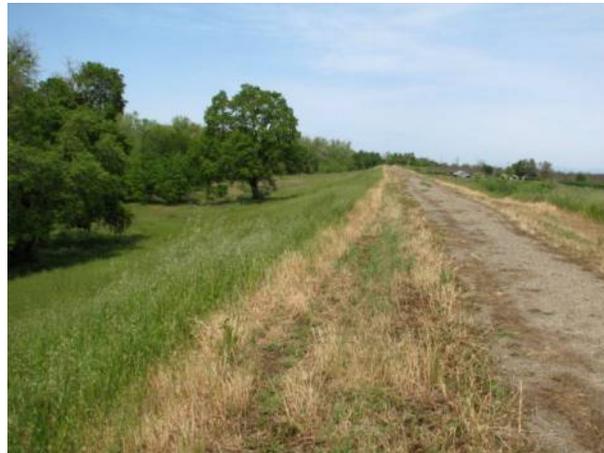
Levee Mile Report Line	1
Start Levee Mile	0.00
End Levee Mile	11.19
Location	Water Side
Category	Earthen Levee
Item	Vegetation
Water side vegetation levee mile 0.00.	
cathom_s_20100520_063.jpg

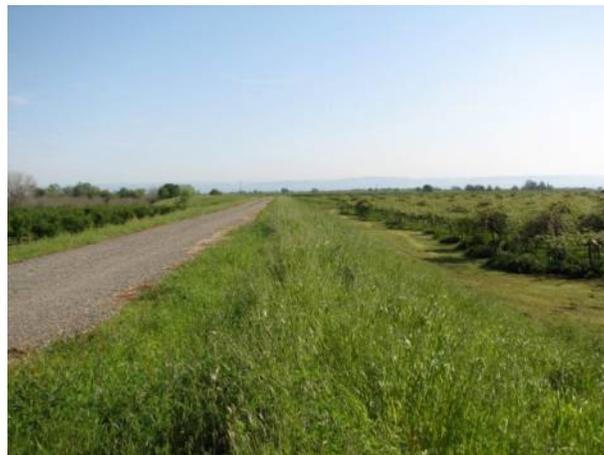
Levee Mile Report Line	2
Start Levee Mile	0.00
End Levee Mile	11.19
Location	Land Side
Category	Earthen Levee
Item	Vegetation
Land side vegetation levee mile 6.69.	
cathom_s_20100520_055.jpg

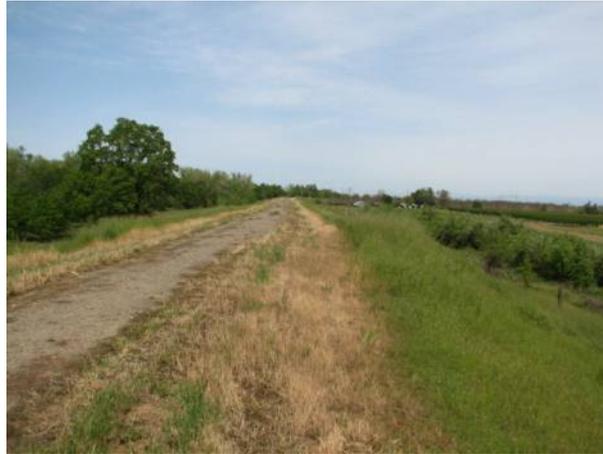
Levee Mile Report Line	2
Start Levee Mile	0.00
End Levee Mile	11.19
Location	Land Side
Category	Earthen Levee
Item	Vegetation
Land side vegetation levee mile 0.00.	
cathom_s_20100520_064.jpg

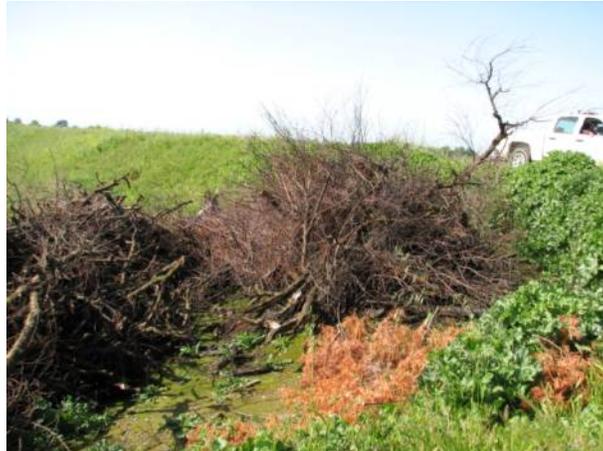
Levee Mile Report Line	13
Start Levee Mile	9.30
End Levee Mile	9.30
Location	Land Side
Category	Earthen Levee
Item	Encroachments
Land side levee mile 9.30.	
cathom_s_20100520_056.jpg

12	8.38	8.38	Earthen Levee	Animal Control	WS	C	Exterminate rodents and backfill and compact or grout burrows.	39.278210 ° -121.608864 °	39.278210 ° -121.608864 °	36
13	9.30	9.30	Earthen Levee	Encroachments	LS	M	Prunings	39.285883 ° -121.600353 °	39.285883 ° -121.600353 °	3 Y
14	9.43	9.43	Earthen Levee	Animal Control	LS	C	Exterminate rodents and backfill and compact or grout burrows.	39.287716 ° -121.600591 °	39.287716 ° -121.600591 °	37
15	9.59	9.59	Earthen Levee	Trim / Thin Trees	LS	C	Trim trees to at least five feet above ground level.	39.289906 ° -121.601758 °	39.289906 ° -121.601758 °	38
16	9.91	9.91	Earthen Levee	Vegetation	LS	C	Control annual grass and weeds on the levee slopes and easements.	39.293100 ° -121.605911 °	39.293100 ° -121.605911 °	39
17	10.74	11.11	Earthen Levee	Vegetation	WS	M	Remove the wild growth other than native grasses from the levee slopes.	39.300812 ° -121.617528 °	39.305892 ° -121.617715 °	23

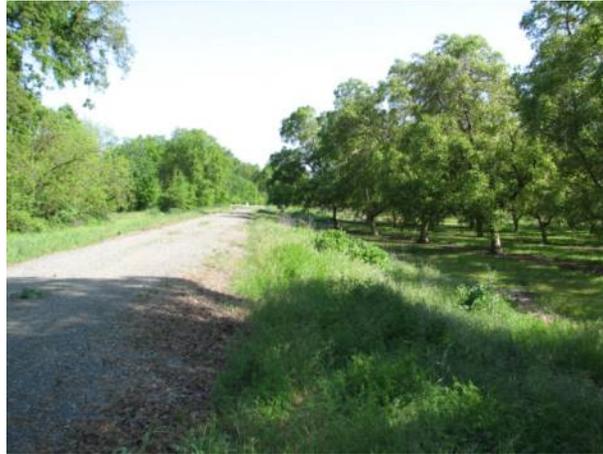
Levee Mile Report Line	1
Start Levee Mile	0.00
End Levee Mile	2.89
Location	Land Side
Category	Earthen Levee
Item	Vegetation
Land side vegetation levee mile 0.00.	
cathom_s_20100520_057.jpg

LMIR No	Levee Mile		Category	Item	Location *	Rating **	Action/Comment	GPS Latitude/Longitude		Issue No. Photo
	Start	End						Start	End	
1	0.00	2.89	Earthen Levee	Vegetation	LS	M	Control annual grass and weeds on the levee slopes and easements.	39.307868 ° -121.617070 °	39.299152 ° -121.571802 °	3 Y
2	0.00	2.89	Earthen Levee	Vegetation	WS	M	Control annual grass and weeds on the levee slopes and easements.	39.307869 ° -121.617070 °	39.299152 ° -121.571801 °	1 Y
3	0.17	0.17	Earthen Levee	Trim / Thin Trees	WS	M	Trim trees over roadway to at least 12 feet above ground level.	39.310032 ° -121.616338 °	39.310032 ° -121.616338 °	2
4	1.91	1.91	Earthen Levee	Animal Control	WS	C	No rodents visible, but rodent burrows visible; need to backfill and compact or grout borrows.	39.303247 ° -121.587677 °	39.303247 ° -121.587677 °	4
5	2.81	2.81	Earthen Levee	Vegetation	WS	M	Remove the wild growth other than native grasses from the levee slopes.	39.299653 ° -121.573072 °	39.299653 ° -121.573072 °	6

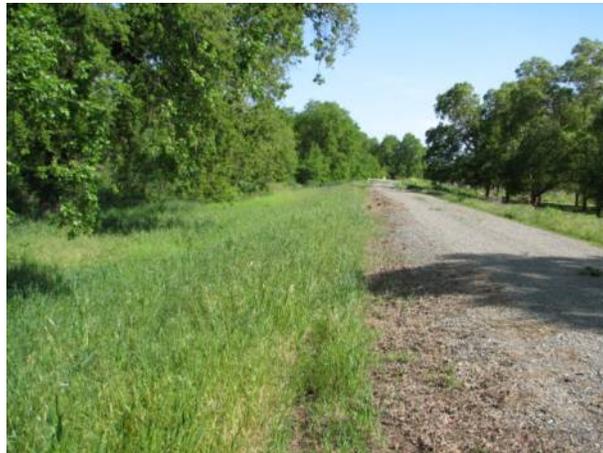
Levee Mile Report Line	2
Start Levee Mile	0.00
End Levee Mile	2.89
Location	Water Side
Category	Earthen Levee
Item	Vegetation
Water side vegetation levee mile 0.00.	
cathom_s_20100520_058.jpg
