**Flood Control Project Maintenance
Levee Inspections****LMA District Cover Sheet****Spring 2013 Levee Inspection Results****Reclamation District No. 0010 Honcut**

Spring 2013 Levee Inspection Results

Reclamation District No. 0010 Honcut

Waterway				Bank	Unit Miles
Unit No. 01 Simmerly Slough				Right	7.68
	Spring (March - May)	Summer (June - August)	(September - November) Fall	Winter (December - February)	
Unit Maintenance Rating (Fall Only)					
Date of Inspection	04/17/2013 - 04/17/2013				
DWR Inspector	Rick Burnett				
Accompanied By	Finlay Williams

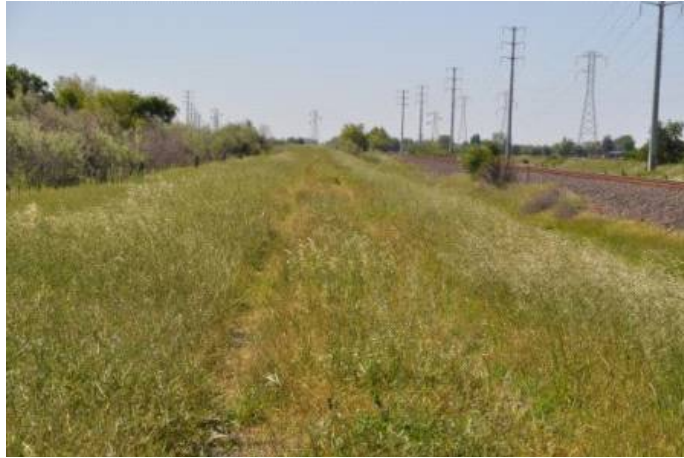
Levee Mile Report Line	4
Start Levee Mile	0.00
End Levee Mile	7.66
Location	Land Side
Category	
Item	Vegetation
RD 10, Unit 1 - Typical vegetation on levee crown and both slopes.	
rburnett_s_20130417_228.JPG

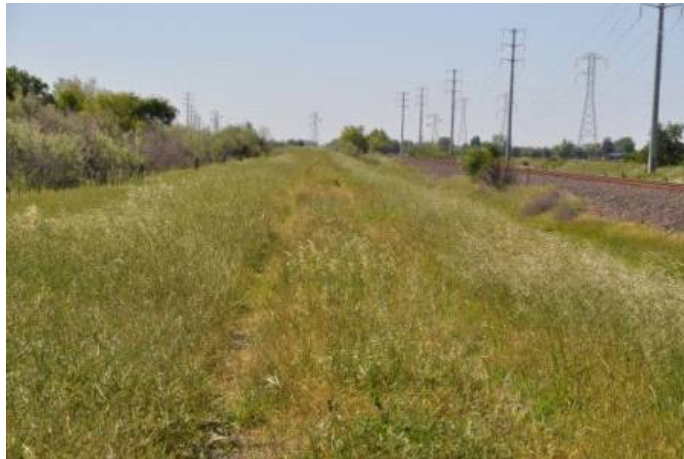
Levee Mile Report Line	5
Start Levee Mile	0.00
End Levee Mile	7.66
Location	Water Side
Category	
Item	Vegetation
RD 10, Unit 1 - Typical vegetation on levee crown and both slopes.	
rburnett_s_20130417_229.JPG

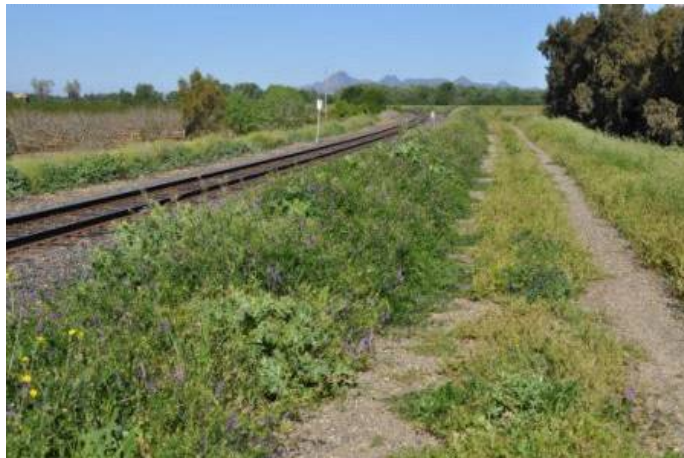
Levee Mile Report Line	6
Start Levee Mile	0.00
End Levee Mile	0.72
Location	Crown
Category	
Item	Vegetation
RD 10, Unit 1 - Vegetation on levee crown.	
rburnett_s_20130417_227.JPG

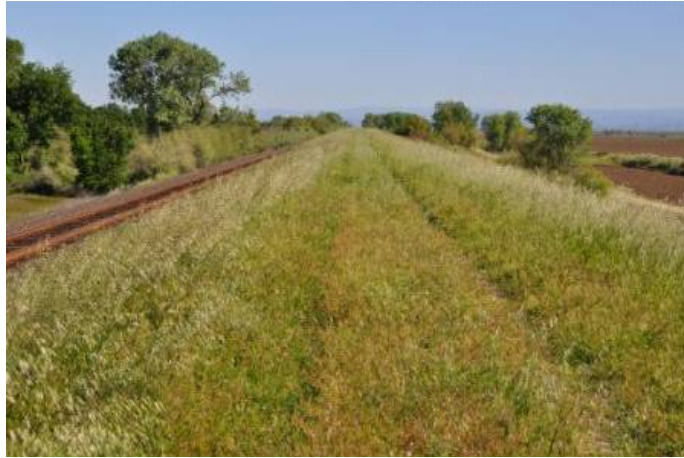
Levee Mile Report Line	8
Start Levee Mile	1.62
End Levee Mile	7.66
Location	Crown
Category	
Item	Vegetation
RD 10, Unit 1 - Vegetation on levee crown.	
rburnett_s_20130417_226.JPG

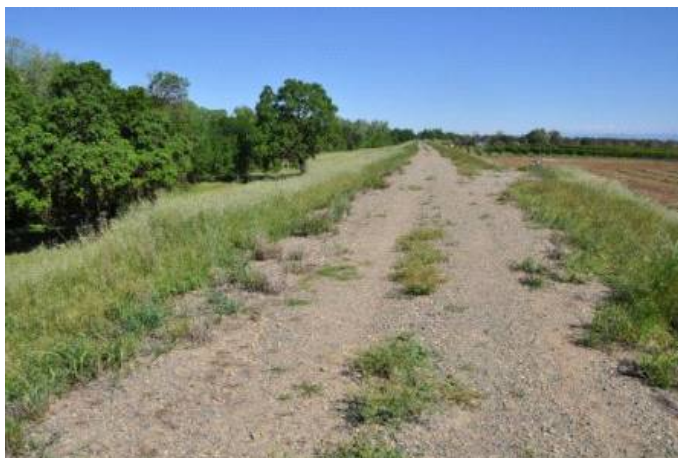
Levee Mile Report Line	2
Start Levee Mile	0.02
End Levee Mile	11.24
Location	Water Side
Category	
Item	Vegetation
RD 10, Unit 2 - Seasonal vegetation, both slopes.	
rburnett_s_20130416_215.JPG

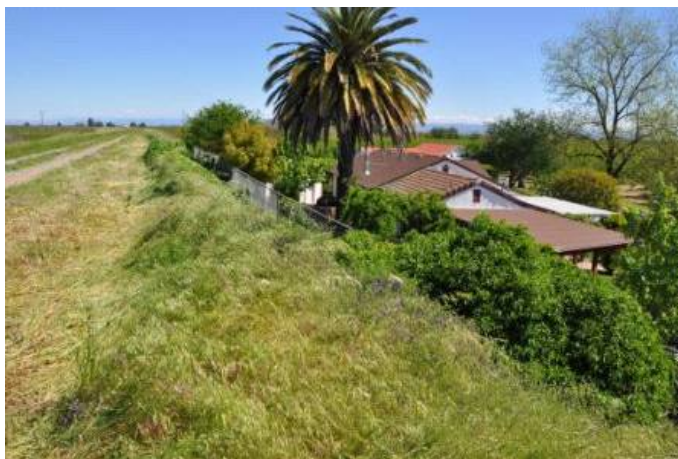
Levee Mile Report Line	3
Start Levee Mile	1.35
End Levee Mile	1.35
Location	Land Side
Category	
Item	Vegetation
RD 10, Unit 2 L/M 1.35 - Looking north at landscaped and fenced slope.	
rburnett_s_20130416_214.JPG

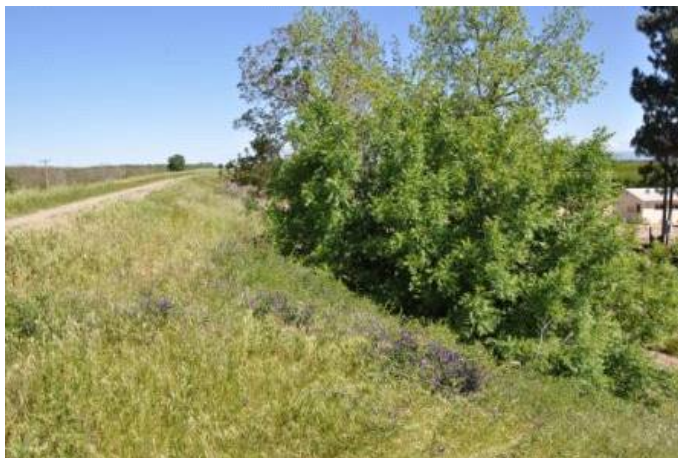
Levee Mile Report Line	4
Start Levee Mile	2.10
End Levee Mile	2.10
Location	Land Side
Category	
Item	Trim / Thin Trees
RD 10, Unit 2 - Trim tree.	
rburnett_s_20130416_216.JPG

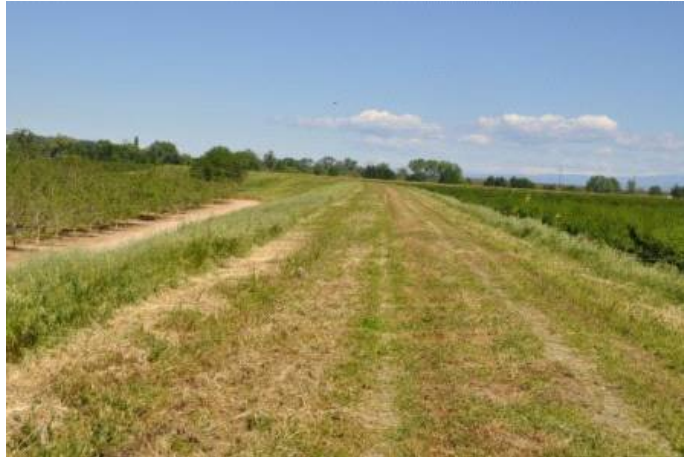
Levee Mile Report Line	5
Start Levee Mile	6.15
End Levee Mile	6.68
Location	Crown
Category	
Item	Vegetation

RD 10, Unit 2 - vegetation covers crown roadway.

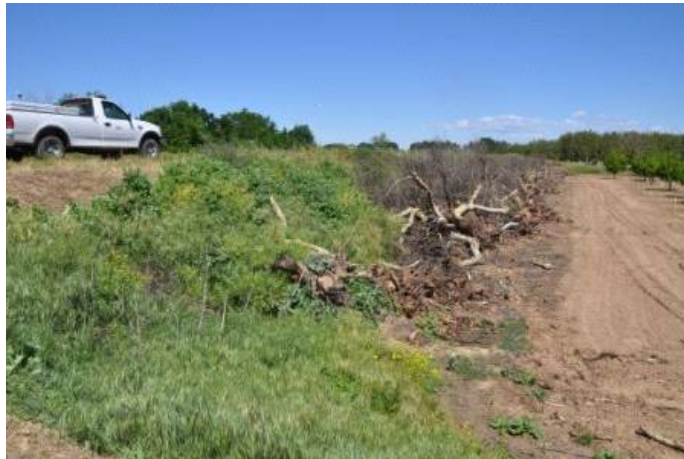
Levee Mile Report Line	7
Start Levee Mile	9.31
End Levee Mile	9.37
Location	Land Side
Category	
Item	Encroachments

RD 10, Unit 2 - pruning piles on L/S levee slope.

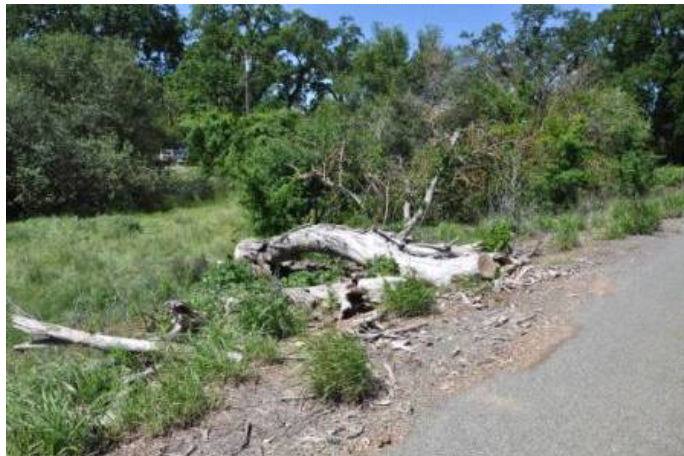
Levee Mile Report Line	14
Start Levee Mile	10.67
End Levee Mile	10.67
Location	Water Side
Category	
Item	Encroachments

RD 10, Unit 2 - Dead tree on W/S slope.

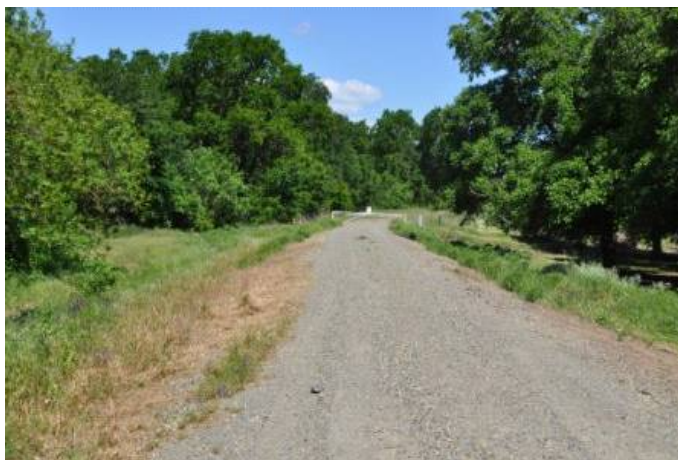
Levee Mile Report Line	1
Start Levee Mile	0.02
End Levee Mile	2.99
Location	Land Side
Category	
Item	Vegetation

RD 10, Unit 3 - Typical vegetation on both slopes.

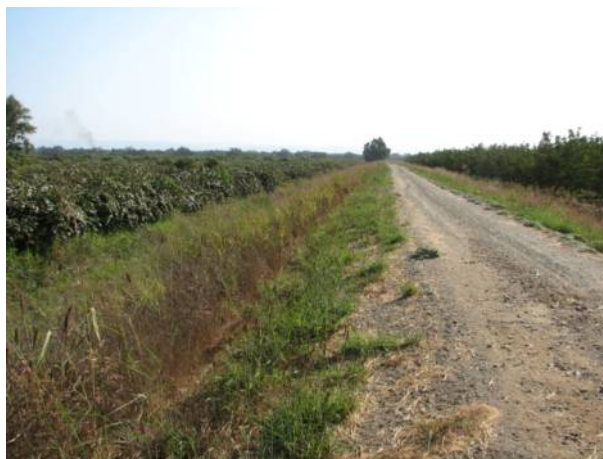
Levee Mile Report Line	3
Start Levee Mile	0.06
End Levee Mile	1.24
Location	Water Side
Category	
Item	Vegetation

Levee mile 0.18, the waterside slope.

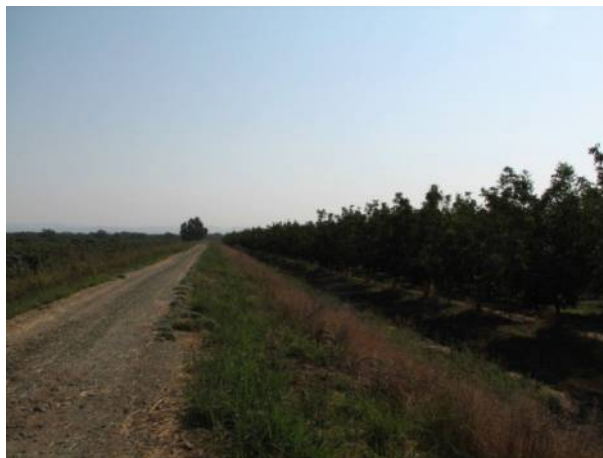
Levee Mile Report Line	4
Start Levee Mile	0.06
End Levee Mile	1.35
Location	Land Side
Category	
Item	Vegetation

Levee mile 0.18, the landside slope.

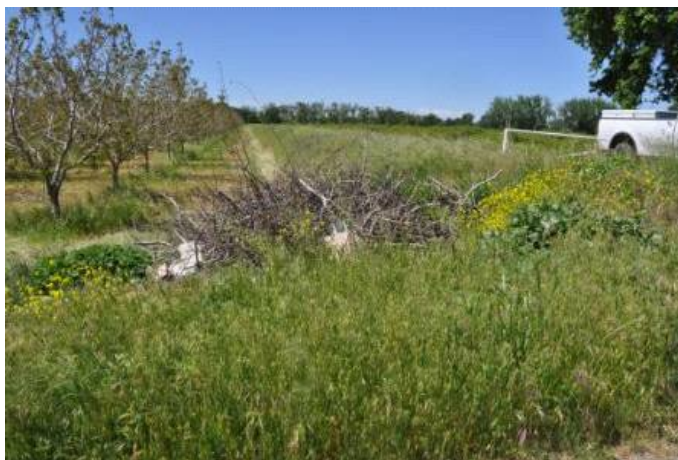
Levee Mile Report Line	6
Start Levee Mile	0.17
End Levee Mile	0.52
Location	Land Side
Category	
Item	Encroachments

RD 10, Unit 3 - Typical of pruning piles.

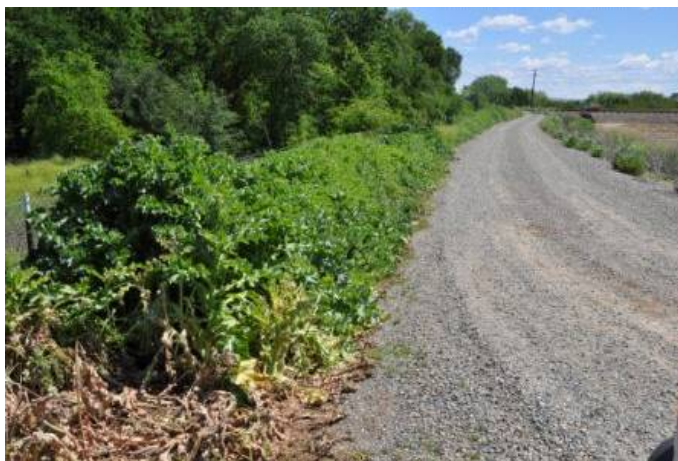
Levee Mile Report Line	7
Start Levee Mile	1.24
End Levee Mile	1.35
Location	Water Side
Category	
Item	Vegetation

RD 10, Unit 3 - Vegetation

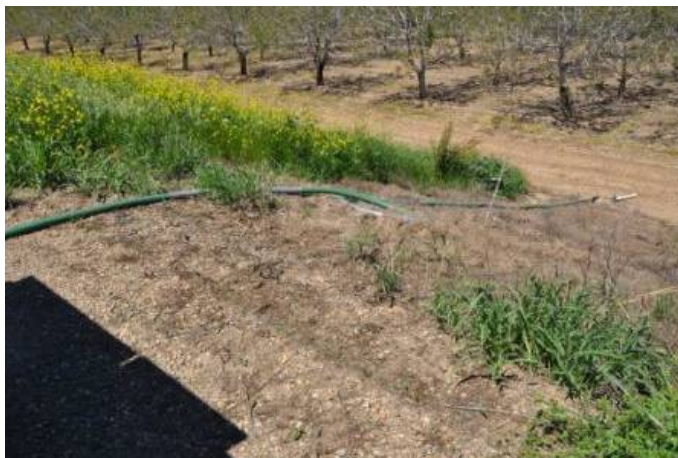
Levee Mile Report Line	11
Start Levee Mile	1.84
End Levee Mile	1.84
Location	Water Side
Category	
Item	Encroachments

RD 10, Unit 3 - Temp. pipe on W/S slope.

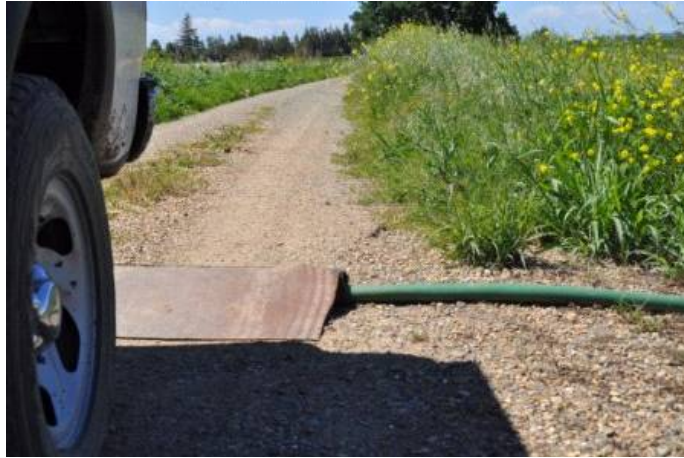
Levee Mile Report Line	11
Start Levee Mile	1.84
End Levee Mile	1.84
Location	Water Side
Category	
Item	Encroachments
Temp. pipe crosses levee crown and down L/S sope.	
rburnett_s_20130416_225.JPG
