**Flood Control Project Maintenance
Levee Inspections**
LMA District Cover Sheet
Spring 2015 Levee Inspection Results

Reclamation District No. 0010 Honcut

Spring 2015 Levee Inspection Results

Waterway		Bank	Unit Miles
Unit No. 01 Simmerly Slough		Right	7.65

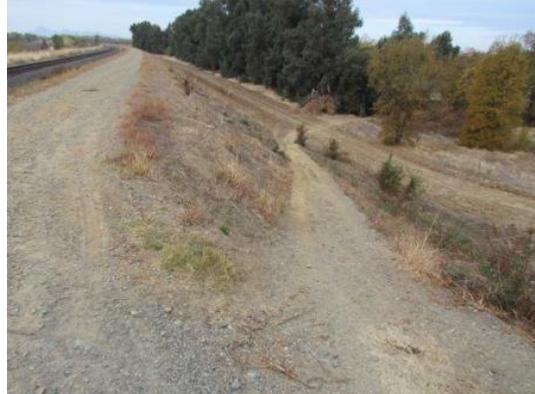
Photo 1 of 1 : SP_2015_RD0010_163_48_20150401_00001.jpg

LM Start	0.72	Rating **	M	Issue No.	48
LM End	0.72	Issue Type +	Ob	Location *	LS
Category	Earthen Levee			GPS Latitude/Longitude	
				Start	End
Item	Slope Stability			39.161198 °	39.161198 °
				-121.597102 °	-121.597102 °
DWR ID	DWR_RD0010_01_f_2013_48				
Action/Comments					
Repair the levee slope damaged by vehicle traffic and prevent access where possible.

This photo was taken from the crown looking down the landward slope at an ATV access road that has been formed over time to provide access to the waterward side. Fall 2013.

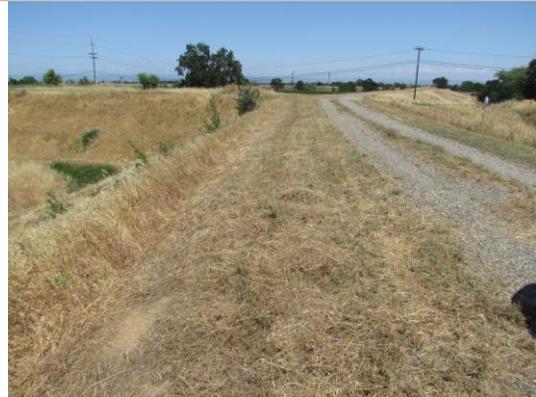
Photo 1 of 1 : SP_2015_RD0010_163_27_20150513_00020.jpg

LM Start	1.75	Rating **	A/W	Issue No.	27
LM End	1.75	Issue Type +	Ma	Location *	WS
Category	Earthen Levee			GPS Latitude/Longitude	
				Start	End
Item	Vegetation			39.171218 °	39.171218 °
				-121.585602 °	-121.585602 °
DWR ID	DWR_RD0010_01_s_2015_27				
Action/Comments					
Control annual grass and weeds on the levee slopes and easements.

View of the waterside vegetation facing upstream.

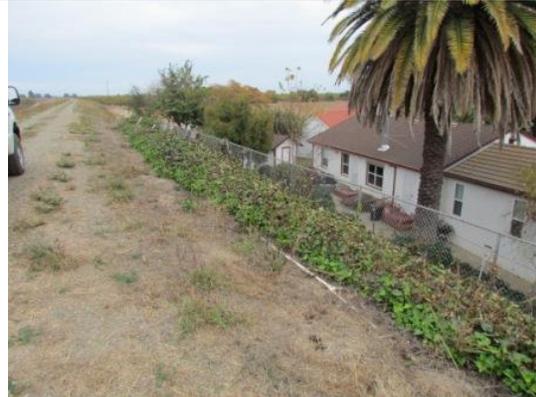
Photo 1 of 1 : SP_2015_RD0010_164_9_20150401_00001.jpg

LM Start	1.34	Rating **	M	Issue No.	9
LM End	1.34	Issue Type +	En	Location *	LS
Category	Earthen Levee		GPS Latitude/Longitude		
			Start	End	
Item	Vegetation		39.182957 °	39.182957 °	
			-121.609800 °	-121.609800 °	
DWR ID	DWR_RD0010_02_s_2012_9				
Action/Comments					
Landscaping

This photo was taken from the crown looking down the landward slope at landscaping and a fence. Fall 2013.

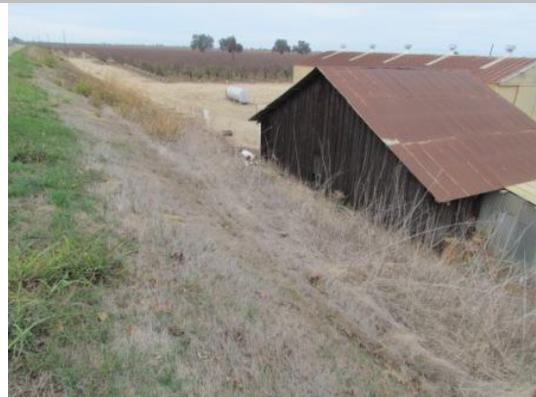
Photo 1 of 1 : SP_2015_RD0010_164_65_20150401_00002.jpg

LM Start	2.12	Rating **	M	Issue No.	65
LM End	2.12	Issue Type +	En	Location *	LS
Category	Earthen Levee		GPS Latitude/Longitude		
			Start	End	
Item	Encroachments		39.194178 °	39.194178 °	
			-121.607880 °	-121.607880 °	
DWR ID	DWR_RD0010_02_f_2013_65				
Action/Comments					
Building

This photo was taken from the crown facing north looking down the landward levee slope at an outbuilding near the levee toe. Fall 2013.

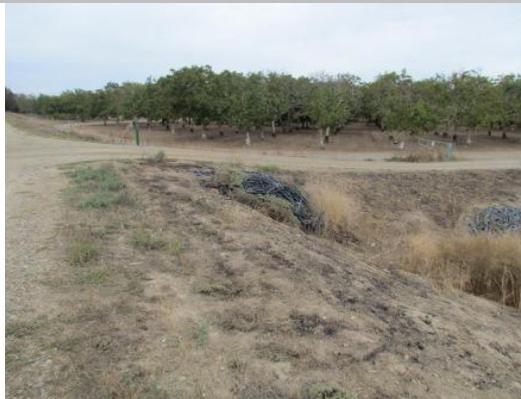
Photo 1 of 1 : SP_2015_RD0010_164_70_20150401_00004.jpg

LM Start	9.33	Rating **	M	Issue No.	70
LM End	9.33	Issue Type +	En	Location *	LS
Category	Earthen Levee			GPS Latitude/Longitude	
				Start	End
Item	Encroachments			39.286826 °	39.286826 °
				-121.600418 °	-121.600418 °
DWR ID	DWR_RD0010_02_f_2013_70				
Action/Comments					
Landscape Irrigation Inspector Comments: Irrigation piping on landward levee slope.

This photo was taken from the crown facing north looking down the landward levee slope at irrigation pipe at the toe. Fall 2014.

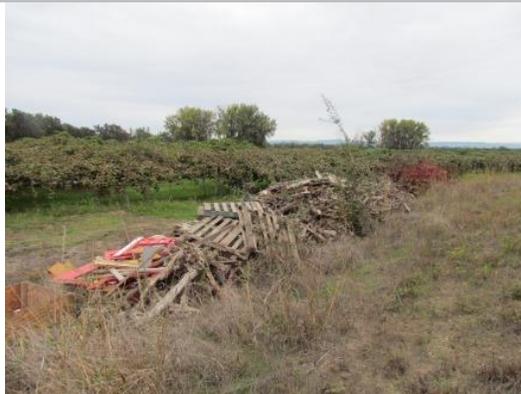
Photo 1 of 1 : SP_2015_RD0010_165_7_20150401_00001.jpg

LM Start	0.02	Rating **	U	Issue No.	7
LM End	0.02	Issue Type +	En	Location *	WS
Category	Earthen Levee		GPS Latitude/Longitude		
			Start	End	
Item	Encroachments		39.310189 °	39.310189 °	
			-121.615980 °	-121.615980 °	
DWR ID	DWR_RD0010_03_s_2014_7				
Action/Comments					
Prunings

This photo was taken from the levee crown facing east looking down the waterward slope at a pruning pile at the levee toe. Fall 2014.

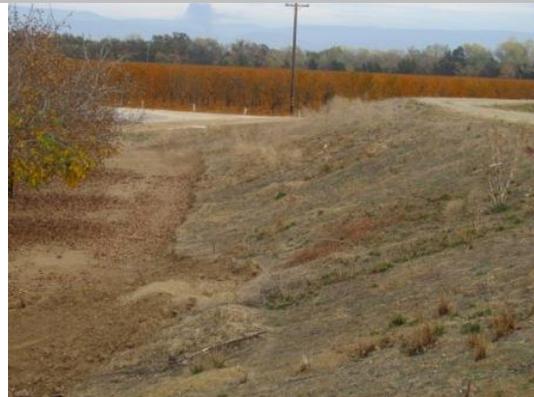
Photo 1 of 1 : SP_2015_RD0010_165_18_20150401_00002.jpg

LM Start	1.67	Rating **	M	Issue No.	18
LM End	1.67	Issue Type +	Ma	Location *	WS
Category	Earthen Levee			GPS Latitude/Longitude	
				Start	End
Item	Slope Stability			39.302904 °	39.302904 °
				-121.588578 °	-121.588578 °
DWR ID	DWR_RD0010_03_f_2013_18				
Action/Comments					
Repair the levee slope damaged by vehicle traffic and prevent access where possible. Inspector Comments: Toe cut at edge of waterward side of levee.

This photo was taken from the levee crown facing north looking down the waterward slope at agricultural tilling causing a cut at the levee toe. Fall 2013.

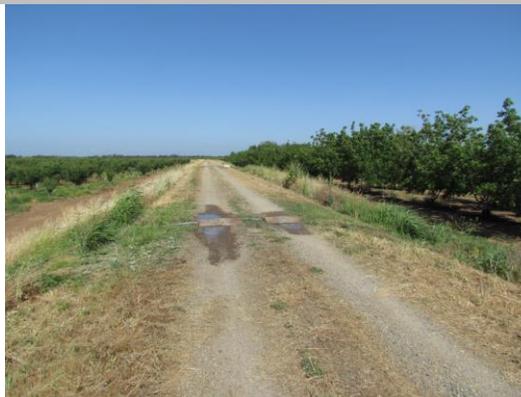
Photo 2 of 2 : SP_2015_RD0010_165_8_20150513_00007.jpg

LM Start	2.39	Rating **	M	Issue No.	8 (cont)
LM End	2.39	Issue Type +	En	Location *	CR
Category	Earthen Levee			GPS Latitude/Longitude	
				Start	End
Item	Encroachments			39.302027 °	39.302027 °
				-121.575715 °	-121.575715 °
DWR ID	DWR_RD0010_03_s_2015_8				
Action/Comments					
Pipe Inspector Comments: Total of three running across top of crown.

View of the three irrigation hoses from the crown facing upstream.
