**Flood Control Project Maintenance
Levee Inspections**
LMA District Cover Sheet
Spring 2016 Levee Inspection Results

Reclamation District No. 0010 Honcut

Spring 2016 Levee Inspection Results

Waterway		Bank	Unit Miles
Unit No. 01 Simmerly Slough		Right	7.65

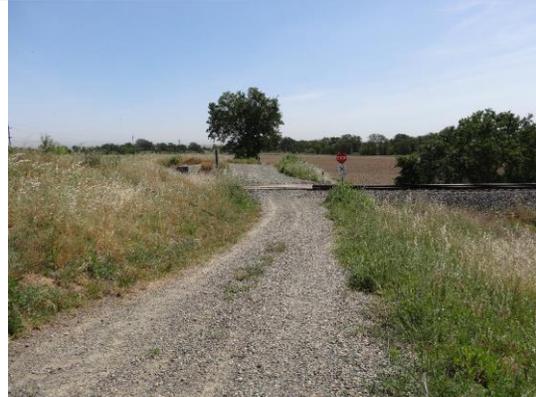
Photo 1 of 2 : UCIP_SP_2016_27791_51501.jpg

LM Start	0.00	Rating **	M	Issue No.	79
LM End	0.00	Issue Type +	En	Location *	N/A
Category	Supplemental			GPS Latitude/Longitude	
				Start	End
Item	DWR UCIP Field Study			39.169234 °	39.169234 °
				-121.586203 °	-121.586203 °
DWR ID					
Comment Code					
Inspector Comment					
FS_ID:27791 DS_ID:21268 EP_NO: N/A Repair Type: Non-Urgent Crossing Status: Found UCIP Comments: Vegetation has been cleared from slope. This crossing is referenced in the USACE Periodic Inspection as item USACE_CESPK_HON1_2013_p_0158. FIELD_STRUCT_DESC: 24-inch CM drainpipe through the levee, 30.0 feet below the crown. Flap gate on the waterward end. Slide gate on the landward end. Concrete saddle and apron on waterward side. (USACE-1955). This entry matches the Drainage or Irrigation Structure referenced in O&M manual (Station 1+00). FS Date: 4/29/2013

View of levee crown looking downstream.

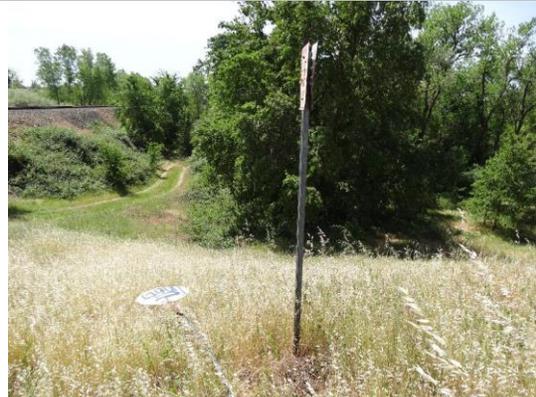
Photo 2 of 2 : UCIP_SP_2016_27791_51500.jpg

Pipe marker visible on ground--sign has been bent.

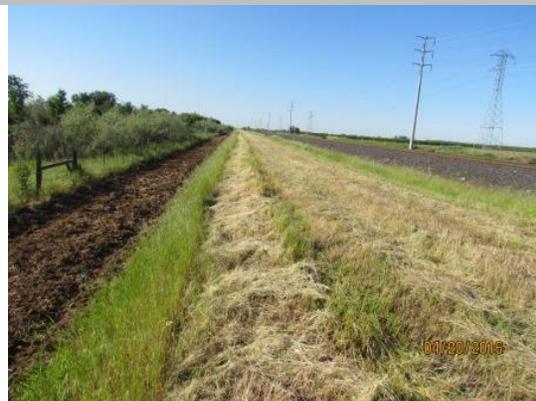
Photo 1 of 1 : SP_2016_RD0010_163_31_20160421_00062.jpg

View of typical vegetation on the waterside looking downstream.

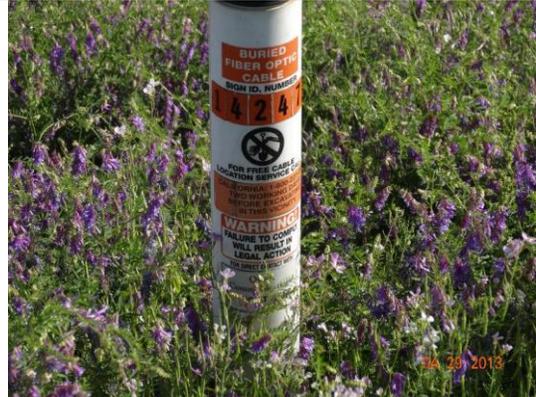
Photo 1 of 2 : UCIP_SP_2016_27712_51365.jpg

LM Start	0.23	Rating **	M	Issue No.	76
LM End	0.23	Issue Type +	En	Location *	WS
Category	Supplemental			GPS Latitude/Longitude	
				Start	End
Item	DWR UCIP Field Study			39.163407 °	39.163407 °
				-121.605645 °	-121.605645 °
DWR ID					
Comment Code					
Inspector Comment					
FS_ID:27712 DS_ID:24653 EP_NO: N/A Repair Type: Non-Urgent Crossing Status: Indicator Found UCIP Comments: Need to contact owner--unable to determine if crossing is authorized (no permit found) also need to determine if crossing goes through levee. FIELD_STRUCT_DESC: Fiber optic line markers on levee slope unable to determine if line goes through levee. FS Date: 4/29/2013

Contact information for buried fiber optic cable.

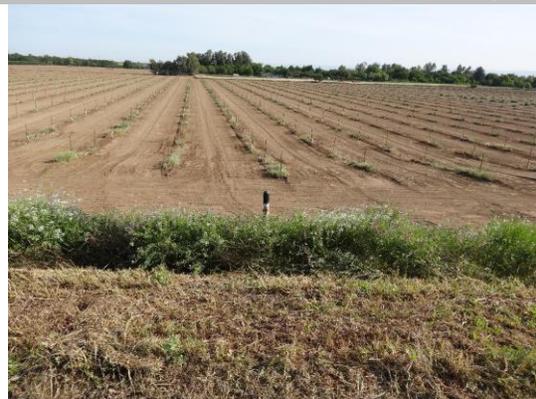
Photo 2 of 2 : UCIP_SP_2016_27712_51364.jpg

Marker visible on landward side.

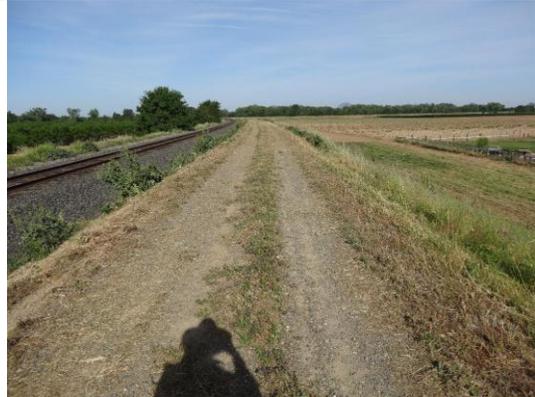
Photo 1 of 2 : UCIP_SP_2016_24806_44540.jpg

Comment Code					
Inspector Comment					
FS_ID:24806 DS_ID:21257 EP_NO: 13015 Repair Type: Non-Urgent Crossing Status: Found UCIP Comments: New gravel indicates work was recently completed. Will need to contact owner to obtain information pertaining to work completed. Need to contact owner to determine if crossing is still active and to determine last inspection date. Will need copy of letter showing crossings passed inspection. This crossing is referenced in the USACE Periodic Inspection as item USACE_CESPK_HON1_2013_p_0075. FIELD_STRUCT_DESC: 4-inch pipe sleeved through an 8-inch pipe through the levee, 30.0 feet below the crown. Annular spaced grouted. Cutoff walls on both ends within the levee. (Permit No. 13015-1981) FS Date: 4/29/2013

View of levee crown looking upstream.

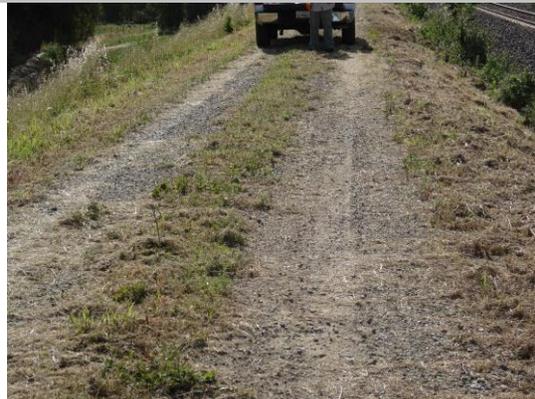
Photo 2 of 2 : UCIP_SP_2016_24806_44541.jpg

View of levee crown looking downstream.

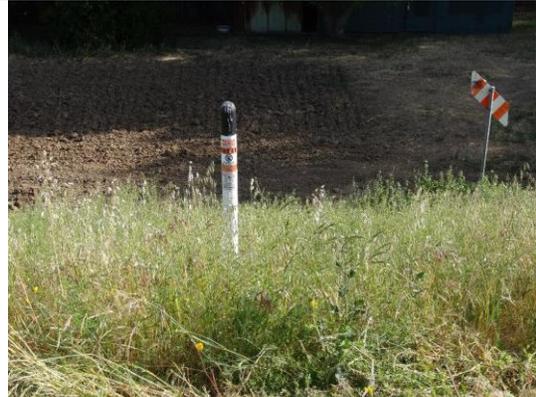
Photo 1 of 2 : UCIP_SP_2016_27713_51366.jpg

LM Start	0.41	Rating **	M	Issue No.	77
LM End	0.41	Issue Type +	En	Location *	WS
Category	Supplemental			GPS Latitude/Longitude	
				Start	End
Item	DWR UCIP Field Study			39.162853 °	39.162853 °
				-121.602435 °	-121.602435 °
DWR ID					
Comment Code					
Inspector Comment					
FS_ID:27713 DS_ID:24654 EP_NO: N/A Repair Type: Non-Urgent Crossing Status: Indicator Found UCIP Comments: Need to contact owner--unable to determine if crossing is authorized (no permit found) also need to determine if crossing goes through levee. FIELD_STRUCT_DESC: Fiber optic line markers on levee slope unable to determine if line goes through levee. FS Date: 4/29/2013

View of landward side--communication line marker.

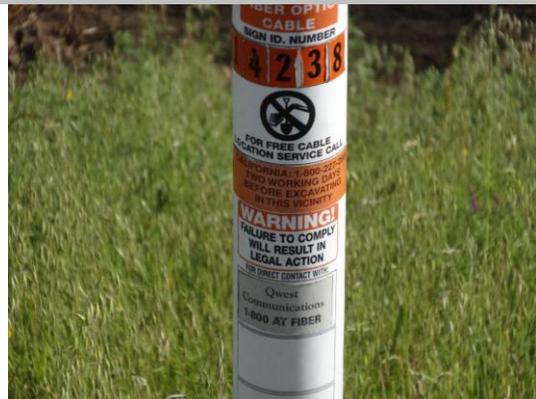
Photo 2 of 2 : UCIP_SP_2016_27713_51367.jpg

Contact information for communication line.

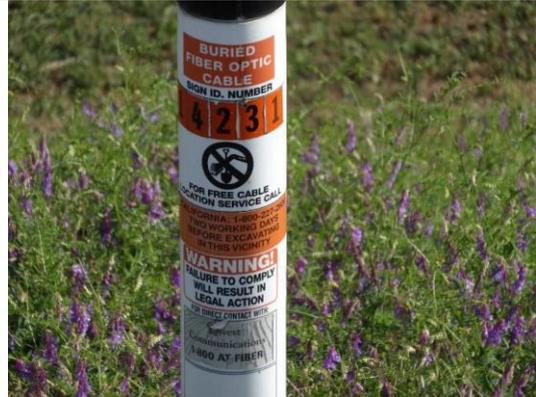
Photo 1 of 2 : UCIP_SP_2016_27710_51361.jpg

LM Start	0.53	Rating **	M	Issue No.	75
LM End	0.53	Issue Type +	En	Location *	WS
Category	Supplemental			GPS Latitude/Longitude	
				Start	End
Item	DWR UCIP Field Study			39.162277 °	39.162277 °
				-121.600219 °	-121.600219 °
DWR ID					
Comment Code					
Inspector Comment					
FS_ID:27710 DS_ID:24655 EP_NO: N/A Repair Type: Non-Urgent Crossing Status: Indicator Found UCIP Comments: Need to contact owner--unable to determine if crossing is authorized (no permit found) also need to determine if crossing goes through levee. FIELD_STRUCT_DESC: Fiber optic line markers on levee slope unable to determine if line goes through levee. FS Date: 4/29/2013

Contact information for fiber optic cable and ID number.

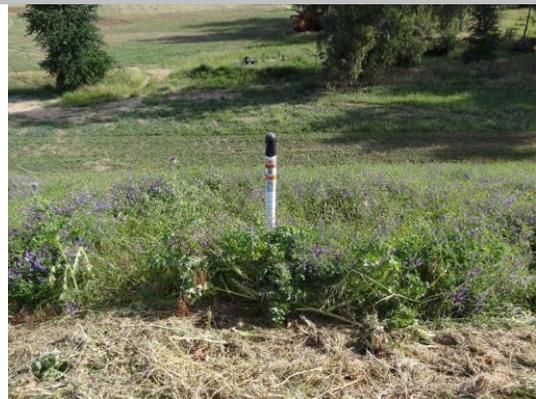
Photo 2 of 2 : UCIP_SP_2016_27710_51360.jpg

View of marker located on landward side.

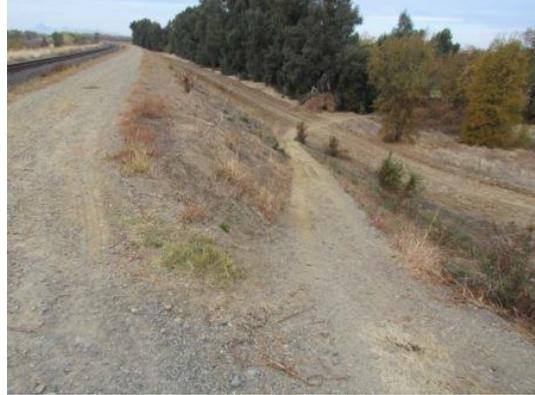
Photo 1 of 2 : SP_2016_RD0010_163_48_20160307_00007.jpg

LM Start	0.72	Rating **	M	Issue No.	48
LM End	0.72	Issue Type +	Ob	Location *	LS
Category	Earthen Levee		GPS Latitude/Longitude		
			Start	End	
Item	Slope Stability		39.161198 °	39.161198 °	
			-121.597102 °	-121.597102 °	
DWR ID	DWR_RD0010_01_f_2013_48				
Comment Code					
S3 : Repair the levee slope damaged by vehicle traffic and prevent access where possible.					
Inspector Comment					
Ramp is caused by constant ATV use on levee slope.

This photo was taken from the crown looking down the landward slope at an ATV access road that has been formed over time to provide access to the waterward side. Fall 2013.

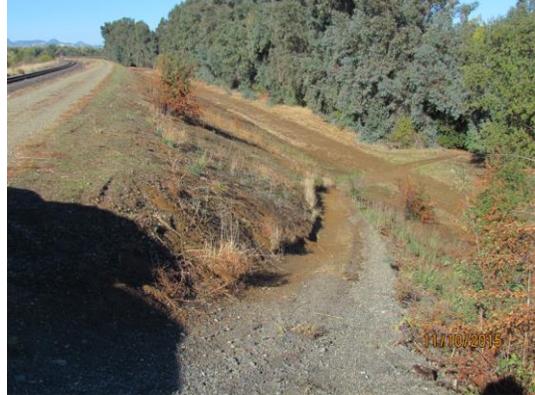
Photo 2 of 2 : SP_2016_RD0010_163_48_20160307_00008.jpg

View of the slope stability on the landward side of the levee looking downstream. Fall 2015.

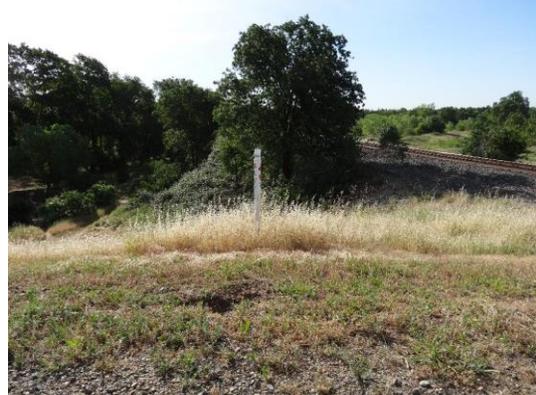
Photo 1 of 2 : UCIP_SP_2016_27715_51371.jpg

LM Start	0.72	Rating **	M	Issue No.	78
LM End	0.72	Issue Type +	En	Location *	LS
Category	Supplemental			GPS Latitude/Longitude	
				Start	End
Item	DWR UCIP Field Study			39.161229 °	39.161229 °
				-121.597072 °	-121.597072 °
DWR ID					
Comment Code					
Inspector Comment					
FS_ID:27715 DS_ID:24656 EP_NO: N/A Repair Type: Non-Urgent Crossing Status: Indicator Found UCIP Comments: Need to contact owner--unable to determine if crossing is authorized (no permit found) also need to determine if crossing goes through levee. FIELD_STRUCT_DESC: Fiber optic line markers on levee slope unable to determine if line goes through levee. FS Date: 4/29/2013

View of marker located on waterward side.

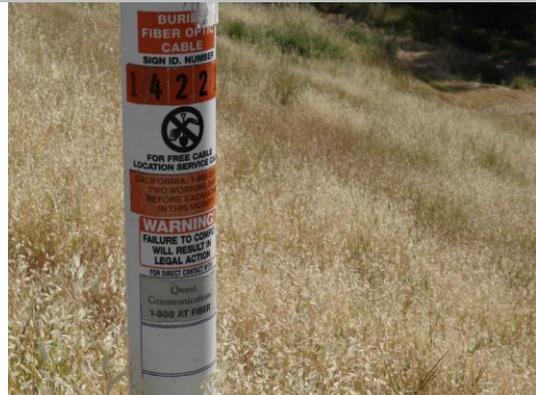
Photo 2 of 2 : UCIP_SP_2016_27715_51370.jpg

Contact information and ID number for buried fiber optic cable.

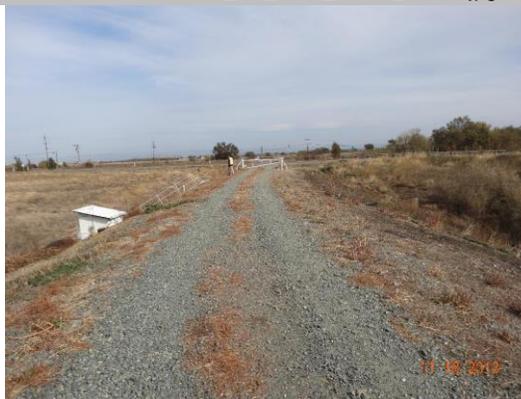
Photo 2 of 2 : UCIP_SP_2016_27725_51387.jpg

FS_ID:27725
 DS_ID:21262
 EP_NO: N/A
 Repair Type: Non-Urgent
 Crossing Status: Found
 UCIP Comments: Crossing appears not to be in use--need to contact owner. Need to coordinate with owner to determine status of crossing. If crossing is no longer in use owner will need to contact the CVFPB to comply with Title 23. This crossing is referenced in the USACE Periodic Inspection as item USACE_CESPK_HON1_2013_p_0012.
 FIELD_STRUCT_DESC: 10-inch steel pipe through the levee, 7.3 feet below the crown. Siphon breaker in CM riser on the waterward slope. Pump on the waterward berm-pump not present. Switch house on the waterward slope-no switch house present. 24-inch concrete standpipe at the landward toe. (USACE-1955). This entry matches the Drainage or Irrigation Structure referenced in O&M manual (Station 14+82).
 Concrete pad is still present on waterward side.
 FS Date: 4/29/2013

View of levee crown looking downstream.

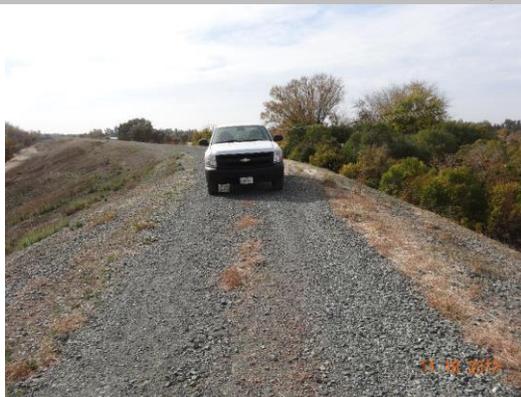
Photo 1 of 2 : UCIP_SP_2016_24810_44576.jpg

Comment Code					
Inspector Comment					
FS_ID:24810 DS_ID:21263 EP_NO: N/A Repair Type: Non-Urgent Crossing Status: Found UCIP Comments: Pipe has been capped on waterward side--see photos. Need to coordinate with DWR Inspector to determine whether crossing is compliant with Title 23. This crossing is referenced in the USACE Periodic Inspection as item USACE_CESPK_HON1_2013_p_0016. FIELD_STRUCT_DESC: 10-inch steel pipe through the levee, 6.8 feet below the crown. Steel cutoff plate around pipe at center of levee. Siphon breaker in CM riser on the waterward slope. Pump on concrete base on the waterward berm-not present. 36-inch concrete standpipe at the landward toe. Metal shed and service pole on the waterward slope-not present. (USACE-1955). This entry matches the Drainage or Irrigation Structure referenced in O&M manual (Station 14+16). FS Date: 4/29/2013

View of levee crown lookin upstream.

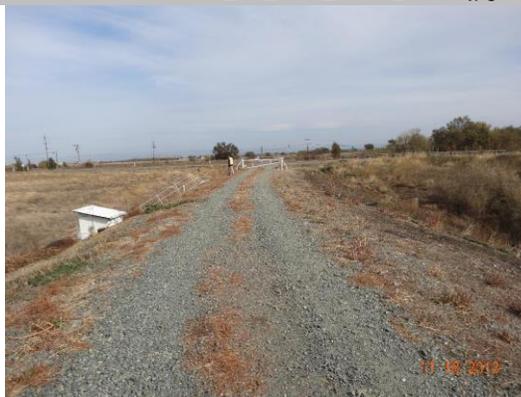
Photo 2 of 2 : UCIP_SP_2016_24810_44577.jpg

View of levee crown looking downstream.

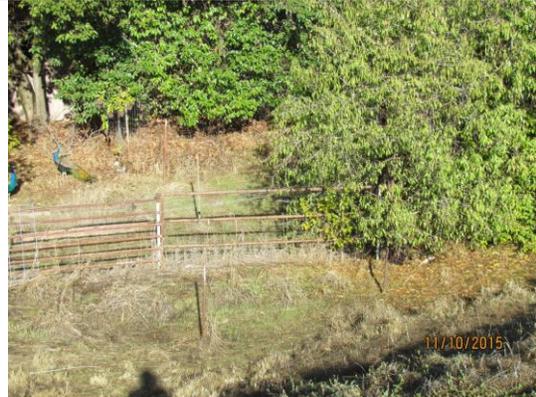
Photo 1 of 1 : SP_2016_RD0010_163_2_20160307_00001.jpg

View of the fence at the toe of the levee on the landward side of the levee. Fall 2015.

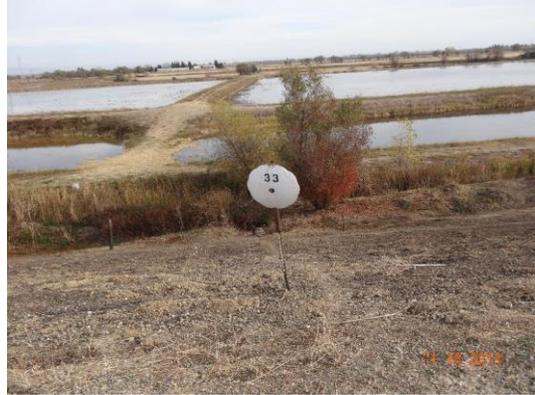
Photo 1 of 2 : UCIP_SP_2016_27745_51429.jpg

LM Start	2.14	Rating **	M	Issue No.	85
LM End	2.14	Issue Type +	En	Location *	LS
Category	Supplemental			GPS Latitude/Longitude	
				Start	End
Item	DWR UCIP Field Study			39.176936 °	39.176936 °
				-121.584848 °	-121.584848 °
DWR ID					
Comment Code					
Inspector Comment					
FS_ID:27745 DS_ID:21271 EP_NO: N/A Repair Type: Non-Urgent Crossing Status: Found UCIP Comments: Unable to determine if crossing is still present on landward side--need to confirm. Need to contact owner to determine status of crossing. This crossing is referenced in the USACE Periodic Inspection as item USACE_CESPK_HON1_2013_p_0185. FIELD_STRUCT_DESC: 24-inch pipe through the levee, 30.0 feet below the crown. Flap gate on waterward end. Concrete headwall at both toes. FS Date: 4/29/2013

View of waterward side--marker indicating crossing visible on waterward shoulder.

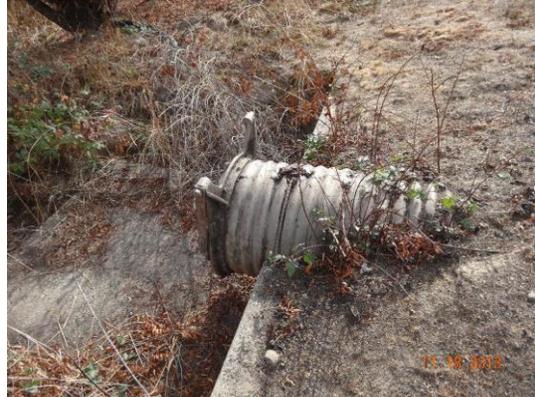
Photo 2 of 2 : UCIP_SP_2016_27745_51432.jpg

View of pipe, headwall, and flap gate located on waterward side.

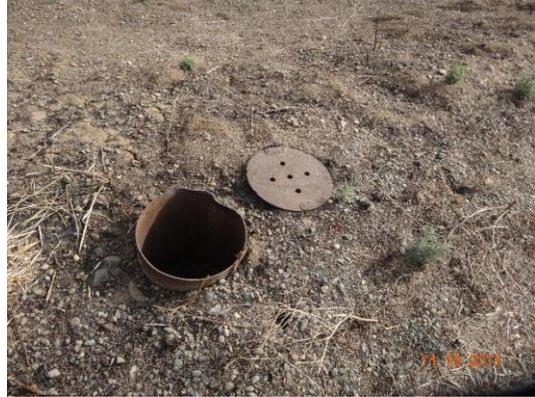
Photo 2 of 2 : UCIP_SP_2016_24815_44605.jpg

Comment Code					
Inspector Comment					
<p>FS_ID:24815 DS_ID:21272 EP_NO: 14020 Repair Type: Urgent Crossing Status: Indicator Found UCIP Comments: Unable to determine status of crossing--sink hole was observed as part of the USACE Periodic Inspection Report dated May 2013. Need to coordinate with owner to determine status of crossing. If crossing is no longer in use owner will need to contact the CVFPB to comply with Title 23. Need to confirm with Finney to determine if pump and controls belong to pipe crossing located on landward side. This crossing is referenced in the USACE Periodic Inspection as item USACE_CESPK_HON1_2013_p_0192. FIELD_STRUCT_DESC: 10-inch steel drainpipe sleeved through a 16-inch steel pipe, 5.0 feet below the crown. Annular gap grouted. Concrete cutoff wall around pipe at center of levee. Siphon breaker at waterward shoulder. Flap gate and concrete headwall at waterward end. (Permit No. 14020-1986) FS Date: 4/29/2013</p>

View of riser with damage lid located on waterward shoulder.

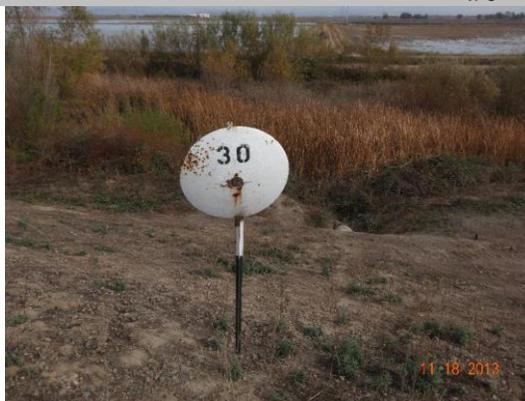
Photo 1 of 2 : UCIP_SP_2016_27747_51441.jpg

View of waterwar side--marker indicating crossing located on waterward shoulder.

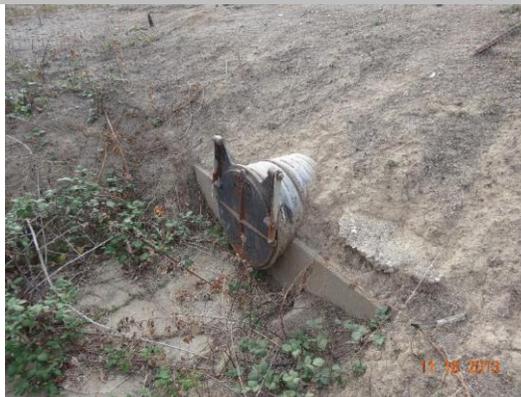
Photo 2 of 2 : UCIP_SP_2016_27747_51445.jpg

View of pipe, flap gate, and headwall located on waterward toe.

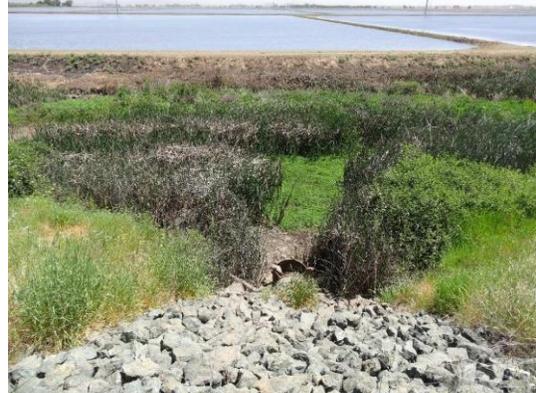
Photo 2 of 2 : UCIP_SP_2016_24872_44809.jpg

View of waterward side during April.

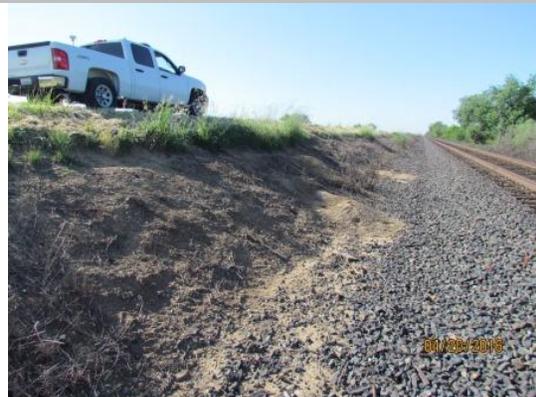
Photo 1 of 1 : SP_2016_RD0010_163_41_20160421_00071.jpg

View of multiple active ground squirrel holes on landside slope looking downstream.

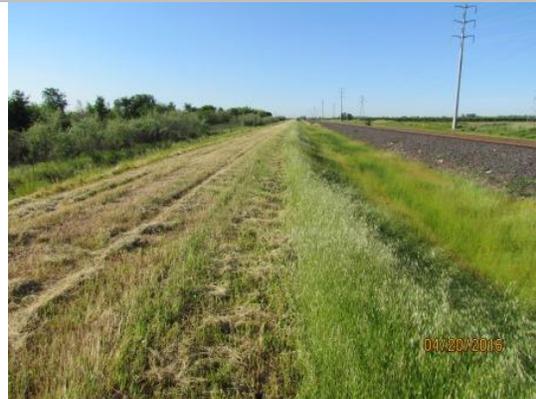
Photo 1 of 1 : SP_2016_RD0010_163_29_20160421_00060.jpg

View of typical vegetation on the land side looking downstream.

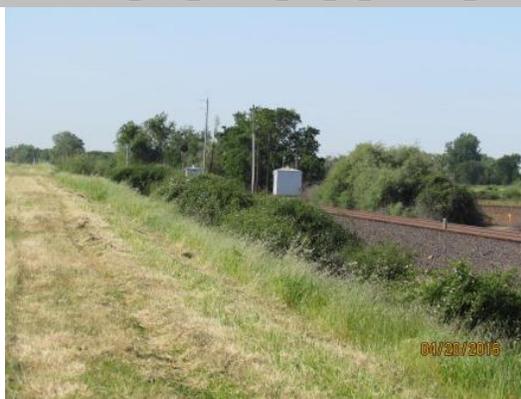
Photo 1 of 1 : SP_2016_RD0010_163_36_20160421_00070.jpg

View looking downstream landside of wild rosebushes that are blocking visibility at the toe.

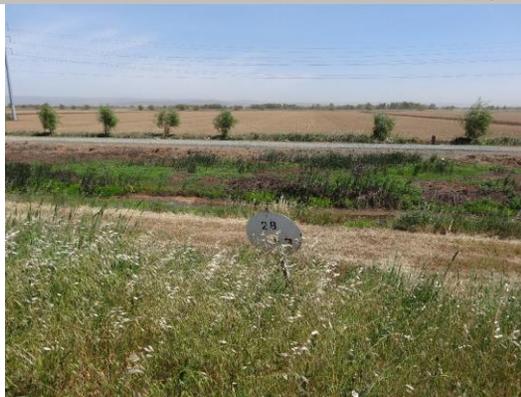
Photo 1 of 2 : UCIP_SP_2016_24438_43503.jpg

Marker visible on waterward shoulder.

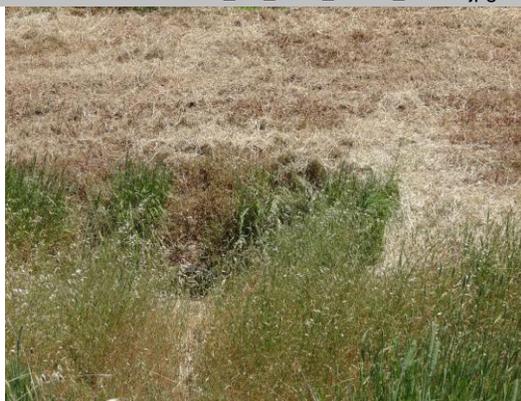
Photo 2 of 2 : UCIP_SP_2016_24438_43502.jpg

View of waterward toe where pipe daylights.

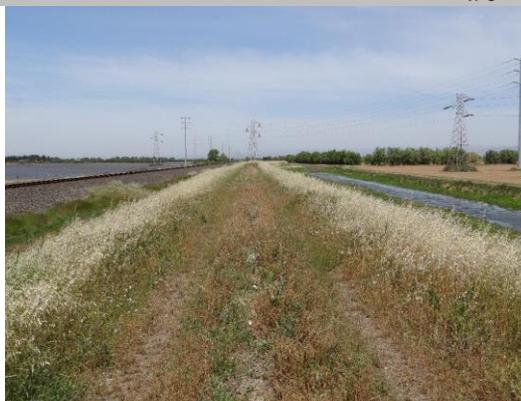
Photo 1 of 2 : UCIP_SP_2016_27532_51129.jpg

View of levee looking upstream.

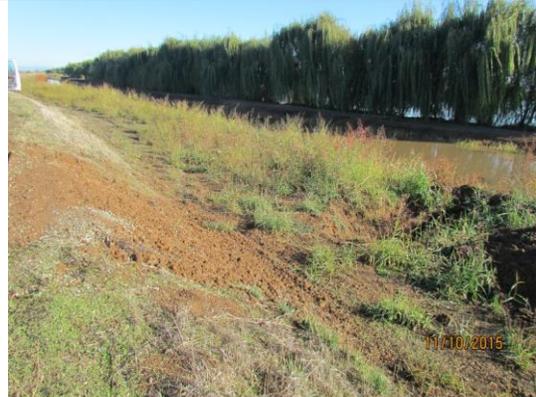
Photo 2 of 8 : SP_2016_RD0010_163_27_20160307_00003.jpg

View of the trench on the waterward side of the levee looking upstream. Works seem to have been done on the levee slope as well. Fall 2015.

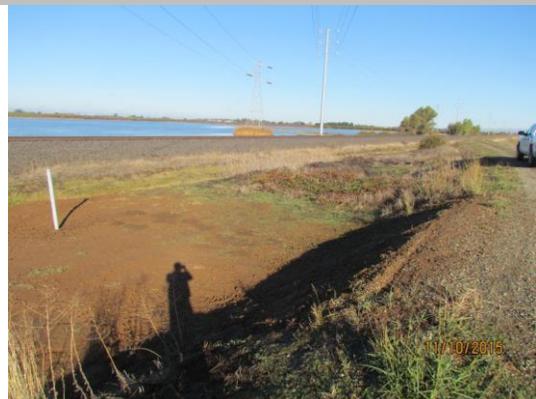
Photo 4 of 8 : SP_2016_RD0010_163_27_20160307_00005.jpg

Perspective view of the culvert on the landward side of the levee looking upstream. Fall 2015.

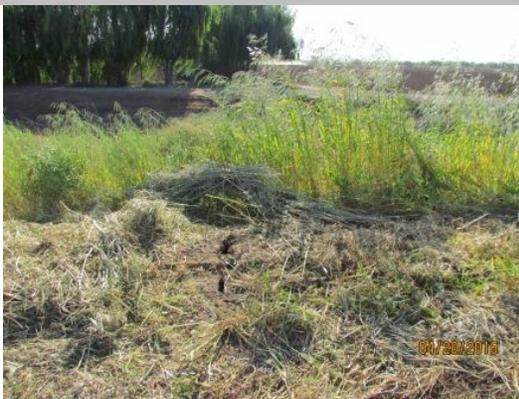
Photo 6 of 8 : SP_2016_RD0010_163_27_20160509_00074.jpg

Cracks in crown due to pipe crossing waterside Spring. 2016.

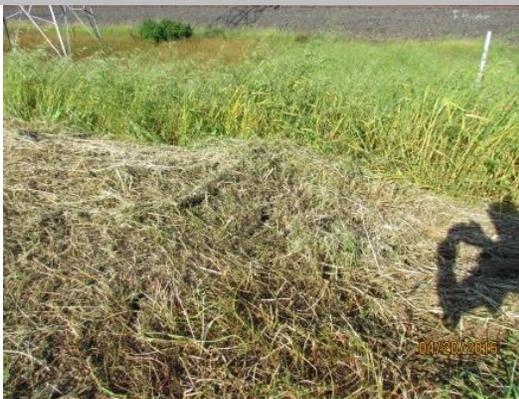
Photo 7 of 8 : SP_2016_RD0010_163_27_20160509_00075.jpg

Cracks and settlement in crown caused by pipe crossing landside. Spring 2016.

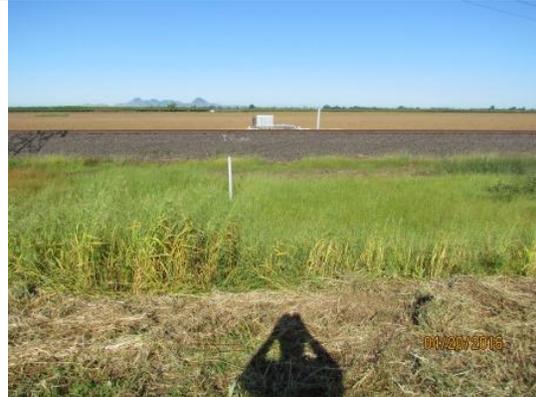
Photo 8 of 8 : SP_2016_RD0010_163_27_20160509_00076.jpg

View of pump associated with pipe crossing. Spring 2016.

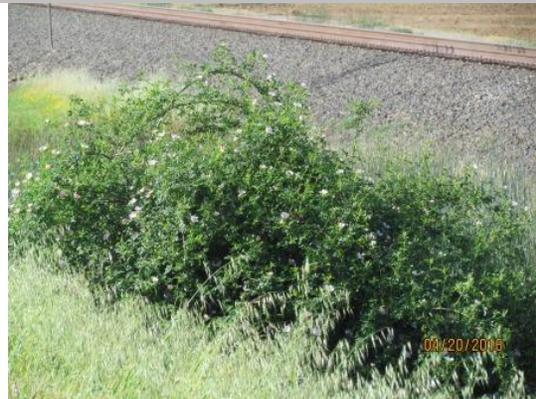
Photo 1 of 1 : SP_2016_RD0010_163_34_20160421_00065.jpg

View of thick wild rose bush that obstructs visibility of the landside slope and toe.

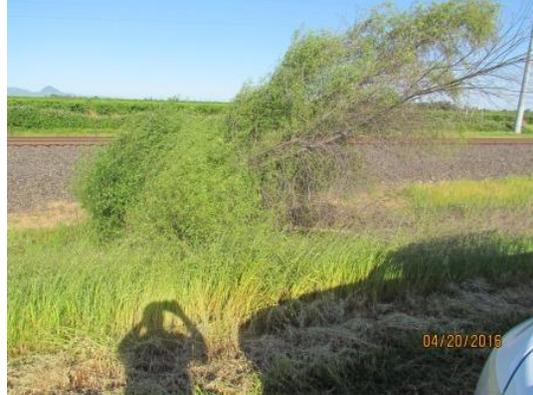
Photo 1 of 1 : SP_2016_RD0010_163_32_20160421_00064.jpg

View of a tree that needs to be removed. Small trees 4" in diameter at chest height should be removed before they get to big. View of landside.

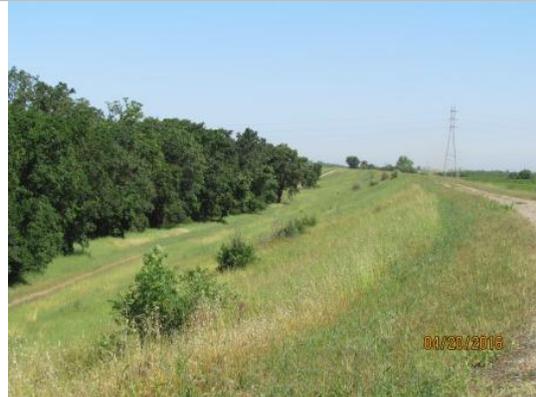
Photo 1 of 1 : SP_2016_RD0010_164_24_20160421_00064.jpg

View of typical vegetation on the waterside looking upstream.

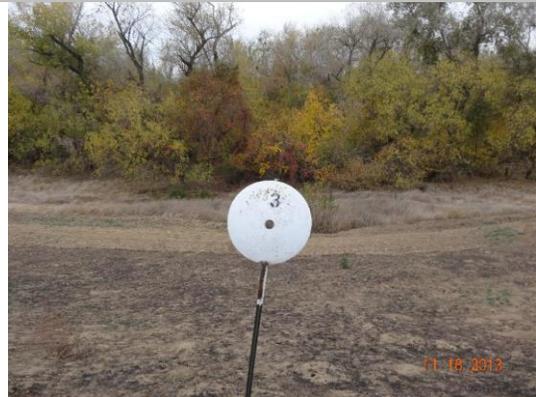
Photo 1 of 2 : UCIP_SP_2016_27533_51135.jpg

View of waterward side.

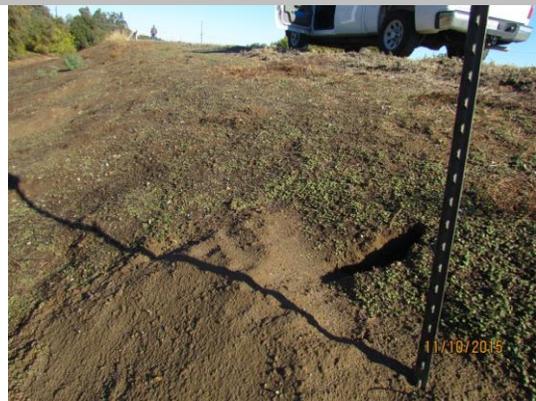
Photo 1 of 1 : SP_2016_RD0010_164_28_20160307_00003.jpg

View of the rodent hole on the waterward side of the levee looking upstream. Fall 2015.

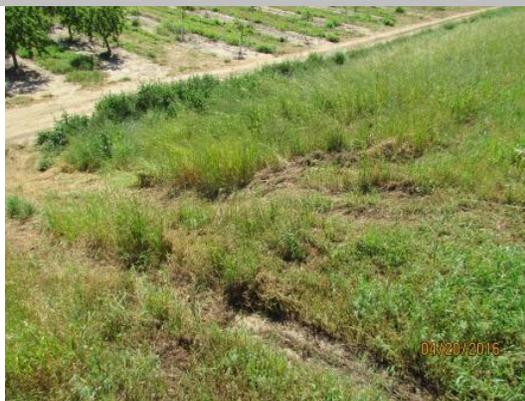
Photo 1 of 1 : SP_2016_RD0010_164_26_20160421_00066.jpg

Rutting on landside slope due to vehicle traffic.

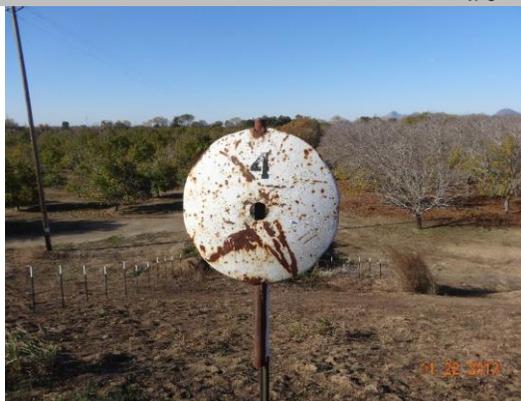
Photo 1 of 2 : UCIP_SP_2016_24821_44640.jpg

Marker visible on waterward side--No. 4.

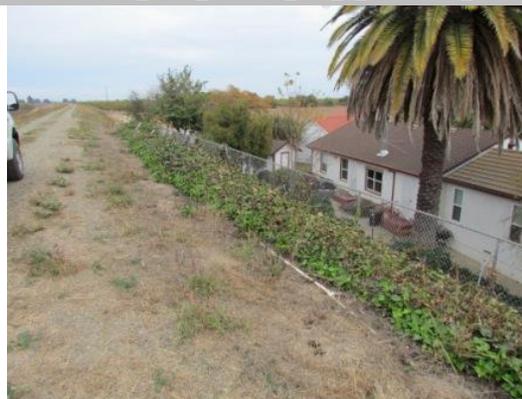
Photo 1 of 2 : SP_2016_RD0010_164_9_20160307_00001.jpg

This photo was taken from the crown looking down the landward slope at landscaping and a fence. Fall 2013.

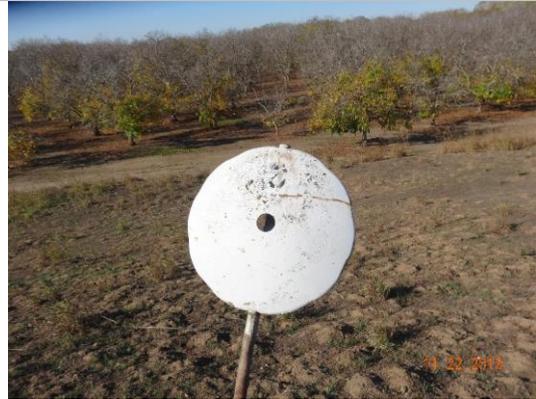
Photo 1 of 2 : UCIP_SP_2016_27773_51461.jpg

Marker visible on waterward side.

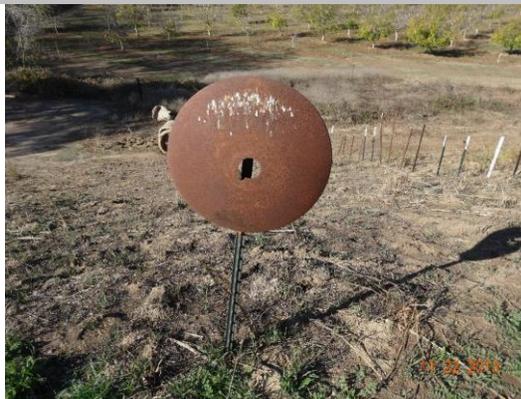
Photo 1 of 2 : UCIP_SP_2016_24824_44658.jpg

Marker visible on waterward side.

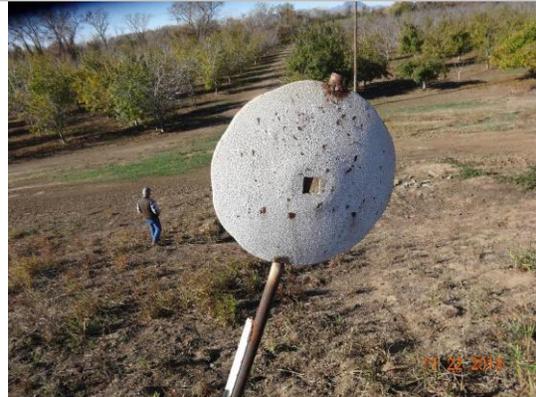
Photo 1 of 3 : UCIP_SP_2016_24825_44664.jpg

Marker visible on waterward side.

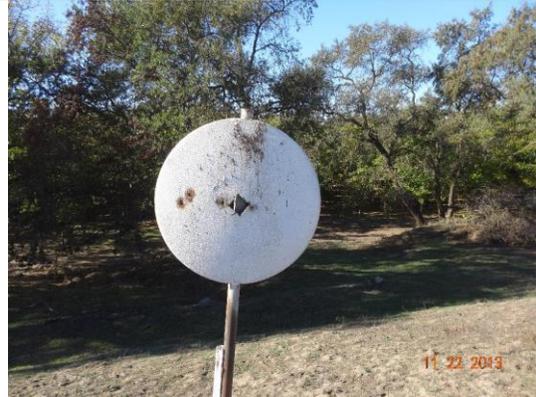
Photo 1 of 2 : UCIP_SP_2016_24826_44669.jpg

View of marker located on waterward shoulder, no reference number is visible.

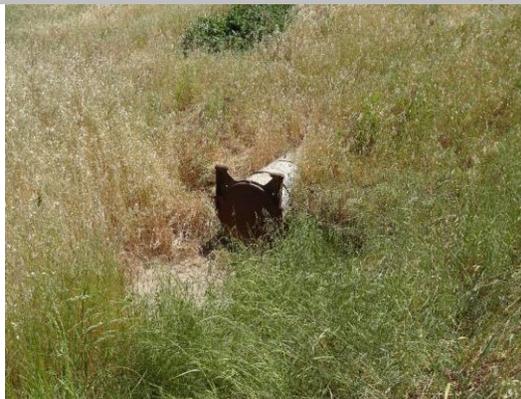
Photo 2 of 2 : UCIP_SP_2016_24751_44376.jpg

View of flap gate on waterward side.

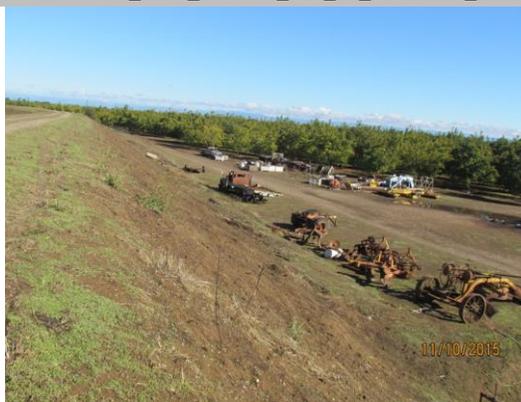
Photo 1 of 1 : SP_2016_RD0010_164_31_20160307_00004.jpg

View of the equipment at the toe of the levee on the landward side of the levee looking upstream. Fall 2015.

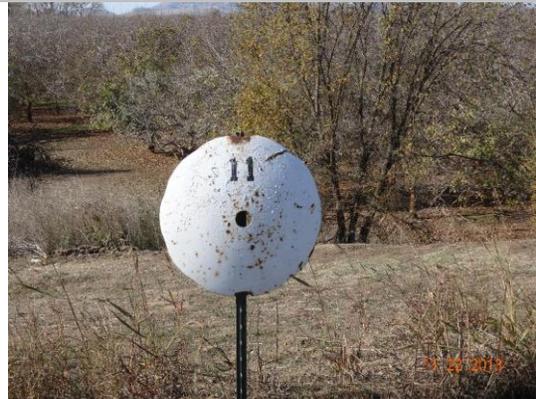
Photo 1 of 2 : UCIP_SP_2016_27774_51467.jpg

Marker visible on waterward shoulder, Reference ID No. 11 for crossing.

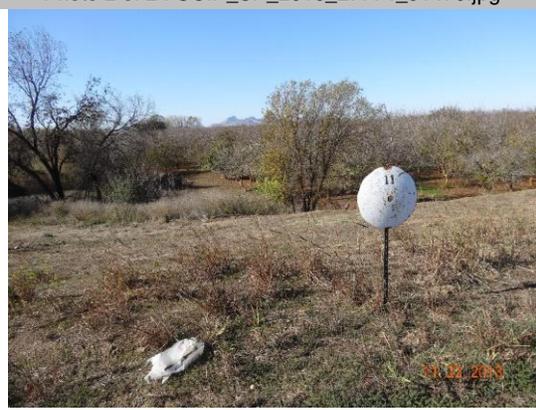
Photo 2 of 2 : UCIP_SP_2016_27774_51470.jpg

View of waterward side.

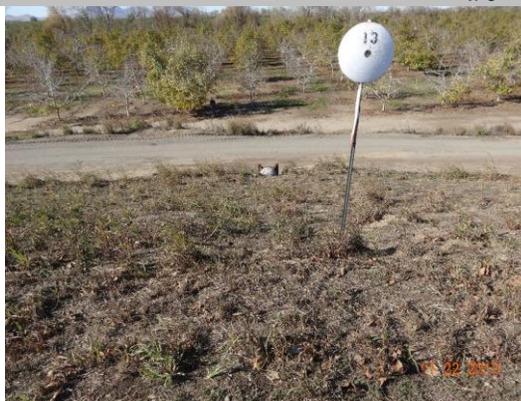
Photo 1 of 2 : UCIP_SP_2016_27793_51514.jpg

View of marker located on waterward shoulder, pipe is reference as No. 13.

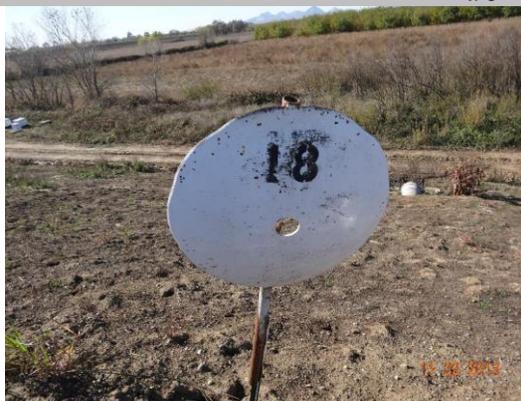
Photo 1 of 2 : UCIP_SP_2016_24834_44715.jpg

Marker visible on waterward shoulder, crossing is referenced as No. 18.

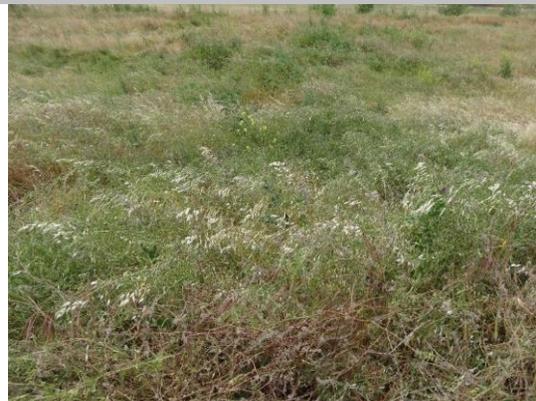
Photo 1 of 2 : UCIP_SP_2016_24768_44450.jpg

View of waterward slope.

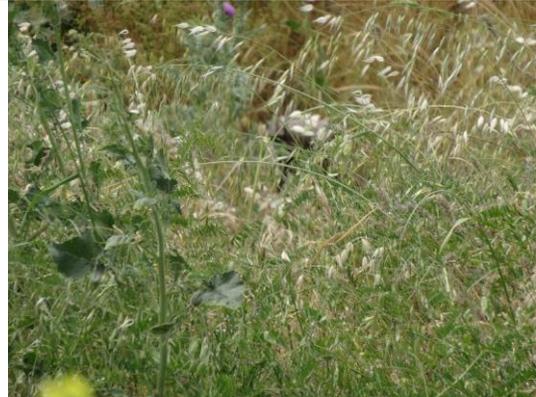
Photo 2 of 2 : UCIP_SP_2016_24768_44451.jpg

Dense vegetation on landward side.

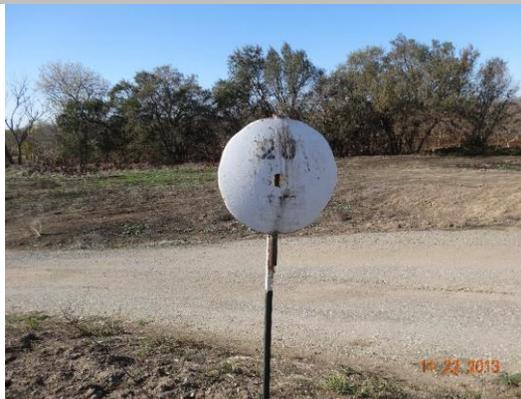
Photo 1 of 2 : UCIP_SP_2016_24769_44454.jpg

Marker visible on waterward side shoulder, crossing is referenced as No. 20.

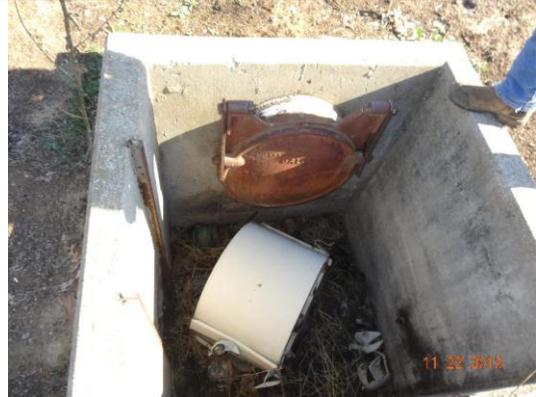
Photo 2 of 2 : UCIP_SP_2016_24769_44453.jpg

View of flap gate located inside concrete distribution box. Debris scattered inside box.

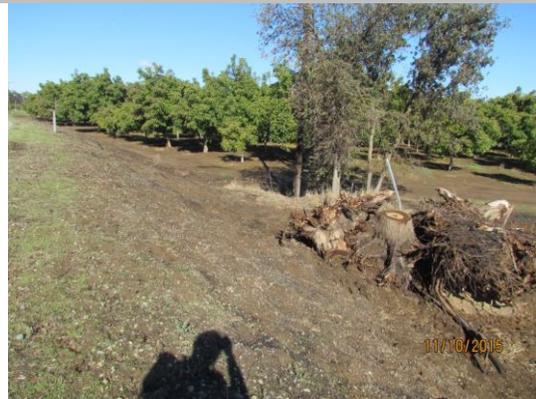
Photo 1 of 1 : SP_2016_RD0010_164_36_20160307_00006.jpg

View of the wood stumps on the landward side of the levee looking upstream. Fall 2015.

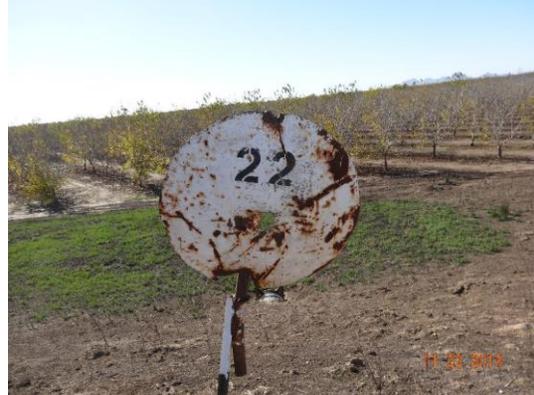
Photo 1 of 2 : UCIP_SP_2016_27776_51478.jpg

Marker visible on waterward shoulder, crossing referenced as No. 22.

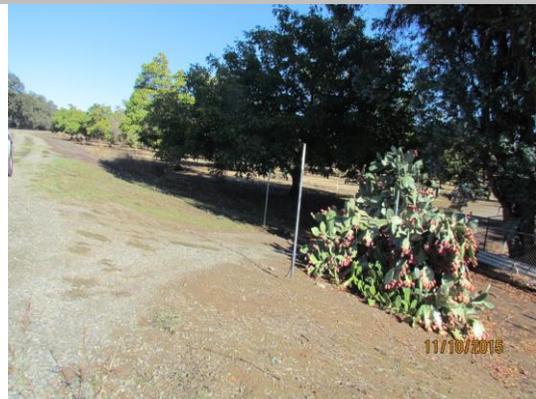
Photo 1 of 1 : SP_2016_RD0010_164_37_20160307_00007.jpg

View of the cactus on the landward side of the levee looking upstream. Fall 2015.

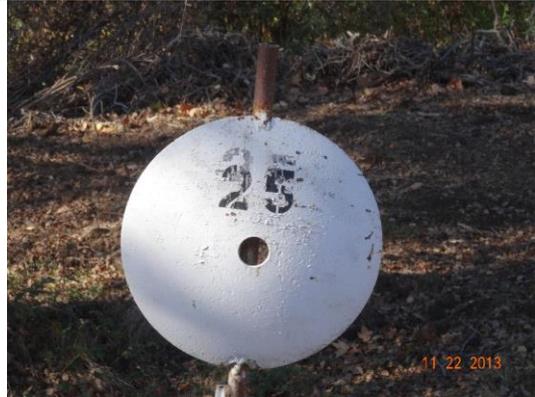
Photo 1 of 2 : UCIP_SP_2016_24840_44753.jpg

Marker visible on waterward side, crossing is referenced as No. 25.

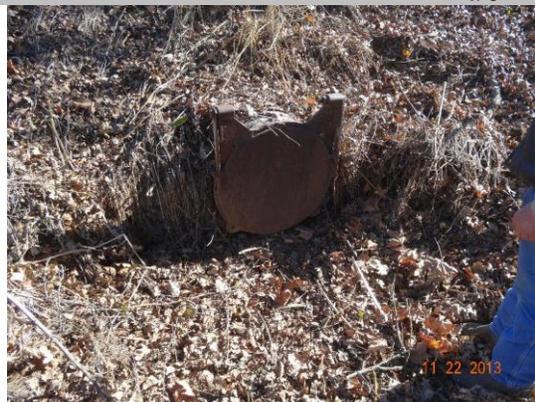
Photo 2 of 2 : UCIP_SP_2016_24840_44752.jpg

View of flap gate located on waterward side.

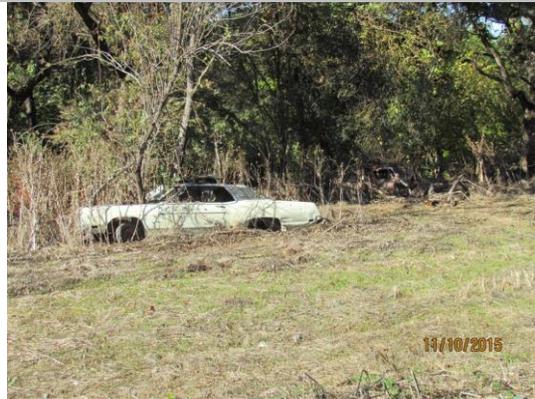
Photo 1 of 1 : SP_2016_RD0010_164_38_20160307_00008.jpg

View of the abandoned cars on the waterward side of the levee. Fall 2015.

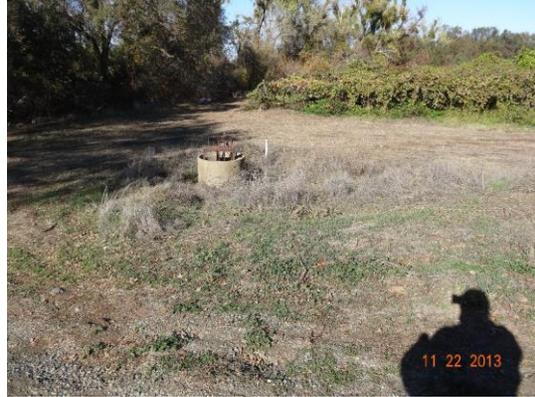
Photo 1 of 2 : UCIP_SP_2016_24841_44759.jpg

View of waterward side.

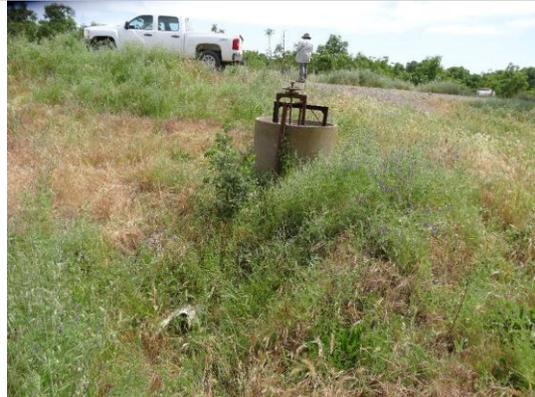
Photo 2 of 2 : UCIP_SP_2016_24841_44757.jpg

View of concrete standpipe and plastic pipe extension visible on waterward side.

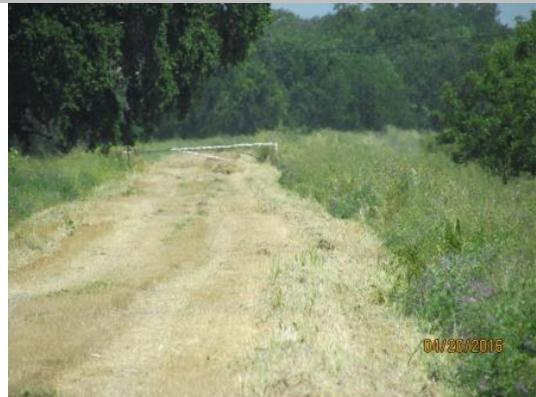
Photo 1 of 1 : SP_2016_RD0010_165_5_20160421_00012.jpg

View of vegetation that has overgrown the crown looking upstream.
