**Flood Control Project Maintenance
Levee Inspections**
LMA District Cover Sheet
Spring 2019 Levee Inspection Results

Reclamation District No. 0010 Honcut

Spring 2019 Levee Inspection Results

Waterway			Bank	Unit Miles
Unit No. 01 Simmerly Slough			Right	7.65
	Spring (March - May)	Summer (June - August)	(September - November) Fall	Winter (December - February)
Unit Maintenance Rating (Fall Only)				
Date of Inspection	5/16/2019 - 5/16/2019			
DWR Inspector	Sterling York			
Accompanied By	Finlay Williams

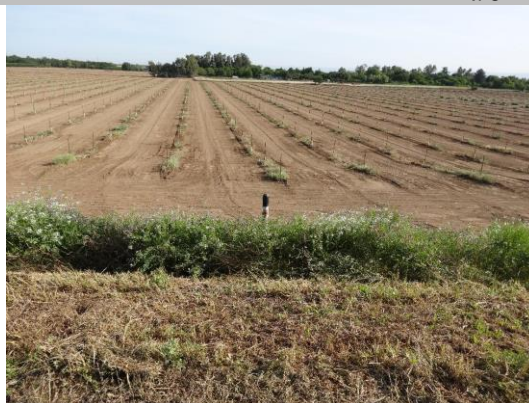
Photo 2 of 2 : UCIP_SP_2019_27712_51364.jpg

LM Start	0.23	Rating **	M	Issue No.	67 (cont)	
LM End	0.23	Issue Type +	En	Location *		
Category	Supplemental			GPS Latitude/Longitude		
				Start	End	
Item	DWR UCIP Field Study			39.163407 °	39.163407 °	
				-121.605645 °	-121.605645 °	
DWR ID	24653					
Comment Code						
Inspector Comment						
FS_ID:27712						
DS_ID:24653						
EP_NO: N/A						
Repair Type: Non-Urgent						
Crossing Status: Indicator Found						
UCIP Comments: 04/29/2013 Need to contact owner--unable to determine if crossing is authorized (no permit found) also need to determine if crossing goes through levee. (DWR UCIP - O. Magana)						
FIELD_STRUCT_DESC: Fiber optics line markers on the levee slope.						
Unable to determine if this line goes through the levee. This line was field discovered.						
FS Date: 4/29/2013

Marker visible on landward side.

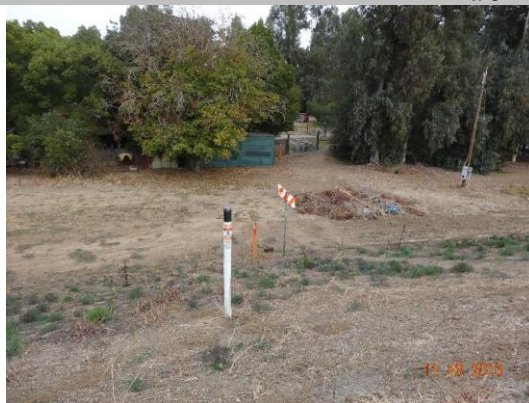
Photo 3 of 3 : UCIP_SP_2019_24806_44543.jpg

Comment Code						
Inspector Comment						
FS_ID:24806 DS_ID:21257 EP_NO: 13015 Repair Type: Non-Urgent Crossing Status: Found UCIP Comments: 04/29/2013 New gravel indicates work was recently completed. Will need to contact owner to obtain information pertaining to work completed. Need to contact owner to determine if crossing is still active and to determine last inspection date. Will need copy of letter showing crossings passed inspection. This crossing is referenced in the USACE Periodic Inspection as item USACE_CESPK_HON1_2013_p_0075. (DWR UCIP - O. Magana) FIELD_STRUCT_DESC: 4-inch steel natural gas pipeline sleeved through an 8-inch pipe through the levee, 30 feet below the crown. Annular space grouted. Cutoff wall on each end within the levee. (Plans to reinforce an existing 4-inch gas main with a parallel 4-inch main through the levee authorized under Permit No. 13015, 1980 - Pacific Gas and Electric Company [PG&E]). [Additional Reference(s): DWR Levee Log, 2005]. FS Date: 4/29/2013

View of landward side--gas marker and conduit line marker.

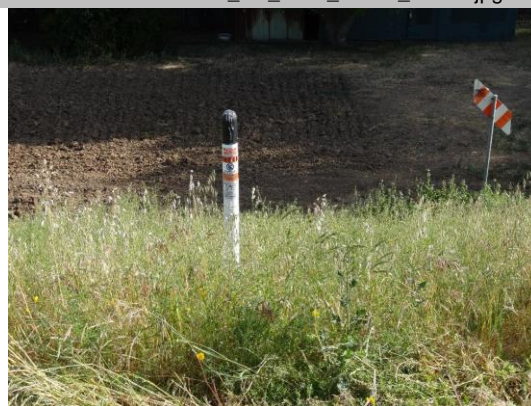
Photo 1 of 2 : UCIP_SP_2019_27713_51366.jpg

LM Start	0.41	Rating **	M	Issue No.	69
LM End	0.41	Issue Type +	En	Location *	
Category	Supplemental			GPS Latitude/Longitude	
				Start	End
Item	DWR UCIP Field Study			39.162853 °	39.162853 °
				-121.602435 °	-121.602435 °
DWR ID	24654				
Comment Code					
Inspector Comment					
FS_ID:27713 DS_ID:24654 EP_NO: N/A Repair Type: Non-Urgent Crossing Status: Indicator Found UCIP Comments: 04/29/2013 Need to contact owner--unable to determine if crossing is authorized (no permit found) also need to determine if crossing goes through levee. (DWR UCIP - O. Magana) FIELD_STRUCT_DESC: Fiber optics line markers on levee slope. Unable to determine if line goes through the levee. This line was field discovered. FS Date: 4/29/2013

View of landward side--communication line marker.

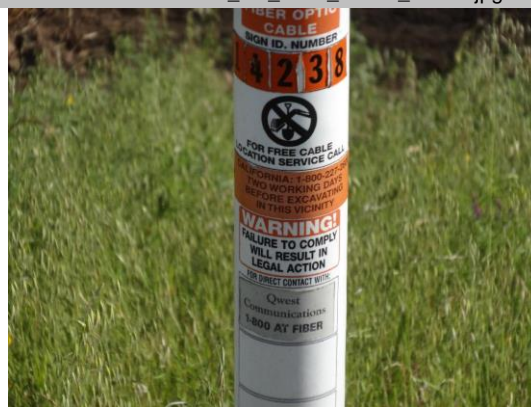
Photo 2 of 2 : UCIP_SP_2019_27713_51367.jpg

Contact information for communication line.

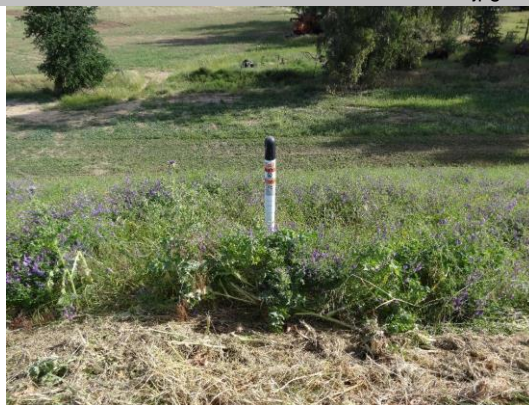
Photo 2 of 2 : UCIP_SP_2019_27710_51360.jpg

LM Start	0.53	Rating **	M	Issue No.	70
LM End	0.53	Issue Type +	En	Location *	
Category	Supplemental			GPS Latitude/Longitude	
				Start	End
Item	DWR UCIP Field Study			39.162277 °	39.162277 °
				-121.600219 °	-121.600219 °
DWR ID	24655				
Comment Code					
Inspector Comment					
FS_ID:27710					
DS_ID:24655					
EP_NO: N/A					
Repair Type: Non-Urgent					
Crossing Status: Indicator Found					
UCIP Comments: 04/29/2013 Need to contact owner--unable to determine if crossing is authorized (no permit found) also need to determine if crossing goes through levee. (DWR UCIP - O. Magana)					
FIELD_STRUCT_DESC: Fiber optics line markers on levee slope.					
Unable to determine if line goes through the levee. This line was field discovered.					
FS Date: 4/29/2013

View of marker located on landward side.

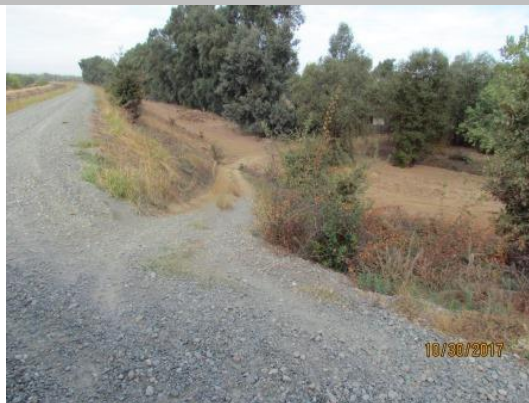
Photo 1 of 1 : SP_2019_RD0010_163_48_20190305_00009.jpg

LM Start	0.72	Rating **	M	Issue No.	48
LM End	0.72	Issue Type +	Ma	Location *	LS
Category	Earthen Levee			GPS Latitude/Longitude	
				Start	End
Item	Slope Stability			39.161198 °	39.161198 °
				-121.597102 °	-121.597102 °
DWR ID	DWR_RD0010_01_f_2013_48				
Comment Code					
S3 : Repair the levee slope damaged by vehicle traffic and prevent access where possible.					
Inspector Comment					
Ramp is caused by constant ATV foot traffic use on levee slope.

View of the slope stability caused by foot traffic on the landward side of the levee looking downstream.

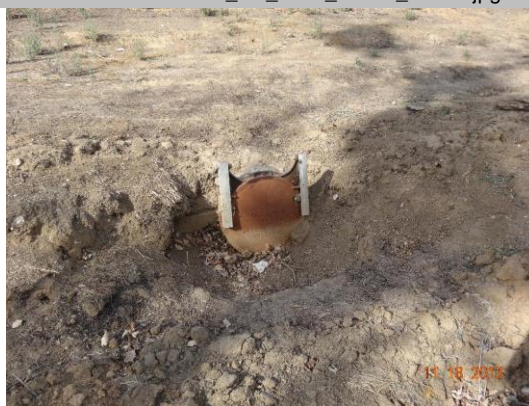
Photo 3 of 3 : UCIP_SP_2019_27748_51451.jpg

Comment Code						
Inspector Comment						
FS_ID:27748						
DS_ID:21261						
EP_NO: N/A						
Repair Type: No Action Needed						
Crossing Status: Found						
UCIP Comments: 04/29/2013 No signs of damage to levee present during inspection. This crossing is referenced in the USACE Periodic Inspection as item USACE_CESPK_HON1_2013_p_0037 and 0040. (DWR UCIP - O. Magana)						
FIELD_STRUCT_DESC: 24-inch corrugated metal gravity drainage pipe through the levee, 29.5 feet below the crown. Two corrugated metal cutoff walls around the pipe on each end. Slide gate on the landside (LS) end. Flap gate on the waterside (WS) end. Concrete headwall at the LS toe. [Additional Reference(s): DWR Levee Log, 2005. USACE Sacramento O&M Manual 151, May 1953, (Station 37+66)].						
FS Date: 4/29/2013

View of flap gate located on waterward side.

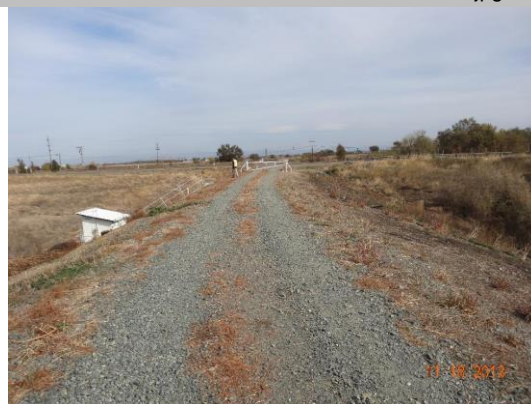
Photo 2 of 3 : UCIP_SP_2019_27725_51387.jpg

Comment Code					
Inspector Comment					
FS_ID:27725 DS_ID:21262 EP_NO: N/A Repair Type: Non-Urgent Crossing Status: Found UCIP Comments: 04/29/2013 Crossing appears not to be in use--need to contact owner. Need to coordinate with owner to determine status of crossing. If crossing is no longer in use owner will need to contact the CVFPB to comply with Title 23. This crossing is referenced in the USACE Periodic Inspection as item USACE_CESPK_HON1_2013_p_0012. (DWR UCIP - O. Magana) FIELD_STRUCT_DESC: 10-inch steel irrigation discharge pipe through the levee, 7.3 feet below the crown. Siphon breaker in a corrugated metal pipe (CMP) riser on the waterside (WS) slope. Pump on the WS berm. Pump not present. Switch house on the WS slope. No switch house present. 24-inch concrete standpipe at the landside (LS) toe. Concrete pad is still present on the WS. [Additional Reference(s): DWR Levee Log, 2005. USACE Sacramento O&M Manual 151, May 1953, (Station 14+82)]. FS Date: 4/29/2013

View of levee crown looking downstream.

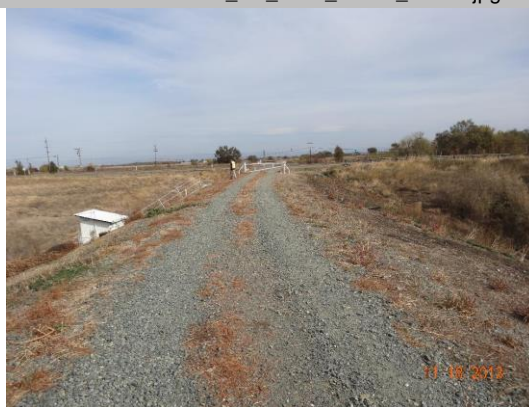
Photo 2 of 3 : UCIP_SP_2019_24810_44577.jpg

Comment Code						
Inspector Comment						
FS_ID:24810 DS_ID:21263 EP_NO: N/A Repair Type: Non-Urgent Crossing Status: Found UCIP Comments: 04/29/2013 Pipe has been capped on waterward side--see photos. Need to coordinate with DWR Inspector to determine whether crossing is compliant with Title 23. This crossing is referenced in the USACE Periodic Inspection as item USACE_CESPK_HON1_2013_p_0016. (DWR UCIP - O. Magana) FIELD_STRUCT_DESC: 10-inch steel irrigation discharge pipe through the levee, 6.8 feet below the crown. Steel cutoff plate around the pipe at the center of the levee. Siphon breaker in corrugated metal pipe (CMP) riser on the waterside (WS) slope. Pump on a concrete base on the WS berm, not present. 36-inch concrete standpipe at the landside (LS) toe. Metal shed and service pole on the WS slope, not present. [Additional Reference(s): DWR Levee Log, 2005. USACE Sacramento O&M Manual 151, May 1953, (Station 14+16)]. FS Date: 4/29/2013

View of levee crown looking downstream.

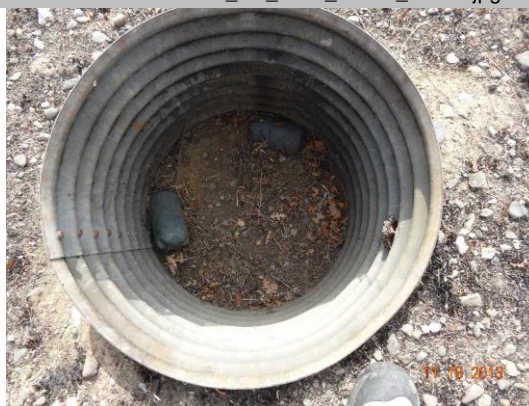
Photo 3 of 3 : UCIP_SP_2019_24810_44575.jpg

Comment Code						
Inspector Comment						
FS_ID:24810 DS_ID:21263 EP_NO: N/A Repair Type: Non-Urgent Crossing Status: Found UCIP Comments: 04/29/2013 Pipe has been capped on waterward side--see photos. Need to coordinate with DWR Inspector to determine whether crossing is compliant with Title 23. This crossing is referenced in the USACE Periodic Inspection as item USACE_CESPK_HON1_2013_p_0016. (DWR UCIP - O. Magana) FIELD_STRUCT_DESC: 10-inch steel irrigation discharge pipe through the levee, 6.8 feet below the crown. Steel cutoff plate around the pipe at the center of the levee. Siphon breaker in corrugated metal pipe (CMP) riser on the waterside (WS) slope. Pump on a concrete base on the WS berm, not present. 36-inch concrete standpipe at the landside (LS) toe. Metal shed and service pole on the WS slope, not present. [Additional Reference(s): DWR Levee Log, 2005. USACE Sacramento O&M Manual 151, May 1953, (Station 14+16)]. FS Date: 4/29/2013

Siphon breaker has been buried inside CMP riser.

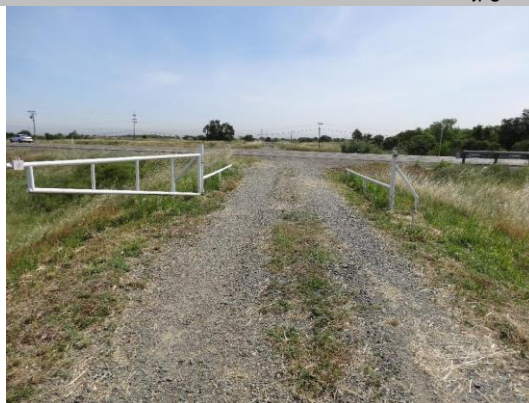
Photo 2 of 3 : UCIP_SP_2019_24811_44581.jpg

Comment Code						
Inspector Comment						
FS_ID:24811 DS_ID:21264 EP_NO: N/A Repair Type: No Action Needed Crossing Status: Found UCIP Comments: 04/29/2013 This crossing is referenced in the USACE Periodic Inspection as item USACE_CESPK_HON1_2013_p_0004. (DWR UCIP - O. Magana) FIELD_STRUCT_DESC: [Reclamation District No. 10 (RD0010) Drainage Plant] 16-inch steel drainage discharge pipe through the levee, 7 feet below the crown. Steel cutoff plate around the pipe at the center of the levee. Siphon breaker on the landside (LS) slope. Flap gate on the waterside (WS) end. Pump in a pit at the LS toe with steps along the LS slope. Saddle and 8-foot splash apron at the discharge end of the pipe. Concrete headwall at the LS toe. Metal shed on the LS slope. [Additional Reference(s): DWR Levee Log, 2005. USACE Sacramento O&M Manual 151, May 1953, (Station 13+88)]. FS Date: 4/29/2013

View of levee crown looking downstream--access gate near HWY 70.

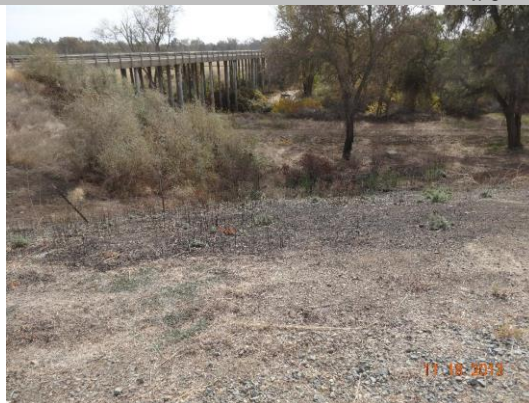
Photo 3 of 3 : UCIP_SP_2019_24811_44585.jpg

Comment Code						
Inspector Comment						
FS_ID:24811 DS_ID:21264 EP_NO: N/A Repair Type: No Action Needed Crossing Status: Found UCIP Comments: 04/29/2013 This crossing is referenced in the USACE Periodic Inspection as item USACE_CESPK_HON1_2013_p_0004. (DWR UCIP - O. Magana) FIELD_STRUCT_DESC: [Reclamation District No. 10 (RD0010) Drainage Plant] 16-inch steel drainage discharge pipe through the levee, 7 feet below the crown. Steel cutoff plate around the pipe at the center of the levee. Siphon breaker on the landside (LS) slope. Flap gate on the waterside (WS) end. Pump in a pit at the LS toe with steps along the LS slope. Saddle and 8-foot splash apron at the discharge end of the pipe. Concrete headwall at the LS toe. Metal shed on the LS slope. [Additional Reference(s): DWR Levee Log, 2005. USACE Sacramento O&M Manual 151, May 1953, (Station 13+88)]. FS Date: 4/29/2013

View of waterward side.

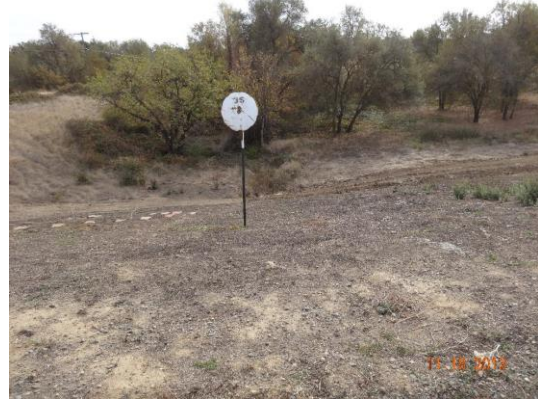
Photo 1 of 3 : UCIP_SP_2019_53136_44588.jpg

FS_ID:53136
DS_ID:21318
EP_NO: N/A
Repair Type: Urgent
Crossing Status: Found
UCIP Comments: 10/18/2018 No change since the last inspection. Pipe remains Urgent due to deteriorated wall (visible holes present inside) near WS flap gate. This pipe is part of DWR's Deferred Maintenance Project (DMP). According to LMA representative, the video inspection of DMP pipes is expected to be completed next year. Levee height is about 25-30 feet. (O. Magana - DWR UCIP)7/01/2016 Pipe wall in poor condition--deteriorated pipe wall indicated by holes at the inlet and outlet pipe collar. Recommend internal integrity inspection of the pipe through the levee to determine extent of damage. (DWR UCIP - omagana)4/29/2013 Holes present on pipe wall. Need to contact owner to notify of issue with pipe. Also need to contact DWR Inspector and CVFPB to determine how to address issue. This crossing is referenced in the USACE Periodic Inspection as item USACE_CESPK_HON1_2013_p_0140. Pipe should be 30-inch instead of 36-inch mentioned Periodic Inspection. (DWR UCIP - omagana) FIELD_STRUCT_DESC: 30-inch corrugated metal gravity drainage pipe through the levee, approximately 30 feet below the crown. Two corrugated metal cutoff walls around the pipe on each side. Saddle and splash apron at the waterside (WS) discharge point. Concrete headwall and sluice gate on the landside (LS). [Additional Reference(s): DWR Levee Log, 2005. USACE Sacramento O&M Manual 151, May 1953, (Station 10+38)].

View of WS--marker present on WS shoulder.

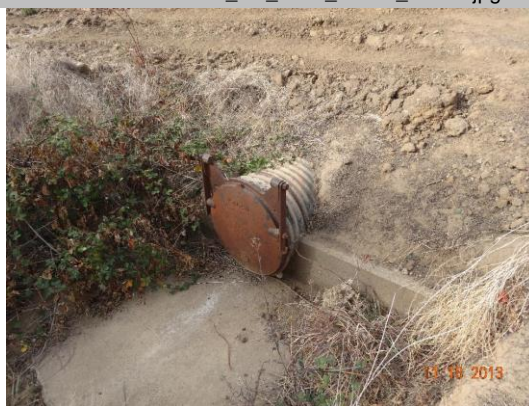
Photo 2 of 3 : UCIP_SP_2019_53136_44587.jpg

View of headwall, pipe, and flap gate located on WS.

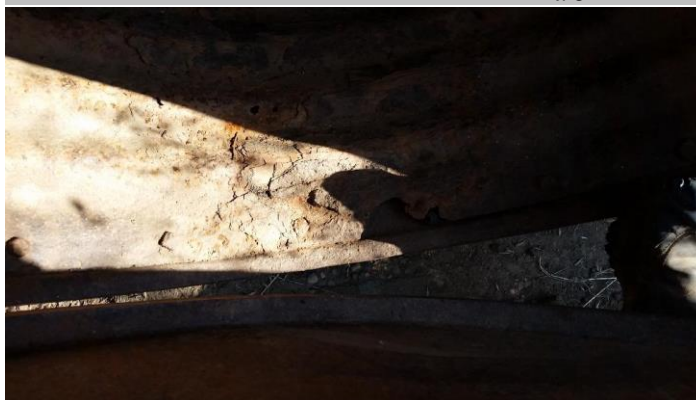
Photo 3 of 3 : UCIP_SP_2019_53136_75321.jpg

Deteriorated pipe wall at the outlet (WS).

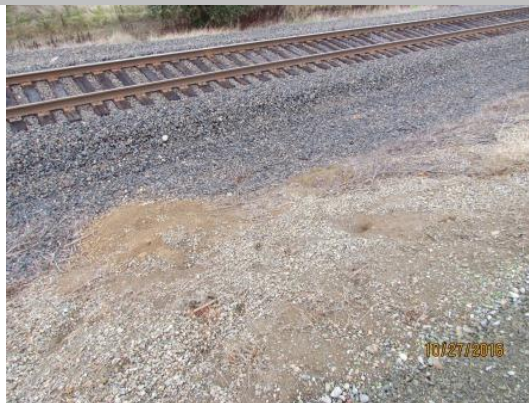
Photo 1 of 1 : SP_2019_RD0010_163_65_20190305_00021.jpg

View of squirrel holes on the landside, no rodent activity was observed.

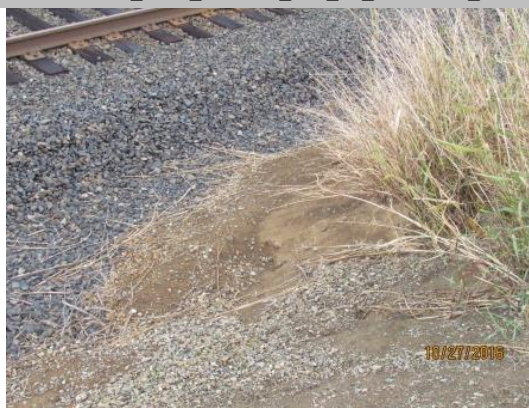
Photo 1 of 1 : SP_2019_RD0010_163_64_20190305_00020.jpg

View of squirrel holes on the landside, no rodent activity was observed.

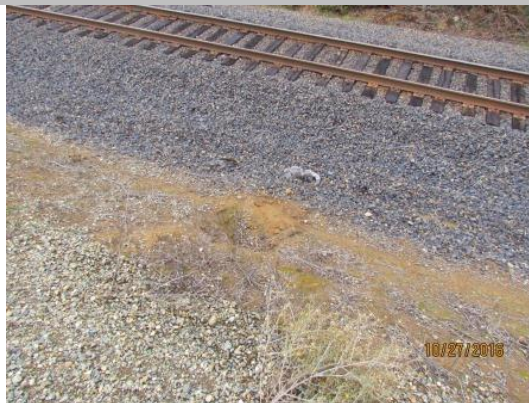
Photo 1 of 1 : SP_2019_RD0010_163_63_20190305_00019.jpg

View of squirrel holes on the landside, no rodent activity was observed.

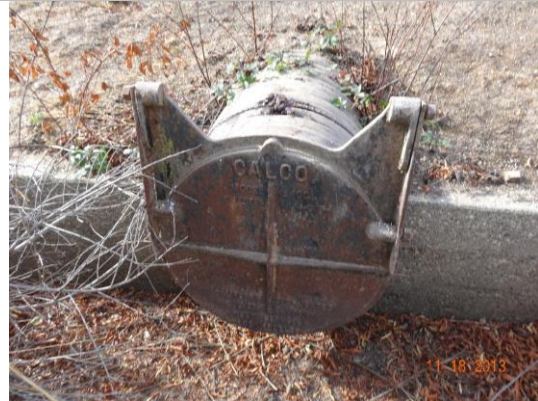
Photo 3 of 3 : UCIP_SP_2019_27745_51431.jpg

Flap gate appears to be in good condition.

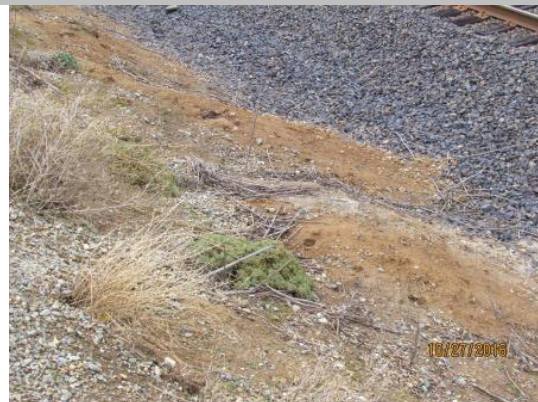
Photo 1 of 1 : SP_2019_RD0010_163_61_20190305_00018.jpg

View of squirrel holes on the landside slope and toe, no rodent activity was observed.

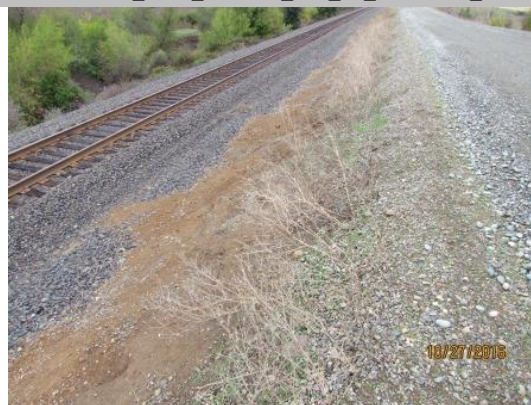
Photo 1 of 1 : SP_2019_RD0010_163_60_20190305_00017.jpg

View of squirrel holes on the landside slope and toe, no rodent activity was observed.

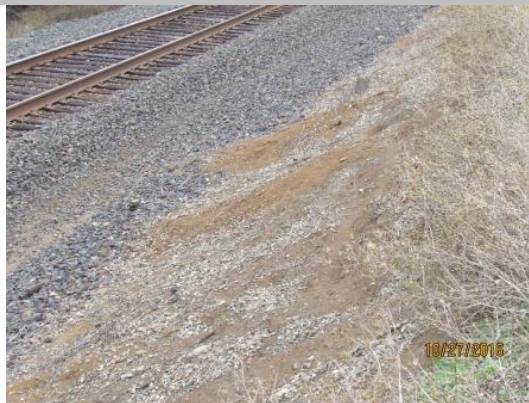
Photo 1 of 1 : SP_2019_RD0010_163_59_20190305_00016.jpg

View of squirrel holes on the landside slope and toe, no rodent activity was observed.

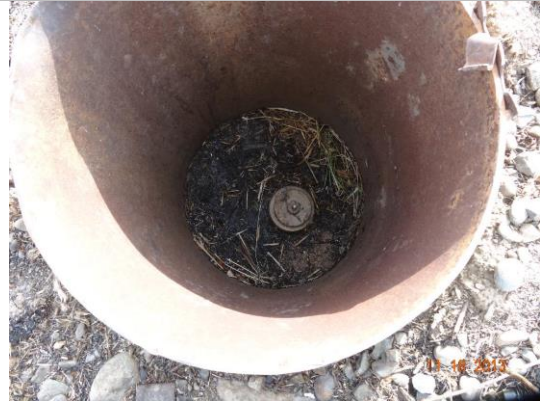
Photo 3 of 3 : UCIP_SP_2019_53137_44606.jpg

View of siphon breaker located inside steel riser.

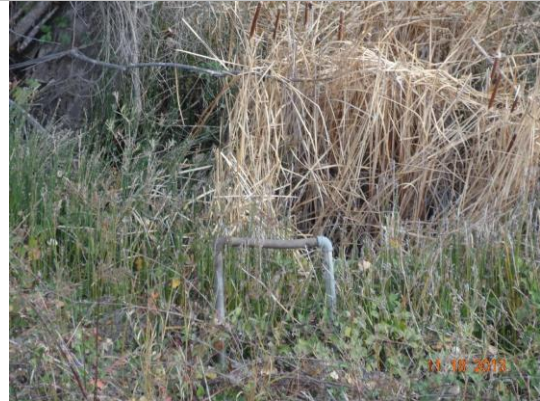
Photo 3 of 3 : UCIP_SP_2019_24816_44612.jpg

Unable to confirm crossing--only visible sign is U shaped pipe through vegetation.

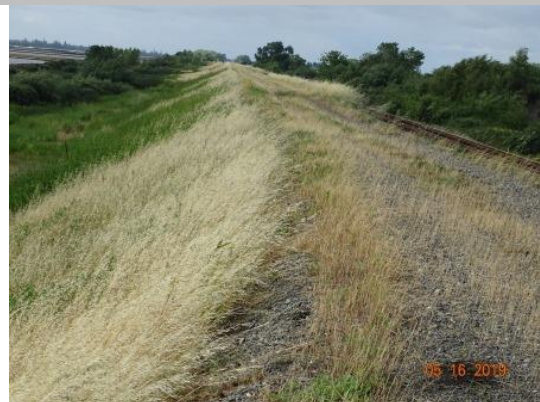
Photo 1 of 1 : SP_2019_RD0010_163_28_20190520_00082.jpg

View looking downstream crown at the annual vegetation that needs to be maintained, Spring 2019.

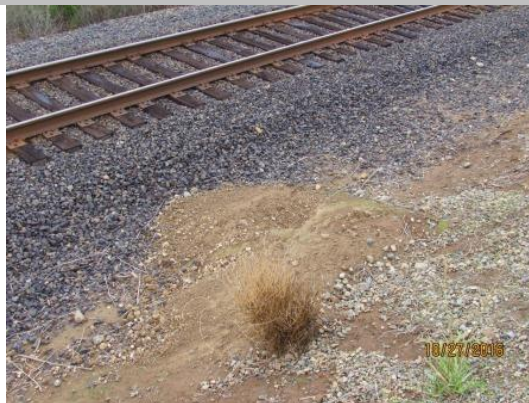
Photo 1 of 1 : SP_2019_RD0010_163_52_20190305_00013.jpg

View of squirrel holes on the landside slope and toe, no rodent activity was observed. Fall 2016.

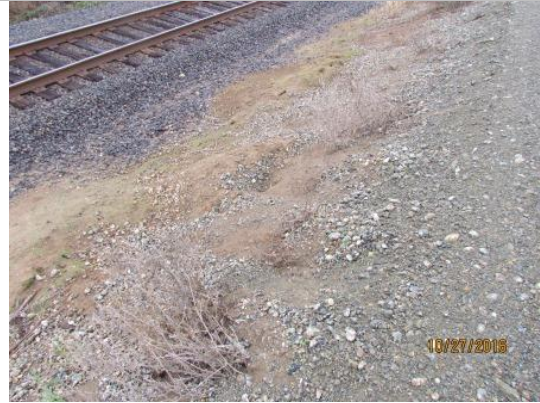
Photo 1 of 1 : SP_2019_RD0010_163_50_20190305_00011.jpg

View of squirrel holes on the landside slope and toe, no rodent activity was observed.

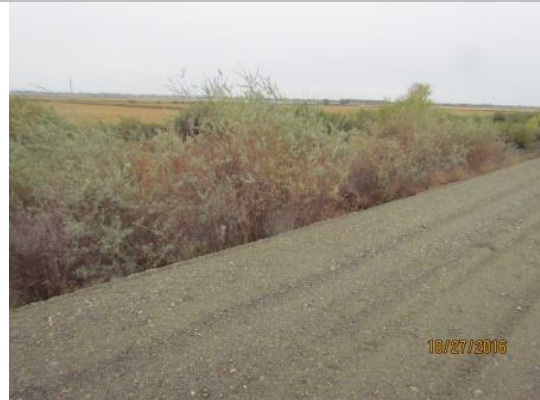
Photo 1 of 1 : SP_2019_RD0010_163_49_20190305_00010.jpg

View of small starter willow trees on the landside looking upstream.

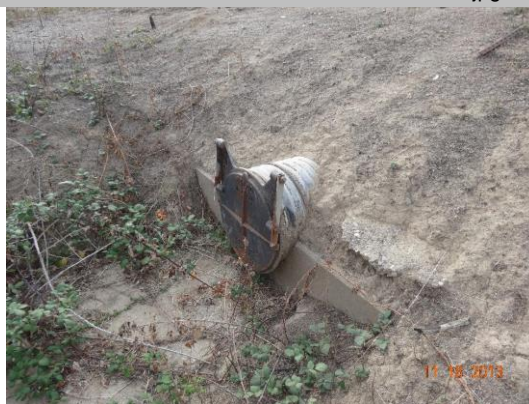
Photo 2 of 3 : UCIP_SP_2019_27747_51445.jpg

View of pipe, flap gate, and headwall located on waterward toe.

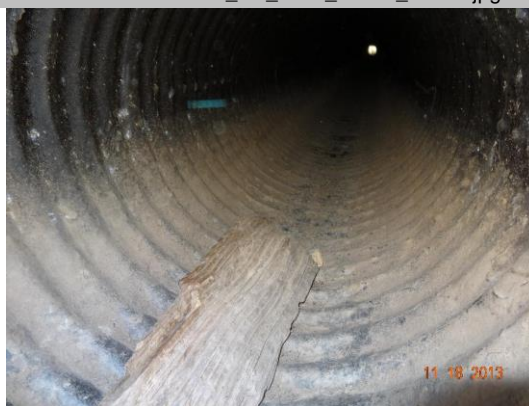
Photo 3 of 3 : UCIP_SP_2019_27747_51443.jpg

Internal view of pipe wall using camera with flash.

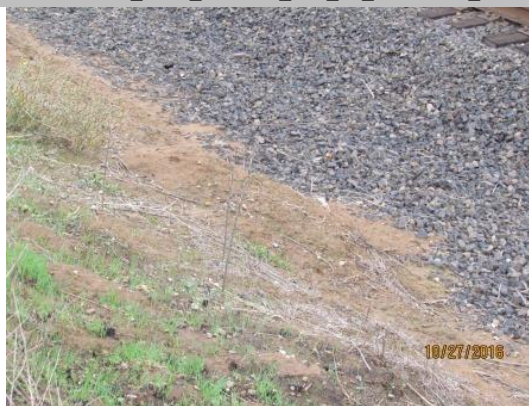
Photo 1 of 1 : SP_2019_RD0010_163_46_20190305_00007.jpg

View of squirrel holes on the landside slope and toe, no rodent activity was observed.

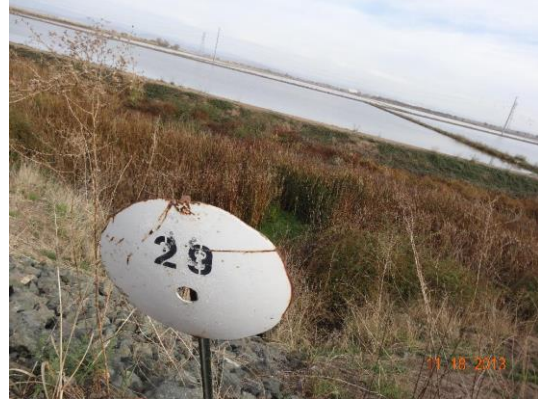
Photo 1 of 3 : UCIP_SP_2019_53138_44811.jpg

Marker for pipe crossing visible on WS shoulder.

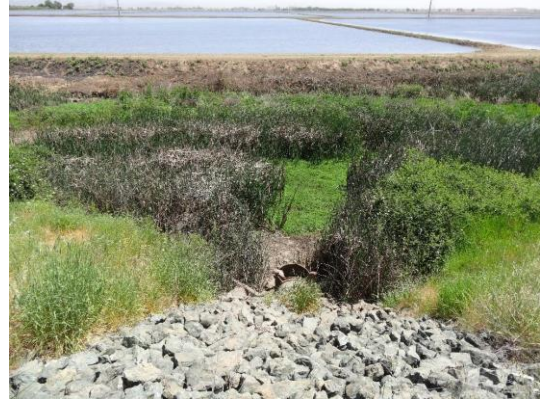
Photo 2 of 3 : UCIP_SP_2019_53138_44809.jpg

View of WS during April.

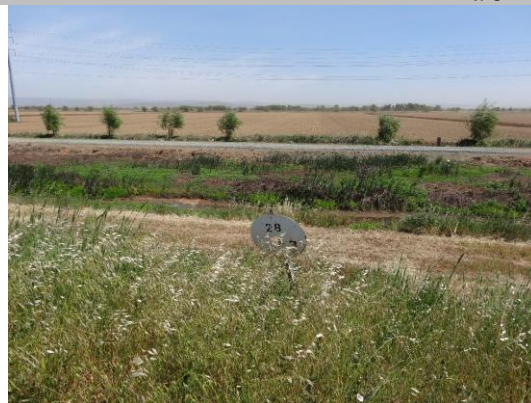
Photo 1 of 3 : UCIP_SP_2019_24438_43503.jpg

Marker visible on waterward shoulder.

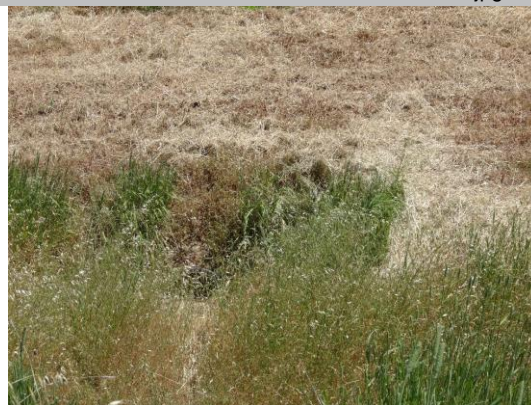
Photo 2 of 3 : UCIP_SP_2019_24438_43502.jpg

View of waterward toe where pipe daylights.

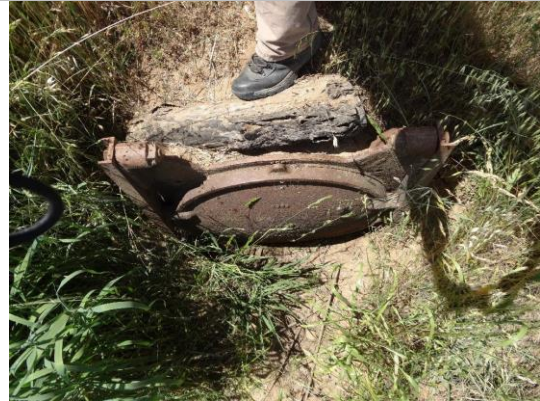
Photo 3 of 3 : UCIP_SP_2019_24438_43501.jpg

Pipe and flap gate confirmed on waterward side.

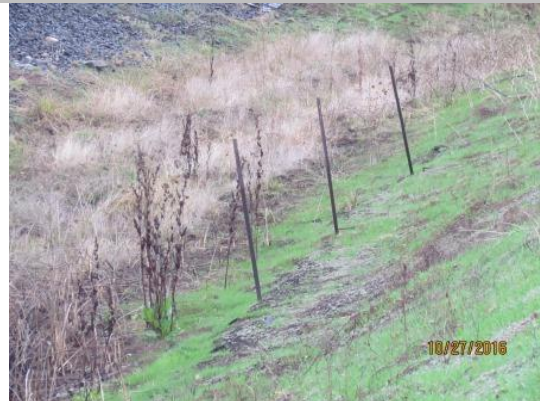
Photo 1 of 1 : SP_2019_RD0010_163_33_20190305_00001.jpg

View of fence post that run along the landside levee toe, looking upstream.

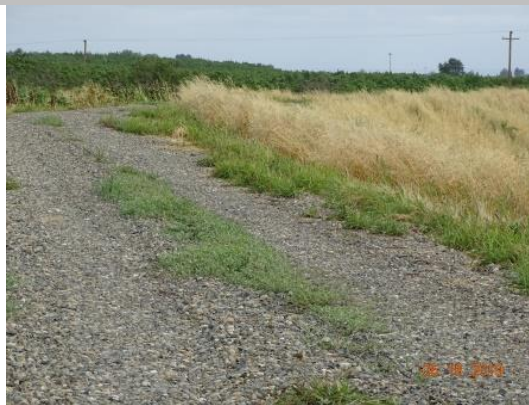
Photo 1 of 1 : SP_2019_RD0010_164_43_20190520_00101.jpg

View looking upstream landside at the annual vegetation that needs maintenance, Spring 2019.

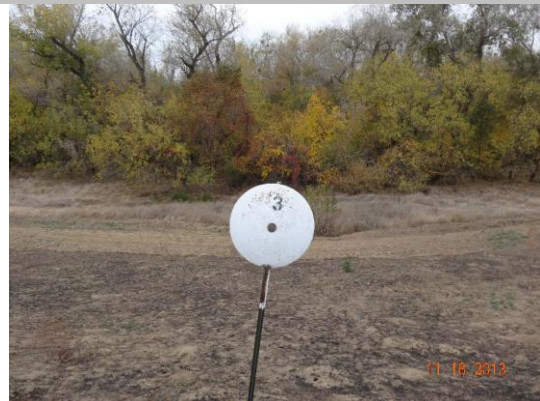
Photo 1 of 3 : UCIP_SP_2019_27533_51135.jpg

View of waterward side.

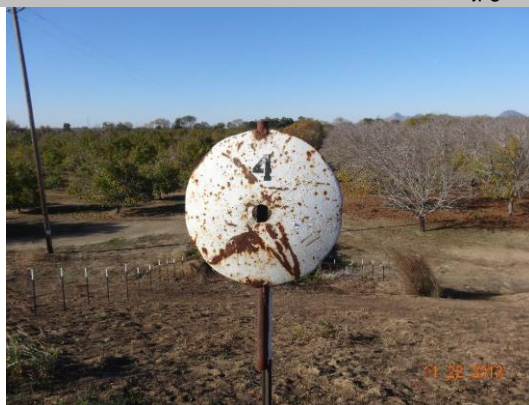
Photo 1 of 3 : UCIP_SP_2019_24821_44640.jpg

Marker visible on waterward side--No. 4.

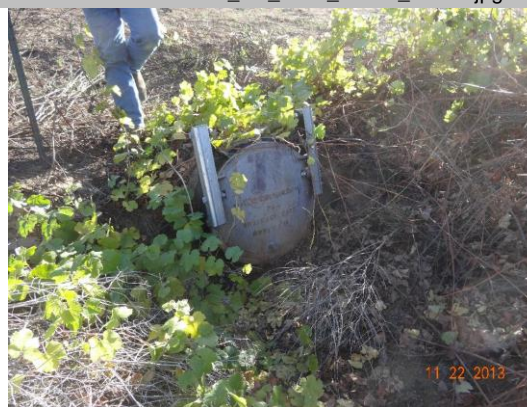
Photo 3 of 3 : UCIP_SP_2019_24821_44638.jpg

View of flap gate located on waterward side.

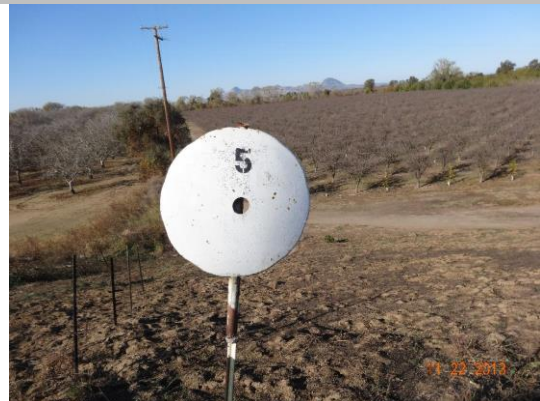
Photo 1 of 3 : UCIP_SP_2019_24822_44647.jpg

Marker visible on waterward side--No. 5.

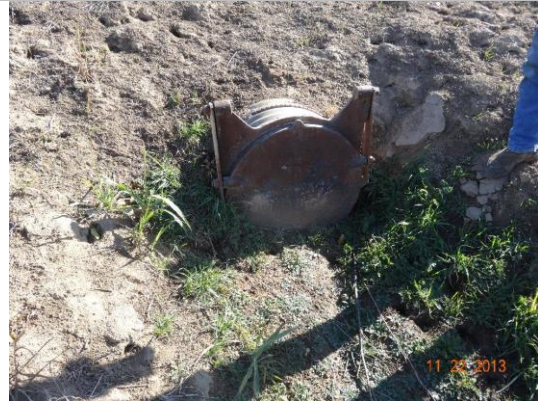
Photo 3 of 3 : UCIP_SP_2019_27773_51464.jpg

View of gate on waterward side.

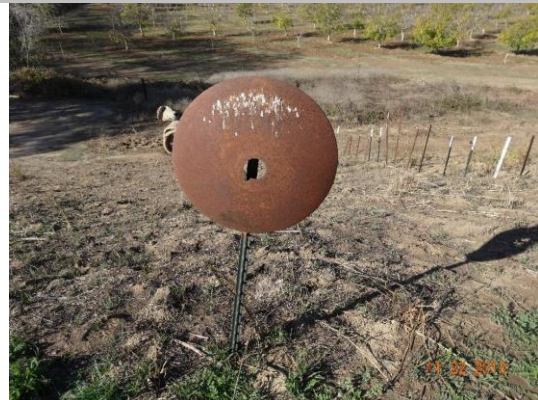
Photo 1 of 3 : UCIP_SP_2019_52889_44658.jpg

Marker visible on waterward side.

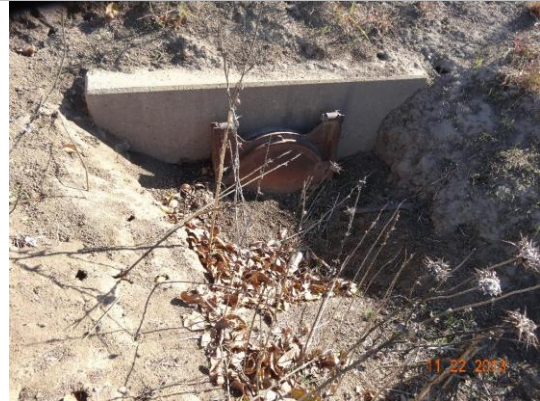
Photo 3 of 3 : UCIP_SP_2019_24825_44662.jpg

Flap gate located on waterward side--debris blocking gate.

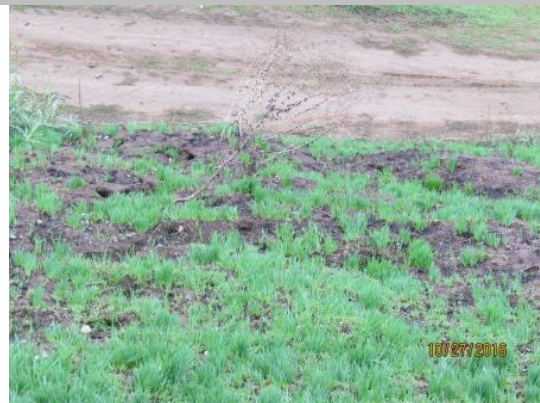
Photo 1 of 1 : SP_2019_RD0010_164_68_20190305_00023.jpg

View of rodent holes on waterside slope, no evidence of rodent activity.

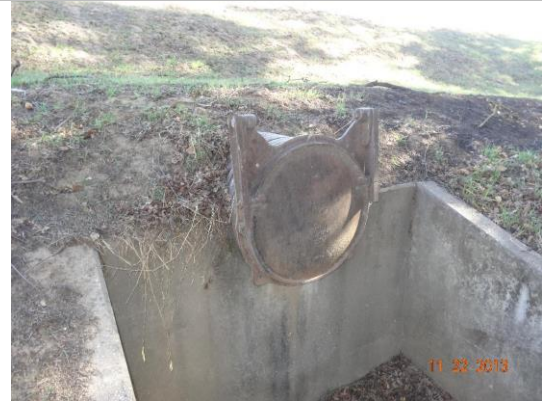
Photo 3 of 3 : UCIP_SP_2019_24826_44673.jpg

View of flapgate on concrete head wall on waterward side.

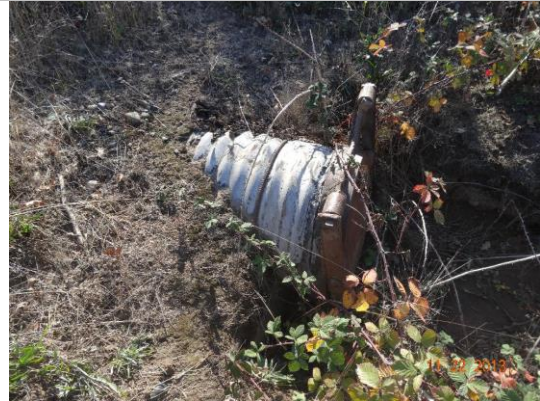
Photo 3 of 3 : UCIP_SP_2019_27774_51469.jpg

View of flap gate located on waterward side.

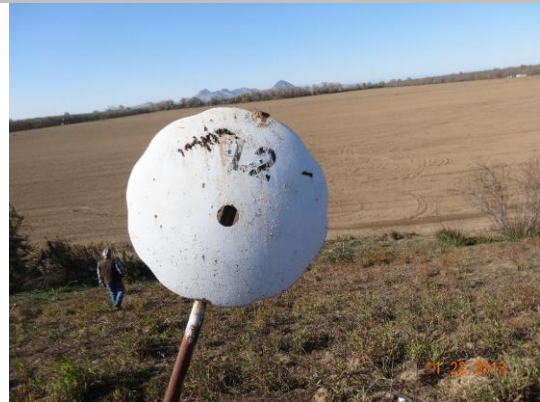
Photo 1 of 3 : UCIP_SP_2019_24828_44680.jpg

View of marker located on waterward shoulder--crossing referenced as No. 12.

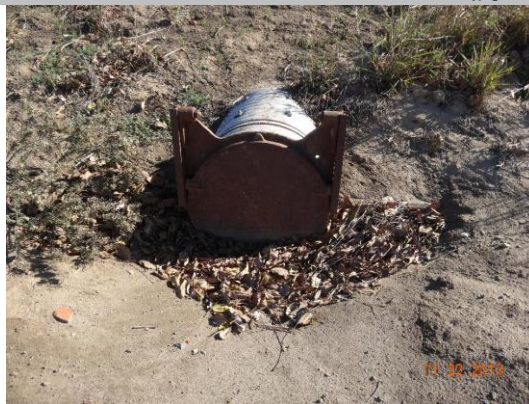
Photo 2 of 3 : UCIP_SP_2019_27793_51517.jpg

View of flap gate located on waterward side.

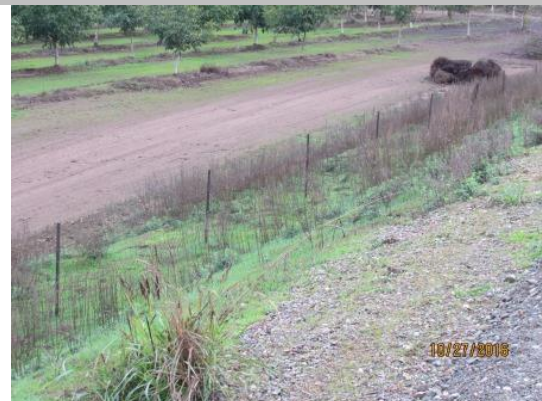
Photo 1 of 1 : SP_2019_RD0010_164_55_20190305_00020.jpg

View of fence at landside levee toe looking downstream.

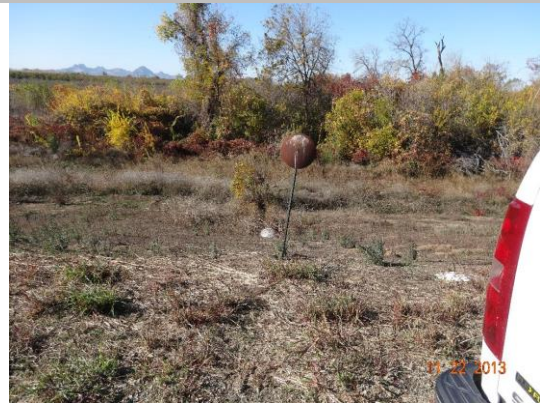
Photo 1 of 3 : UCIP_SP_2019_24831_44700.jpg

Visible marker located on waterward shoulder--no id number noted.

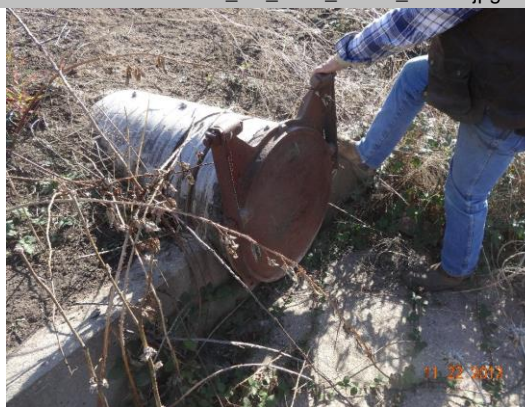
Photo 3 of 3 : UCIP_SP_2019_24831_44698.jpg

Flap gate visible on waterward side.

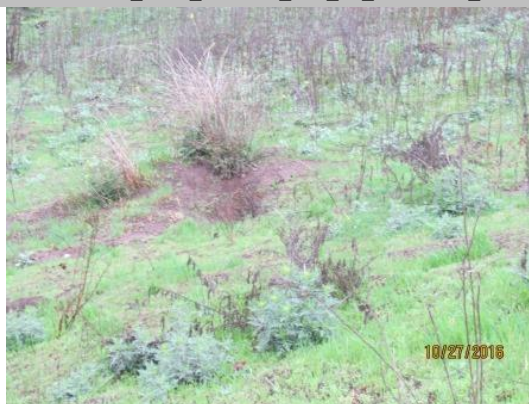
Photo 1 of 1 : SP_2019_RD0010_164_35_20190305_00012.jpg

View of rodent hole on waterside.

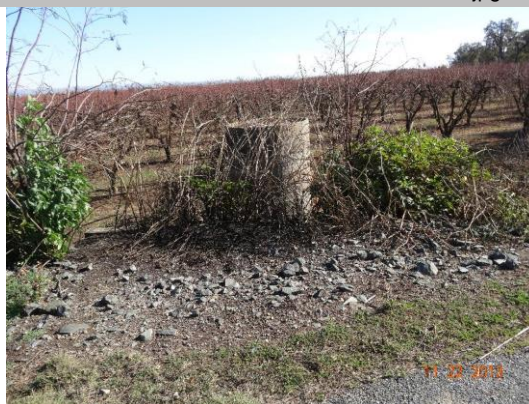
Photo 2 of 3 : UCIP_SP_2019_24839_44742.jpg

View of standpipe located on landward side.

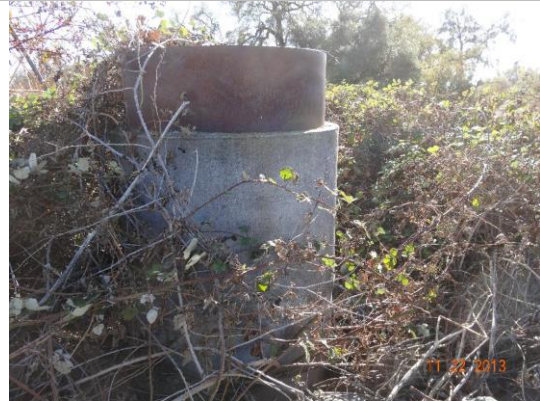
Photo 3 of 3 : UCIP_SP_2019_24839_44748.jpg

View of standpipe located on waterward side.

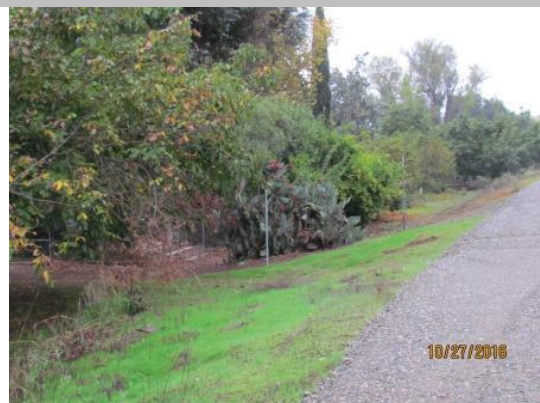
Photo 1 of 1 : SP_2019_RD0010_164_37_20190305_00013.jpg

View of the cactus on the landward side of the levee looking downstream.

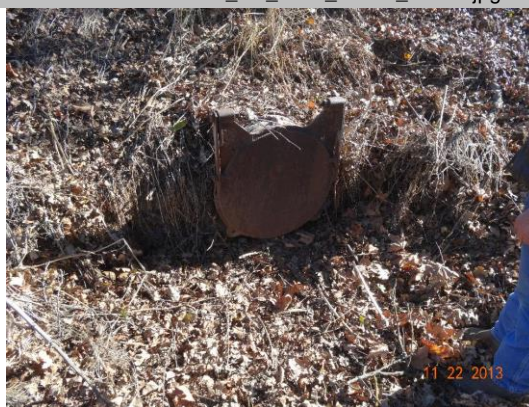
Photo 2 of 3 : UCIP_SP_2019_24840_44752.jpg

View of flap gate located on waterward side.

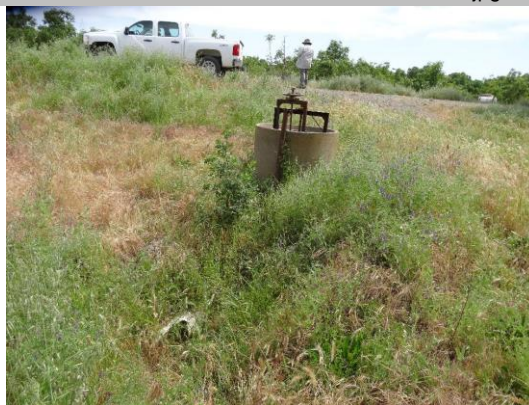
Photo 2 of 3 : UCIP_SP_2019_24841_44757.jpg

View of concrete standpipe and plastic pipe extension visible on waterward side.

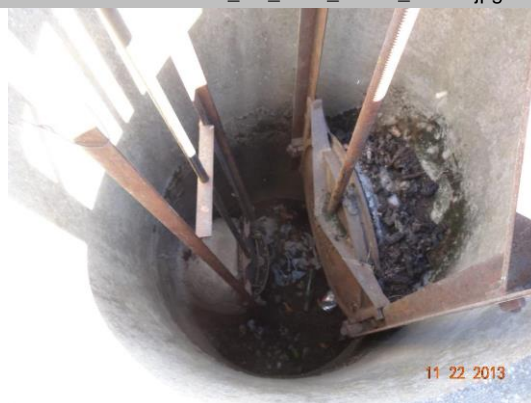
Photo 3 of 3 : UCIP_SP_2019_24841_44758.jpg

Inside view of concrete standpipe with 2 screw gates inside.

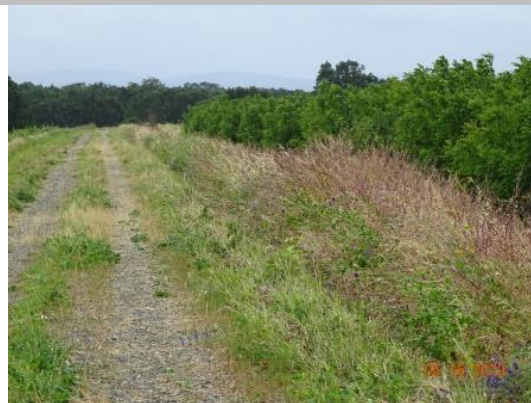
Photo 1 of 1 : SP_2019_RD0010_165_7_20190520_00013.jpg

View looking downstream at the waterside of the annual vegetation that needs maintenance, Spring 2019.
