**Flood Control Project Maintenance  
Levee Inspections**  
**LMA District Cover Sheet**  
**Spring 2020 Levee Inspection Results**

**Reclamation District No. 0010 Honcut**

**Spring 2020 Levee Inspection Results**

Waterway			Bank	Unit Miles
Unit No. 01 Simmerly Slough			Right	7.65
	Spring (March - May)	Summer (June - August)	(September - November) Fall	Winter (December - February)
Unit Maintenance Rating (Fall Only)				
Date of Inspection	4/28/2020 - 4/28/2020			
DWR Inspector	Sterling York			
Accompanied By	Finlay Williams

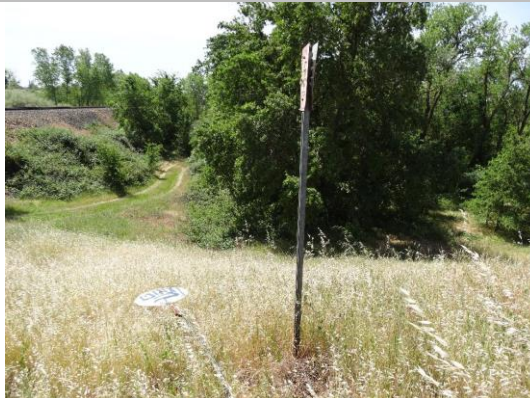
Photo 2 of 3 : UCIP\_SP\_2020\_27791\_51500.jpg

Pipe marker visible on ground--sign has been bent.

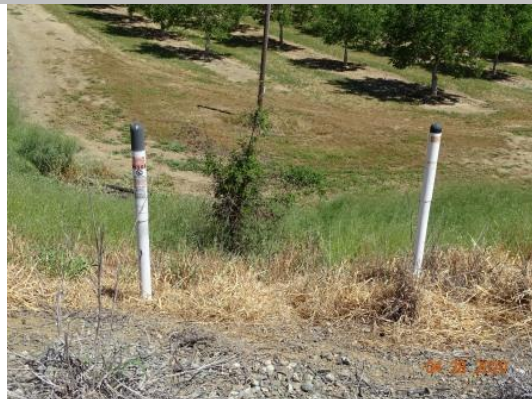
Photo 1 of 1 : SP\_2020\_RD0010\_163\_44\_20200429\_00085.jpg

View looking upstream landside at small starter tree on levee slope, Spring 2020.

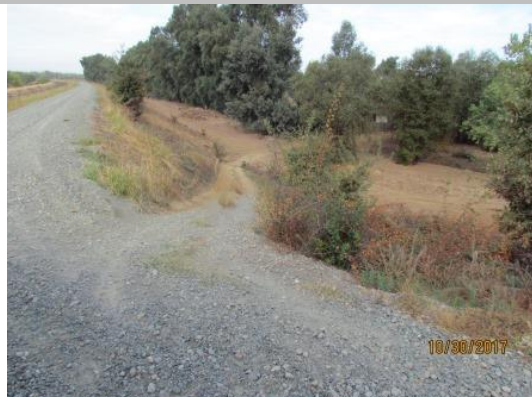
Photo 1 of 1 : SP\_2020\_RD0010\_163\_48\_20200227\_00013.jpg

LM Start	0.72	Rating **	A/W	Issue No.	48
LM End	0.72	Issue Type +	Ma	Location *	LS
Category	Earthen Levee			GPS Latitude/Longitude	
				Start	End
Item	Slope Stability			39.161198 °	39.161198 °
				-121.597102 °	-121.597102 °
DWR ID	DWR_RD0010_01_f_2013_48				
Comment Code					
S3 : Repair the levee slope damaged by vehicle traffic and prevent access where possible.					
Inspector Comment					
Ramp is caused by constant ATV foot traffic use on levee slope, there is no sign of separation, cracking, or caving.

View of the slope stability caused by foot traffic on the landward side of the levee looking downstream.

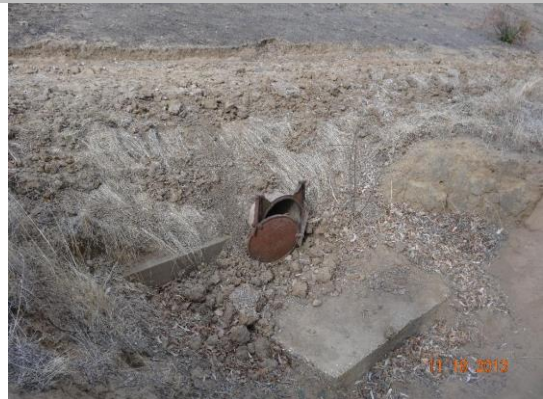
Photo 3 of 3 : UCIP\_SP\_2020\_50058\_51414.jpg

DS\_ID:21258  
FS\_ID:50058  
EP\_NO: N/A  
Repair Type: Non-Urgent  
Crossing Status: Found  
UCIP Comments: 7/01/2016 Gate has been repaired--WS gate is functional. LS gate still needs new stem for the gate to properly function--stem is bent. USACE's PI issue references permit number 13710 this is incorrect permit is associated with DS\_ID 21259 (CLM 0.767). (DWR UCIP - omagana)4/29/2013 Damaged flap gate on waterward side and damaged stem on screw gate on landward side. Need to contact owner to determine if crossing is still active. If crossing is still in use owner will need to address damage on flap gate and screw gate. If crossing is no longer in use owner will need to contact the CVFPB to comply with Title 23. This crossing is referenced in the USACE Periodic Inspection as item USACE\_CESPK\_HON1\_2013\_p\_0053 and 0057. (DWR UCIP - omagana)  
FIELD\_STRUCT\_DESC: 24-inch corrugated metal gravity drainage pipe through the levee, 31 feet below the crown. Two corrugated metal cutoff walls around pipe. Concrete headwall at each end. Flap gate on the waterside (WS) end. Slide gate on the landside (LS) end. Pipe discharges into 6-foot concrete splash apron on the WS. [Additional Reference(s): DWR Levee Log, 2005. USACE Sacramento O&M Manual 151, May 1953, (Station 46+60)].

Damage flap gate located on WS.

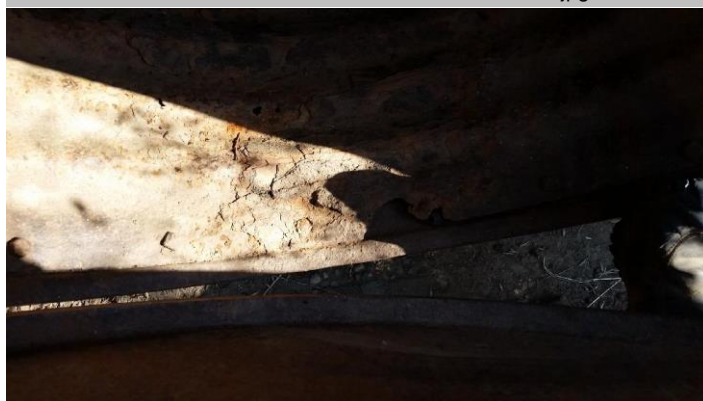
Photo 3 of 3 : UCIP\_SP\_2020\_53136\_75321.jpg

DS\_ID:21318  
FS\_ID:53136  
EP\_NO: N/A  
Repair Type: Urgent  
Crossing Status: Found  
UCIP Comments: 10/18/2018 No change since the last inspection. Pipe remains Urgent due to deteriorated wall (visible holes present inside) near WS flap gate. This pipe is part of DWR's Deferred Maintenance Project (DMP). According to LMA representative, the video inspection of DMP pipes is expected to be completed next year. Levee height is about 25-30 feet. (O. Magana - DWR UCIP)7/01/2016 Pipe wall in poor condition--deteriorated pipe wall indicated by holes at the inlet and outlet pipe collar. Recommend internal integrity inspection of the pipe through the levee to determine extent of damage. (DWR UCIP - omagana)4/29/2013 Holes present on pipe wall. Need to contact owner to notify of issue with pipe. Also need to contact DWR Inspector and CVFPB to determine how to address issue. This crossing is referenced in the USACE Periodic Inspection as item USACE\_CESPK\_HON1\_2013\_p\_0140. Pipe should be 30-inch instead of 36-inch mentioned Periodic Inspection. (DWR UCIP - omagana)

Deteriorated pipe wall at the outlet (WS).

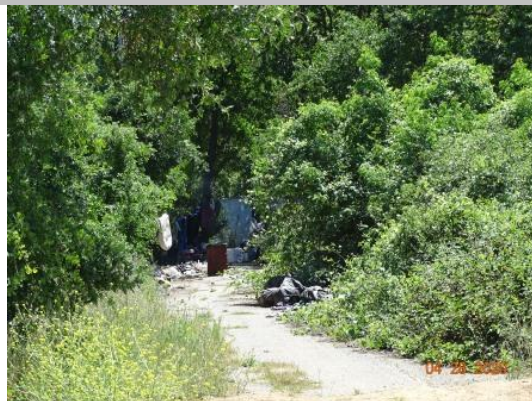
Photo 1 of 1 : SP\_2020\_RD0010\_163\_29\_20200430\_00087.jpg

View looking waterside at unauthorized campers, Spring 2020.

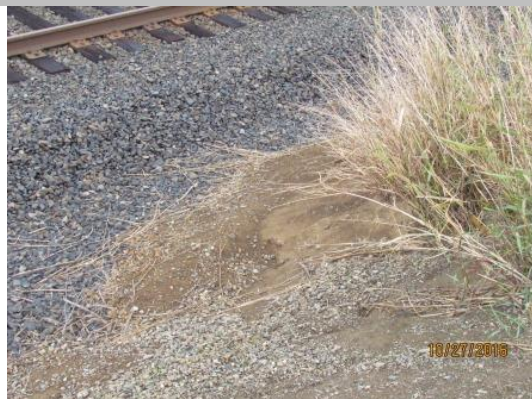
Photo 1 of 1 : SP\_2020\_RD0010\_163\_64\_20200227\_00024.jpg

View of squirrel holes on the landside, no rodent activity was observed.

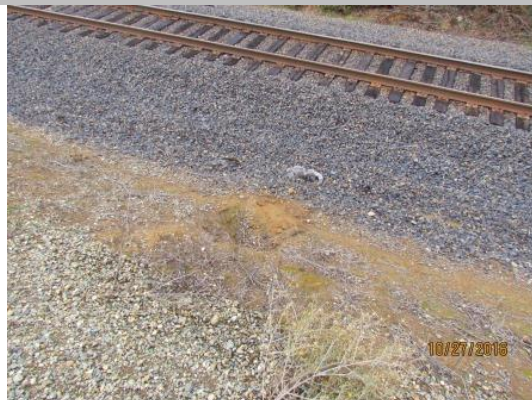
Photo 1 of 1 : SP\_2020\_RD0010\_163\_63\_20200227\_00023.jpg

View of squirrel holes on the landside, no rodent activity was observed.

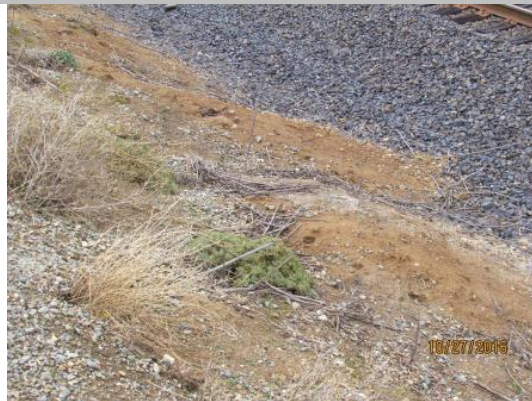
Photo 1 of 1 : SP\_2020\_RD0010\_163\_61\_20200227\_00022.jpg

View of squirrel holes on the landside slope and toe, no rodent activity was observed.

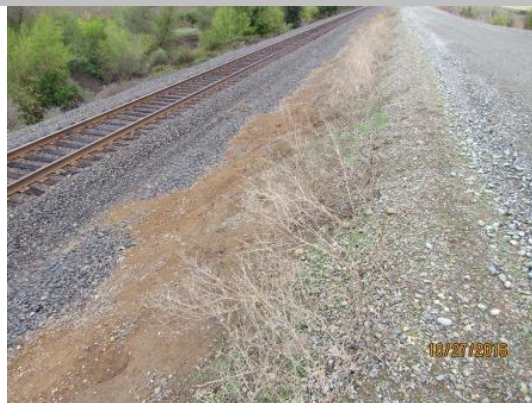
Photo 1 of 1 : SP\_2020\_RD0010\_163\_60\_20200227\_00021.jpg

View of squirrel holes on the landside slope and toe, no rodent activity was observed.

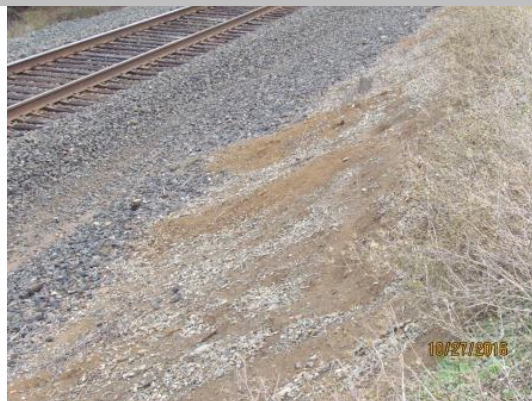
Photo 1 of 1 : SP\_2020\_RD0010\_163\_59\_20200227\_00020.jpg

View of squirrel holes on the landside slope and toe, no rodent activity was observed.

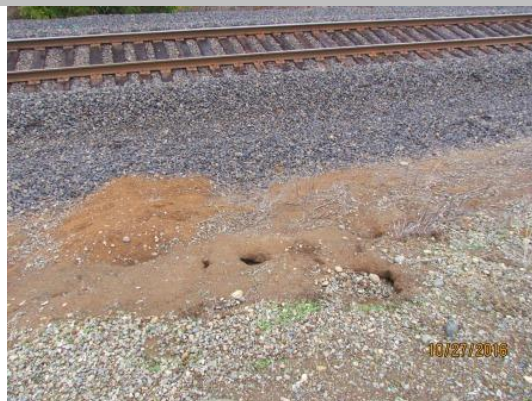
Photo 1 of 1 : SP\_2020\_RD0010\_163\_58\_20200227\_00019.jpg

View of squirrel holes on the landside slope and toe, no rodent activity was observed.

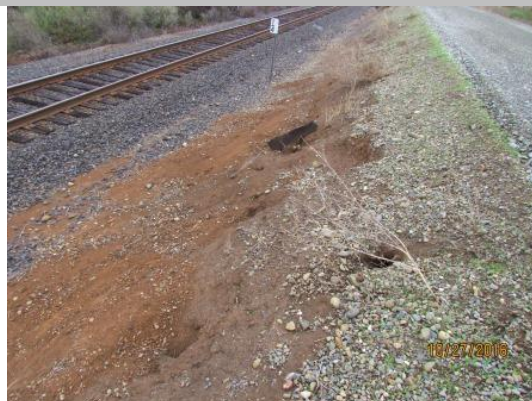
Photo 1 of 1 : SP\_2020\_RD0010\_163\_57\_20200227\_00018.jpg

View of squirrel holes on the landside slope and toe, no rodent activity was observed.

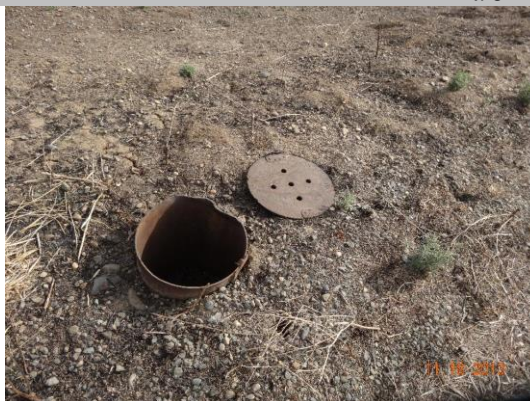
Photo 2 of 3 : UCIP\_SP\_2020\_53137\_44605.jpg

View of riser with damage lid located on WS shoulder.

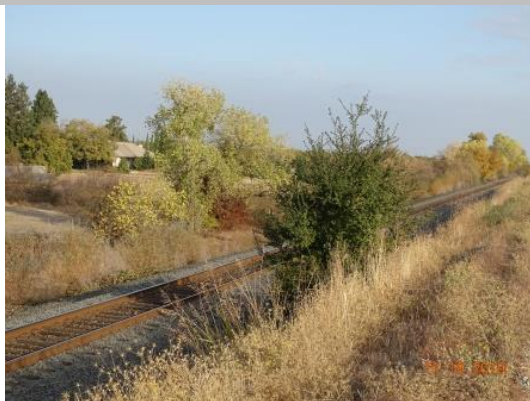
Photo 1 of 1 : SP\_2020\_RD0010\_163\_36\_20200227\_00004.jpg

View looking upstream landside at small starter trees that need to be removed, Fall 2019.

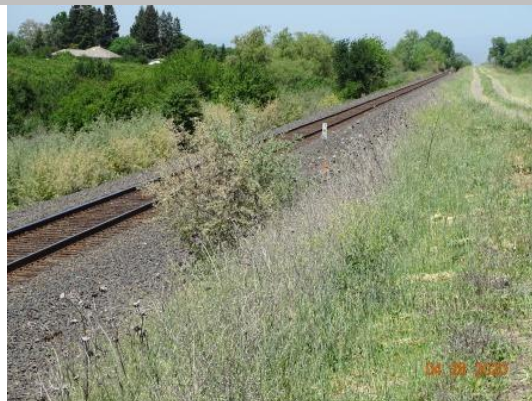
Photo 1 of 1 : SP\_2020\_RD0010\_163\_70\_20200430\_00090.jpg

View looking upstream landside at small starter tree on levee slope, Spring 2020.

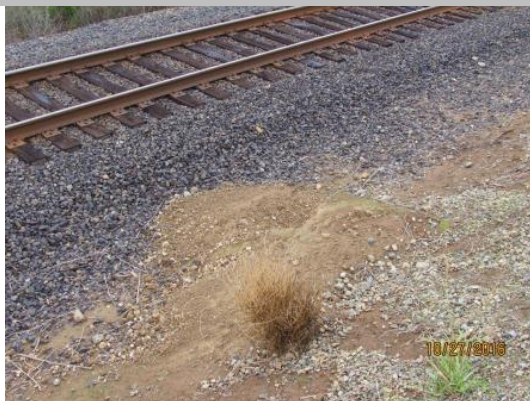
Photo 1 of 1 : SP\_2020\_RD0010\_163\_52\_20200227\_00017.jpg

View of squirrel holes on the landside slope and toe, no rodent activity was observed. Fall 2016.

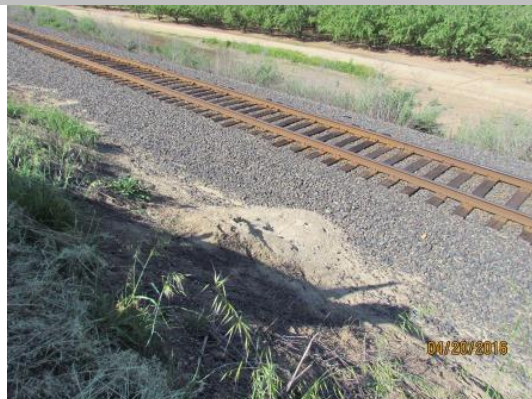
Photo 1 of 1 : SP\_2020\_RD0010\_163\_51\_20200227\_00016.jpg

View of large burrow on landside.

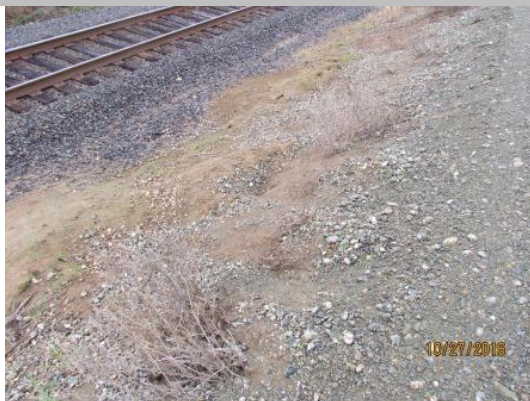
Photo 1 of 1 : SP\_2020\_RD0010\_163\_50\_20200227\_00015.jpg

View of squirrel holes on the landside slope and toe, no rodent activity was observed.

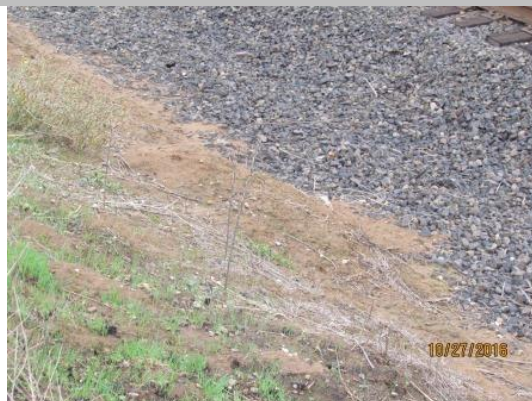
Photo 1 of 1 : SP\_2020\_RD0010\_163\_46\_20200227\_00011.jpg

View of squirrel holes on the landside slope and toe, no rodent activity was observed.

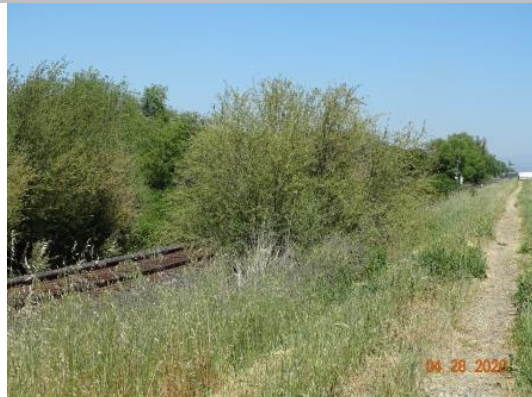
Photo 1 of 1 : SP\_2020\_RD0010\_163\_54\_20200430\_00095.jpg

View looking upstream landside at small starter tree on levee slope, Spring 2020.

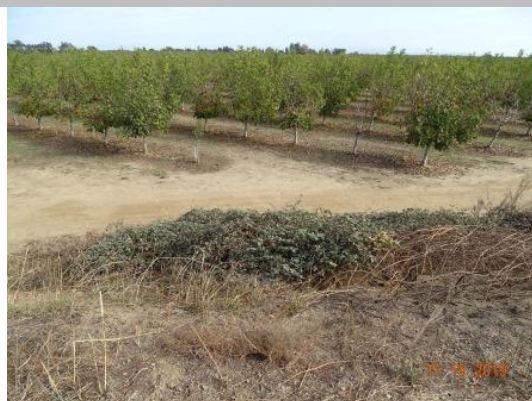
Photo 1 of 1 : SP\_2020\_RD0010\_164\_58\_20200227\_00018.jpg

View looking at blackberry bushes on the landside levee slope that need to be removed, Fall 2019.

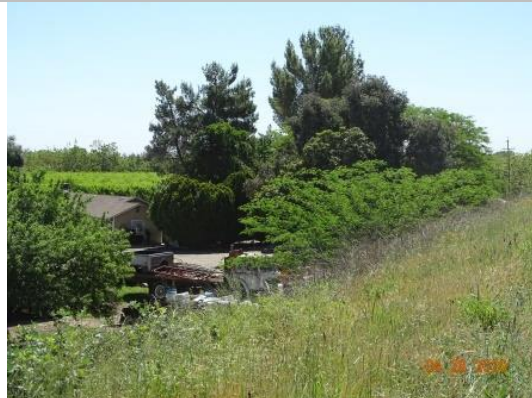
Photo 1 of 1 : SP\_2020\_RD0010\_164\_64\_20200429\_00105.jpg

View looking downstream landside at small starter trees on levee slope, Spring 2020.

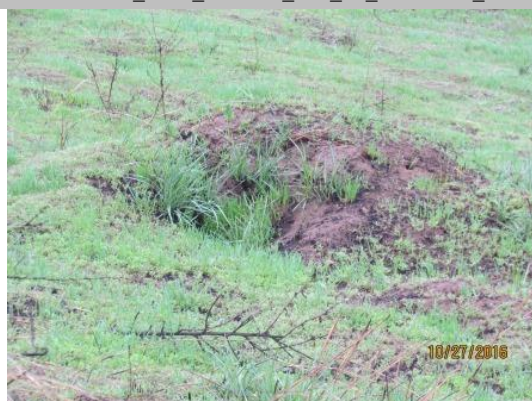
Photo 1 of 1 : SP\_2020\_RD0010\_164\_33\_20200227\_00006.jpg

View of rodent hole that has more than 2 cubic feet of material, this hole is not active but needs to be backfilled properly.

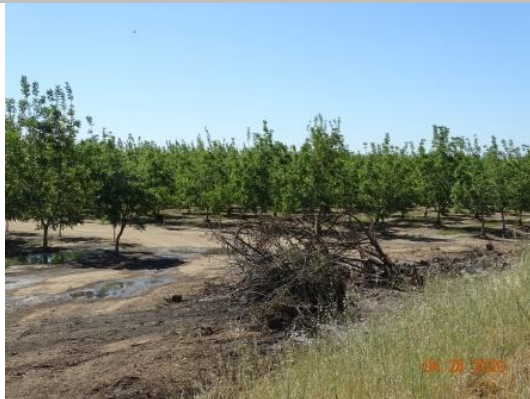
Photo 1 of 1 : SP\_2020\_RD0010\_164\_59\_20200429\_00100.jpg

View looking downstream at prunings on levee toe, Spring 2020.

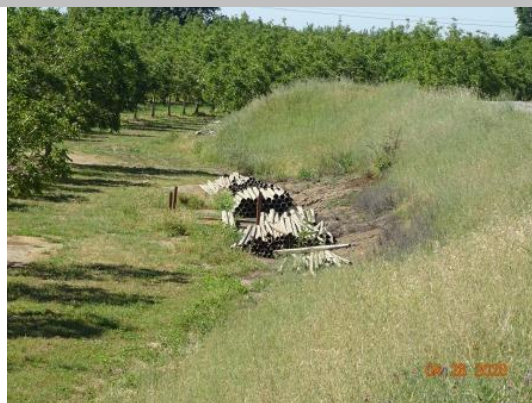
Photo 1 of 1 : SP\_2020\_RD0010\_164\_51\_20200429\_00098.jpg

View looking downstream landside at irrigation pipe material on the levee slope, Spring 2020.

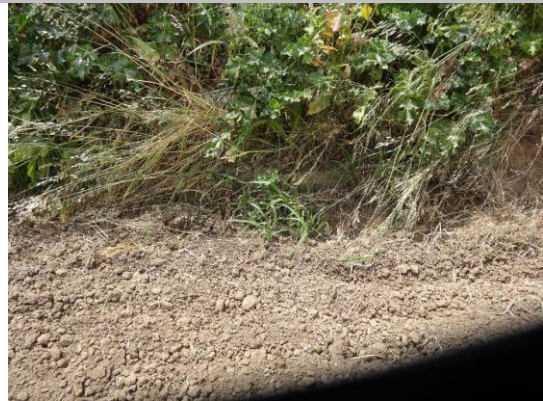
Photo 3 of 3 : UCIP\_SP\_2020\_24768\_44449.jpg

View of concrete headwall visible through dense vegetation.

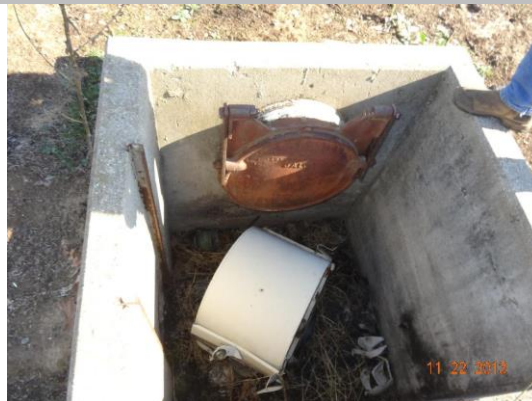
Photo 2 of 3 : UCIP\_SP\_2020\_24769\_44453.jpg

View of flap gate located inside concrete distribution box. Debris scattered inside box.

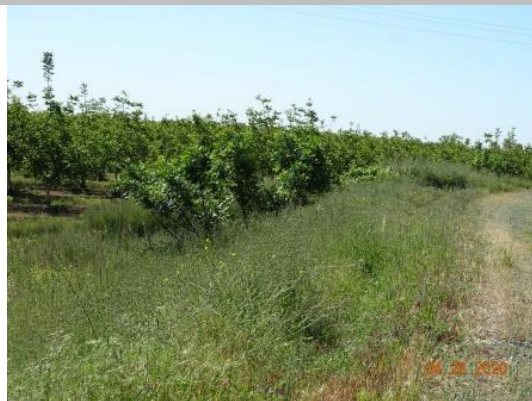
Photo 1 of 1 : SP\_2020\_RD0010\_164\_43\_20200429\_00093.jpg

View looking downstream landside at small starter tree on levee slope, Spring 2020.

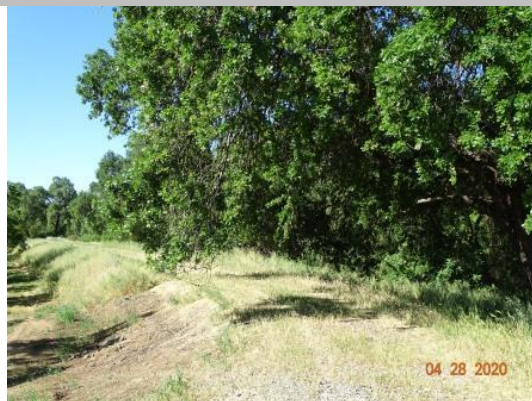
Photo 1 of 1 : SP\_2020\_RD0010\_164\_38\_20200429\_00092.jpg

View looking downstream crown at low hanging branches over the crown, Spring 2020.

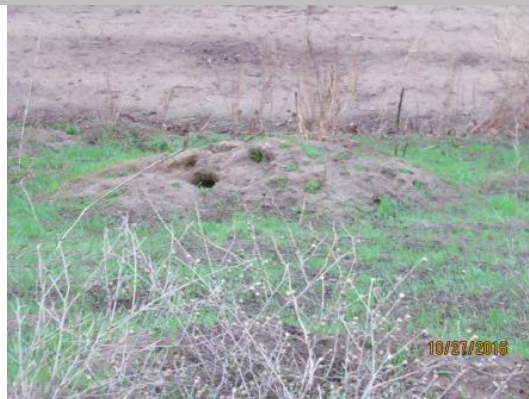
Photo 1 of 1 : SP\_2020\_RD0010\_165\_6\_20200227\_00001.jpg

View of waterside slope, no squirrel activity seen, but rodent holes need to be back filled properly.

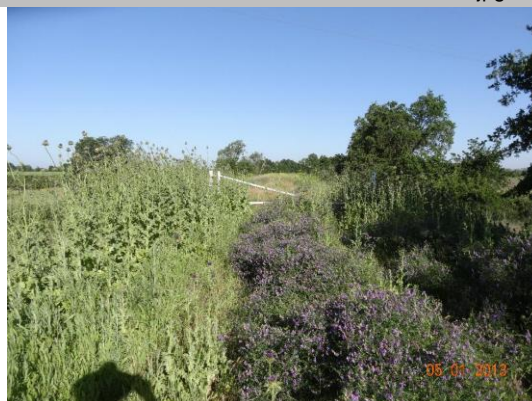
Photo 2 of 2 : UCIP\_SP\_2020\_24883\_44821.jpg

View of levee crown--dense vegetation.
