**Flood Control Project Maintenance
Levee Inspections
Unit Cover Sheet**

Reclamation District No. 0010 Honcut

Levee Inspection Report By Mile - Spring 2021

Waterway	Bank	Unit Miles	Inspection Start/End	Inspector
Unit No. 01 Simmerly Slough	Right	7.65	04/14/2021 04/14/2021	Brooks Weisser

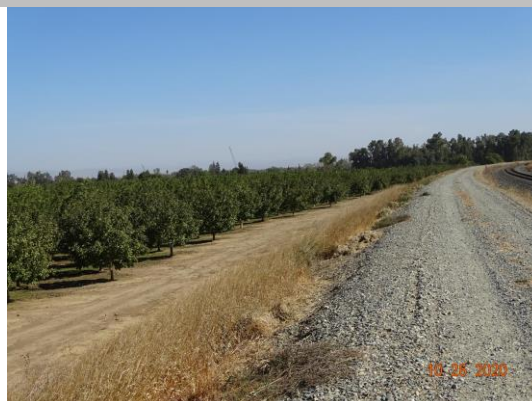
Photo 1 of 1 : SP_2021_RD0010_163_28_20210301_00001.jpg

View of annual vegetation on landside slope that needs to be maintained, Fall 2020.

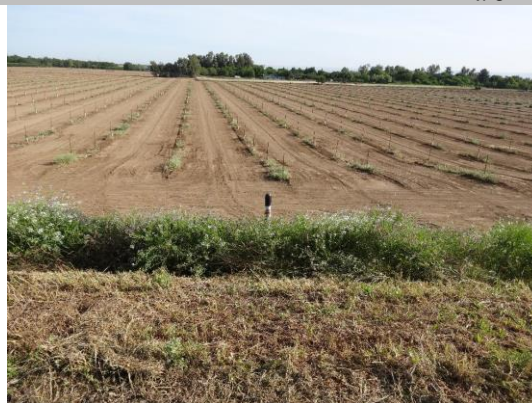
Photo 2 of 2 : UCIP_SP_2021_62537_51364.jpg

LM Start	0.23	Rating **	M	Issue No.	1	
LM End	0.23	Issue Type +	En	Location *		
Category	Supplemental			GPS Latitude/Longitude		
				Start	End	
Item	DWR UCIP Field Study			39.163407 °	39.163407 °	
				-121.605645 °	-121.605645 °	
DWR ID	24653					
Comment Code						
Inspector Comment						
FS_ID:62537						
DS_ID:24653						
EP_NO: N/A						
Repair Type: Non-Urgent						
Crossing Status: Indicator Found						
UCIP Comments: 04/29/2013 Need to contact owner--unable to determine if crossing is authorized (no permit found) also need to determine if crossing goes through levee. (O. Magana - DWR UCIP)						
FIELD_STRUCT_DESC: Fiber optics line markers on the levee slope.						
Unable to determine if this line goes through the levee. This line was field discovered.						
FS Date: 4/29/2013

Marker visible on landward side.

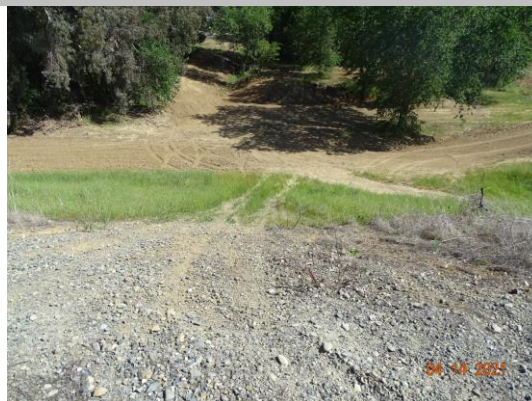
Photo 1 of 1 : SP_2021_RD0010_163_71_20210427_00111.jpg

LM Start	0.68	Rating **	A/W	Issue No.	71
LM End	0.68	Issue Type +	Ma	Location *	LS
Category	Earthen Levee			GPS Latitude/Longitude	
				Start	End
Item	Slope Stability			39.161381 °	39.161381 °
				-121.597657 °	-121.597657 °
DWR ID	DWR_RD0010_01_f_2020_71				
Comment Code					
S3 : Repair the levee slope damaged by vehicle traffic and prevent access where possible.					
Inspector Comment					
Ramp is caused by constant ATV foot traffic use on levee slope, there is no sign of separation, cracking, or caving, Spring 2021

View of the slope stability caused by foot traffic on the landward side of the levee, Spring 2021.

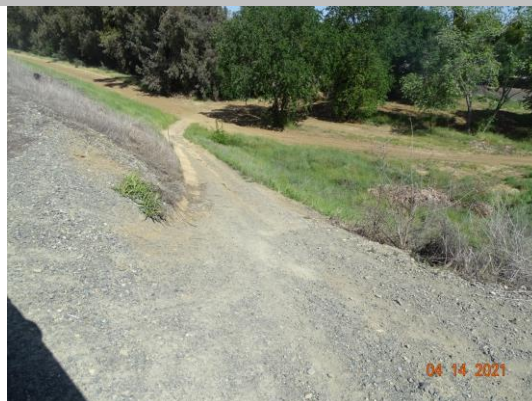
Photo 1 of 1 : SP_2021_RD0010_163_48_20210427_00112.jpg

LM Start	0.72	Rating **	A/W	Issue No.	48
LM End	0.72	Issue Type +	Ma	Location *	LS
Category	Earthen Levee			GPS Latitude/Longitude	
				Start	End
Item	Slope Stability			39.161198 °	39.161198 °
				-121.597102 °	-121.597102 °
DWR ID	DWR_RD0010_01_f_2013_48				
Comment Code					
S3 : Repair the levee slope damaged by vehicle traffic and prevent access where possible.					
Inspector Comment					
Ramp is caused by constant ATV foot traffic use on levee slope, there is no sign of separation, cracking, or caving, Sprign 2021.

View of the slope stability caused by foot traffic on the landward side of the levee looking downstream, Spring 2021.

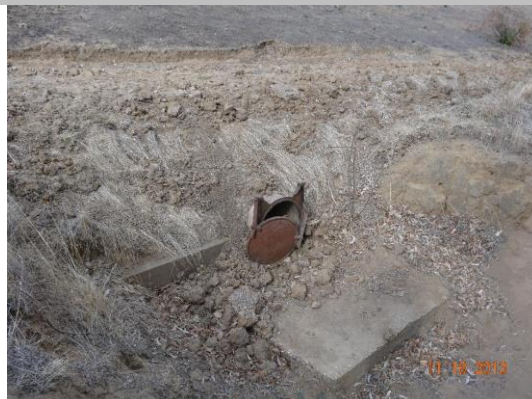
Photo 3 of 3 : UCIP_SP_2021_62557_51414.jpg

Damage flap gate located on WS.

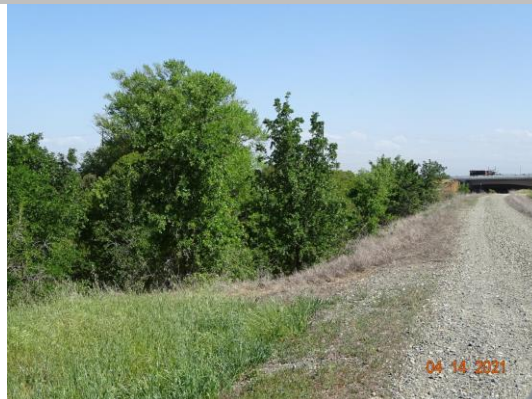
Photo 1 of 1 : SP_2021_RD0010_163_45_20210427_00113.jpg

View looking upstream landside at small starter trees on levee slope, Spring 2021.

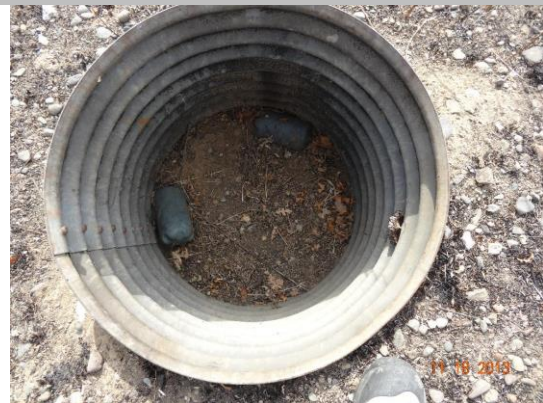
Photo 3 of 3 : UCIP_SP_2021_62549_44575.jpg

Siphon breaker has been buried inside CMP riser.

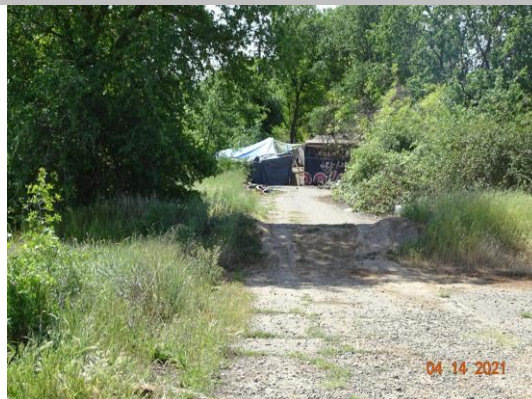
Photo 1 of 1 : SP_2021_RD0010_163_29_20210427_00114.jpg

View looking waterside at unauthorized campers, Spring 2021.

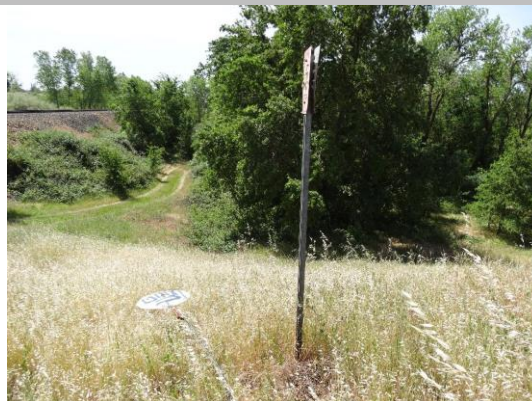
Photo 2 of 3 : UCIP_SP_2021_62535_51500.jpg

Pipe marker visible on ground--sign has been bent.

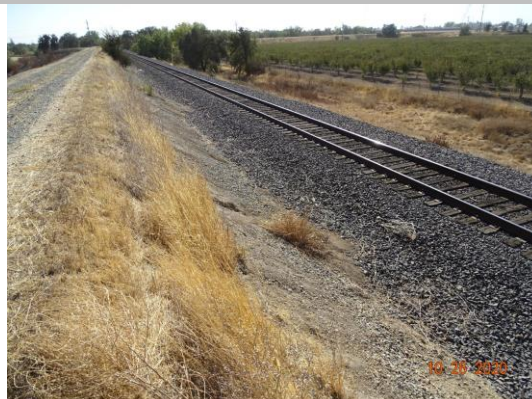
Photo 1 of 1 : SP_2021_RD0010_163_64_20210301_00036.jpg

View of squirrel holes on the landside, no rodent activity was observed, Fall 2020.

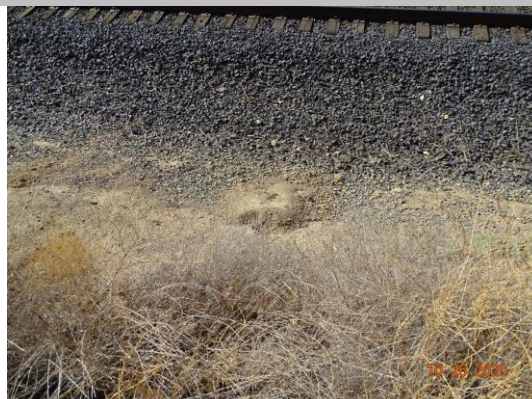
Photo 1 of 1 : SP_2021_RD0010_163_63_20210301_00035.jpg

View of squirrel holes on the landside, no rodent activity was observed, Fall 2020.

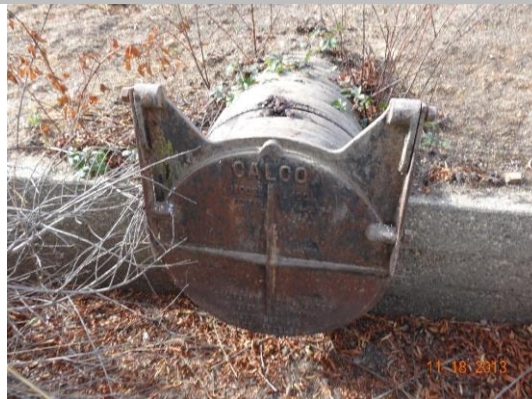
Photo 3 of 3 : UCIP_SP_2021_27745_51431.jpg

Flap gate appears to be in good condition.

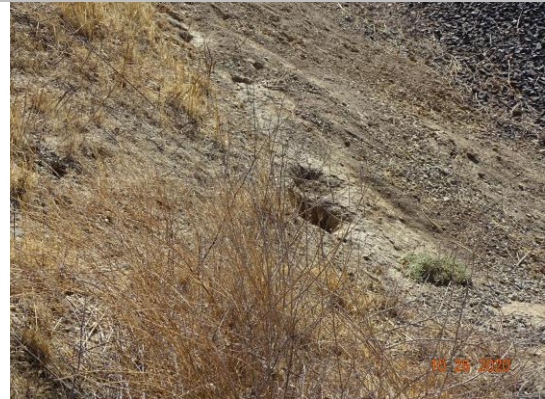
Photo 1 of 1 : SP_2021_RD0010_163_61_20210301_00033.jpg

View of squirrel holes on the landside slope and toe, no rodent activity was observed, Fall 2020.

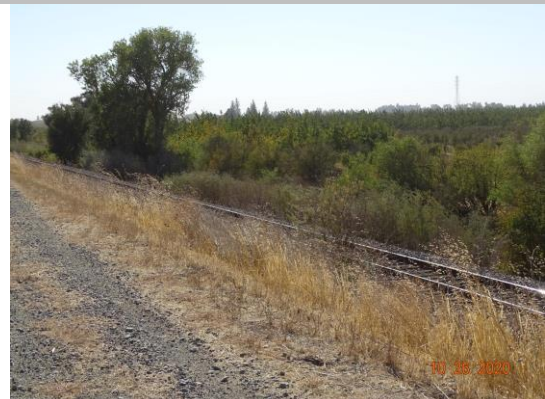
Photo 1 of 1 : SP_2021_RD0010_163_69_20210301_00040.jpg

View looking downstream landside at small starter trees that need to be removed, Fall 2020

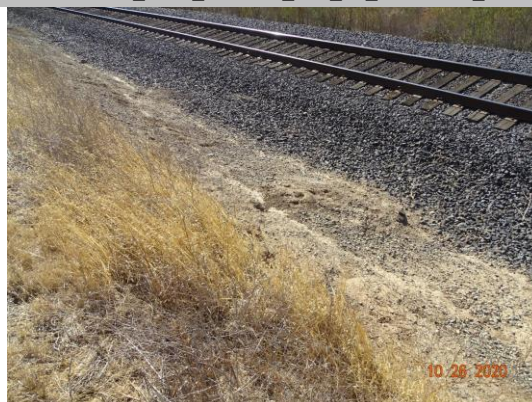
Photo 1 of 1 : SP_2021_RD0010_163_60_20210301_00032.jpg

View of squirrel holes on the landside slope and toe, no rodent activity was observed, Fall 2020.

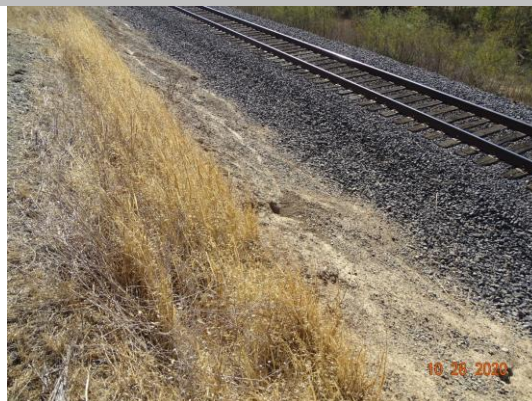
Photo 1 of 1 : SP_2021_RD0010_163_59_20210301_00031.jpg

View of squirrel holes on the landside slope and toe, no rodent activity was observed, Fall 2020.

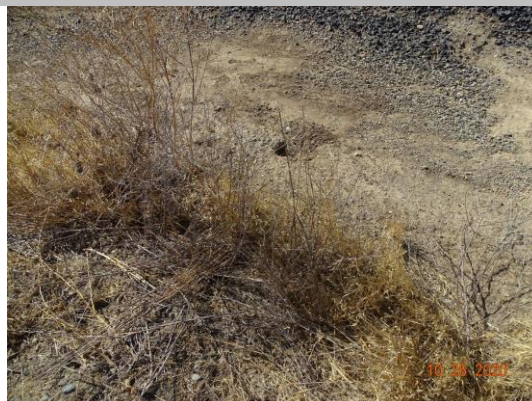
Photo 1 of 1 : SP_2021_RD0010_163_58_20210301_00030.jpg

View of squirrel holes on the landside slope and toe, no rodent activity was observed, Fall 2020.

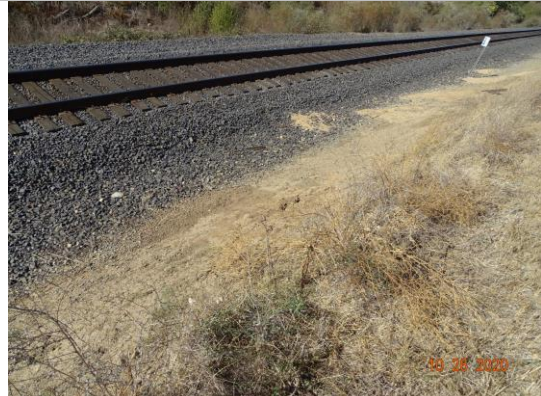
Photo 1 of 1 : SP_2021_RD0010_163_57_20210301_00029.jpg

View of squirrel holes on the landside slope and toe, no rodent activity was observed, Fall 2020.

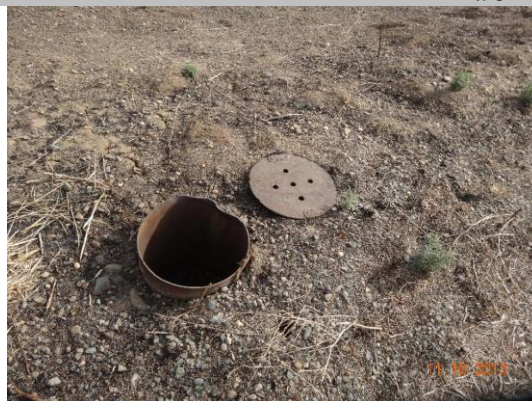
Photo 2 of 3 : UCIP_SP_2021_53137_44605.jpg

View of riser with damage lid located on WS shoulder.

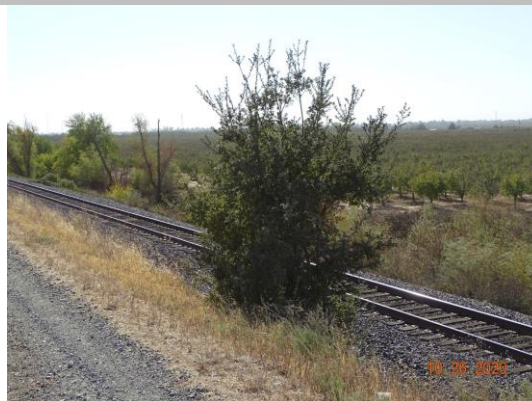
Photo 1 of 1 : SP_2021_RD0010_163_36_20210301_00008.jpg

View looking downstream landside at small starter trees that need to be removed, Fall 2020.

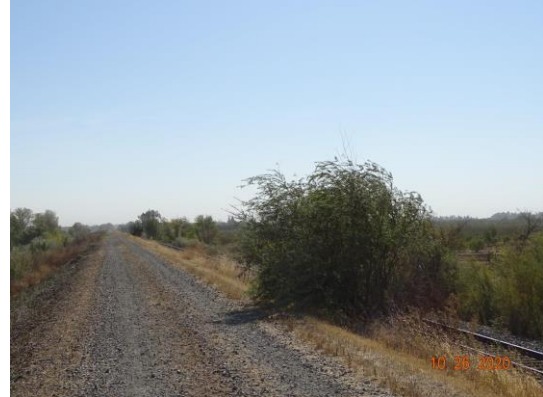
Photo 1 of 1 : SP_2021_RD0010_163_38_20210301_00010.jpg

View looking downstream landside at small starter trees that need to be removed, Fall 2020.

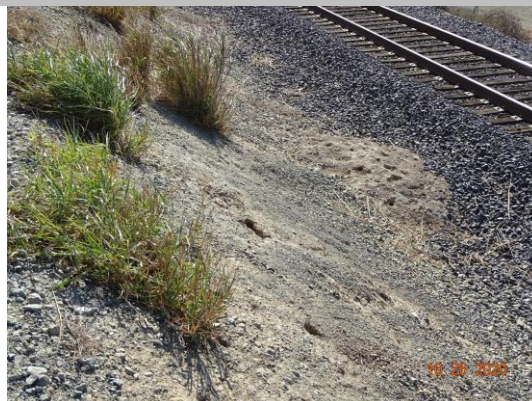
Photo 1 of 1 : SP_2021_RD0010_163_52_20210301_00024.jpg

View of squirrel holes on the landside slope and toe, no rodent activity was observed. Fall 2020.

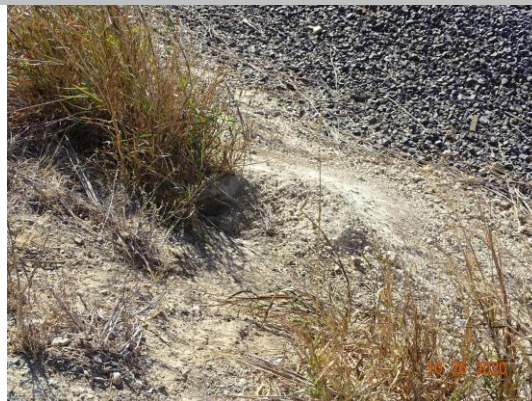
Photo 1 of 1 : SP_2021_RD0010_163_51_20210301_00023.jpg

View of large burrow on landside, Fall 2020.

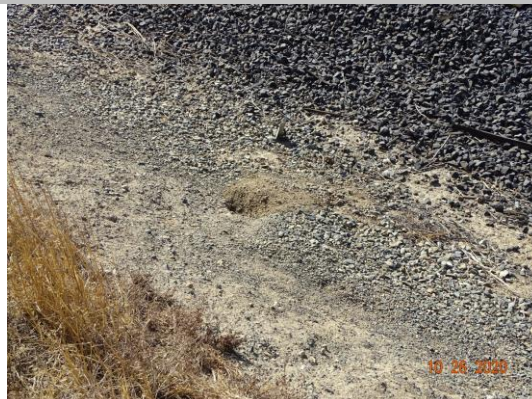
Photo 1 of 1 : SP_2021_RD0010_163_50_20210301_00022.jpg

View of squirrel holes on the landside slope and toe, no rodent activity was observed, Fall 2020.

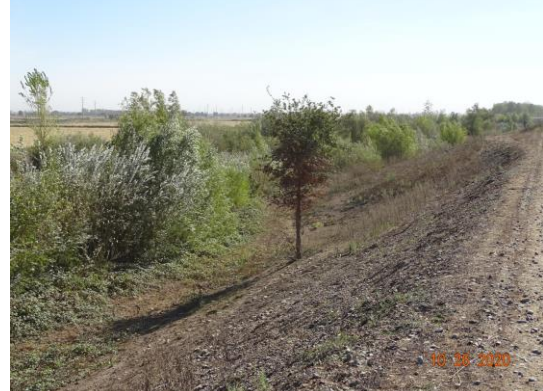
Photo 1 of 1 : SP_2021_RD0010_163_30_20210301_00003.jpg

View looking downstream waterside at small starter tree on levee slope, Fall 2020.

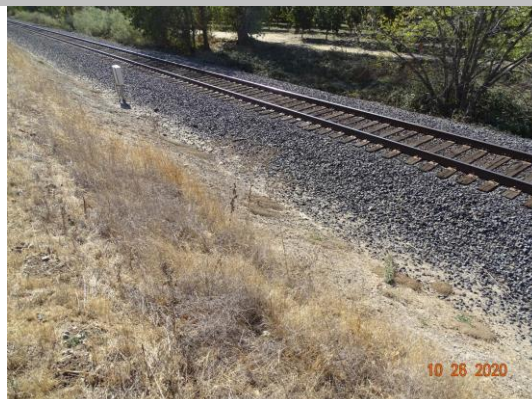
Photo 1 of 1 : SP_2021_RD0010_163_46_20210301_00018.jpg

View of squirrel holes on the landside slope and toe, no rodent activity was observed, Fall 2020

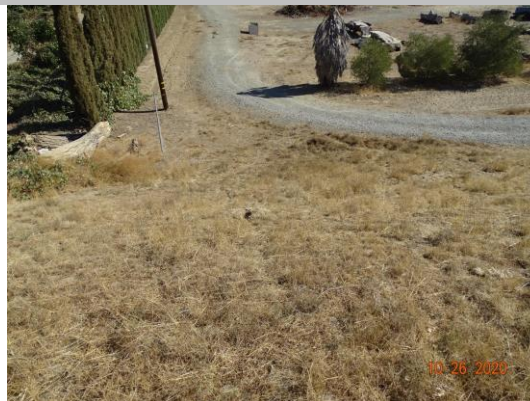
Photo 1 of 1 : SP_2021_RD0010_164_7_20210301_00001.jpg

View of rodent hole that needs to be backfilled, Fall 2020.

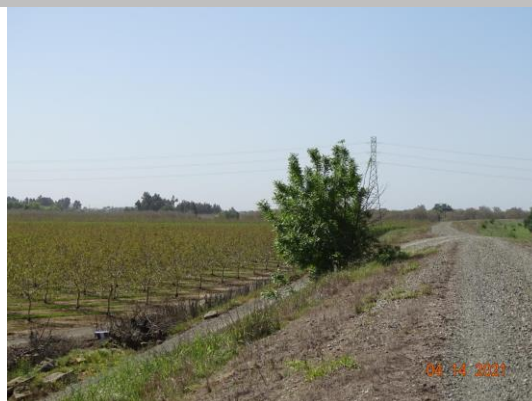
Photo 1 of 1 : SP_2021_RD0010_164_70_20210427_00150.jpg

View looking downstream landside at small starter tree on levee slope, Spring 2021.

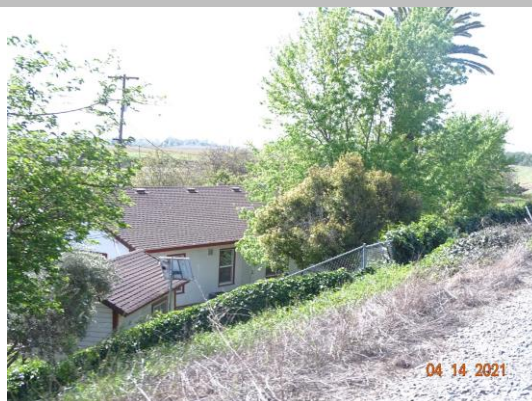
Photo 1 of 1 : SP_2021_RD0010_164_9_20210427_00148.jpg

View of homeowners landscaping and fence that encroaches on the landside levee slope, looking downstream, Spring 2021.

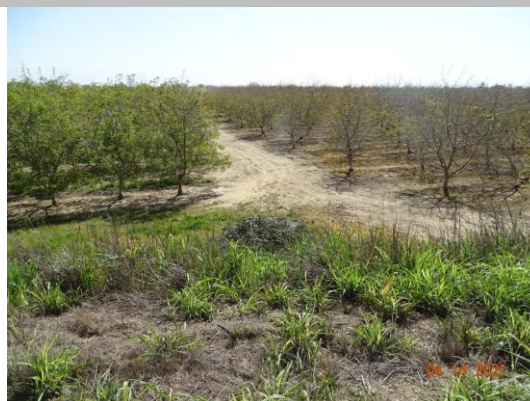
Photo 1 of 1 : SP_2021_RD0010_164_75_20210427_00147.jpg

View of debris on landside toe, Spring 2021.

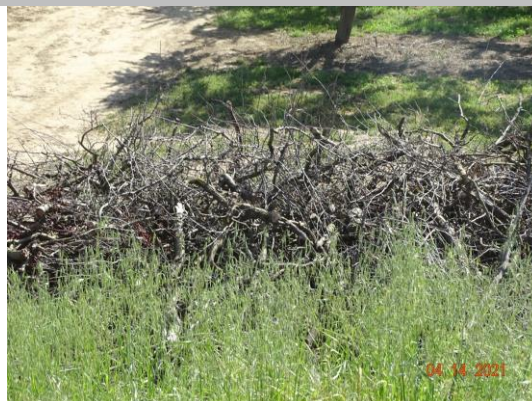
Photo 1 of 1 : SP_2021_RD0010_164_54_20210427_00142.jpg

View of a pile of prunings on the landside toe that needs to be removed, Spring 2021.

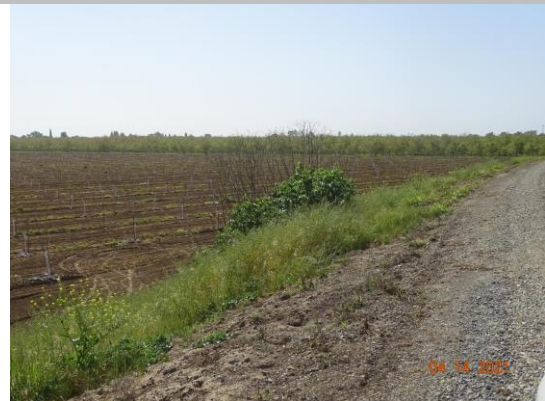
Photo 1 of 1 : SP_2021_RD0010_164_62_20210427_00137.jpg

View looking downstream landside at small starter tree on levee slope, Spring 2021.

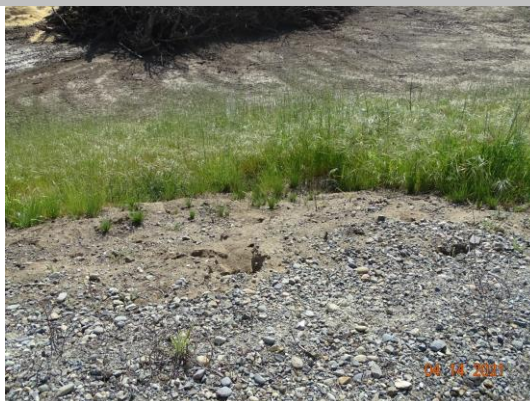
Photo 1 of 1 : SP_2021_RD0010_164_49_20210427_00135.jpg

View of rodent holes on landside slope that need to be backfilled, Spring 2021.

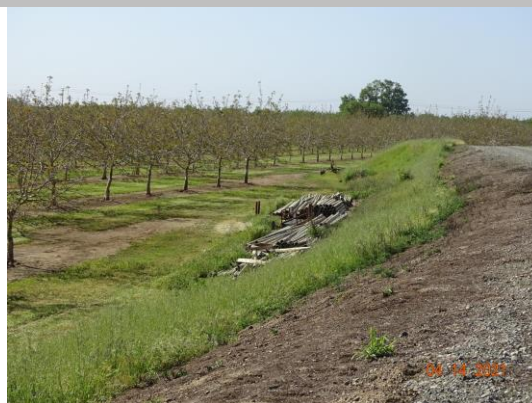
Photo 1 of 1 : SP_2021_RD0010_164_51_20210427_00128.jpg

View looking downstream landside at irrigation pipe material on the levee slope, Spring 2021.

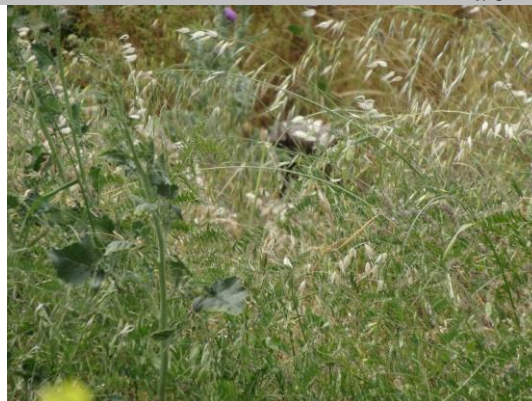
Photo 2 of 3 : UCIP_SP_2021_24768_44451.jpg

Dense vegetation on landward side.

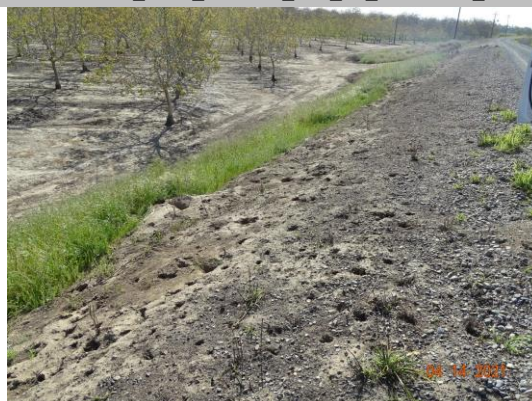
Photo 1 of 1 : SP_2021_RD0010_164_30_20210427_00126.jpg

View of rodent activity on the land side slope, Spring 2021.

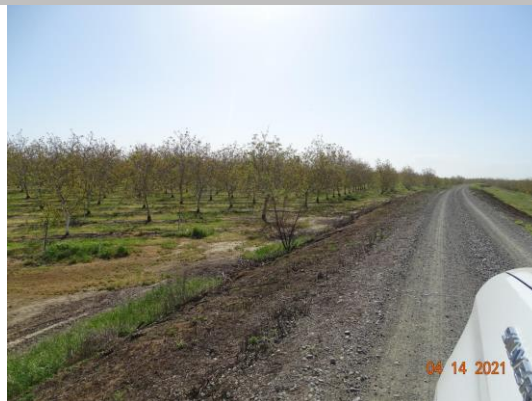
Photo 1 of 1 : SP_2021_RD0010_164_46_20210427_00122.jpg

View looking downstream landside at small starter tree on levee slope, Spring 2021.

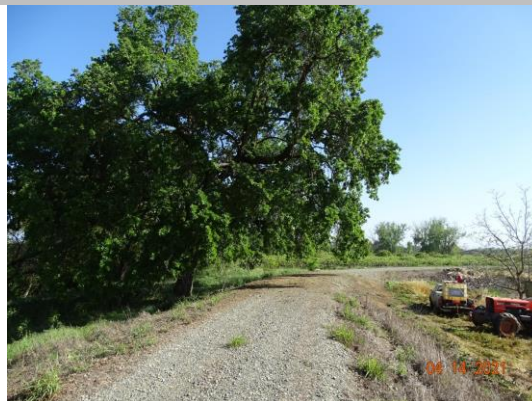
Photo 1 of 1 : SP_2021_RD0010_164_38_20210427_00117.jpg

View looking upstream crown at low hanging branches over the crown, Spring 2021.

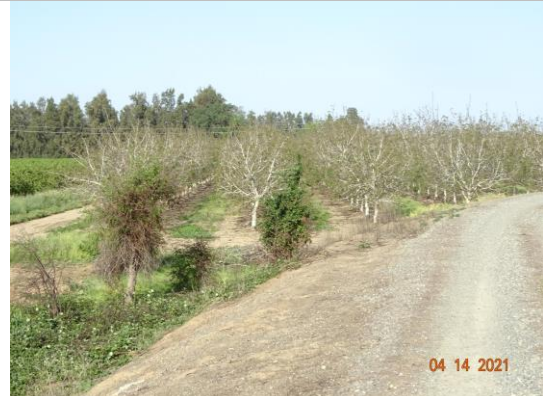
Photo 1 of 1 : SP_2021_RD0010_165_13_20210427_00040.jpg

View looking downstream landside at a small starter trees that needs to be removed, Spring 2021

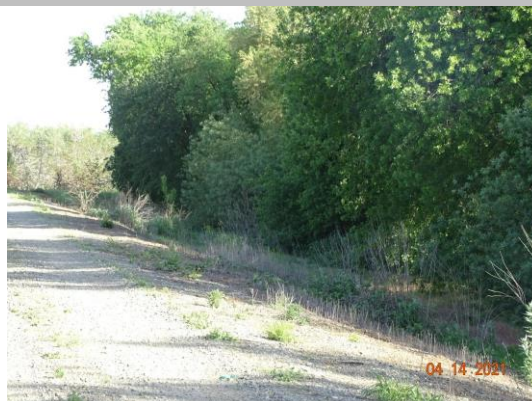
Photo 1 of 1 : SP_2021_RD0010_165_9_20210427_00036.jpg

View looking downstream waterside at a small starter tree that needs to be removed, Spring 2021.

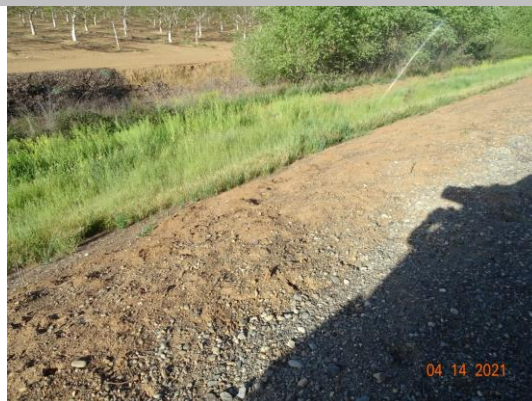
Photo 1 of 1 : SP_2021_RD0010_165_4_20210427_00031.jpg

View of rodent holes on landside slope that need to be backfilled, Spring 2021

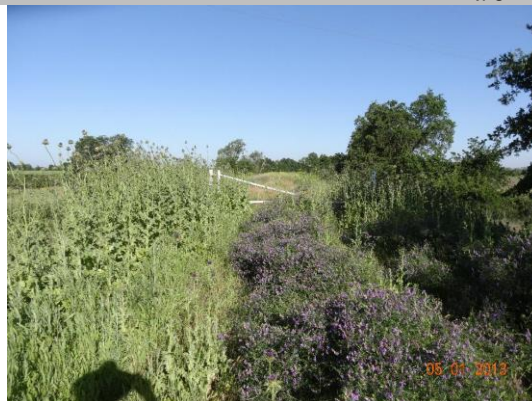
Photo 2 of 2 : UCIP_SP_2021_24883_44821.jpg

View of levee crown--dense vegetation.
