Flood Control Project Maintenance Levee Inspections LMA District Cover Sheet

Reclamation District No. 0010 Honcut

**Flood Control Project Maintenance
Levee Inspections
Unit Cover Sheet**

Waterway			Bank	Unit Miles
Unit No. 01 Simmerly Slough			Right	7.65
	Spring (March - May)	Summer (June - August)	(September - November) Fall	Winter (December - February)
Unit Maintenance Rating (Fall Only)				
Date of Inspection	5/5/2022 - 5/5/2022			
DWR Inspector	Brooks Weisser			
Accompanied By	Finlay Williams

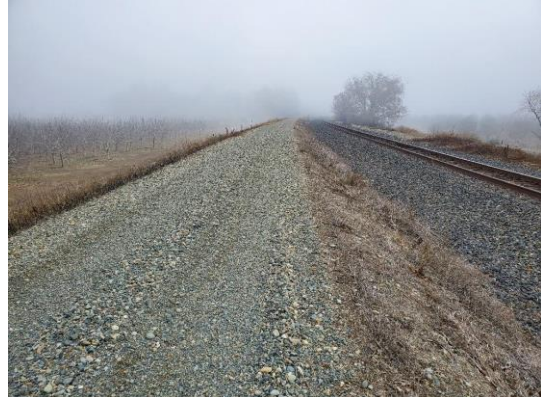
Photo 1 of 3 : UCIP_SP_2022_70580_97560.jpg

Comment Code						
Inspector Comment						
FS_ID:70580 DS_ID:24652 EP_NO: N/A Repair Type: Non-Urgent Crossing Status: Indicator Found UCIP Comments: 12/21/2020 Record has been updated to Non-Urgent. No permit was found authorizing this encroachment. Owner of this encroachment, Kinder Morgan, will need to coordinate with the CVFPB to meet Title 23 requirements for regulated streams. No maintenance or inspection records were made available to determine integrity of the line within Simmerly Slough. (O. Magana - DWR UCIP)01/24/2014 Spoke with Brian Gamble and crossing does not cross levee at this point the line goes parallel to along Valley Sub Railroad tracks towards Marysville. Crossing was kept for LMA's records. No action further action needed. (O. Magana - DWR UCIP)12/03/2013 Spoke to Frank Villalobos (supervisor-530-624-4048) and Doug Hubbard (maps-916-416-2972) was told to contact Brian Gamble (916-869-7148) to find out additional information about crossing and the status. Additional information can be requested through Kinder Morgan's Engineering Department by sending email to pipelineinquiries@kindermorgan.com ATTN: Engineering Department (O. Magana - DWR UCIP)04/29/2013 Unable to determine if crossing goes through the levee. Need to contact owner. Will need copy of letter showing crossings passed inspection. (O. Magana - DWR UCIP) FIELD_STRUCT_DESC: *NOT THROUGH LEVEE* Natural gas pipeline of an unknown size or material parallel to the levee, at an unknown depth. Gas line markers visible on the waterside (WS). No markers on the landside (LS). Pipeline does not cross the levee. This line was field discovered. (No permit found authorizing this pipe. Owner is Kinder Morgan). FS Date: 12/21/2020

Overview of levee crown looking upstream towards crossing.

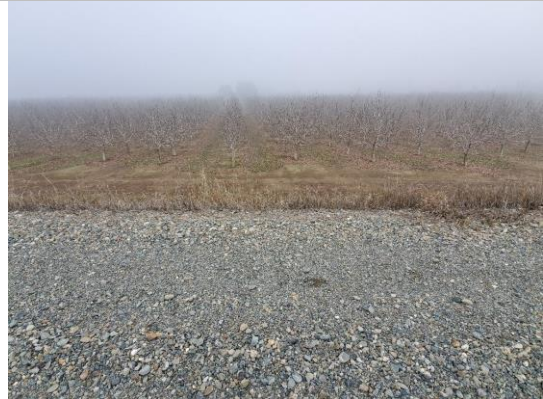
Photo 3 of 3 : UCIP_SP_2022_70580_97562.jpg

LS view: overview of LS.

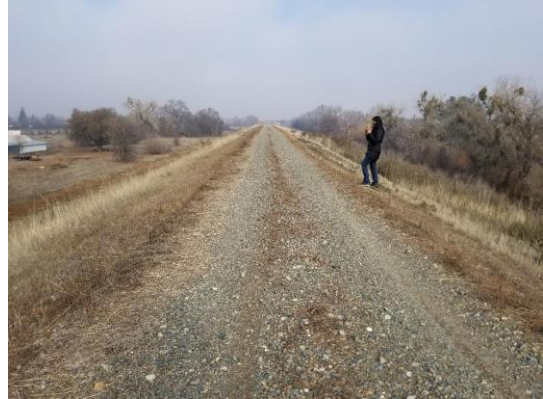
Photo 1 of 1 : UCIP_SP_2022_70545_97602.jpg

Comment Code					
Inspector Comment					
FS_ID:70545 DS_ID:21259 EP_NO: 13710 Repair Type: Non-Urgent Crossing Status: Not Found UCIP Comments: 12/21/2020 Record has been updated to Non-Urgent. DWR DMP geophysical study found a positive signal of pipe at latitude, longitude 39.161848, -121.596554. Coordinates were updated from 39.161775, -121.596592 to 39.161848, -121.596554. No signage or evidence of pipe was found during site inspection. Record will remain in UCIP's database and site should be monitored for integrity issues that might arise with buried pipe. (O. Magana - DWR UCIP) FIELD_STRUCT_DESC: 12-inch coated steel gravity drainage pipe through the levee, 4.0 feet below the crown. Steel cutoff wall around the pipe at the center of the levee. Siphon breaker on the apex of the pipe at the landside (LS) shoulder. Pipe extends from a drainage ditch on the landside (LS), through the levee, to a low-water channel. (12-inch drainage pipe authorized under Permit No. 13710, 1983 - Ted Kinyon). [Additional Reference(s): DWR Levee Log, 2005, (HLM 0.77)]. FS Date: 12/21/2020

Overview of levee crown looking upstream towards pipe location.

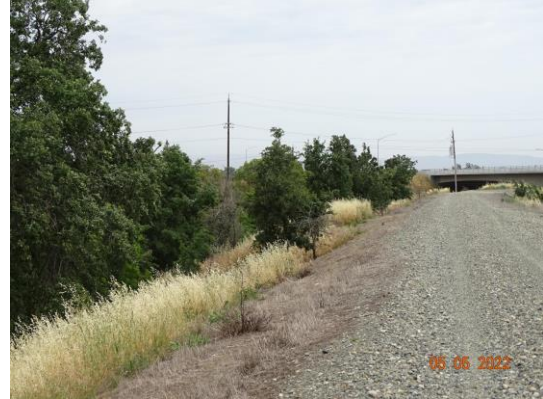
Photo 1 of 1 : SP_2022_RD0010_163_45_20220516_00134.jpg

View looking upstream landside at small starter trees on levee slope, Spring 2022.

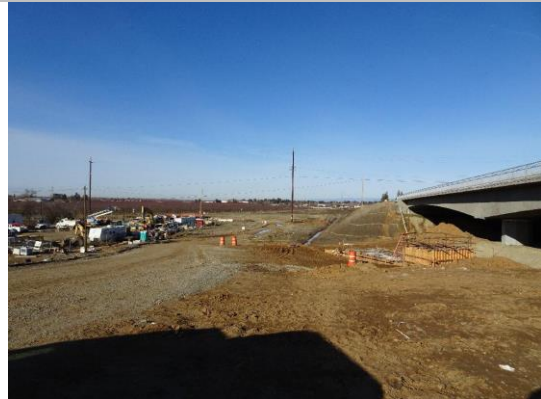
Photo 1 of 3 : UCIP_SP_2022_70570_99123.jpg

LS view: overview of the previous location associated with 10-inch pipe. View is of Caltrans State Highway 70 Construction work and impact to levee.

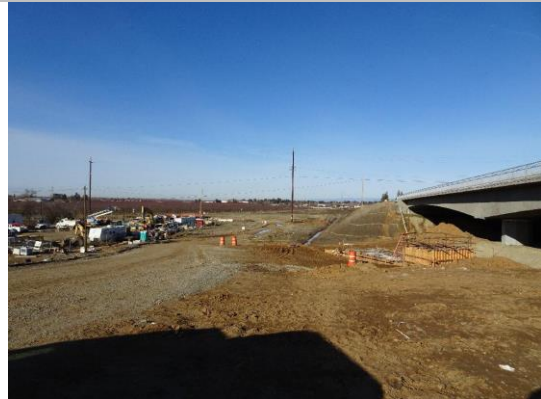
Photo 1 of 3 : UCIP_SP_2022_70571_97610.jpg

LS view: Caltrans' construction site, photo 1 of 4.

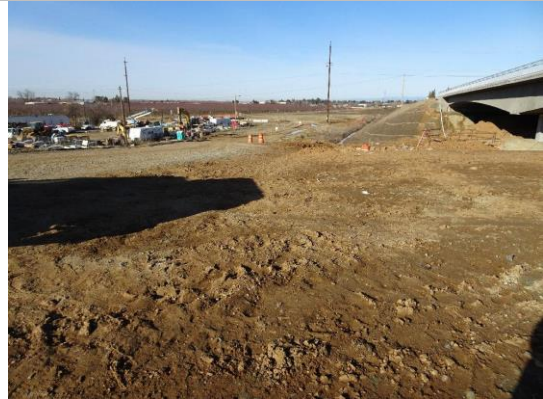
Photo 3 of 3 : UCIP_SP_2022_70571_97608.jpg

WS view: Caltrans' construction site, photo 3 of 4.

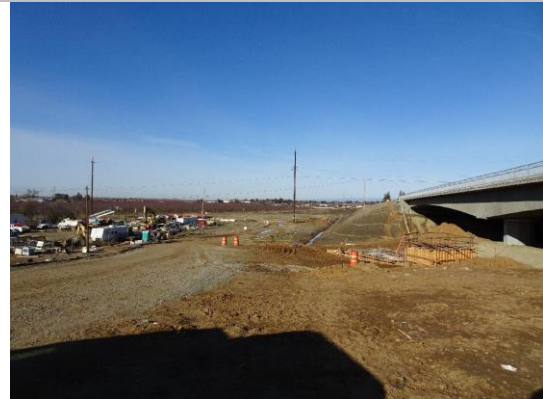
Photo 1 of 3 : UCIP_SP_2022_70550_97613.jpg

LS view: Caltrans' construction site, photo 1 of 6.

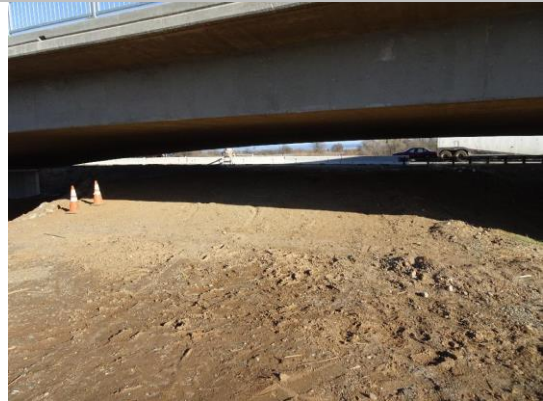
Photo 3 of 3 : UCIP_SP_2022_70550_97615.jpg

Overview of levee crown alignment under newly constructed HWY 70, photo 3 of 6.

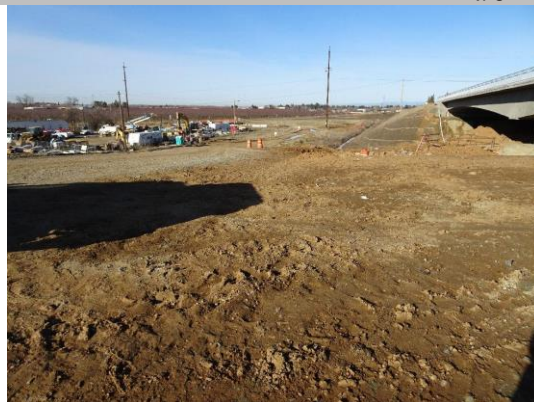
Photo 2 of 3 : UCIP_SP_2022_70551_97618.jpg

Overview of construction access road previously levee.

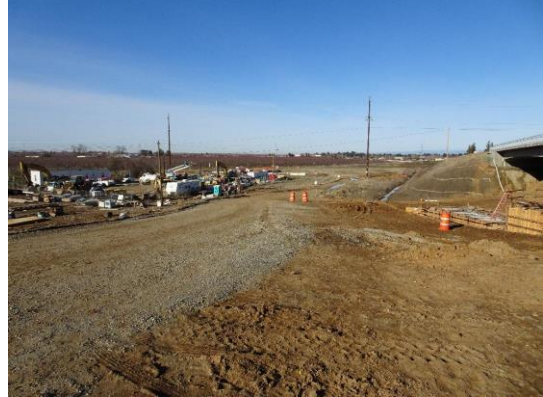
Photo 3 of 3 : UCIP_SP_2022_70551_97619.jpg

LS view: overview of LS used as staging area for Caltrans' construction project.

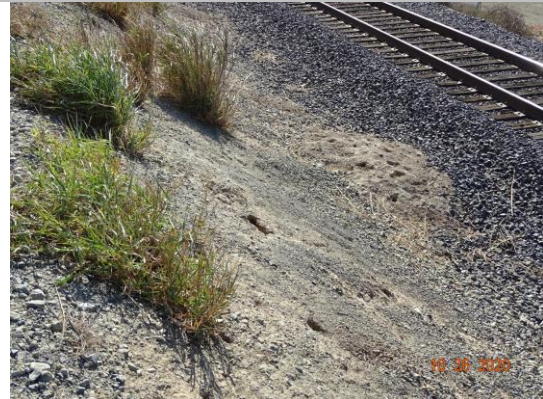
Photo 1 of 1 : SP_2022_RD0010_163_52_20220314_00021.jpg

View of squirrel holes on the landside slope and toe, no rodent activity was observed. Fall 2020.

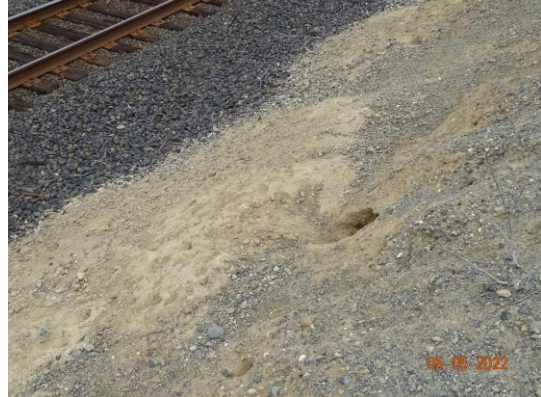
Photo 1 of 1 : SP_2022_RD0010_163_50_20220516_00145.jpg

View of squirrel holes on the landside slope and toe, no rodent activity was observed, Spring 2022.

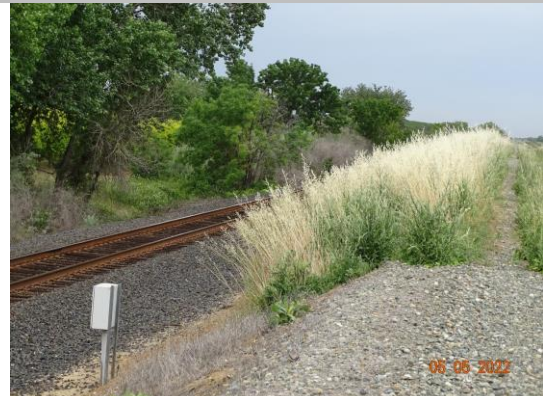
Photo 1 of 1 : SP_2022_RD0010_163_78_20220516_00137.jpg

View of annual vegetation on the landside slope, Spring 2022.

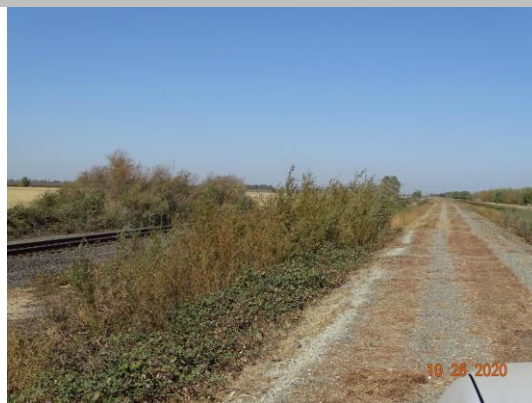
Photo 1 of 1 : SP_2022_RD0010_163_33_20220314_00005.jpg

View looking upstream landside at small starter trees on levee slope, Fall 2020.

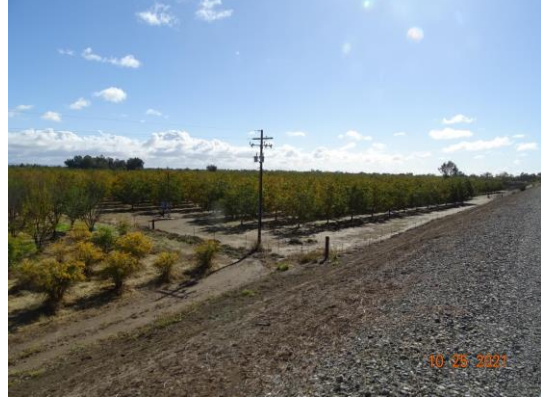
Photo 1 of 1 : SP_2022_RD0010_164_79_20220314_00037.jpg

View of fence that runs along landside toe, Fall 2021.

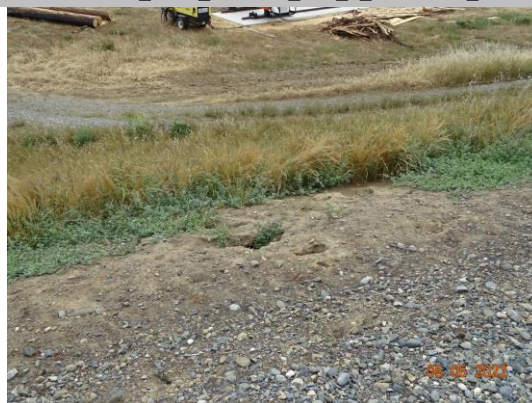
Photo 1 of 1 : SP_2022_RD0010_164_7_20220510_00172.jpg

View of rodent hole that needs to be backfilled, Spring 2022.

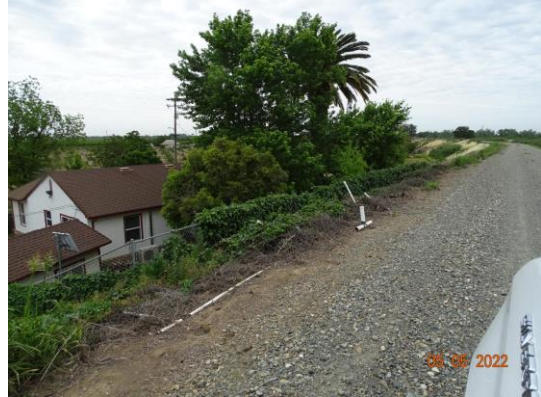
Photo 1 of 1 : SP_2022_RD0010_164_9_20220510_00166.jpg

View of homeowners landscaping and fence that encroaches on the landside levee slope, looking downstream, Spring 2022.

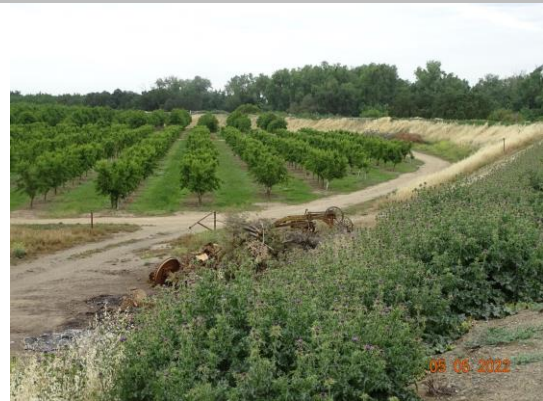
Photo 1 of 1 : SP_2022_RD0010_164_40_20220510_00155.jpg

View of a small pile of prunings on the landside toe that needs to be removed, Spring 2022.

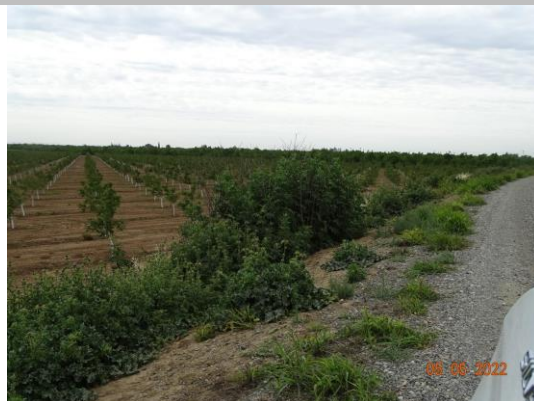
Photo 1 of 1 : SP_2022_RD0010_164_62_20220510_00151.jpg

View looking downstream landside at small starter tree on levee slope, Spring 2022.

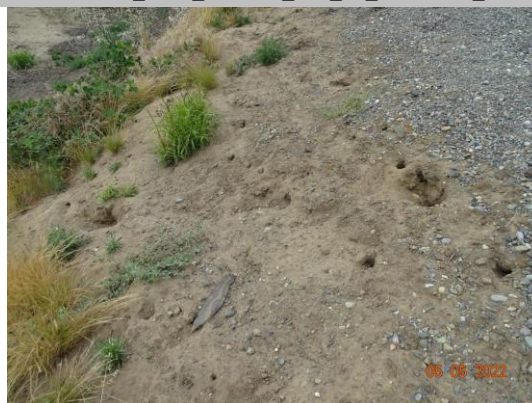
Photo 1 of 1 : SP_2022_RD0010_164_49_20220510_00150.jpg

View of rodent holes on landside slope that need to be backfilled, Spring 2022.

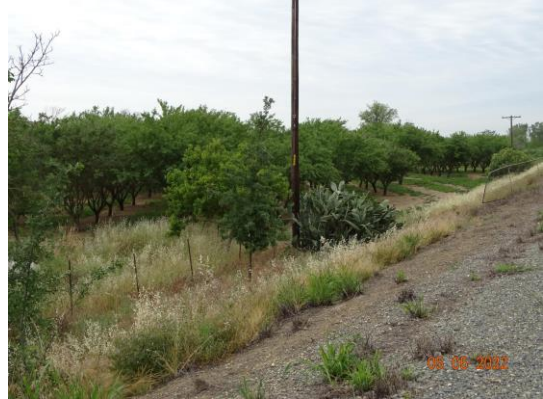
Photo 1 of 1 : SP_2022_RD0010_164_41_20220510_00144.jpg

View looking downstream landside of a landscape bush at the levee toe, Spring 2022.

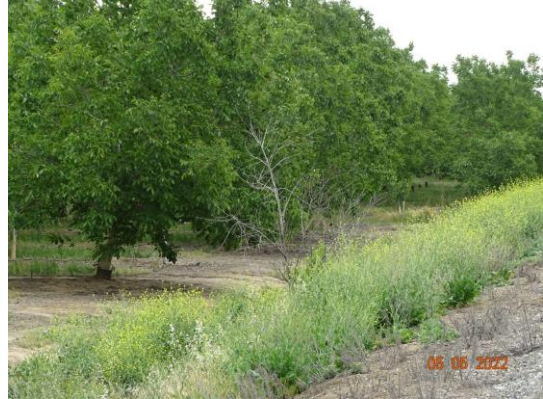
Photo 1 of 1 : SP_2022_RD0010_164_46_20220510_00137.jpg

View looking downstream landside at small starter tree on levee slope, Spring 2022.

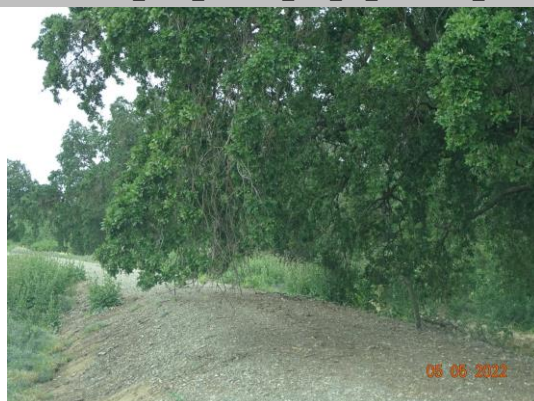
Photo 1 of 1 : SP_2022_RD0010_164_38_20220510_00133.jpg

View looking downstream crown at low hanging branches over the crown, Spring 2022.

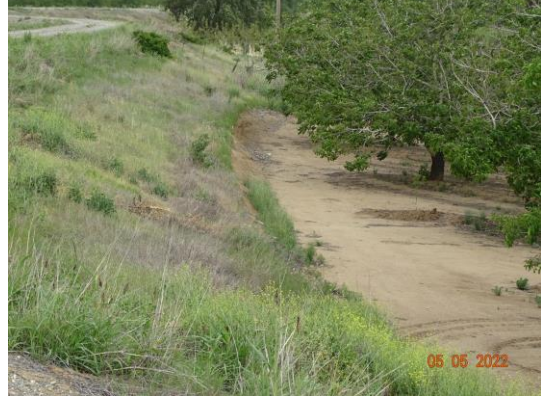
Photo 1 of 1 : SP_2022_RD0010_165_7_20220510_00034.jpg

View looking downstream waterside at a 2 foot vertical cut in the levee toe.
