**Flood Control Project Maintenance
Levee Inspections**

Maintenance Issue Types Only, Levee Inspection Report By Mile - Fall 2014

Reclamation District No. 0010 Honcut

Waterway	Bank	Unit Miles	Inspection Start/End	Inspector
Unit No. 01 Simmerly Slough	Right	7.65	10/23/2014 10/23/2014	Matthew Hoffman

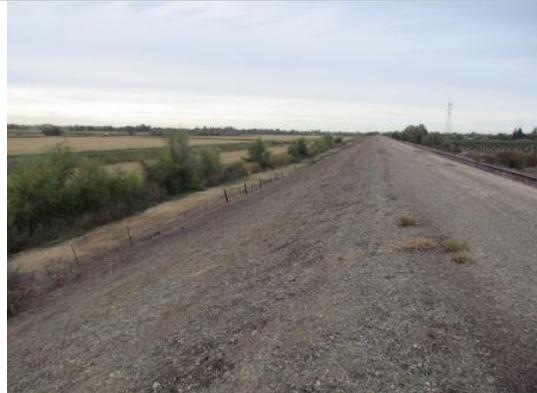
Photo 1 of 1 : FA_2014_RD0010_163_341_20141103_00298.jpg

LM Start	2.34	Rating **	A	Issue No.	341
LM End	2.34	Issue Type +	Ma	Location *	WS
Category	Earthen Levee		GPS Latitude/Longitude		
			Start	End	
Item	Vegetation		39.179694 °	39.179694 °	
			-121.584516 °	-121.584516 °	
DWR ID	DWR_RD0010_01_f_2014_341				
Action/Comments					
Control annual grass and weeds on the levee slopes and easements.

This photo was taken from the crown facing south looking down the waterward levee slope at acceptable vegetation maintenance. Fall 2014.

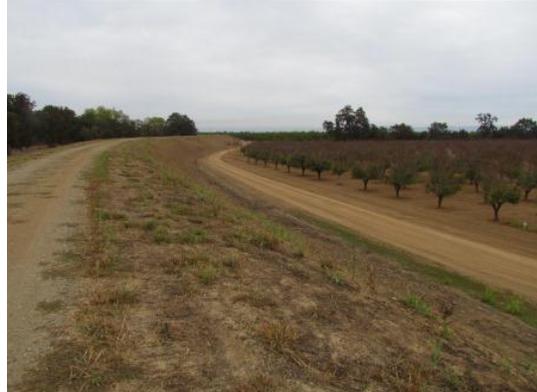
Photo 1 of 1 : FA_2014_RD0010_164_524_20141103_00503.jpg

LM Start	4.33	Rating **	A	Issue No.	524
LM End	4.33	Issue Type +	Ma	Location *	LS
Category	Earthen Levee		GPS Latitude/Longitude		
			Start	End	
Item	Vegetation		39.225274 °	39.225274 °	
			-121.613502 °	-121.613502 °	
DWR ID	DWR_RD0010_02_f_2014_524				
Action/Comments					
Control annual grass and weeds on the levee slopes and easements.

This photo was taken from the crown facing north looking down the landward levee slope at acceptable vegetation maintenance. Fall 2014.

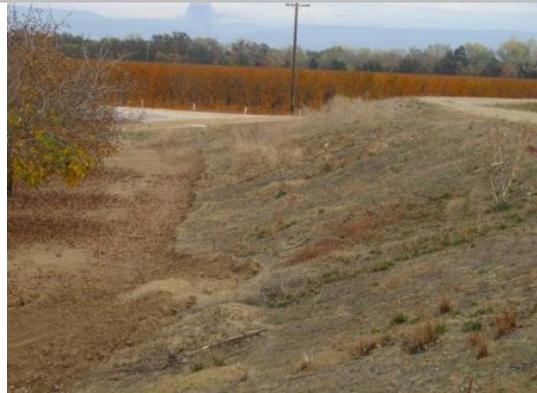
Photo 1 of 1 : FA_2014_RD0010_165_18_20141020_00004.jpg

LM Start	1.85	Rating **	M	Issue No.	18
LM End	1.85	Issue Type +	Ma	Location *	WS
Category	Earthen Levee		GPS Latitude/Longitude		
			Start	End	
Item	Slope Stability		39.302904 °	39.302904 °	
			-121.588578 °	-121.588578 °	
DWR ID	DWR_RD0010_03_f_2013_18				
Action/Comments					
Repair the levee slope damaged by vehicle traffic and prevent access where possible. Inspector Comments: Toe cut at edge of waterward side of levee.

This photo was taken from the levee crown facing north looking down the waterward slope at agricultural tilling causing a cut at the levee toe. Fall 2013.

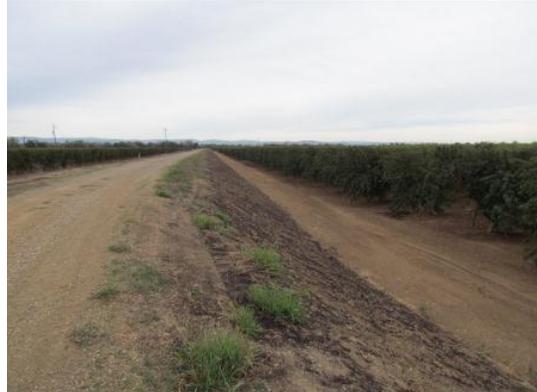
Photo 1 of 1 : FA_2014_RD0010_165_135_20141103_00108.jpg

LM Start	1.93	Rating **	A	Issue No.	135
LM End	1.93	Issue Type +	Ma	Location *	LS
Category	Earthen Levee		GPS Latitude/Longitude		
			Start	End	
Item	Vegetation		39.303418 °	39.303418 °	
			-121.587260 °	-121.587260 °	
DWR ID	DWR_RD0010_03_f_2014_135				
Action/Comments					
Control annual grass and weeds on the levee slopes and easements.

This photo was taken from the levee crown facing east looking down the landward slope at acceptable vegetation maintenance. Fall 2014.
