**Flood Control Project Maintenance
Levee Inspections**

Maintenance Issue Types Only, Levee Inspection Report By Mile - Fall 2015

Reclamation District No. 0010 Honcut

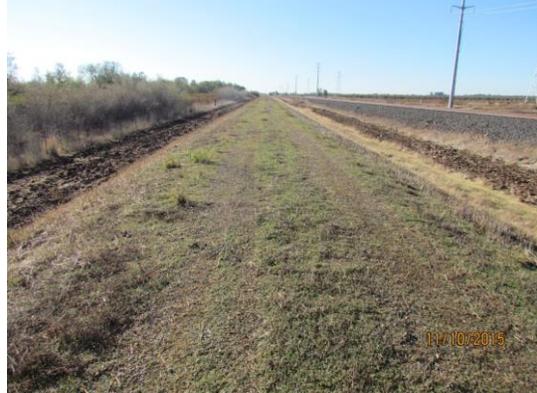
Photo 1 of 1 : FA_2015_RD0010_163_28_20151113_00024.jpg

LM Start	3.57	Rating **	A/W	Issue No.	28
LM End	7.64	Issue Type +	Ma	Location *	CR
Category	Earthen Levee			GPS Latitude/Longitude	
				Start	End
Item	Crown Surface / Depressions / Rutting			39.197526 °	39.255993 °
				-121.582294 °	-121.574930 °
DWR ID	DWR_RD0010_01_f_2015_28				
Action/Comments					
Add appropriate material and re-grade the levee to bring the crown above the design elevation. Inspector Comments: Crown needs to be re-graded. LMA is in the proces of regrading the levee in correspondence with DWR.

View of the crown of the levee looking downstream. Fall 2015.

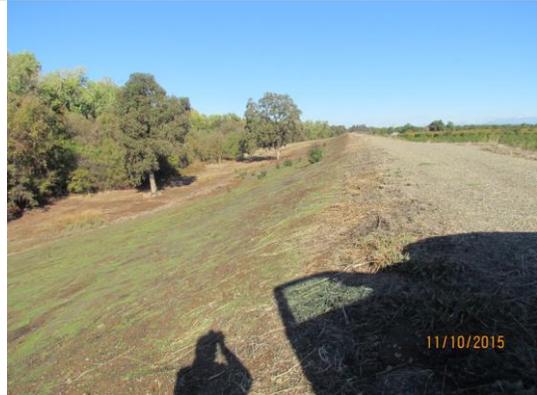
Photo 1 of 1 : FA_2015_RD0010_164_25_20151113_00020.jpg

LM Start	0.03	Rating **	A	Issue No.	25
LM End	11.36	Issue Type +	Ma	Location *	WS
Category	Earthen Levee			GPS Latitude/Longitude	
				Start	End
Item	Vegetation			39.164091 °	39.310068 °
				-121.610076 °	-121.616287 °
DWR ID	DWR_RD0010_02_f_2015_25				
Action/Comments					
Control annual grass and weeds on the levee slopes and easements. Inspector Comments: Levee has been burned and dragged.

View of the vegetation on the waterward side of the levee looking upstream. Fall 2015.

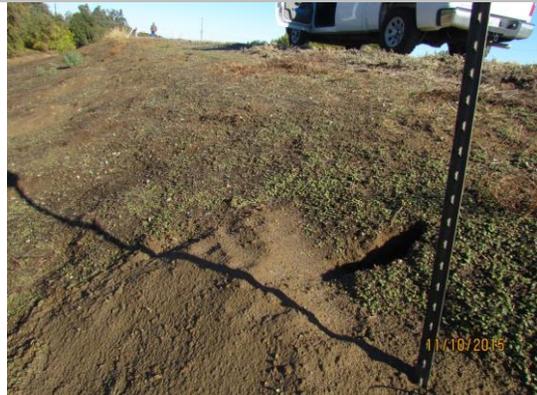
Photo 1 of 1 : FA_2015_RD0010_164_28_20151113_00021.jpg

LM Start	0.38	Rating **	M	Issue No.	28
LM End	0.38	Issue Type +	Ma	Location *	WS
Category	Earthen Levee			GPS Latitude/Longitude	
				Start	End
Item	Animal Control			39.169231 °	39.169231 °
				-121.610711 °	-121.610711 °
DWR ID	DWR_RD0010_02_f_2015_28				
Action/Comments					
No rodents visible, but rodent burrows visible; need to backfill and compact or grout burrows.

View of the rodent hole on the waterward side of the levee looking upstream. Fall 2015.

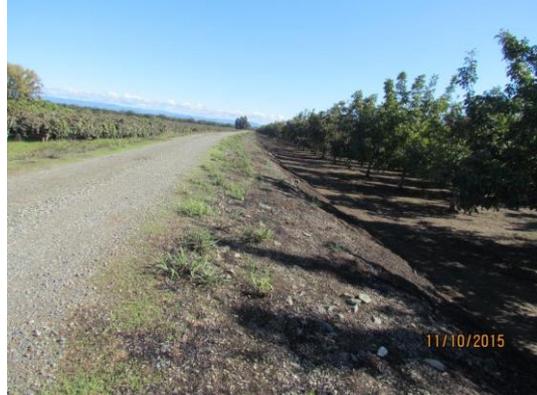
Photo 1 of 1 : FA_2015_RD0010_165_4_20151113_00008.jpg

LM Start	0.00	Rating **	A	Issue No.	4
LM End	2.80	Issue Type +	Ma	Location *	LS
Category	Earthen Levee		GPS Latitude/Longitude		
			Start	End	
Item	Vegetation		39.310069 °	39.298537 °	
			-121.616287 °	-121.569954 °	
DWR ID	DWR_RD0010_03_f_2015_4				
Action/Comments					
Control annual grass and weeds on the levee slopes and easements. Inspector Comments: Vegetation has been burned.

View of the vegetation on the landward side of the levee looking upstream. Fall 2015.

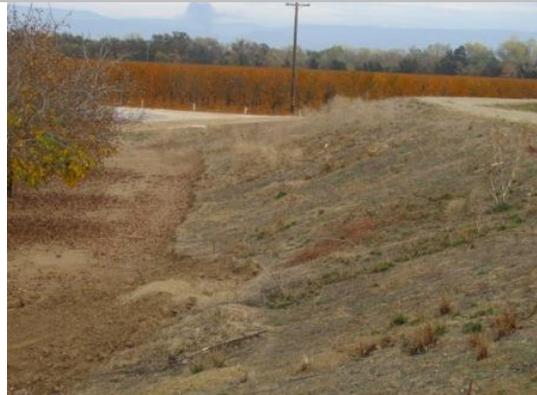
Photo 1 of 1 : FA_2015_RD0010_165_18_20151030_00004.jpg

LM Start	1.67	Rating **	M	Issue No.	18
LM End	1.67	Issue Type +	Ma	Location *	WS
Category	Earthen Levee		GPS Latitude/Longitude		
			Start	End	
Item	Slope Stability		39.302904 °	39.302904 °	
			-121.588578 °	-121.588578 °	
DWR ID	DWR_RD0010_03_f_2013_18				
Action/Comments					
Repair the levee slope damaged by vehicle traffic and prevent access where possible. Inspector Comments: Toe cut at edge of waterward side of levee.

This photo was taken from the levee crown facing north looking down the waterward slope at agricultural tilling causing a cut at the levee toe. Fall 2013.
