**Flood Control Project Maintenance  
Levee Inspections**

**Maintenance Issue Types Only, Levee Inspection Report By Mile - Spring 2015**

**Reclamation District No. 0010 Honcut**

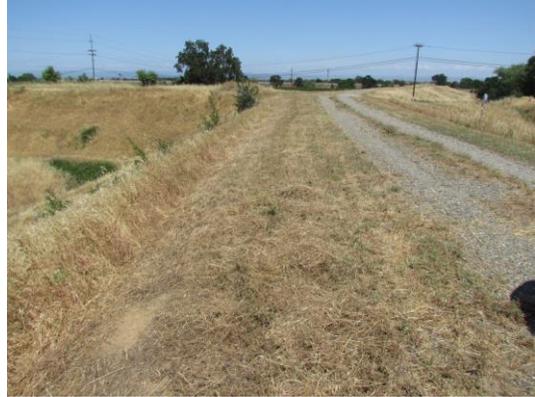
Photo 1 of 1 : SP\_2015\_RD0010\_163\_27\_20150513\_00020.jpg

LM Start	<b>1.75</b>	Rating **	A/W	Issue No.	<b>27</b>
LM End	<b>1.75</b>	Issue Type +	Ma	Location *	WS
Category	Earthen Levee		GPS Latitude/Longitude		
			Start	End	
Item	Vegetation		39.171218 °	39.171218 °	
			-121.585602 °	-121.585602 °	
DWR ID	DWR_RD0010_01_s_2015_27				
Action/Comments					
Control annual grass and weeds on the levee slopes and easements.

View of the waterside vegetation facing upstream.

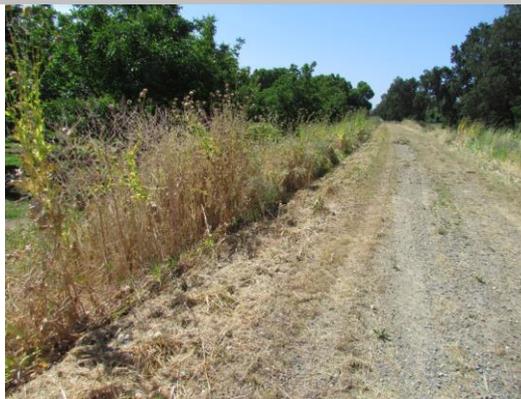
Photo 1 of 1 : SP\_2015\_RD0010\_164\_25\_20150513\_00021.jpg

LM Start	<b>0.02</b>	Rating **	M	Issue No.	<b>25</b>
LM End	<b>11.34</b>	Issue Type +	Ma	Location *	LS
Category	Earthen Levee			GPS Latitude/Longitude	
				Start	End
Item	Vegetation			39.309737 °	39.309737 °
				-121.616523 °	-121.616523 °
DWR ID	DWR_RD0010_02_s_2015_25				
Action/Comments					
Control annual grass and weeds on the levee slopes and easements.

View of the landside vegetation facing downstream.

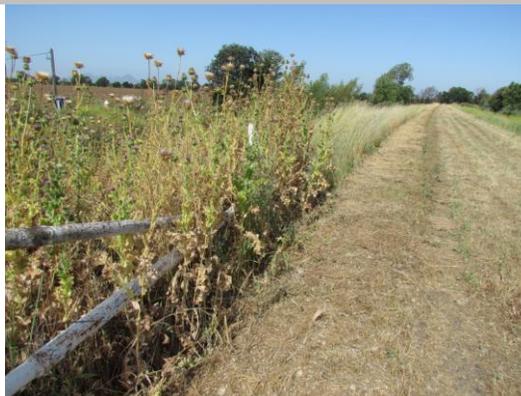
Photo 1 of 1 : SP\_2015\_RD0010\_165\_6\_20150513\_00008.jpg

LM Start	<b>0.01</b>	Rating **	M	Issue No.	<b>6</b>
LM End	<b>2.79</b>	Issue Type +	Ma	Location *	WS
Category	Earthen Levee		GPS Latitude/Longitude		
			Start	End	
Item	Vegetation		39.310060 °	39.298583 °	
			-121.616223 °	-121.570043 °	
DWR ID	DWR_RD0010_03_s_2015_6				
Action/Comments					
Control annual grass and weeds on the levee slopes and easements.

View of the vegetation on the waterside of the levee facing upstream.

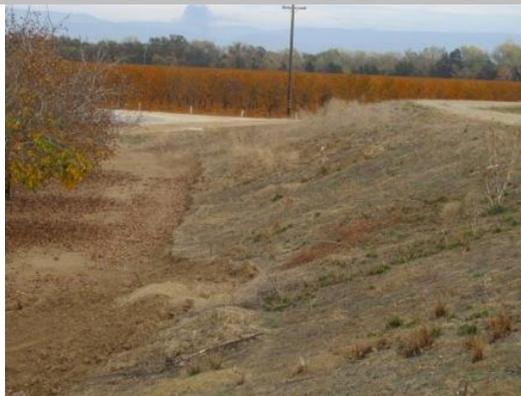
Photo 1 of 1 : SP\_2015\_RD0010\_165\_18\_20150401\_00002.jpg

LM Start	<b>1.67</b>	Rating **	M	Issue No.	<b>18</b>
LM End	<b>1.67</b>	Issue Type +	Ma	Location *	WS
Category	Earthen Levee		GPS Latitude/Longitude		
			Start	End	
Item	Slope Stability		39.302904 °	39.302904 °	
			-121.588578 °	-121.588578 °	
DWR ID	DWR_RD0010_03_f_2013_18				
Action/Comments					
Repair the levee slope damaged by vehicle traffic and prevent access where possible. Inspector Comments: Toe cut at edge of waterward side of levee.

This photo was taken from the levee crown facing north looking down the waterward slope at agricultural tilling causing a cut at the levee toe. Fall 2013.
