**Flood Control Project Maintenance
Levee Inspections**

Fall 2008 Levee Maintenance Deficiency Summary Report

Reclamation District No. 0017

**Flood Control Project Maintenance
Levee Inspections
Unit Cover Sheet
Fall 2008 Levee Inspection Results
Reclamation District No. 0017**

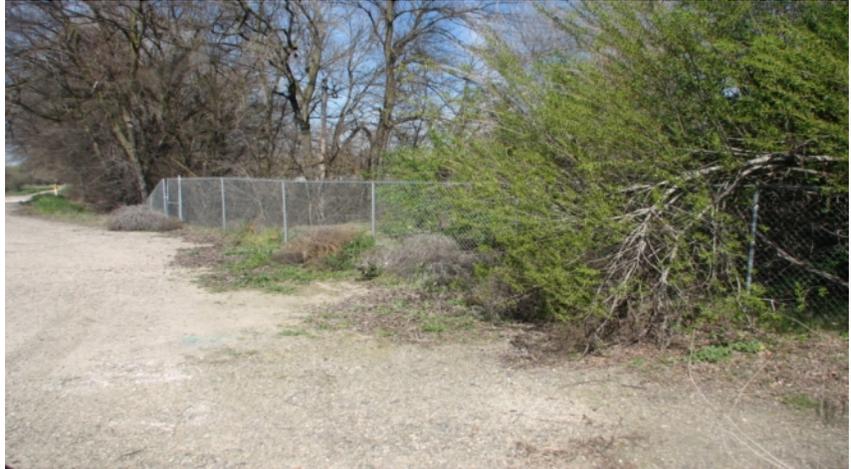
Levee Mile Report Line	1
Start Levee Mile	0.00
End Levee Mile	0.02
Location	
Category	Earthen Levee
Item	Encroachments
Fence on landside shoulder from LM 0.00 to 0.02

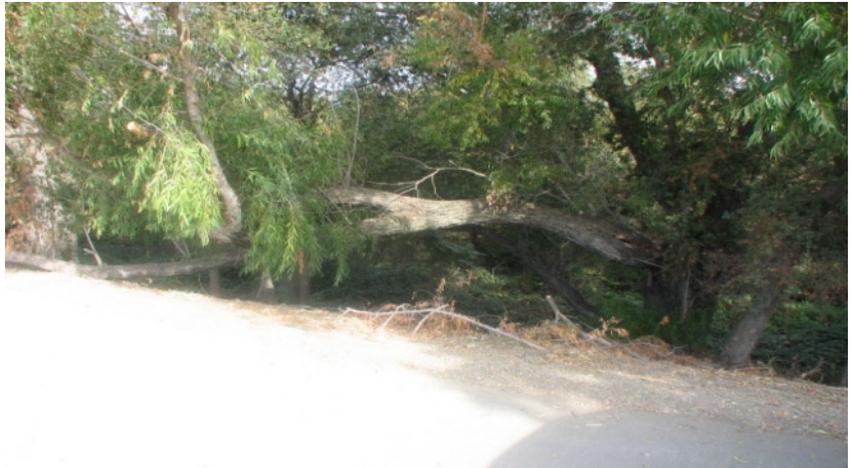
6	0.19	0.19	Earthen Levee	Encroachments	WS M	Tree or limb Inspector Comments: Down tree limb laying on waterside slope.		37.913254 ° -121.293366 °	37.913254 ° -121.293366 °	Y	10
7	0.48	0.51	Earthen Levee	Encroachments	WS M	Prunings		37.912770 ° -121.298426 °	37.912853 ° -121.298865 °		11
8	0.57	0.57	Earthen Levee	Encroachments	LS M	Prunings		37.913288 ° -121.299812 °	37.913288 ° -121.299812 °		6
9	0.88	0.98	Earthen Levee	Animal Control	WS M	No rodents visible, but rodent burrows visible; need to backfill and compact or grout borrows.		37.915093 ° -121.304609 °	37.915308 ° -121.306368 °		12
10	1.19	1.19	Earthen Levee	Trim / Thin Trees	WS M	Trim trees to at least five feet above ground level.		37.915875 ° -121.309795 °	37.915875 ° -121.309795 °		7

Levee Mile Report Line	6
Start Levee Mile	0.19
End Levee Mile	0.19
Location	
Category	Earthen Levee
Item	Encroachments
Down tree branch on waterside slope

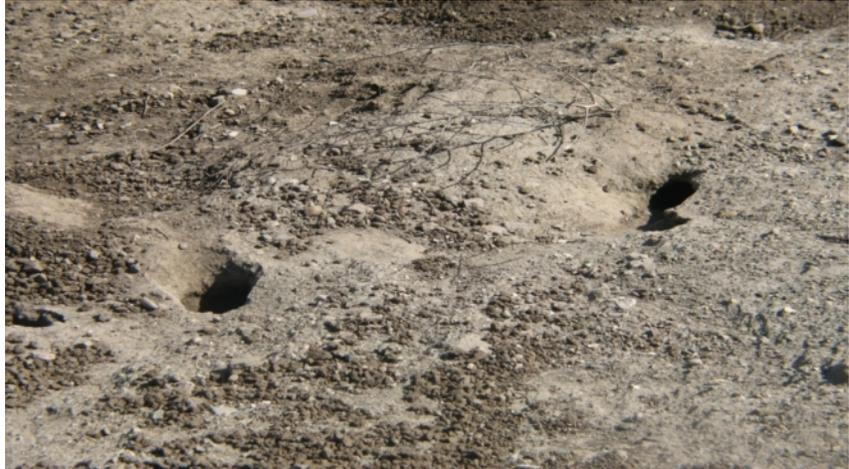
Levee Mile Report Line	2
Start Levee Mile	2.19
End Levee Mile	2.23
Location	
Category	Earthen Levee
Item	Animal Control
Squirrel borrows on landside slope heavy infestation from LM 2.19 to 2.60

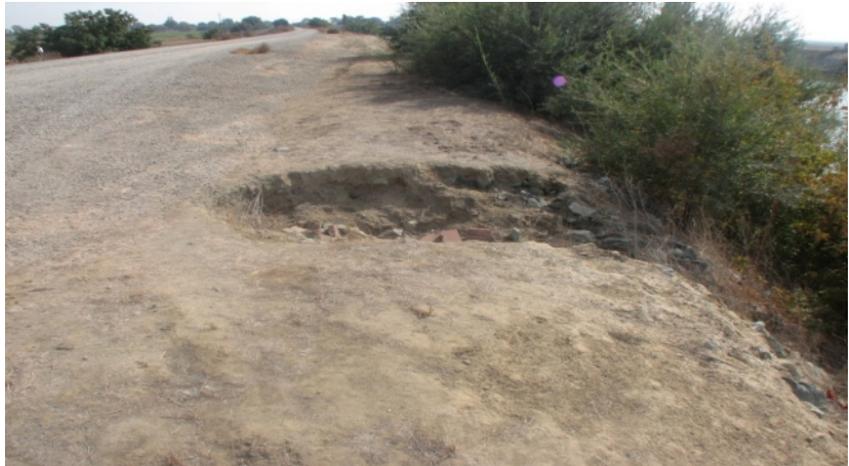
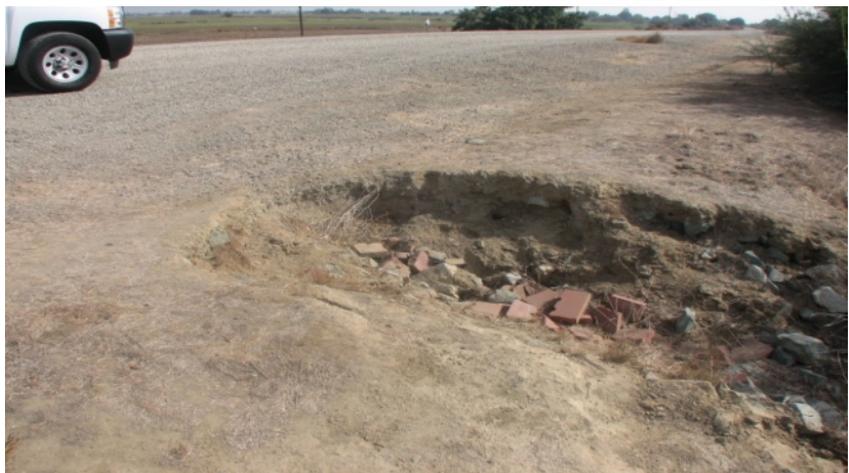
Levee Mile Report Line	6
Start Levee Mile	3.46
End Levee Mile	3.46
Location	
Category	Earthen Levee
Item	Slope Stability
Looking upstream at slope instability on waterside shoulder.

Levee Mile Report Line	6
Start Levee Mile	3.46
End Levee Mile	3.46
Location	
Category	Earthen Levee
Item	Slope Stability
Looking eastward at slope instability on waterside shoulder.

5	3.28	3.50	Earthen Levee	Animal Control	LS	M	No rodents visible, but rodent burrows visible; need to backfill and compact or grout borrows.	37.873488 ° -121.330377 °	37.870739 ° -121.328831 °		40
6	3.46	3.46	Earthen Levee	Slope Stability	WS	M	Repair slope instability.	37.871252 ° -121.329132 °	37.871252 ° -121.329132 °	Y	41
7	3.72	3.72	Earthen Levee	Trim / Thin Trees	LS	M	Trim trees to at least five feet above ground level.	37.867972 ° -121.326938 °	37.867972 ° -121.326938 °		42
8	3.78	3.78	Earthen Levee	Trim / Thin Trees	WS	M	Trim trees to at least five feet above ground level.	37.867083 ° -121.326715 °	37.867083 ° -121.326715 °		43
9	3.79	3.96	Earthen Levee	Animal Control	LS	M	No rodents visible, but rodent burrows visible; need to backfill and compact or grout borrows.	37.866847 ° -121.326766 °	37.865406 ° -121.325434 °		44
10	3.86	3.86	Earthen Levee	Trim / Thin Trees	LS	M	Trim trees to at least five feet above ground level.	37.865970 ° -121.326801 °	37.865970 ° -121.326801 °		45

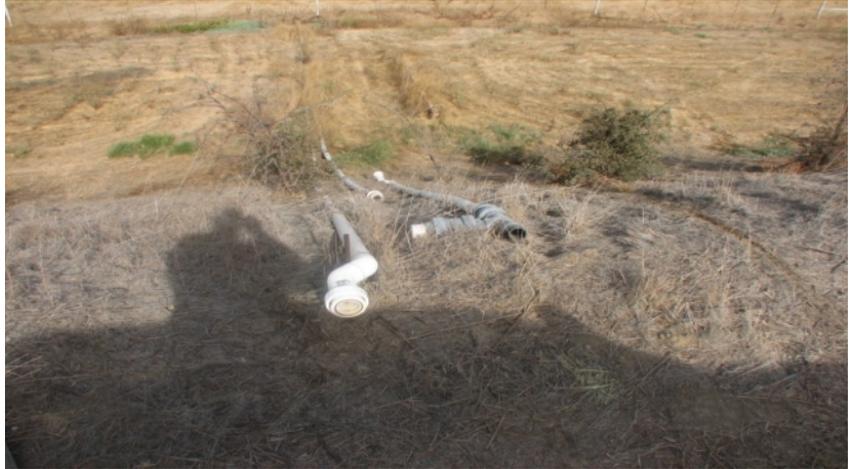
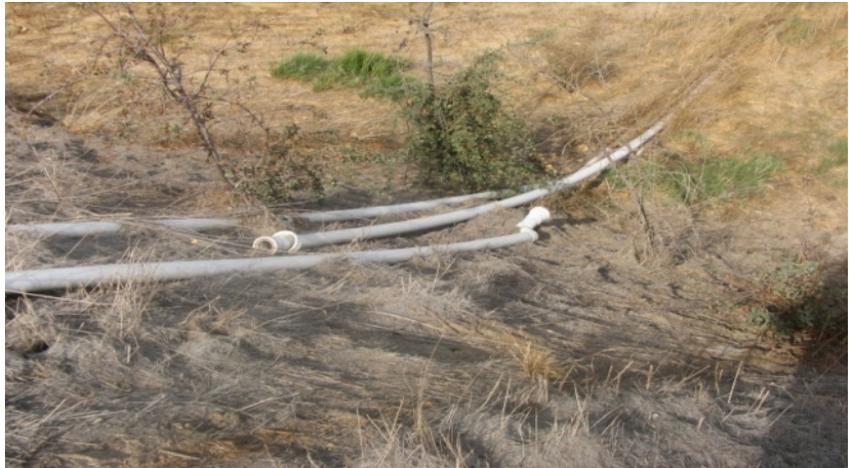
Levee Mile Report Line	13
Start Levee Mile	4.21
End Levee Mile	4.21
Location	
Category	Earthen Levee
Item	Encroachments
Looking eastward at abandoned PVC pipes on landward slope.

Levee Mile Report Line	13
Start Levee Mile	4.21
End Levee Mile	4.21
Location	
Category	Earthen Levee
Item	Encroachments
Looking northward at abandoned PVC pipes on landward slope.

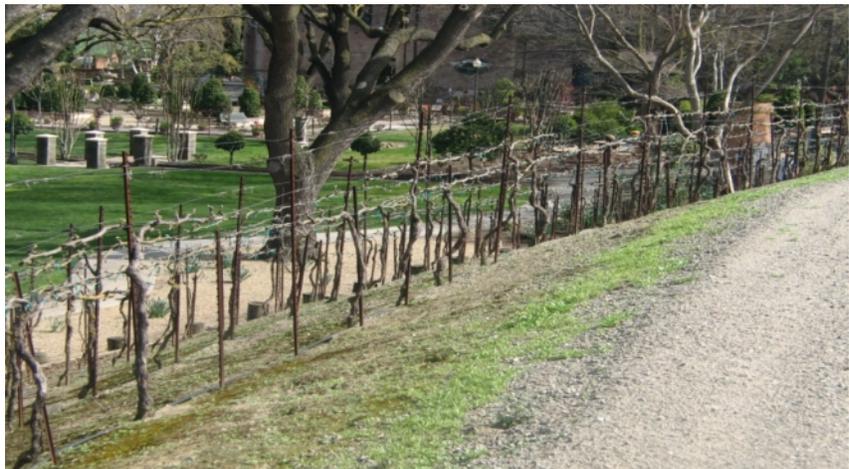
Levee Mile Report Line	15
Start Levee Mile	4.28
End Levee Mile	4.32
Location	
Category	Earthen Levee
Item	Encroachments
Grape vines on landside slope from LM 4.28 to 4.32

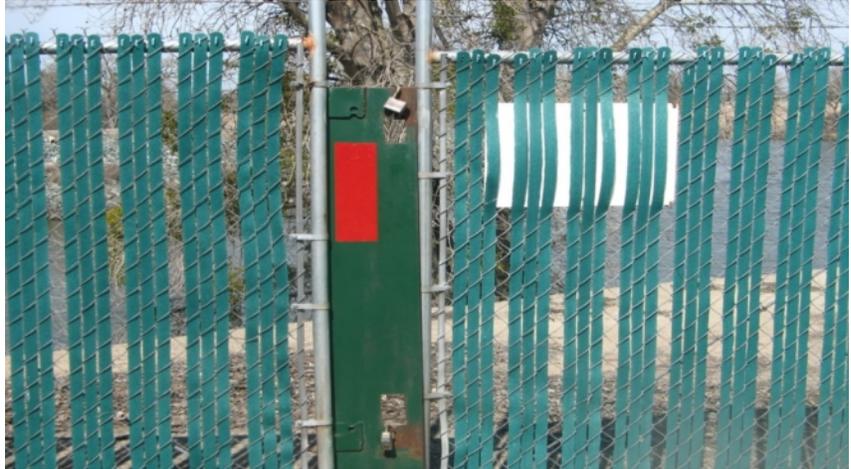
Levee Mile Report Line	16
Start Levee Mile	4.40
End Levee Mile	4.40
Location	
Category	Earthen Levee
Item	Repair Gates
Gate at LM 4.40 hard to lock gate due to alignment of gate.

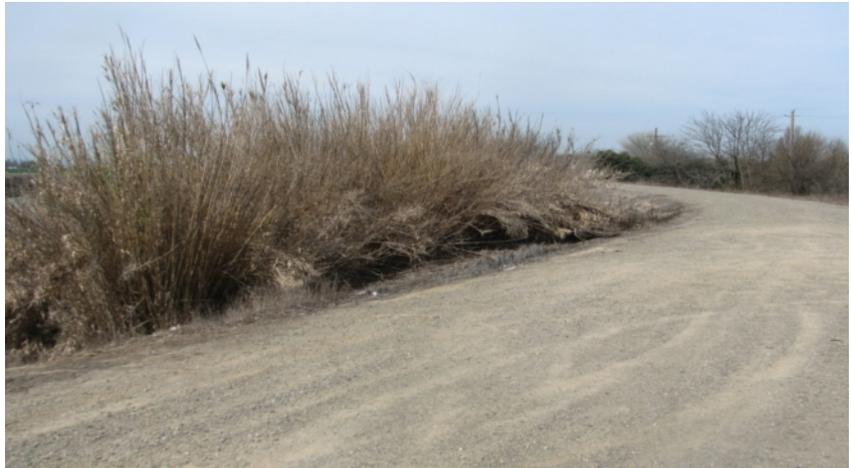
Levee Mile Report Line	20
Start Levee Mile	4.58
End Levee Mile	4.60
Location	
Category	Earthen Levee
Item	Vegetation
Dead bamboo on waterside slope at LM 4.58 (Remove dead bambo)

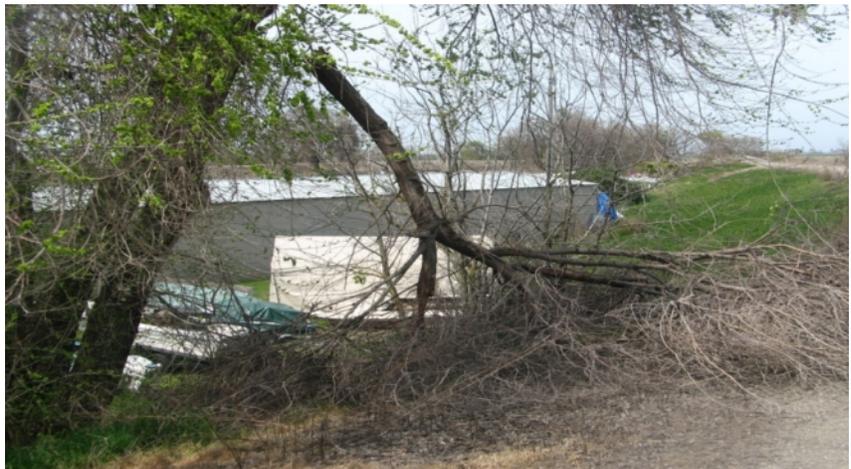
Levee Mile Report Line	24
Start Levee Mile	5.55
End Levee Mile	5.55
Location	
Category	Earthen Levee
Item	Encroachments
Broken tree limb at LM 5.55

24	5.55	5.55	Earthen Levee	Encroachments	WS	M	Tree or limb Inspector Comments: Cut and remove broken tree limb from levee slope.	37.850507 ° -121.320432 °	37.850507 ° -121.320432 °	Y	17
25	5.59	5.59	Earthen Levee	Trim / Thin Trees	LS	M	Trim trees to at least five feet above ground level.	37.849975 ° -121.320142 °	37.849975 ° -121.320142 °		18
26	5.59	5.59	Earthen Levee	Trim / Thin Trees	LS	M	Trim trees to at least five feet above ground level.	37.850057 ° -121.320125 °	37.850057 ° -121.320125 °		53
27	5.62	5.85	Earthen Levee	Encroachments	LS	PO	Landscaping	37.849472 ° -121.320159 °	37.848582 ° -121.323647 °		54
28	5.70	5.74	Earthen Levee	Trim / Thin Trees	LS	M	Trim trees to at least five feet above ground level.	37.849109 ° -121.321391 °	37.849244 ° -121.322014 °		55
29	5.77	5.77	Earthen Levee	Vegetation	WS	M	Elderberries are blocking visibility and flood fight capability.	37.849267 ° -121.322590 °	37.849267 ° -121.322590 °	Y	19

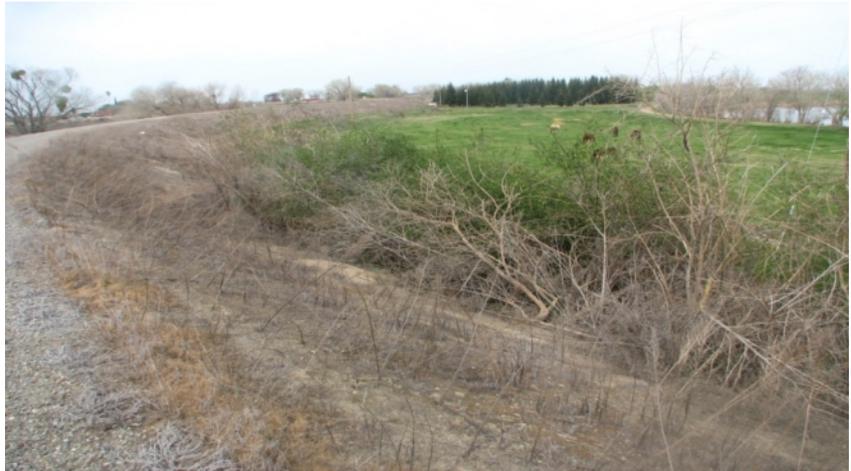
Levee Mile Report Line	32
Start Levee Mile	6.35
End Levee Mile	6.36
Location	
Category	Earthen Levee
Item	Vegetation
Elderberry blocking view of waterside toe from LM 6.35 to 6.36

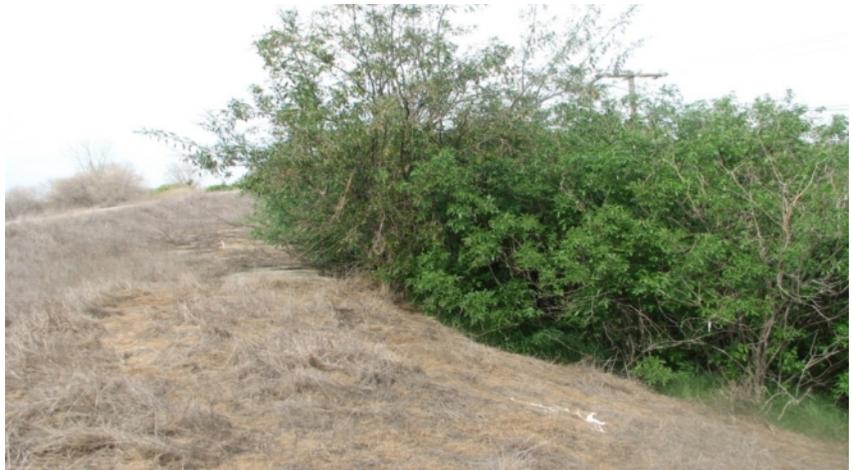
Levee Mile Report Line	39
Start Levee Mile	7.67
End Levee Mile	7.69
Location	
Category	Earthen Levee
Item	Vegetation
Elderberry blocking view of landside slope and toe from LM 7.67 to 7.69

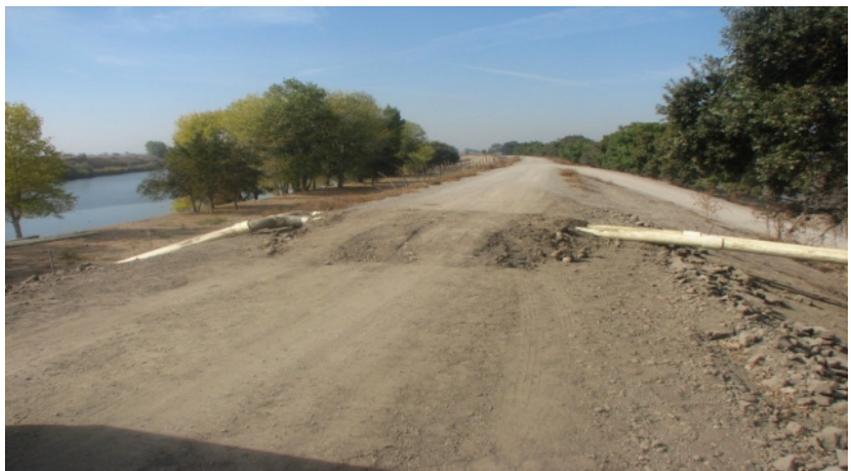
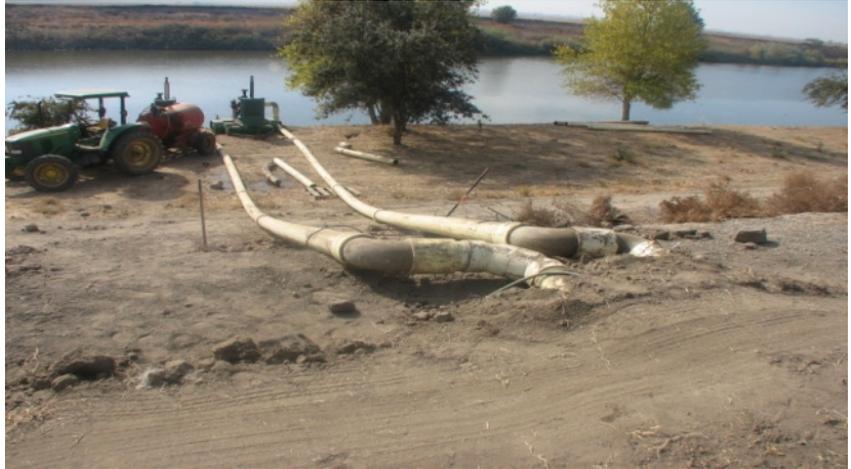
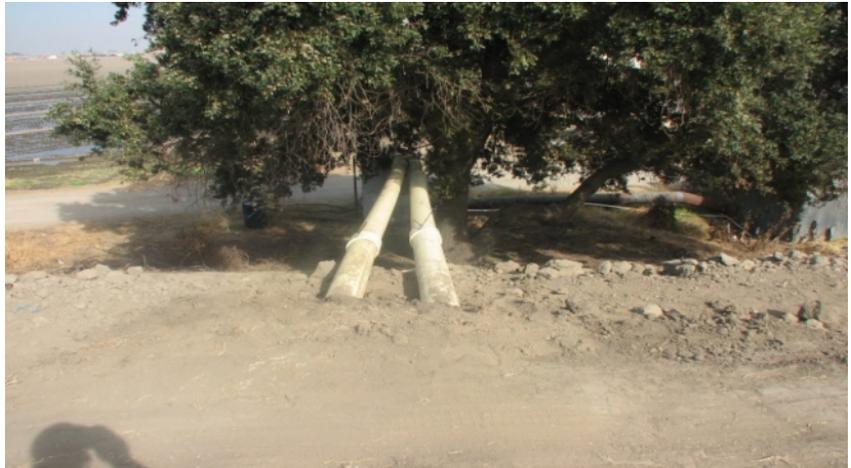
Levee Mile Report Line	47
Start Levee Mile	11.28
End Levee Mile	11.28
Location	
Category	Earthen Levee
Item	Encroachments
Looking downstream at two 6-inch pvc pipes across levee crown with ramp.

Levee Mile Report Line	47
Start Levee Mile	11.28
End Levee Mile	11.28
Location	
Category	Earthen Levee
Item	Encroachments
Looking westward at two 6-inch pvc pipes with pumps on waterward slope and bern.

Levee Mile Report Line	47
Start Levee Mile	11.28
End Levee Mile	11.28
Location	
Category	Earthen Levee
Item	Encroachments
Looking eastward at two 6-inch pvc pipes connected to irrigation well on landside toe.

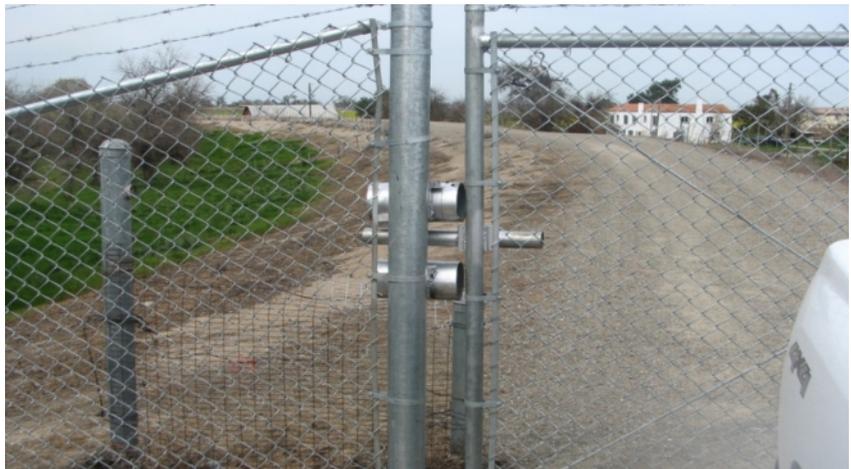
Levee Mile Report Line	50
Start Levee Mile	11.42
End Levee Mile	11.42
Location	
Category	Earthen Levee
Item	Repair Gates
Gate with a faulty locking system at LM 11.42

49	11.38	11.42	Earthen Levee	Encroachments	LS	PO	Fences	37.804343 ° -121.312226 °	37.803726 ° -121.312039 °		69
50	11.42	11.42	Earthen Levee	Repair Gates	CR	A	Inspector Comments: Need to change locking system. Hard to lock and unlock gate.	37.803762 ° -121.312027 °	37.803762 ° -121.312027 °	Y	30
51	11.62	11.62	Earthen Levee	Vegetation	LS	M	Remove the wild growth other than native grasses from the levee slopes.	37.800888 ° -121.311997 °	37.800888 ° -121.311997 °		70
52	11.90	11.90	Earthen Levee	Encroachments	WS	M	Tree or limb	37.797467 ° -121.311045 °	37.797467 ° -121.311045 °	Y	31
53	12.29	12.29	Earthen Levee	Trim / Thin Trees	LS	M	Trim trees to at least five feet above ground level.	37.793823 ° -121.305991 °	37.793823 ° -121.305991 °		71
54	13.45	13.45	Earthen Levee	Trim / Thin Trees	WS	M	Trim trees to at least five feet above ground level.	37.779355 ° -121.299948 °	37.779355 ° -121.299948 °		33

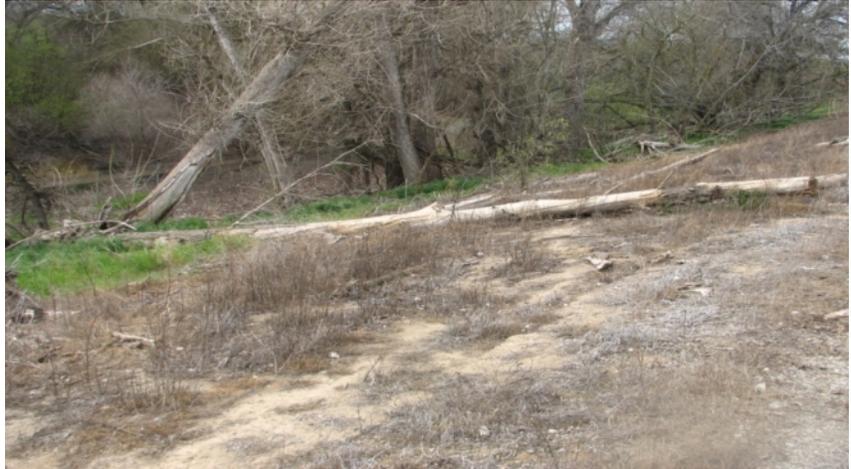
Levee Mile Report Line	52
Start Levee Mile	11.90
End Levee Mile	11.90
Location	
Category	Earthen Levee
Item	Encroachments
Tree limbs on waterwater slope at LM 11.90

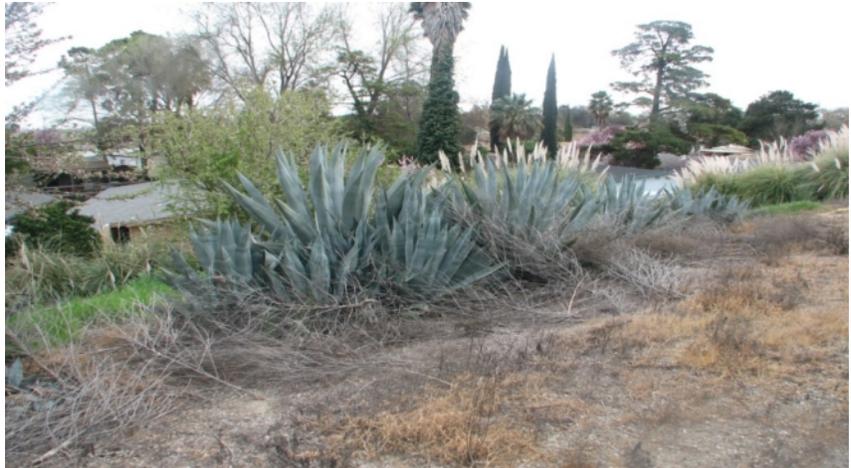
Levee Mile Report Line	56
Start Levee Mile	13.66
End Levee Mile	13.66
Location	
Category	Earthen Levee
Item	Encroachments
Catus (Landscaping) on landside slope blocking view at LM 13.66
