**Flood Control Project Maintenance  
Levee Inspections**

**Fall 2010 Levee Maintenance Deficiency Summary Report**

***San Joaquin River Basin***

**Reclamation District No. 0017 Mossdale**

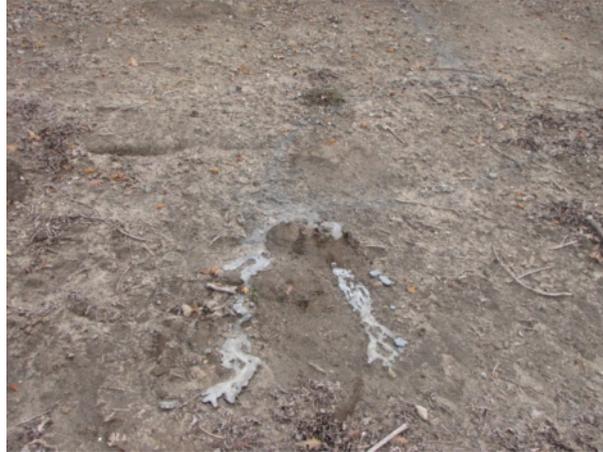
Levee Mile Report Line	2
Start Levee Mile	0.56
End Levee Mile	0.58
Location	Land Side
Category	Earthen Levee
Item	Animal Control

Looking east at grouted rodent holes on landside slope.

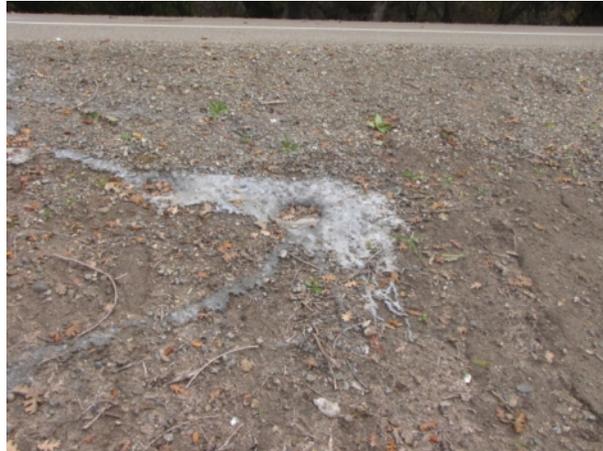
Levee Mile Report Line	2
Start Levee Mile	0.56
End Levee Mile	0.58
Location	Land Side
Category	Earthen Levee
Item	Animal Control

Looking east at grouted rodent holes on landside slope.

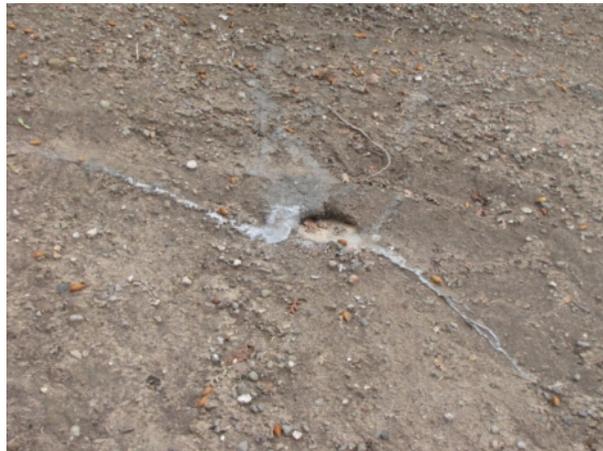
Levee Mile Report Line	2
Start Levee Mile	0.56
End Levee Mile	0.58
Location	Land Side
Category	Earthen Levee
Item	Animal Control

Looking southeast at grouted rodent holes on landside slope.

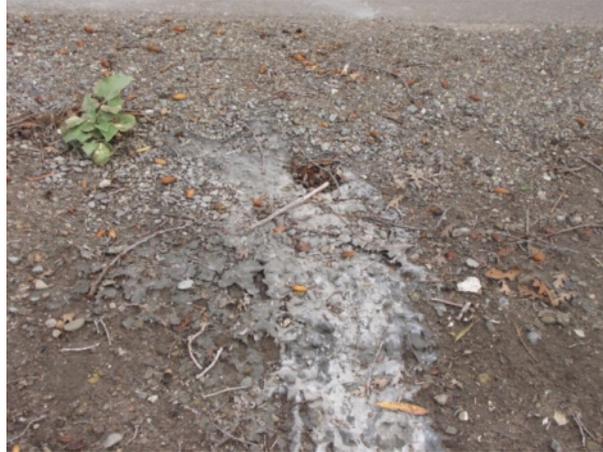
Levee Mile Report Line	2
Start Levee Mile	0.56
End Levee Mile	0.58
Location	Land Side
Category	Earthen Levee
Item	Animal Control
Looking east at grouted rodent holes on landside shoulder.	
richard_f_20101202_475.jpg

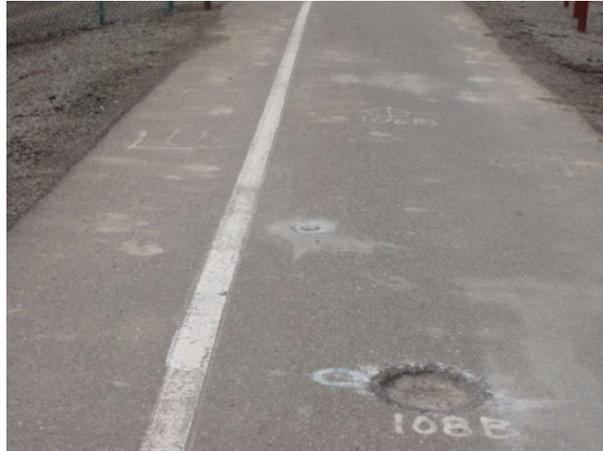
5	0.82	0.82	Earthen Levee	Animal Control	CR	A	Exterminate rodents and backfill and compact or grout burrows. Inspector Comments: This item was identified with an Unacceptable rating in the USACE PI report for the San Joaquin River East Levee System (MOS1_2009_a_0039). Reinspecton on 12/2/10 verifies that repairs were made as indicated in the 11/8/10 letter from KSN.	37.915060 ° -121.303615 °	37.915060 ° -121.303615 °	10 Y
6	0.86	0.86	Earthen Levee	Trim / Thin Trees	WS	N	Tree stumps.	37.915078 ° -121.304228 °	37.915078 ° -121.304228 °	4
7	0.92	0.92	Earthen Levee	Animal Control	LS	A	Exterminate rodents and backfill and compact or grout burrows. Inspector Comments: This item was identified with an Unacceptable rating in the USACE PI report for the San Joaquin River East Levee System (MOS1_2009_a_0047). Reinspecton on 12/2/10 verifies that repairs were made as indicated in the 11/8/10 letter from KSN.	37.915071 ° -121.305483 °	37.915071 ° -121.305483 °	11 Y

Levee Mile Report Line	5
Start Levee Mile	0.82
End Levee Mile	0.82
Location	Crown
Category	Earthen Levee
Item	Animal Control
Looking north at grouted rodent hole on levee crown.	
richard_f_20101202_476.jpg

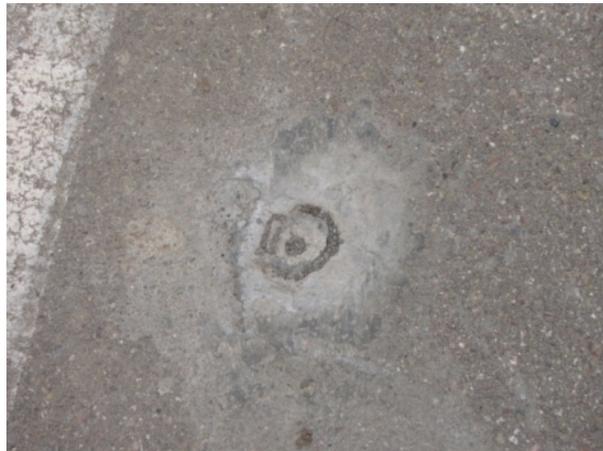
Levee Mile Report Line	5
Start Levee Mile	0.82
End Levee Mile	0.82
Location	Crown
Category	Earthen Levee
Item	Animal Control
Looking at top of grouted rodent hole on levee crown.	
richard_f_20101202_477.jpg

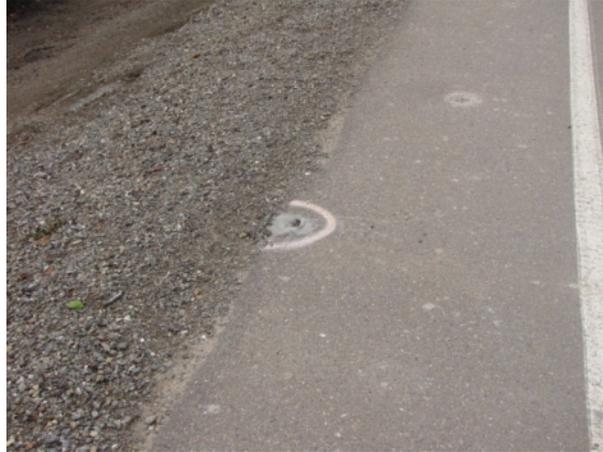
Levee Mile Report Line	7
Start Levee Mile	0.92
End Levee Mile	0.92
Location	Land Side
Category	Earthen Levee
Item	Animal Control
Looking northwest at grouted rodent hole on landside crown and shoulder.	
richard_f_20101202_478.jpg

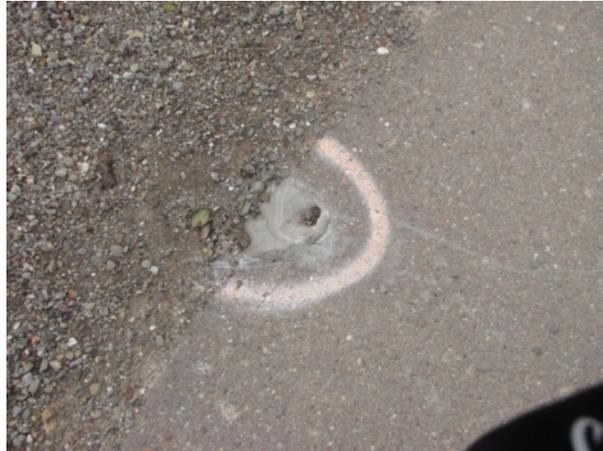
Levee Mile Report Line	7
Start Levee Mile	0.92
End Levee Mile	0.92
Location	Land Side
Category	Earthen Levee
Item	Animal Control
Looking at top of grouted rodent hole on landside crown and shoulder.	
richard_f_20101202_479.jpg

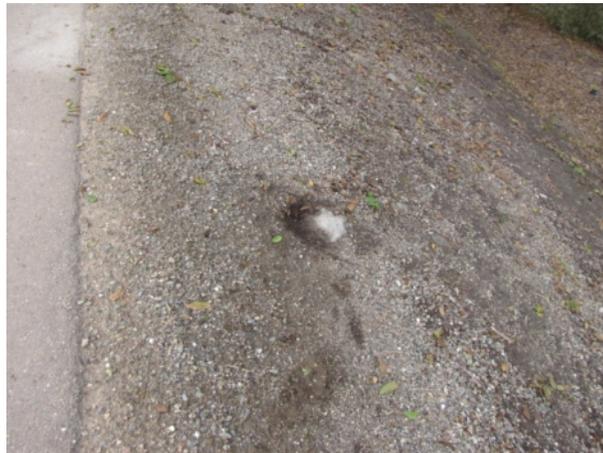
8	0.92	0.92	Earthen Levee	Trim / Thin Trees	WS	N	Tree stumps. Inspector Comments: Three stumps at this location.	37.915087 ° -121.305312 °	37.915087 ° -121.305312 °	6
9	0.93	0.93	Earthen Levee	Animal Control	WS	A	Exterminate rodents and backfill and compact or grout burrows. Inspector Comments: This item was identified with an Unacceptable rating in the USACE PI report for the San Joaquin River East Levee System (MOS1_2009_a_0048). Reinspecton on 12/2/10 verifies that repairs were made as indicated in the 11/8/10 letter from KSN.	37.915073 ° -121.305575 °	37.915073 ° -121.305575 °	12 Y

Levee Mile Report Line	9
Start Levee Mile	0.93
End Levee Mile	0.93
Location	Water Side
Category	Earthen Levee
Item	Animal Control
Looking north at grouted rodent hole on waterside shoulder.	
richard_f_20101202_480.jpg

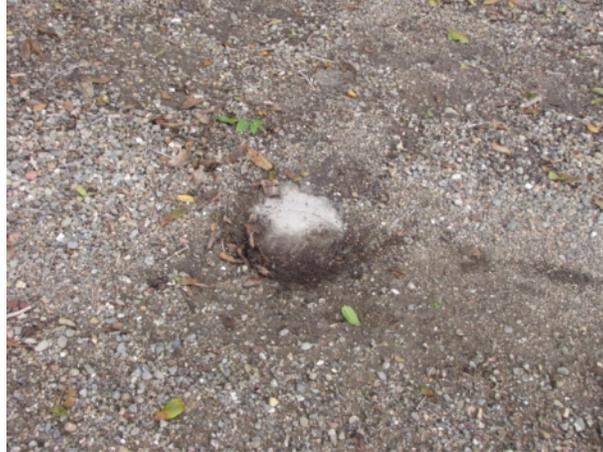
Levee Mile Report Line	9
Start Levee Mile	0.93
End Levee Mile	0.93
Location	Water Side
Category	Earthen Levee
Item	Animal Control
Looking west at grouted rodent hole on waterside shoulder.	
richard_f_20101202_481.jpg

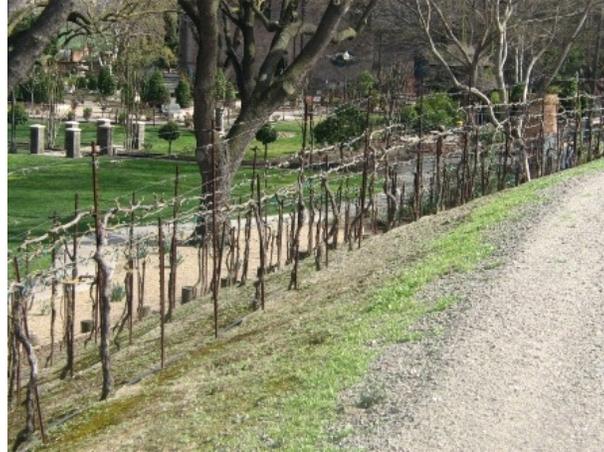
Levee Mile Report Line	7
Start Levee Mile	4.28
End Levee Mile	4.32
Location	Land Side
Category	Earthen Levee
Item	Encroachments
Grape vines on landside slope from LM 4.28 to 4.32	
richard_f_20100921_073.jpg

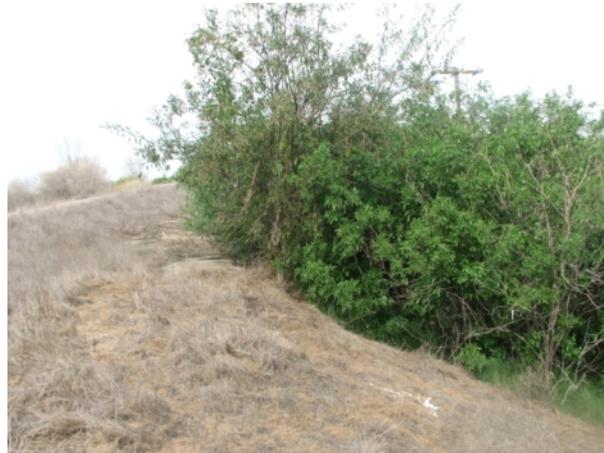
11	6.04	6.04	Earthen Levee	Encroachments	LS	C	Abandoned vehicles	37.846433 ° -121.322490 °	37.846433 ° -121.322490 °	78
12	7.67	7.69	Earthen Levee	Vegetation	LS	M	Elderberries are blocking visibility and flood fight capability.	37.828095 ° -121.309945 °	37.827920 ° -121.309847 °	25 Y
13	8.56	8.56	Earthen Levee	Animal Control	LS	C	Exterminate rodents and backfill and compact or grout burrows.	37.821270 ° -121.318282 °	37.821270 ° -121.318282 °	80
14	9.40	9.40	Earthen Levee	Vegetation	LS	M	Elderberries are blocking visibility and flood fight capability.	37.815243 ° -121.317470 °	37.815243 ° -121.317470 °	9
15	9.99	10.00	Supplemental	DWR Erosion Survey	WS	C	Inspector Comments: 9/07/2010: Site has been repaired by placing shot rock as revetment. Site was previously rated "M". [2010 SiteID: RD0017U02RM52.8]	37.811165 ° -121.318605 °	37.811165 ° -121.318605 °	4

Levee Mile Report Line	12
Start Levee Mile	7.67
End Levee Mile	7.69
Location	Land Side
Category	Earthen Levee
Item	Vegetation
Elderberry blocking view of landside slope and toe from LM 7.67 to 7.69	
richard_f_20100921_074.jpg

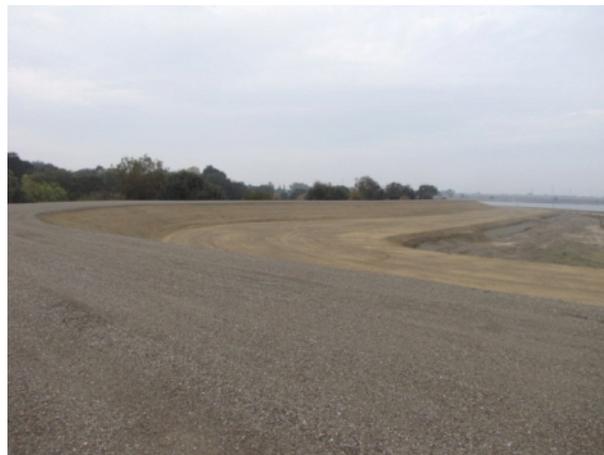
Levee Mile Report Line	22
Start Levee Mile	14.33
End Levee Mile	14.33
Location	Land Side
Category	Earthen Levee
Item	Crown Surface / Depressions / Rutting
Looking northwest at repaired (depression/Rutting) on landside levee slope.	
dpesaven_f_20101202_485.jpg

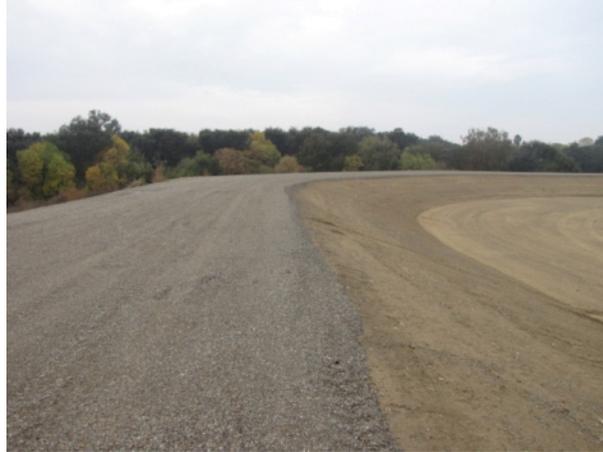
Levee Mile Report Line	22
Start Levee Mile	14.33
End Levee Mile	14.33
Location	Land Side
Category	Earthen Levee
Item	Crown Surface / Depressions / Rutting
Looking west at repaired (Depression/Rutting) on landside levee slope with stability berm.	
dpesaven_f_20101202_486.jpg

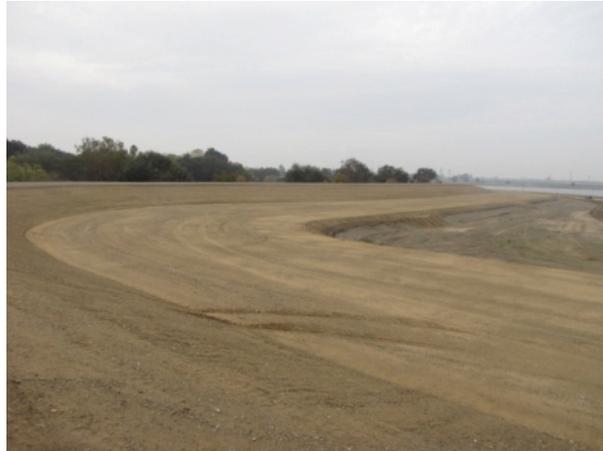
Levee Mile Report Line	22
Start Levee Mile	14.33
End Levee Mile	14.33
Location	Land Side
Category	Earthen Levee
Item	Crown Surface / Depressions / Rutting
Looking north at repaired (Depression/Rutting) on landside levee slope with stability berm.	
dpesaven_f_20101202_487.jpg
