**Flood Control Project Maintenance  
Levee Inspections  
LMA District Cover Sheet  
Spring 2010 Levee Inspection Results**

**Reclamation District No. 0017 Mossdale**

**Levee Inspection Report By Mile - Spring 2010**

Waterway	Bank	Unit Miles	Inspection Start/End	Inspector
Unit No. 02 San Joaquin River	Right	14.45	04/19/2010 04/20/2010	Richard Willoughby

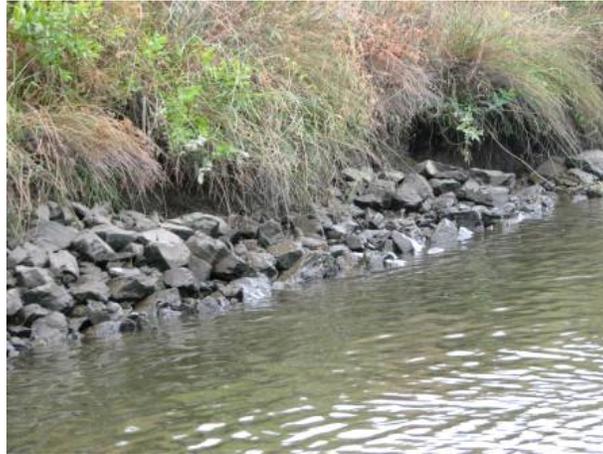
Levee Mile Report Line	4
Start Levee Mile	0.68
End Levee Mile	0.69
Location	Water Side
Category	Supplemental
Item	DWR Erosion Survey
<p>2009: Undercutting of the toe just above the existing rip rap; note there is a housing development on the landside of the levee (refer to Aerial Atlas) [2009 SiteID:RD0017U2RM43.95]</p>	
<p>SJR2009_RM43.95U2 092909A.JPG</p>

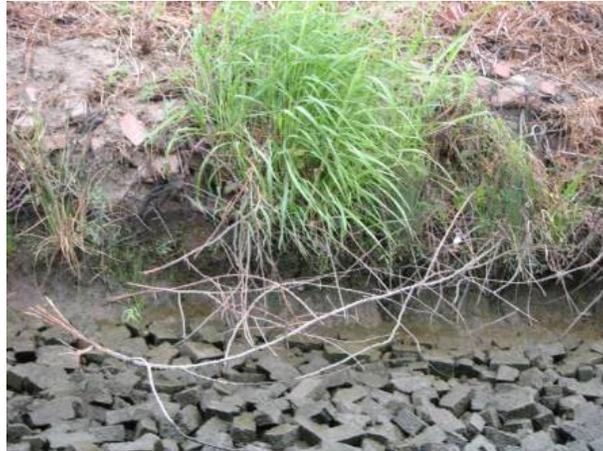
Levee Mile Report Line	4
Start Levee Mile	0.68
End Levee Mile	0.69
Location	Water Side
Category	Supplemental
Item	DWR Erosion Survey
<p>2009: Undercutting of the toe just above the existing rip rap; note there is a housing development on the landside of the levee (refer to Aerial Atlas) [2009 SiteID:RD0017U2RM43.95]</p>	
<p>SJR2009_RM43.95U2 092909D.JPG</p>

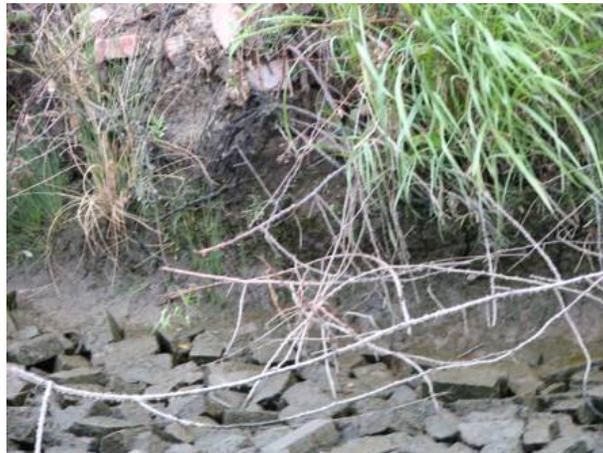
Levee Mile Report Line	4
Start Levee Mile	0.68
End Levee Mile	0.69
Location	Water Side
Category	Supplemental
Item	DWR Erosion Survey
<p>2009: Undercutting of the toe just above the existing rip rap; note there is a housing development on the landside of the levee (refer to Aerial Atlas) [2009 SiteID:RD0017U2RM43.95]</p>	
<p>SJR2009_RM43.95U2 092909E.JPG</p>

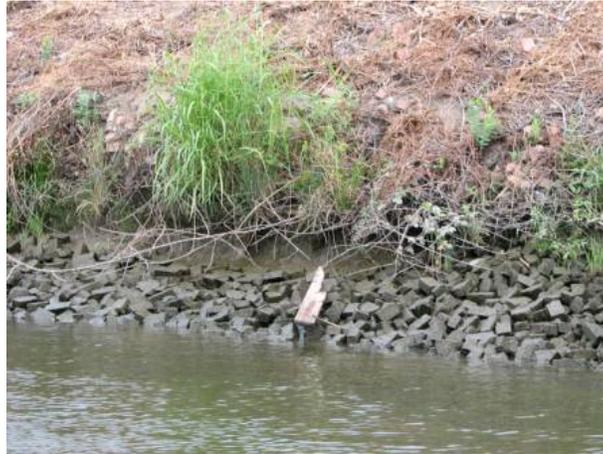
Levee Mile Report Line	4
Start Levee Mile	0.68
End Levee Mile	0.69
Location	Water Side
Category	Supplemental
Item	DWR Erosion Survey
<p>2009: Undercutting of the toe just above the existing rip rap; note there is a housing development on the landside of the levee (refer to Aerial Atlas) [2009 SiteID:RD0017U2RM43.95]</p>	
<p>SJR2009_RM43.95U2 092909F.JPG</p>

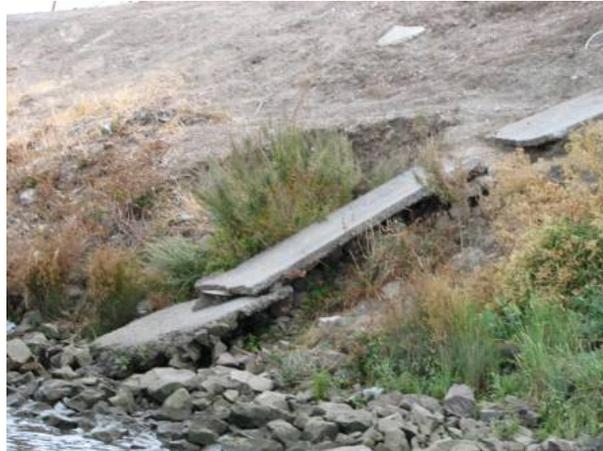
Levee Mile Report Line	8
Start Levee Mile	2.89
End Levee Mile	2.89
Location	Water Side
Category	Supplemental
Item	DWR Erosion Survey
<p>2009: pocket erosion just below and across the abutment of Howard Road Bridge; existing toe rip rap and concrete slabs in place; erosion may develop into a larger pocket erosion if no corrective action is taken [2009 SiteID:RD0017U2RM46.13]</p>	
<p>SJR2009_RM46.13U2 092909A.JPG</p>

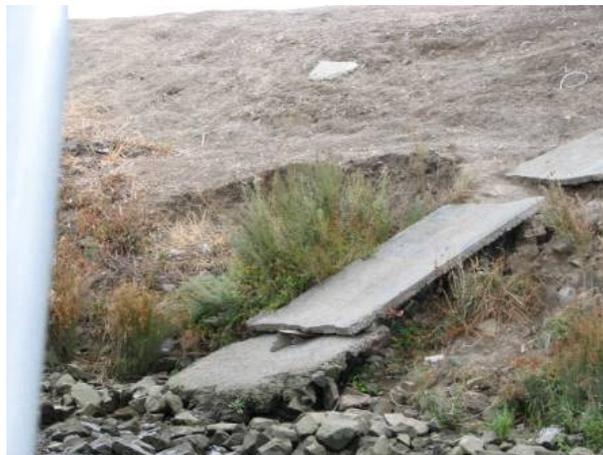
Levee Mile Report Line	8
Start Levee Mile	2.89
End Levee Mile	2.89
Location	Water Side
Category	Supplemental
Item	DWR Erosion Survey
<p>2009: pocket erosion just below and across the abutment of Howard Road Bridge; existing toe rip rap and concrete slabs in place; erosion may develop into a larger pocket erosion if no corrective action is taken [2009 SiteID:RD0017U2RM46.13]</p>	
<p>SJR2009_RM46.13U2 092909B.JPG</p>

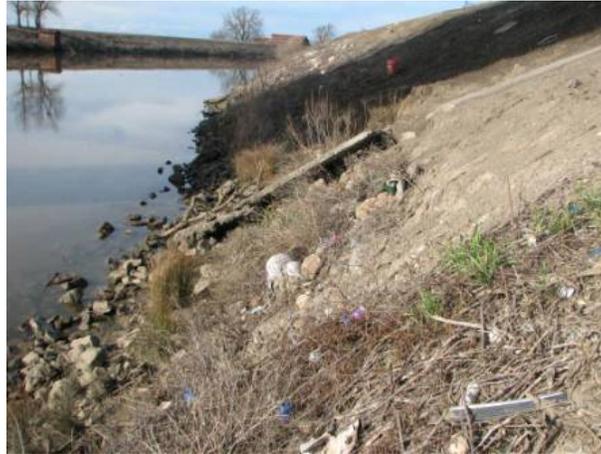
Levee Mile Report Line	8
Start Levee Mile	2.89
End Levee Mile	2.89
Location	Water Side
Category	Supplemental
Item	DWR Erosion Survey
<p>2009: pocket erosion just below and across the abutment of Howard Road Bridge; existing toe rip rap and concrete slabs in place; erosion may develop into a larger pocket erosion if no corrective action is taken [2009 SiteID:RD0017U2RM46.13]</p> <p>SJR2009_RM46.13U2 050210C.JPG</p>

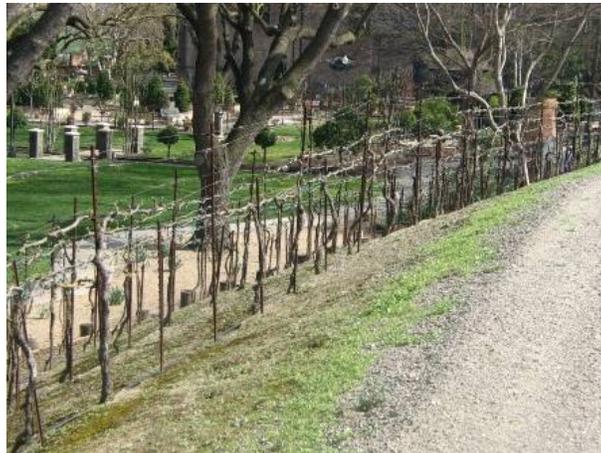
Levee Mile Report Line	12
Start Levee Mile	4.28
End Levee Mile	4.32
Location	Land Side
Category	Earthen Levee
Item	Encroachments
<p>Grape vines on landside slope from LM 4.28 to 4.32</p> <p>richard_s_20100505_032.jpg</p>

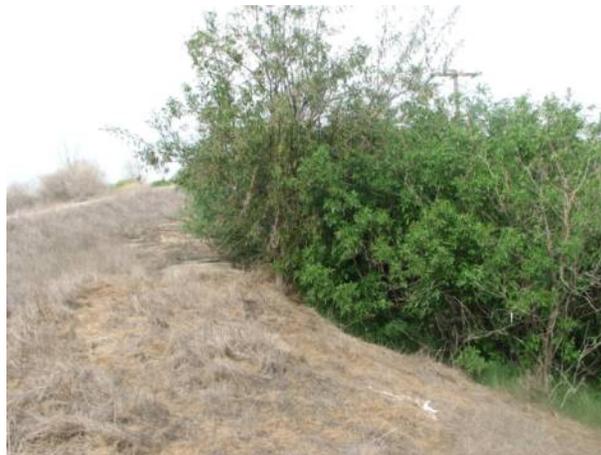
Levee Mile Report Line	19
Start Levee Mile	7.67
End Levee Mile	7.69
Location	Land Side
Category	Earthen Levee
Item	Vegetation
<p>Elderberry blocking view of landside slope and toe from LM 7.67 to 7.69</p> <p>richard_s_20100505_033.jpg</p>

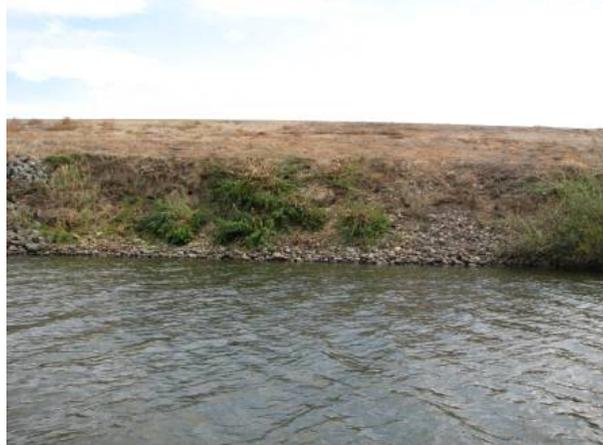
Levee Mile Report Line	23
Start Levee Mile	9.99
End Levee Mile	10.00
Location	Water Side
Category	Supplemental
Item	DWR Erosion Survey
<p>2009: A 50-ft section of the lower slope has slumped just above the existing rip rap; there is also rip rap protection along the levee toe [2009 SiteID:RD0017U2RM52.8]</p>	
<p>SJR2009_RM52.80U2 092809A.JPG</p>

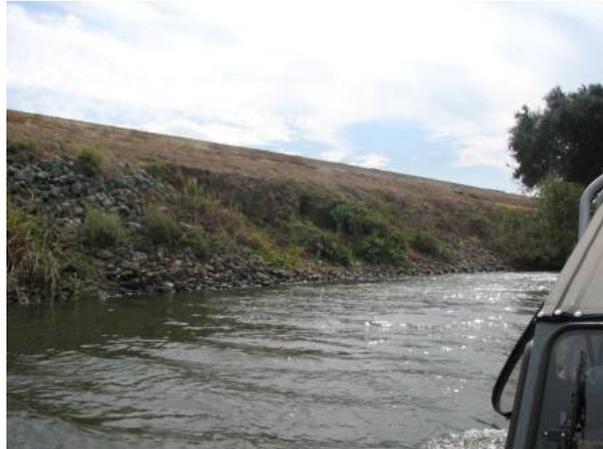
Levee Mile Report Line	23
Start Levee Mile	9.99
End Levee Mile	10.00
Location	Water Side
Category	Supplemental
Item	DWR Erosion Survey
<p>2009: A 50-ft section of the lower slope has slumped just above the existing rip rap; there is also rip rap protection along the levee toe [2009 SiteID:RD0017U2RM52.8]</p>	
<p>SJR2009_RM52.80U2 092809B.JPG</p>

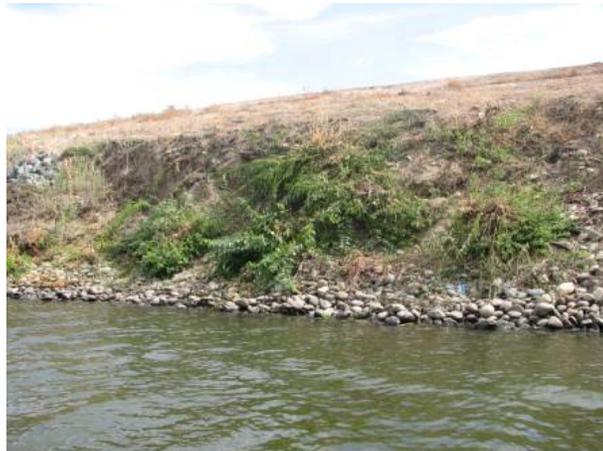
Levee Mile Report Line	23
Start Levee Mile	9.99
End Levee Mile	10.00
Location	Water Side
Category	Supplemental
Item	DWR Erosion Survey
<p>2009: A 50-ft section of the lower slope has slumped just above the existing rip rap; there is also rip rap protection along the levee toe [2009 SiteID:RD0017U2RM52.8]</p>	
<p>SJR2009_RM52.80U2 092809C.JPG</p>

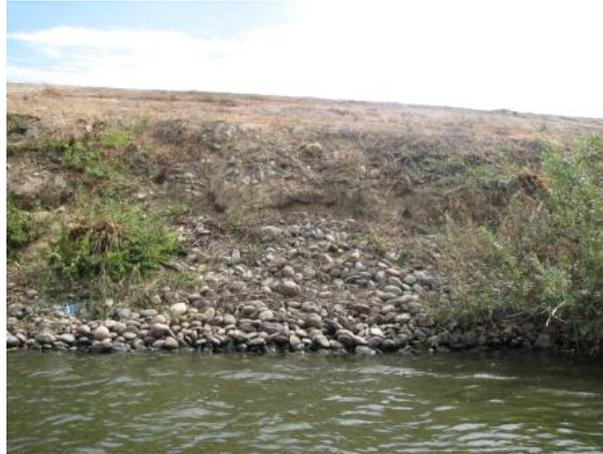
Levee Mile Report Line	23
Start Levee Mile	9.99
End Levee Mile	10.00
Location	Water Side
Category	Supplemental
Item	DWR Erosion Survey
<p>2009: A 50-ft section of the lower slope has slumped just above the existing rip rap; there is also rip rap protection along the levee toe [2009 SiteID:RD0017U2RM52.8]</p>	
<p>SJR2009_RM52.80U2 092809D.JPG</p>

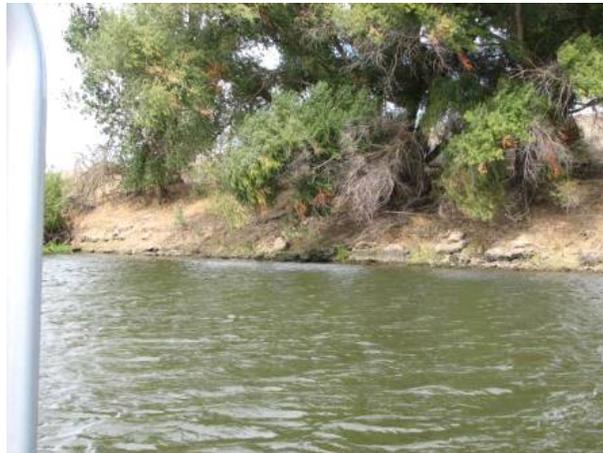
Levee Mile Report Line	25
Start Levee Mile	10.64
End Levee Mile	10.68
Location	Water Side
Category	Supplemental
Item	DWR Erosion Survey
<p>2009: No major change observed; erosion site is immediately upstream of rehabilitation site ; recommend annual monitoring of site per Critical Erosion Sites Evaluation 2008 Report; note site # is the same as RM53.7, LM10.59; previously rated "U" [2009 SiteID:RD0017U2RM53.54]</p>	
<p>SJR2009_RM53.54U2 092809D.JPG</p>

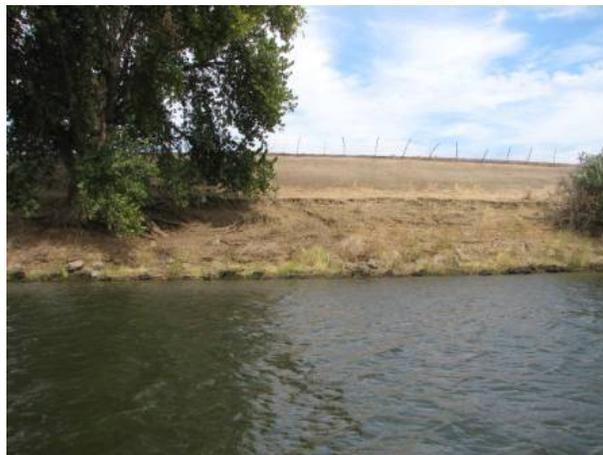
Levee Mile Report Line	25
Start Levee Mile	10.64
End Levee Mile	10.68
Location	Water Side
Category	Supplemental
Item	DWR Erosion Survey
<p>2009: No major change observed; erosion site is immediately upstream of rehabilitation site ; recommend annual monitoring of site per Critical Erosion Sites Evaluation 2008 Report; note site # is the same as RM53.7, LM10.59; previously rated "U" [2009 SiteID:RD0017U2RM53.54]</p>	
<p>SJR2009_RM53.54U2 092809C.JPG</p>

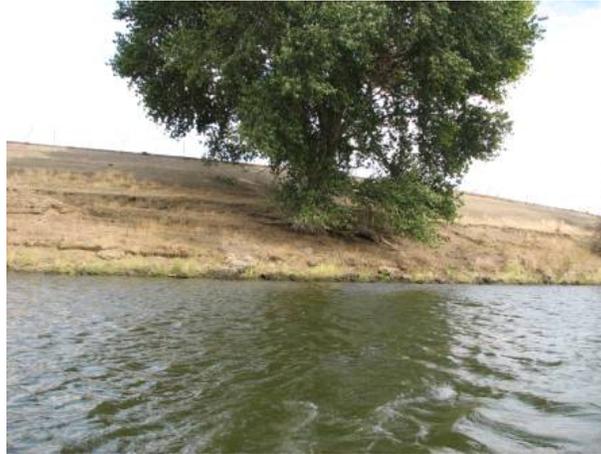
Levee Mile Report Line	25
Start Levee Mile	10.64
End Levee Mile	10.68
Location	Water Side
Category	Supplemental
Item	DWR Erosion Survey
<p>2009: No major change observed; erosion site is immediately upstream of rehabilitation site ; recommend annual monitoring of site per Critical Erosion Sites Evaluation 2008 Report; note site # is the same as RM53.7, LM10.59; previously rated "U" [2009 SiteID:RD0017U2RM53.54]</p>	
<p>SJR2009_RM53.54U2 092809A.JPG</p>

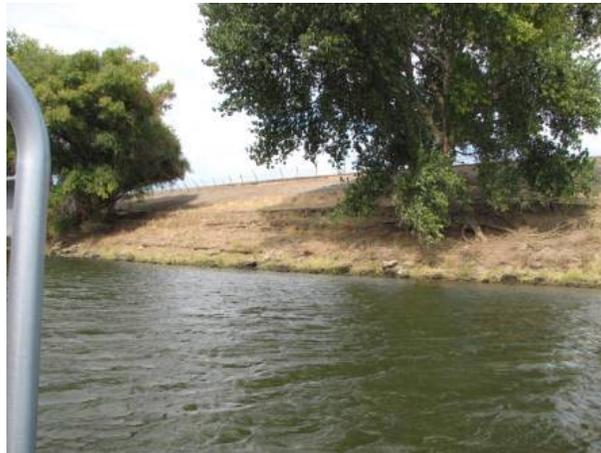
Levee Mile Report Line	25
Start Levee Mile	10.64
End Levee Mile	10.68
Location	Water Side
Category	Supplemental
Item	DWR Erosion Survey
<p>2009: No major change observed; erosion site is immediately upstream of rehabilitation site ; recommend annual monitoring of site per Critical Erosion Sites Evaluation 2008 Report; note site # is the same as RM53.7, LM10.59; previously rated "U" [2009 SiteID:RD0017U2RM53.54]</p>	
<p>SJR2009_RM53.54U2 092809B.JPG</p>

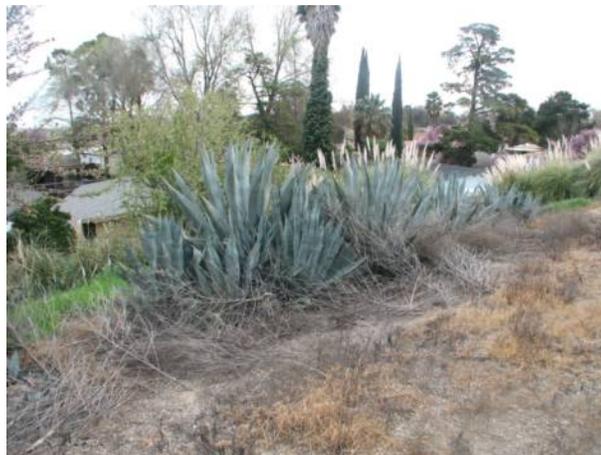
Levee Mile Report Line	27
Start Levee Mile	13.66
End Levee Mile	13.66
Location	Land Side
Category	Earthen Levee
Item	Encroachments
<p>Catus (Landscaping) on landside slope blocking view at LM 13.66</p>	
<p>richard_s_20100505_034.jpg</p>
