**Flood Control Project Maintenance
Levee Inspections
LMA District Cover Sheet
Spring 2013 Levee Inspection Results**

Reclamation District No. 0017 Mossdale

Spring 2013 Levee Inspection Results

Waterway	Bank	Unit Miles
Unit No. 01 French Camp Slough	Left	1.79

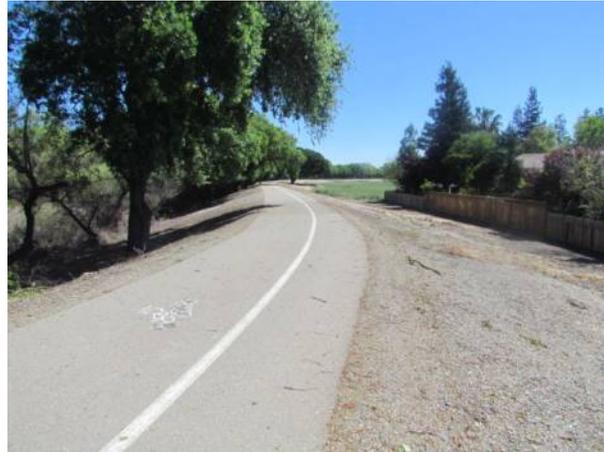
Levee Mile Report Line	4
Start Levee Mile	0.00
End Levee Mile	1.78
Location	Land Side
Category	
Item	Vegetation
Looking at typical view of landward slope.	
richard_s_20130411_062.JPG

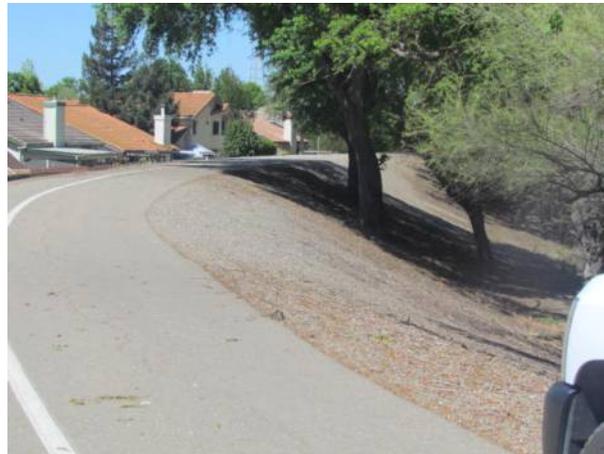
Levee Mile Report Line	5
Start Levee Mile	0.00
End Levee Mile	1.78
Location	Water Side
Category	
Item	Vegetation
Looking north at typical view of waterward slope.	
richard_s_20130411_063.JPG

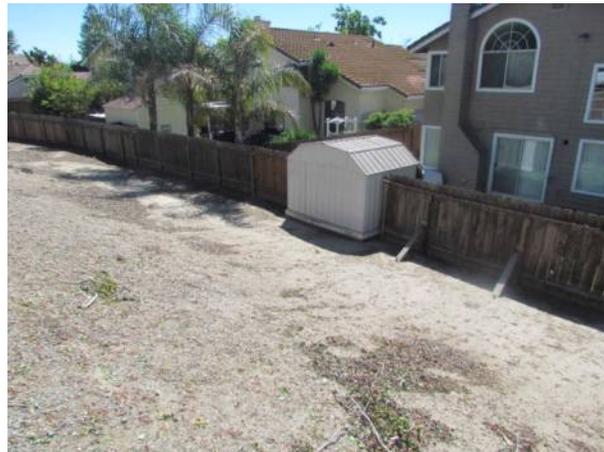
Levee Mile Report Line	6
Start Levee Mile	0.47
End Levee Mile	0.47
Location	Land Side
Category	
Item	Encroachments
Looking west at tool shed on landside berm.	
richard_s_20130411_060.JPG

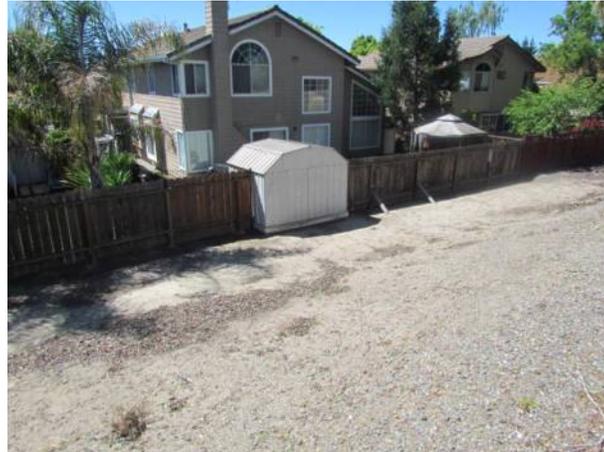
Levee Mile Report Line	6
Start Levee Mile	0.47
End Levee Mile	0.47
Location	Land Side
Category	
Item	Encroachments
Looking northwest at tool shed on landside berm.	
richard_s_20130411_061.JPG

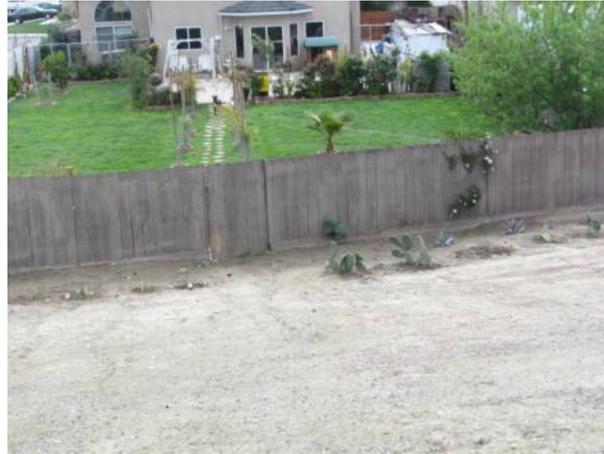
Levee Mile Report Line	3
Start Levee Mile	0.83
End Levee Mile	0.83
Location	Land Side
Category	
Item	Encroachments
Looking west at new cactus plantings on landside toe.	
richard_s_20130304_270.jpg

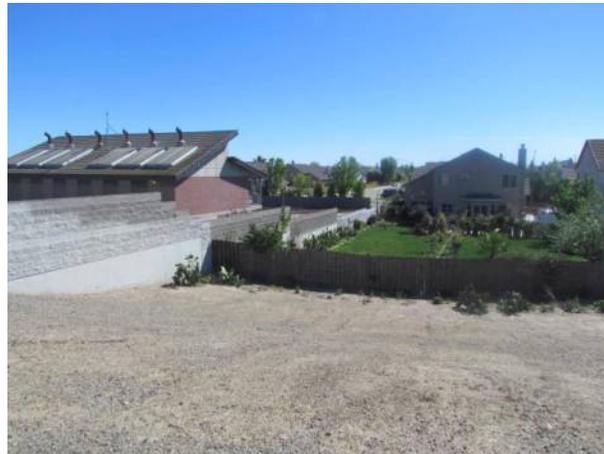
Levee Mile Report Line	3
Start Levee Mile	0.83
End Levee Mile	0.83
Location	Land Side
Category	
Item	Encroachments
Looking at north end of cactus on landward toe and berm.	
richard_s_20130411_064.JPG

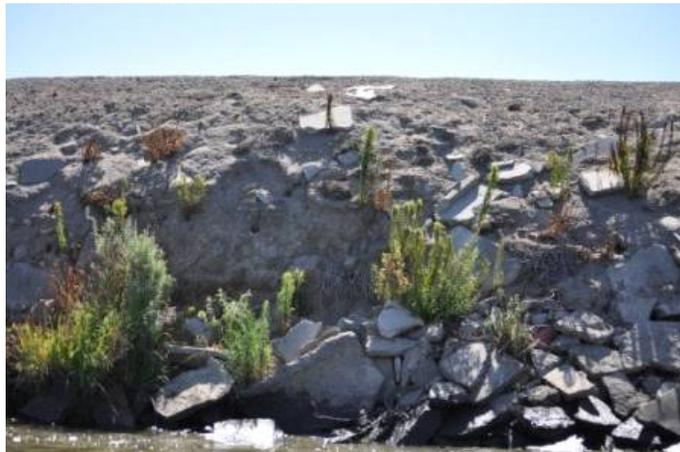
Levee Mile Report Line	4
Start Levee Mile	1.08
End Levee Mile	1.08
Location	Water Side
Category	Supplemental
Item	DWR Erosion Survey
Front view of erosion site. Note the concrete blocks and vegetation.	
richard_s_20130304_268.jpg

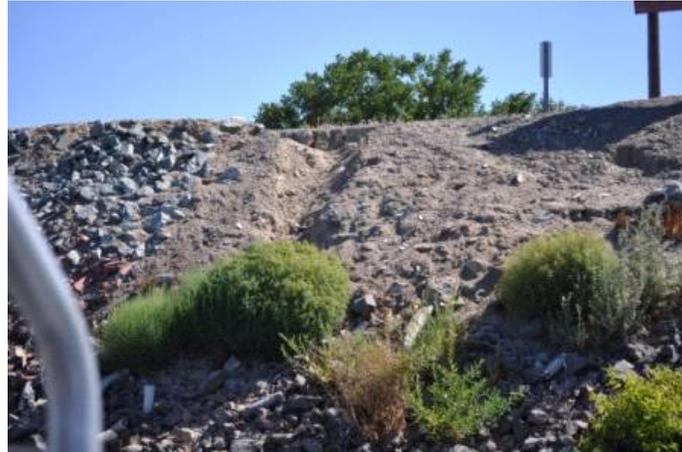
Levee Mile Report Line	6
Start Levee Mile	3.46
End Levee Mile	3.46
Location	Water Side
Category	Supplemental
Item	DWR Erosion Survey

Front view of the site. Note the riprap protection next to the site.

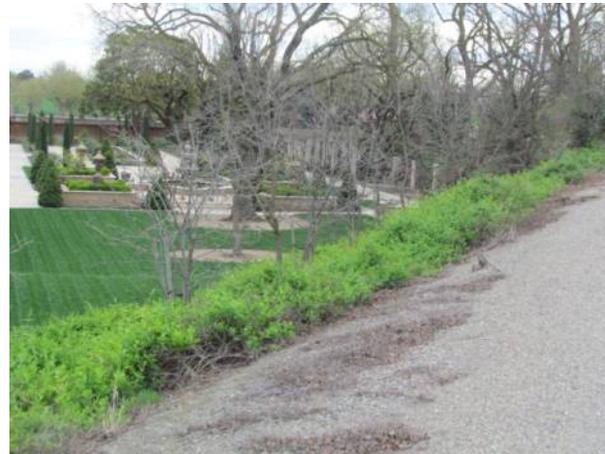
Levee Mile Report Line	8
Start Levee Mile	4.24
End Levee Mile	4.27
Location	Land Side
Category	
Item	Vegetation

Looking southeast at dense ground cover on landside slope.

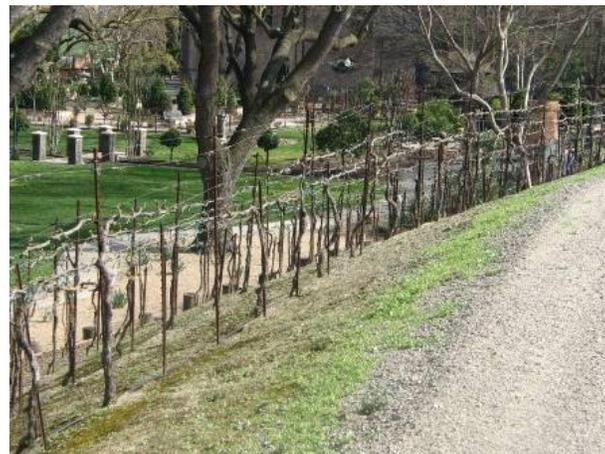
Levee Mile Report Line	9
Start Levee Mile	4.28
End Levee Mile	4.32
Location	Land Side
Category	
Item	Encroachments

Grape vines on landside slope from LM 4.28 to 4.32

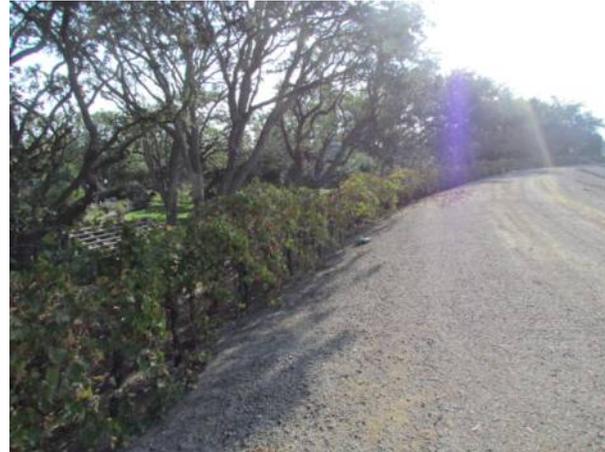
Levee Mile Report Line	9
Start Levee Mile	4.28
End Levee Mile	4.32
Location	Land Side
Category	
Item	Encroachments
Looking southeast at grape vines on landside slope	
richard_s_20130304_272.jpg

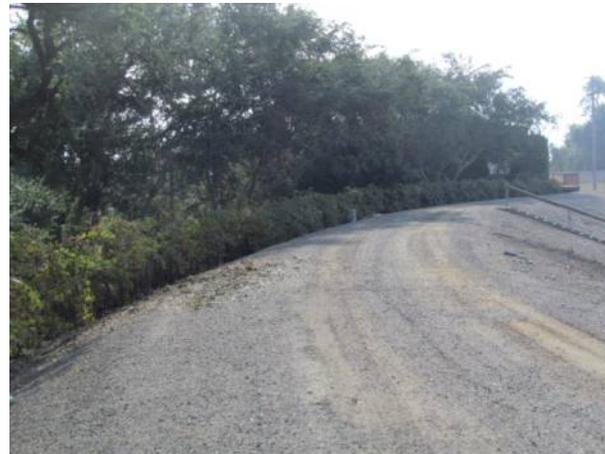
Levee Mile Report Line	9
Start Levee Mile	4.28
End Levee Mile	4.32
Location	Land Side
Category	
Item	Encroachments
Looking south at landscaping with grape vines on landside slope	
richard_s_20130304_273.jpg

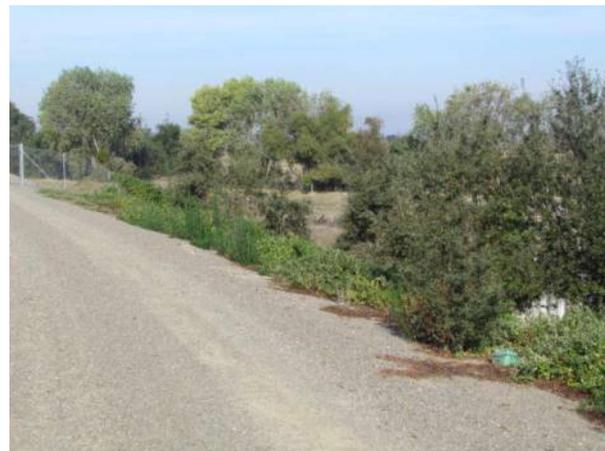
Levee Mile Report Line	9
Start Levee Mile	4.28
End Levee Mile	4.32
Location	Land Side
Category	
Item	Encroachments
Looking northeast at dense landscaping on landside slope.	
richard_s_20130304_274.jpg

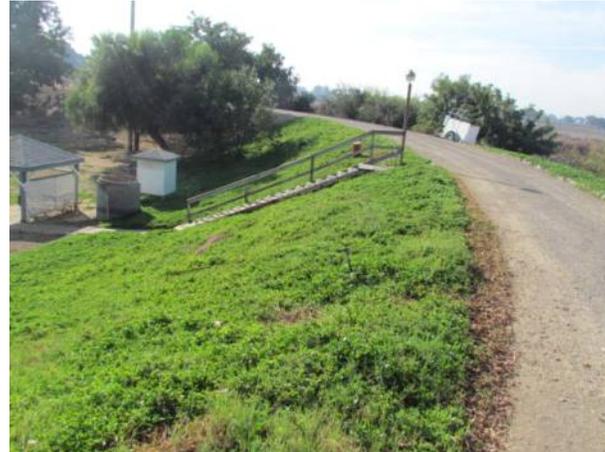
Levee Mile Report Line	10
Start Levee Mile	4.42
End Levee Mile	4.44
Location	Land Side
Category	
Item	Vegetation
Looking southeast at ground cover on landside slope.	
richard_s_20130304_266.jpg

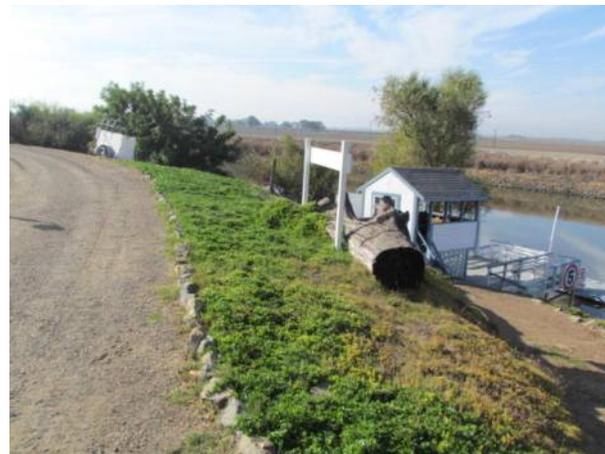
Levee Mile Report Line	10
Start Levee Mile	4.42
End Levee Mile	4.44
Location	Land Side
Category	
Item	Vegetation
Looking southwest at landscaping and boat dock on waterside slope and channel.	
richard_s_20130304_267.jpg

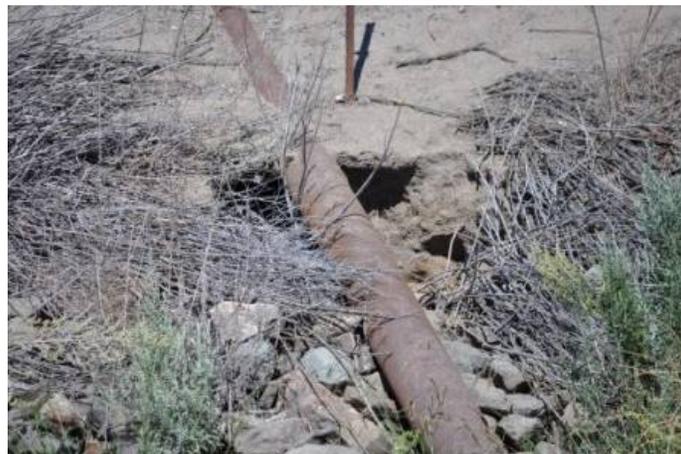
Levee Mile Report Line	13
Start Levee Mile	5.43
End Levee Mile	5.43
Location	Water Side
Category	Supplemental
Item	DWR Erosion Survey
Close view of the erosion and the pipe	
richard_s_20130304_275.jpg

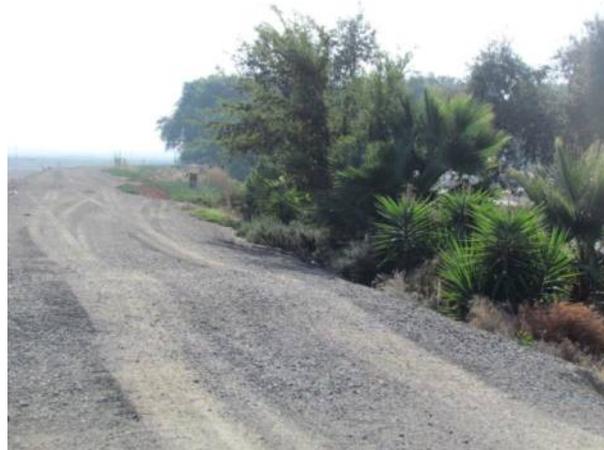
Levee Mile Report Line	16
Start Levee Mile	5.62
End Levee Mile	5.85
Location	Land Side
Category	
Item	Vegetation
Looking south at overgrown landscaping on waterside slope.	
richard_s_20130304_278.jpg

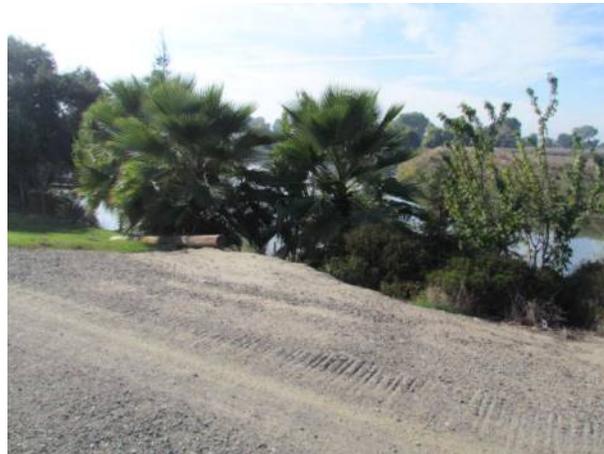
Levee Mile Report Line	16
Start Levee Mile	5.62
End Levee Mile	5.85
Location	Land Side
Category	
Item	Vegetation
Looking west at landscaping on waterside slope.	
richard_s_20130304_279.jpg

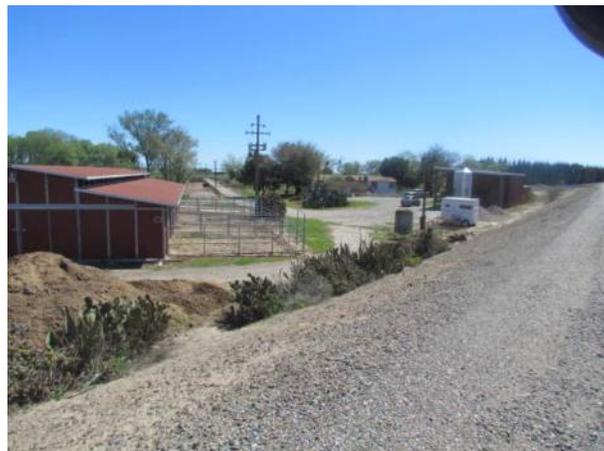
18	5.98	5.98		Vegetation	LS M Ma	V2 : Remove the wild growth other than native grasses from the levee slopes. Inspector Comments: Cactus on landside toe.	37.847107 ° -121.323238 °	37.847107 ° -121.323238 °	16 Y
DWR ID: DWR_RD0017_02_s_2013_16									
19	6.00	6.00		Encroachments	LS M En	EQ : Equipment Inspector Comments: Equipment should be removed outside the ten foot easement.	37.846935 ° -121.323045 °	37.846935 ° -121.323045 °	17 Y
DWR ID: DWR_RD0017_02_s_2013_17									
20	6.82	7.07		Encroachments	LS A/W En	CR : Crops Inspector Comments: Alfalfa five feet from levee toe.	37.838668 ° -121.316663 °	37.835402 ° -121.315262 °	13
DWR ID: DWR_RD0017_02_s_2012_13									
21	7.29	7.29		Trim / Thin Trees	LS M Ma	T1 : Trim trees to at least five feet above ground level.	37.833162 ° -121.312715 °	37.833162 ° -121.312715 °	18
DWR ID: DWR_RD0017_02_s_2013_18									
22	7.51	7.51		Trim / Thin Trees	LS M Ma	T1 : Trim trees to at least five feet above ground level.	37.830350 ° -121.310880 °	37.830350 ° -121.310880 °	4

Levee Mile Report Line	18
Start Levee Mile	5.98
End Levee Mile	5.98
Location	Land Side
Category	
Item	Vegetation
Looking southeast at cactus on landward toe.	
richard_s_20130411_065.JPG

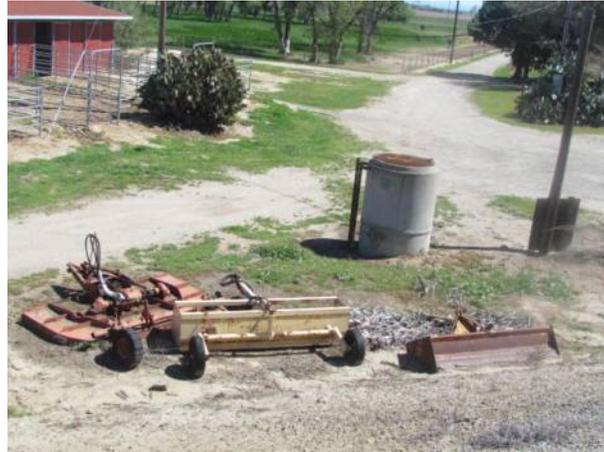
Levee Mile Report Line	19
Start Levee Mile	6.00
End Levee Mile	6.00
Location	Land Side
Category	
Item	Encroachments
Looking east at farm equipment on landward toe.	
richard_s_20130411_066.JPG

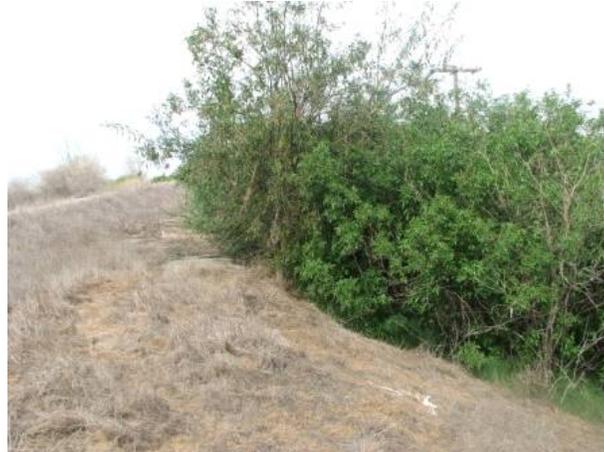
DWR ID: DWR_RD0017_02_s_2012_4									
23	7.67	7.69		Vegetation	LS M Ma	V4 : Elderberries are blocking visibility and flood fight capability.	37.828095 ° -121.309945 °	37.827920 ° -121.309847 °	25 Y
DWR ID: DWR_RD0017_02_s_2012_25									
24	9.40	9.40		Vegetation	LS M Ma	V4 : Elderberries are blocking visibility and flood fight capability.	37.815243 ° -121.317470 °	37.815243 ° -121.317470 °	9
DWR ID: DWR_RD0017_02_s_2012_9									
25	12.47	12.47		Encroachments	WSA/W Ma	PI : Pipe Inspector Comments: Abandoned irrigation pipe	37.791269 ° -121.306252 °	37.791269 ° -121.306252 °	569 Y
DWR ID: DWR_RD0017_02_f_2012_569									
26	13.43	13.43		Trim / Thin Trees	LS A/W Ma	T1 : Trim trees to at least five feet above ground level.	37.779633 ° -121.299992 °	37.779633 ° -121.299992 °	570
DWR ID: DWR_RD0017_02_s_2012_570									
27	14.02	14.26		Animal Control	WSA/W Ma	A1 : Exterminate rodents and backfill and compact or grout burrows.	37.774285 ° -121.295703 °	37.773138 ° -121.291763 °	37

Levee Mile Report Line	23
Start Levee Mile	7.67
End Levee Mile	7.69
Location	Land Side
Category	
Item	Vegetation
Elderberry blocking view of landside slope and toe from LM 7.67 to 7.69	
richard_s_20130304_276.jpg

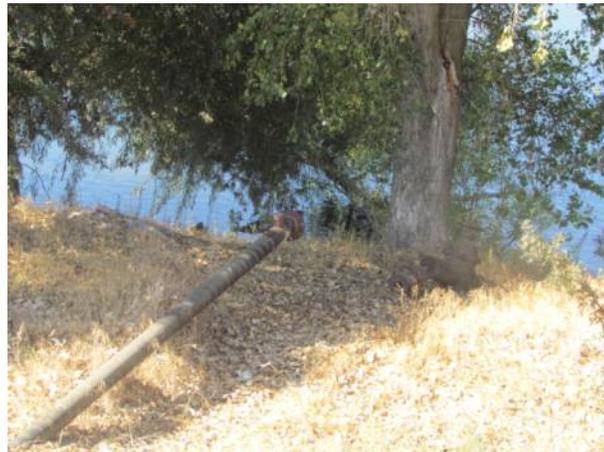
Levee Mile Report Line	25
Start Levee Mile	12.47
End Levee Mile	12.47
Location	Water Side
Category	
Item	Encroachments
Looking west at disconnected pipe on waterside slope.	
richard_s_20130304_280.JPG

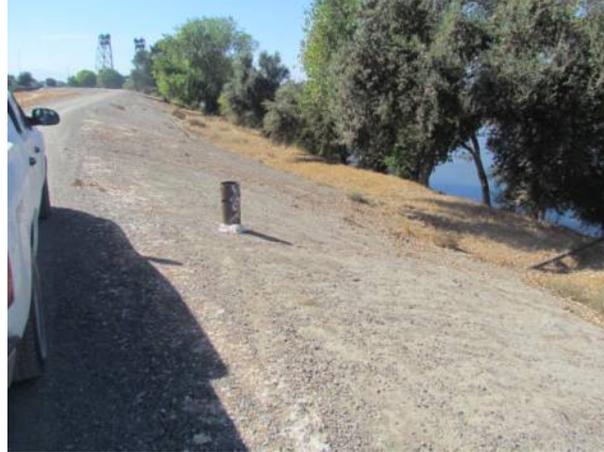
Levee Mile Report Line	25
Start Levee Mile	12.47
End Levee Mile	12.47
Location	Water Side
Category	
Item	Encroachments
Looking southwest at siphon on waterside shoulder and slope.	
richard_s_20130304_281.JPG

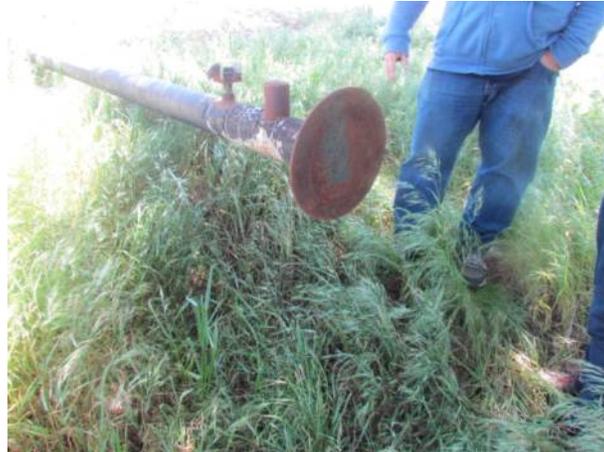
Levee Mile Report Line	25
Start Levee Mile	12.47
End Levee Mile	12.47
Location	Water Side
Category	
Item	Encroachments
Looking southeast at cap on abandoned irrigation pipe on waterward slope.	
richard_s_20130411_067.JPG
