**Flood Control Project Maintenance  
Levee Inspections**

**Maintenance Issue Types Only, Levee Inspection Report By Mile - Fall 2014**

**Reclamation District No. 0017 Mossdale**

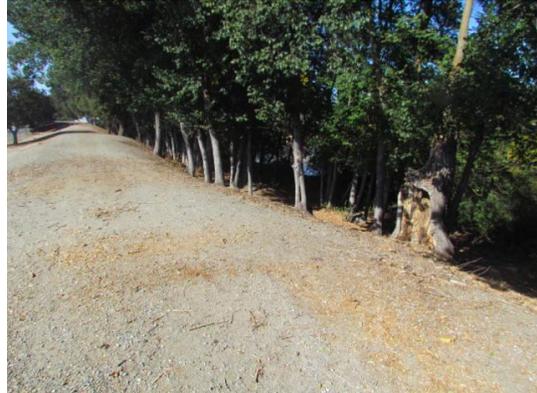
Photo 1 of 4 : FA\_2014\_RD0017\_303\_12\_20141023\_00004.jpg

LM Start	<b>0.03</b>	Rating **	A	Issue No.	<b>12</b>
LM End	<b>0.03</b>	Issue Type +	Ma	Location *	WS
Category	Earthen Levee		GPS Latitude/Longitude		
			Start	End	
Item	Encroachments		37.911629 °	37.911629 °	
			-121.291585 °	-121.291585 °	
DWR ID	DWR_RD0017_01_s_2014_12				
Action/Comments					
Tree or limb

Looking north at corrected site.

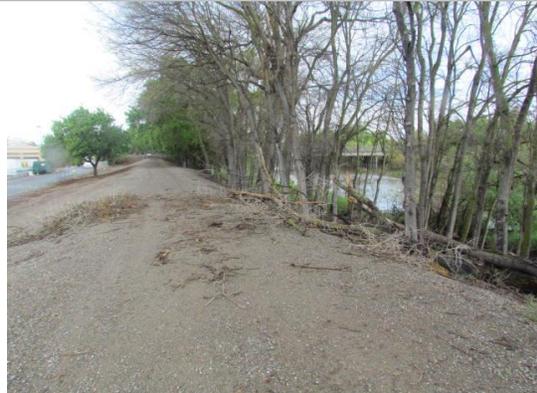
Photo 2 of 4 : FA\_2014\_RD0017\_303\_12\_20141010\_00001.jpg

Looking north at tree limbs across levee crown and slope.

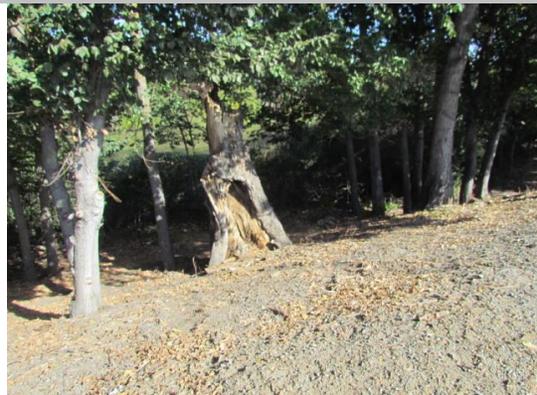
Photo 3 of 4 : FA\_2014\_RD0017\_303\_12\_20141023\_00003.jpg

Looking east at corrected site.

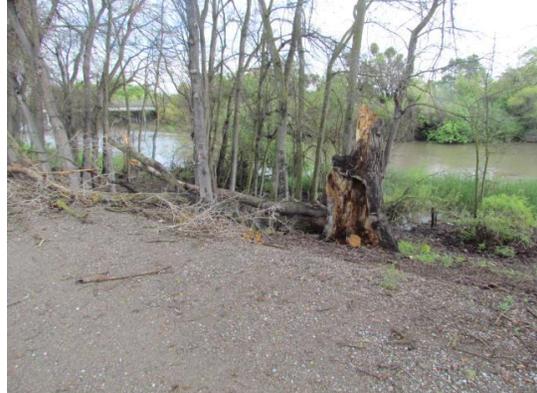
Photo 4 of 4 : FA\_2014\_RD0017\_303\_12\_20141010\_00002.jpg

LM Start	<b>0.03</b>	Rating **	A	Issue No.	<b>12 (cont)</b>
LM End	<b>0.03</b>	Issue Type +	Ma	Location *	WS
Category	Earthen Levee		GPS Latitude/Longitude		
			Start	End	
Item	Encroachments		37.911629 °	37.911629 °	
			-121.291585 °	-121.291585 °	
DWR ID	DWR_RD0017_01_s_2014_12				
Action/Comments					
Tree or limb

Looking northeast at down tree on waterward slope.

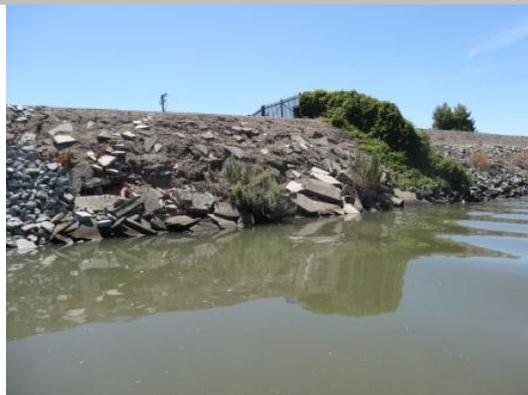
Photo 1 of 1 : SJR2014\_RD0017U02RM44.32\_1.jpg

LM Start	<b>1.08</b>	Rating **	U	Issue No.	<b>6</b>
LM End	<b>1.08</b>	Issue Type +	Ma	Location *	WS
Category	Supplemental		GPS Latitude/Longitude		
			Start	End	
Item	DWR Erosion Survey		37.902530 °	37.902530 °	
			-121.325690 °	-121.325690 °	
DWR ID					
Action/Comments					
Inspector Comments: 6/19/2014: No significant change observed. 08/13/2013: No significant change at this site. 08/07/2012: The erosion is nearly vertical, and has developed upward to halfway of the levee slope. The protecting concrete blocks have been washed away. Animal activities are visible. [2014 Site ID:RD0017U02RM44.32]

Front view of the erosion site. Note the concrete blocks and vegetation.

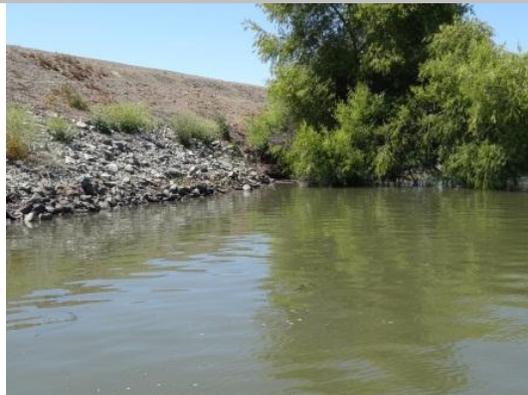
Photo 1 of 1 : SJR2014\_RD0017U02RM44.52\_1.jpg

LM Start	<b>1.28</b>	Rating **	M	Issue No.	<b>14</b>
LM End	<b>1.28</b>	Issue Type +	Ma	Location *	WS
Category	Supplemental		GPS Latitude/Longitude		
			Start	End	
Item	DWR Erosion Survey		37.899510 °	37.899510 °	
			-121.326030 °	-121.326030 °	
DWR ID					
Action/Comments					
Inspector Comments: 06/19/2014: The erosion has been repaired. A minor erosion is still visible near the tree. 08/13/2013: A mid-size tree is present immediately upstream of the erosion, which could block the view of the site. Some debris is visible. [2014 Site ID:RD0017U02RM44.52]

View from downstream.

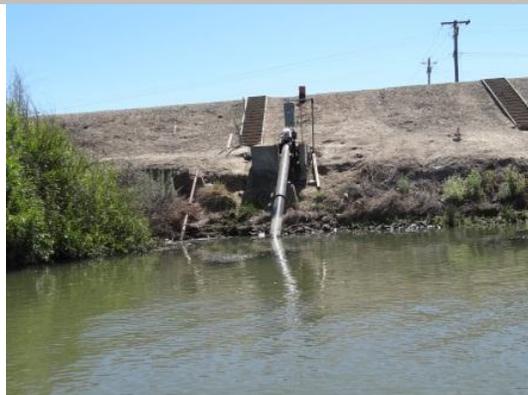
Photo 1 of 1 : SJR2014\_RD0017U02RM45.94\_1.jpg

LM Start	<b>2.66</b>	Rating **	M	Issue No.	<b>92</b>
LM End	<b>2.66</b>	Issue Type +	Ma	Location *	WS
Category	Supplemental		GPS Latitude/Longitude		
			Start	End	
Item	DWR Erosion Survey		37.881020 °	37.881020 °	
			-121.332260 °	-121.332260 °	
DWR ID					
Action/Comments					
Inspector Comments: 6/19/2014: The erosion was probably caused by the irrigation pipe found at the site. [2014 Site ID:RD0017U02RM45.94]

Close view of the erosion site.

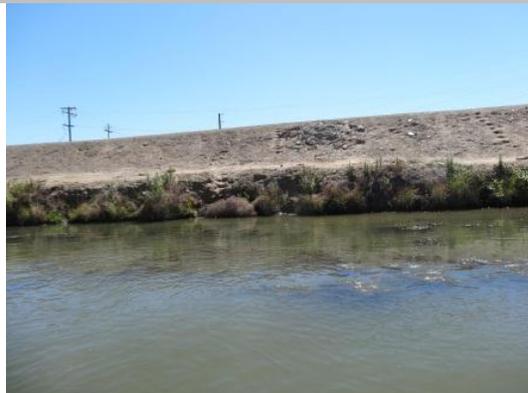
Photo 1 of 1 : SJR2014\_RD0017U02RM45.95\_1.jpg

LM Start	<b>2.71</b>	Rating **	M	Issue No.	<b>93</b>
LM End	<b>2.73</b>	Issue Type +	Ma	Location *	WS
Category	Supplemental		GPS Latitude/Longitude		
			Start	End	
Item	DWR Erosion Survey		37.880710 °	37.880710 °	
			-121.332200 °	-121.332200 °	
DWR ID					
Action/Comments					
Inspector Comments: 6/19/2014: The erosion is in the river bank which has an estimated 10-ft wide berm. [2014 Site ID:RD0017U02RM45.95]

Front view of the erosion along the water edge. Note the vegetation at the erosion site.

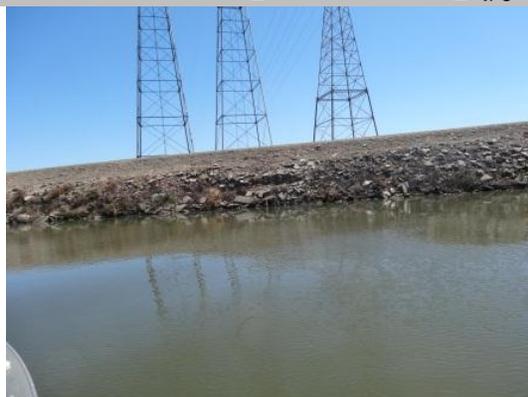
Photo 1 of 1 : SJR2014\_RD0017U02RM46.1\_1.jpg

LM Start	<b>2.81</b>	Rating **	M	Issue No.	<b>95</b>
LM End	<b>2.81</b>	Issue Type +	Ma	Location *	WS
Category	Supplemental			GPS Latitude/Longitude	
				Start	End
Item	DWR Erosion Survey			37.878660 °	37.878660 °
				-121.332400 °	-121.332400 °
DWR ID					
Action/Comments					
Inspector Comments: 06/19/2014: A pocket erosion was found during the boat survey. [2014 Site ID:RD0017U02RM46.1]

Front view of the erosion.

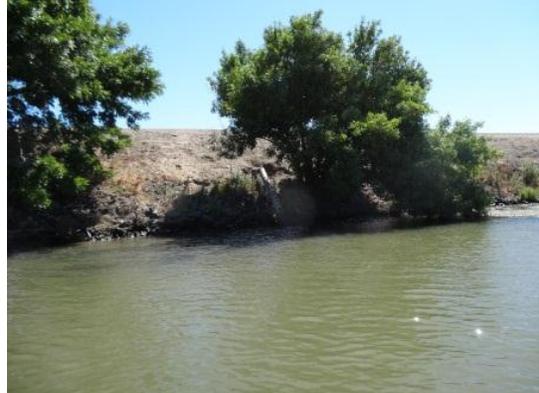
Photo 1 of 1 : SJR2014\_RD0017U02RM46.89\_1.jpg

LM Start	<b>3.62</b>	Rating **	M	Issue No.	<b>96</b>
LM End	<b>3.62</b>	Issue Type +	Ma	Location *	WS
Category	Supplemental			GPS Latitude/Longitude	
				Start	End
Item	DWR Erosion Survey			37.868500 °	37.868500 °
				-121.327670 °	-121.327670 °
DWR ID					
Action/Comments					
Inspector Comments: 06/19/2014: The erosion is near a large tree and probably has been caused by the irrigation pipe on the site. [2014 Site ID:RD0017U02RM46.89]

Front view of the erosion. Note the tree and the irrigation pipe.

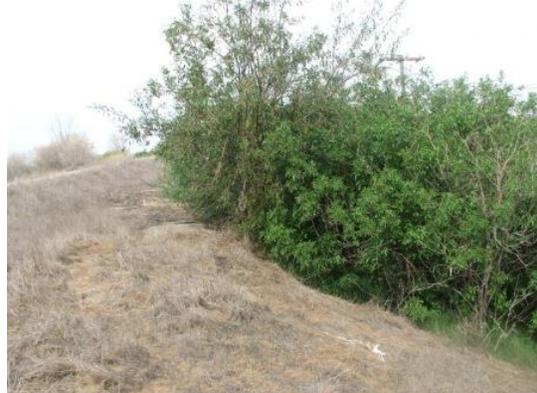
Photo 1 of 1 : FA\_2014\_RD0017\_304\_25\_20141010\_00016.jpg

LM Start	<b>7.67</b>	Rating **	M	Issue No.	<b>25</b>
LM End	<b>7.69</b>	Issue Type +	Ma	Location *	LS
Category	Earthen Levee		GPS Latitude/Longitude		
			Start	End	
Item	Vegetation		37.828095 °	37.827920 °	
			-121.309945 °	-121.309847 °	
DWR ID	DWR_RD0017_02_s_2012_25				
Action/Comments					
Elderberries are blocking visibility and flood fight capability.

Elderberry blocking view of landside slope and toe from LM 7.67 to 7.69

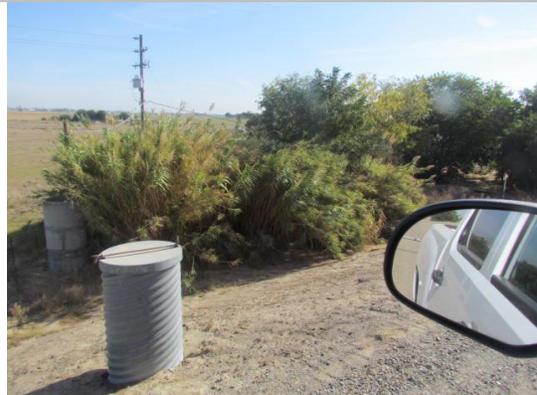
Photo 1 of 1 : FA\_2014\_RD0017\_304\_9\_20141023\_00028.jpg

LM Start	<b>9.40</b>	Rating **	M	Issue No.	<b>9</b>
LM End	<b>9.40</b>	Issue Type +	Ma	Location *	LS
Category	Earthen Levee		GPS Latitude/Longitude		
			Start	End	
Item	Vegetation		37.815243 °	37.815243 °	
			-121.317470 °	-121.317470 °	
DWR ID	DWR_RD0017_02_s_2012_9				
Action/Comments					
Elderberries are blocking visibility and flood fight capability.

Looking east at bamboo at landward toe.
