**Flood Control Project Maintenance
Levee Inspections**

Maintenance Issue Types Only, Levee Inspection Report By Mile - Spring 2015

Reclamation District No. 0017 Mossdale

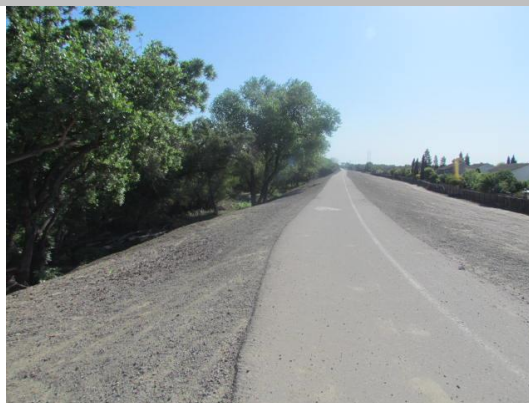
Photo 1 of 1 : SP_2015_RD0017_303_10_20150416_00002.jpg

LM Start	0.00	Rating **	M	Issue No.	10
LM End	1.76	Issue Type +	Ma	Location *	WS
Category	Earthen Levee			GPS Latitude/Longitude	
				Start	End
Item	Vegetation				o
					o
DWR ID	DWR_RD0017_01_s_2015_10				
Action/Comments					
Control annual grass and weeds on the levee slopes and easements.

Looking south at typical view of waterward slope.

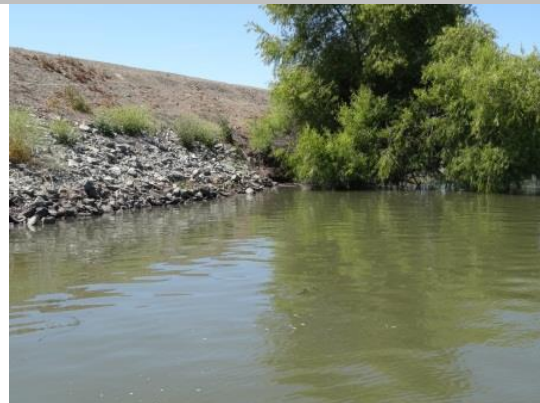
Photo 1 of 1 : SP_2015_RD0017_304_14_20150309_00010.jpg

LM Start	1.29	Rating **	M	Issue No.	14
LM End	1.29	Issue Type +	Ma	Location *	WS
Category	Supplemental			GPS Latitude/Longitude	
				Start	End
Item	DWR Erosion Survey			37.899510 °	37.899510 °
				-121.326030 °	-121.326030 °
DWR ID	DWR_RD0017_02_s _ 2015_14				
Action/Comments					
Inspector Comments: 06/19/2014: The erosion has been repaired. A minor erosion is still visible near the tree.					
08/13/2013: A mid-size tree is present immediately upstream of the erosion, which could block the view of the site. Some debris is visible.					
[2014 Site ID:RD0017U02RM44.52]

View from downstream.

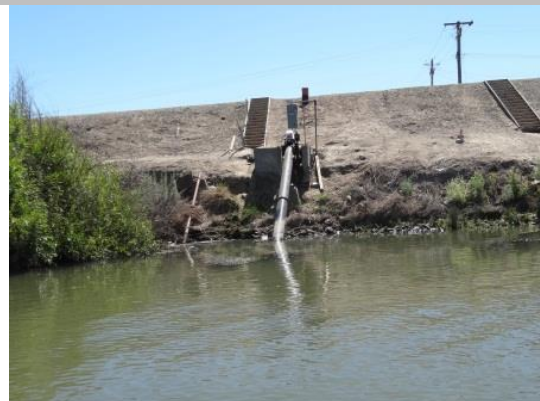
Photo 1 of 1 : SP_2015_RD0017_304_92_20150309_00015.jpg

LM Start	2.66	Rating **	M	Issue No.	92
LM End	2.66	Issue Type +	Ma	Location *	WS
Category	Supplemental			GPS Latitude/Longitude	
				Start	End
Item	DWR Erosion Survey			37.881020 °	37.881020 °
				-121.332260 °	-121.332260 °
DWR ID	DWR_RD0017_02_s _ 2015_92				
Action/Comments					
Inspector Comments: 6/19/2014: The erosion was probably caused by the irrigation pipe found at the site. [2014 Site ID:RD0017U02RM45.94]

Close view of the erosion site.

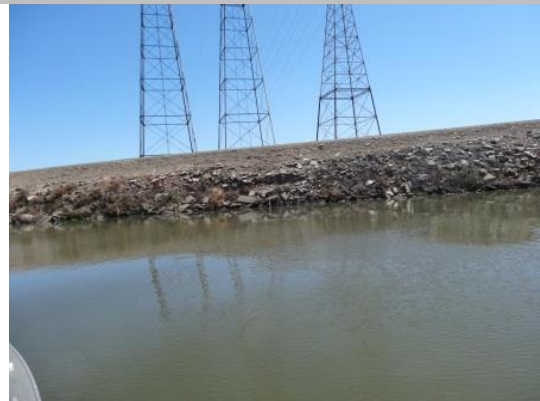
Photo 1 of 1 : SP_2015_RD0017_304_95_20150309_00017.jpg

LM Start	2.82	Rating **	M	Issue No.	95
LM End	2.82	Issue Type +	Ma	Location *	WS
Category	Supplemental			GPS Latitude/Longitude	
				Start	End
Item	DWR Erosion Survey			37.878660 °	37.878660 °
				-121.332400 °	-121.332400 °
DWR ID	DWR_RD0017_02_s _ 2015_95				
Action/Comments					
Inspector Comments: 06/19/2014: A pocket erosion was found during the boat survey. [2014 Site ID:RD0017U02RM46.1]

Front view of the erosion.

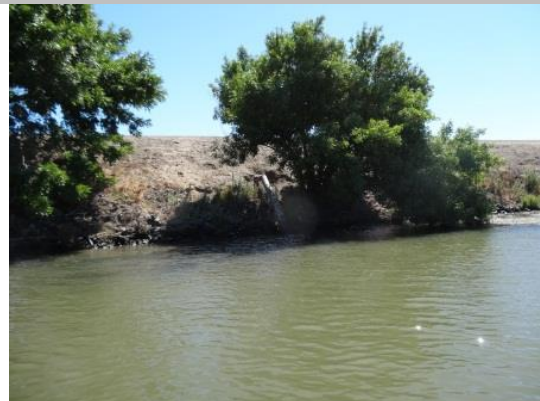
Photo 1 of 1 : SP_2015_RD0017_304_96_20150309_00018.jpg

LM Start	3.63	Rating **	M	Issue No.	96
LM End	3.63	Issue Type +	Ma	Location *	WS
Category	Supplemental			GPS Latitude/Longitude	
				Start	End
Item	DWR Erosion Survey			37.868500 °	37.868500 °
				-121.327670 °	-121.327670 °
DWR ID	DWR_RD0017_02_s _ 2015_96				
Action/Comments					
Inspector Comments: 06/19/2014: The erosion is near a large tree and probably has been caused by the irrigation pipe on the site. [2014 Site ID:RD0017U02RM46.89]

Front view of the erosion. Note the tree and the irrigation pipe.

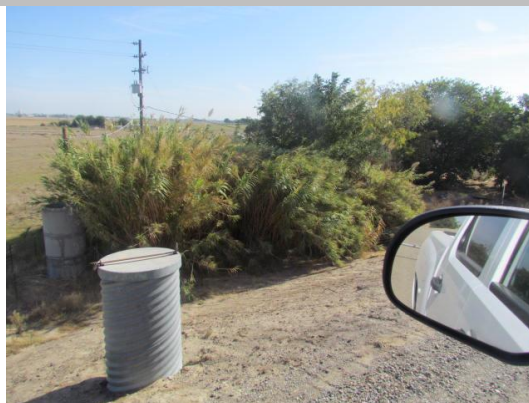
Photo 1 of 1 : SP_2015_RD0017_304_9_20150309_00005.jpg

LM Start	9.28	Rating **	M	Issue No.	9
LM End	9.28	Issue Type +	Ma	Location *	LS
Category	Earthen Levee			GPS Latitude/Longitude	
				Start	End
Item	Vegetation			37.815243 °	37.815243 °
				-121.317470 °	-121.317470 °
DWR ID	DWR_RD0017_02_s _ 2012_9				
Action/Comments					
Elderberries are blocking visibility and flood fight capability.

Looking east at bamboo at landward toe.
