**Flood Control Project Maintenance
Levee Inspections**

Maintenance Issue Types Only, Levee Inspection Report By Mile - Spring 2016

Reclamation District No. 0017 Mossdale

Waterway	Bank	Unit Miles	Inspection Start/End	Inspector
Unit No. 01 French Camp Slough	Left	1.76	04/05/2016 04/05/2016	Richard Willoughby

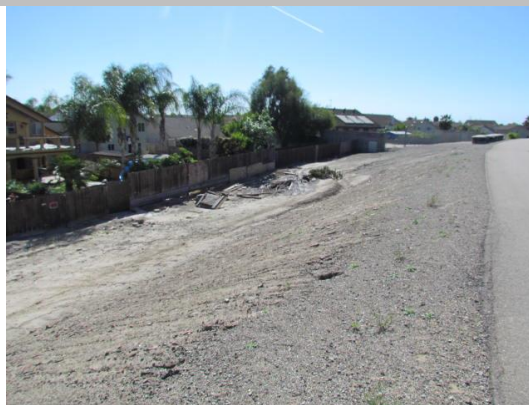
Photo 1 of 2 : SP_2016_RD0017_304_77_20160408_00194.jpg

LM Start	0.77	Rating **	M	Issue No.	77
LM End	0.77	Issue Type +	Ma	Location *	LS
Category	Earthen Levee			GPS Latitude/Longitude	
				Start	End
Item	Encroachments			37.906106 °	37.906106 °
				-121.323060 °	-121.323060 °
DWR ID	DWR_RD0017_02_s_2016_77				
Comment Code					
PR : Prunings					
Inspector Comment					
Landowner piling prunings at landward toe.

Looking east at pruning at landward toe.

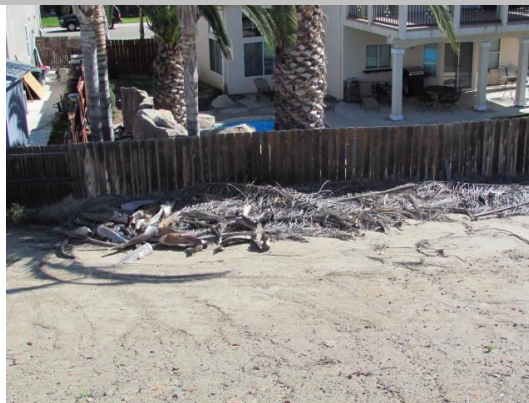
Photo 2 of 2 : SP_2016_RD0017_304_77_20160408_00195.jpg

LM Start	0.77	Rating **	M	Issue No.	77 (cont)	
LM End	0.77	Issue Type +	Ma	Location *	LS	
Category	Earthen Levee			GPS Latitude/Longitude		
				Start	End	
Item	Encroachments			37.906106 °	37.906106 °	
				-121.323060 °	-121.323060 °	
DWR ID	DWR_RD0017_02_s_2016_77					
Comment Code						
PR : Prunings						
Inspector Comment						
Landowner piling prunings at landward toe.

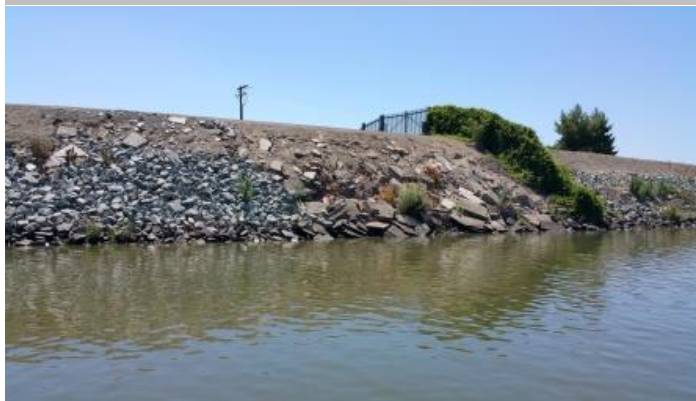
Photo 1 of 2 : SP_2016_RD0017_304_2_20160404_00004.jpg

LM Start	1.08	Rating **	U	Issue No.	2
LM End	1.08	Issue Type +	Ma	Location *	WS
Category	Supplemental			GPS Latitude/Longitude	
				Start	End
Item	DWR Erosion Survey			37.902530 °	37.902530 °
				-121.325690 °	-121.325690 °
DWR ID	DWR_RD0017_02_s_2016_2				
Comment Code					
Inspector Comment					
06/24/2015: No significant change observed.					
6/19/2014: No significant change observed.					
08/13/2013: No significant change at this site.					
08/07/2012: The erosion is nearly vertical, and has developed upward					
to halfway of the levee slope. The protecting concrete blocks have been					
washed away. Animal activities are visible. [2015 Site					
ID:RD0017U02RM44.32]

Front view of the erosion site. Note the concrete blocks and vegetation.

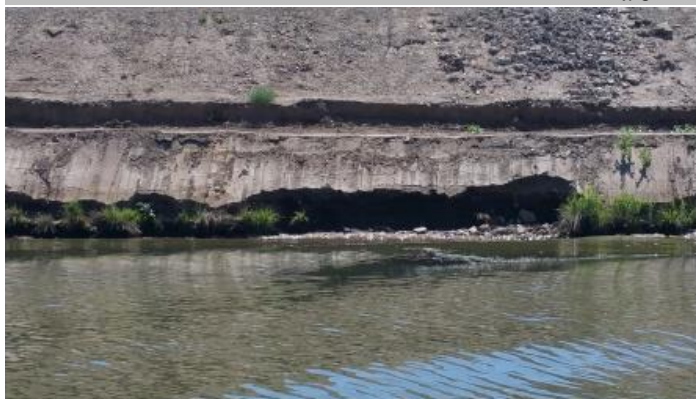
Photo 2 of 2 : SP_2016_RD0017_304_6_20160404_00007.jpg

LM Start	2.67	Rating **	M	Issue No.	6 (cont)	
LM End	2.69	Issue Type +	Ma	Location *	WS	
Category	Supplemental			GPS Latitude/Longitude		
				Start		End
Item	DWR Erosion Survey			37.880710 °		37.880710 °
				-121.332200 °		-121.332200 °
DWR ID	DWR_RD0017_02_s_2016_6					
Comment Code						
Inspector Comment						
06/24/2015: Levee has been cut at the mid slope and a temporary step has been made for unknow purpose. More erosion has been found at the site.						
6/19/2014: The erosion is in the river bank which has an estimated 10-ft wide berm. [2015 Site ID:RD0017U02RM45.95]

Close view of the erosion.

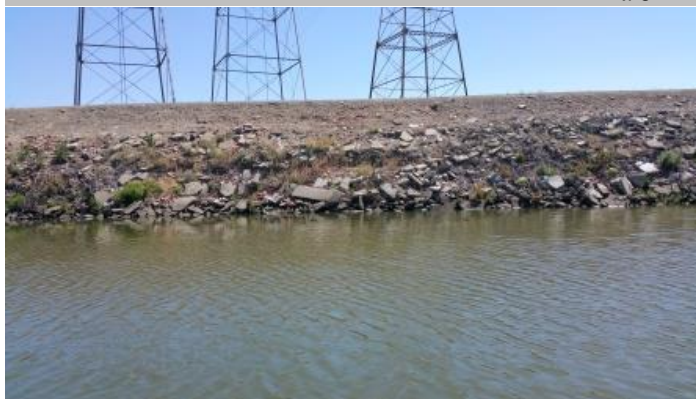
Photo 1 of 2 : SP_2016_RD0017_304_8_20160404_00008.jpg

LM Start	2.82	Rating **	M	Issue No.	8
LM End	2.82	Issue Type +	Ma	Location *	WS
Category	Supplemental			GPS Latitude/Longitude	
				Start	End
Item	DWR Erosion Survey			37.878660 °	37.878660 °
				-121.332400 °	-121.332400 °
DWR ID	DWR_RD0017_02_s_2016_8				
Comment Code					
Inspector Comment					
06/24/2015: No significant change observed.					
06/19/2014: A pocket erosion was found during the boat survey. [2015					
Site ID:RD0017U02RM46.1]

Front view of the erosion.

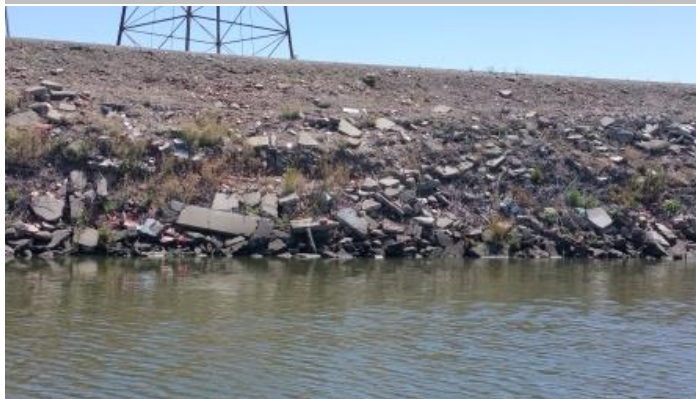
Photo 2 of 2 : SP_2016_RD0017_304_8_20160404_00009.jpg

Close view of the erosion. The slope protection is poor.

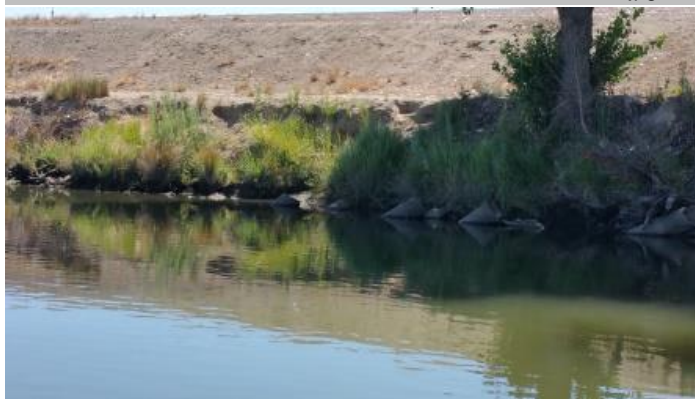
Photo 1 of 2 : SP_2016_RD0017_304_10_20160404_00011.jpg

LM Start	3.63	Rating **	M	Issue No.	10
LM End	3.63	Issue Type +	Ma	Location *	WS
Category	Supplemental			GPS Latitude/Longitude	
				Start	End
Item	DWR Erosion Survey			37.868500 °	37.868500 °
				-121.327670 °	-121.327670 °
DWR ID	DWR_RD0017_02_s_2016_10				
Comment Code					
Inspector Comment					
06/24/2015: No significant change observed. 06/19/2014: The erosion is near a large tree and probably has been caused by the irrigation pipe on the site. [2015 Site ID:RD0017U02RM46.89]

Front view of the erosion. Note the tree and the irrigation pipe.

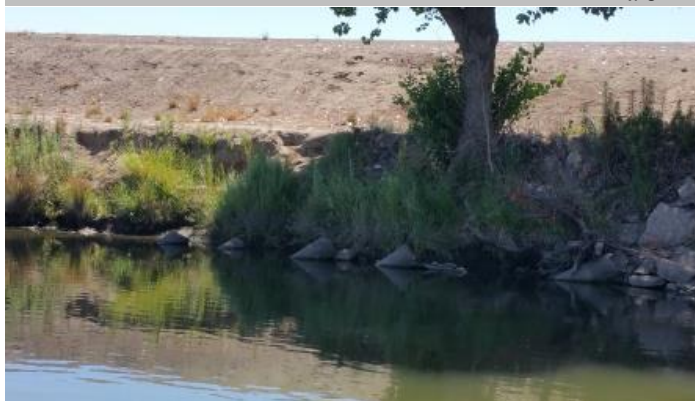
Photo 2 of 2 : SP_2016_RD0017_304_10_20160404_00012.jpg

Close view of the erosion.

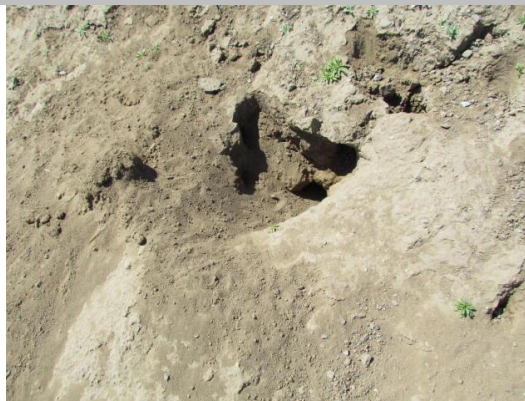
Photo 1 of 3 : SP_2016_RD0017_304_78_20160408_00196.jpg

Looking north at rodent holes on landward slope.

LM Start	4.98	Rating **	U	Issue No.	78
LM End	5.12	Issue Type +	Ma	Location *	WS
Category	Earthen Levee			GPS Latitude/Longitude	
				Start	End
Item	Animal Control			37.854875 °	37.853192 °
				-121.319542 °	-121.320200 °
DWR ID	DWR_RD0017_02_s_2016_78				
Comment Code					
A1 : Exterminate rodents and backfill and compact or grout burrows.					
Inspector Comment

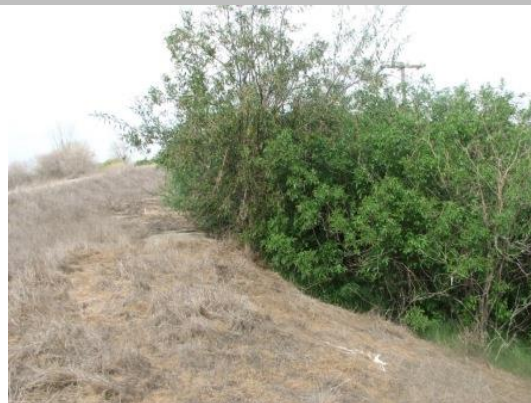
Photo 1 of 1 : SP_2016_RD0017_304_25_20160404_00013.jpg

LM Start	7.58	Rating **	M	Issue No.	25
LM End	7.60	Issue Type +	Ma	Location *	LS
Category	Earthen Levee			GPS Latitude/Longitude	
				Start	End
Item	Vegetation			37.828095 °	37.827920 °
				-121.309945 °	-121.309847 °
DWR ID	DWR_RD0017_02_s _ 2012_25				
Comment Code					
V4 : Elderberries are blocking visibility and flood fight capability.					
Inspector Comment

Elderberry blocking view of landside slope and toe.

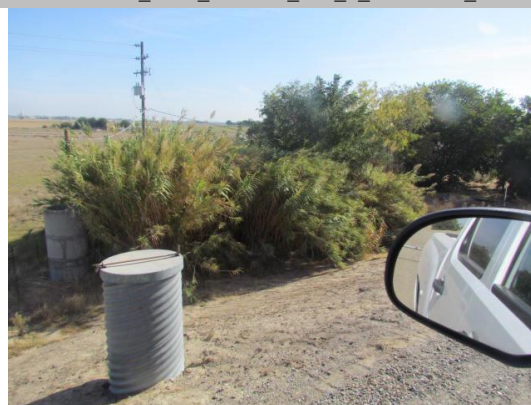
Photo 1 of 1 : SP_2016_RD0017_304_9_20160404_00010.jpg

LM Start	9.29	Rating **	U	Issue No.	9
LM End	9.29	Issue Type +	Ma	Location *	LS
Category	Earthen Levee			GPS Latitude/Longitude	
				Start	End
Item	Vegetation			37.815270 °	37.815270 °
				-121.317692 °	-121.317692 °
DWR ID	DWR_RD0017_02_s _ 2012_9				
Comment Code					
V4 : Elderberries are blocking visibility and flood fight capability.					
Inspector Comment					
Elderberry at landside toe.

Looking east at bamboo at landward toe.
