**Flood Control Project Maintenance  
Levee Inspections**

## Maintenance Issue Types Only, Levee Inspection Report By Mile - Spring 2017

### Reclamation District No. 0017 Mossdale

Waterway	Bank	Unit Miles	Inspection Start/End	Inspector
Unit No. 01 French Camp Slough	Left	1.76	03/29/2017 03/29/2017	Richard Willoughby

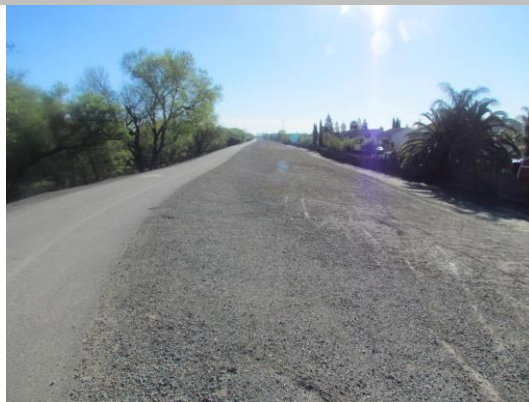
Photo 1 of 1 : SP\_2017\_RD0017\_303\_10\_20170330\_00016.jpg

LM Start	0.00	Rating **	A	Issue No.	10
LM End	1.76	Issue Type +	Ma	Location *	LS
Category	Earthen Levee			GPS Latitude/Longitude	
				Start	End
Item	Vegetation			37.911248 °	37.915968 °
				-121.291064 °	-121.320733 °
DWR ID	DWR_RD0017_01_s_2017_10				
Comment Code					
V1 : Control annual grass and weeds on the levee slopes and easements.					
Inspector Comment

Looking south at typical view of landward slope.

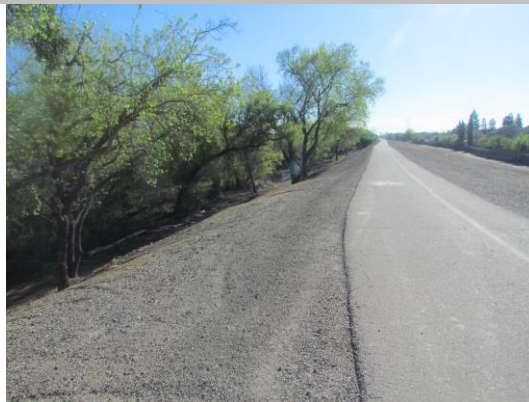
Photo 1 of 1 : SP\_2017\_RD0017\_303\_11\_20170330\_00017.jpg

LM Start	0.00	Rating **	A	Issue No.	11
LM End	1.76	Issue Type +	Ma	Location *	WS
Category	Earthen Levee			GPS Latitude/Longitude	
				Start	End
Item	Vegetation			37.911248 °	37.915968 °
				-121.291064 °	-121.320733 °
DWR ID	DWR_RD0017_01_s_2017_11				
Comment Code					
V1 : Control annual grass and weeds on the levee slopes and easements.					
Inspector Comment

Looking southeast at typical view of waterward slope.

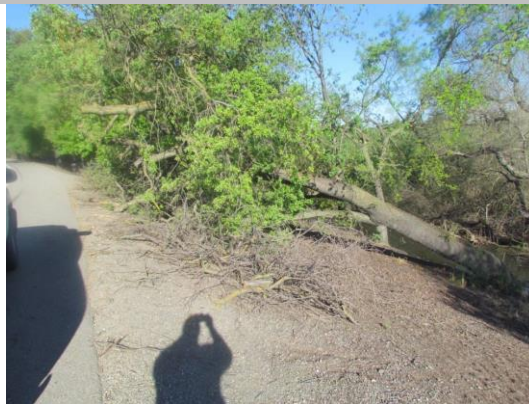
Photo 1 of 1 : SP\_2017\_RD0017\_303\_9\_20170330\_00018.jpg

LM Start	0.28	Rating **	M	Issue No.	9	
LM End	0.28	Issue Type +	Ma	Location *	WS	
Category	Earthen Levee			GPS Latitude/Longitude		
				Start	End	
Item	Encroachments			37.913503 °	37.913503 °	
				-121.294952 °	-121.294952 °	
DWR ID	DWR_RD0017_01_s_2017_9					
Comment Code						
TR : Tree or limb						
Inspector Comment						
Fallen tree on waterward slope.

Looking northeast at fallen tree on waterward slope.

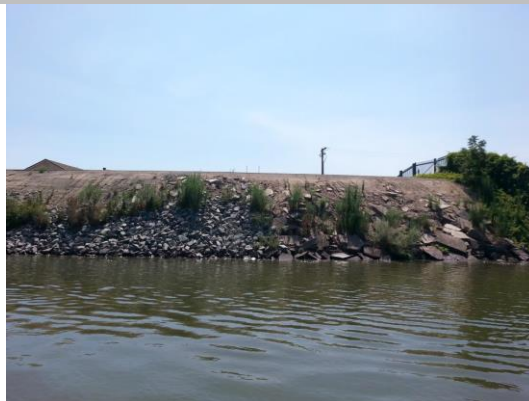
Photo 1 of 3 : SP\_2017\_RD0017\_304\_2\_20170316\_00003.jpg

LM Start	1.08	Rating **	U	Issue No.	2
LM End	1.08	Issue Type +	Ma	Location *	WS
Category	Supplemental			GPS Latitude/Longitude	
				Start	End
Item	DWR Erosion Survey			37.902530 °	37.902530 °
				-121.325690 °	-121.325690 °
DWR ID	DWR_RD0017_02_s_2017_2				
Comment Code					
Inspector Comment					
07/25/2016: No significant change observed.					
06/24/2015: No significant change observed.					
06/19/2014: No significant change observed.					
08/13/2013: No significant change at this site.					
08/07/2012: The erosion is nearly vertical, and has developed upward to halfway of the levee slope. The protecting concrete blocks have been washed away. Animal activities are visible. [2016 Site ID:RD0017U02RM44.32]. Repaired site

Front view of the erosion site. Note the concrete blocks and vegetation at the site.

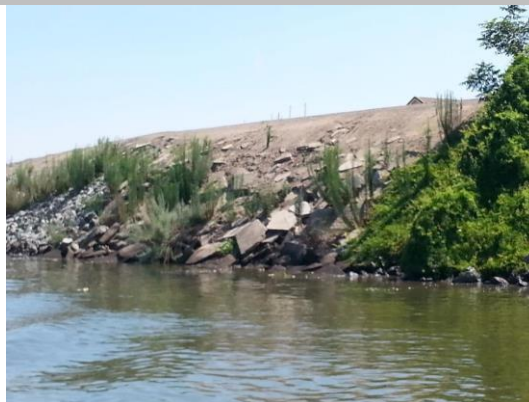
Photo 2 of 3 : SP\_2017\_RD0017\_304\_2\_20170316\_00004.jpg

Close view of the erosion.

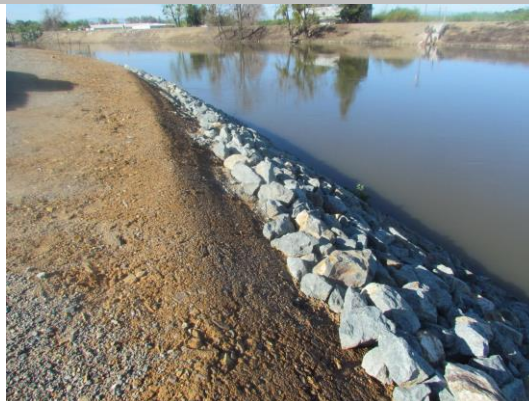
Photo 3 of 3 : SP\_2017\_RD0017\_304\_2\_20170330\_00191.jpg

LM Start	1.08	Rating **	U	Issue No.	2 (cont)	
LM End	1.08	Issue Type +	Ma	Location *	WS	
Category	Supplemental			GPS Latitude/Longitude		
				Start	End	
Item	DWR Erosion Survey			37.902530 °	37.902530 °	
				-121.325690 °	-121.325690 °	
DWR ID	DWR_RD0017_02_s_2017_2					
Comment Code						
Inspector Comment						
07/25/2016: No significant change observed.						
06/24/2015: No significant change observed.						
06/19/2014: No significant change observed.						
08/13/2013: No significant change at this site.						
08/07/2012: The erosion is nearly vertical, and has developed upward						
to halfway of the levee slope. The protecting concrete blocks have been						
washed away. Animal activities are visible. [2016 Site						
ID:RD0017U02RM44.32]. Repaired site

Looking south at repaired site on waterward slope. (Spring 2017)

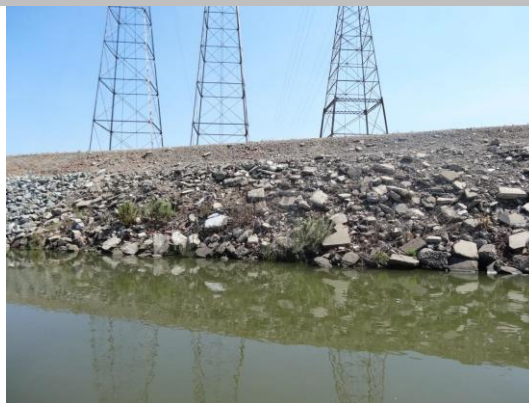
Photo 1 of 2 : SP\_2017\_RD0017\_304\_83\_20170316\_00009.jpg

LM Start	2.82	Rating **	M	Issue No.	83
LM End	2.82	Issue Type +	Ma	Location *	WS
Category	Supplemental			GPS Latitude/Longitude	
				Start	End
Item	DWR Erosion Survey			37.878660 °	37.878660 °
				-121.332400 °	-121.332400 °
DWR ID	DWR_RD0017_02_s_2017_83				
Comment Code					
Inspector Comment					
07/25/2016: No significant change observed.					
06/24/2015: No significant change observed.					
06/19/2014: A pocket erosion was found during the boat survey. [2016					
Site ID:RD0017U02RM46.1]

Front view of the erosion.

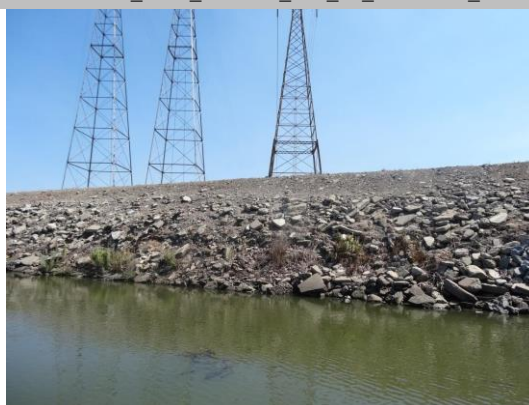
Photo 2 of 2 : SP\_2017\_RD0017\_304\_83\_20170316\_00010.jpg

Close view of the erosion. The slope protection is poor.

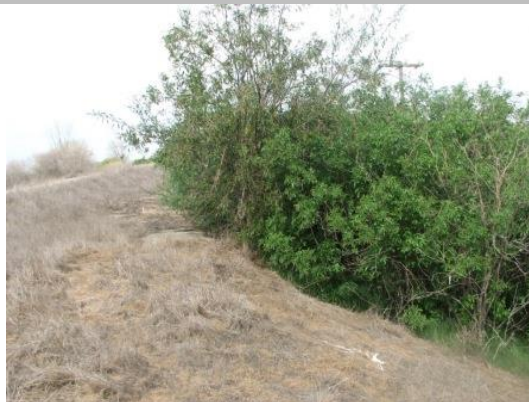
Photo 1 of 1 : SP\_2017\_RD0017\_304\_25\_20170316\_00006.jpg

LM Start	7.58	Rating **	M	Issue No.	25
LM End	7.60	Issue Type +	Ma	Location *	LS
Category	Earthen Levee			GPS Latitude/Longitude	
				Start	End
Item	Vegetation			37.828095 °	37.827920 °
				-121.309945 °	-121.309847 °
DWR ID	DWR_RD0017_02_s_2012_25				
Comment Code					
V4 : Elderberries are blocking visibility and flood fight capability.					
Inspector Comment

Elderberry blocking view of landside slope and toe.

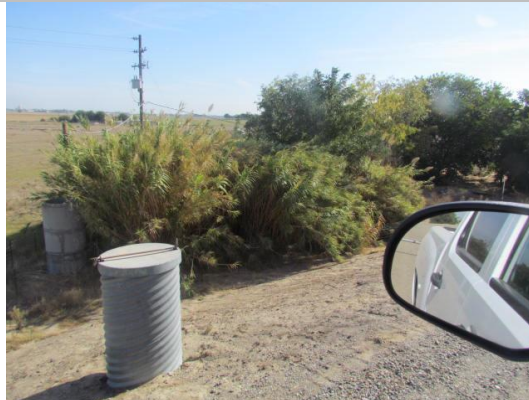
Photo 1 of 1 : SP\_2017\_RD0017\_304\_9\_20170316\_00005.jpg

LM Start	9.29	Rating **	M	Issue No.	9
LM End	9.29	Issue Type +	Ma	Location *	LS
Category	Earthen Levee			GPS Latitude/Longitude	
				Start	End
Item	Vegetation			37.815270 °	37.815270 °
				-121.317692 °	-121.317692 °
DWR ID	DWR_RD0017_02_s_2012_9				
Comment Code					
V4 : Elderberries are blocking visibility and flood fight capability.					
Inspector Comment					
Bamboo & elderberries at landside toe.

Looking east at bamboo and elderberries at landward toe.

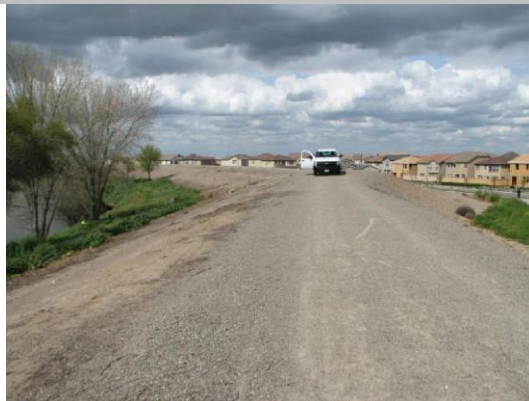
Photo 1 of 3 : UCIP\_SP\_2017\_40702\_72481.jpg

FS\_ID:40702  
 DS\_ID:806  
 EP\_NO: N/A  
 Repair Type: Non-Urgent  
 Crossing Status: Found  
 UCIP Comments: No pipe found during site visit only air valve and power meter. Dense vegetation along waterward slope recommend clearing vegetation from slope to conduct proper pipe inspection. If crossing is no longer in use owner will need to coordinate with DWR inspector and CVFPB to remove according to Title 23 requirements.  
 FIELD\_STRUCT\_DESC: \*REMOVED\* 20-inch Steel drain pipe through the levee 5-feet below the crown. Siphon breaker in steel riser on WS shoulder and a flap gate on the WS toe Permit No. 3799, 1961. Pipe removed under Permit No. 15318, 1989. Drainage or Irrigation Structure referenced in O&M manual (HLM 12.16). (USACE O&M, 1963)  
 FS Date: 2/4/2010

Overview of levee crown at crossing.

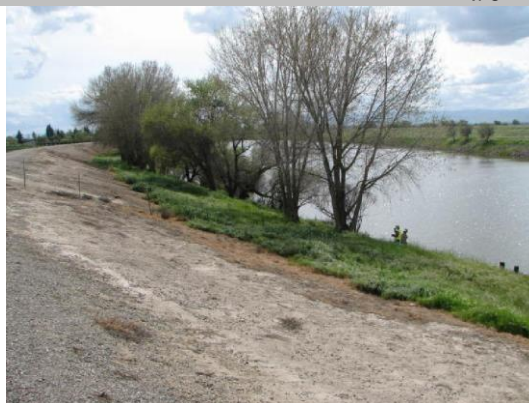
Photo 2 of 3 : UCIP\_SP\_2017\_40702\_72480.jpg

View of waterward side.

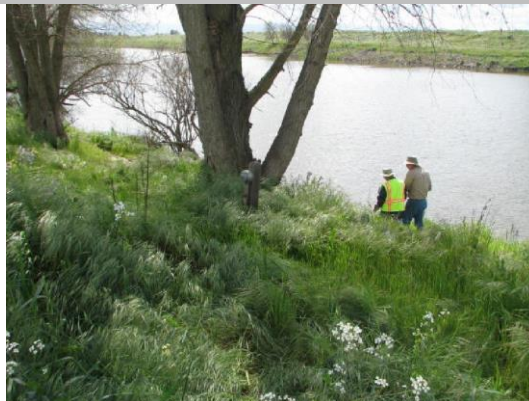
Photo 3 of 3 : UCIP\_SP\_2017\_40702\_72483.jpg

Item	DWR UCIP LMA Responsibility			37.793831 °	37.793831 °	
				-121.305989 °	-121.305989 °	
DWR ID						
Comment Code						
Inspector Comment						
FS_ID:40702						
DS_ID:806						
EP_NO: N/A						
Repair Type: Non-Urgent						
Crossing Status: Found						
UCIP Comments: No pipe found during site visit only air valve and power meter. Dense vegetation along waterward slope recommend clearing vegetation from slope to conduct proper pipe inspection. If crossing is no longer in use owner will need to coordinate with DWR inspector and CVFPB to remove according to Title 23 requirements.						
FIELD_STRUCT_DESC: *REMOVED* 20-inch Steel drain pipe through the levee 5-feet below the crown. Siphon breaker in steel riser on WS shoulder and a flap gate on the WS toe Permit No. 3799, 1961. Pipe removed under Permit No. 15318, 1989. Drainage or Irrigation Structure referenced in O&M manual (HLM 12.16). (USACE O&M, 1963)

Dense vegetation along waterward slope--abandoned electrical box is visible through dense vegetation.

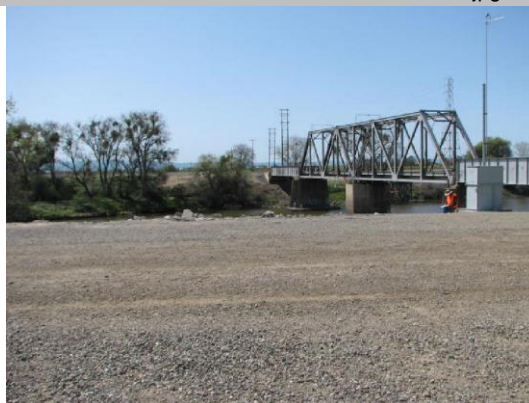
Photo 1 of 3 : UCIP\_SP\_2017\_40715\_72548.jpg

FS\_ID:40715  
DS\_ID:809  
EP\_NO: N/A  
Repair Type: Non-Urgent  
Crossing Status: Found  
UCIP Comments: No information was obtained from desk study. This crossing was found during field visit. Need to contact owner to obtain additional details about crossing (installation date and permit) and status.  
FIELD\_STRUCT\_DESC: \*ABANDONED\* 18-inch pipe through the levee, 5.8 feet below the crown. Gate valve and siphon breaker on the waterward slope. Flap gate on the waterward end. One CM cutoff wall (Reclamation District No. 17 Drainage Plant). Pump on the landward side. Installed by USCE 1961. This entry matches the Drainage or Irrigation Structure referenced in O&M manual (HLM 13.36). (USACE O&M, 1963). Welded Steel plate installed over one end of pipe under Permit No. 14450, 1988.  
FS Date: 2/4/2010

View of levee crown at crossing.

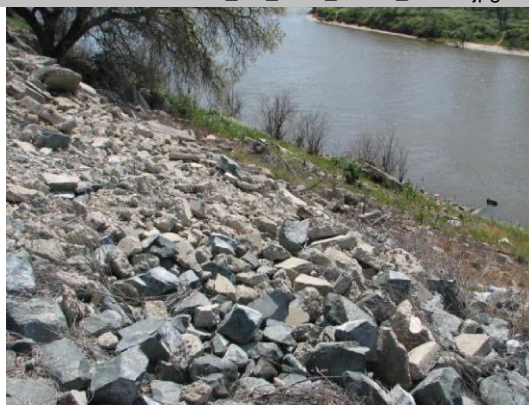
Photo 2 of 3 : UCIP\_SP\_2017\_40715\_72551.jpg

View of waterward side, photo 1 of 2.

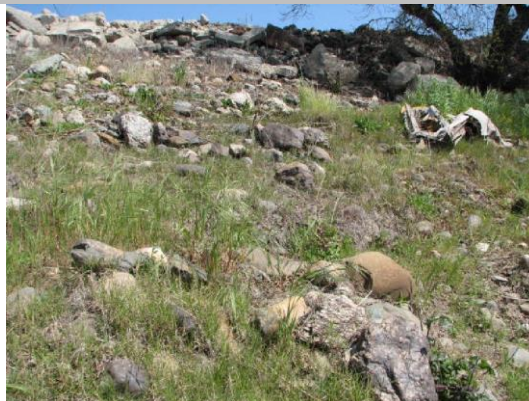
Photo 3 of 3 : UCIP\_SP\_2017\_40715\_72549.jpg

FS\_ID:40715  
 DS\_ID:809  
 EP\_NO: N/A  
 Repair Type: Non-Urgent  
 Crossing Status: Found  
 UCIP Comments: No information was obtained from desk study. This crossing was found during field visit. Need to contact owner to obtain additional details about crossing (installation date and permit) and status.  
 FIELD\_STRUCT\_DESC: \*ABANDONED\* 18-inch pipe through the levee, 5.8 feet below the crown. Gate valve and siphon breaker on the waterward slope. Flap gate on the waterward end. One CM cutoff wall (Reclamation District No. 17 Drainage Plant). Pump on the landward side. Installed by USCE 1961. This entry matches the Drainage or Irrigation Structure referenced in O&M manual (HLM 13.36). (USACE O&M, 1963). Welded Steel plate installed over one end of pipe under Permit No. 14450, 1988.  
 FS Date: 2/4/2010

View of waterward side, photo 2 of 2.
