**Flood Control Project Maintenance
Levee Inspections**

Maintenance Issue Types Only, Levee Inspection Report By Mile - Spring 2018

Reclamation District No. 0017 Mossdale

Waterway	Bank	Unit Miles	Inspection Start/End	Inspector
Unit No. 01 French Camp Slough	Left	1.76	05/08/2018 05/08/2018	Richard Willoughby

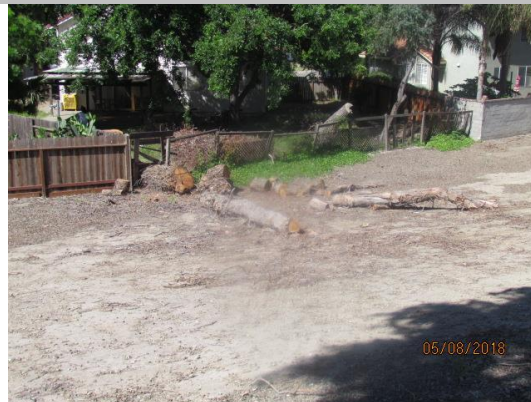
Photo 1 of 1 : SP_2018_RD0017_303_11_20180511_00017.jpg

LM Start	0.71	Rating **	M	Issue No.	11
LM End	0.71	Issue Type +	Ma	Location *	
Category	Earthen Levee			GPS Latitude/Longitude	
				Start	End
Item	Encroachments			37.914831 °	37.914831 °
				-121.301732 °	-121.301732 °
DWR ID	DWR_RD0017_01_s_2018_11				
Comment Code					
TR : Tree or limb					
Inspector Comment					
Fallen tree on landside slope and toe.

Looking west at tree limbs on landward slope and toe. (Spring 2018)

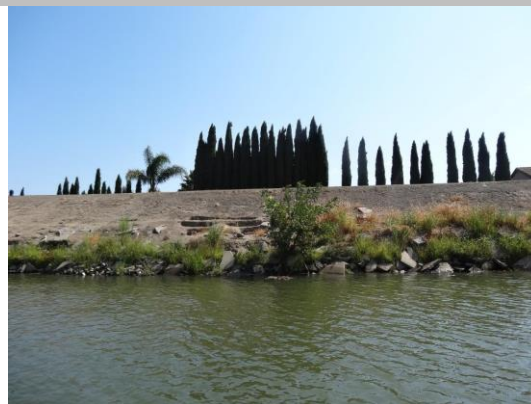
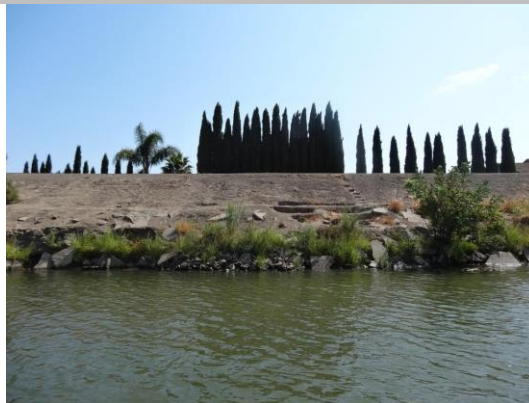
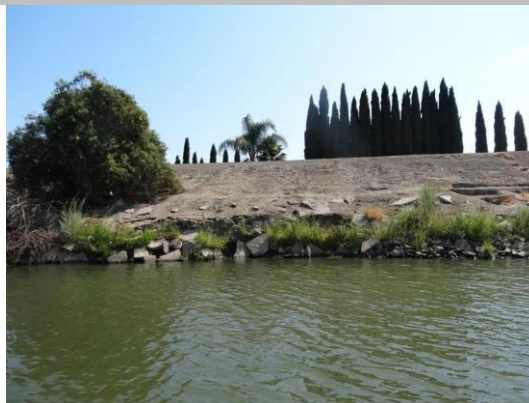
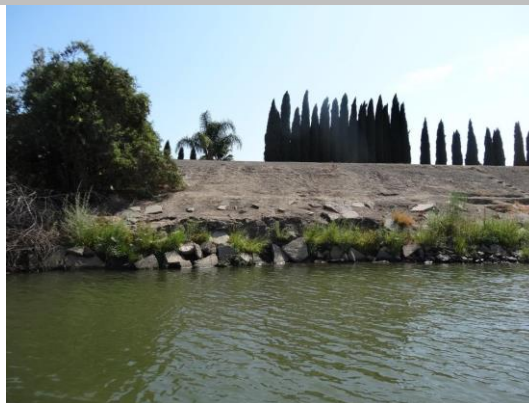
LM Start	0.25	Rating **	M	Issue No.	2
LM End	0.26	Issue Type +	Ma	Location *	WS
Category	Supplemental			GPS Latitude/Longitude	
				Start	End
Item	DWR Erosion Survey			37.913048 °	37.913048 °
				-121.323561 °	-121.323561 °
DWR ID	RD0017U02RM43.51				
Comment Code					
Inspector Comment					
09/13/2017: Erosion occurs along the levee toe. [2017 Site ID:RD0017U02RM43.51]

Front view of the erosion.

Close view of the erosion.

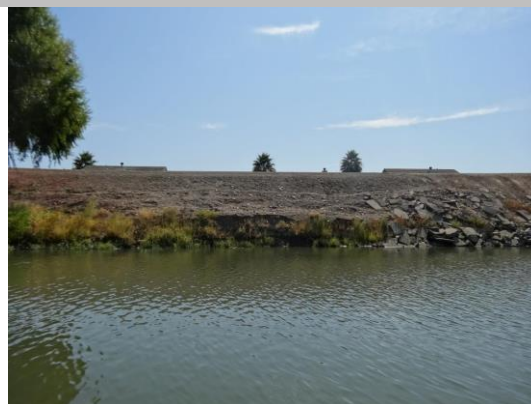
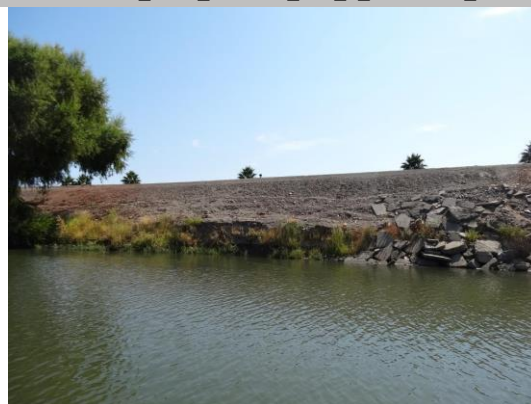
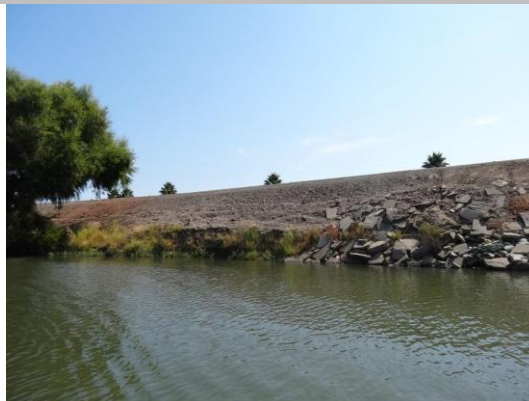
LM Start	0.91	Rating **	M	Issue No.	3
LM End	0.91	Issue Type +	Ma	Location *	WS
Category	Supplemental			GPS Latitude/Longitude	
				Start	End
Item	DWR Erosion Survey			37.904310 °	37.904310 °
				-121.323386 °	-121.323386 °
DWR ID	RD0017U02RM44.14				
Comment Code					
Inspector Comment					
09/13/2017: The erosion is located upstream of a big tree. [2017 Site ID:RD0017U02RM44.14]

Front view of the erosion.

Looking downstream at the erosion.

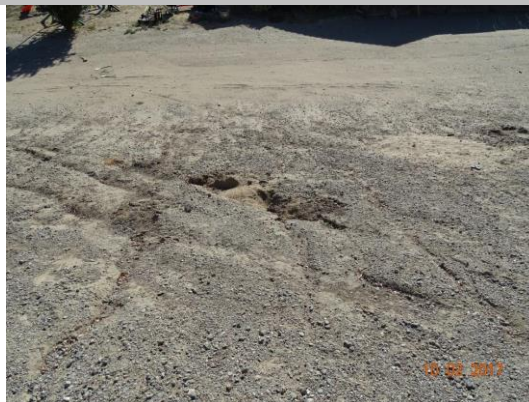
Photo 1 of 1 : SP_2018_RD0017_304_70_20180323_00011.jpg

LM Start	1.43	Rating **	M	Issue No.	70
LM End	1.43	Issue Type +	Ma	Location *	LS
Category	Earthen Levee			GPS Latitude/Longitude	
				Start	End
Item	Slope Stability			37.897508 °	37.897508 °
				-121.326671 °	-121.326671 °
DWR ID	DWR_RD0017_02_f_2017_70				
Comment Code					
S3 : Repair the levee slope damaged by vehicle traffic and prevent access where possible.					
Inspector Comment

Looking east at the landside slope.

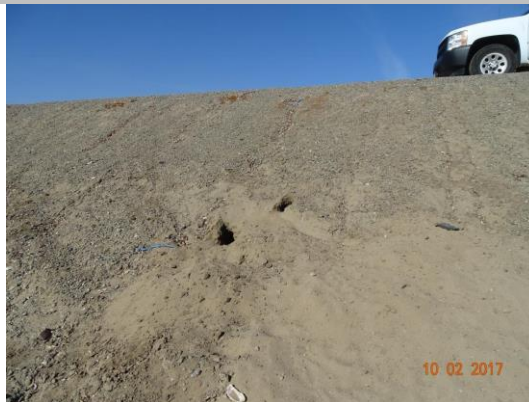
Photo 1 of 1 : SP_2018_RD0017_304_75_20180323_00013.jpg

LM Start	1.43	Rating **	M	Issue No.	75
LM End	1.43	Issue Type +	Ma	Location *	LS
Category	Earthen Levee			GPS Latitude/Longitude	
				Start	End
Item	Animal Control			37.897467 °	37.897467 °
				-121.326690 °	-121.326690 °
DWR ID	DWR_RD0017_02_f_2017_75				
Comment Code					
A3 : No rodents visible, but rodent burrows visible; need to backfill and compact or grout burrows.					
Inspector Comment

Looking west at the landside slope.

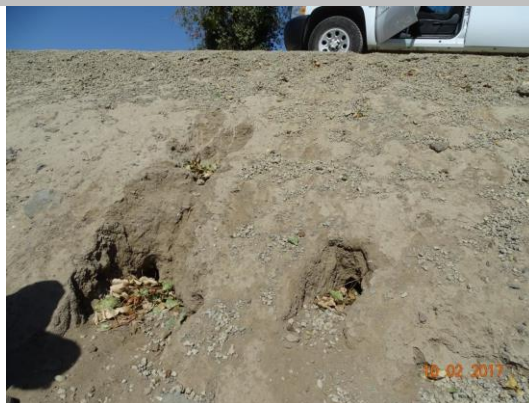
Photo 1 of 1 : SP_2018_RD0017_304_85_20180323_00015.jpg

LM Start	9.24	Rating **	M	Issue No.	85
LM End	9.24	Issue Type +	Ma	Location *	LS
Category	Earthen Levee			GPS Latitude/Longitude	
				Start	End
Item	Animal Control			37.815269 °	37.815269 °
				-121.316805 °	-121.316805 °
DWR ID	DWR_RD0017_02_f_2017_85				
Comment Code					
A3 : No rodents visible, but rodent burrows visible; need to backfill and compact or grout burrows.					
Inspector Comment

Looking north at landside slope.

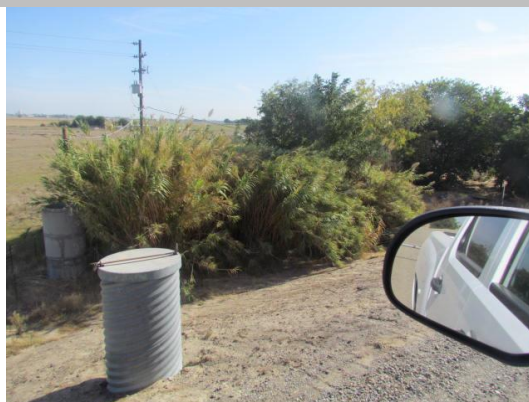
Photo 1 of 1 : SP_2018_RD0017_304_9_20180323_00010.jpg

LM Start	9.29	Rating **	M	Issue No.	9
LM End	9.29	Issue Type +	Ma	Location *	LS
Category	Earthen Levee			GPS Latitude/Longitude	
				Start	End
Item	Vegetation			37.815270 °	37.815270 °
				-121.317692 °	-121.317692 °
DWR ID	DWR_RD0017_02_s_2012_9				
Comment Code					
V4 : Elderberries are blocking visibility and flood fight capability.					
Inspector Comment					
Bamboo & elderberries at landside toe.

Looking east at bamboo and elderberries at landward toe.

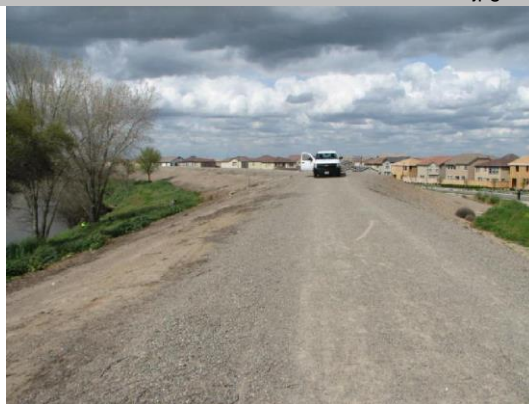
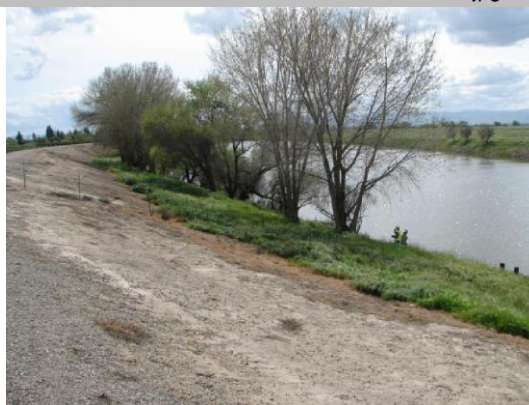
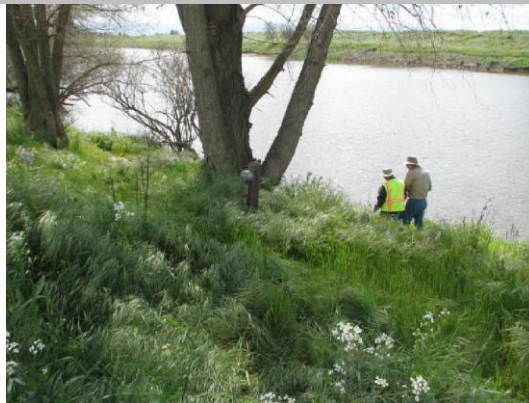
UCIP Comments: No pipe found during site visit only air valve and power meter. Dense vegetation along waterward slope recommend clearing vegetation from slope to conduct proper pipe inspection. If crossing is no longer in use owner will need to coordinate with DWR inspector and CVFPB to remove according to Title 23 requirements.

FIELD_STRUCT_DESC: *REMOVED* 20-inch steel drainage pipe through the levee 5-feet below the crown. Siphon breaker in steel riser on waterside (WS) shoulder and a flap gate on the WS toe. (20-inch pipe authorized under Permit No. 3799, 1961 - Libbey-Owens-Ford Glass Company; 24-inch pipe removed under Permit No. 15318, 1989 - Libbey-Owens-Ford Glass Co. & Reclamation District 17 [RD0017], 20-inch pipe installed) [Additional Reference(s): DWR Levee Logs, 1981, 2003, 20-inch. USACE San Joaquin O&M Manual Unit No. 2, May 1963, (HLM 12.16), 20-inch pipe]

Dense vegetation along waterward slope--abandoned electrical box is visible through dense vegetation.

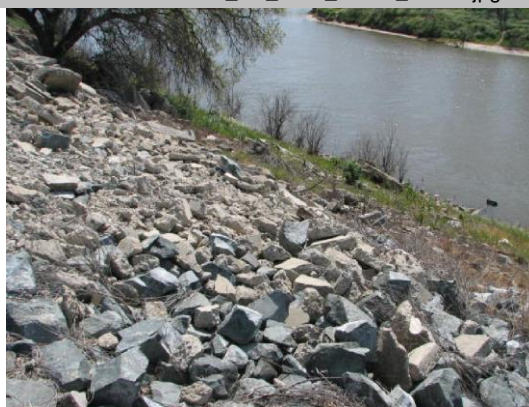
FS_ID:40715
 DS_ID:809
 EP_NO: N/A
 Repair Type: Non-Urgent
 Crossing Status: Found
 UCIP Comments: No information was obtained from desk study. This crossing was found during field visit. Need to contact owner to obtain additional details about crossing (installation date and permit) and status.
 FIELD_STRUCT_DESC: *ABANDONED* [Reclamation District No. 17 Drainage Plant] 18-inch drainage pipe of unknown material through the levee, 5.8 feet below the crown. Gate valve and siphon breaker on the waterside (WS) slope. Flap gate on the WS end. One CM cutoff wall. Pump on the landside (LS). (18-inch pipe Installed by USACE in 1961 -- no permit found; existing 18-inch pipe removed under Permit No. 14450, 1988 - R. H. Brown, two 18-inch pipes installed) [Additional Reference(s): DWR Levee Logs, 1981, 2003. USACE San Joaquin O&M Manual Unit No. 2, May 1963, (HLM 13.36)]
 FS Date: 2/4/2010

View of levee crown at crossing.

View of waterward side, photo 1 of 2.
