**Flood Control Project Maintenance
Levee Inspections**

Maintenance Issue Types Only, Levee Inspection Report By Mile - Spring 2019

Reclamation District No. 0017 Mossdale

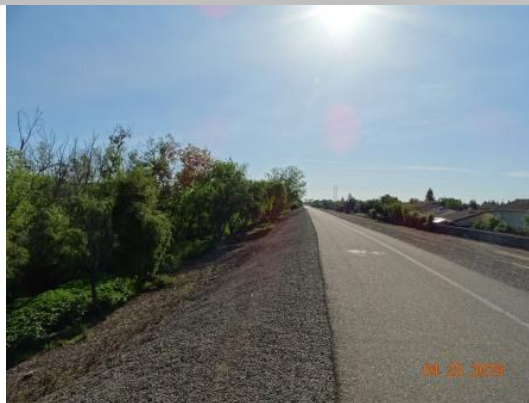
Photo 1 of 1 : SP_2019_RD0017_303_10_20190430_00018.jpg

LM Start	0.00	Rating **	A	Issue No.	10
LM End	1.77	Issue Type +	Ma	Location *	WS
Category	Earthen Levee			GPS Latitude/Longitude	
				Start	End
Item	Vegetation			37.911282 °	37.915953 °
				-121.291128 °	-121.320798 °
DWR ID	DWR_RD0017_01_s_2019_10				
Comment Code					
V1 : Control annual grass and weeds on the levee slopes and easements.					
Inspector Comment					
The annual vegetation is well maintained.

Typical view of vegetation on wateside slope. (Spring 2019)

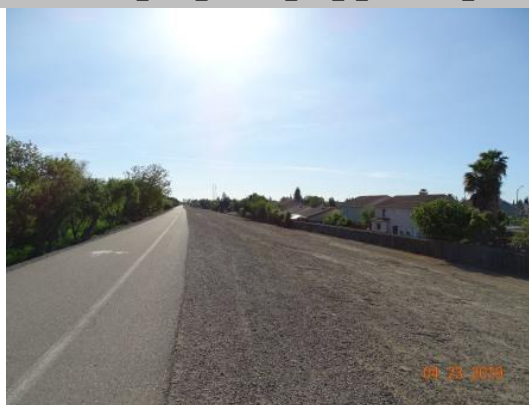
Photo 1 of 1 : SP_2019_RD0017_303_9_20190430_00017.jpg

LM Start	0.00	Rating **	A	Issue No.	9
LM End	1.76	Issue Type +	Ma	Location *	LS
Category	Earthen Levee			GPS Latitude/Longitude	
				Start	End
Item	Vegetation			37.911283 °	37.915954 °
				-121.291140 °	-121.320794 °
DWR ID	DWR_RD0017_01_s_2019_9				
Comment Code					
V1 : Control annual grass and weeds on the levee slopes and easements.					
Inspector Comment					
The annual vegetation is well maintained.

Typical view of vegetation on landside slope. (Spring 2019)

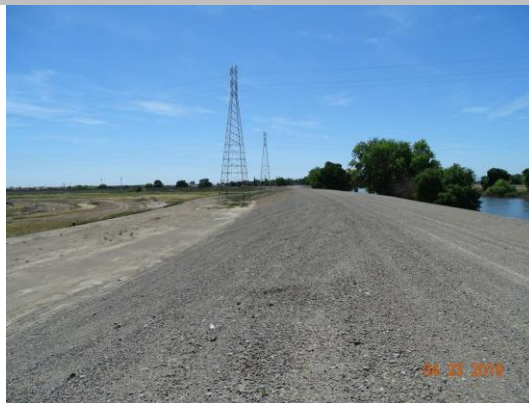
Photo 1 of 1 : SP_2019_RD0017_304_74_20190430_00194.jpg

LM Start	0.01	Rating **	A	Issue No.	74
LM End	14.25	Issue Type +	Ma	Location *	LS
Category	Earthen Levee			GPS Latitude/Longitude	
				Start	End
Item	Vegetation			37.915911 °	37.772169 °
				-121.320877 °	-121.289313 °
DWR ID	DWR_RD0017_02_s_2019_74				
Comment Code					
V1 : Control annual grass and weeds on the levee slopes and easements.					
Inspector Comment					
The annual vegetation is well maintained.

Typical view of vegetation on landside slope. (Spring 2019)

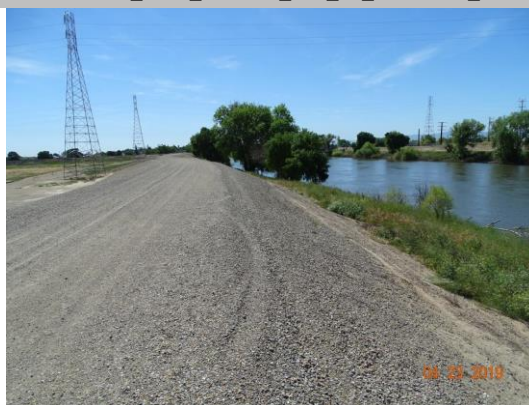
Photo 1 of 1 : SP_2019_RD0017_304_68_20190430_00195.jpg

LM Start	0.01	Rating **	A	Issue No.	68
LM End	14.26	Issue Type +	Ma	Location *	WS
Category	Earthen Levee			GPS Latitude/Longitude	
				Start	End
Item	Vegetation			37.915907 °	37.772166 °
				-121.320883 °	-121.289265 °
DWR ID	DWR_RD0017_02_s_2019_68				
Comment Code					
V1 : Control annual grass and weeds on the levee slopes and easements.					
Inspector Comment					
The annual vegetation is well maintained.

Typical view of vegetation on waterside slope. (Spring 2019)

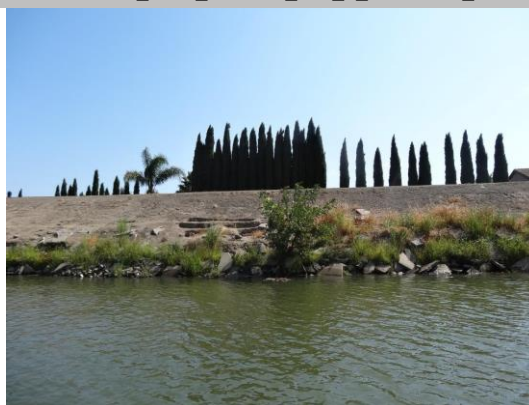
Photo 1 of 2 : SP_2019_RD0017_304_2_20190313_00003.jpg

LM Start	0.25	Rating **	M	Issue No.	2
LM End	0.26	Issue Type +	Ma	Location *	WS
Category	Supplemental			GPS Latitude/Longitude	
				Start	End
Item	DWR Erosion Survey			37.913048 °	37.913048 °
				-121.323561 °	-121.323561 °
DWR ID	RD0017U02RM43.51				
Comment Code					
Inspector Comment					
09/13/2017: Erosion occurs along the levee toe. [2017 Site ID:RD0017U02RM43.51].

Front view of the erosion.

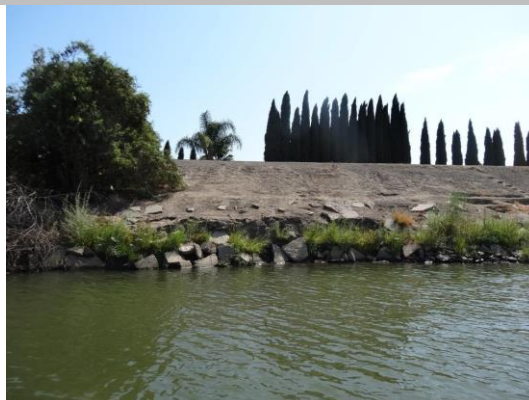
Photo 2 of 2 : SP_2019_RD0017_304_2_20190313_00004.jpg

Close view of the erosion.

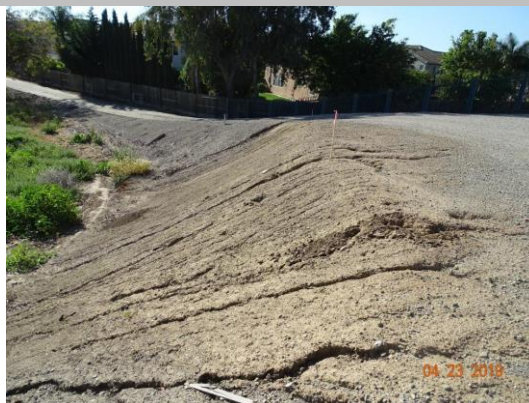
Photo 1 of 1 : SP_2019_RD0017_304_78_20190430_00196.jpg

LM Start	1.22	Rating **	M	Issue No.	78
LM End	1.22	Issue Type +	Ma	Location *	LS
Category	Earthen Levee			GPS Latitude/Longitude	
				Start	End
Item	Erosion / Bank Caving			37.900391 °	37.900391 °
				-121.325514 °	-121.325514 °
DWR ID	DWR_RD0017_02_s_2019_78				
Comment Code					
E2 : Schedule repair of erosion site prior to the next inspection.					
Inspector Comment					
Rills located on the landside slope were caused by surface runoff and are scheduled for repair in the summer of 2019.

Rills caused by surface runoff, scheduled to be repaired late spring 2019. (Spring 2019)

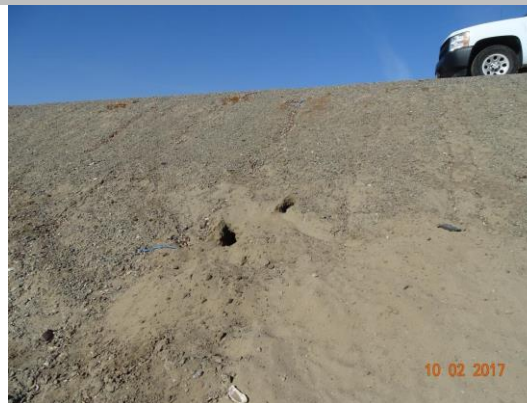
Photo 1 of 1 : SP_2019_RD0017_304_75_20190313_00008.jpg

LM Start	1.43	Rating **	M	Issue No.	75
LM End	1.43	Issue Type +	Ma	Location *	LS
Category	Earthen Levee			GPS Latitude/Longitude	
				Start	End
Item	Animal Control			37.897467 °	37.897467 °
				-121.326690 °	-121.326690 °
DWR ID	DWR_RD0017_02_f_2017_75				
Comment Code					
A3 : No rodents visible, but rodent burrows visible; need to backfill and compact or grout burrows.					
Inspector Comment

Looking west at the landside slope.

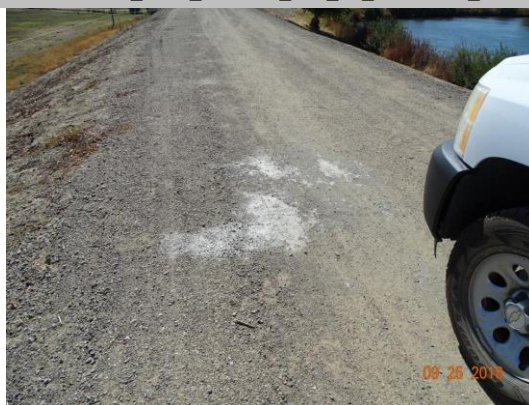
Photo 1 of 2 : SP_2019_RD0017_304_82_20190313_00010.jpg

LM Start	4.84	Rating **	A/W	Issue No.	82
LM End	4.84	Issue Type +	Ma	Location *	LS
Category	Earthen Levee			GPS Latitude/Longitude	
				Start	End
Item	Animal Control			37.856633 °	37.856633 °
				-121.319411 °	-121.319411 °
DWR ID	DWR_RD0017_02_f_2017_82				
Comment Code					
A1 : Exterminate rodents and backfill and compact or grout burrows.					
Inspector Comment					
District grouted rodent holes.

Looking south at typical view of grouted rodent holes on landward shoulder. (Fall 2018)

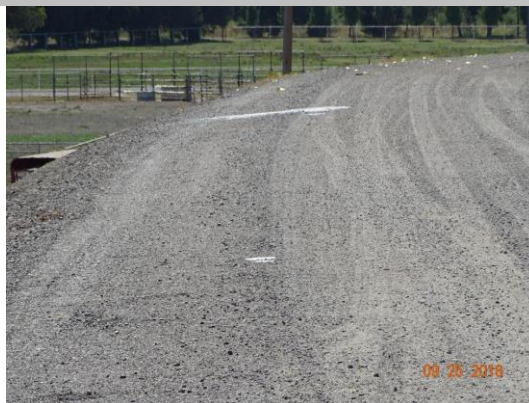
Photo 2 of 2 : SP_2019_RD0017_304_82_20190313_00011.jpg

Looking southeast at typical view of grouted rodent holes on landward shoulder and slope. (Fall 2018)

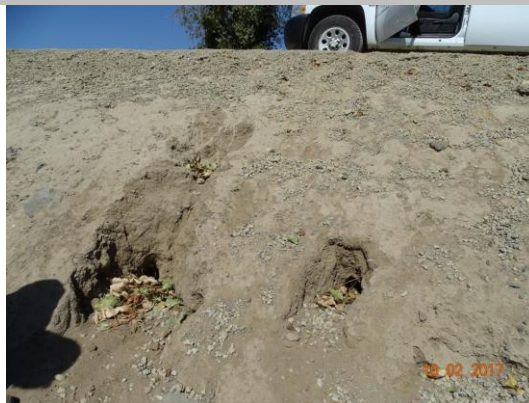
Photo 1 of 1 : SP_2019_RD0017_304_85_20190313_00012.jpg

LM Start	9.24	Rating **	M	Issue No.	85
LM End	9.24	Issue Type +	Ma	Location *	LS
Category	Earthen Levee			GPS Latitude/Longitude	
				Start	End
Item	Animal Control			37.815269 °	37.815269 °
				-121.316805 °	-121.316805 °
DWR ID	DWR_RD0017_02_f_2017_85				
Comment Code					
A3 : No rodents visible, but rodent burrows visible; need to backfill and compact or grout burrows.					
Inspector Comment

Looking north at landside slope.

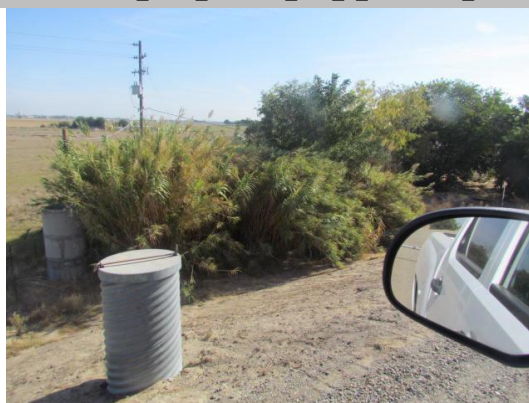
Photo 1 of 1 : SP_2019_RD0017_304_9_20190313_00005.jpg

LM Start	9.29	Rating **	M	Issue No.	9
LM End	9.29	Issue Type +	Ma	Location *	LS
Category	Earthen Levee			GPS Latitude/Longitude	
				Start	End
Item	Vegetation			37.815270 °	37.815270 °
				-121.317692 °	-121.317692 °
DWR ID	DWR_RD0017_02_s_2012_9				
Comment Code					
V4 : Elderberries are blocking visibility and flood fight capability.					
Inspector Comment					
Bamboo & elderberries at landside toe.

Looking east at bamboo and elderberries at landward toe.

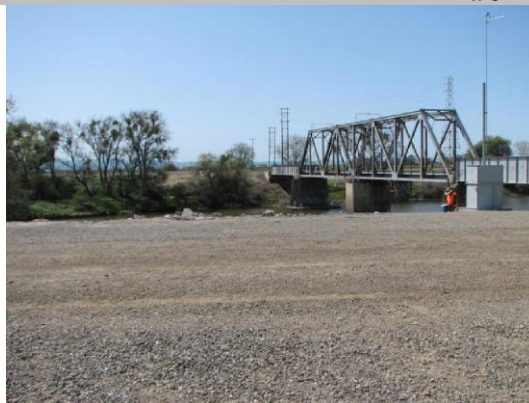
Photo 1 of 3 : UCIP_SP_2019_40715_72548.jpg

Comment Code						
Inspector Comment						
FS_ID:40715 DS_ID:809 EP_NO: N/A Repair Type: Non-Urgent Crossing Status: Found UCIP Comments: No information was obtained from desk study. This crossing was found during field visit. Need to contact owner to obtain additional details about crossing (installation date and permit) and status. FIELD_STRUCT_DESC: *ABANDONED* [Reclamation District No. 17 Drainage Plant] 18-inch drainage pipe of unknown material through the levee, 5.8 feet below the crown. Gate valve and siphon breaker on the waterside (WS) slope. Flap gate on the WS end. One CM cutoff wall. Pump on the landside (LS). (18-inch pipe Installed by USACE in 1961 -- no permit found; existing 18-inch pipe removed under Permit No. 14450, 1988 - R. H. Brown, two 18-inch pipes installed) [Additional Reference(s): DWR Levee Logs, 1981, 2003. USACE San Joaquin O&M Manual Unit No. 2, May 1963, (HLM 13.36)] FS Date: 2/4/2010

View of levee crown at crossing.

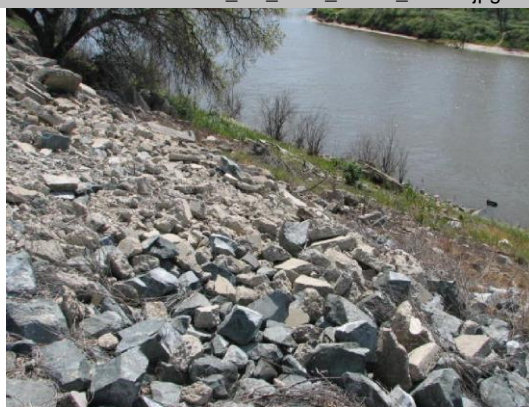
Photo 2 of 3 : UCIP_SP_2019_40715_72551.jpg

View of waterward side, photo 1 of 2.

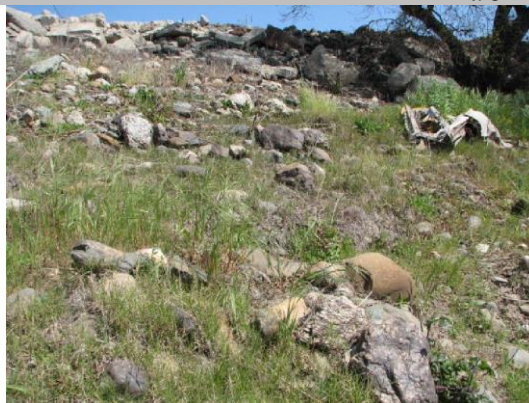
Photo 3 of 3 : UCIP_SP_2019_40715_72549.jpg

Item	DWR UCIP LMA Responsibility			37.779470 °	37.779470 °	
				-121.299953 °	-121.299953 °	
DWR ID	809					
Comment Code						
Inspector Comment						
FS_ID:40715 DS_ID:809 EP_NO: N/A Repair Type: Non-Urgent Crossing Status: Found UCIP Comments: No information was obtained from desk study. This crossing was found during field visit. Need to contact owner to obtain additional details about crossing (installation date and permit) and status. FIELD_STRUCT_DESC: *ABANDONED* [Reclamation District No. 17 Drainage Plant] 18-inch drainage pipe of unknown material through the levee, 5.8 feet below the crown. Gate valve and siphon breaker on the waterside (WS) slope. Flap gate on the WS end. One CM cutoff wall. Pump on the landside (LS). (18-inch pipe Installed by USACE in 1961 -- no permit found; existing 18-inch pipe removed under Permit No. 14450, 1988 - R. H. Brown, two 18-inch pipes installed) [Additional Reference(s): DWR Levee Logs, 1981, 2003. USACE San Joaquin O&M Manual Unit No. 2, May 1963, (HLM 13.36)] FS Date: 2/4/2010

View of waterward side, photo 2 of 2.
