**Flood Control Project Maintenance  
Levee Inspections**

**Maintenance Issue Types Only, Levee Inspection Report By Mile - Spring 2020**

**Reclamation District No. 0017 Mossdale**

Waterway	Bank	Unit Miles	Inspection Start/End	Inspector
Unit No. 01 French Camp Slough	Left	1.76	03/19/2020 03/19/2020	Alberto De Leon

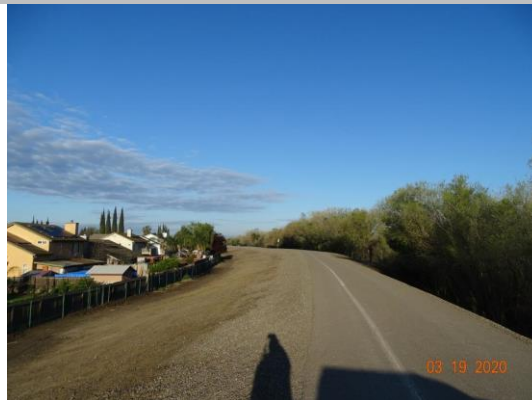
Photo 1 of 1 : SP\_2020\_RD0017\_303\_12\_20200323\_00018.jpg

LM Start	1.02	Rating **	A	Issue No.	12
LM End	1.02	Issue Type +	Ma	Location *	LS
Category	Earthen Levee			GPS Latitude/Longitude	
				Start	End
Item	Vegetation			37.915650 °	37.915650 °
				-121.307253 °	-121.307253 °
DWR ID	DWR_RD0017_01_s_2020_12				
Comment Code					
V1 : Control annual grass and weeds on the levee slopes and easements.					
Inspector Comment

Typical view of well maintained vegetation on landside slope. Spring 2020

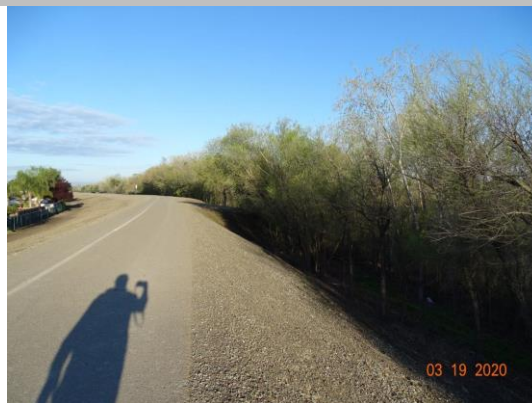
Photo 1 of 1 : SP\_2020\_RD0017\_303\_13\_20200323\_00019.jpg

LM Start	1.02	Rating **	A	Issue No.	13
LM End	1.02	Issue Type +	Ma	Location *	WS
Category	Earthen Levee			GPS Latitude/Longitude	
				Start	End
Item	Vegetation			37.915650 °	37.915650 °
				-121.307254 °	-121.307254 °
DWR ID	DWR_RD0017_01_s_2020_13				
Comment Code					
V1 : Control annual grass and weeds on the levee slopes and easements.					
Inspector Comment

Typical view of well maintained vegetation on waterside slope. Spring 2020

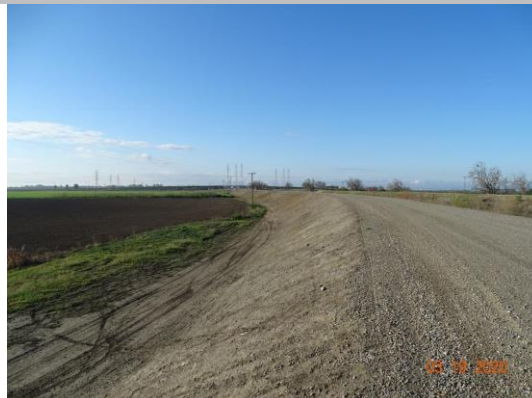
Photo 1 of 1 : SP\_2020\_RD0017\_304\_67\_20200323\_00186.jpg

LM Start	2.25	Rating **	A	Issue No.	67
LM End	2.25	Issue Type +	Ma	Location *	LS
Category	Earthen Levee			GPS Latitude/Longitude	
				Start	End
Item	Vegetation			37.886888 °	37.886888 °
				-121.330666 °	-121.330666 °
DWR ID	DWR_RD0017_02_s_2020_67				
Comment Code					
V1 : Control annual grass and weeds on the levee slopes and easements.					
Inspector Comment

Typical view of well maintained vegetation on landside slope. Spring 2020

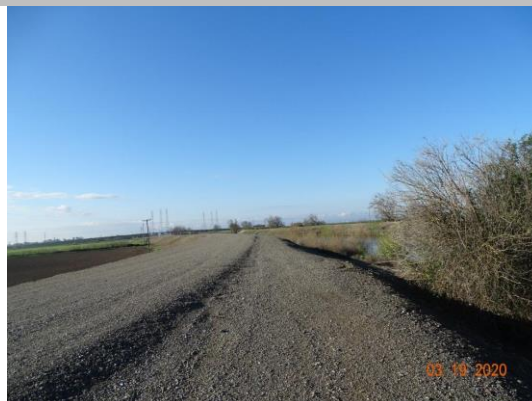
Photo 1 of 1 : SP\_2020\_RD0017\_304\_68\_20200323\_00187.jpg

LM Start	2.25	Rating **	A	Issue No.	68	
LM End	2.25	Issue Type +	Ma	Location *	WS	
Category	Earthen Levee			GPS Latitude/Longitude		
				Start		End
Item	Vegetation			37.886888 °		37.886888 °
				-121.330667 °		-121.330667 °
DWR ID	DWR_RD0017_02_s_2020_68					
Comment Code						
V1 : Control annual grass and weeds on the levee slopes and easements.						
Inspector Comment

Typical view of well maintained vegetation on waterside slope. Spring 2020

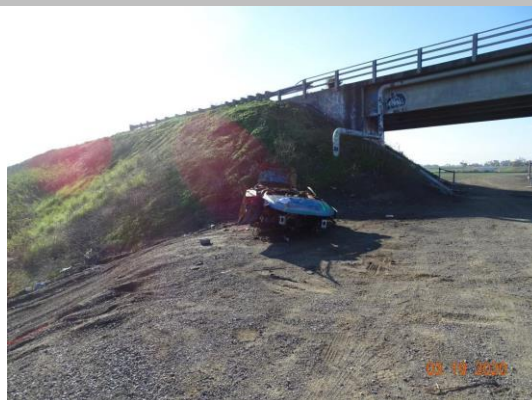
Photo 1 of 1 : SP\_2020\_RD0017\_304\_69\_20200323\_00188.jpg

LM Start	2.87	Rating **	M	Issue No.	69
LM End	2.87	Issue Type +	Ma	Location *	LS
Category	Earthen Levee			GPS Latitude/Longitude	
				Start	End
Item	Encroachments			37.878043 °	37.878043 °
				-121.331606 °	-121.331606 °
DWR ID	DWR_RD0017_02_s_2020_69				
Comment Code					
AV : Abandoned vehicles					
Inspector Comment

View of an abandoned vehicle on landside shoulder. Spring 2020

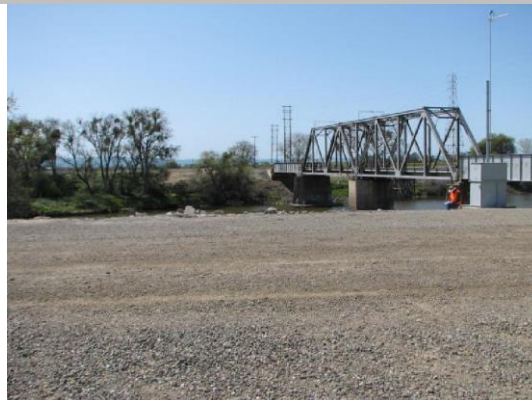
Photo 1 of 3 : UCIP\_SP\_2020\_40715\_72548.jpg

LM Start	13.28	Rating **	M	Issue No.	158	
LM End	13.28	Issue Type +	Ma	Location *		
Category	Supplemental			GPS Latitude/Longitude		
				Start	End	
Item	DWR UCIP LMA Responsibility			37.779470 °	37.779470 °	
				-121.299953 °	-121.299953 °	
DWR ID	809

Comment Code						
Inspector Comment						
DS_ID:809 FS_ID:40715 EP_NO: N/A Repair Type: Non-Urgent Crossing Status: Found UCIP Comments: No information was obtained from desk study. This crossing was found during field visit. Need to contact owner to obtain additional details about crossing (installation date and permit) and status. FIELD_STRUCT_DESC: *ABANDONED* [Reclamation District No. 17 Drainage Plant] 18-inch drainage pipe of unknown material through the levee, 5.8 feet below the crown. Gate valve and siphon breaker on the waterside (WS) slope. Flap gate on the WS end. One CM cutoff wall. Pump on the landside (LS). (18-inch pipe Installed by USACE in 1961 -- no permit found; existing 18-inch pipe removed under Permit No. 14450, 1988 - R. H. Brown, two 18-inch pipes installed) [Additional Reference(s): DWR Levee Logs, 1981, 2003. USACE San Joaquin O&M Manual Unit No. 2, May 1963, (HLM 13.36)] FS Date: 2/4/2010

View of levee crown at crossing.

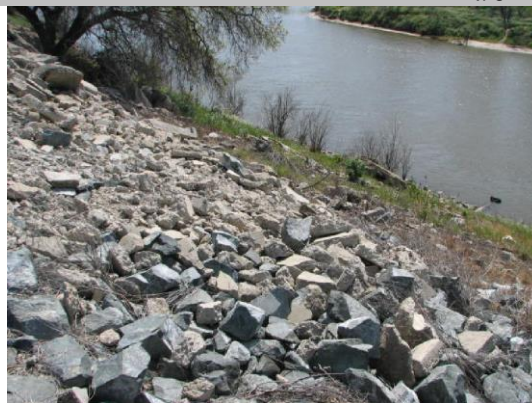
Photo 2 of 3 : UCIP\_SP\_2020\_40715\_72551.jpg

View of waterward side, photo 1 of 2.

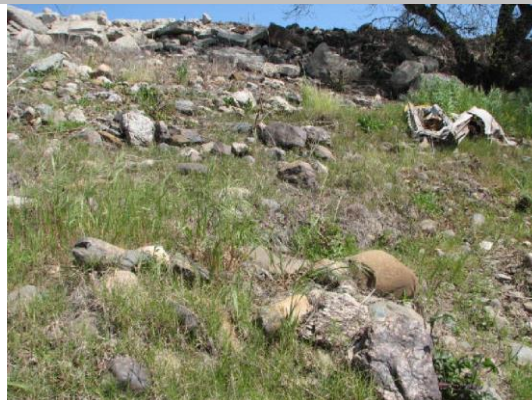
Photo 3 of 3 : UCIP\_SP\_2020\_40715\_72549.jpg

View of waterward side, photo 2 of 2.
