**Flood Control Project Maintenance
Levee Inspections**

Maintenance Issue Types Only, Levee Inspection Report By Mile - Spring 2021

Reclamation District No. 0017 Mossdale

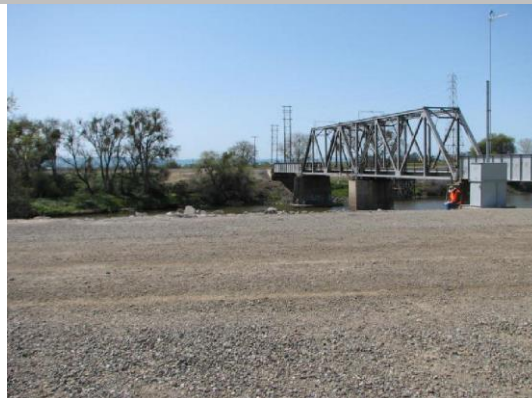
Photo 1 of 3 : UCIP_SP_2021_40715_72548.jpg

LM Start	13.28	Rating **	M	Issue No.	66	
LM End	13.28	Issue Type +	Ma	Location *		
Category	Supplemental			GPS Latitude/Longitude		
				Start	End	
Item	DWR UCIP LMA Responsibility			37.779470 °	37.779470 °	
				-121.299953 °	-121.299953 °	
DWR ID	809

Comment Code						
Inspector Comment						
FS_ID:40715 DS_ID:809 EP_NO: N/A Repair Type: Non-Urgent Crossing Status: Found UCIP Comments: No information was obtained from desk study. This crossing was found during field visit. Need to contact owner to obtain additional details about crossing (installation date and permit) and status. FIELD_STRUCT_DESC: *ABANDONED* [Reclamation District No. 17 Drainage Plant] 18-inch drainage pipe of unknown material through the levee, 5.8 feet below the crown. Gate valve and siphon breaker on the waterside (WS) slope. Flap gate on the WS end. One CM cutoff wall. Pump on the landside (LS). (18-inch pipe Installed by USACE in 1961 -- no permit found; existing 18-inch pipe removed under Permit No. 14450, 1988 - R. H. Brown, two 18-inch pipes installed) [Additional Reference(s): DWR Levee Logs, 1981, 2003. USACE San Joaquin O&M Manual Unit No. 2, May 1963, (HLM 13.36)] FS Date: 2/4/2010

View of levee crown at crossing.

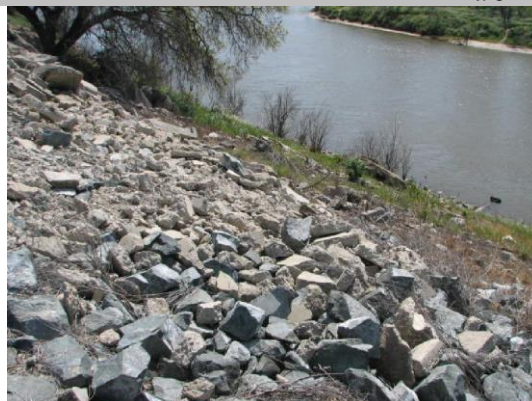
Photo 2 of 3 : UCIP_SP_2021_40715_72551.jpg

View of waterward side, photo 1 of 2.

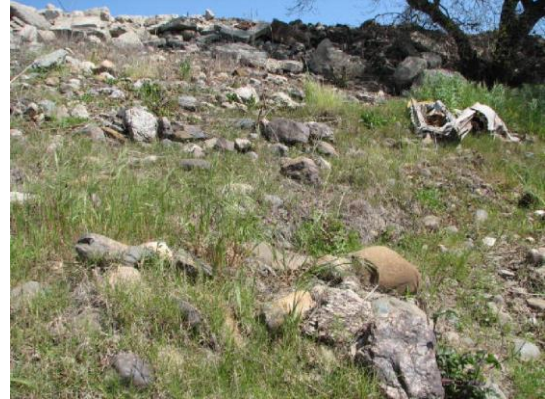
Photo 3 of 3 : UCIP_SP_2021_40715_72549.jpg

View of waterward side, photo 2 of 2.
