**Flood Control Project Maintenance
Levee Inspections**

Maintenance Issue Types Only, Levee Inspection Report By Mile - Spring 2022

Reclamation District No. 0017 Mossdale

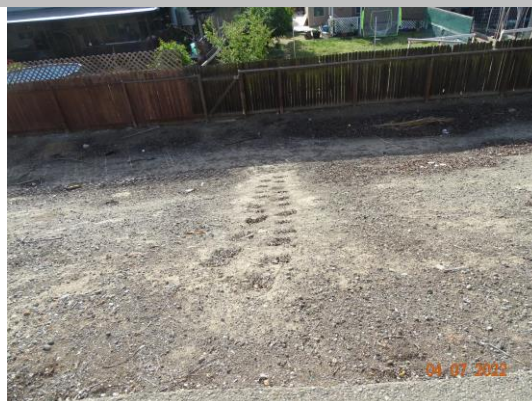
Photo 1 of 1 : SP_2022_RD0017_304_56_20220412_00168.jpg

LM Start	0.10	Rating **	M	Issue No.	56	
LM End	0.10	Issue Type +	Ma	Location *	LS	
Category	Earthen Levee			GPS Latitude/Longitude		
				Start		End
Item	Erosion / Foot Traffic			37.914790 °		37.914790 °
				-121.321926 °		-121.321926 °
DWR ID	DWR_RD0017_02_s_2022_56					
Comment Code						
E3 : Repair the levee slope damaged by foot traffic and prevent access where possible.						
Inspector Comment

View of steps cut into the landside slope. Spring 2022

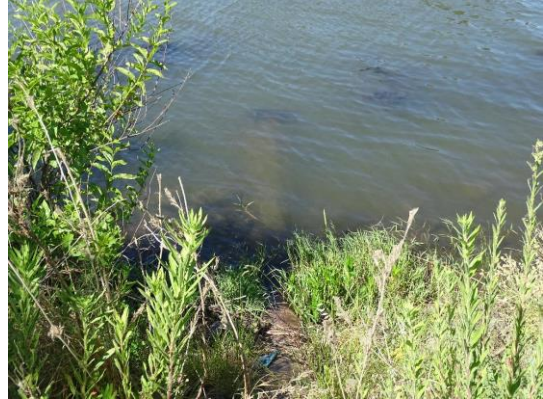
Photo 2 of 3 : UCIP_SP_2022_67818_100052.jpg

Water-Side: view of pipe in water at toe.

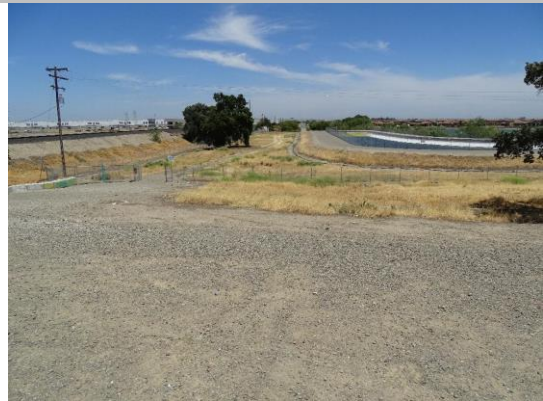
Photo 3 of 3 : UCIP_SP_2022_67818_100031.jpg

Land-Side: view of slope.
